517 - 525 FANSHAWE PARK ROAD EAST
LONDON, ONTARIO
TREE ASSESSMENT REPORT
FOR REZONING APPLICATION

PREPARED BY: RON KOUDYS LANDSCAPE
ARCHITECTS INC

DATE: AUGUST 2021

RKLA PROJECT #: 21-115

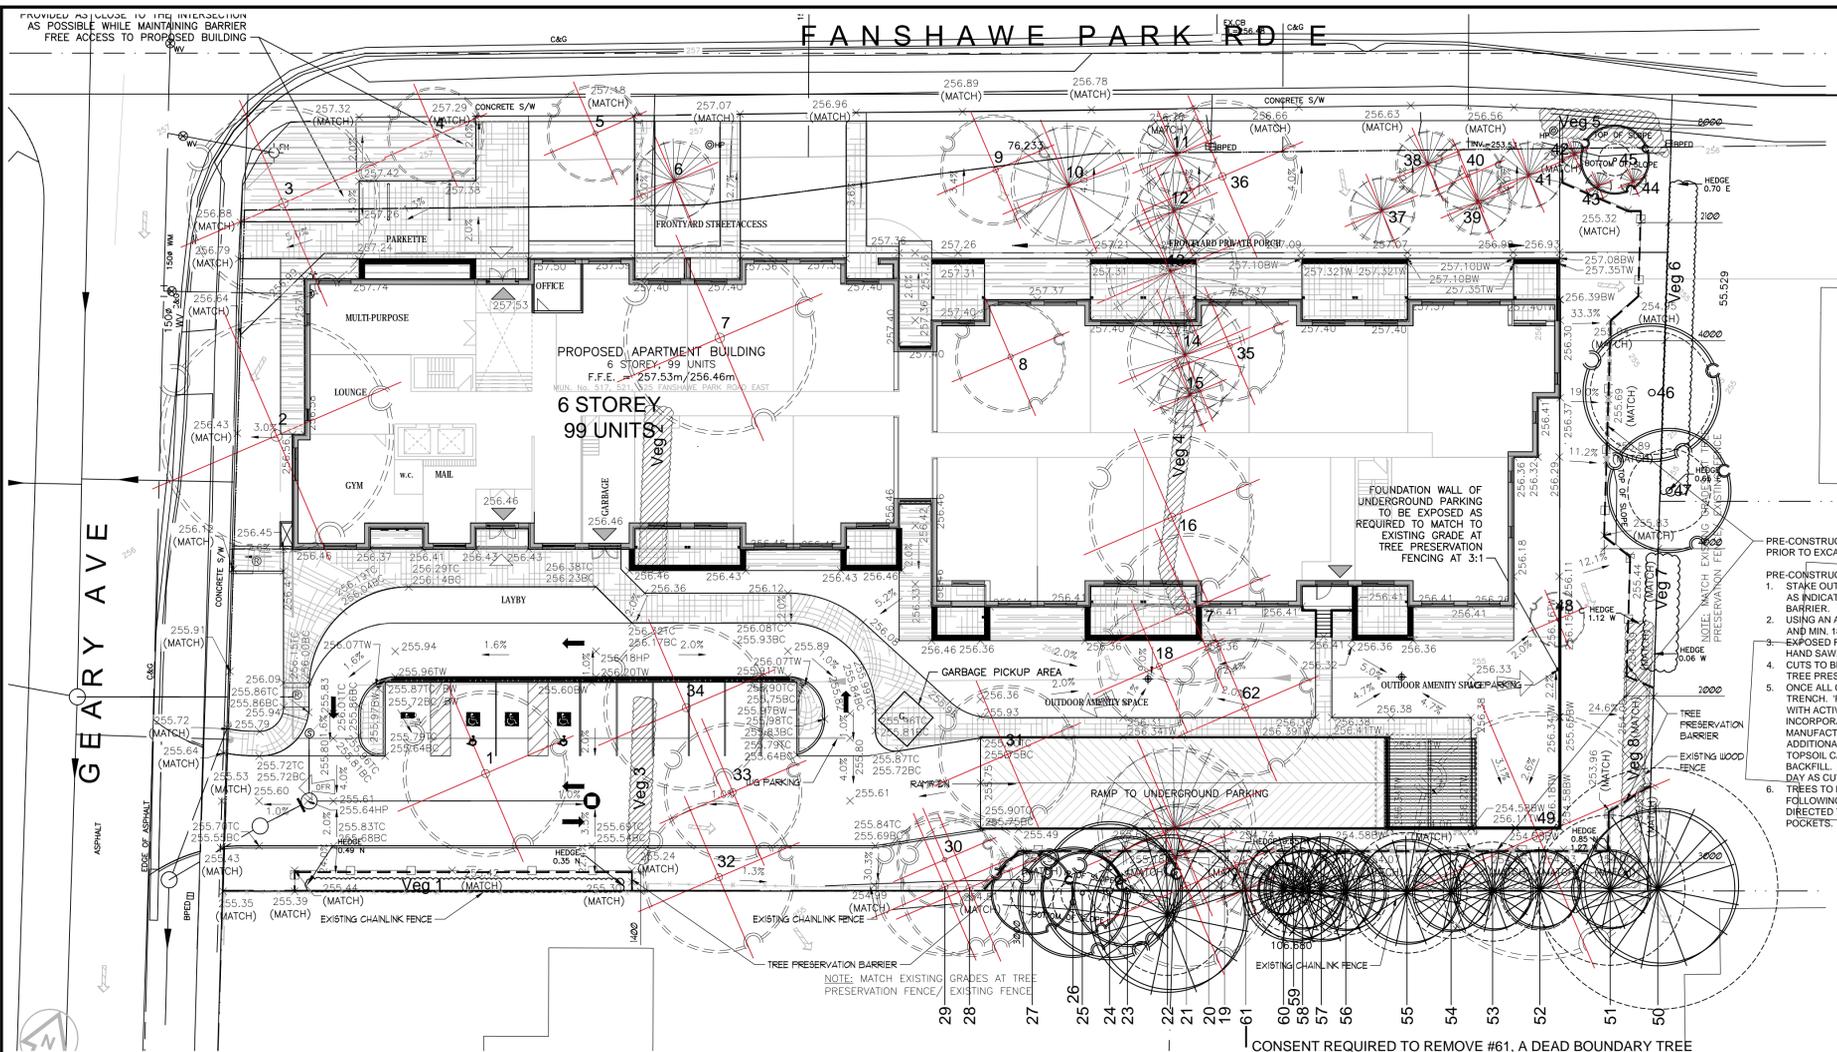
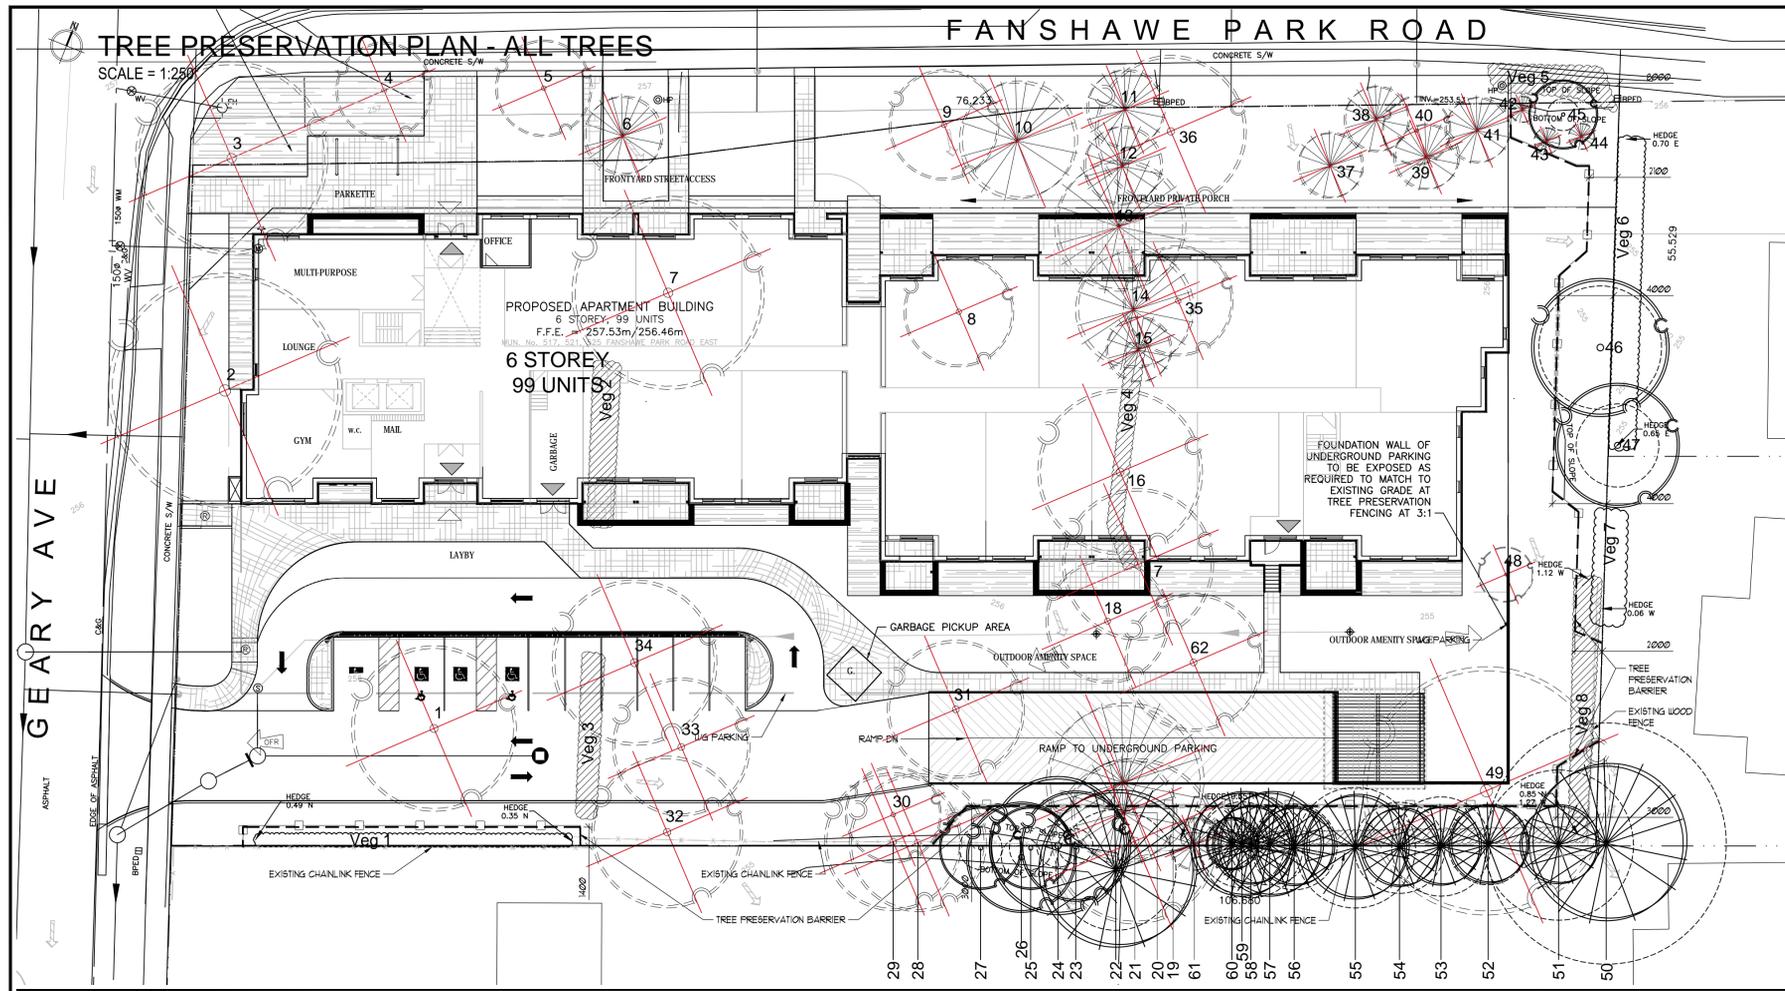
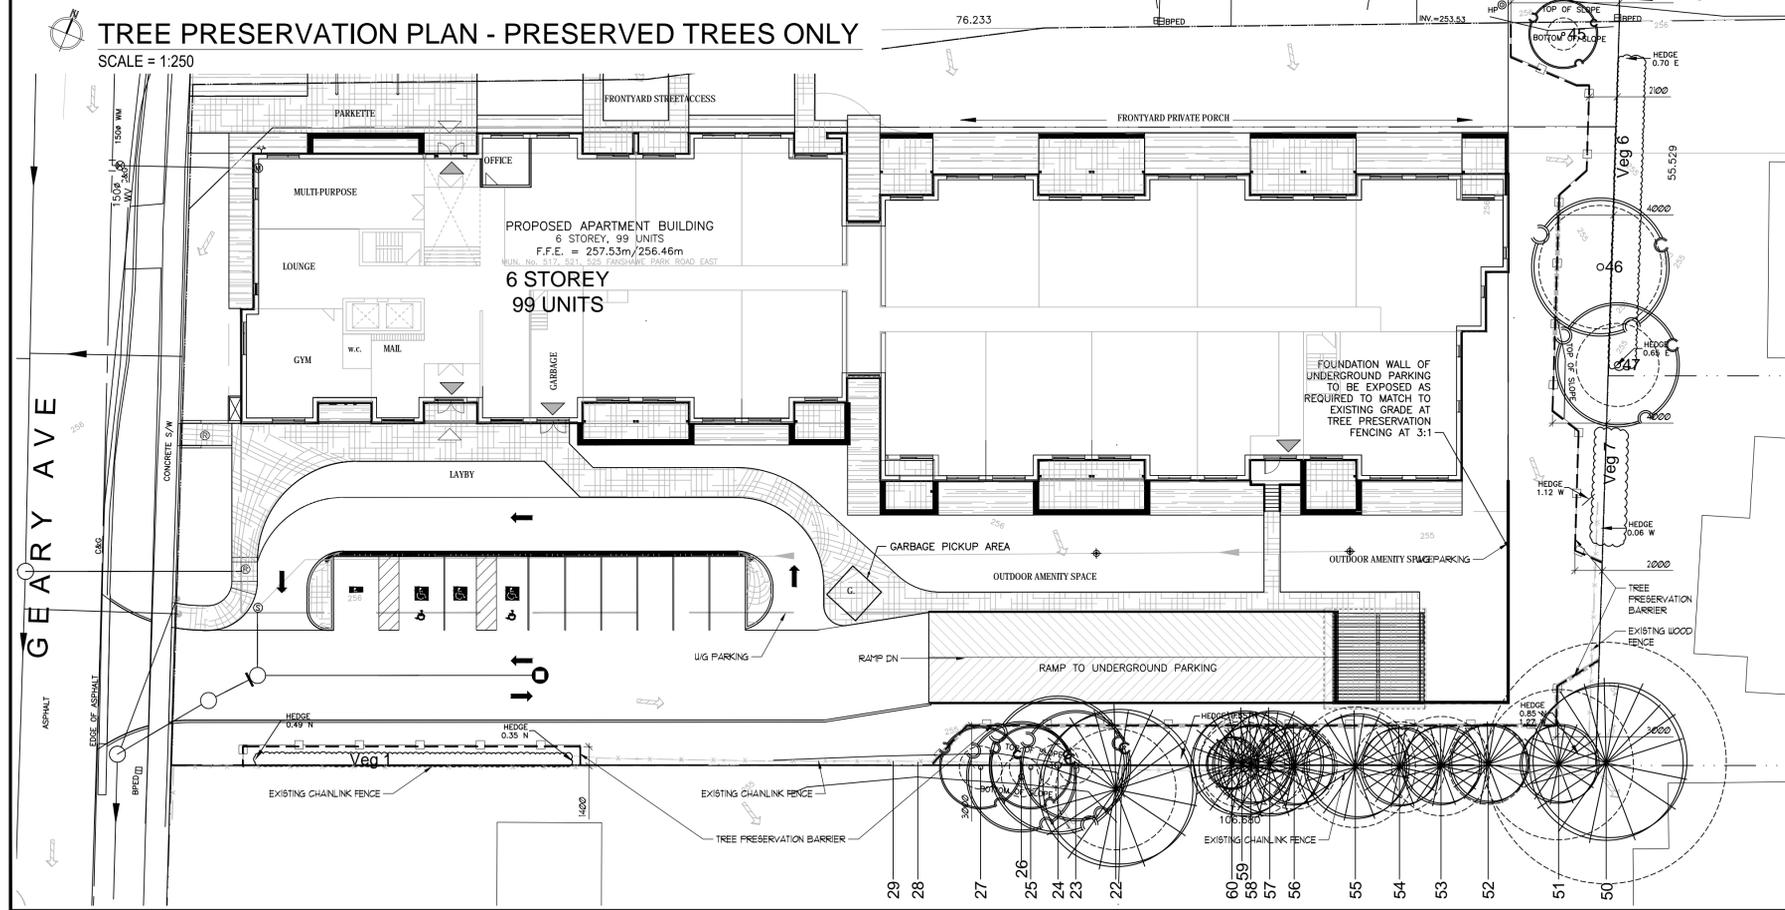
TREE PRESERVATION PLAN
SCALE = 1:250

TREES & VEGETATION UNITS RECOMMENDED FOR REMOVAL - TREES (42), VEGETATION UNITS (5)

6	White Spruce	City ROW	29	3	4	good	good	Limbed up 2m, a bit scraggly	direct conflict with proposed site plan	remove	developer to apply for consensual removal from City via trees@london.ca
7	Norway Maple	subject site	37	7	4	good	fair	Wide flare, elevated at base, minor trunk wounds, scaffold branch cracking	direct conflict with proposed site plan	remove	none
8	Magnolia	subject site	31, 21, 8, 18	4	5	fair	good	Multistem 4, unbalanced crown, low crown epicormic growth, loose branches	direct conflict with proposed site plan	remove	none
9	Alder Maple	subject site	<20	4	4	poor	poor	Multistem 12, stems emerging from ground base of original (now dead) tree stump, significant rot	poor condition	remove	none
10	Norway Spruce	subject site	46	45	5	good	good	Limbed up 2.5m	conflict with required grading	remove	none
11	Scotch Pine	subject site	31	3	3	fair	good	Limbed up 4m	conflict with required grading	remove	none

12	Scotch Pine	subject site	30	3	3	fair	fair	Diminished leader, dead wood, ording root, limbed up 4m	conflict with required grading	remove	none
13	Scotch Pine	subject site	50	5	5	good	good	Limbed up 4m	direct conflict with proposed site plan	remove	none
14	Alder Maple	subject site	<20	45	4	poor	poor	Multistem 5, stems emerging from ground base of original (now dead) tree stump, significant rot, gnarly base	direct conflict with proposed site plan & poor condition	remove	none
15	Eastern Red Cedar	subject site	30	25	5	good	good	Limbed up 5m, columnar leaders	direct conflict with proposed site plan	remove	none
16	Norway Maple	subject site	32, 12	6	5	good	good	Multistem 2, on slope within coniferous hedge	direct conflict with proposed site plan	remove	none
17	Norway Maple	subject site	35, 23, 16, 11, 6	5	5	fair	good	Multistem 5, primary union below grade, on slope, scraggly form	direct conflict with proposed site plan	remove	none

ID#	COMMON NAME	LOCATION	DBH (cm)	SIZE (CAMPY RADIUS (m))	HEALTH & CONDITION	COMMENTS	EXPECTED CONSTRUCTION IMPACT (CRZ = critical root zone)	RECOMMENDATIONS	NOTES		
30	Unknown Fruit	subject site	6, 9, 9, 8	35	5	good	good	Multistem 4	significant root damage	remove	none
31	Norway Maple	subject site	50	5	4	fair	fair	Heavily pruned, thin crown, creaking branches, dead wood	direct conflict with proposed site plan	remove	none
32	Norway Maple	subject site	40	55	5	good	good	Minor bark cracking	significant root damage	remove	none
33	Apple	subject site	37	5	5	good	good	Minor dead wood and epicormic growth	direct conflict with proposed site plan	remove	none
34	Apple	subject site	38, 22, 9	6	4	fair	fair	Multistem 1, dead wood, scraggly form, half of root system under flagstone patio	direct conflict with proposed site plan	remove	none
35	Royal Red Norway Maple	subject site	33	4	5	good	good	Slight lean NE	direct conflict with proposed site plan	remove	none

36	Royal Red Norway Maple	subject site	47	55	5	good	good	Minor salt damage, lesions on trunk - may need to confirm canopy health after but break	conflict with removal of adjacent ex. driveway and necessary grading	remove	none
37	Colorado Blue Spruce	subject site	25	25	5	good	good	Full form, branched to grade	conflict with required grading	remove	none
38	Colorado Blue Spruce	subject site	25	25	5	good	good	Full form, branched to grade	conflict with required grading	remove	none
39	Colorado Blue Spruce	subject site	25	25	5	good	good	Full form but a bit thin, branched to grade	conflict with required grading	remove	none
40	Royal Red Norway Maple	subject site	18	25	5	good	good	Suppressed, heavy S	conflict with required grading	remove	none
41	Colorado Blue Spruce	subject site	25	25	5	good	good	Full form, branched to grade	conflict with required grading	remove	none
42	Columnar Blue Spruce	subject site	19	1	5	good	good	Limbed up 1m	Not suitable for the landscape, opens up space for full development of tree #45	remove	none

43	Columnar Blue Spruce	subject site	19	1	5	good	good	Limbed up 1m	Not suitable for the landscape, opens up space for full development of tree #45	remove	none
44	Columnar Blue Spruce	subject site	11	1	5	good	good	Limbed up 1m	Not suitable for the landscape, opens up space for full development of tree #45	remove	none
45	Honeylocust	subject site	10	2	2	good	good	Mostly dead	direct conflict with proposed site plan	remove	none
46	Silver Maple	subject site	95	9	5	poor	at	Minor dead wood, full form, excellent condition for a mature Silver Maple	direct conflict with proposed site plan	remove	none
47	White Spruce	BOUNDARY subject site & 831 Stonebrook Cres	20	2	1	good	good	dead	dead tree	remove	CONSENT REQUIRED
48	Apple	subject site	25	25	2	poor	poor	Significant vertical trunk wound with rot, dead limbs, heavily pruned	direct conflict with proposed site plan	remove	none

TREES RECOMMENDED FOR REMOVAL WITHIN THE CITY ROW REQUIRE APPLICATION TO THE CITY FOR CONSENSUAL REMOVAL. TO BE EXECUTED AT THE TIME OF APPLICATION FOR SPA. THIS APPLIES TO THE FOLLOWING: TREE # 3, 4, 5 & 6 AND VEG UNIT # 5

PRE-CONSTRUCTION ROOT PRUNING REQUIRED PRIOR TO EXCAVATION OR GRADING ACTIVITIES.

1. STAKE OUT THE LINE OF TREE PRESERVATION - AS INDICATED BY THE TREE PRESERVATION BARRIER.
2. USING AN AIR SPADE, CUT A TRENCH 6" - 10" WIDE AND MIN. 18" DEEP.
3. EXPOSED ROOTS TO BE CLEANLY CUT WITH A HAND SAW, CHAIN SAW, OR BYPASS PRUNERS. CUTS TO BE MADE 3" TO 6" INSIDE THE PROPOSED TREE PRESERVATION BARRIER LOCATION.
4. ONCE ALL CUTS ARE MADE, REPLACE SOIL IN THE TRENCH. "ROOT RESCUE" OR A SIMILAR PRODUCT WITH ACTIVE MYCORRHIZAL FUNGI TO BE INCORPORATED INTO BACKFILL AS PER MANUFACTURER SPECIFICATIONS. IF ADDITIONAL SOIL IS REQUIRED, 2WAY MIX TOPSOIL CAN ALSO BE INCORPORATED INTO THE BACKFILL. BACKFILLING TO OCCUR WITHIN SAME DAY AS CUTS ARE MADE.
5. TREES TO BE WATERED WITHIN ONE DAY FOLLOWING ROOT PRUNING - WITH WATER DIRECTED TO THE TRENCH TO SETTLE LARGE AIR POCKETS.
