**Legacy Village Strategic
Conservation Plan – 850
Highbury Avenue North,
London ON**

November 16, 2022

File: 160940807

LEGACY VILLAGE STRATEGIC CONSERVATION PLAN – 850 Highbury Avenue North, London ON

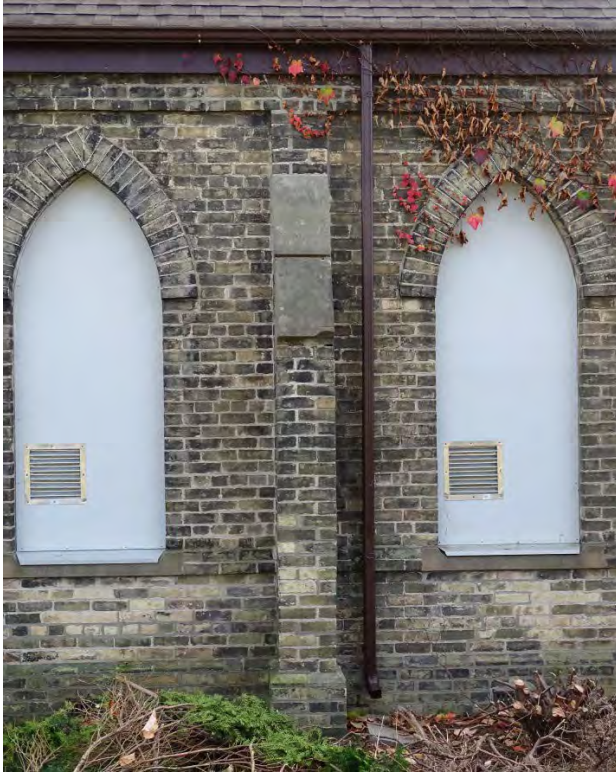
Figure No. 16: North Elevation – Main Roof RWL (Photo No. 13.1)

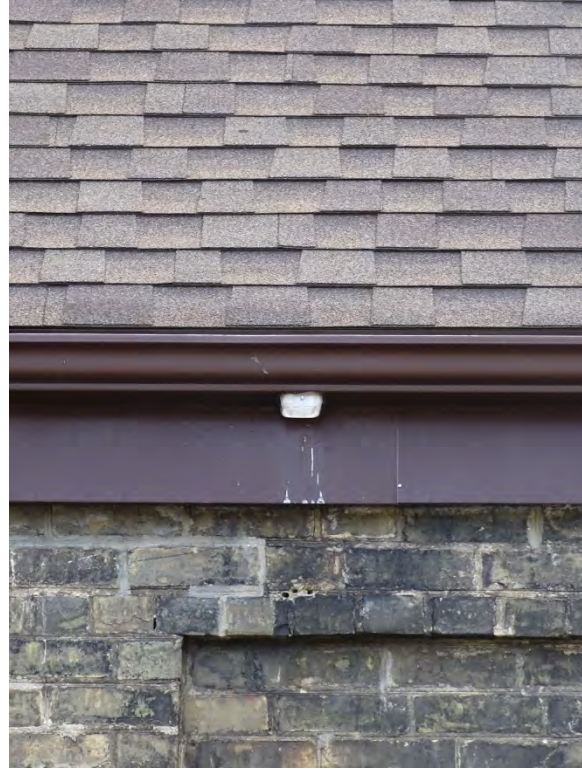
The rainwater disposal system, inclusive of gutter and rain water leader, is intact on the south side of the West Entrance but does not extend to grade. The rain water leader on the north side is missing.

Figure No. 17: North Elevation – Main Roof Gutter and Missing RWL (Photo No. 13.0)

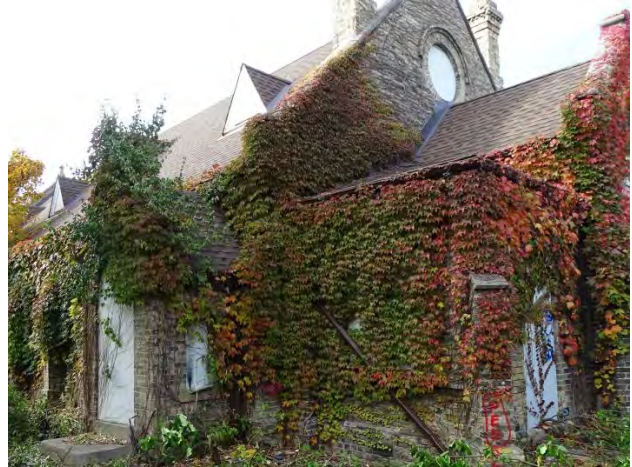
Figure No. 21: South Elevation – South Entrance Wing Gutter and Broken RWL (Photo No. 15.4)

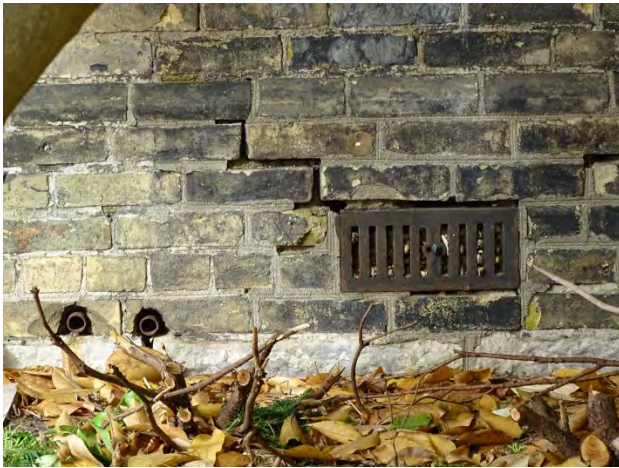
Figure No. 34: South Elevation – Nave – Crack in Brick Wall (Photo No. 22.6)

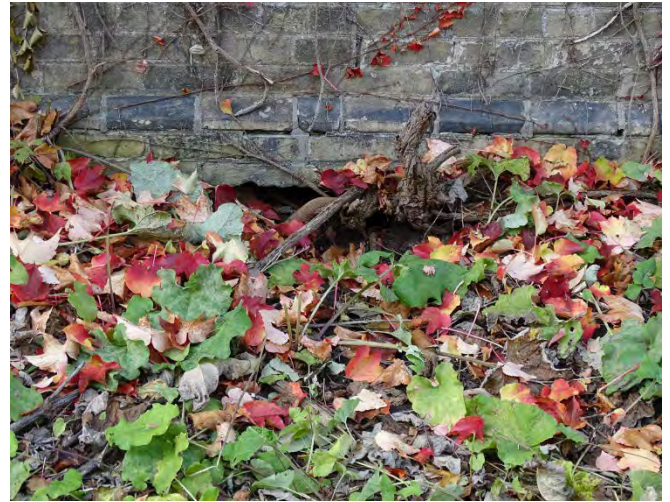
Figure No. 53: East Elevation – Sanctuary Missing Foundation Detail (Photo No. 29.1)

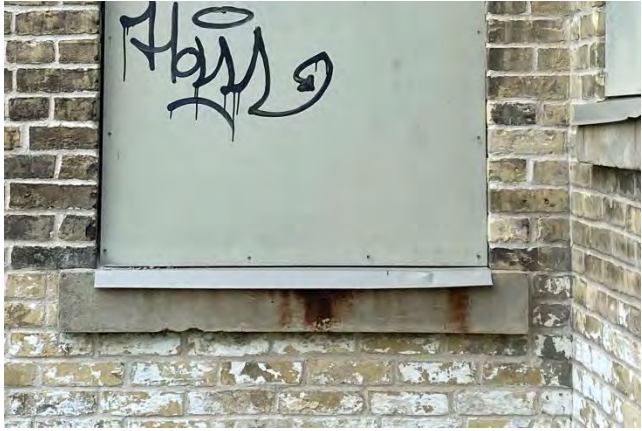
Figure No. 115: Stained Stone Sill (Photo No. 24.11)

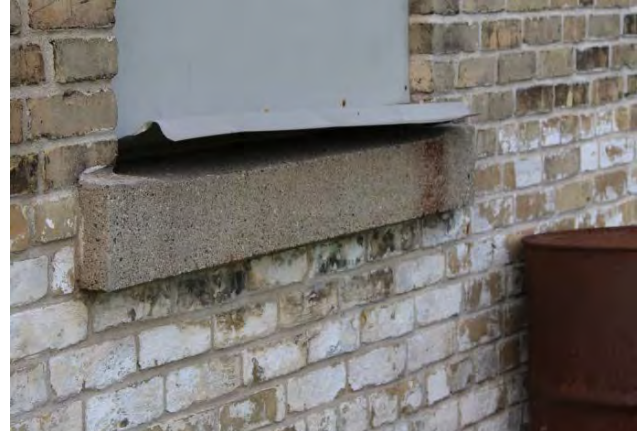
Figure No. 116: Damaged Sill Protection (Photo No. 24.12)

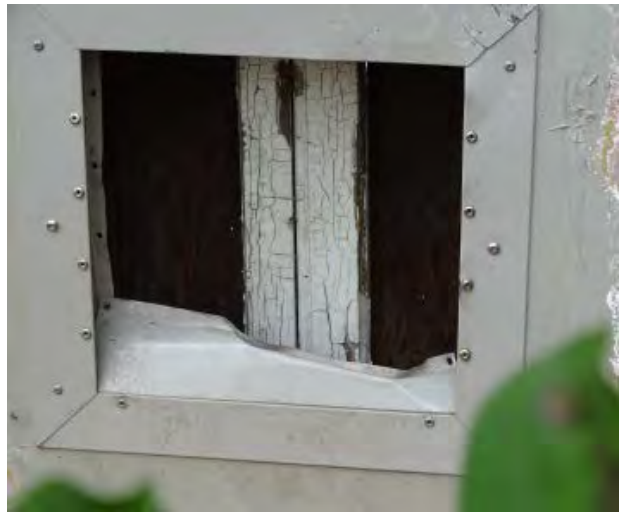
Figure No. 259: Missing Vent (Photo No. 106.33)

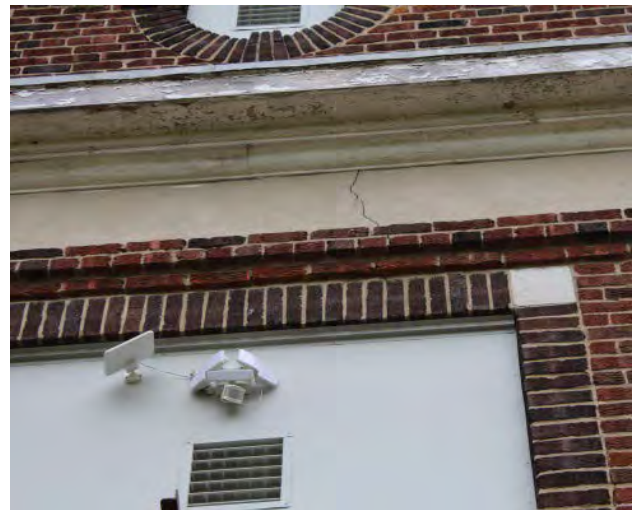
Figure No. 290: North Elevation Frontispiece Crack Detail (Photo No. 9.1)

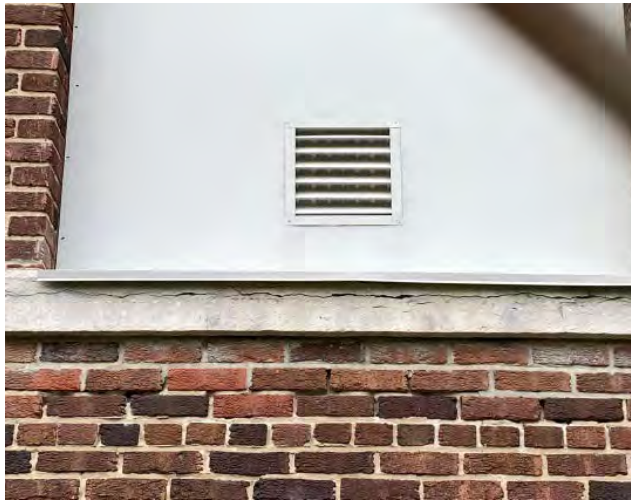
Figure No. 319: East Elevation Cracked Sill (Photo No. 19.5)

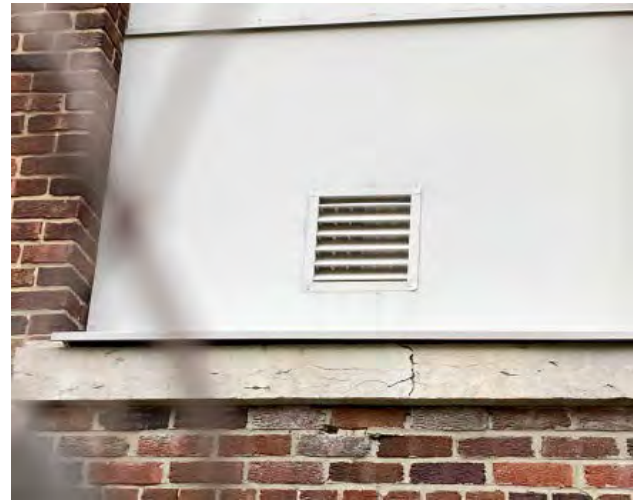
Figure No. 320: East Elevation Cracked Sill (Photo No. 19.6)

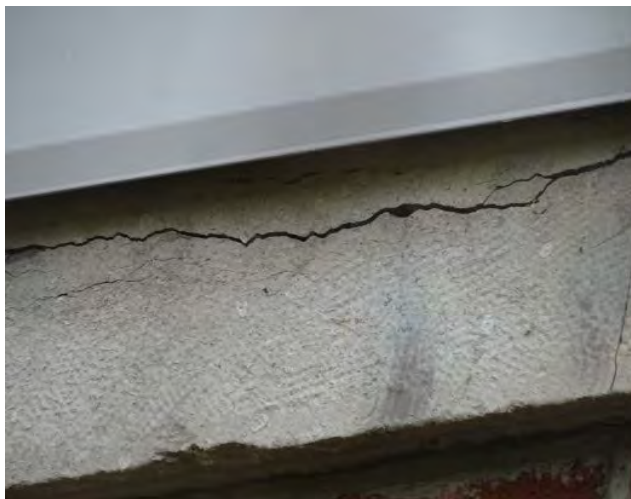
Figure No. 321: East Elevation Cracked Sill Detail (Photo No. 19.8)

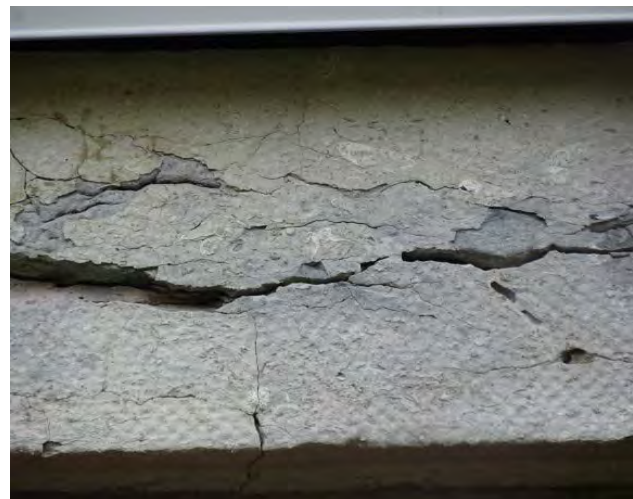
Figure No. 322: East Elevation Cracked Sill Detail (Photo No. 19.9)

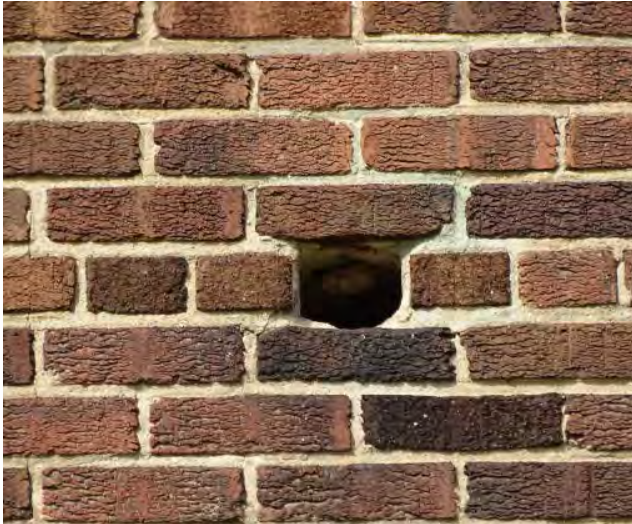
Figure No. 323: South Gable Penetration in Masonry (Photo No. 20.2)

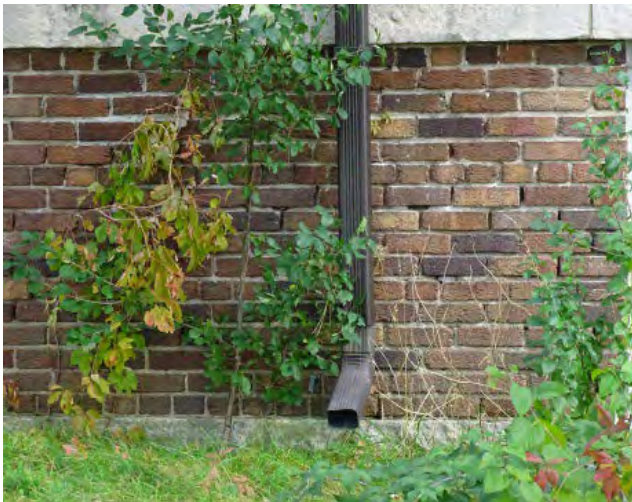
Figure No. 325: West Elevation (Centre) Missing Mortar (Photo No. 21.1)

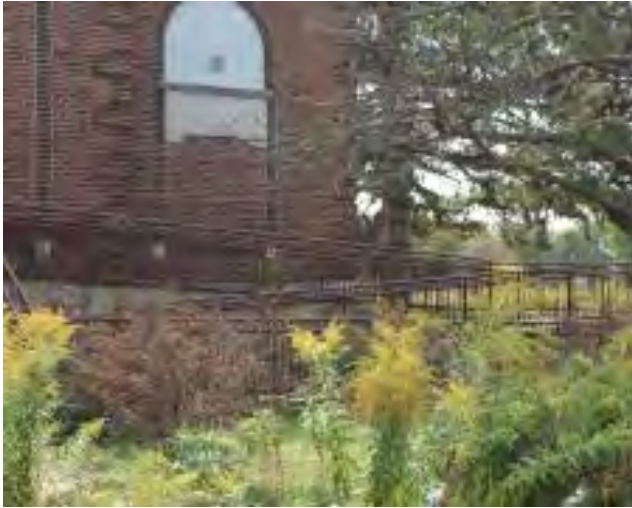
Figure No. 346: North Elevation, Ramp (Photo No. 28.0)

The front concrete entrance stairs and ramp were stained and had areas of vegetative growth. The retaining walls around the ramp had graffiti. The round metal handrails, posts and anchorage generally appeared intact though chipping and peeling paint was noted.

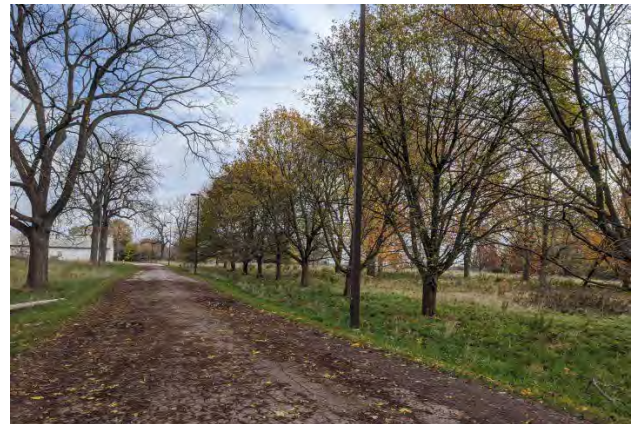
Figure No. 356: View to east along Section 3, failed asphalt paving, grass roadside shoulders and ditches (Photo No. 2.2)

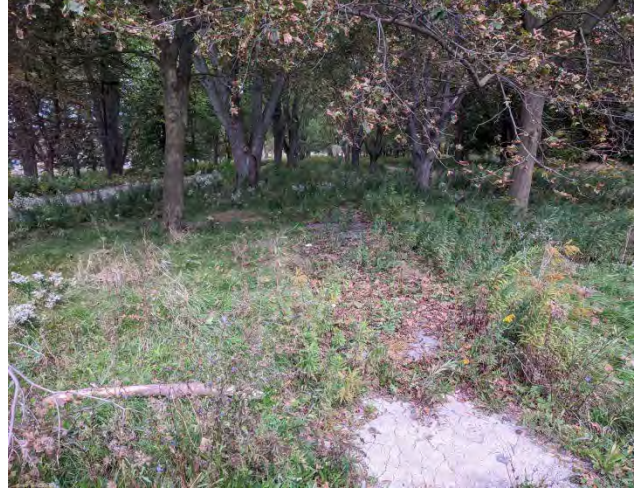
Figure No. 374: View to north of central concrete walkway, poor condition (Photo No. 7.3)

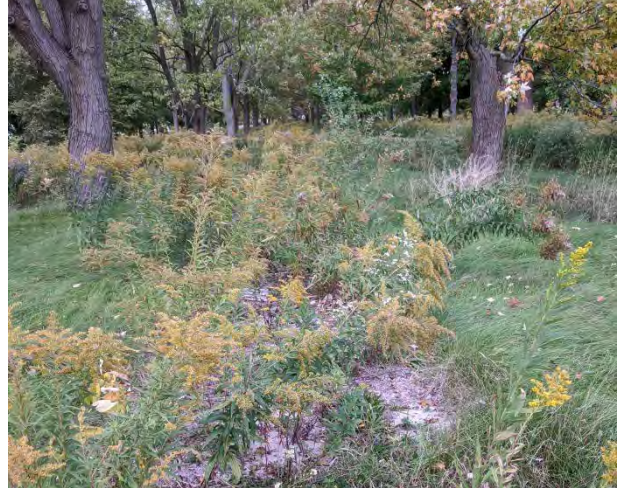
Figure No. 380: View to north along centre concrete walkway in poor condition (Photo No. 8.1)
