# **257 - 263 SPRINGBANK DRIVE LONDON, ONTARIO TREE ASSESSMENT REPORT FOR SITE PLAN APPROVAL**

**PREPARED BY:           RON KOUDYS LANDSCAPE  
  ARCHITECTS INC**

**DATE:                        JULY, 2022**

**RKLA PROJECT #:       19-271**

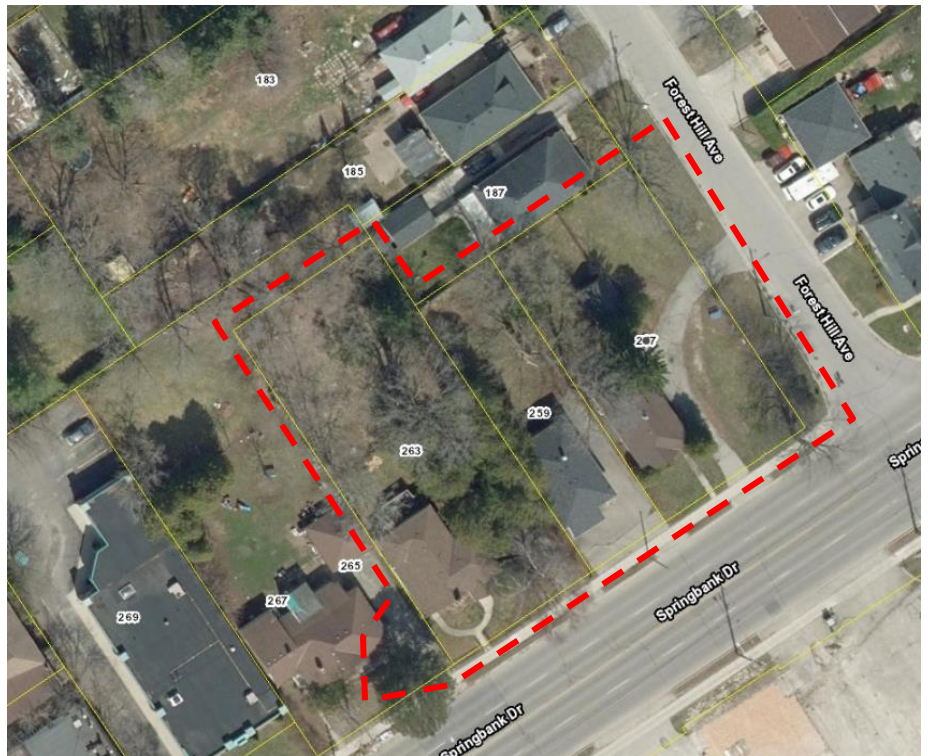
Figure 1 - Image capture from City of London online mapping with 2021 aerial image. Scope of tree inventory noted by red dashed line.

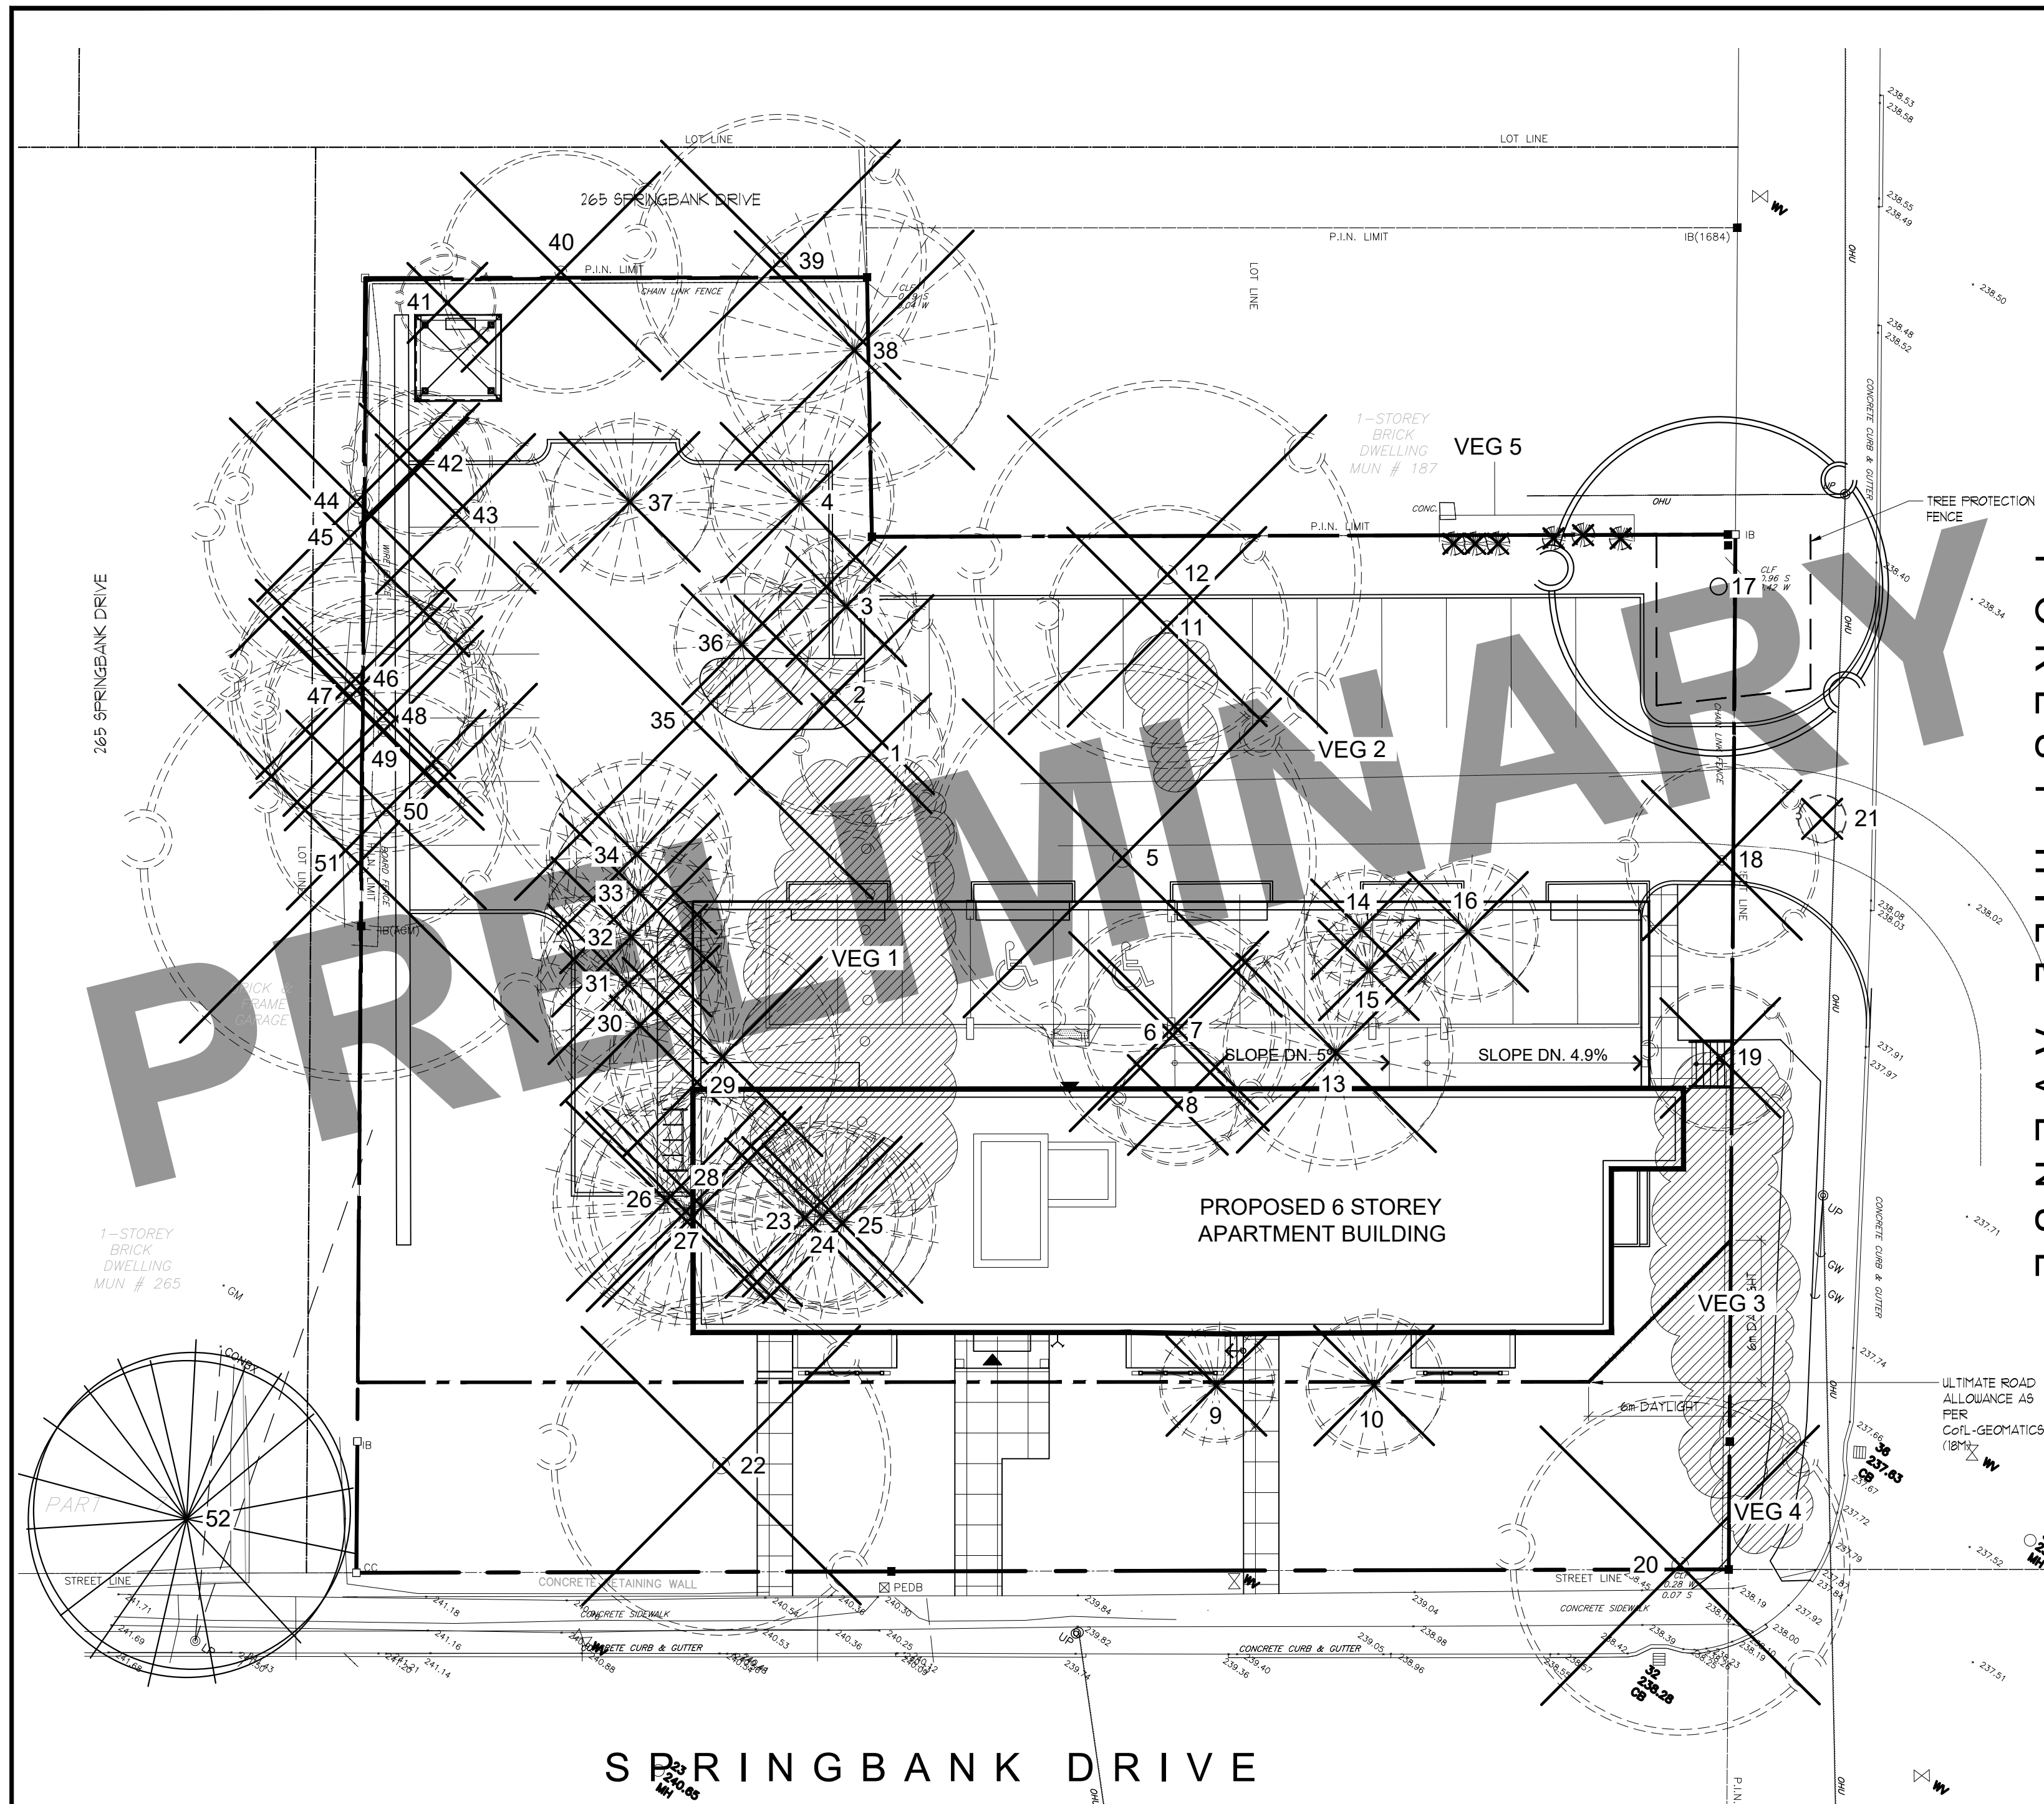
### TREE PRESERVATION PLAN

### TREES AND VEG UNITS RECOMMENDED FOR REMOVAL

TREES (50), VEGETATION UNITS (4)

- PRE-CONSTRUCTION RECOMMENDATIONS
- PRIOR TO ANY CONSTRUCTION ACTIVITY, TREE PRESERVATION FENCING IS TO BE INSTALLED AS PER THE ATTACHED TREE PRESERVATION DRAWINGS AND DETAIL.

- WHERE HIGH QUALITY SPECIMENS ARE TO BE PRESERVED ADJACENT TO AREAS SUBJECT TO INTENSIVE CONSTRUCTION ACTIVITIES, THESE TREES ARE TO HAVE ADDITIONAL PROTECTION MEASURES IMPLEMENTED TO PROTECT THEIR TRUNKS FROM MECHANICAL DAMAGE. THESE MEASURES MAY INCLUDE SURROUNDING THE TRUNK WITH WOOD FLANKS. TREES THAT REQUIRE ADDITIONAL PROTECTION WILL BE CLEARLY IDENTIFIED ON THE TREE PRESERVATION PLAN WITH DETAILED INFORMATION ON SPECIFIC PROTECTION MEASURES.
