# **TREE PRESERVATION REPORT FOR ZONING BY-LAW AMENDMENT**

**2118 RICHMOND STREET,  
LONDON, ONTARIO**

Report prepared by  
Ron Koudys Landscape Architects Inc

RKLA Project #17-258

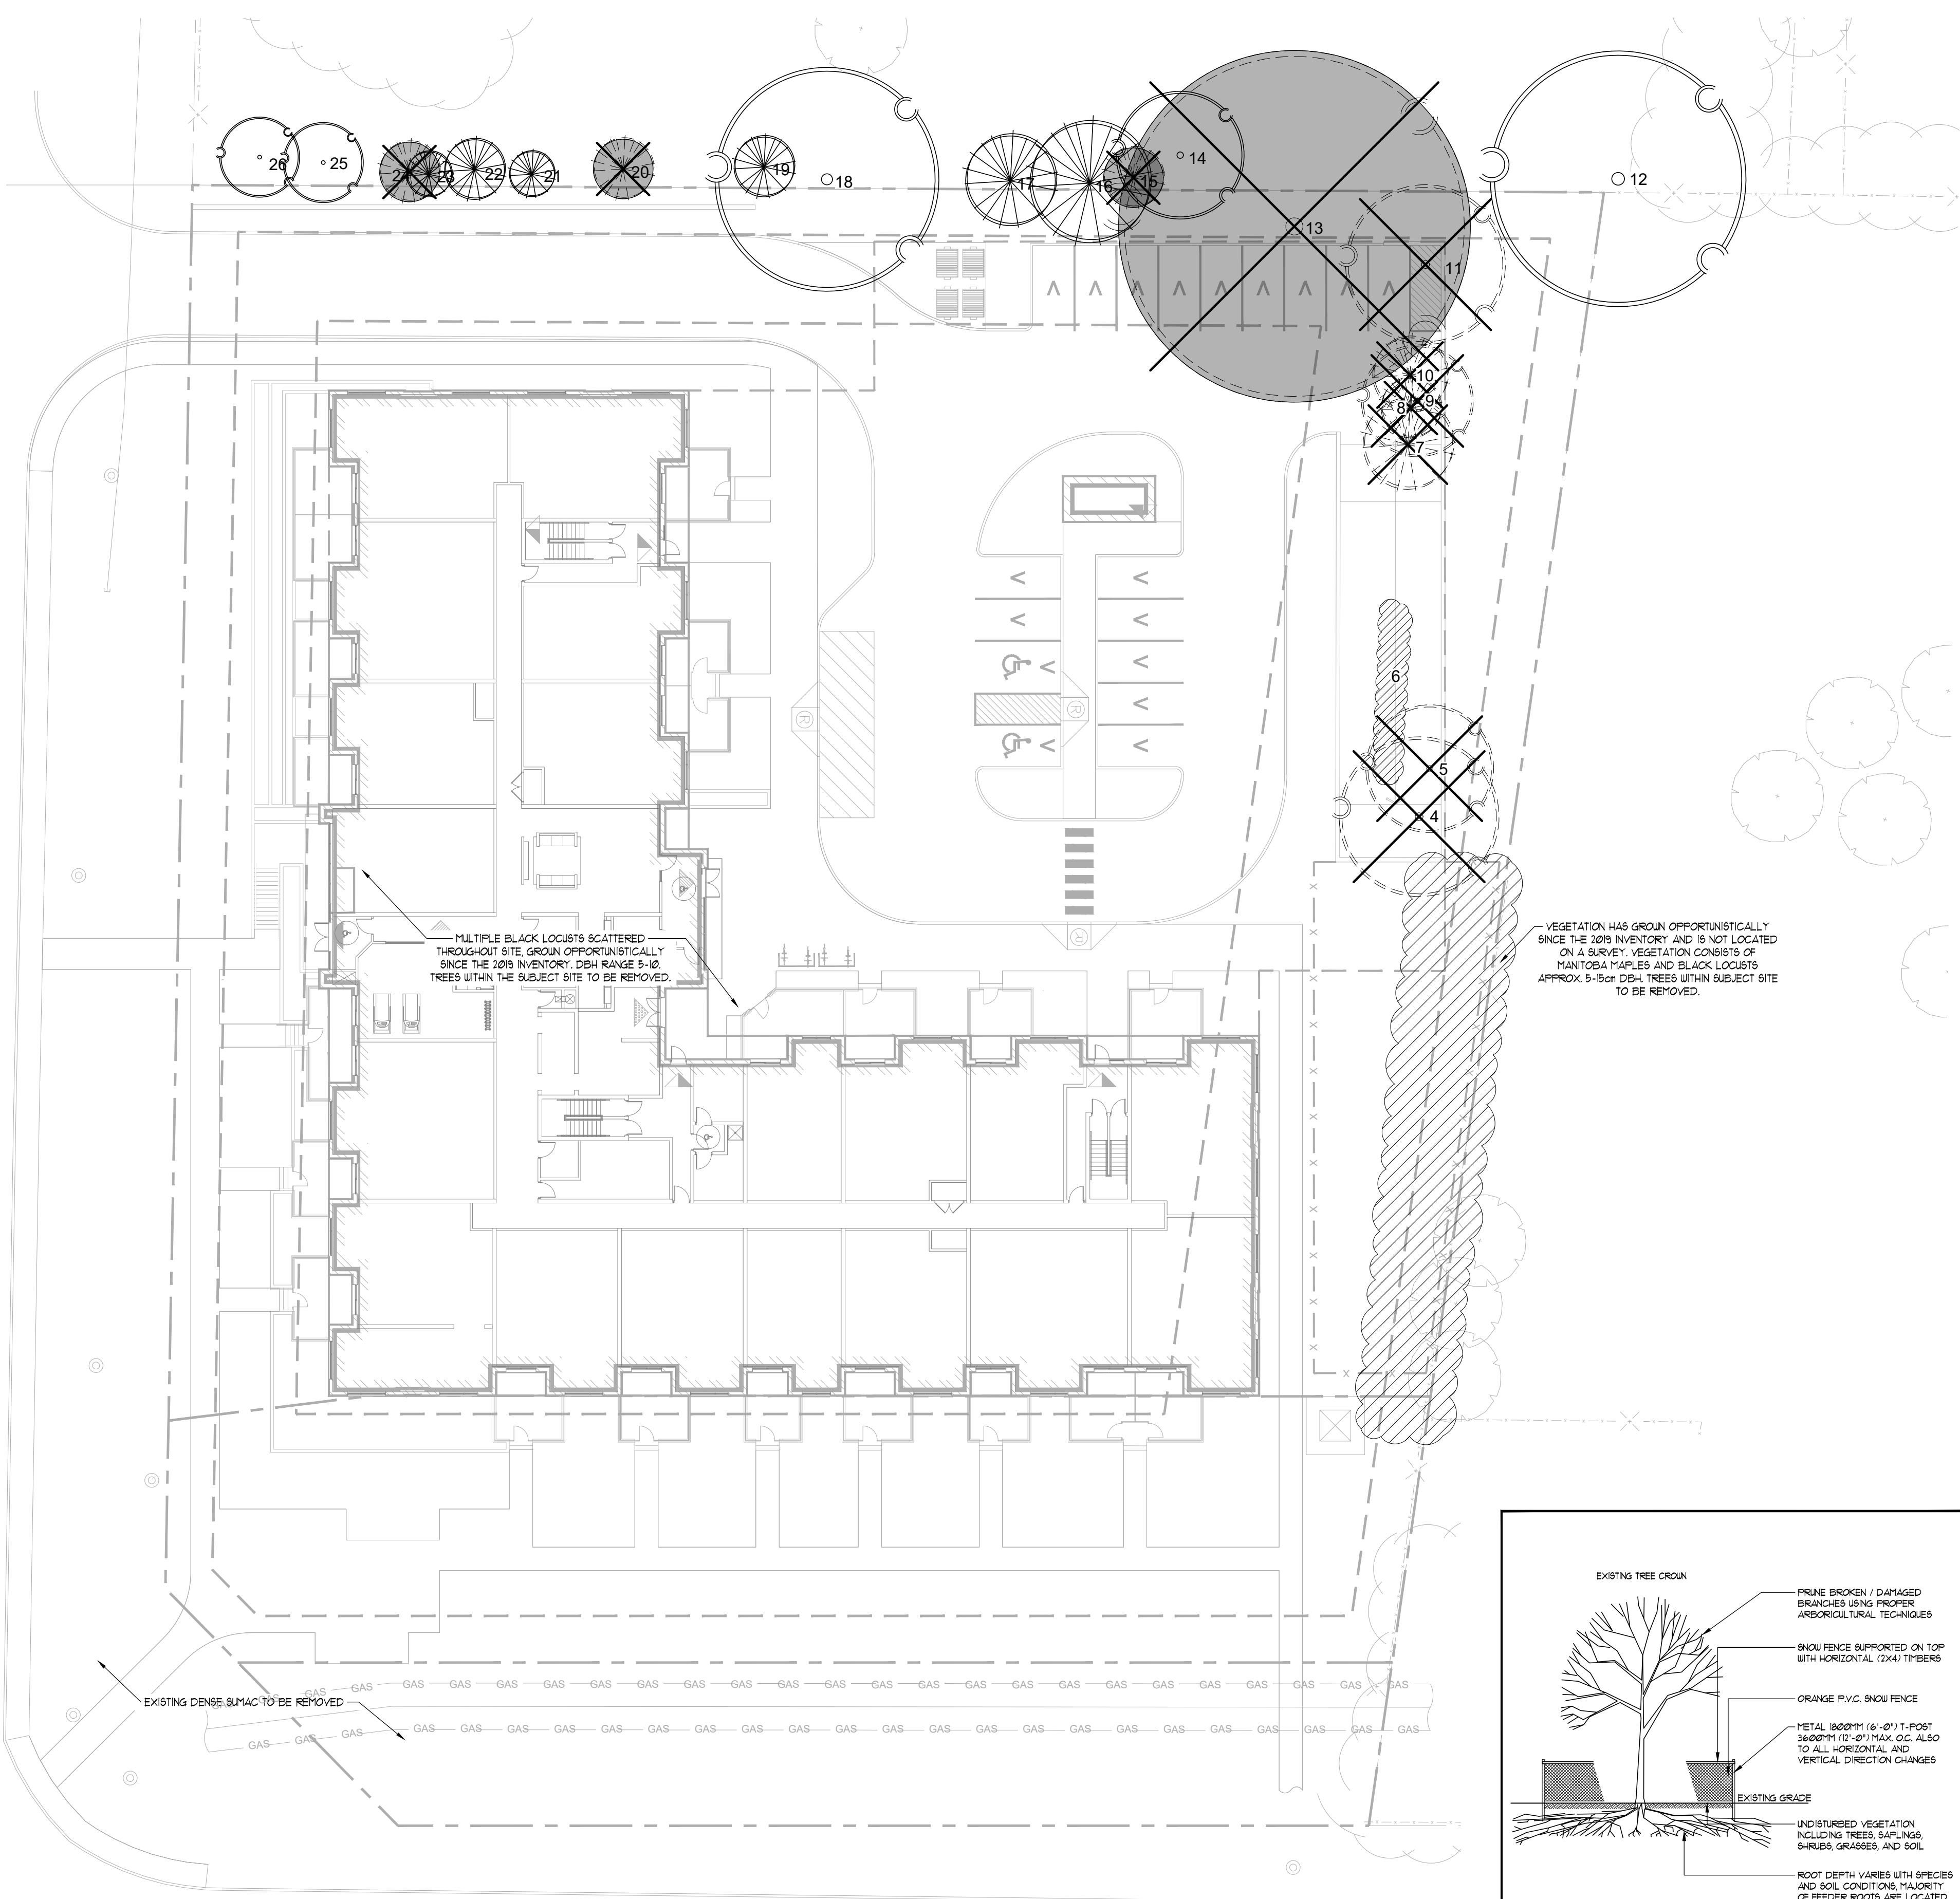
**TREE PRESERVATION PLAN**  
SCALE = 1:250

GENERAL INFORMATION		SIZE	HEALTH		RECOMMENDATION				
ID #	BOTANICAL NAME COMMON NAME	DBH (cm) --approx.	CANOPY RADIUS (m)	CROWN CONDITION 1-DEAD 5-HEALTHY	STRUCTURAL CONDITION	COMMENTS	PROPOSED ACTION	RATIONALE	REQUIREMENT FOR CONSENT
12	<i>Aplans nigra</i> Black Walnut	40	8	4	good	Tree not included in topo survey, exact location to be confirmed prior to any tree work. Assumed beyond the subject site. fence wire wrapped around trunk at 1.2m from grade - no damage yet, minor epicormic growth, canopy heavy	preserve	beyond subject site	n/a
14	<i>Aplans nigra</i> Black Walnut	45	4	4	fair	Beyond subject site. Significant epicormic growth, uneven canopy, susceptible to mid crown	preserve	beyond subject site	n/a
16	<i>Juniperus virginiana</i> Eastern Red Cedar	40	4	3	good	Beyond subject site. grapevine through 50% of canopy	preserve	beyond subject site	n/a
17	<i>Juniperus virginiana</i> Eastern Red Cedar	30	3	3	fair	Beyond subject site. dead branches, particularly on the south side, dead leader, lean north	preserve	beyond subject site	n/a

18	<i>Aplans nigra</i> Black Walnut	34	7	4	fair	Beyond subject site. canopy is entirely to the north of the trunk, only epicormic growth on the south side, soil has been piled around trunk	potential removal - review at the time of SPA	beyond subject site	n/a
19	<i>Picea sp.</i> Spruce	30	2	1	dead	Beyond subject site. completely dead	potential removal - review at the time of SPA	beyond subject site	n/a
21	<i>Picea glauca</i> White Spruce	8	15	3	poor	Beyond subject site. only top 8th of canopy is living, dead leader, dead lower branches	preserve	beyond subject site	n/a
22	<i>Picea glauca</i> White Spruce	35	2	2	fair	Beyond subject site. only top 8th of canopy is living, dead lower branches	preserve	beyond subject site	n/a
23	<i>Juniperus virginiana</i> Eastern Red Cedar	26	15	3	fair	Beyond subject site. only top quarter of canopy is living, canopy heavy to the north	preserve	beyond subject site	n/a

25	<i>Aplans nigra</i> Black Walnut	11	2.5	5	good	Tree not included in topo survey. beyond subject site, location on T-1 is approximate only. crooked trunk	preserve	beyond subject site	n/a
26	<i>Aplans nigra</i> Black Walnut	12	2.5	5	good	Tree not included in topo survey. beyond subject site, location on T-1 is approximate only. codominant leaders	preserve	beyond subject site	n/a

GENERAL INFORMATION		SIZE	HEALTH		RECOMMENDATION				
ID #	BOTANICAL NAME COMMON NAME	DBH (cm) --approx.	CANOPY RADIUS (m)	CROWN CONDITION 1-DEAD 5-HEALTHY	STRUCTURAL CONDITION	COMMENTS	PROPOSED ACTION	RATIONALE	REQUIREMENT FOR CONSENT
4	<i>Aplans nigra</i> Black Walnut	32, 26	5	4	poor	Within subject site. Multistem 2, immediately adjacent to existing interior fence, trunk is completely girdled by fence wire at 5m from grade, included bark at primary union	remove	construction	no
5	<i>Aplans nigra</i> Black Walnut	16, 15, 9	4	5	fair	Within subject site. Multistem 3, adjacent to existing interior fence, included bark and bulge in trunk at primary union	remove	construction	no
6	<i>Thuja occidentalis</i> (hedge)	<10	15	4	good	Within subject site. Immediately adjacent to existing interior fence, hedge row of approx. 15 individual trees, three crowns on southern half of hedge	remove	construction	no
7	<i>Pinus strobus</i> White Pine	27	3	4	fair	Within subject site. Immediately adjacent to existing interior fence, bowed trunk, trunk damage - bark scrape on west side of trunk	remove	construction	no

8	<i>Pinus strobus</i> White Pine	12	2	4	fair	Within subject site. Immediately adjacent to existing interior fence, lean west, thin crown, dead lower canopy, suppressed	remove	construction	no
9	<i>Aplans nigra</i> Black Walnut	21	3.5	5	fair	Within subject site. Immediately adjacent to existing interior fence, codominant leaders, separate	remove	construction	no
10	<i>Pinus strobus</i> White Pine	8	2.5	4	fair	Within subject site. Immediately adjacent to existing interior fence, lean south, curved trunk in upper third of trunk	remove	construction	no
11	<i>Rubus sp.</i> Black Locust	18, 16, 15, 11, 9	5	4	poor	Within subject site. Multistem 5 immediately adjacent to existing interior fence, unions at grade, significant rot at base	remove	construction	no
15	<i>Aplans nigra</i> Black Walnut	65	11	4	good	Within subject site. minor epicormic growth, minor deadwood, top 2/3 of canopy unusually spaced and thinned	previously removed	n/a	n/a

16	<i>Picea sp.</i> Spruce	30	2	1	dead	Beyond subject site. completely dead	tree has fallen over	beyond subject site	n/a
20	<i>Picea sp.</i> Spruce	30	2	1	dead	Beyond subject site. completely dead	tree has fallen over	n/a	n/a
24	<i>Juniperus virginiana</i> Eastern Red Cedar	21	2	3	fair	Beyond subject site. only top quarter of canopy is living, canopy heavy to the north, bowed trunk	tree has fallen over	n/a	n/a

- a) Prior to any construction activity, tree preservation fencing is to be installed as per the attached tree preservation drawings and detail.
- b) Trees approved for removal are to be clearly indicated in the field (marked with spray paint or other agreed upon method) by the project arborist or landscape architect prior to any tree removal operations. All removals to be undertaken by an ISA certified arborist.
