TREE INVENTORY LIST

TREE INVENTORY PLAN

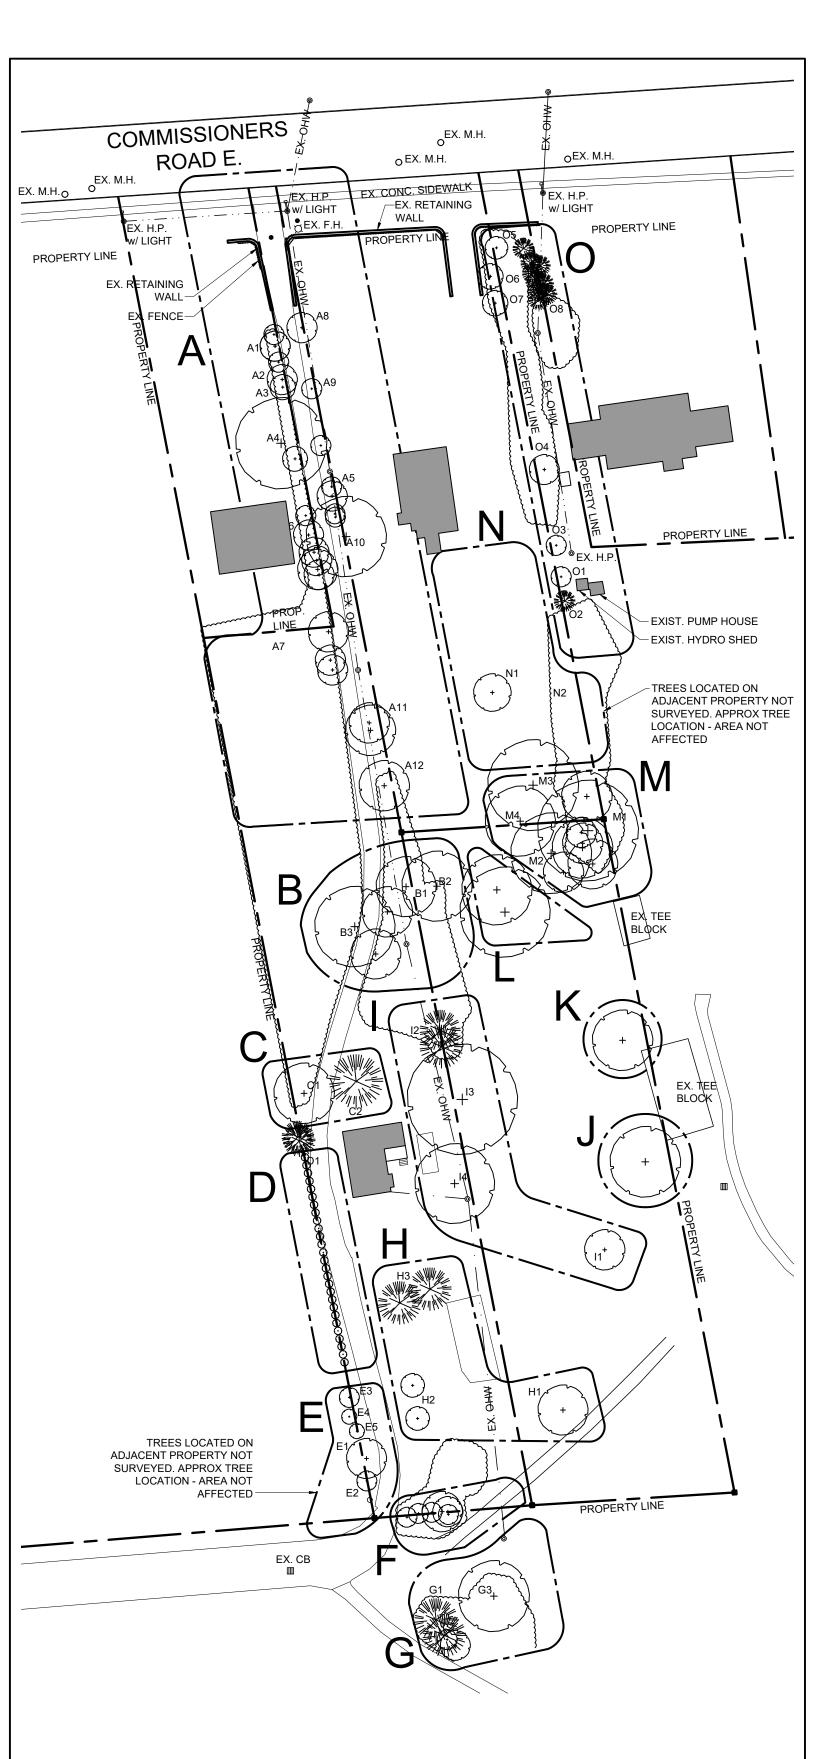
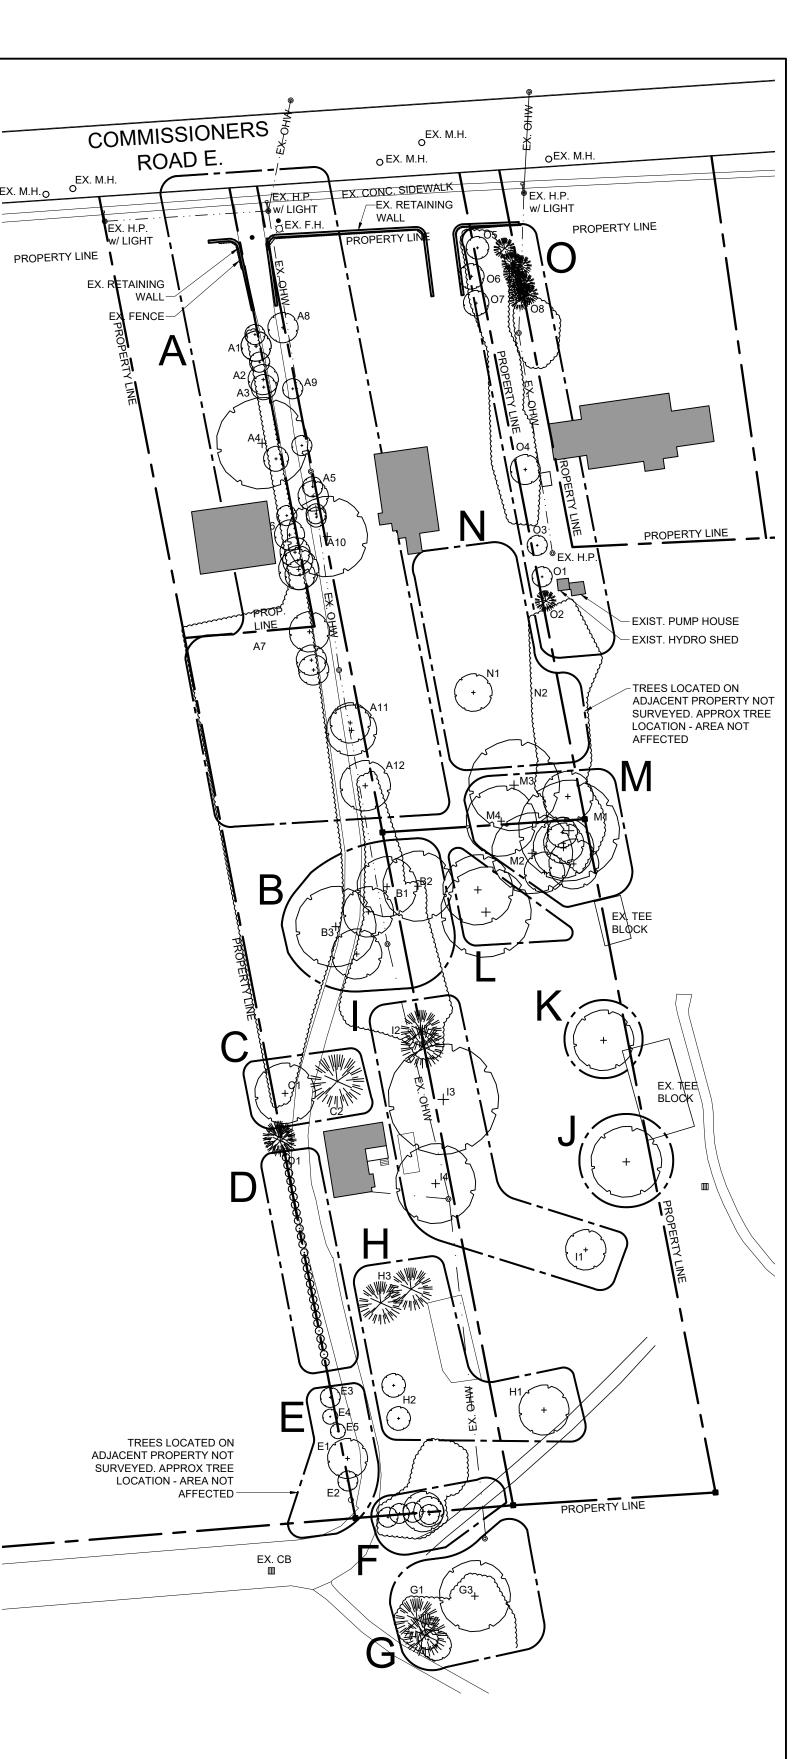
1 TL1 TL1 SCALE: 1:750

pecies Iotanical Name	Common Name	Size DBH (cm)	radius (m)	Condition	Location	Recommended Action
	cer platanoides	Norway Maple	15		poor; growing against fill		
1		Norway Maple	3		10% dieback; fair	west side of driveway on residential property line	Retain / Protect
				2		west side of driveway on residential property line	Retain / Protect
ac	eltis occidentalis	Common Hackberry	17		good; in group of three; understorey of buckthorn, Norway maple, honeysuckle	west side of driveway on residential property line -	Retain / Protect
сс	eltis occidentalis	Common Hackberry Common Hackberry Black Walnut	28 12 80	6m	good		Retain / Protect Retain / Protect
. ,				om	2004	west side of driveway on residential property line	Retain / Protect
		Norway Maple Norway Maple	20	2m	tar spot on leaves tar spot on leaves	east side of driveway within GC ownership	remove
		Norway Maple	7-14		four trees growing in 2.5m space between driveway and new house		Retain / Protect

a ji	uglans nigra	Black Walnut	20-50		23 tree walnut grove; little understorey located between driveway, new house construction (north) and rear yards to the west.	west side of driveway on open area of Highland GC	Retain / Protect
8 a	cer platanoides	Common Hackberry Norway Maple	12 + 23 10-17		two hackberry trees on edge of driveway 8 trees naturalizing on edge of driveway	east side of driveway	Retain / Protect remove
9 a	cer platanoides	Norway Maple	10-17		multi- and single-stem maples growing into overhead wires on edge of driveway and naturalizing the understorey	east side of driveway within GC ownership	remove
		Black Walnut	75		located within adjoining property overhanging driveway. Ash and buckthorn naturalizing adjacent to driveway.	east side of driveway on residential/GC property line	Retain / Protect
		White Oak Norway Maple	48	6m	good poor; growing adjacent to driveway,	On proposed fire route within site On proposed fire route	remove

52		interfering with utilities	within site	remove
	uglans nigra uercus alba	Black Walnut White Oak	50 50		good	Within proposed parking area within site Within proposed parking	remove
		White Oak	82		good	area within site Within grassy area of	remove Retain / Protect
4 r	nix	Grape, honeysuckle, burningbush	3m ht		dense hedgerow	site Within proposed parking area within site	remove
1 j	uglans nigra	Black Walnut	50		good	Within grassy area of	Retain / Protect
2 p	icea abies	Norway Spruce	70	6m	good	site Within grassy area of site	Retain / Protect
1 t	-	White Cedar	3-4m ht		good; lines west side of driveway	on adjoining lot	Retain / Protect
1 j	0 0	Black Walnut White Ash	7+12+22+15 7		good good	on adjoining lot on adjoining lot	Retain / Protect Retain / Protect
4 s	alix var.	Norway Maple Curly Willow Unipor	7 multistem		good good	on adjoining lot on adjoining lot	Retain / Protect Retain / Protect
C	uniperus sp Dense Thicket cer platanoides	Juniper Norway Maple	12-25		good good	on adjoining lot Within proposed fire	Retain / Protect

2 r	nix	Lilac, buckthorn, white cedar	various		Thicket of shrubs containing F1 maples	route of site within grassy area of site	Retain / Protect
_	Dense Grove huja occidentalis	White Cedar	25-40		grove of cedars with dense edges and clear understorey; buckthorn naturalizing on	within grassy area of site	Retain / Protect
2 r	norus alba	Mulberry	10-20		edge Invasive naturalizing in grove	within grassy area of site	Retain / Protect
3 a	cer saccharinum	Silver Maple	120	8m	good	within grassy area of site	Retain / Protect
	uperintendent House Rear Yard nalus sp.	Apple	multistem		poor; 75% dieback	within future building footprint	remove
	cer platanoides Crimson King	Crimson King maple	12		good; young trees	within grassy area of site	Retain / Protect
	icea abies uperintendent House Side Yard	Norway Spruce	40+47	6m	Two trees with 2m clear of branches growing together 3m apart	within grassy area of site	Retain / Protect

Apple	multistem		fair; succoring; 25% dieback	within future building footprint	remove
	inus strobus uercus macrocarpus	White Pine Bur Oak	38+45 125		good; growing together although showing good growth, the tree is	within grassy area of site	Retain / Protect
					compromised by significant splitting along the main trunk 4m above ground level. This splitting poses a danger to other parts of the property.	within grassy area of site	Retain / Protect
	uglans nigra uperintendent House Side Yard	Black Walnut	38		good; pruned for overhead utilities	within grassy area of site	Retain / Protect
1 jı	uglans nigra	Black Walnut	20	3	fair; 10% dieback	within future building footprint	remove
	cer platanoides uperintendent House Side Yard	Norway Maple	15	2	growing into overhead wires	within future building footprint	remove
1 ji	•	Black Walnut	65	5	20% dieback	within future building footprint	remove
1 a		Silver Maple House - property line	"63+76	5	20% dieback	within future building footprint	remove

1 p	inus resinosa	Red Pine	38		good; growing in crowded property line	within future building parking	remove
		Black Walnut Silver Maple	25-40 90		good; Three walnuts growing on/near property line poor	within future building parking North of future parking	remove
4 a 4	cer platanoides Adjacent Lot North of Superintendent	Norway Maple House	43		10% dieback; fair	North of future parking	remove
2 ji E	uglans nigra asement from Commissioners Road to	Ginkgo Black Walnut o Golf Course Black Walnut	25 25-60 25-50		good good; 4 trees Four trees growing into fence; fair	On residential property On residential property	Retain / Protect Retain / Protect
							Retain / Protect
		Scots Pine Norway Maple	22 50		growing with walnuts two trees growing near property line; 20m ht.; good condition	-	Retain / Protect Retain / Protect
4 a	cer platanoides	Norway Maple	15		growing near property line; within mix of buckthorn, ash grape, burningbush; good condition	In easement from Commissioners Road to Golf Course	Retain / Protect

-		Silver Maple Black Walnut	65 50+55	7m	50% dieback; poor good; near hedgerow of plants west of easement		Retain / Protect Retain / Protect
		Black Walnut	22		good; within hedgerow of plants west of easement		Retain / Protect
	uniperus virginiana	Eastern Red Cedar TORY LIST	5m ht		on property east of easement		Retain / Protect
