Arborist Report

Pre-Construction

825 Wharncliffe Road South, London ON N6J 2N9

October 27th, 2023

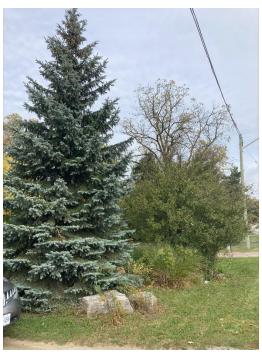
Figure 1: Tree # 1 and #2 Recommended TPF

- Tree #1, a 20 cm DBH Blue Spruce tree is located out front of 825 Wharncliffe Rd South and should not be injured, Tree Protection Fence should be installed to assure the protection of the root zone.

- Tree #2, a 15 cm DBH Apple tree is located out front of 825 Wharncliffe Rd South and should not be injured, Tree Protection Fence should be installed to assure the protection of the root zone.

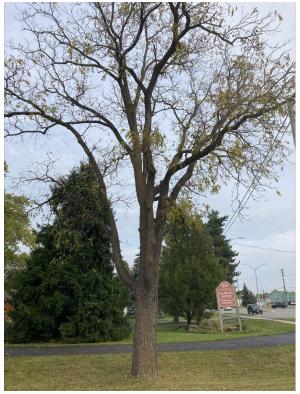
Figure 2: Tree # 3 Recommended TPF

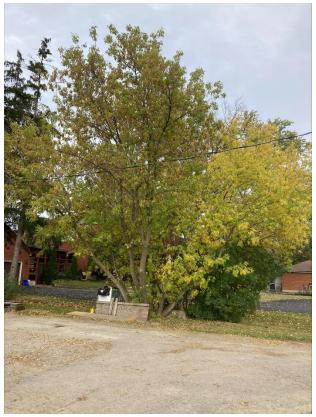
Figure 4: Trees #5 -#14 Recommended TPF

- Trees #3-#17 are located on the neighboring property and are recommended to have Tree Protection Fencing installed to assure the protection of the root zone, these trees will be injured by the construction of the new driveway and are recommended to have a Certified Arborist prune the roots at the limit of the new driveway within the Tree Protection Zone.

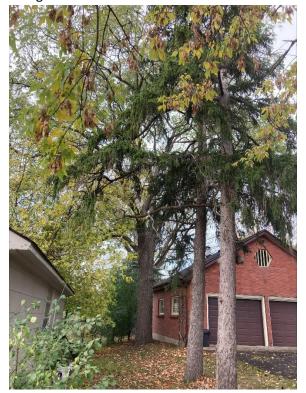
Figure 5: Trees #15, #16, and #17 Recommended TPF

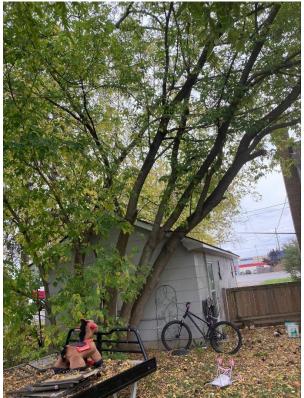
- Trees #18 and #19 are located at the back of the property and are recommended to be removed as they are located in the middle of the proposed parking lot.

Figure 6: Trees # 18 and #19 recommended for removal.

- Tree #18, a 43 cm DBH Manitoba Maple located inside the proposed construction zone where the parking lot is proposed and should be removed.
- Tree #19, a 40 cm DBH Manitoba Maple Located inside the proposed construction zone where the parking lot is proposed and should be removed.
- Tree # 23, a 5 cm DBH juniper that is dead and is recommended to be removed.
- Tree #35 a 35 cm DBH Black Walnut located in the proposed construction zone at the front of the existing house and should be removed.
- Tree # 36, a 37 cm DBH Eastern White Cedar located in the proposed construction zone where the parking lot is proposed and should be removed.

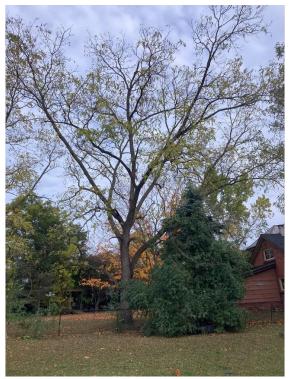
- Trees #20 and #21 are located on the neighboring property and recommended to have Tree Protection Fencing installed to assure the protection of the root zone, these trees will be injured by the construction of the new driveway and are recommended to have a Certified Arborist prune the roots at the limit of the new driveway within the Tree Protection Zone.

Figure 7: Trees #20 and #21 Recommended TPF

Tree Protection Fencing recommended to have Tree Protection Fencing installed to assure the protection of the root zone, the tree will be injured by the construction of the new driveway and is recommended to have a Certified Arborist prune the roots at the limit of the new driveway within the Tree Protection Zone **Tree #21 will need a Permit to Injure.**

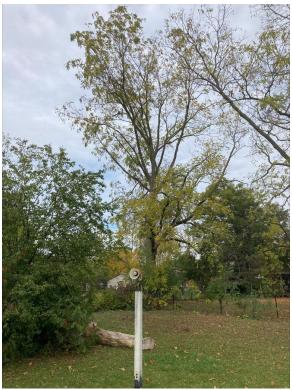
- Tree #23 is located at the back of the property and is recommended to be removed as it is dead.
- Tree #24 is located at the back of the property and is recommended to have Tree Protection Fencing installed to assure the protection of the root zone, this tree will be injured by the construction of the new driveway and is recommended to have a Certified Arborist prune the roots at the limit of the new driveway within the Tree Protection Zone

Figure 8: Trees #22, #23, #24, and #25 remove #23 (dead) TPF for Trees #22 and #24

- Tree #22 is located at the back of the property and is recommended to have Tree Protection Fencing installed to assure the protection of the root zone, this tree will be injured by the construction of the new driveway and is recommended to have a Certified Arborist prune the roots at the limit of the new driveway within the Tree Protection Zone

- Tree #22, a 5 cm DBH Juniper is located at the back of the property and is recommended to have Tree Protection Fencing installed to assure the protection of the root zone, the tree will be injured by the construction of the new driveway and is recommended to have a Certified Arborist prune the roots at the limit of the new driveway within the Tree Protection Zone
- Tree #24, a 5 cm DBH Juniper is located at the back of the property and is recommended to have Tree Protection Fencing installed to assure the protection of the root zone the tree will be injured by the construction of the new driveway and is recommended to have a Certified Arborist prune the roots at the limit of the new driveway within the Tree Protection Zone

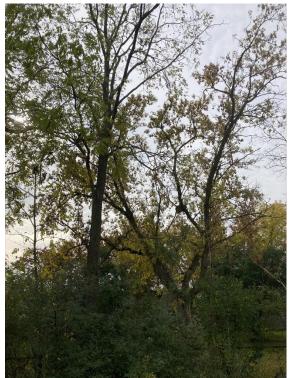
Figure 9: Trees #26 and 27 Recommended TPF for #27

- Tree #26, a 60 cm DBH Manitoba Maple is located on the neighboring property and is recommended to use the existing fencing as Tree Protection Fencing.

- Tree #27, a 38 cm DBH Black Walnut is located on the neighboring property and is recommended to use the existing fencing as Tree Protection Fencing.
- Tree #28, a 55 cm DBH Black Walnut is located on the neighboring property and is recommended to use the existing fencing as Tree Protection Fencing.

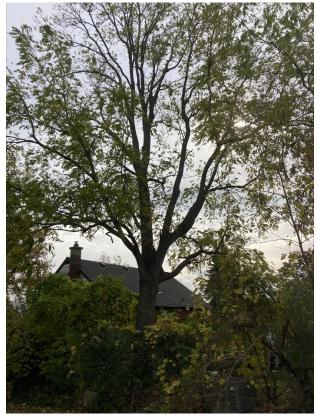
Figure 10: Tree #28 Recommended TPF

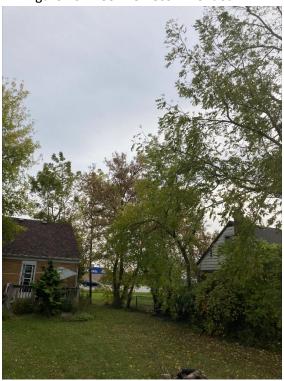
Figure 11: Trees #29, #30, #31, and #32 Recommended TPF

- Trees #29-#33 are located at the side of the property and are recommended to have Tree Protection Fencing installed to assure the protection of the root zone.

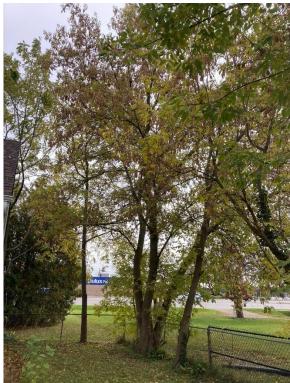
Figure 12: Trees #33 and #34 Recommended TPF

- Tree #34, a 25 cm DBH Black Walnut is located at the side of the property and is recommended to have Tree Protection Fencing installed to assure the protection of the root zone.

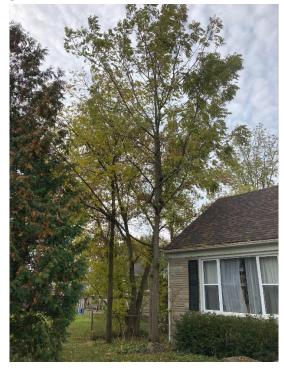
Figure 12: Tree #35 Recommended removal

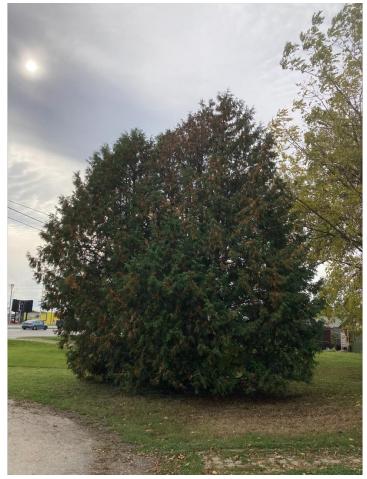
Figure 14: Tree #36 Recommended for removal.

• For Trees #18, #19, #23, #35, and #36 we recommend they be removed.
