## Slope Stability Assessment

*Kilbourne Developments Inc.*

Bostwick Corridor Study  
Bostwick Road  
London, Ontario

## Geotechnical Investigation

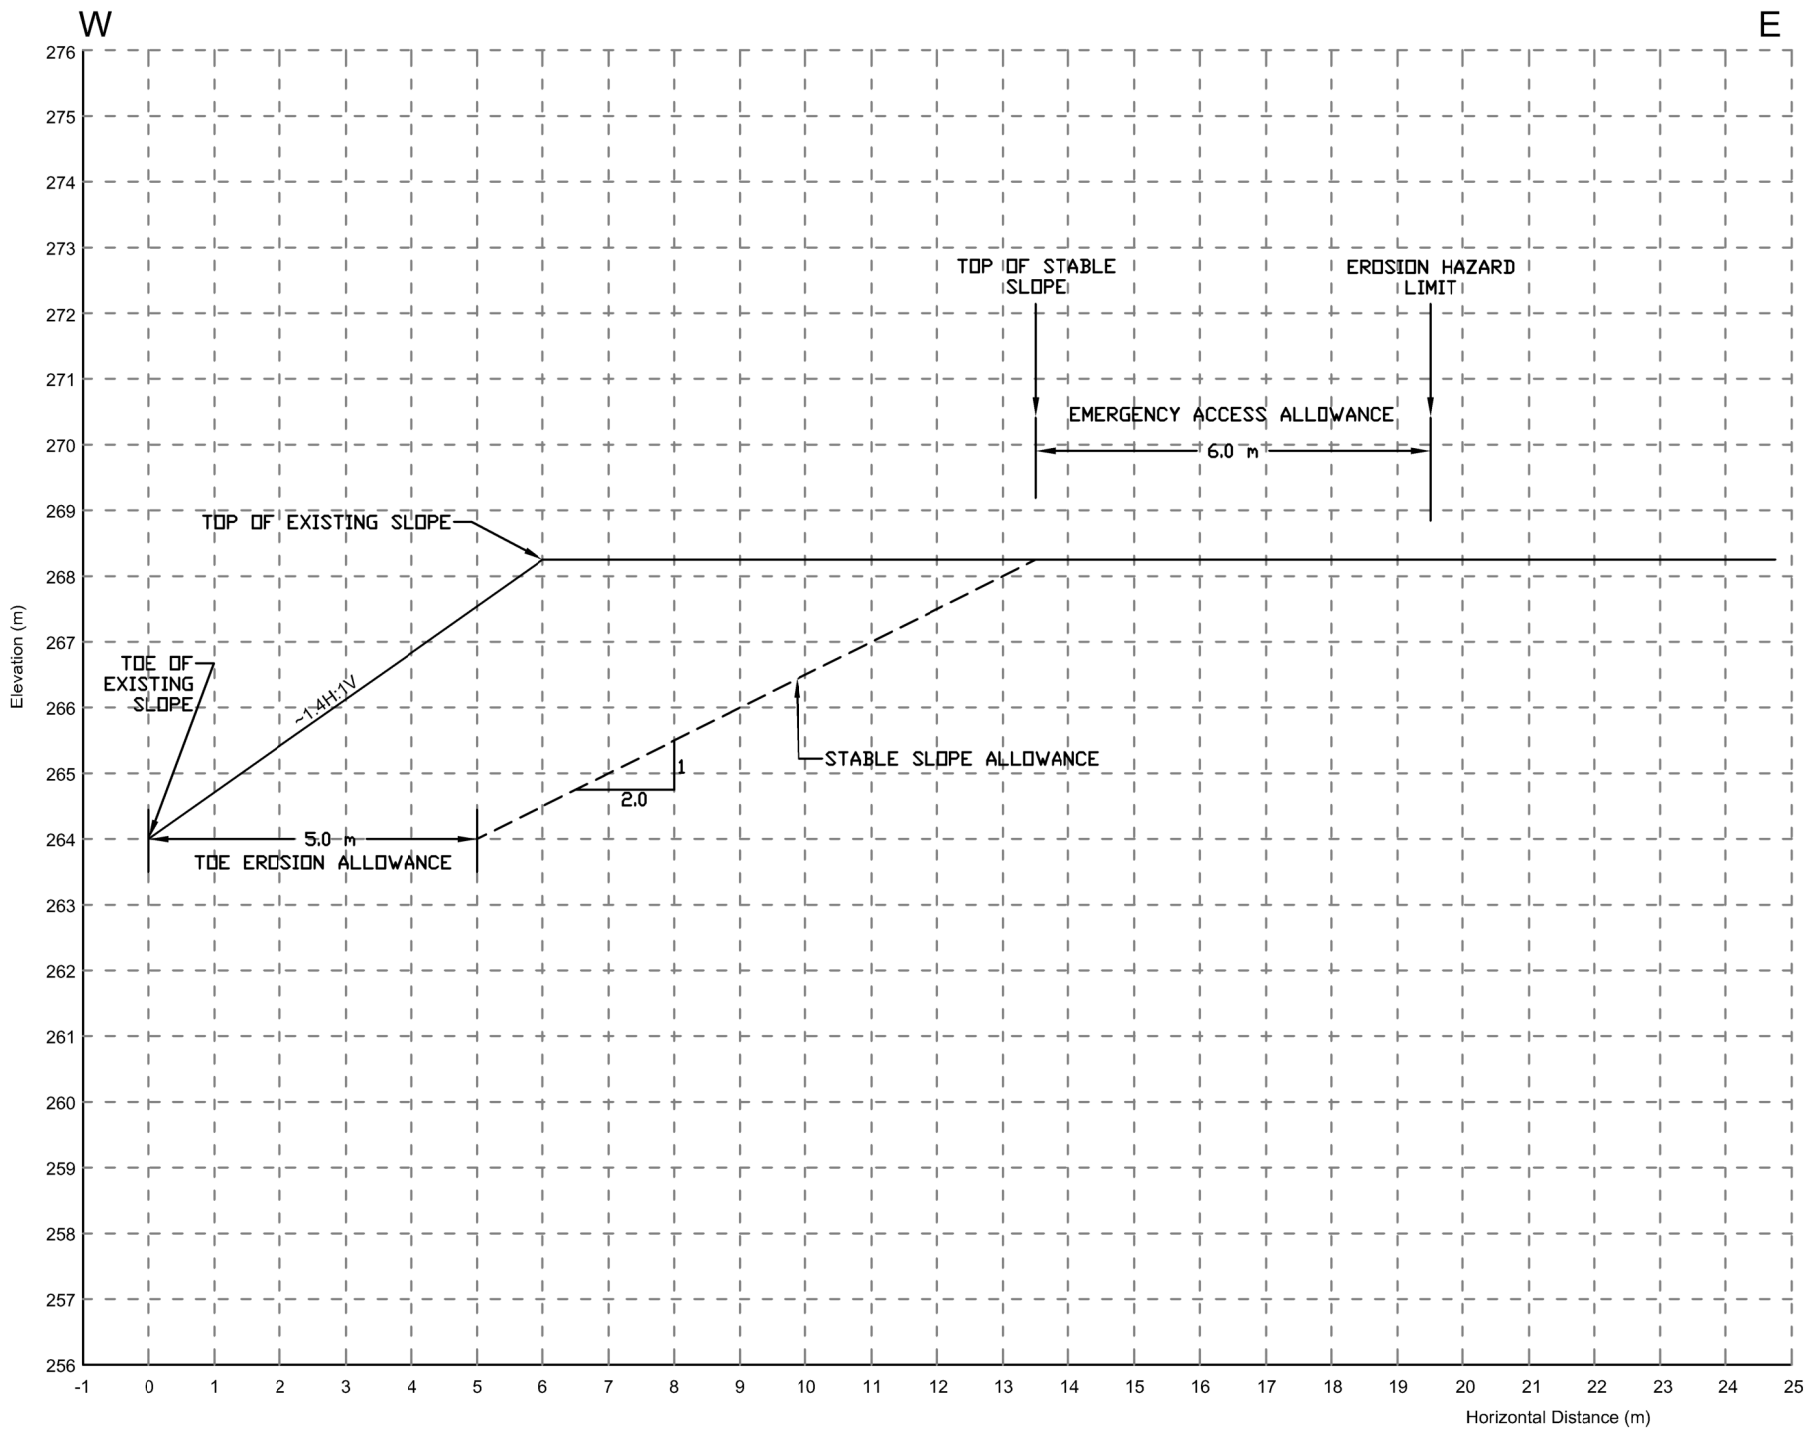
# Cross Section A - A'

| Cross Section Condition | Description of Failure Mode | Computer Factor of Safety |
|---|---|---|
| <b>Cross Section A-A'</b> | Shallow to Moderate Depth Failure (< 2-4 m deep) | 1.15 |
| | Deep Failure (> 4 m deep) | 2.23 |

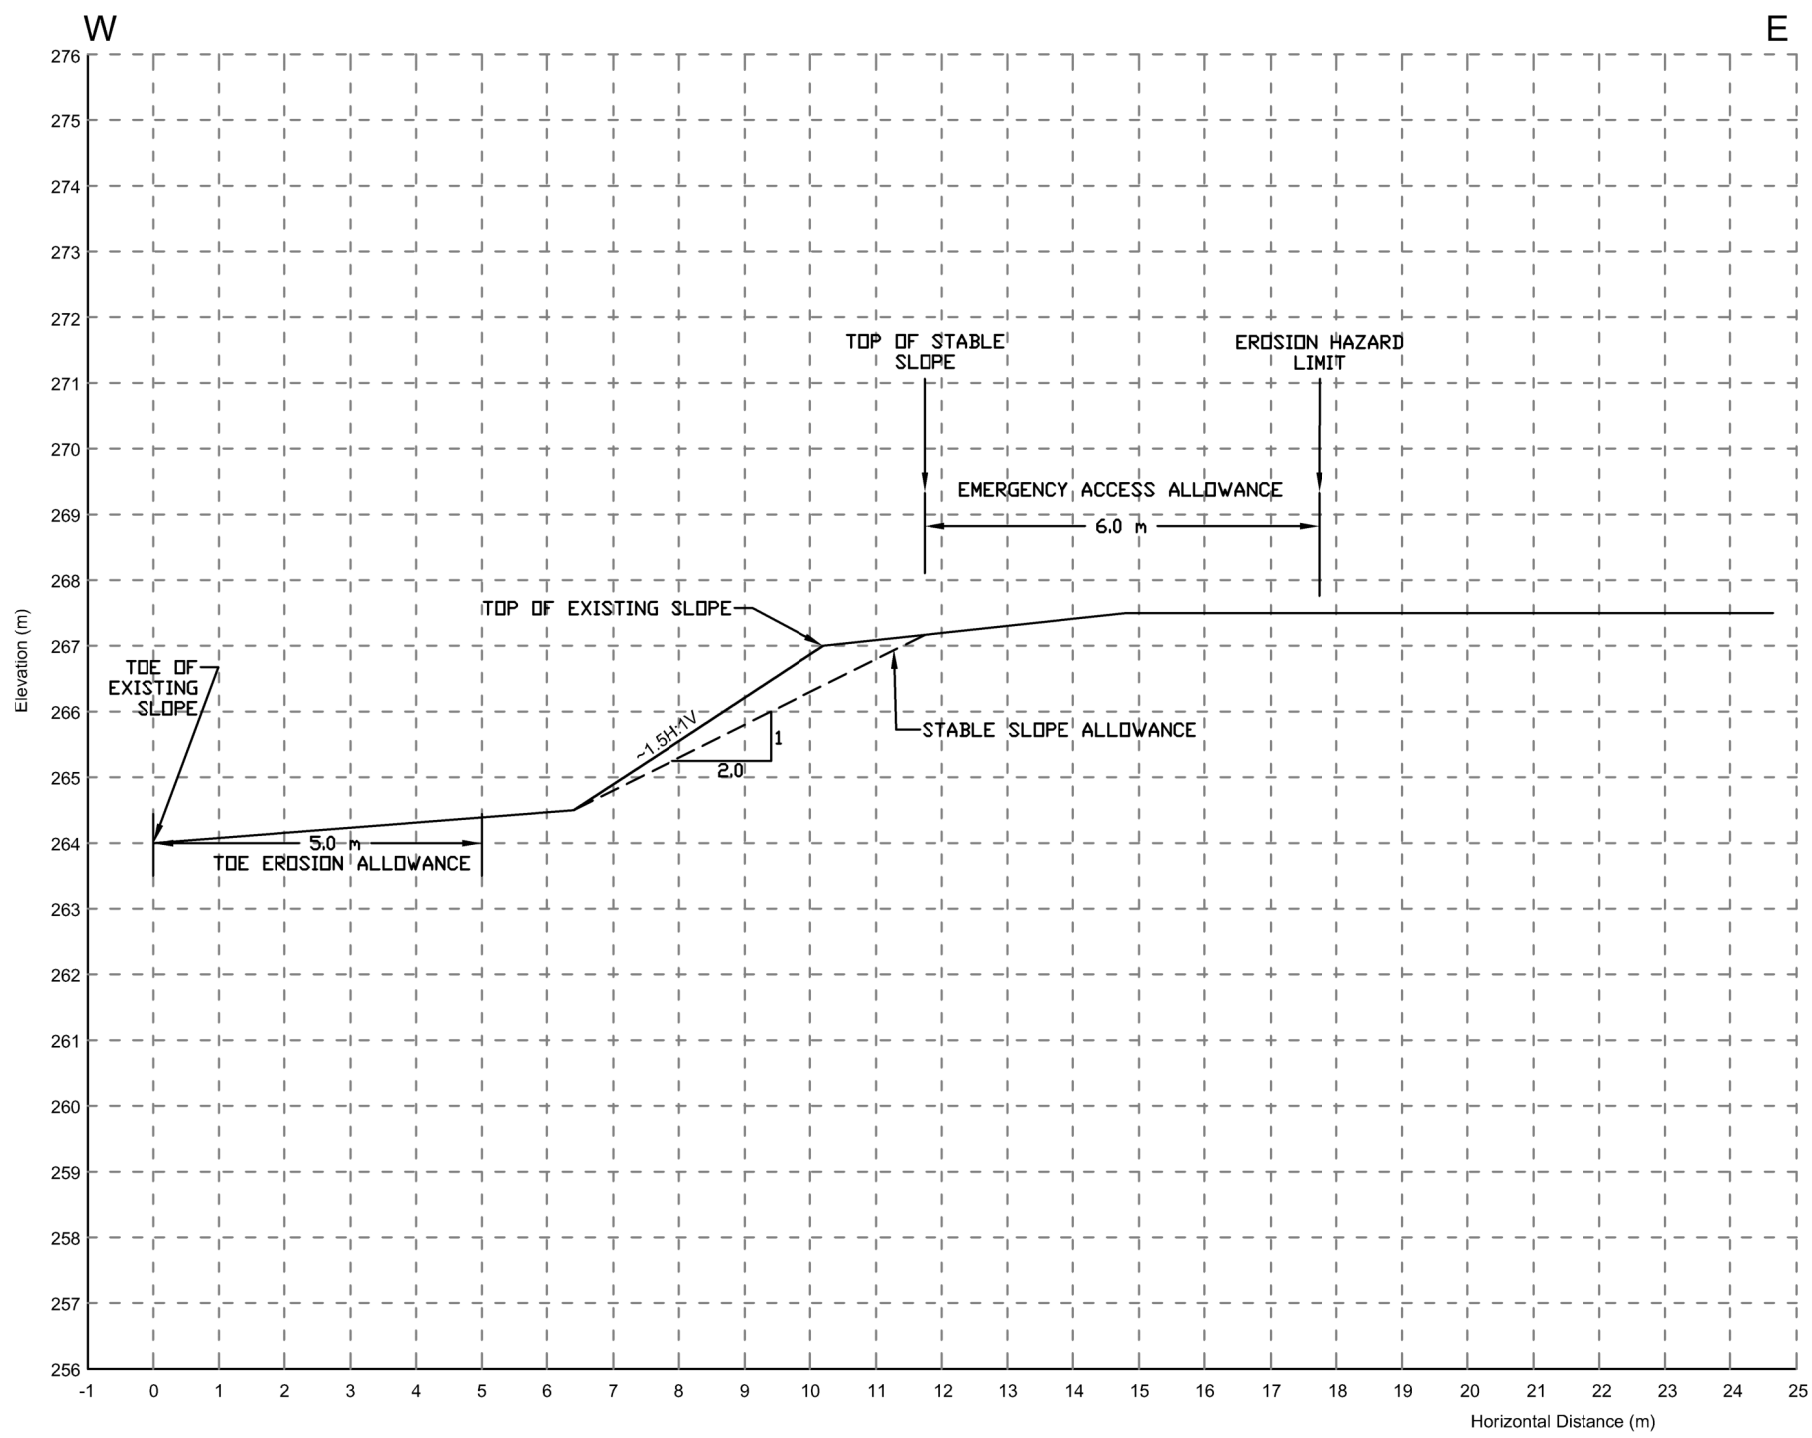
# Cross Section B - B'

| Cross Section Condition | Description of Failure Mode | Computer Factor of Safety |
|---|---|---|
| <b>Cross Section B-B'</b> | Shallow to Moderate Depth Failure (< 2-4 m deep) | 1.21 |
| | Deep Failure (> 4 m deep) | 3.45 |

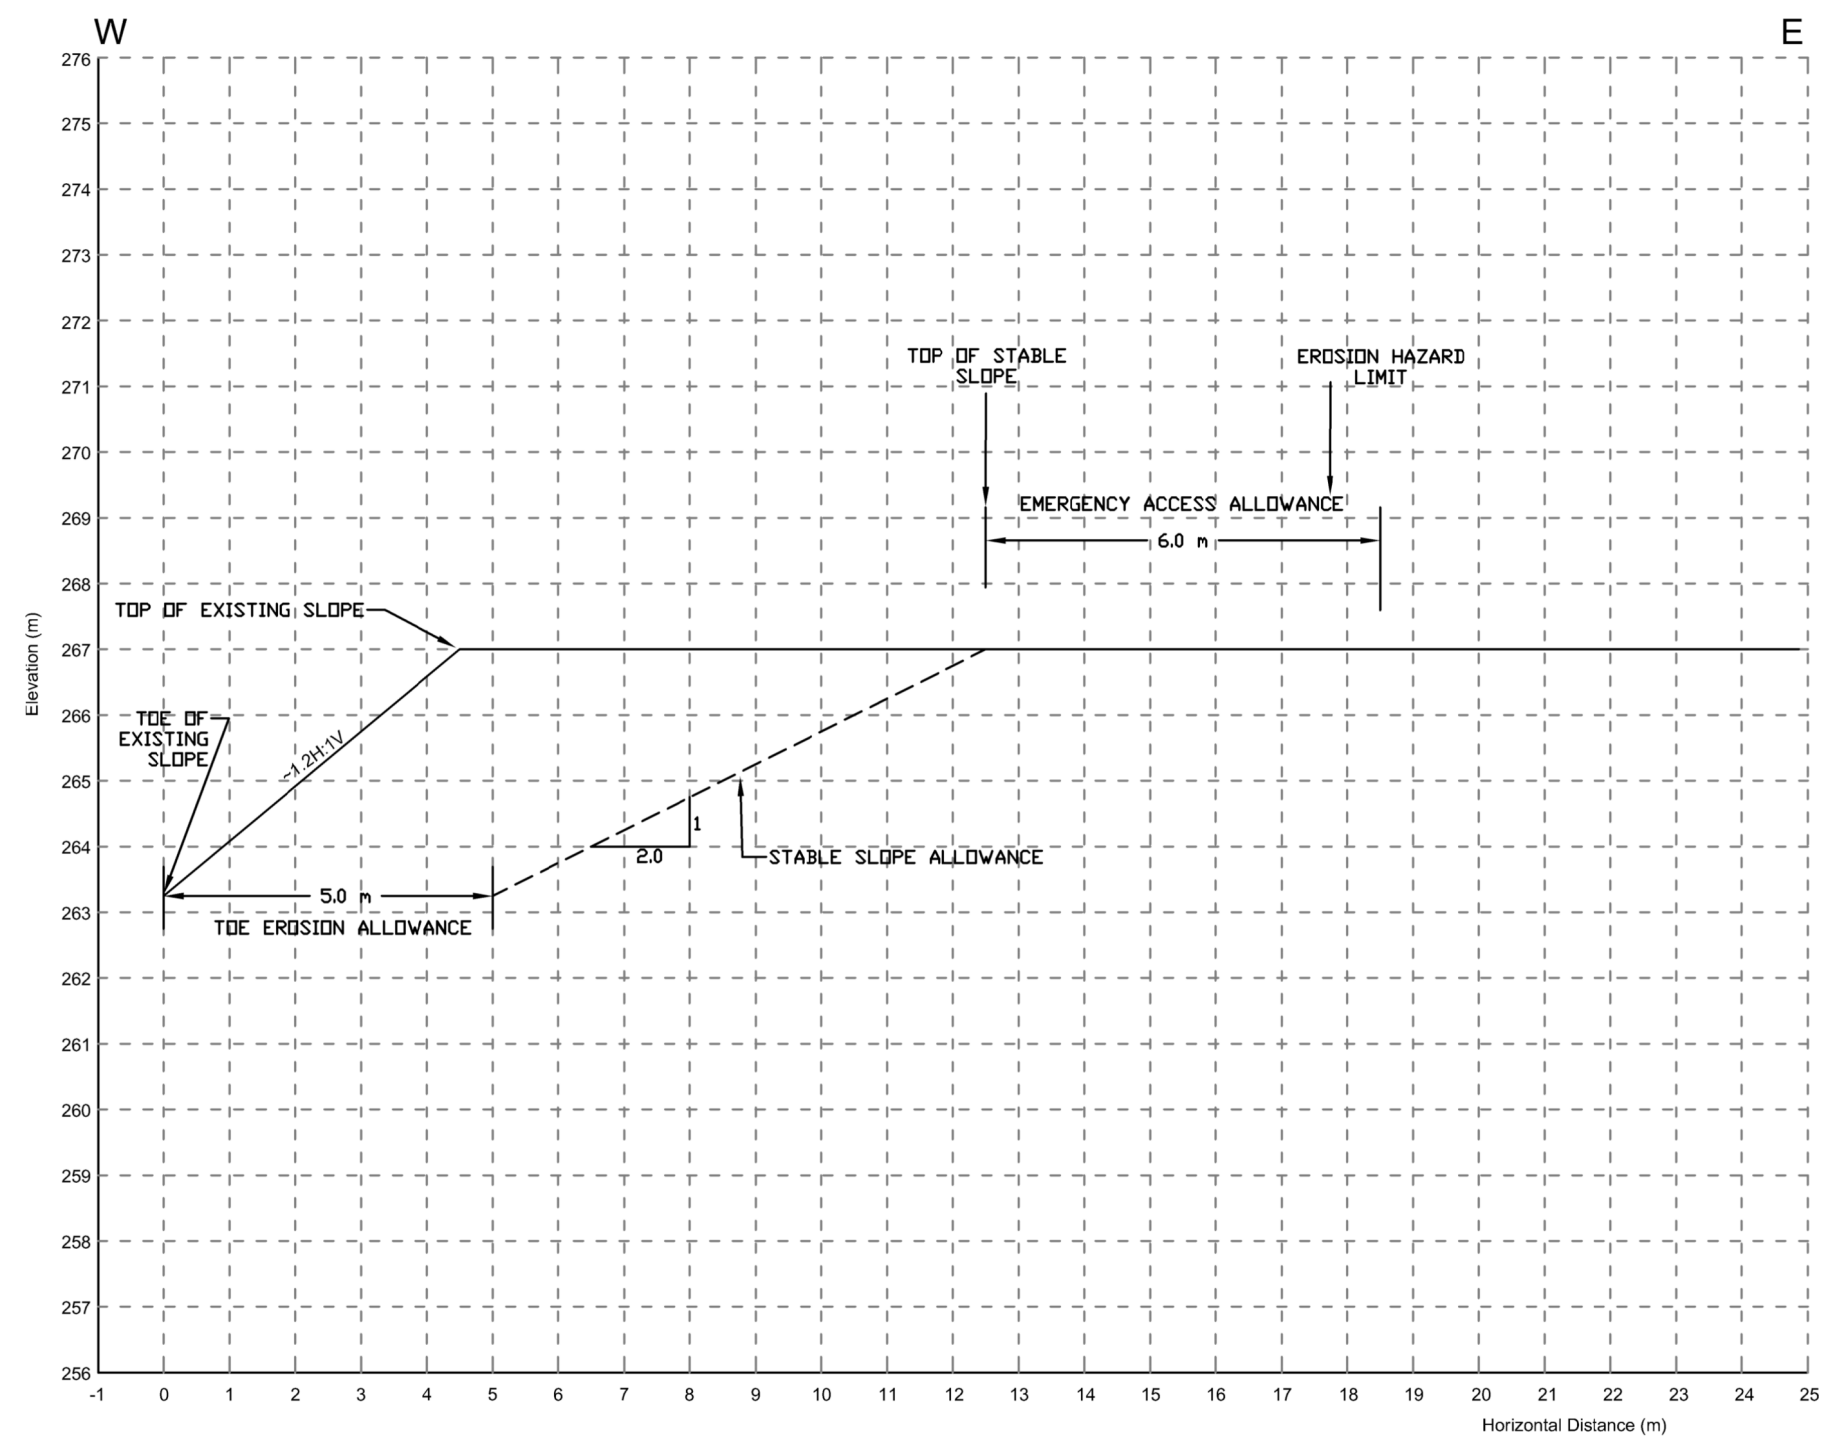
# Cross Section C - C'

| Cross Section Condition | Description of Failure Mode | Computer Factor of Safety |
|---|---|---|
| <b>Cross Section C-C'</b> | Shallow to Moderate Depth Failure (< 2-4 m deep) | 2.15 |
| | Deep Failure (> 4 m deep) | 2.44 |

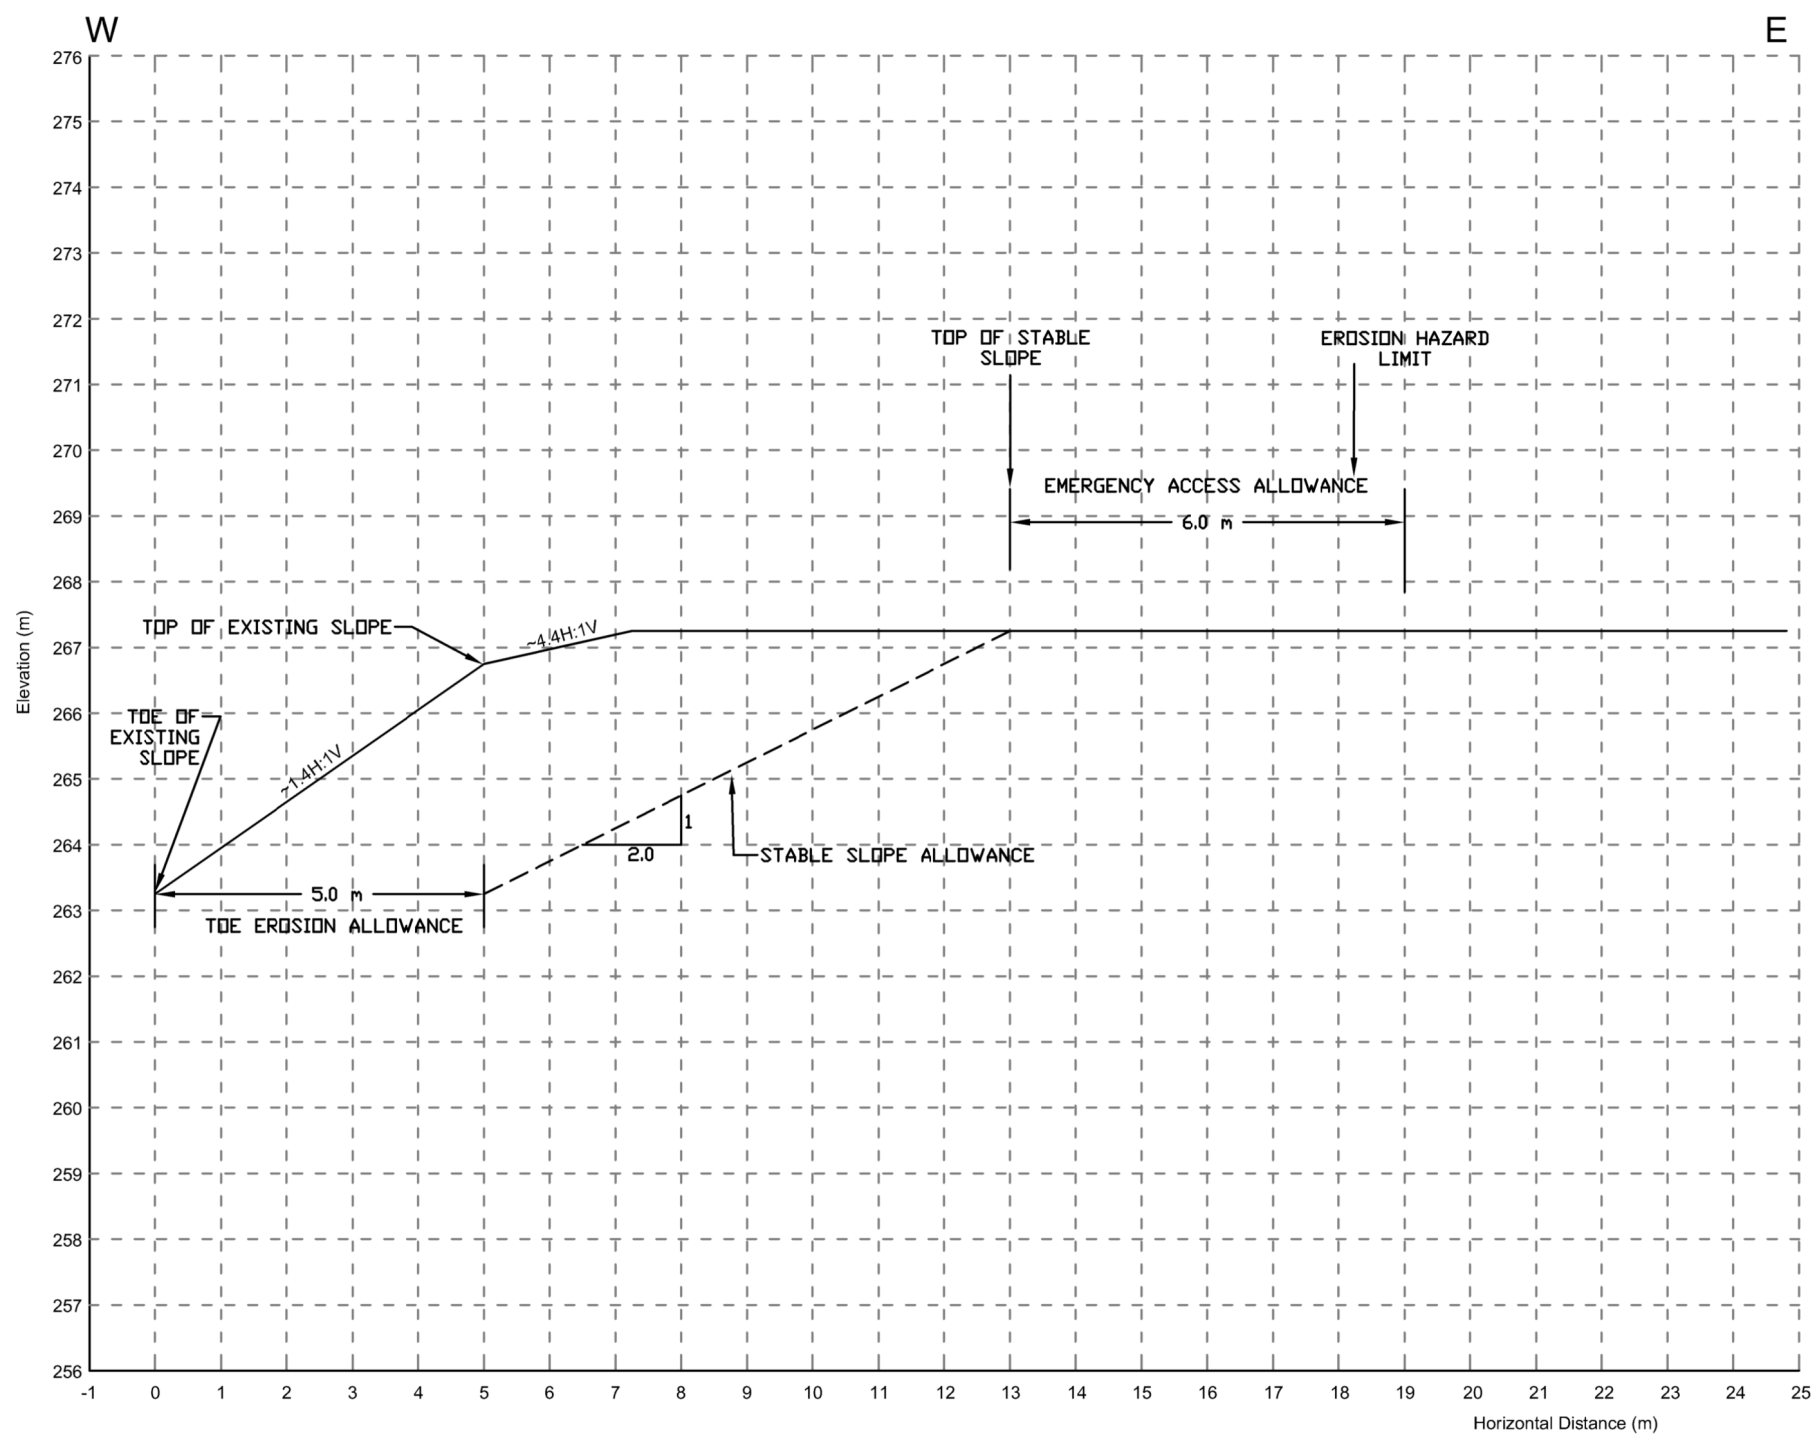
# Cross Section D - D'

| Cross Section Condition | Description of Failure Mode | Computer Factor of Safety |
|---|---|---|
| <b>Cross Section D-D'</b> | Shallow to Moderate Depth Failure (< 2-4 m deep) | 2.20 |
| | Deep Failure (> 4 m deep) | 2.16 |

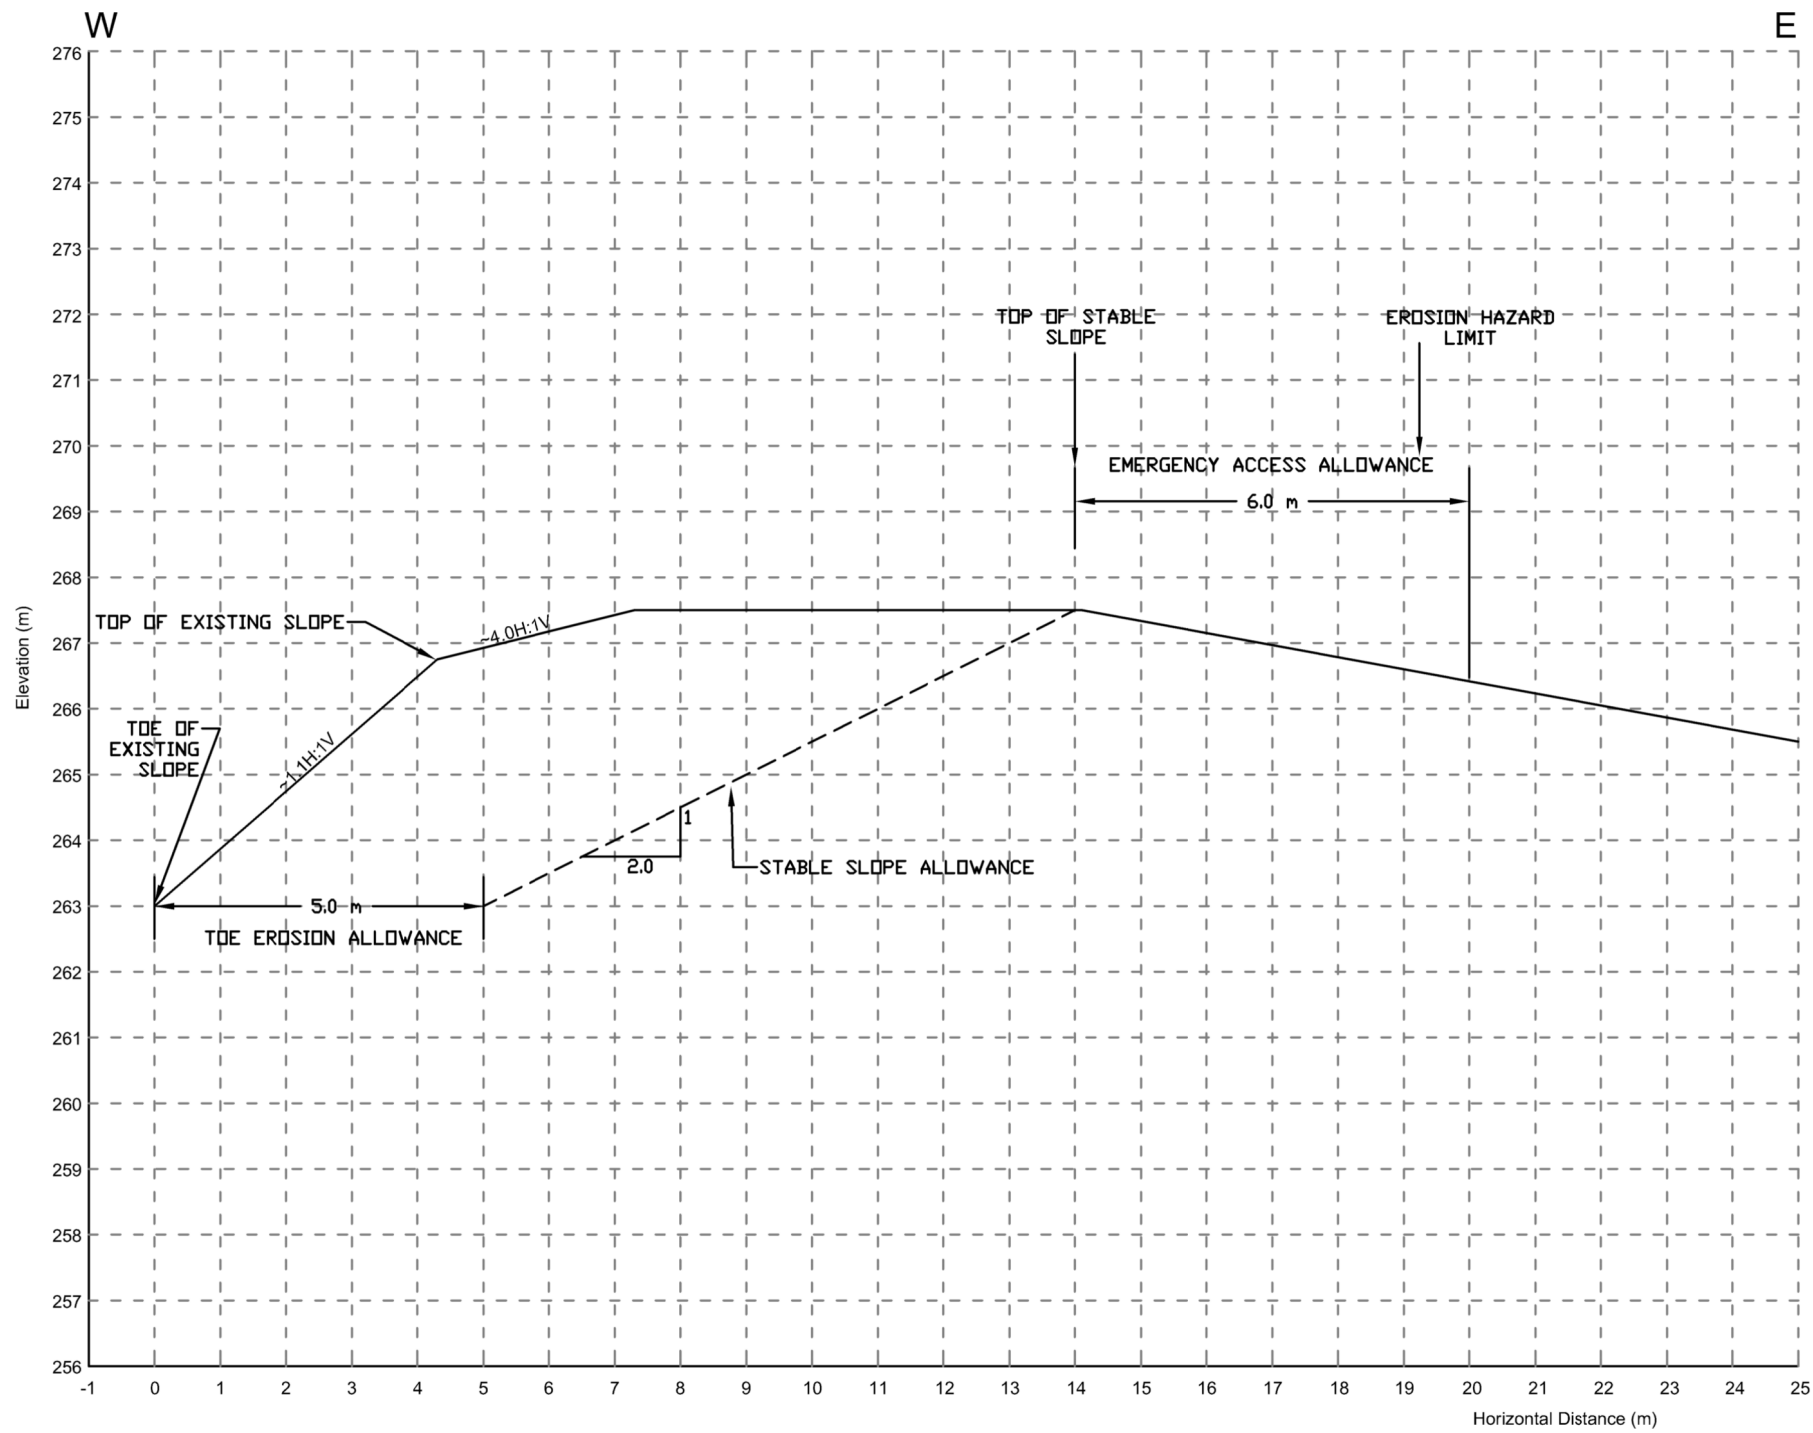
# Cross Section E - E'

| Cross Section Condition | Description of Failure Mode | Computer Factor of Safety |
|---|---|---|
| <b>Cross Section E-E'</b> | Shallow to Moderate Depth Failure (< 2-4 m deep) | 1.12 |
| | Deep Failure (> 4 m deep) | 2.16 |
