517 - 525 FANSHAWE PARK ROAD EAST
LONDON, ONTARIO
TREE ASSESSMENT REPORT
FOR REZONING APPLICATION

PREPARED BY: RON KOUDYS LANDSCAPE
ARCHITECTS INC

DATE: JANUARY 2022

RKLA PROJECT #: 21-115

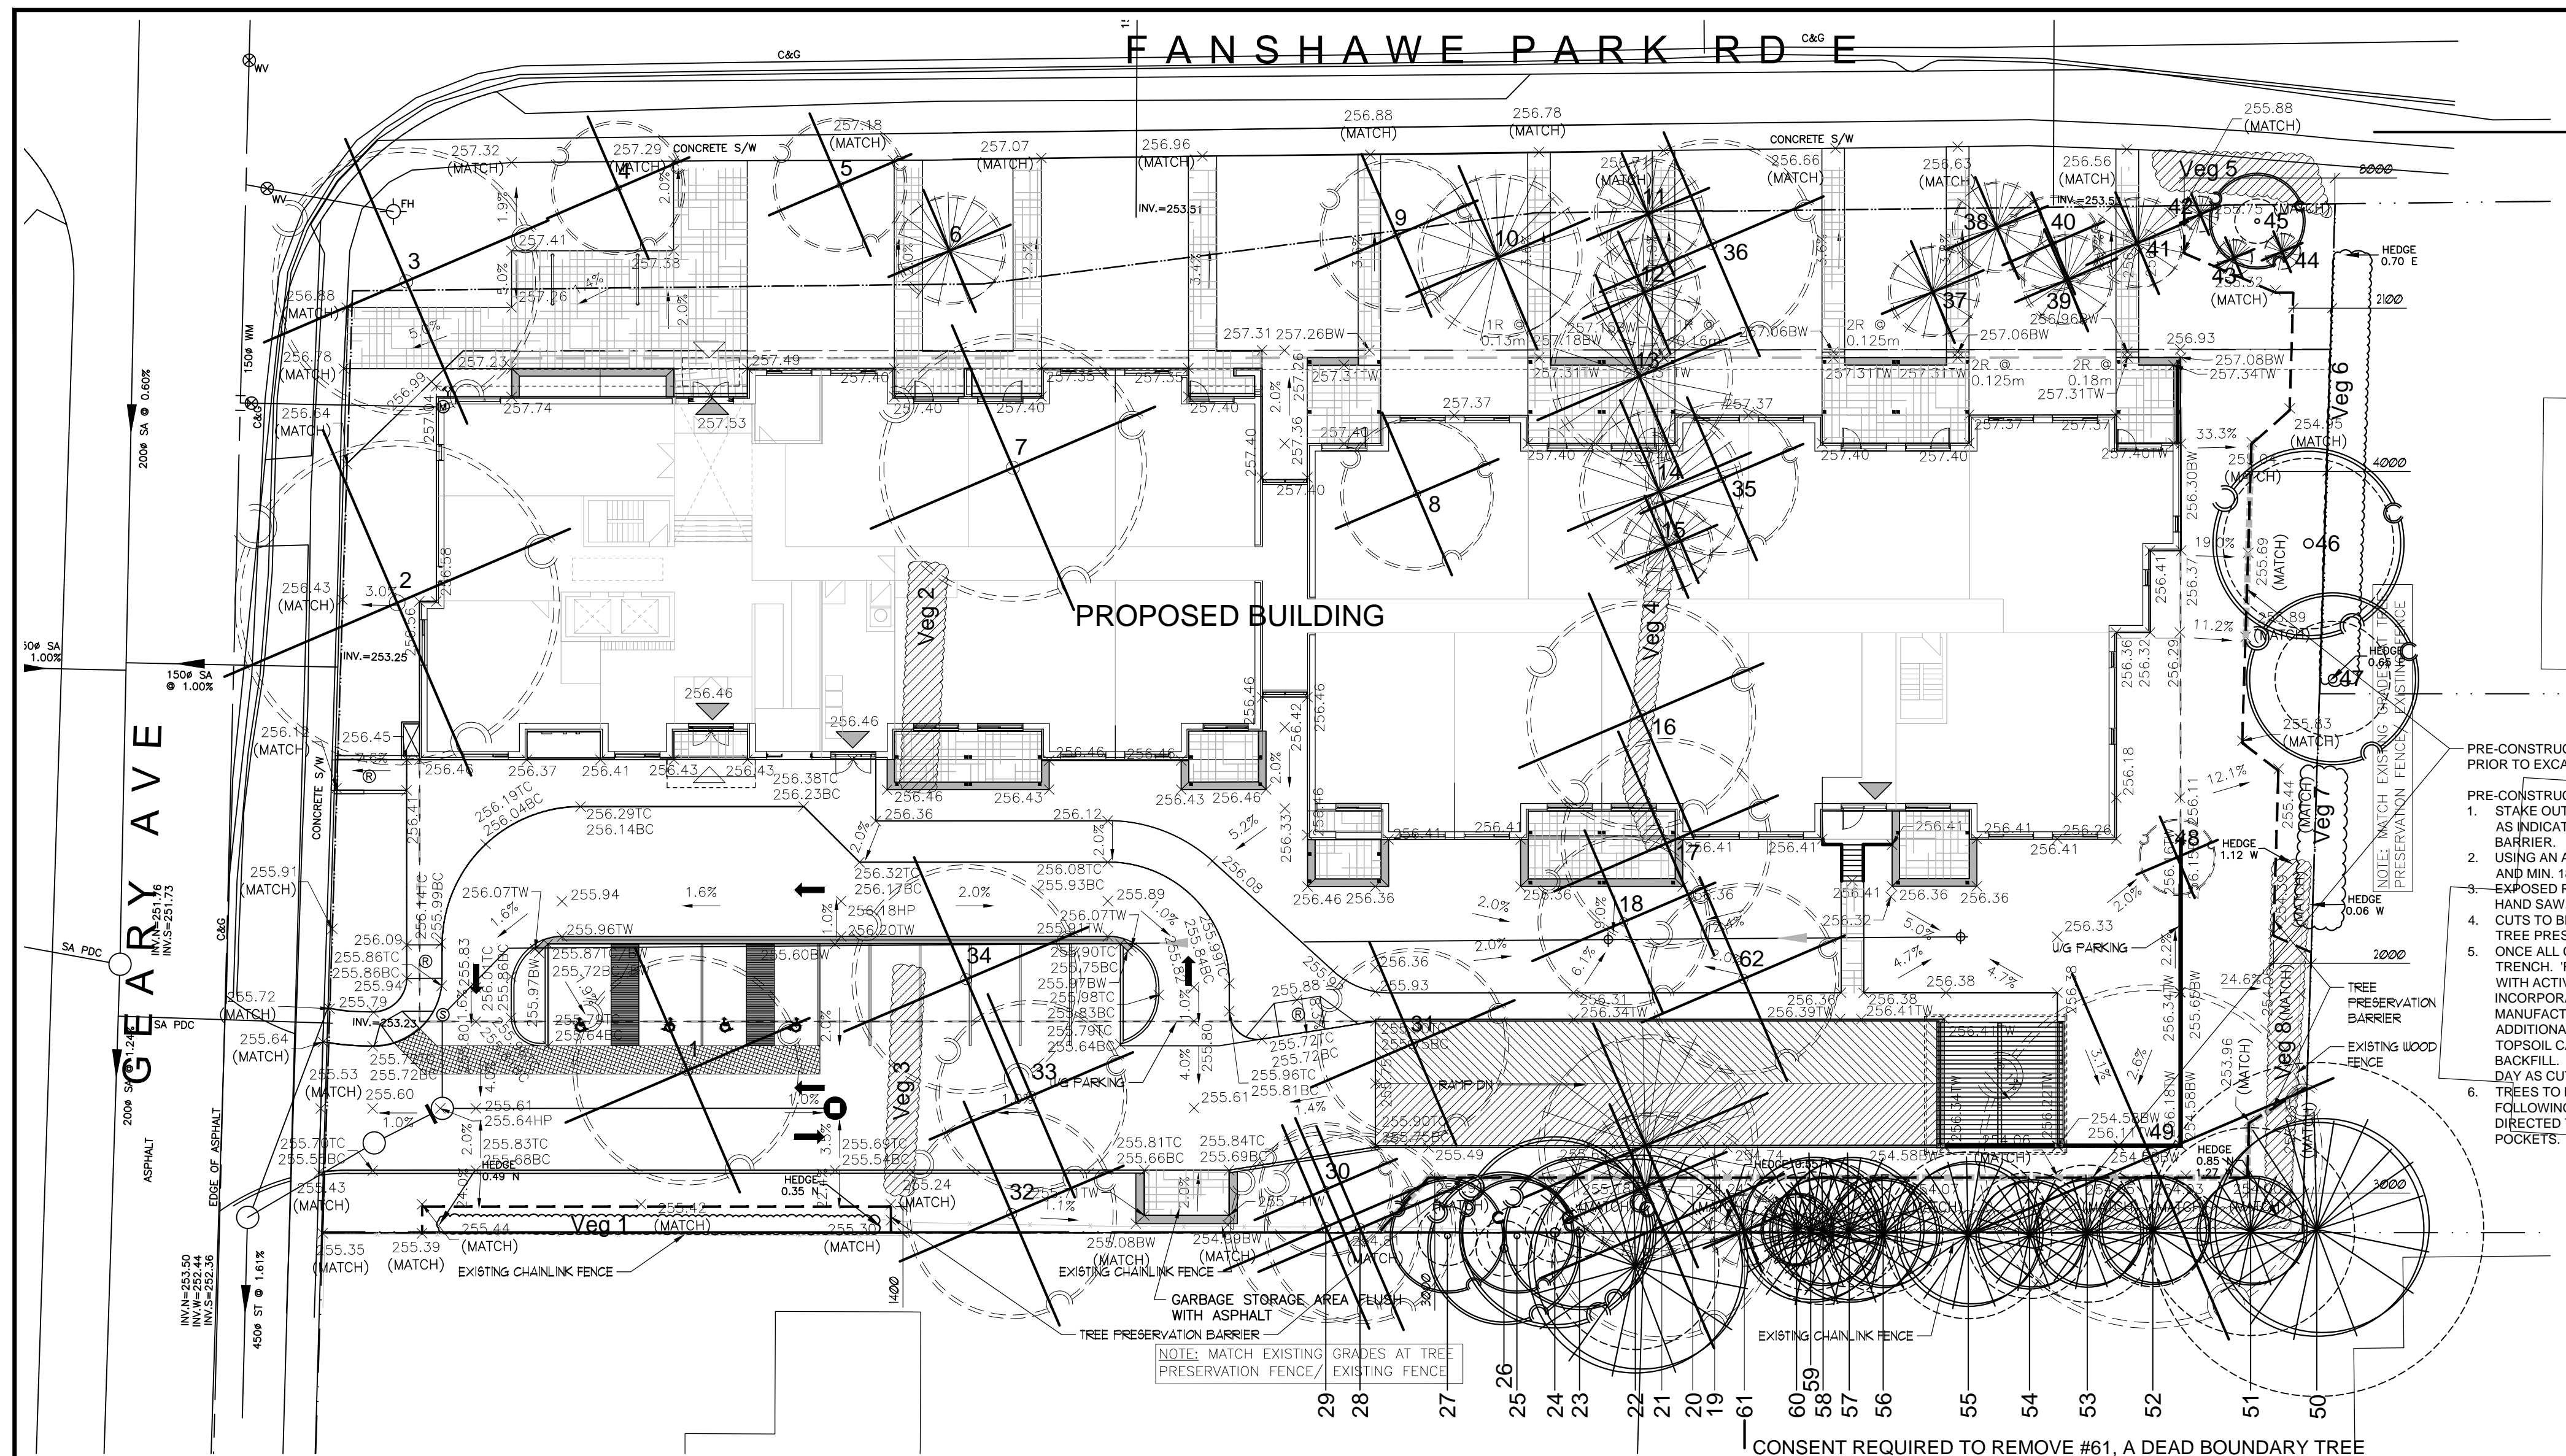
TREE PRESERVATION PLAN
SCALE = 1:250

TREES RECOMMENDED FOR REMOVAL WITHIN THE CITY ROW REQUIRE APPLICATION TO THE CITY FOR CONSENSUAL REMOVAL. TO BE EXECUTED AT THE TIME OF APPLICATION FOR SPA. THIS APPLIES TO THE FOLLOWING: TREE # 3, 4, 5 & 6 AND VEG UNIT # 5

- PRE-CONSTRUCTION ROOT PRUNING INSTRUCTIONS:**
- STAKE OUT THE LINE OF TREE PRESERVATION - AS INDICATED BY THE TREE PRESERVATION BARRIER.
 - USING AN AIR SPADE, CUT A TRENCH 6" - 10" WIDE AND MIN. 18" DEEP.
 - EXPOSED ROOTS TO BE CLEANLY CUT WITH A HAND SAW, CHAIN SAW, OR BYPASS PRUNERS. CUTS TO BE MADE 3" TO 6" INSIDE THE PROPOSED TREE PRESERVATION BARRIER LOCATION.
 - ONCE ALL CUTS ARE MADE, REPLET SOIL IN THE TRENCH. "ROOT RESCUE" OR A SIMILAR PRODUCT WITH ACTIVE MYCORRHIZAL FUNGI TO BE INCORPORATED INTO BACKFILL AS PER MANUFACTURER SPECIFICATIONS. IF ADDITIONAL SOIL IS REQUIRED, 2WAY MIX TOPSOIL CAN ALSO BE INCORPORATED INTO THE BACKFILL. BACKFILLING TO OCCUR WITH SAME DAY AS CUTS ARE MADE.
 - TREES TO BE WATERED WITHIN ONE DAY FOLLOWING ROOT PRUNING - WITH WATER DIRECTED TO THE TRENCH TO SETTLE LARGE AIR POCKETS.
- TEMP. TREE PROTECTION BARRIER - N.T.S.**

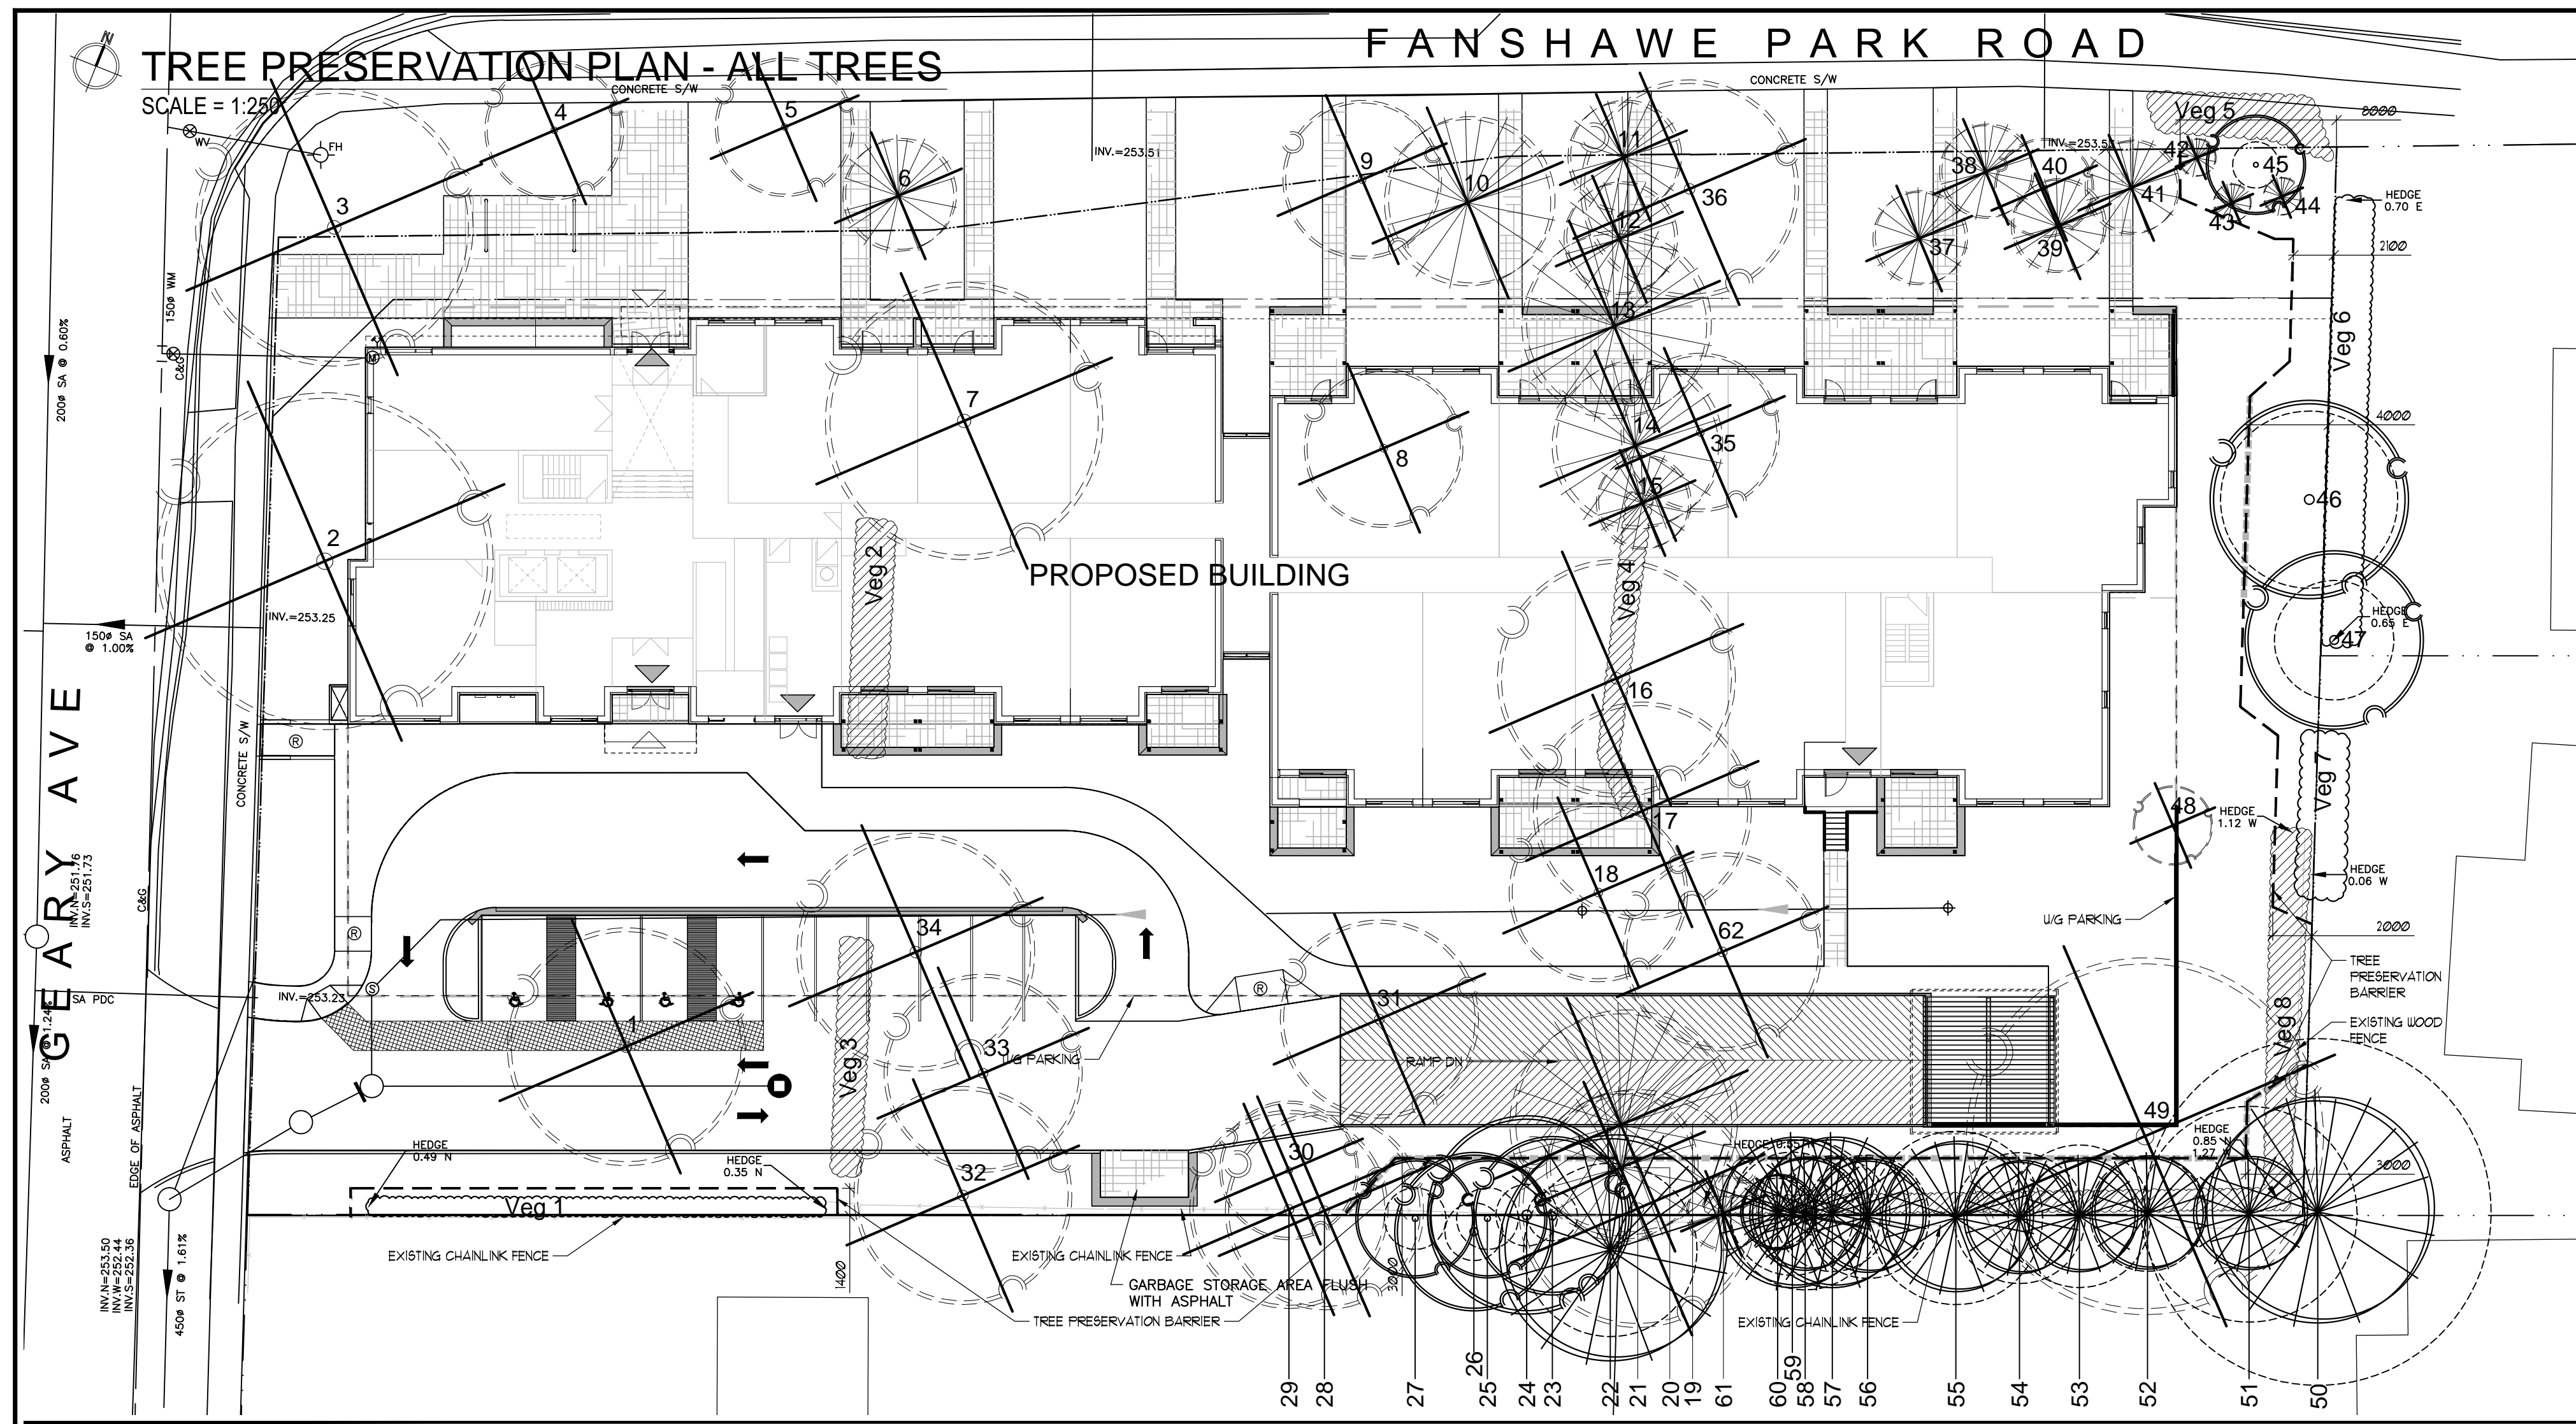
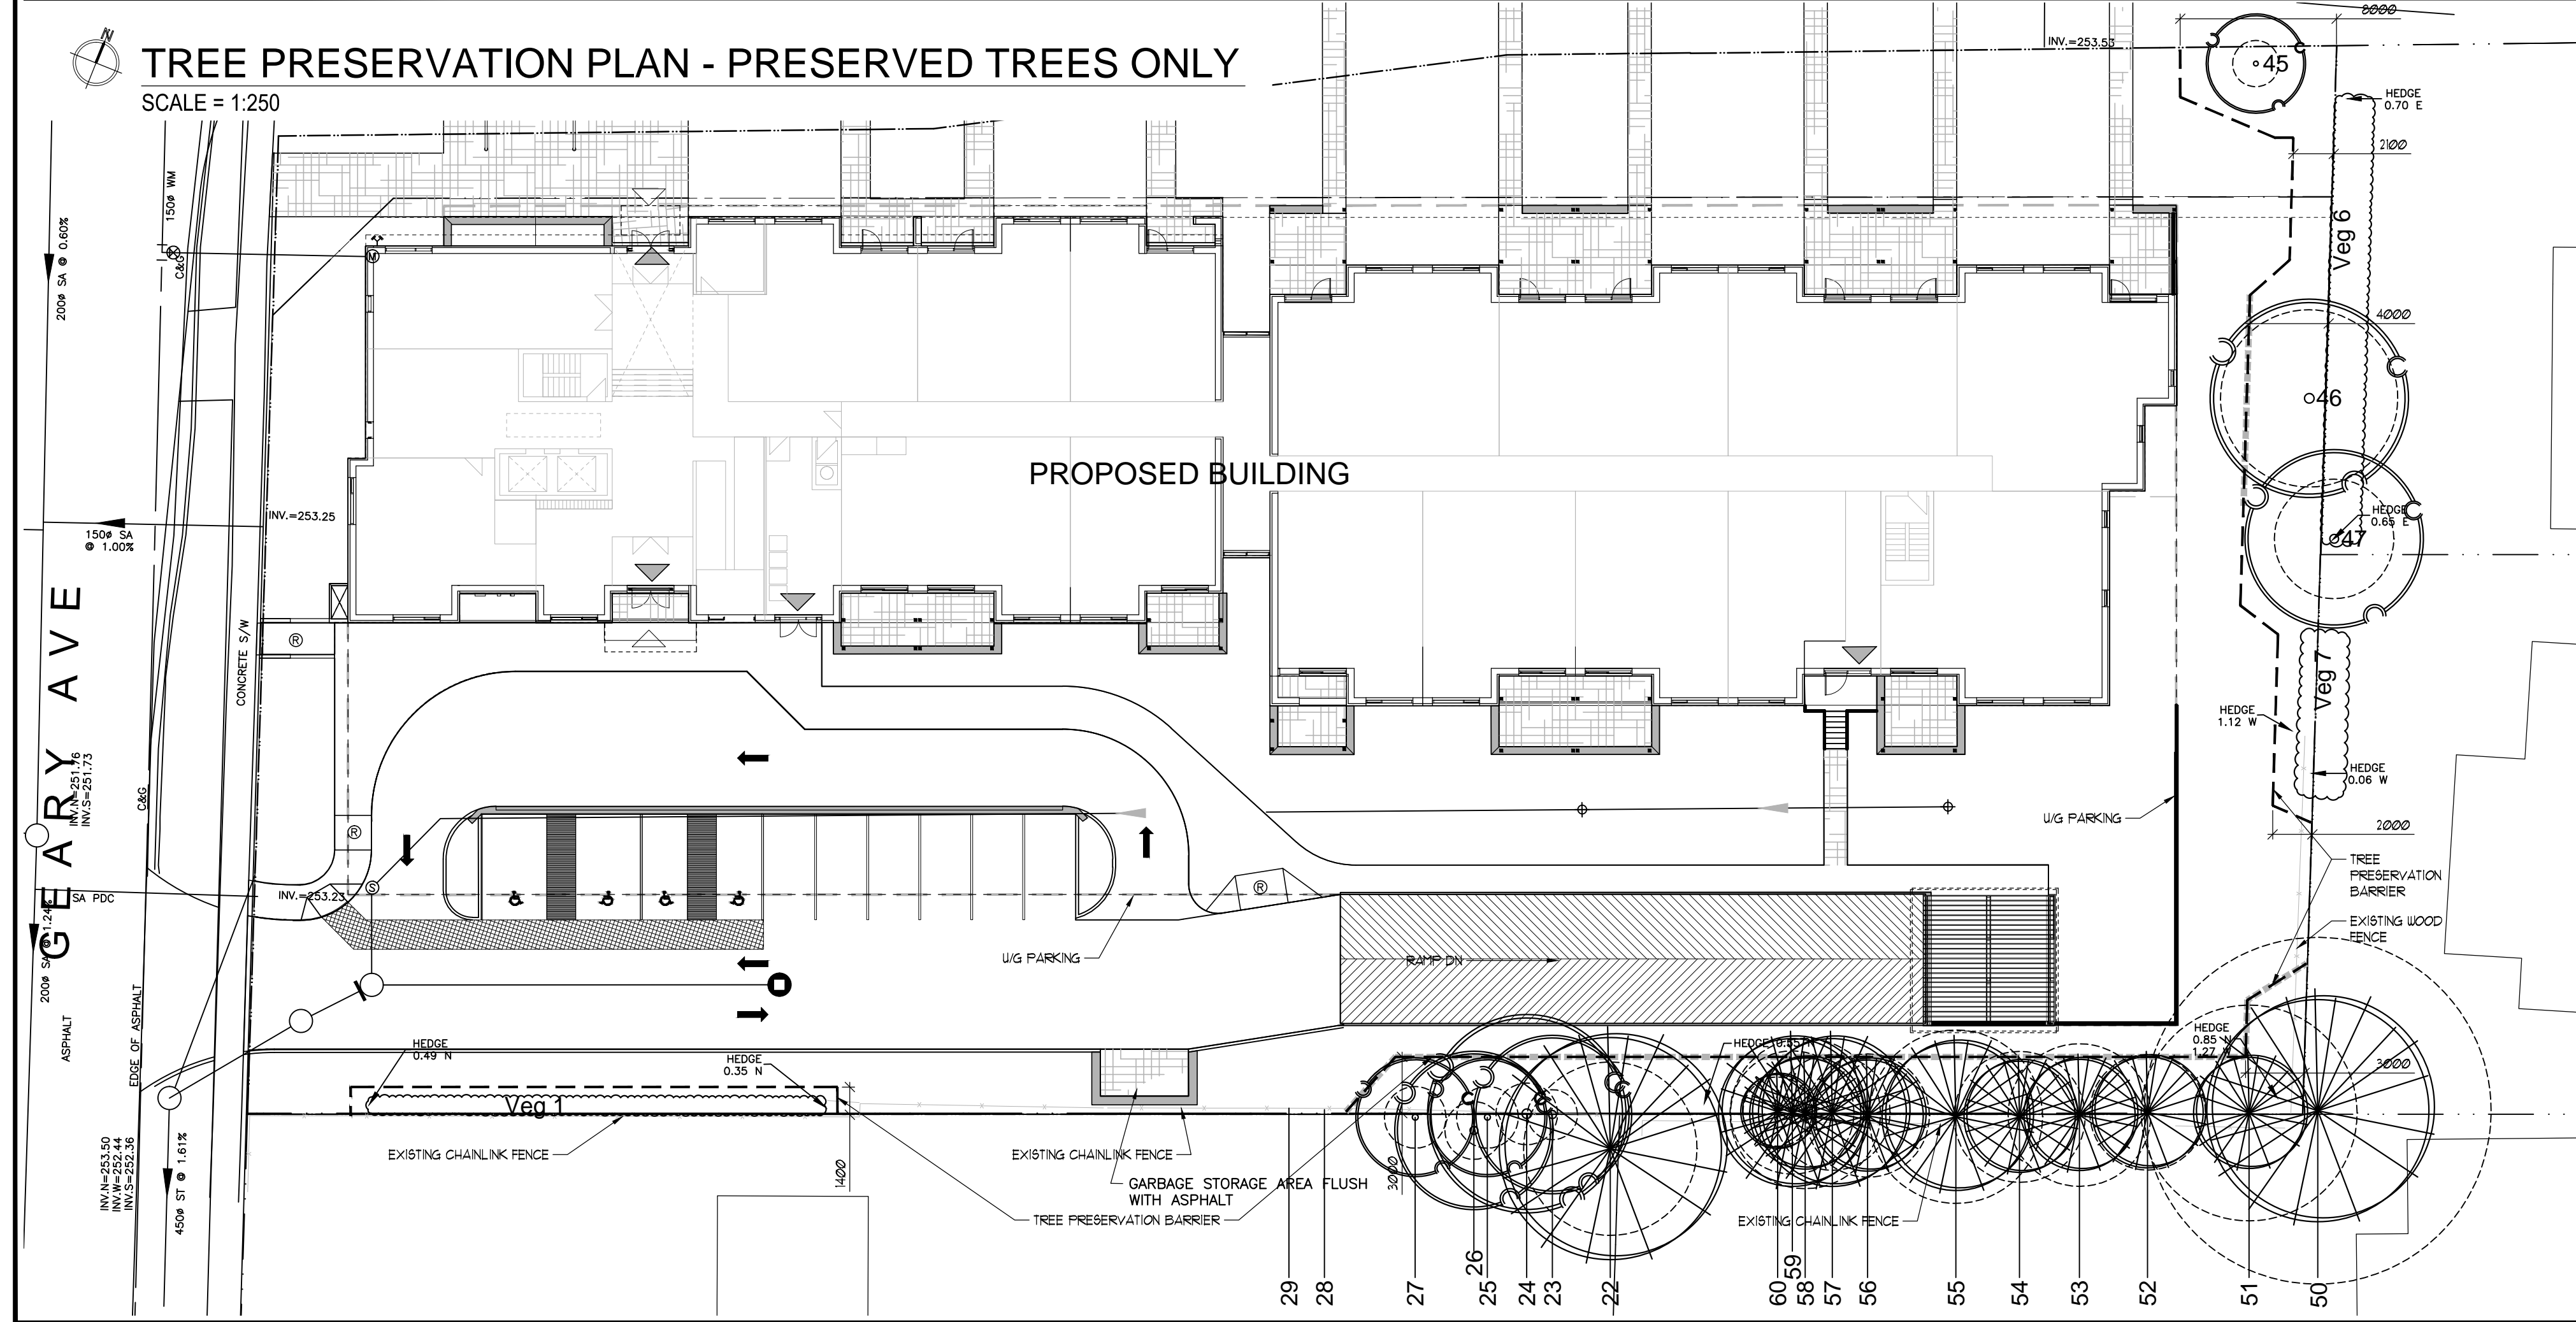
TREES & VEGETATION UNITS RECOMMENDED FOR PRESERVATION TREES (20), VEGETATION UNITS (3)
