16 WETHERED STREET
LONDON, ONTARIO
TREE ASSESSMENT REPORT FOR REZONING

PREPARED BY: RON KOUDYS LANDSCAPE
ARCHITECTS INC

DATE: NOVEMBER, 2020

RKLA PROJECT #: 20-233

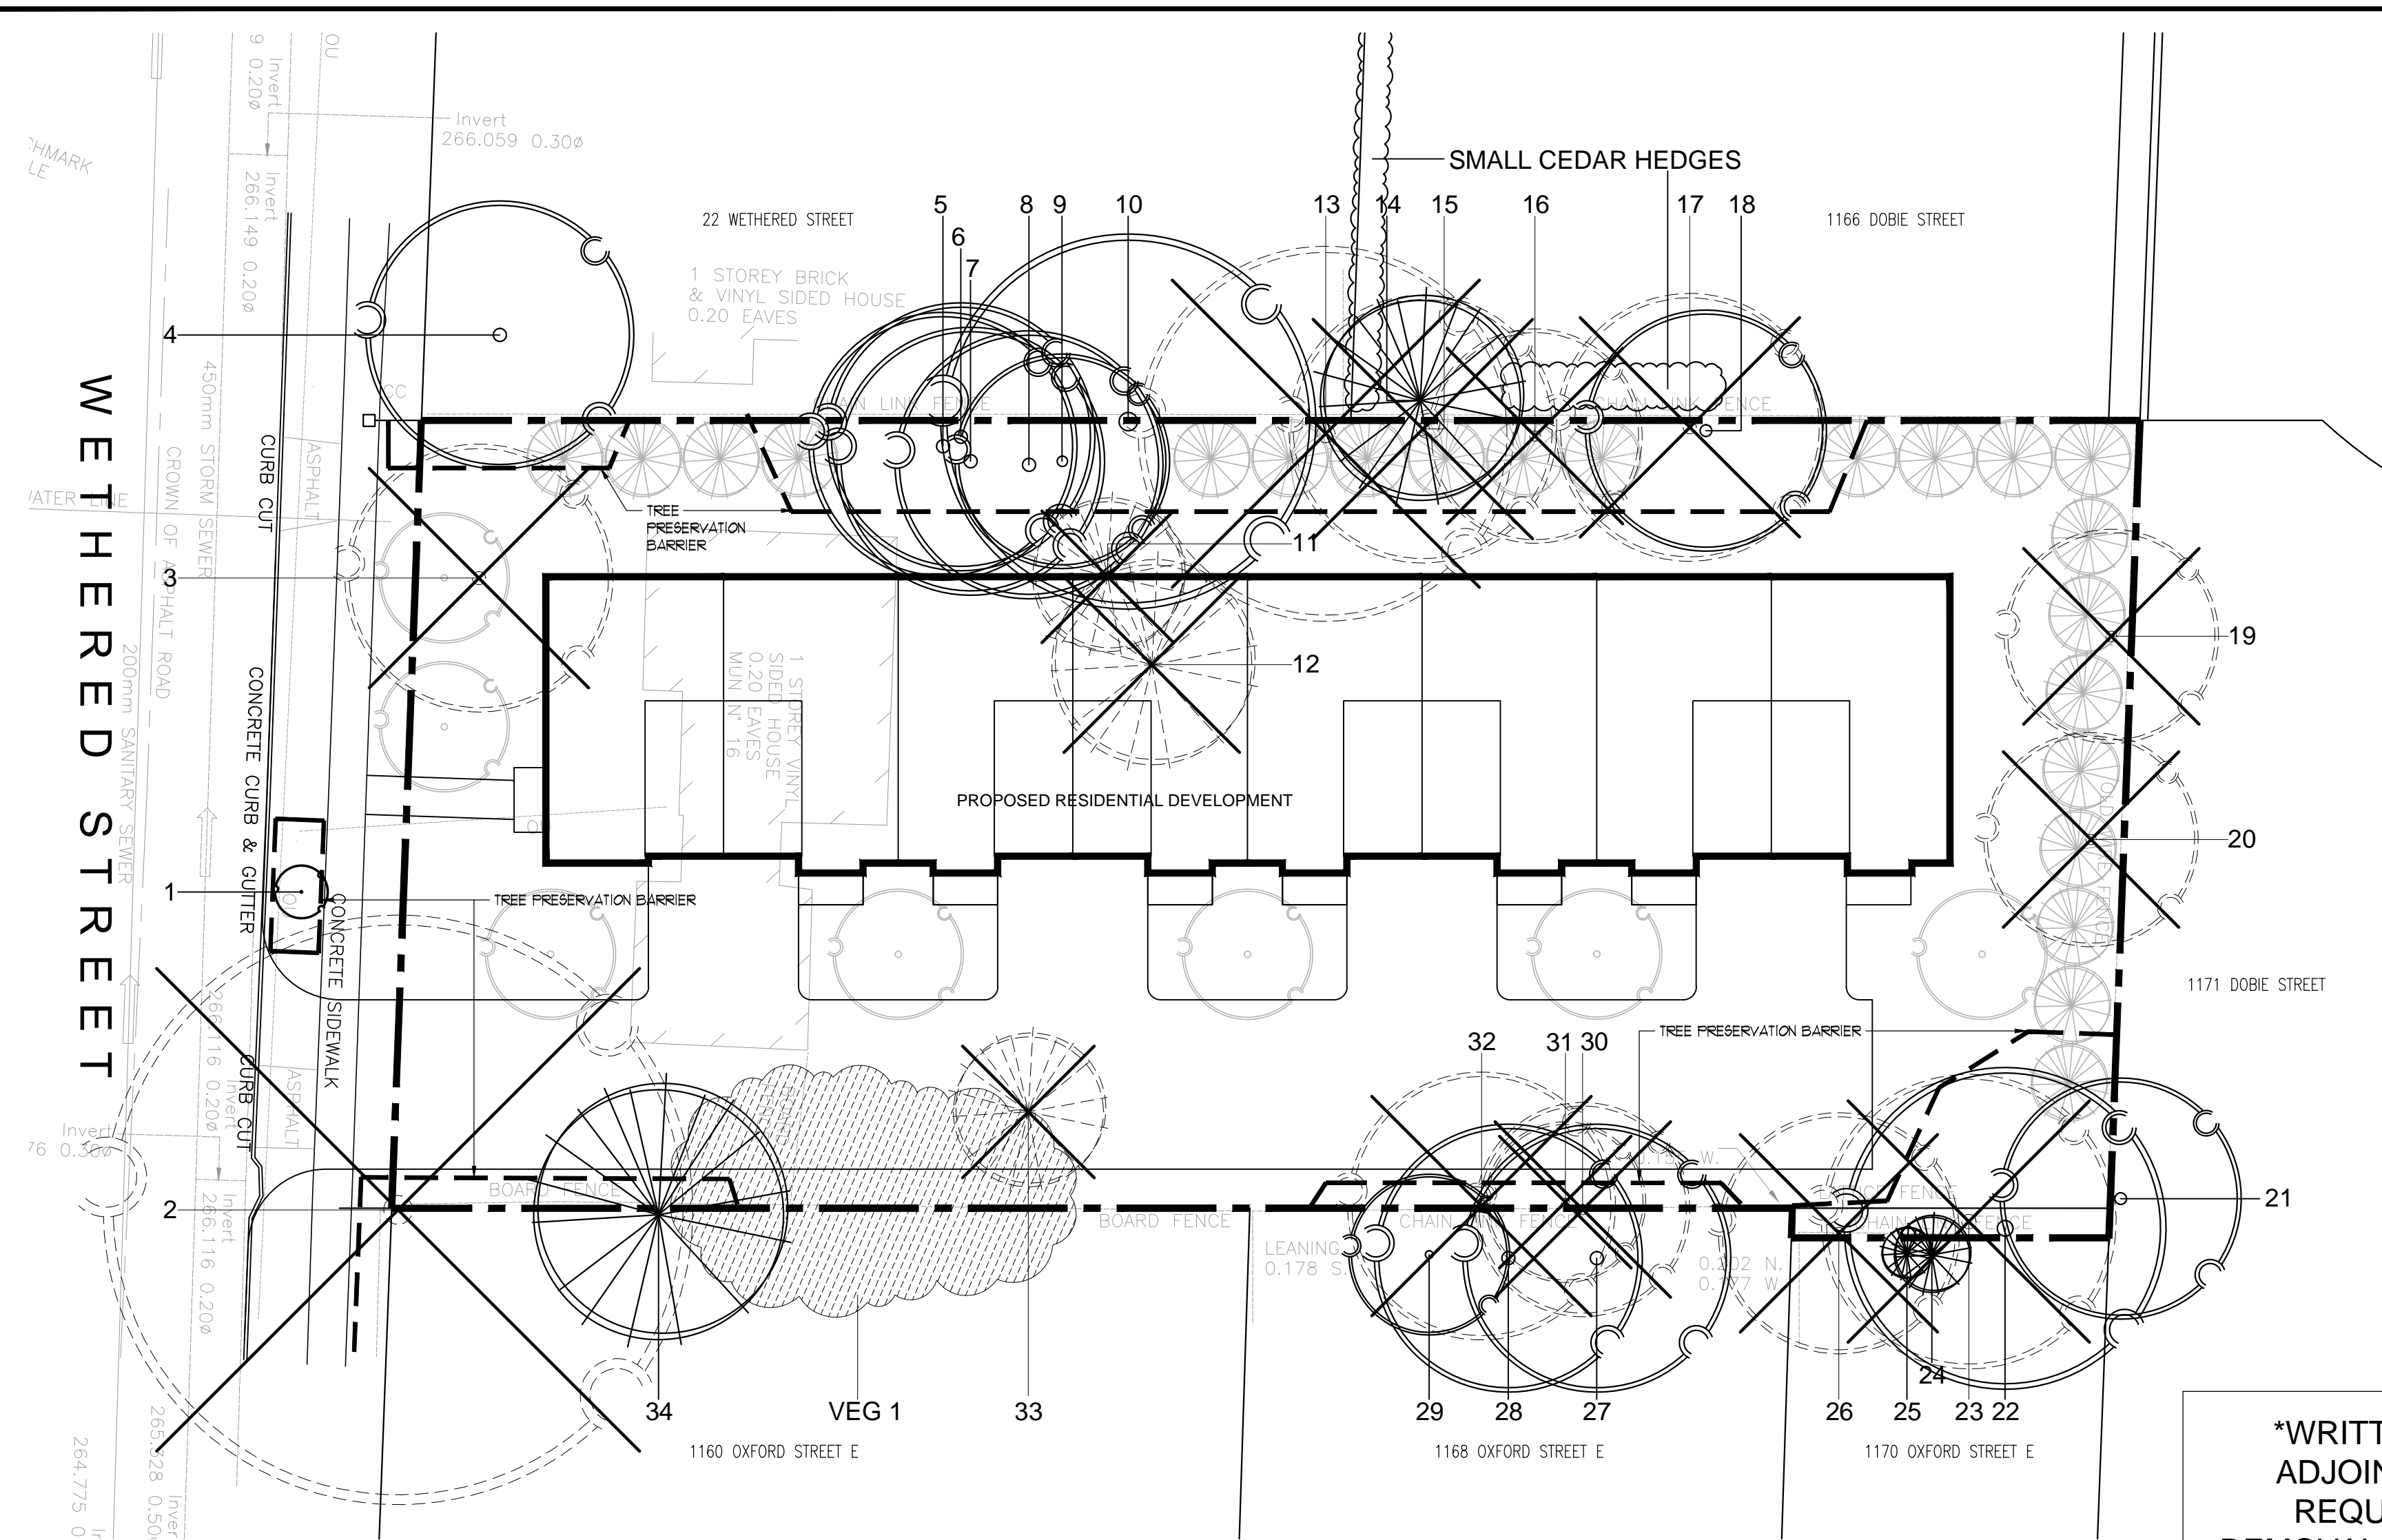
TREE PRESERVATION PLAN
SCALE = 1:200

WRITTEN CONSENT FROM ADJOINING LAND OWNERS REQUIRED FOR LAWFUL REMOVAL OF BOUNDARY TREES

NOTE THAT THE FOLLOWING TREES ARE BOUNDARY TREES, AND REQUIRE WRITTEN CONSENT FROM THE SHARED OWNER TO BE REMOVED: TREE #S 2, 23, 24, 30, 31 & 32
