2060 DUNDAS STREET
LONDON, ONTARIO
TREE ASSESSMENT REPORT
FOR REZONING APPLICATION

DATE: JULY 2021

REVISED: MAY 2022

RKLA PROJECT #: 20-245

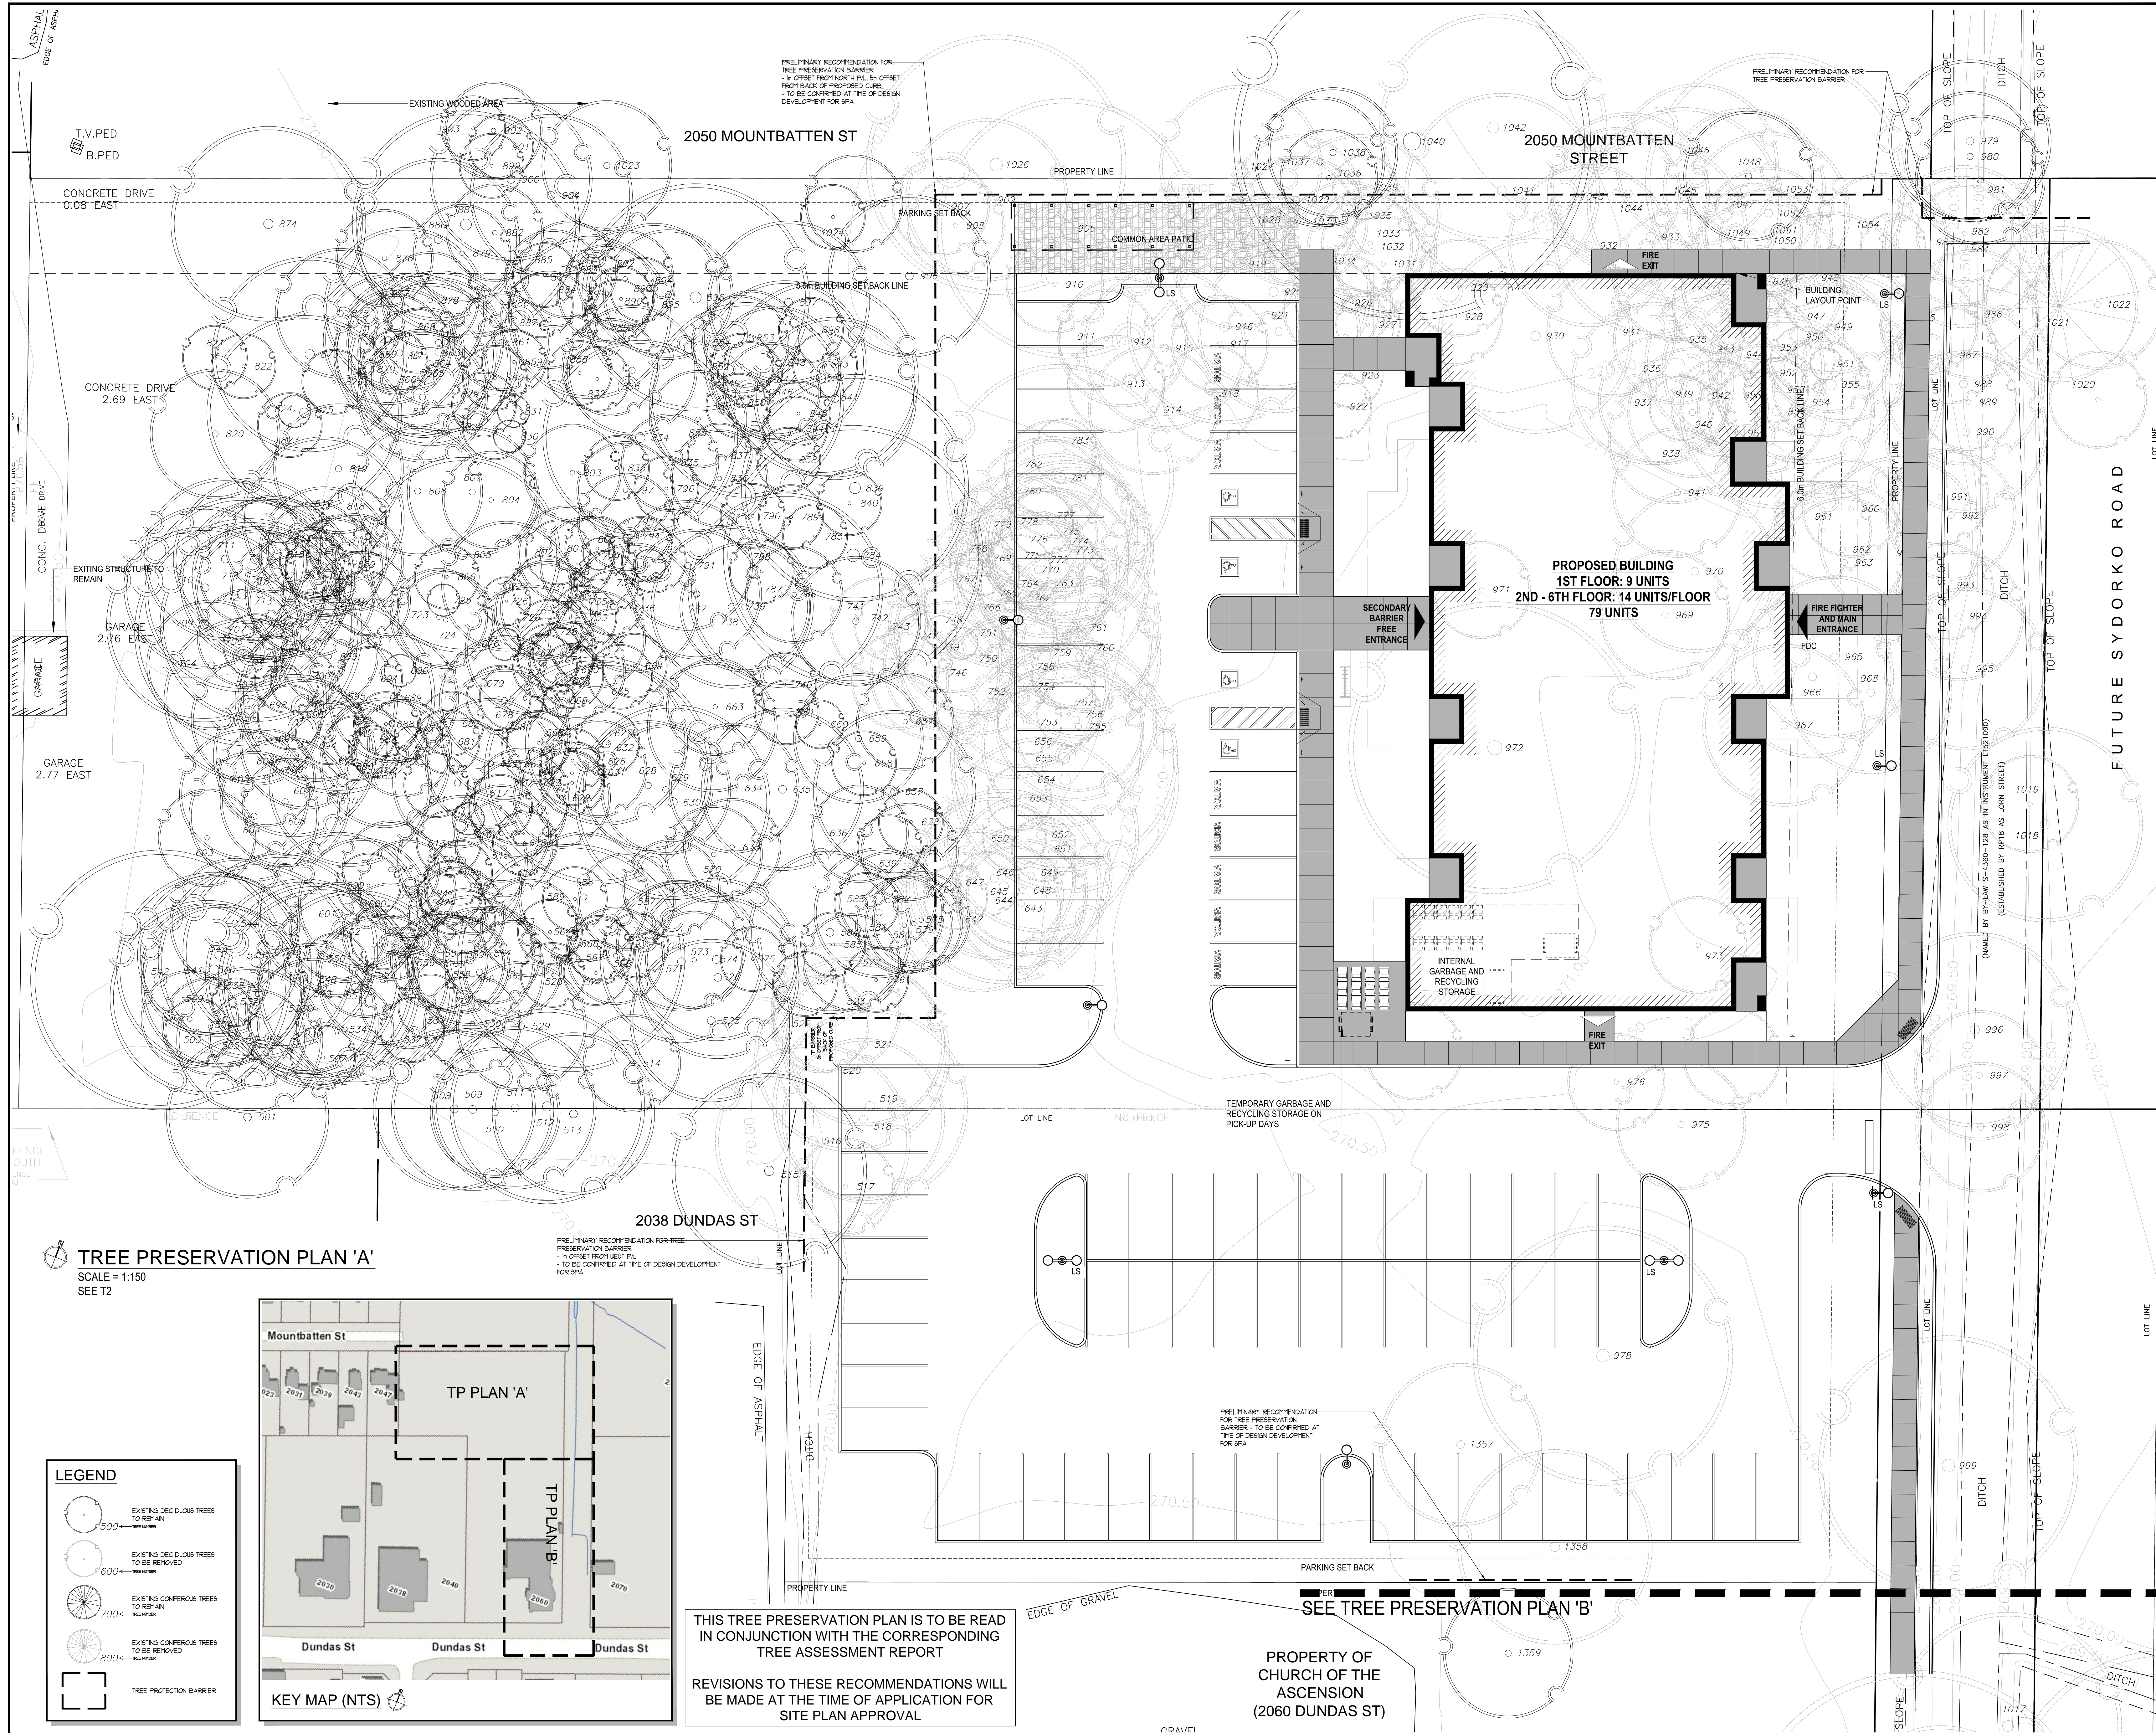
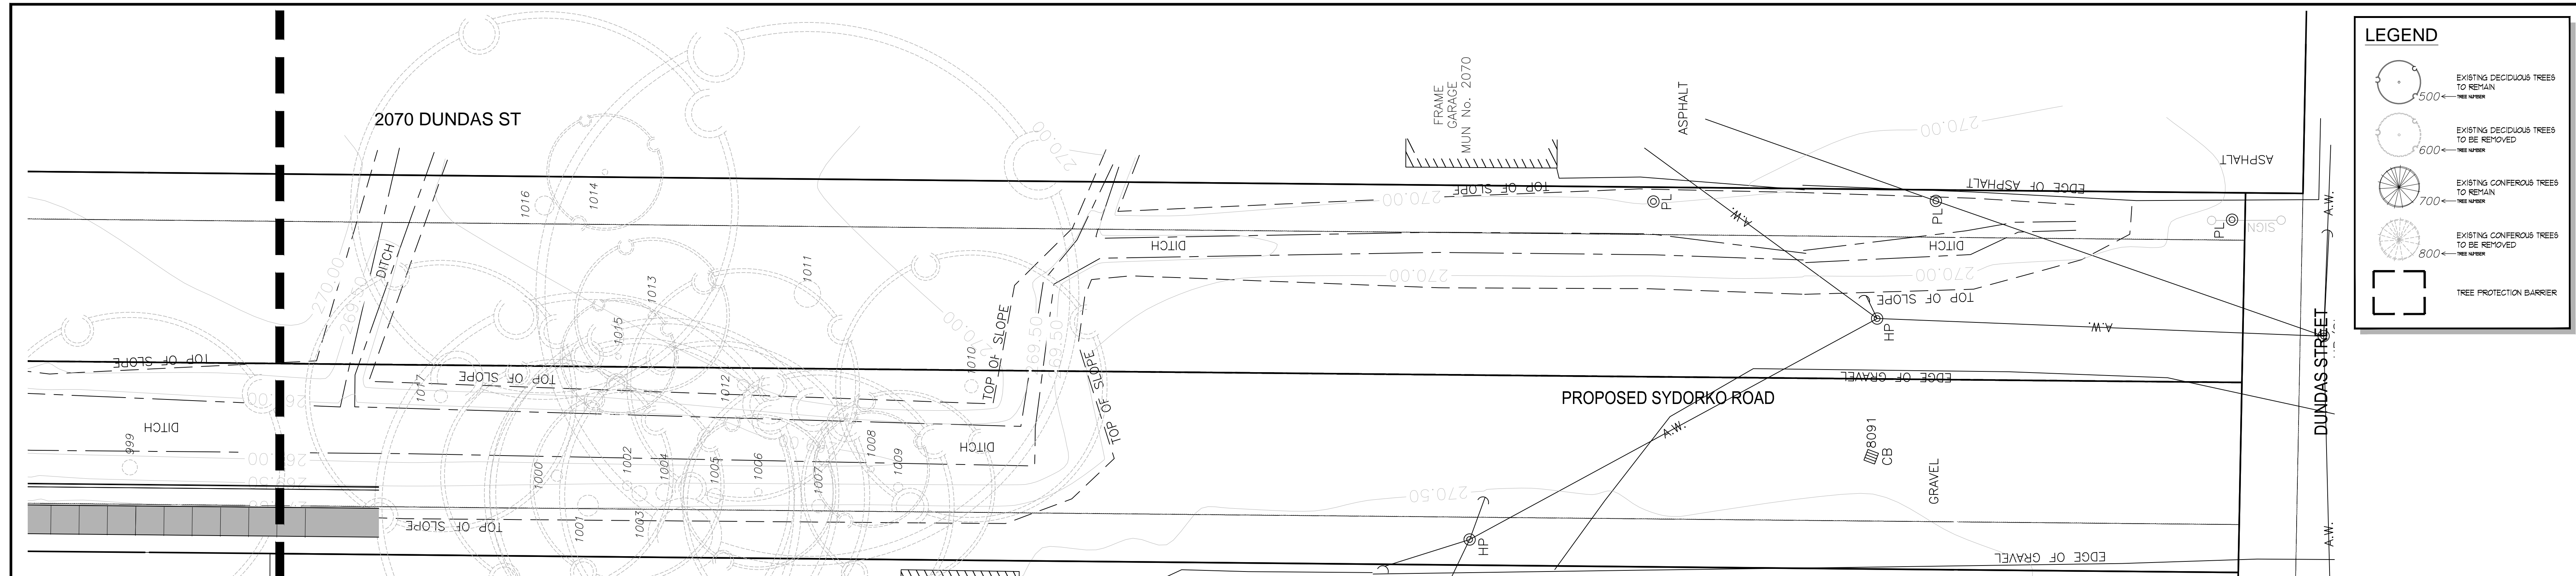
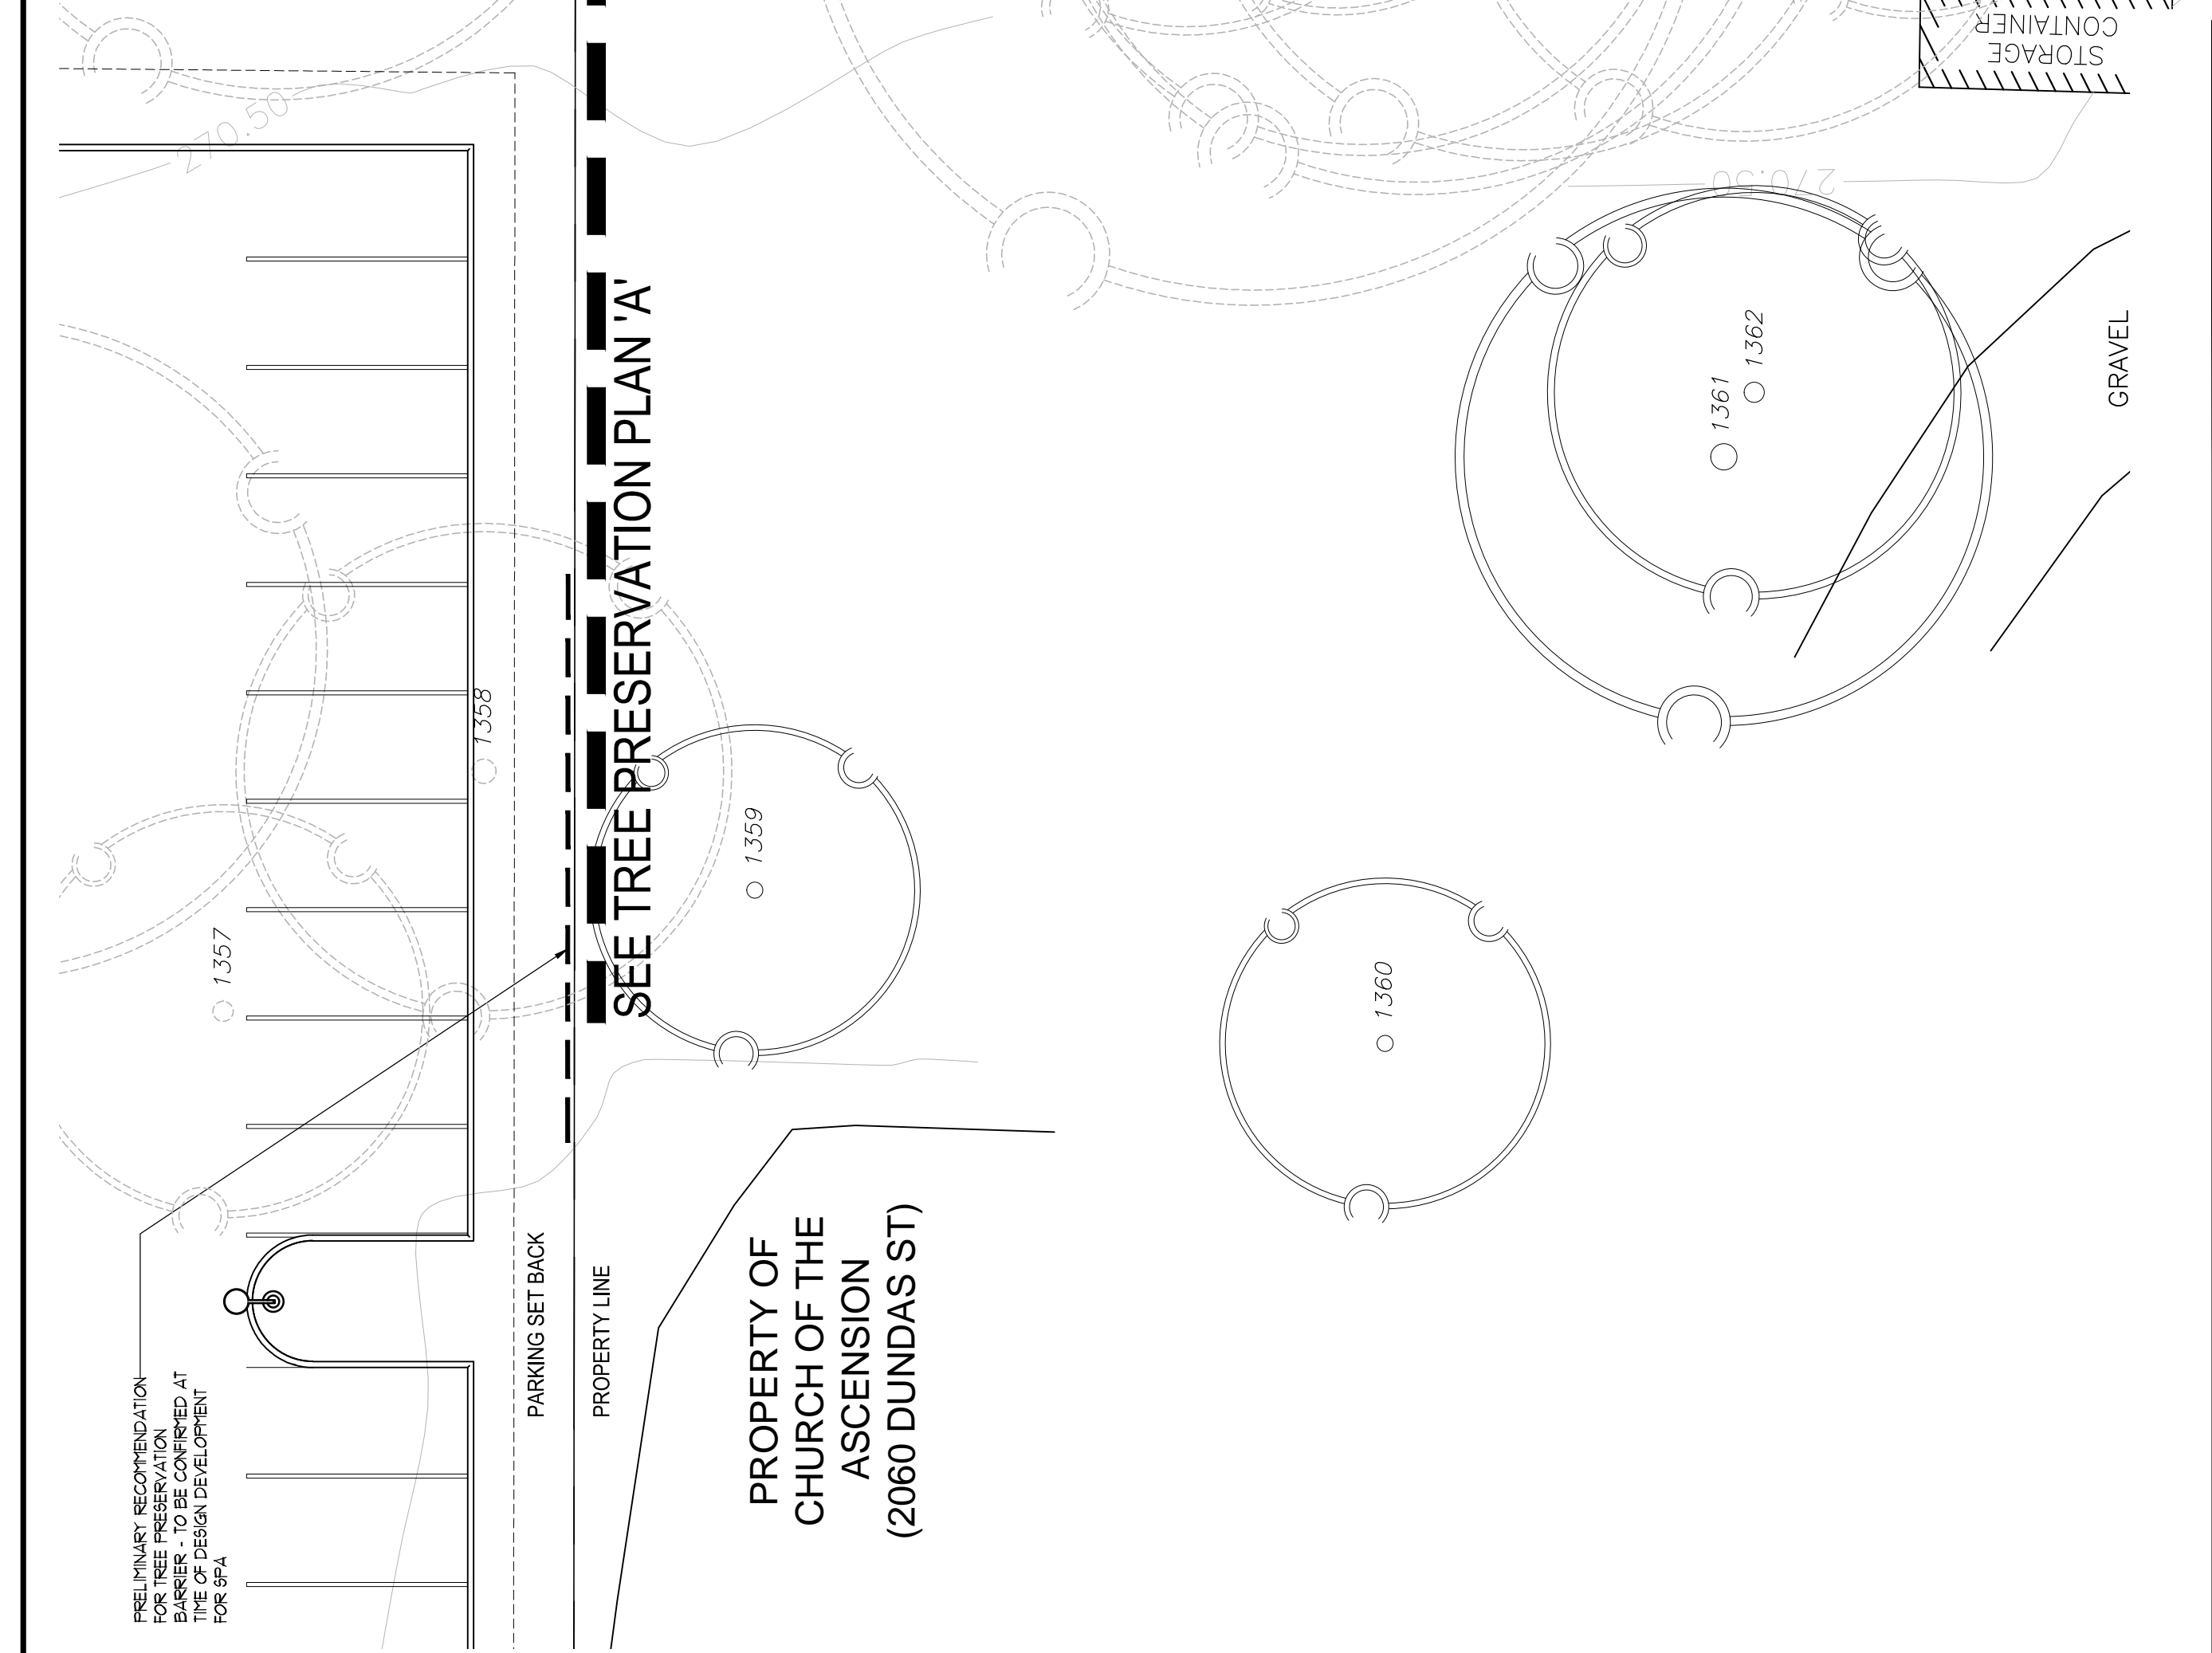
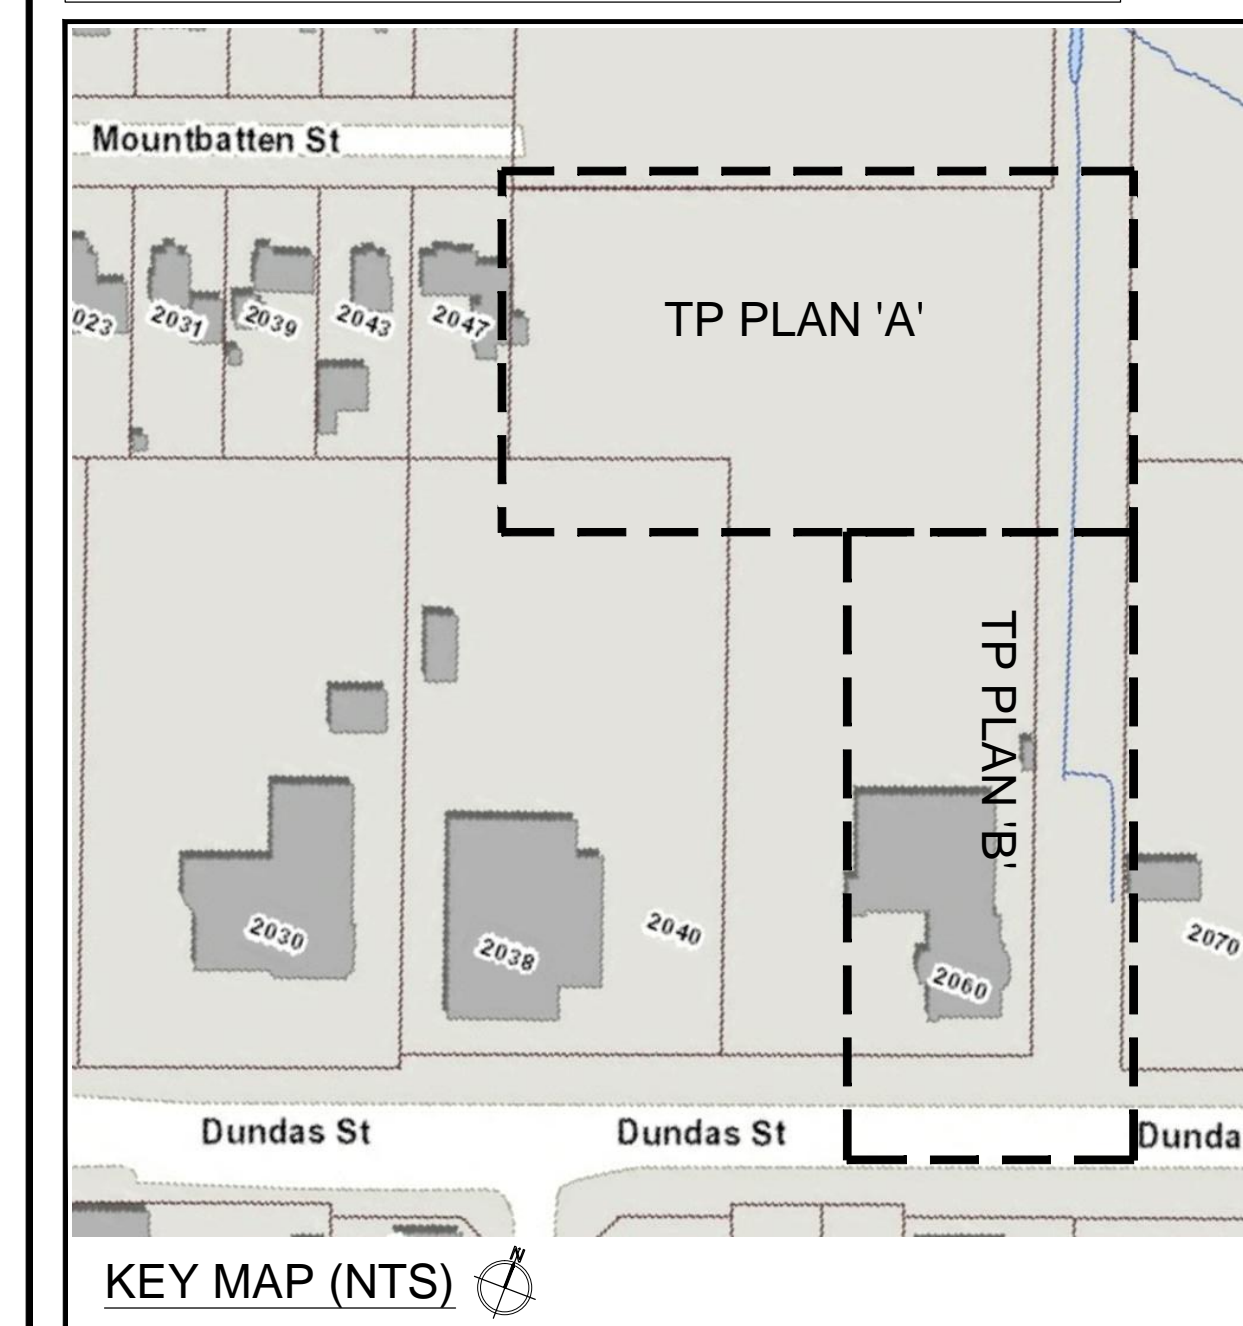
TREE PRESERVATION PLAN 'A'

TREES RECOMMENDED FOR REMOVAL (207 TREES) - TO BE CONFIRMED WITH APPLICATION FOR SPA

THIS TREE PRESERVATION PLAN IS TO BE READ IN CONJUNCTION WITH THE CORRESPONDING TREE ASSESSMENT REPORT

REVISIONS TO THESE RECOMMENDATIONS WILL BE MADE AT THE TIME OF APPLICATION FOR SITE PLAN APPROVAL
