415 BOLER ROAD
LONDON, ONTARIO
TREE ASSESSMENT REPORT
FOR REZONING APPLICATION

PREPARED BY: RON KOUDYS LANDSCAPE
ARCHITECTS INC

DATE: JUNE, 2022

RKLA PROJECT #: 21-302

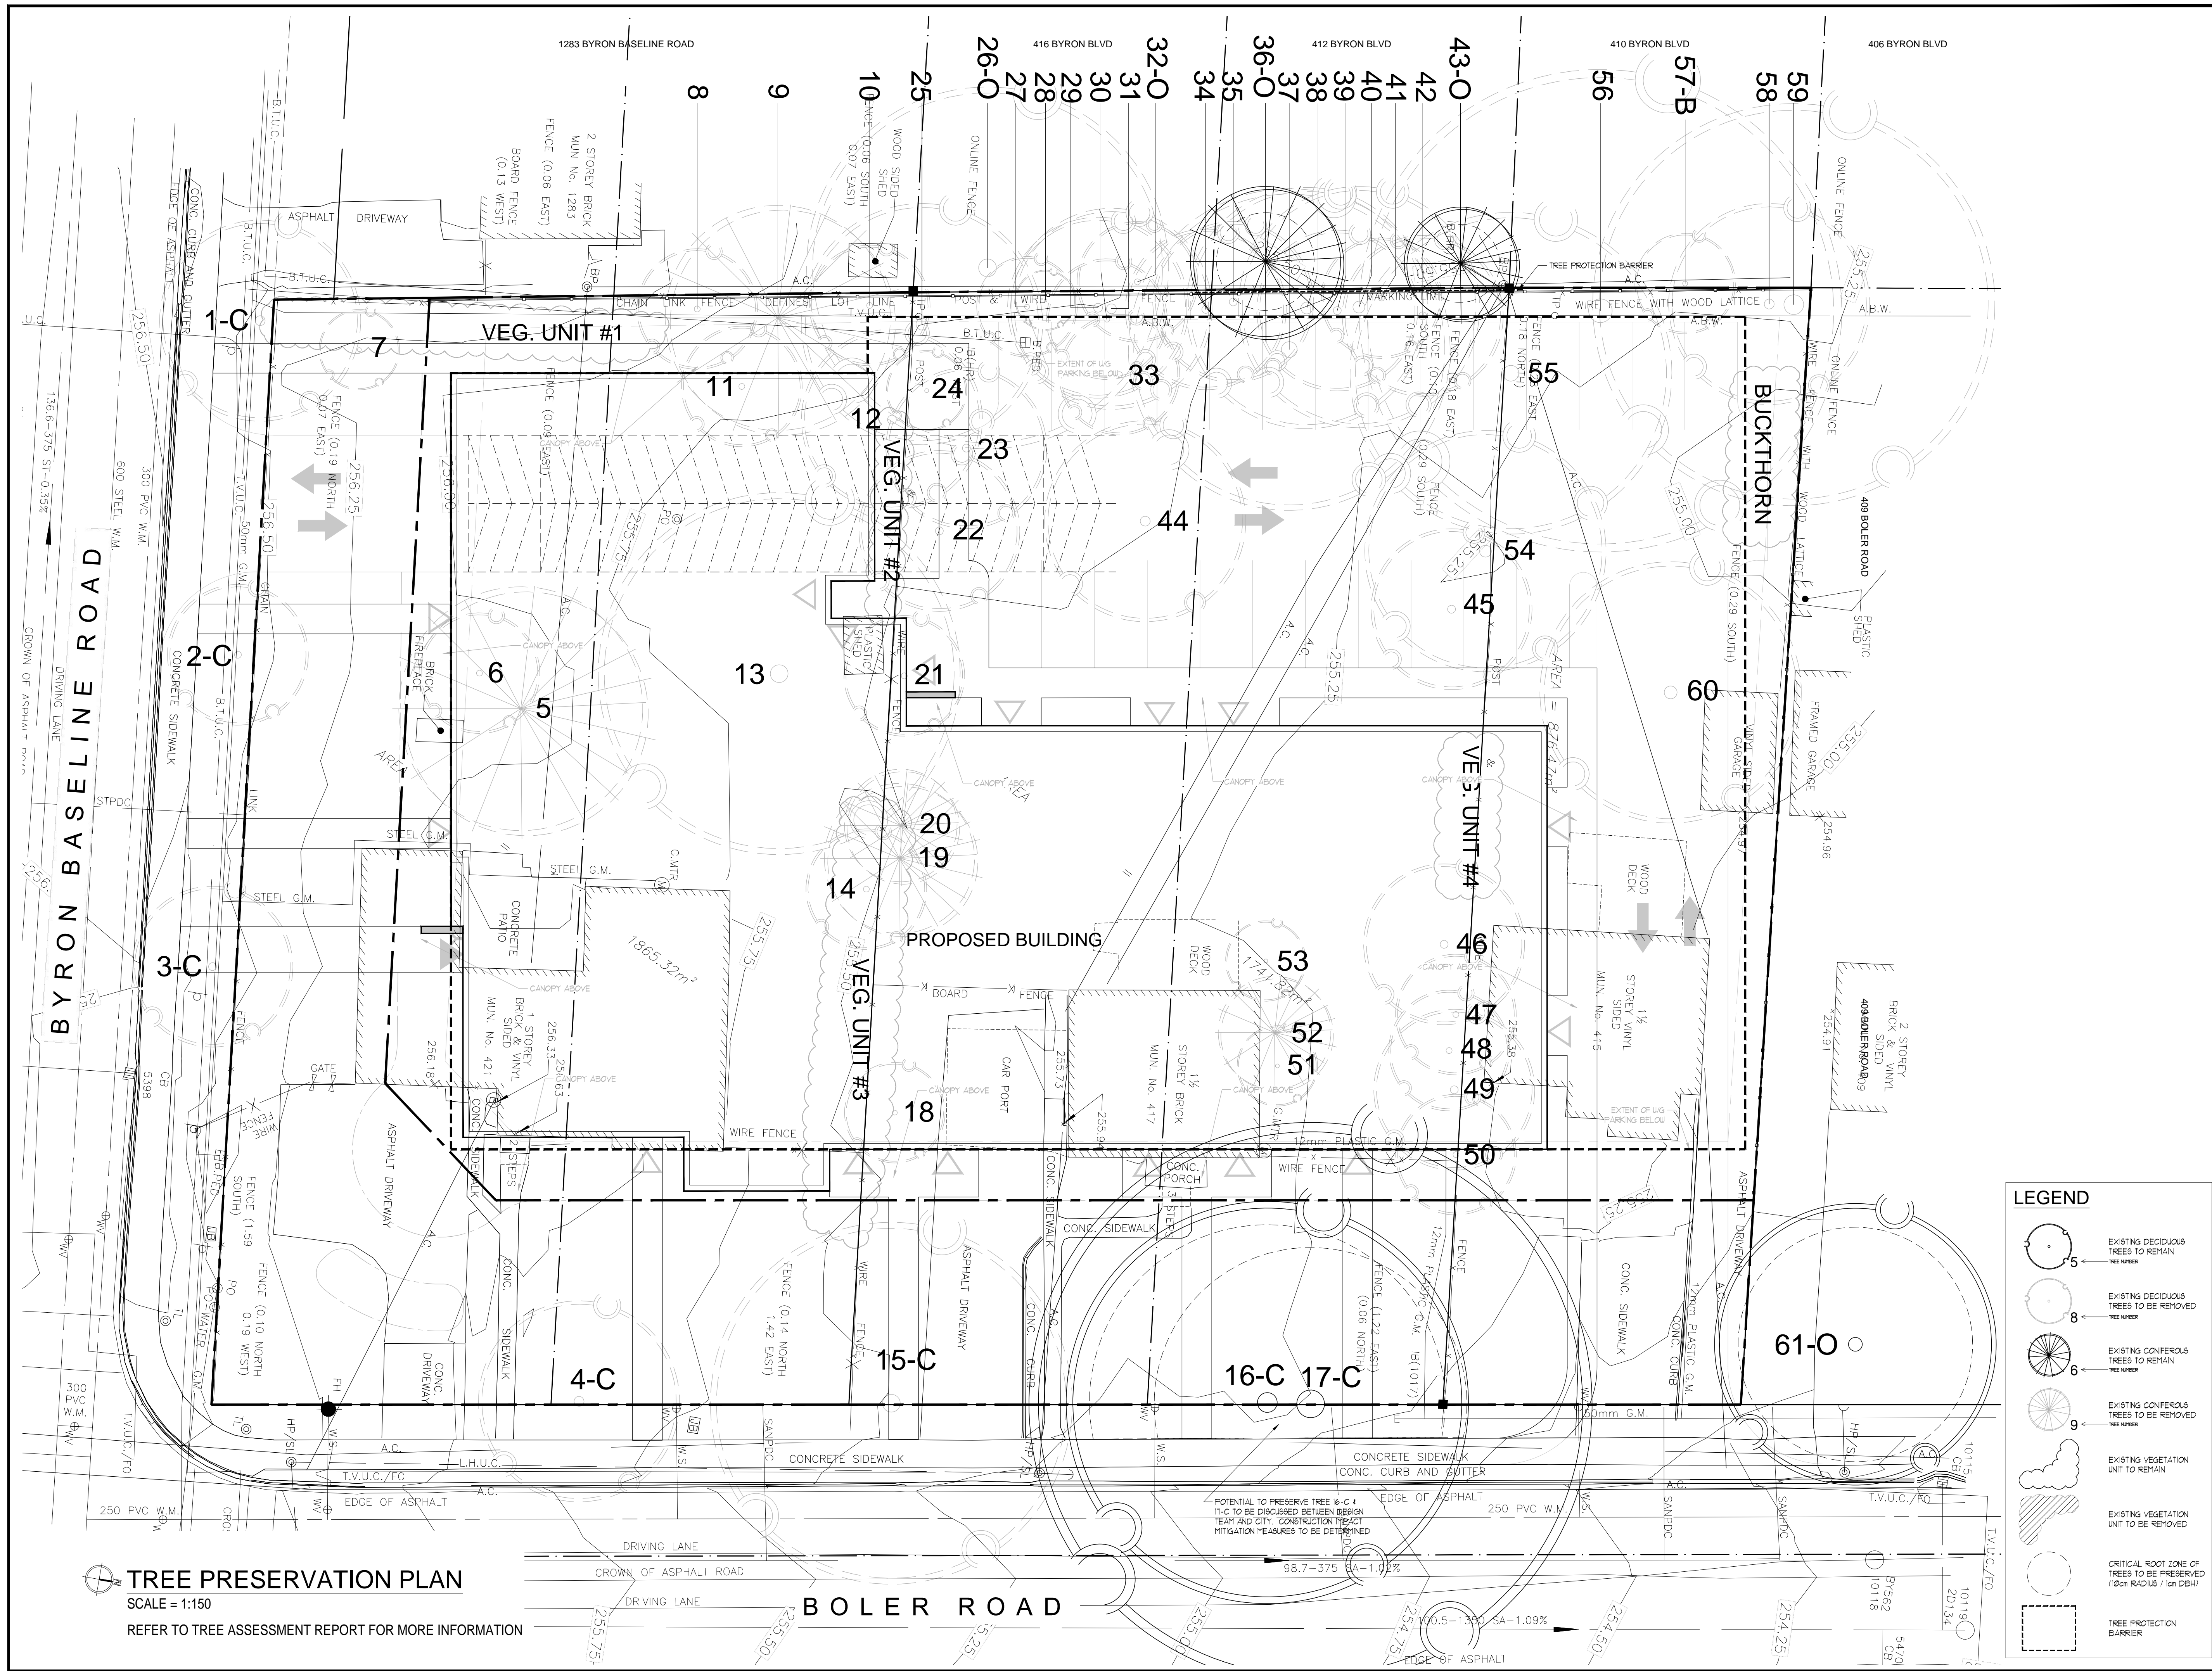
DATE: DECEMBER 2021	SCALE: AS NOTED	DRAWING No. T-1
DRAWN: RKL/A Inc.	CHECKED BY: BRM	
PROJECT No. 21-302Lk ZBA

- Removal of all trees and vegetation units from subject site due to direct conflict with proposed site plan and expected site grading. 48 trees and 4 vegetation units.
- Removal of 5 trees from the City ROW due to conflict with proposed site plan - consent and coordination with City required at time of application for SPA.
- At time of application for SPA, acquire written consent from adjacent land owner(s) for the lawful removal of 3 boundary trees/trees beyond the subject site due to expected construction impacts.
- Design team and City to review and discuss potential to preserve 2 trees within the City ROW
- Preservation of 3 trees beyond the subject site.
- Follow pre, during, and post construction recommendations outlined in the Construction Impact Mitigation Recommendations in this report

- a) Prior to any construction activity, tree preservation fencing is to be installed as per the attached tree preservation drawings and detail.
- b) Trees approved for removal are to be clearly indicated in the field (marked with spray paint or other agreed upon method) by the project arborist or landscape architect prior to any tree removal operations. All removals to be undertaken by an ISA certified arborist.
