1176 Crumlin Sideroad

Tree Preservation Report

February 9, 2023

MTE File No.: 51594-100

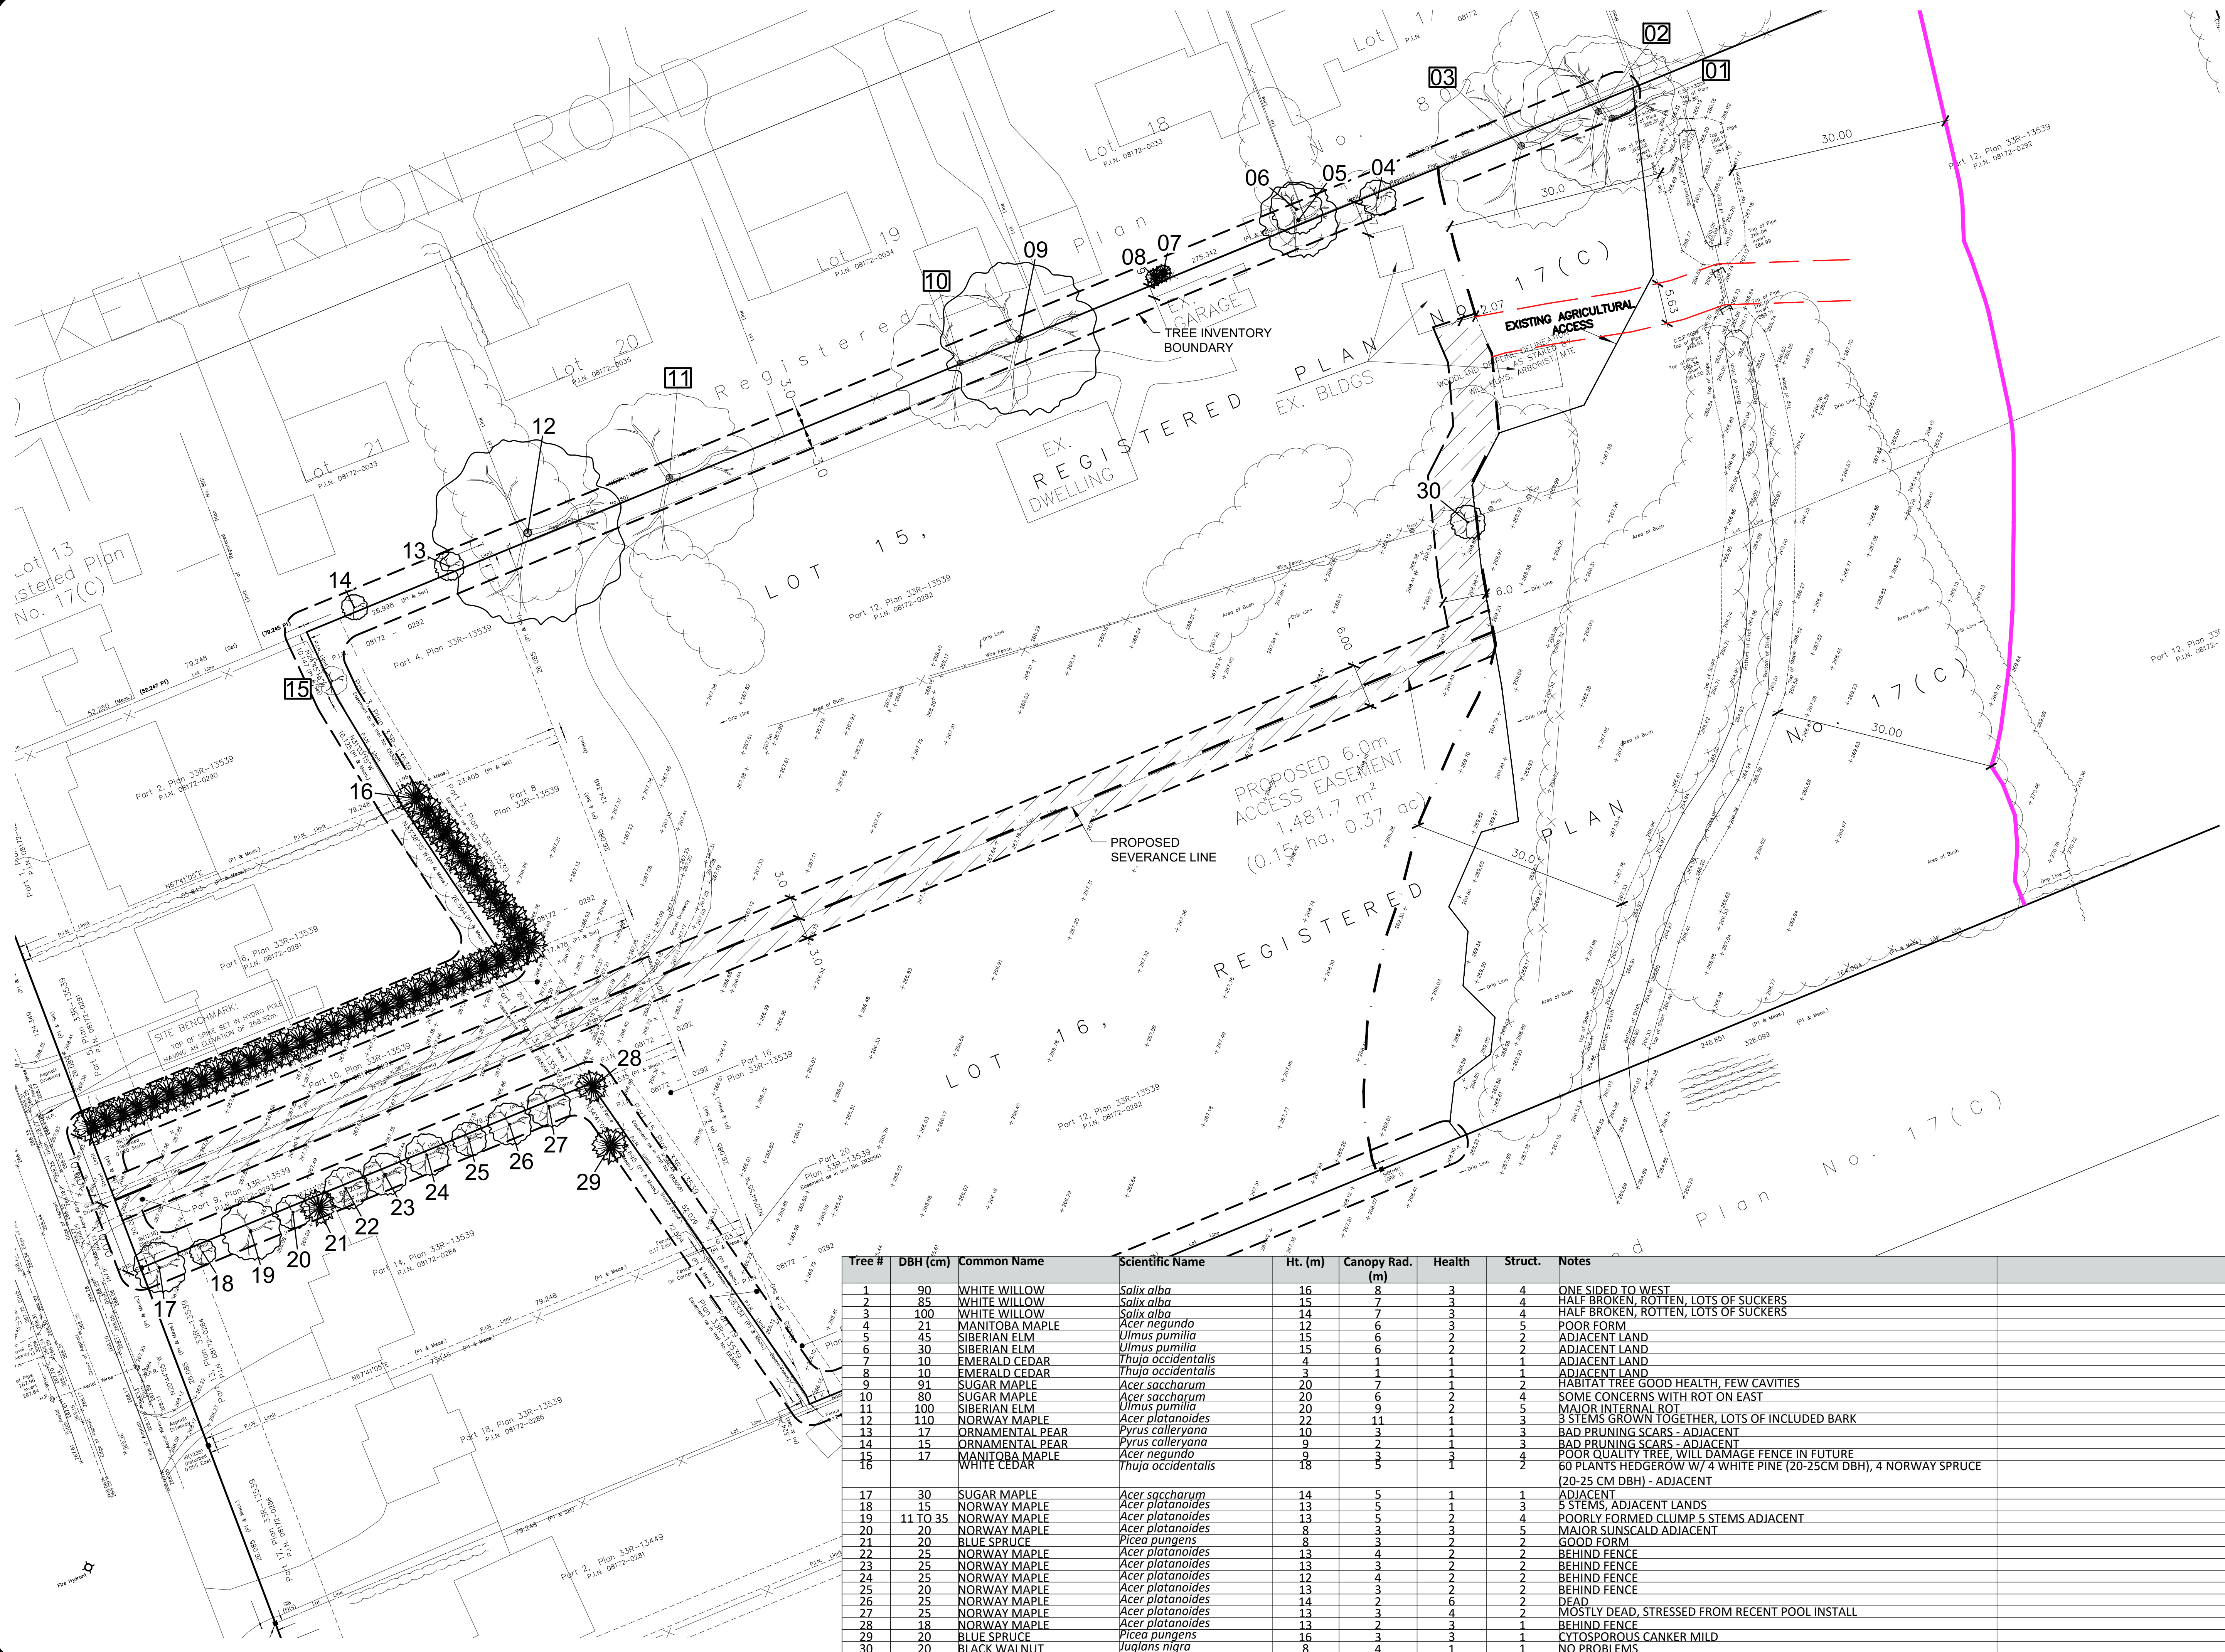
DRAWING
TREE INVENTORY PLAN

Tree 10 is a large Sugar Maple that has exposed, decaying, heartwood on the east side of the trunk. Potential trunk failure is a concern.

Tree 11 is a large Siberian Elm exhibiting major internal rot that is weakening the structure of the tree. Potential trunk failure is a concern.

Tree #	DBH (cm)	Common Name	Scientific Name	Ht. (m)	Canopy Rad. (m)	Health	Struct.	Notes
1	90	WHITE WILLOW	<i>Salix alba</i>	16	8	3	4	ONE SIDED TO WEST
2	85	WHITE WILLOW	<i>Salix alba</i>	15	7	3	4	HALF BROKEN, ROTTEN, LOTS OF SUCKERS
3	100	WHITE WILLOW	<i>Salix alba</i>	14	7	3	4	HALF BROKEN, ROTTEN, LOTS OF SUCKERS
4	21	MANITоба MAPLE	<i>Acer negundo</i>	12	6	2	5	POOR FORM
5	45	SIBERIAN ELM	<i>Ulmus pumila</i>	15	6	2	2	ADJACENT LAND
6	30	SIBERIAN ELM	<i>Ulmus pumila</i>	15	6	2	2	ADJACENT LAND
7	10	EMERALD CEDAR	<i>Thuja occidentalis</i>	4	1	1	1	ADJACENT LAND
8	10	EMERALD CEDAR	<i>Thuja occidentalis</i>	3	1	1	1	ADJACENT LAND
9	91	SUGAR MAPLE	<i>Acer saccharum</i>	20	7	1	2	HABITAT TREE GOOD HEALTH, FEW CAVITIES
10	80	SUGAR MAPLE	<i>Acer saccharum</i>	20	6	2	4	SOME CONCERNS WITH ROT ON EAST
11	100	SIBERIAN ELM	<i>Ulmus pumila</i>	20	9	2	5	MAJOR INTERNAL ROT
12	110	NORWAY MAPLE	<i>Acer platanoides</i>	22	11	1	3	3 STEMS GROWN TOGETHER, LOTS OF INCLUDED BARK

13	17	ORNAMENTAL PEAR	<i>Pyrus calleryana</i>	10	3	1	3	BAD PRUNING SCARS - ADJACENT
14	15	ORNAMENTAL PEAR	<i>Pyrus calleryana</i>	9	2	1	3	BAD PRUNING SCARS - ADJACENT
15	17	MANITоба MAPLE	<i>Acer negundo</i>	9	3	3	4	POOR QUALITY TREE, WILL DAMAGE FENCE IN FUTURE
16		WHITE CEDAR	<i>Thuja occidentalis</i>	18	5	1	2	60 PLANTS HEDGEROW W/ 4 WHITE PINE (20-25CM DBH), 4 NORWAY SPRUCE (20-25 CM DBH) - ADJACENT
17	30	SUGAR MAPLE	<i>Acer saccharum</i>	14	5	1	1	ADJACENT
18	15	NORWAY MAPLE	<i>Acer platanoides</i>	13	5	1	3	5 STEMS, ADJACENT LANDS
19	11 TO 35	NORWAY MAPLE	<i>Acer platanoides</i>	13	5	2	4	POORLY FORMED CLUMP 5 STEMS ADJACENT
20	20	NORWAY MAPLE	<i>Acer platanoides</i>	8	3	3	5	MAJOR SUNSCALD ADJACENT
21	20	BLUE SPRUCE	<i>Picea pungens</i>	8	3	2	2	GOOD FORM
22	25	NORWAY MAPLE	<i>Acer platanoides</i>	13	4	2	2	BEHIND FENCE
23	25	NORWAY MAPLE	<i>Acer platanoides</i>	13	3	2	2	BEHIND FENCE
24	25	NORWAY MAPLE	<i>Acer platanoides</i>	12	4	2	2	BEHIND FENCE

25	20	NORWAY MAPLE	<i>Acer platanoides</i>	13	3	2	2	BEHIND FENCE
26	25	NORWAY MAPLE	<i>Acer platanoides</i>	14	2	6	2	DEAD
27	25	NORWAY MAPLE	<i>Acer platanoides</i>	13	3	4	2	MOSTLY DEAD, STRESSED FROM RECENT POOL INSTALL
28	18	NORWAY MAPLE	<i>Acer platanoides</i>	13	2	3	1	BEHIND FENCE
29	20	BLUE SPRUCE	<i>Picea pungens</i>	16	3	3	1	CYTOSPOROUS CANCKER MILD
30	20	BLACK WALNUT	<i>Juglans nigra</i>	8	4	1	1	NO PROBLEMS

Trees 1, 2 and 3 are overmature White Willow with a history of large limb failure which impacts the neighbour's property. These trees should be felled but the root balls should be left to regrow so they can continue to provide habitat and soil stabilization.

Tree 15 is a small Manitoba Maple growing at the base of the property fence on the north-west side of the property. This tree should be removed to prevent future damage to the fence.
