TREE PRESERVATION REPORT FOR ZONING BY-LAW AMENDMENT

**1982 COMMISSIONERS ROAD EAST
LONDON, ONTARIO**

Report prepared by
Ron Koudys Landscape Architects Inc

RKLA Project #23-155

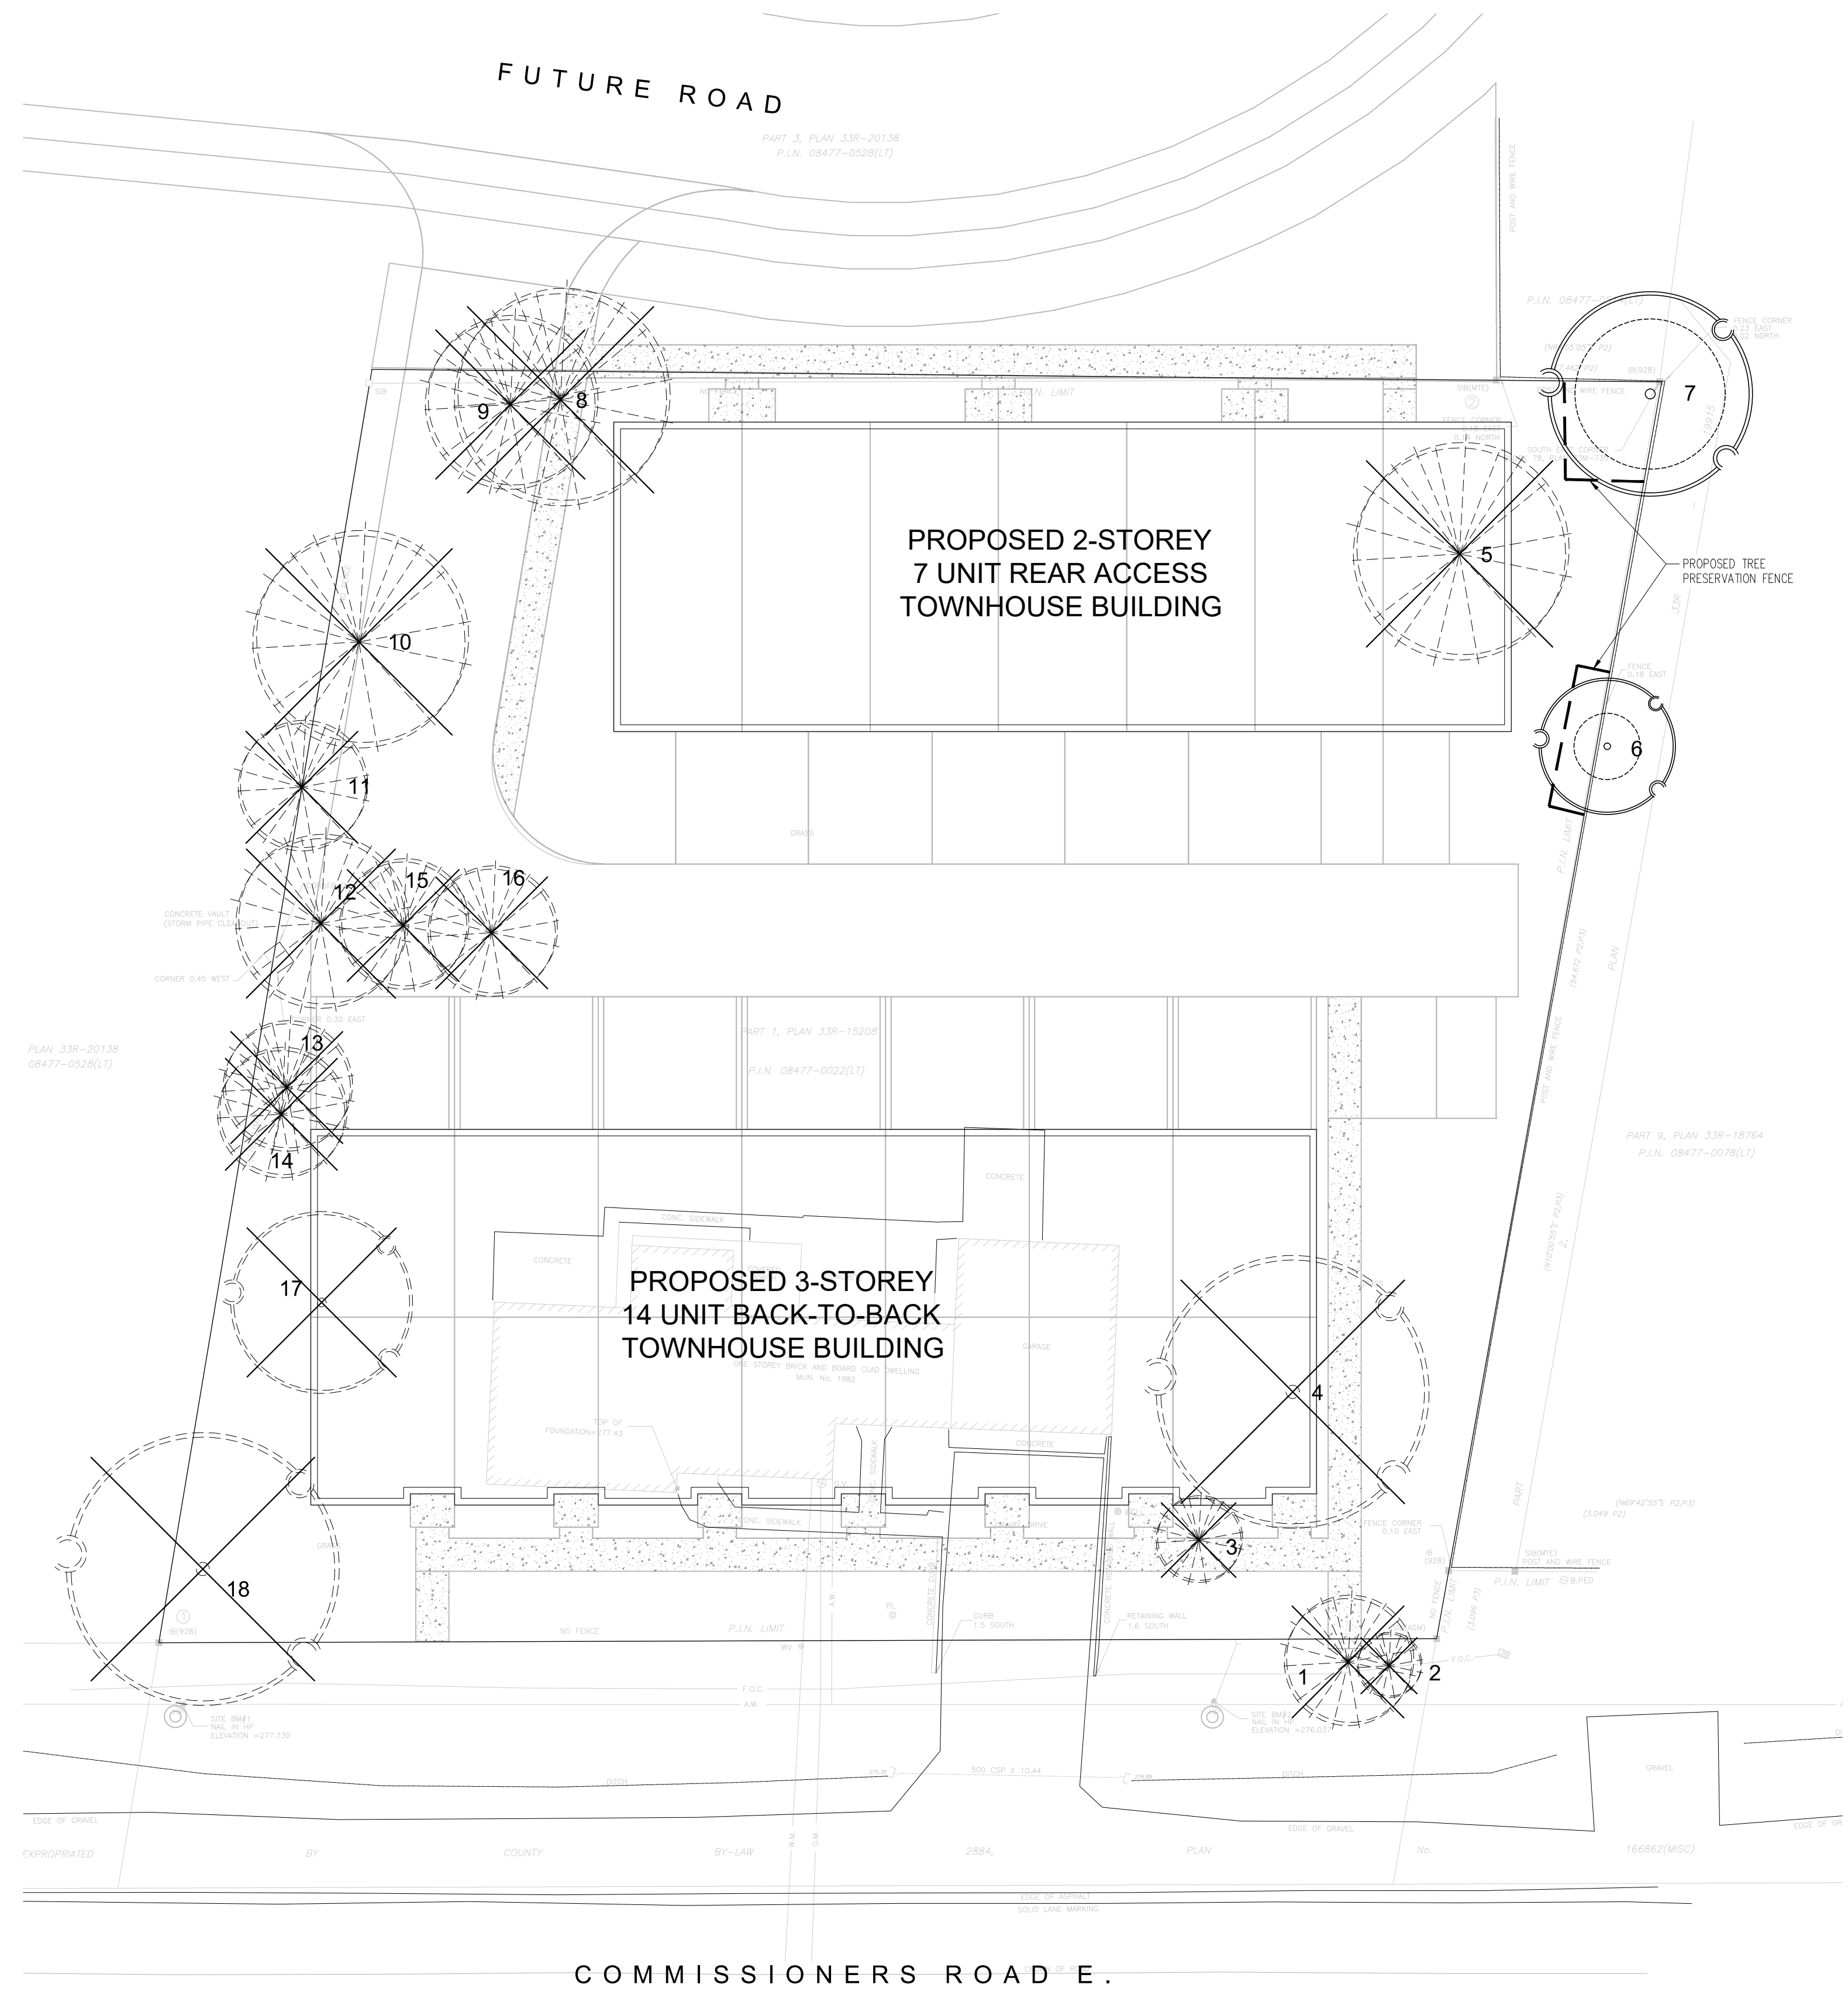
TREE PRESERVATION PLAN
SCALE = 1:200

TREES RECOMMENDED FOR REMOVAL (16)

GENERAL INFORMATION			SIZE		HEALTH & CONDITION			RECOMMENDATIONS				
ID #	BOTANICAL NAME	COMMON NAME	LOCATION	DBH (cm)	CANOPY RADIUS (m)	CROWN CONDITION	STRUCTURAL COMB	STRUCTURAL INTEGRITY	COMMENTS	EXPECTED CONSTRUCTION IMPACTS	RESERVE OR REMOVE	IMPACT MITIGATION / REMOVAL RATIONALE
1	<i>Pinus nigra</i>	Austrian Pine	City ROW Commissioners Road	41	3	1		Fully dead	conflict with proposed sidewalk entrance	remove	construction conflict and tree condition consent from the City of London Required	
2	<i>Pinus nigra</i>	Austrian Pine	City ROW Commissioners Road	26	15	1		Fully dead	conflict with proposed sidewalk entrance	remove	construction conflict and tree condition consent from the City of London Required	
3	<i>Pinus purgens</i> var. <i>glauca</i>	Colorado Blue Spruce	Subject Site	35	2	3	Fair	Fair	Sparse, dead branches, limbed up 2 meters	conflict with proposed building	remove	construction conflict and tree condition

4	<i>Acer platanoides</i>	Norway Maple	Subject Site	36	6	5	Fair	Good	Splitting and peeling bark on limbs, major wound on trunk	conflict with proposed building	remove	construction conflict
5	<i>Picea glauca</i>	White Spruce	Subject Site	-30	5	5	Good	Good	Branched to grade	conflict with proposed building	remove	construction conflict
8	<i>Picea abies</i>	Norway Spruce	Subject Site	63	5	4	Good	Good	Branched to grade	conflict with proposed road	remove	construction conflict
9	<i>Pinus strobus</i>	White Pine	Subject Site	31	4	3	Fair	Fair	Canopy present only in upper branches	conflict with proposed road	remove	construction conflict
10	<i>Picea abies</i>	Norway Spruce	Subject Site	82	5	4	Good	Good	Branched to grade	conflict with proposed road	remove	construction conflict
11	<i>Pinus</i> spp.	Pine	Boundary subject site and 1964 Commissioners Road East	30	3	1			Fully dead	conflict with proposed road	remove	construction conflict consent for removal is required from 1964 Commissioners Road East

12	<i>Picea glauca</i>	White Spruce	Subject Site	45	4	3	Fair	Fair	Sparse crown, epicormic growth, fruiting bodies on trunk	conflict with proposed road	remove	construction conflict
13	<i>Pinus nigra</i>	Austrian Pine	Subject Site	52	3	2	Fair	Fair	Broken lower branches, minor wounds on trunk	conflict with proposed road	remove	construction conflict
14	<i>Pinus nigra</i>	Austrian Pine	Subject Site	28	3	2	Fair	Fair	Broken lower branches, minor wounds on trunk	conflict with proposed road	remove	construction conflict
15	<i>Picea glauca</i>	White Spruce	Subject Site	35	3	3	Fair	Good	Limbed up 3 meters, sparse	conflict with proposed road	remove	construction conflict
16	<i>Picea glauca</i>	White Spruce	Subject Site	34	3	3	Fair	Good	Limbed up 3 meters, sparse	conflict with proposed road	remove	construction conflict
17	<i>Pinus</i> spp.	Pear	Subject Site	80	4	4	Poor	Fair	Large cavity at base to 15 meters, west side of canopy sparse	conflict with proposed building	remove	construction conflict

18	<i>Calatpa speciosa</i>	Calatpa	Subject Site	89	6	3	Poor	Fair	Multiple dead limbs, sparse, sloughing bark	conflict with critical root zone and proposed building	remove	tree condition & construction conflict

TREES RECOMMENDED FOR PRESERVATION (2)

GENERAL INFORMATION			SIZE		HEALTH & CONDITION			RECOMMENDATIONS				
ID #	BOTANICAL NAME	COMMON NAME	LOCATION	DBH (cm)	CANOPY RADIUS (m)	CROWN CONDITION	STRUCTURAL COMB	STRUCTURAL INTEGRITY	COMMENTS	EXPECTED CONSTRUCTION IMPACTS	RESERVE OR REMOVE	IMPACT MITIGATION / REMOVAL RATIONALE
6	<i>Acer negundo</i>	Manitoba Maple	1990 Commissioners Road East	75, 10	3	5	Fair	Good	Multi-stem 2, low primary union	possible impacts from grading requirements	preserve	tree preservation barrier
7	<i>Acer saccharum</i>	Sugar Maple	Subject Site	34	45	4	Good	Good	Full form	possible impacts from grading requirements	preserve	tree preservation barrier
