TREE PRESERVATION REPORT FOR OFFICIAL PLAN AMENDMENT AND ZONING BY-LAW AMENDMENTS

455 HIGHBURY ROAD NORTH LONDON, ONTARIO

Report prepared by Ron Koudys Landscape Architects Inc

April, 2024

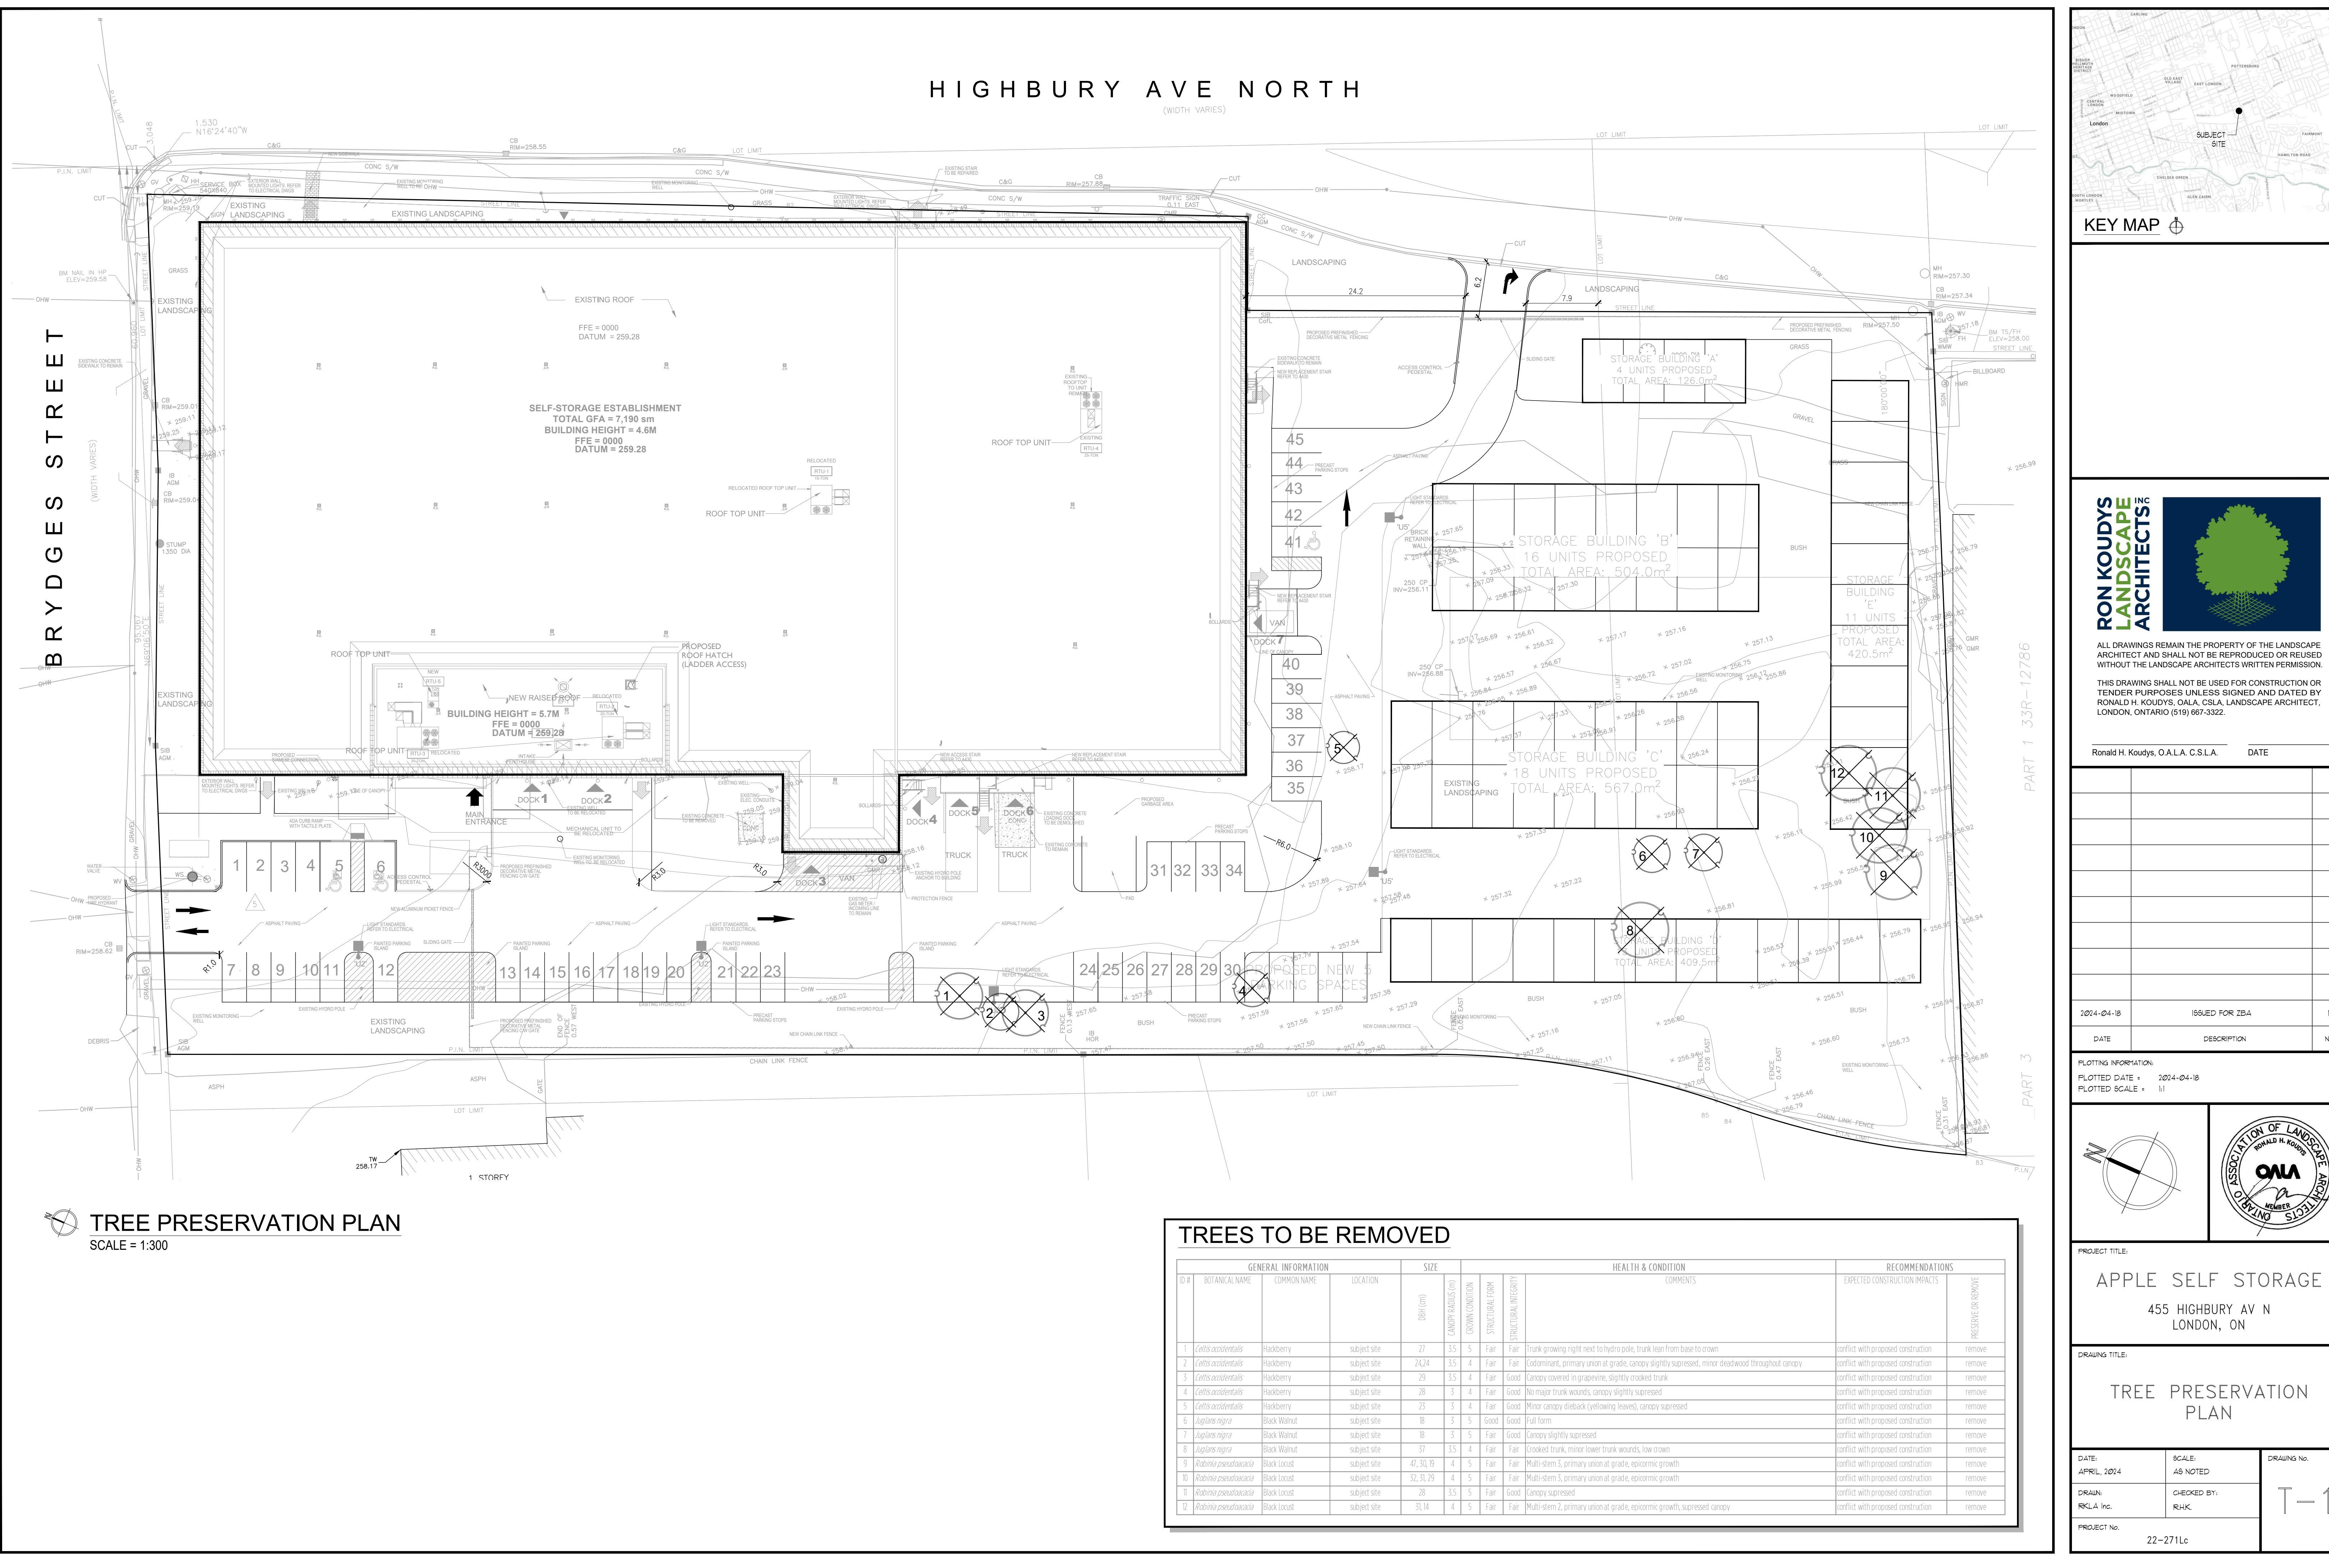
9.0 APPENDIX A - TREE PRESERVATION DRAWINGS

| | GEI | SIZE | | HEALTH & CO | | | | | |
|---|---|---|---|---|---|---|---|---|--|
| 1 | Celtis occidentalis | Hackberry | subject site | 27 | 3.5 | 5 | Fair | Fair | Trunk growing right next to hydro pole, trunk le |
| 2 | Celtis occidentalis | Hackberry | subject site | 24,24 | 3.5 | 4 | Fair | Fair | Codominant, primary union at grade, canopy sl |
| 3 | Celtis occidentalis | Hackberry | subject site | 29 | 3.5 | 4 | Fair | Good | Canopy covered in grapevine, slightly crooked t |
| 4 | Celtis occidentalis | Hackberry | subject site | 28 | 3 | 4 | Fair | Good | No major trunk wounds, canopy slightly supress |
| 5 | Celtis occidentalis | Hackberry | subject site | 23 | 3 | 4 | Fair | Good | Minor canopy dieback (yellowing leaves), canop |
| 6 | Juglans nigra | Black Walnut | subject site | 18 | 3 | 5 | Good | Good | Full form |
| 7 | Juglans nigra | Black Walnut | subject site | 18 | 3 | 5 | Fair | Good | Canopy slightly supressed |
| 8 | Juglans nigra | Black Walnut | subject site | 37 | 3.5 | 4 | Fair | Fair | Crooked trunk, minor lower trunk wounds, low o |
| 9 | Robinia pseudoacacia | Black Locust | subject site | 47, 30, 19 | 4 | 5 | Fair | Fair | Multi-stem 3, primary union at grade, epicormi |
| 10 | Robinia pseudoacacia | Black Locust | subject site | 32, 31, 29 | 4 | 5 | Fair | Fair | Multi-stem 3, primary union at grade, epicormi |
| 11 | Robinia pseudoacacia | Black Locust | subject site | 28 | 3.5 | 5 | Fair | Good | Canopy supressed |
| 12 | Robinia pseudoacacia | Black Locust | subject site | 31, 14 | 4 | 5 | Fair | Fair | Multi-stem 2, primary union at grade, epicormi |

- Removal of all 12 trees located within the subject site required.
- Follow pre-construction recommendations outlined in the Construction Impact Mitigation Recommendations in this report.
