TREE PRESERVATION REPORT FOR ZONING BYLAW AMENDMENT

**934 OXFORD STREET WEST LONDON,
ONTARIO**

Report prepared by
Ron Koudys Landscape Architects Inc

RKLA Project #23-160

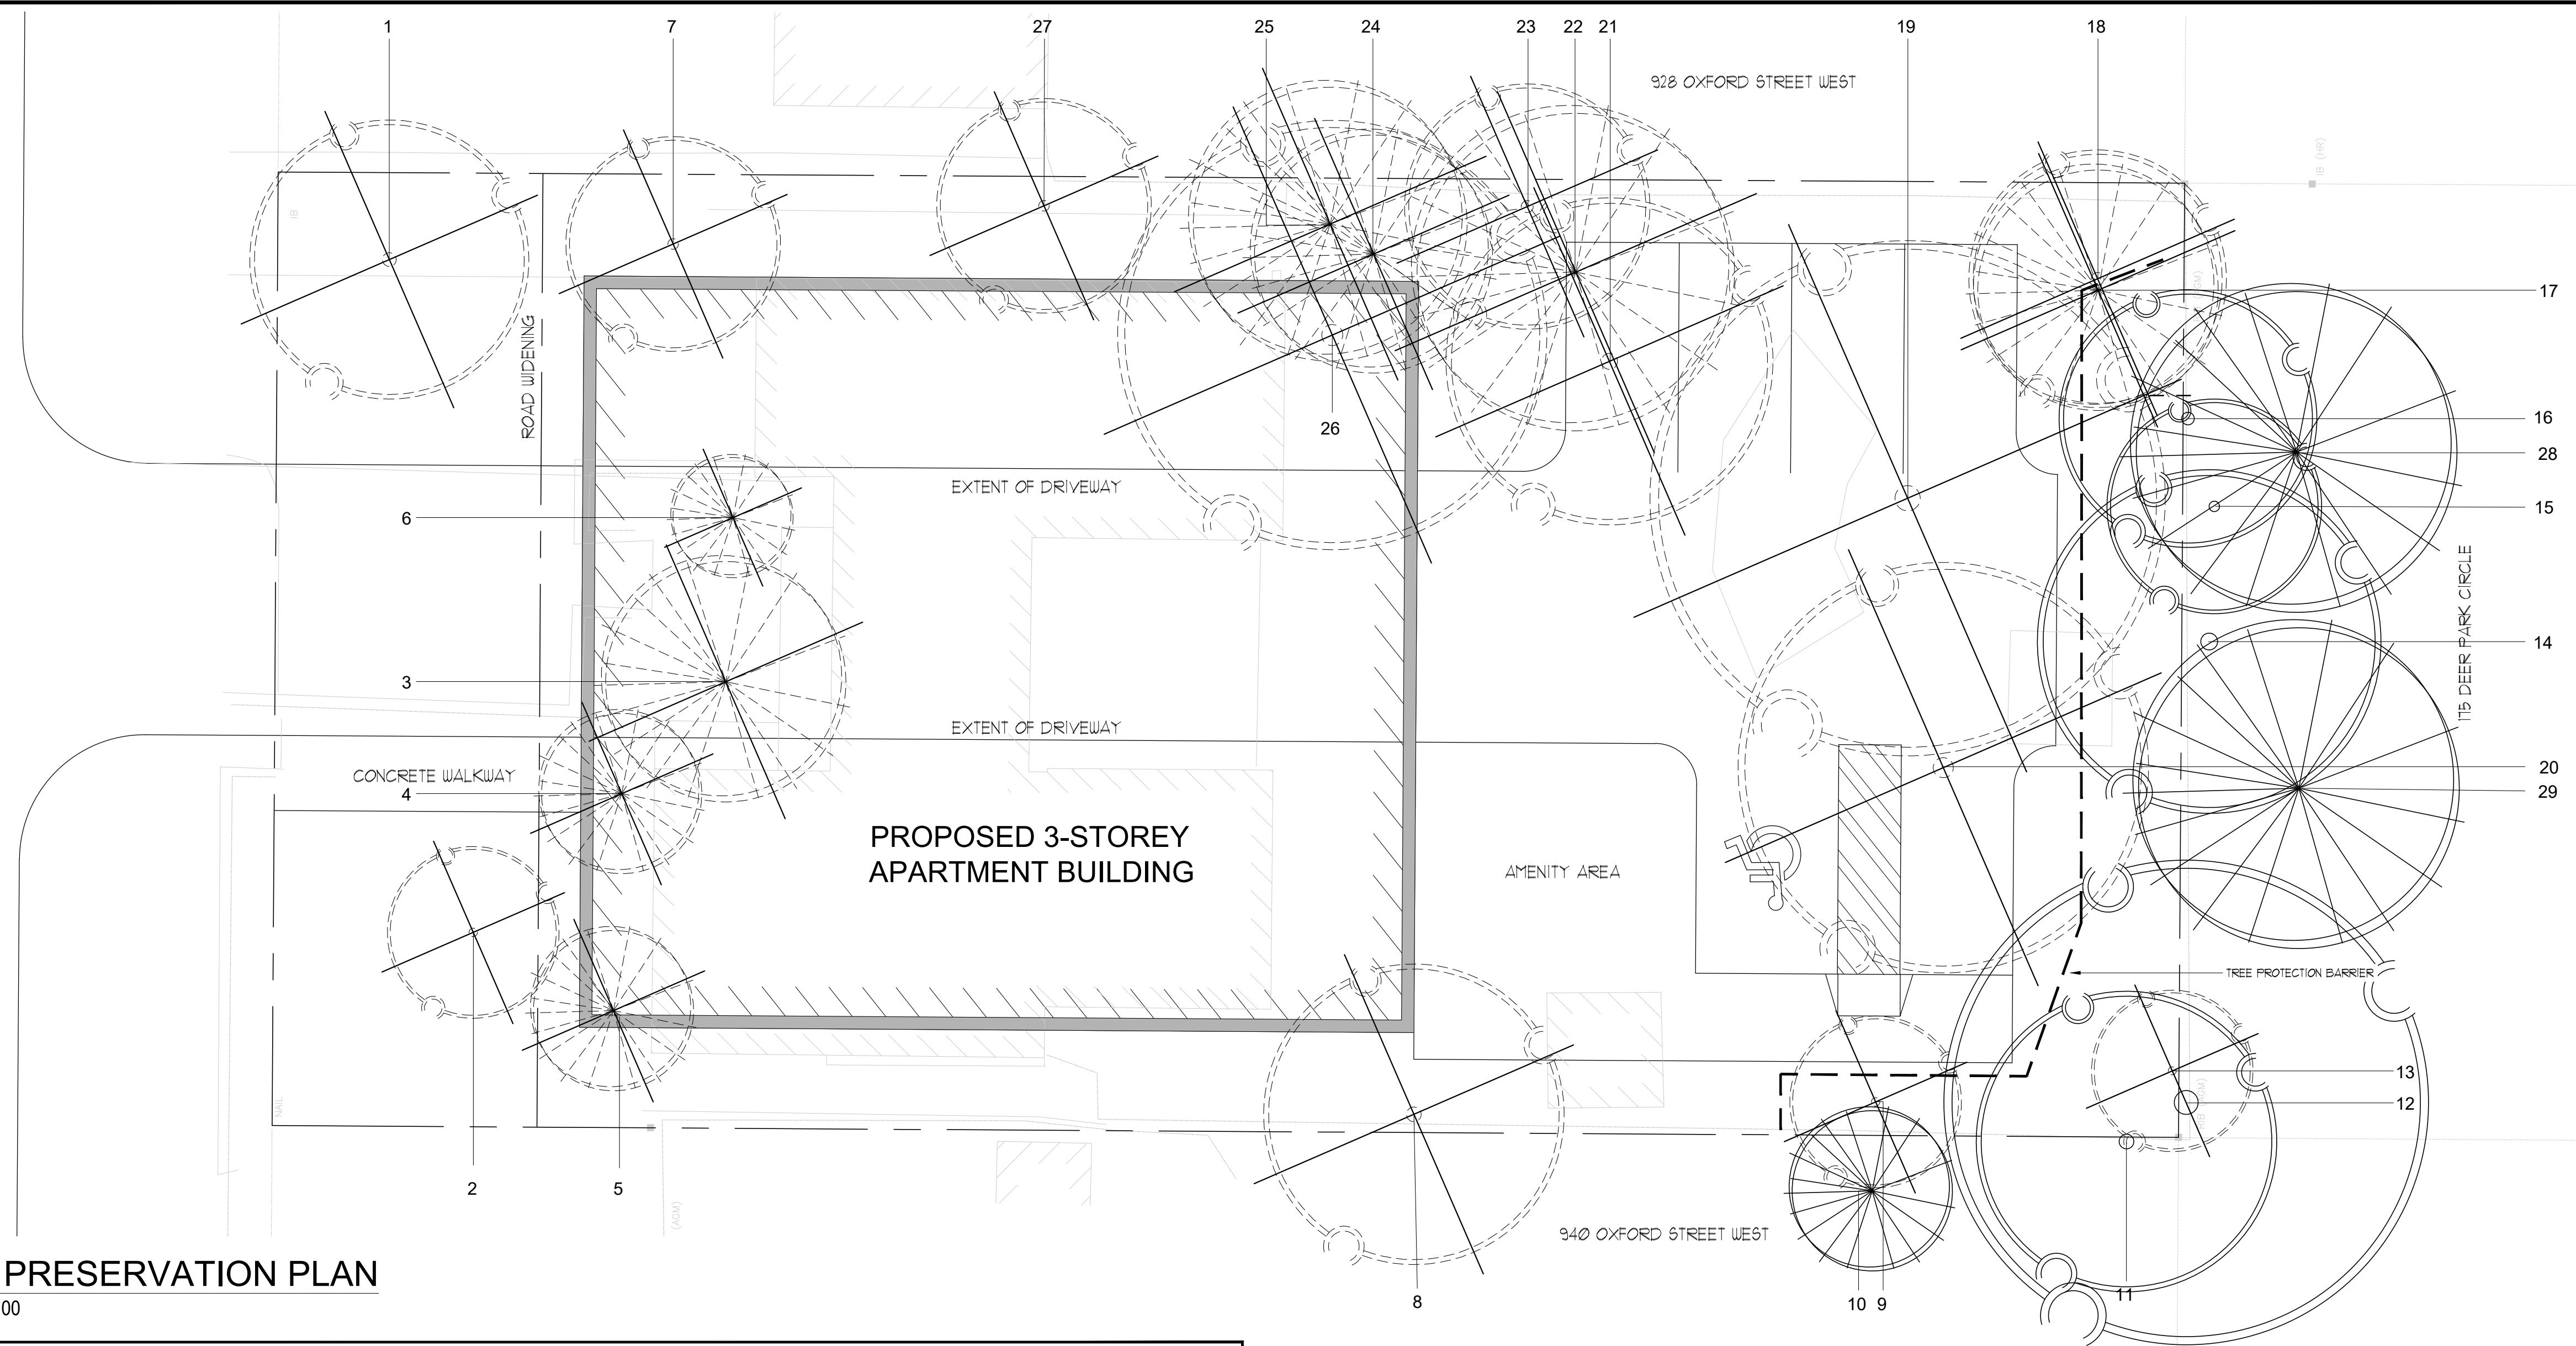
TREE PRESERVATION PLAN
SCALE = 1:100

ID #	GENERAL INFORMATION			SIZE	HEALTH & CONDITION	RECOMMENDATIONS
	BOTANICAL NAME	COMMON NAME	LOCATION			
1	<i>Robinia pseudoacacia</i>	Black Locust	Subject site	45.32/8	3 - 5 Fair	Multi-stem 3, primary union at grade, minor dead branches. Direct conflict with entrance. Remove.
2	<i>Cercis canadensis</i>	Eastern Redbud	Subject site	15.10/5.2	2 - 4 Fair	Multi-stem 4, primary union at grade, minor dead branches. Direct conflict with building. Remove.
3	<i>Thuja</i> spp.	Cedar	Subject site	20.15, 15.16/8	3 - 5 Fair	Multi-stem 5, primary union at grade. Direct conflict with building. Remove.
4	<i>Thuja</i> spp.	Cedar	Subject site	12.9/5	2 - 4 Fair	Multi-stem 3, primary union at grade, tied to house. Direct conflict with building. Remove.
5	<i>Thuja</i> spp.	Cedar	Subject site	14.7, 5.5	2 - 3 Fair	Multi-stem 4, primary union at grade, leans east. Direct conflict with building. Remove.
6	<i>Picea glauca</i>	Alberta Spruce	Subject site	16	15, 4 Fair	Dead canopy with trunk grown at the house foundation. Direct conflict with building. Remove.

7	<i>Fraxinus</i> spp.	Ash	Subject site	16	3 - 5 Fair	Direct conflict with entrance. Remove.
8	<i>Prunus serotina</i>	Black Cherry	Subject site	-35	35, 2 Poor	Trunk wounds, vines grown through trunk and into canopy. Minor conflict with proposed building and parking. Remove.
9	<i>Acer platanoides</i>	Norway Maple	Subject site	11	2 - 2 Good	Slightly suppressed. Minor conflict with proposed parking. Remove.
13	<i>Rhamnus cathartica</i>	Buckthorn	Subject site	13, 12, 10, 6, 5	2 - 7 Poor	Multi-stem 5, multiple dead branches and vines covering majority of canopy. Minor conflict with proposed parking and poor tree condition. Remove.
17	<i>Picea</i> spp.	Spruce spp.	Subject site	37	3 - 2 Poor	Monibund, some canopy at top. Minor conflict with proposed parking. Remove.
18	<i>Acer saccharum</i>	Sugar Maple	Subject site	19	3 - 5 Fair	Minor conflict with proposed parking. Remove.
19	<i>Catalpa speciosa</i>	Northern Catalpa	Subject site	51	6 - 4 Fair	Cavity along trunk, dead branching. Minor conflict with proposed parking. Remove.

20	<i>Juglans nigra</i>	Black Walnut	Subject site	26	5 - 4 Fair	Dead wood. Minor conflict with proposed parking. Remove.
21	<i>Acer saccharum</i>	Sugar Maple	Subject site	25	4 - 5 Good	Good. Minor conflict with proposed parking. Remove.
22	<i>Thuja</i> spp.	Cedar	Subject site	38	4 - 4 Fair	Minor epicormic growth along trunk. Minor conflict with proposed parking. Remove.
23	<i>Rhamnus cathartica</i>	Buckthorn	Subject site	17	3 - 3 Poor	Suppressed branching, cavity at base, leans west. Minor conflict with proposed parking. Remove.
24	<i>Thuja</i> spp.	Cedar	Subject site	15	3 - 2 Fair	Monibund, vines throughout canopy. Minor conflict with proposed parking. Remove.
25	<i>Thuja</i> spp.	Cedar	Subject site	31	35, 2 Fair	Monibund, vines throughout canopy. Minor conflict with proposed parking. Remove.
26	<i>Prunus serotina</i>	Black Cherry	Subject site	47	5 - 3 Fair	Minor trunk wounds, dead wood throughout canopy. Minor conflict with proposed parking. Remove.

27	<i>Robinia pseudoacacia</i>	Black Locust	Subject site	16	3 - 5 Fair	Good. Minor conflict with proposed parking. Remove.

ID #	GENERAL INFORMATION			SIZE	HEALTH & CONDITION	RECOMMENDATIONS
	BOTANICAL NAME	COMMON NAME	LOCATION			
10	<i>Picea abies</i>	Norway Spruce	940 Oxford Street West	-15	2 - 4 Good	Lower suppressed canopy. No conflict. Preserve. Tree protection barrier.
11	<i>Juglans x intermedia</i>	Hybrid Walnut	Boundary Subject site and 940 Oxford Street West	-18	4.5 - 5 Good	Hooked leader towards east, lower suppressed branching. No conflict. Preserve. Tree protection barrier.
12	<i>Celtis occidentalis</i>	Hackberry	Boundary Subject site 175 Deer Park Circle	-45	6 - 5 Fair	Girdling roots, minor dead wood, fence grown. Minor conflict with proposed parking - potential retention, require upon grading. Preserve. Tree protection barrier.
14	<i>Rhamnus cathartica</i>	Buckthorn	175 Deer Park Circle	25	4 - 3 Poor	Stk taken below primary union. Minor potential conflict with grading. Preserve. Tree protection barrier.

15	<i>Rhamnus cathartica</i>	Buckthorn	175 Deer Park Circle	18	3 - 3 Poor	Minor dieback, multiple minor trunk wounds. Minor potential conflict with grading. Preserve. Tree protection barrier.
16	<i>Acer saccharum</i>	Sugar Maple	Boundary Subject site 175 Deer Park Circle	26	4 - 5 Fair	Growing in fence, suppressed branching, slightly suppressed. Minor potential conflict with grading. Preserve. Tree protection barrier.
18	<i>Picea abies</i>	Norway Spruce	175 Deer Park Circle	-40	4 - 4 Good	Good. No conflict. Preserve. Tree protection barrier.
29	<i>Picea abies</i>	Norway Spruce	175 Deer Park Circle	-40	4 - 4 Good	Good. No conflict. Preserve. Tree protection barrier.
