TREE PRESERVATION REPORT FOR ZONING BY-LAW AMENDMENT

**1458 HURON STREET,
LONDON, ONTARIO**

Report prepared by
Ron Koudys Landscape Architects Inc

RKLA Project #23-247

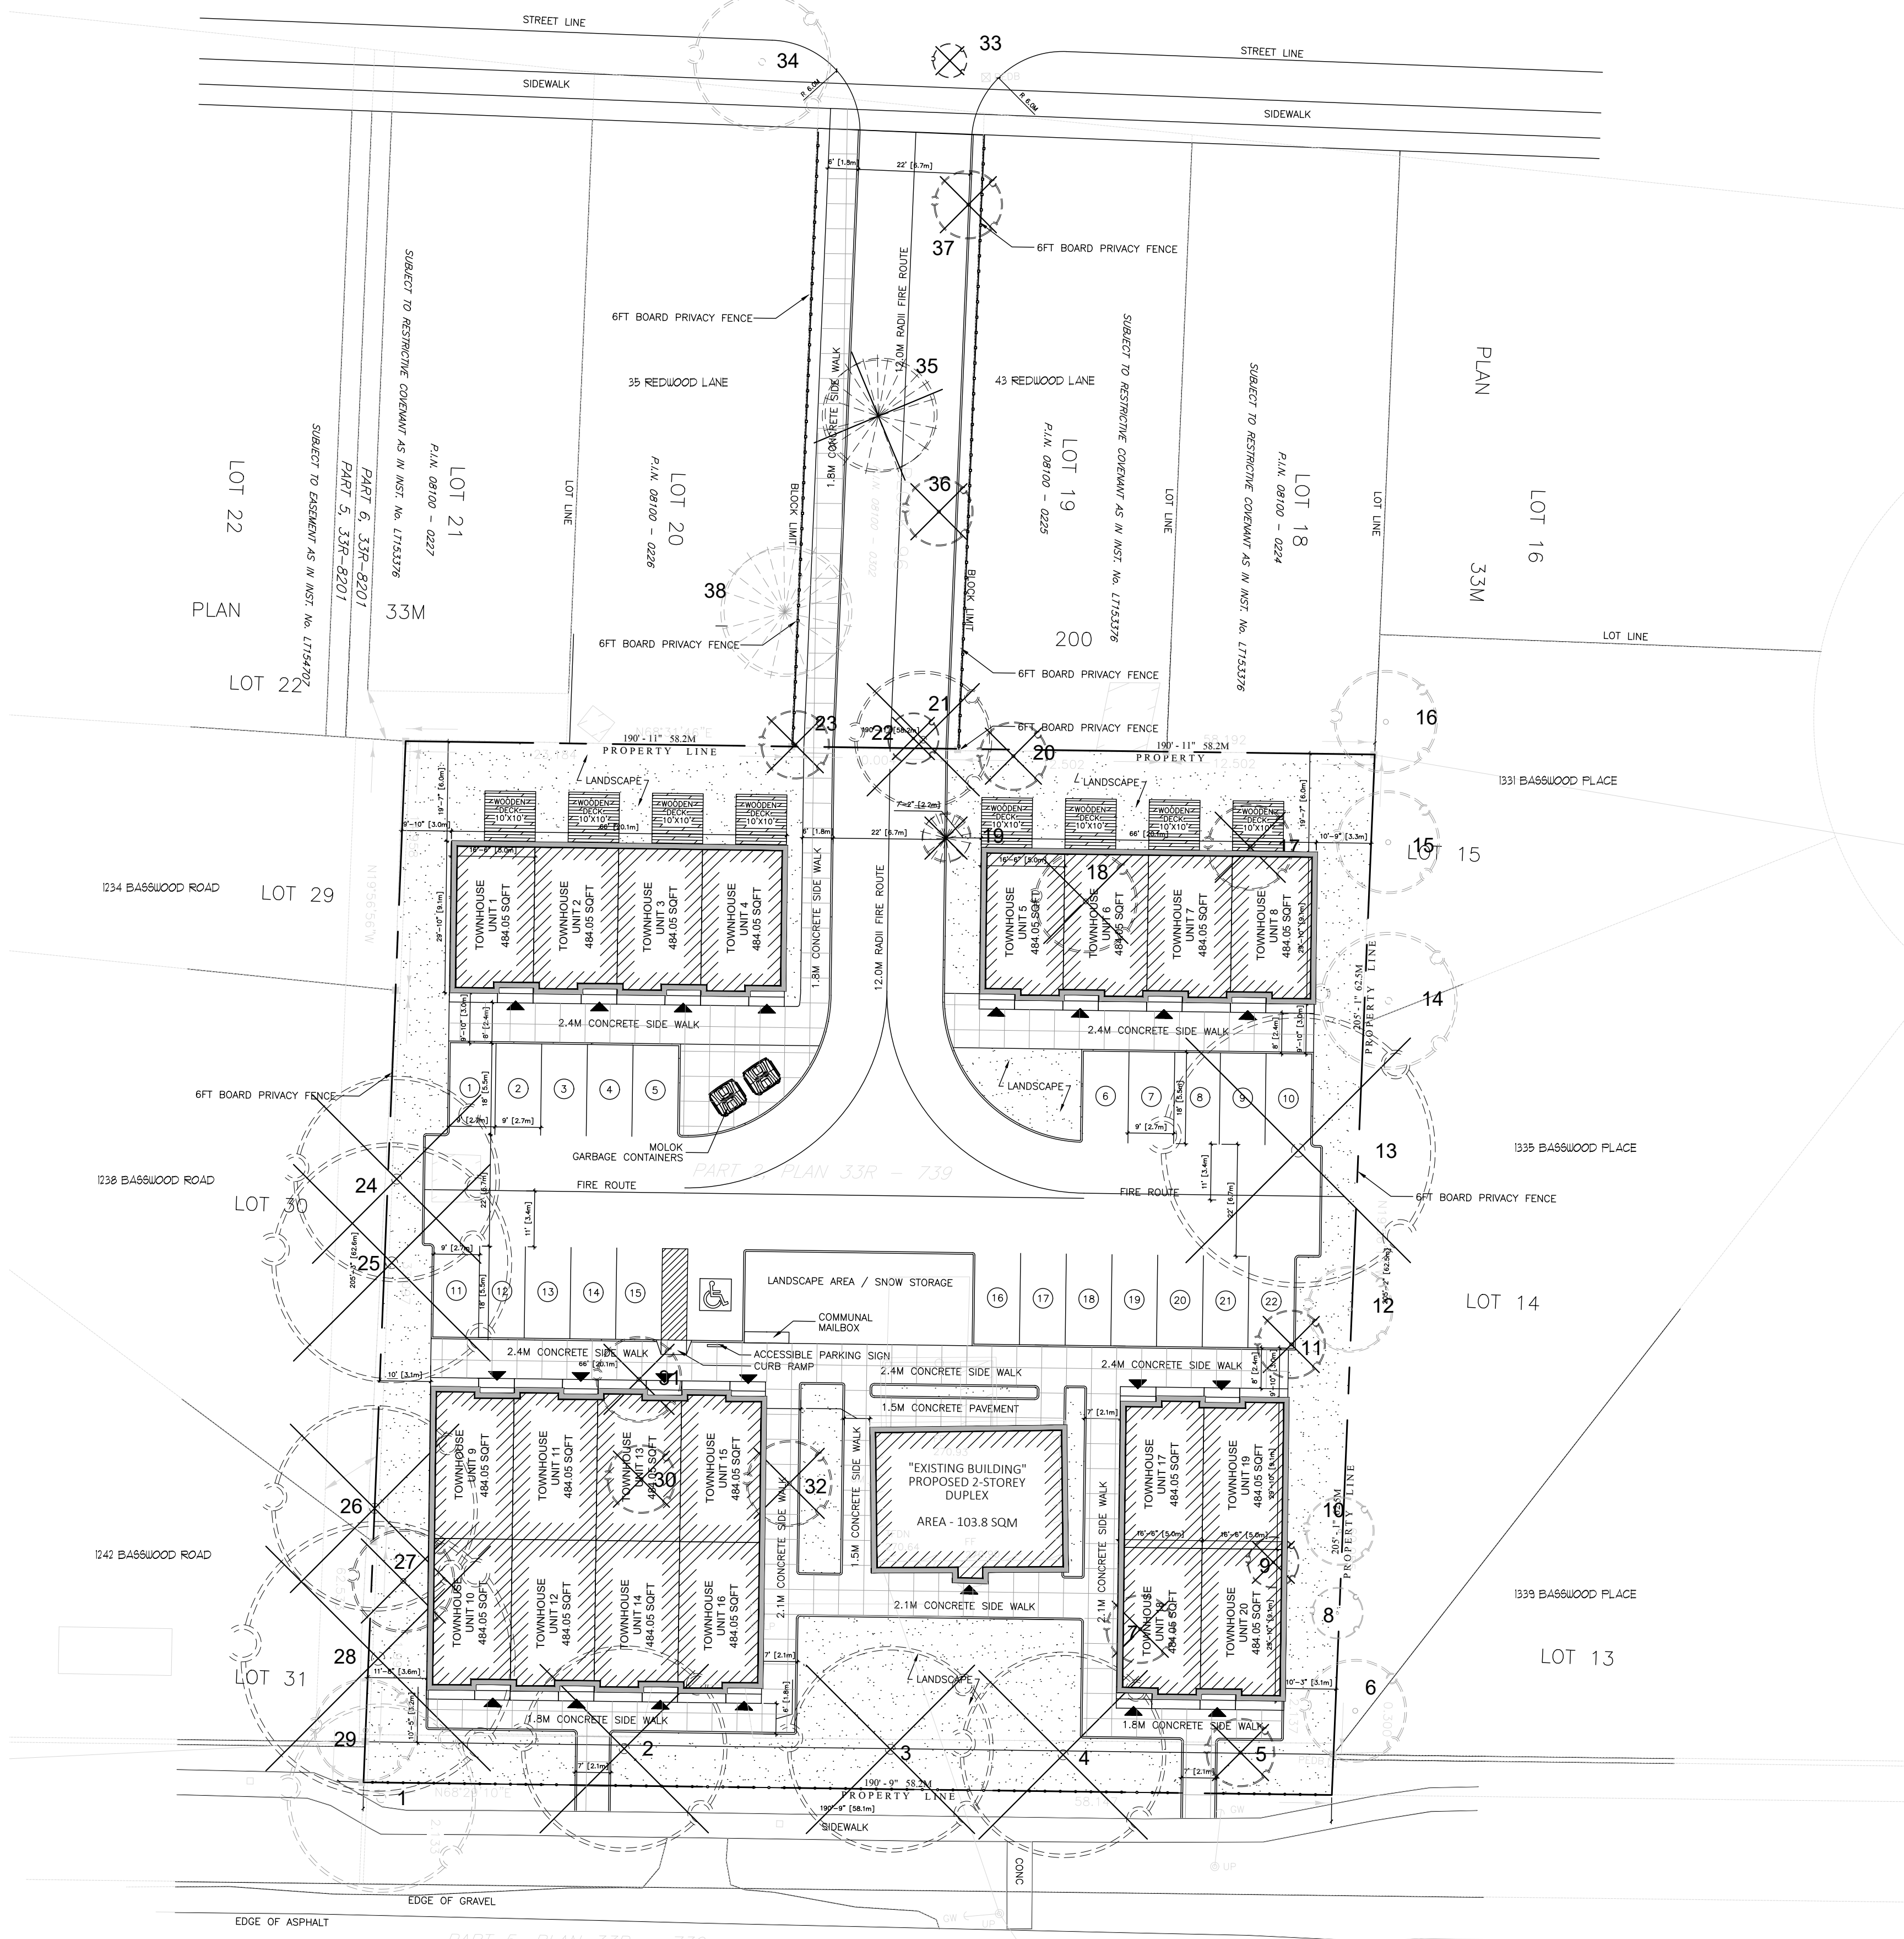
TREE PRESERVATION PLAN
SCALE = 1:250

TREES TO BE REMOVED (27)

7	<i>Malus spp.</i>	Apple	Subject Site - 1458 Huron Street	14	2	5	Good	Fair		direct conflict with proposed construction	remove	
9	<i>Morus alba</i>	White Mulberry	Subject Site - 1458 Huron Street	10	1.5	5	Fair	Poor	Grown in shrub	direct conflict with proposed construction	remove	
11	<i>Acer negundo</i>	Manitoba Maple	Subject Site - 1458 Huron Street	18	2	5	Fair	Poor	Major epic growth	direct conflict with proposed construction	remove	
13	<i>Celtis occidentalis</i>	Hackberry	Subject Site - 1458 Huron Street	61	8	1	Good	Good		direct conflict with proposed construction	remove	
17	<i>Geothlas inaequalis</i>	Honey Locust	Subject Site - 1458 Huron Street	28	2.5	5	Fair	Good		direct conflict with proposed construction	remove	
18	<i>Malus spp.</i>	Apple	Subject Site - 1458 Huron Street	15, 12, 12, 11, 10, 10	3	4	Poor	Poor	Multistem 6, shrubby habit, old stems embedded, major epicormic growth	direct conflict with proposed construction	remove

19	<i>Thuja spp.</i>	Cedar	Subject Site - 1458 Huron Street	8, 5, 5	1.5	5	Fair	Good	Multistem 3	direct conflict with proposed construction	remove	
20	<i>Prunus spp.</i>	Cherry	Subject Site - 1458 Huron Street	15	2	5	Fair	Poor	Epicormic growth	direct conflict with proposed construction	remove	
21	<i>Prunus spp.</i>	Cherry	Subject Site - 39 Redwood Lane	20, 19, 18, 17, 15, 14, 12	4	3	Poor	Fair	Multistem 7, primary union at grade, leaning on existing wood fence	direct conflict with proposed construction	remove	
22	<i>Prunus spp.</i>	Cherry	Subject Site - 39 Redwood Lane	15, 13, 7	1.5	5	Poor	Fair	Multistem 3, primary union at grade	direct conflict with proposed construction	remove	
23	<i>Prunus spp.</i>	Cherry	Subject Site - 39 Redwood Lane	15	2	5	Fair	Good	Slight lean	direct conflict with proposed construction	remove	
24	<i>Acer saccharum</i>	Sugar Maple	Subject Site - 1458 Huron Street	54	6	5	Good	Good		direct conflict with proposed construction	remove

25	<i>Acer saccharum</i>	Sugar Maple	Subject Site - 1458 Huron Street	58	7	5	Fair	Good	Old prune wounds	direct conflict with proposed construction	remove	
26	<i>Geothlas inaequalis</i>	Thorny Locust	Boundary 1458 Huron Street & 1238 Basswood Road	57	6	4	Fair	Fair	Old stem dead, epicormic growth, codominant stems approx. 3meters up trunk, trunk growing into new wood fence	direct conflict with proposed construction	remove	Consent from 1238 Basswood Road required for removal
27	<i>Acer negundo</i>	Manitoba Maple	Subject Site - 1458 Huron Street	17	3	4	Good	Good		direct conflict with proposed construction	remove	
28	<i>Acer saccharum</i>	Sugar Maple	Boundary 1458 Huron Street & 1242 Basswood Road	68	8	5	Fair	Good	Trunk grown through fence (dbh crosses property boundary, considered a boundary tree)	direct conflict with proposed construction	remove	Consent from 1242 Basswood Road required for removal

30	<i>Tilia spp.</i>	Linden	Subject Site - 1458 Huron Street	14	2	5	Good	Good		direct conflict with proposed construction	remove	
31	<i>Tilia spp.</i>	Linden	Subject Site - 1458 Huron Street	24	2.5	5	Good	Good		direct conflict with proposed construction	remove	
32	<i>Tilia spp.</i>	Linden	Subject Site - 1458 Huron Street	27	2.5	5	Good	Good		direct conflict with proposed construction	remove	
33	<i>Acer rubrum</i>	Red Maple	Subject Site - 39 Redwood Lane	5	1	5	Good	Good		direct conflict with proposed construction	remove	
35	<i>Picea pungens</i>	Colorado Spruce	Subject Site - 39 Redwood Lane	34	3.5	5	Good	Good	Branched to grade	direct conflict with proposed construction	remove	
36	<i>Acer spp.</i>	Maple	Subject Site - 39 Redwood Lane	17	2	4	Fair	Fair	Major trunk wound, epicormic growth	direct conflict with proposed construction	remove	
37	<i>Malus spp.</i>	Apple	Subject Site - 39 Redwood Lane	16	2	5	Fair	Fair	Major trunk epicormic growth at base	direct conflict with proposed construction	remove

TREES TO BE PRESERVED (11)

12	<i>Morus alba</i>	White Mulberry	Boundary - Subject site & 1335 Basswood Place	14, 14, 12, 5	2.5	4	Fair	Poor	Multistem 4, fence grown, epicormic growth	potential conflict with proposed grading	preserve	tree protection barrier
14	<i>Acer platanoides</i>	Norway Maple	1338 Basswood Place	40	4	5	Fair	Fair	Low primary union, lower half not visible due to wood fence	minor impact to critical root zone	preserve	existing wood fence to act as tree protection barrier
15	<i>Acer platanoides</i>	Norway Maple	1338 Basswood Place	35	3	5	Fair	Good	Lower half not visible due to wood fence	minor impact to critical root zone	preserve	existing wood fence to act as tree protection barrier
16	<i>Tilia spp.</i>	Linden	1338 Basswood Place	35	3	5	Good	Good	Lower half not visible due to wood fence	N/A	preserve	existing wood fence to act as tree protection barrier
29	<i>Juglans nigra</i>	Black Walnut	Boundary 1458 Huron Street & 1242 Basswood Road	31	3	5	Fair	Good		potential conflict with proposed grading	preserve	tree protection barrier

34	<i>Viburnum</i>	Little Leaf Linden	Subject Site - 39 Redwood Lane	25	3	5	Good	Good		N/A	preserve	tree protection barrier
38	<i>Picea abies</i>	Norway Spruce	35 Redwood Lane	35	4	5	Good	Good	Lower half not visible due to wood fence	potential for removal to be reviewed with civil plans at the time of SPA	review

- a) Prior to any construction activity, tree preservation fencing is to be installed as per the attached tree preservation drawings and detail.
- b) Trees approved for removal are to be clearly indicated in the field (marked with spray paint or other agreed upon method) by the project arborist or landscape architect prior to any tree removal operations. All removals to be undertaken by an ISA certified arborist.
