TREE PRESERVATION REPORT FOR ZONING BY-LAW AMENDMENT

**539 & 543 TOPPING LANE
LONDON, ONTARIO**

Report prepared by
Ron Koudys Landscape Architects Inc

RKLA Project #24-110

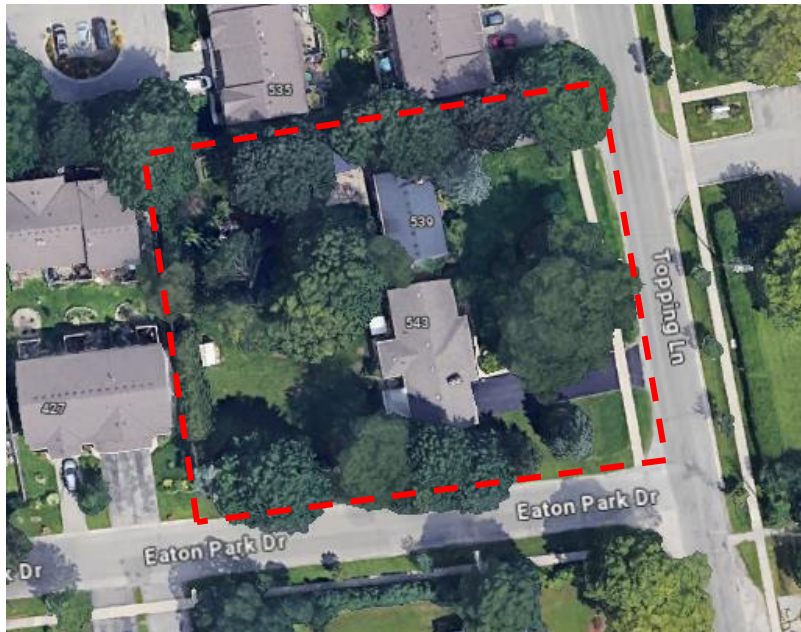
Figure 1 - City of London mapping with 2022 aerial imagery. NTS

Red dashed line - Limit of inventory

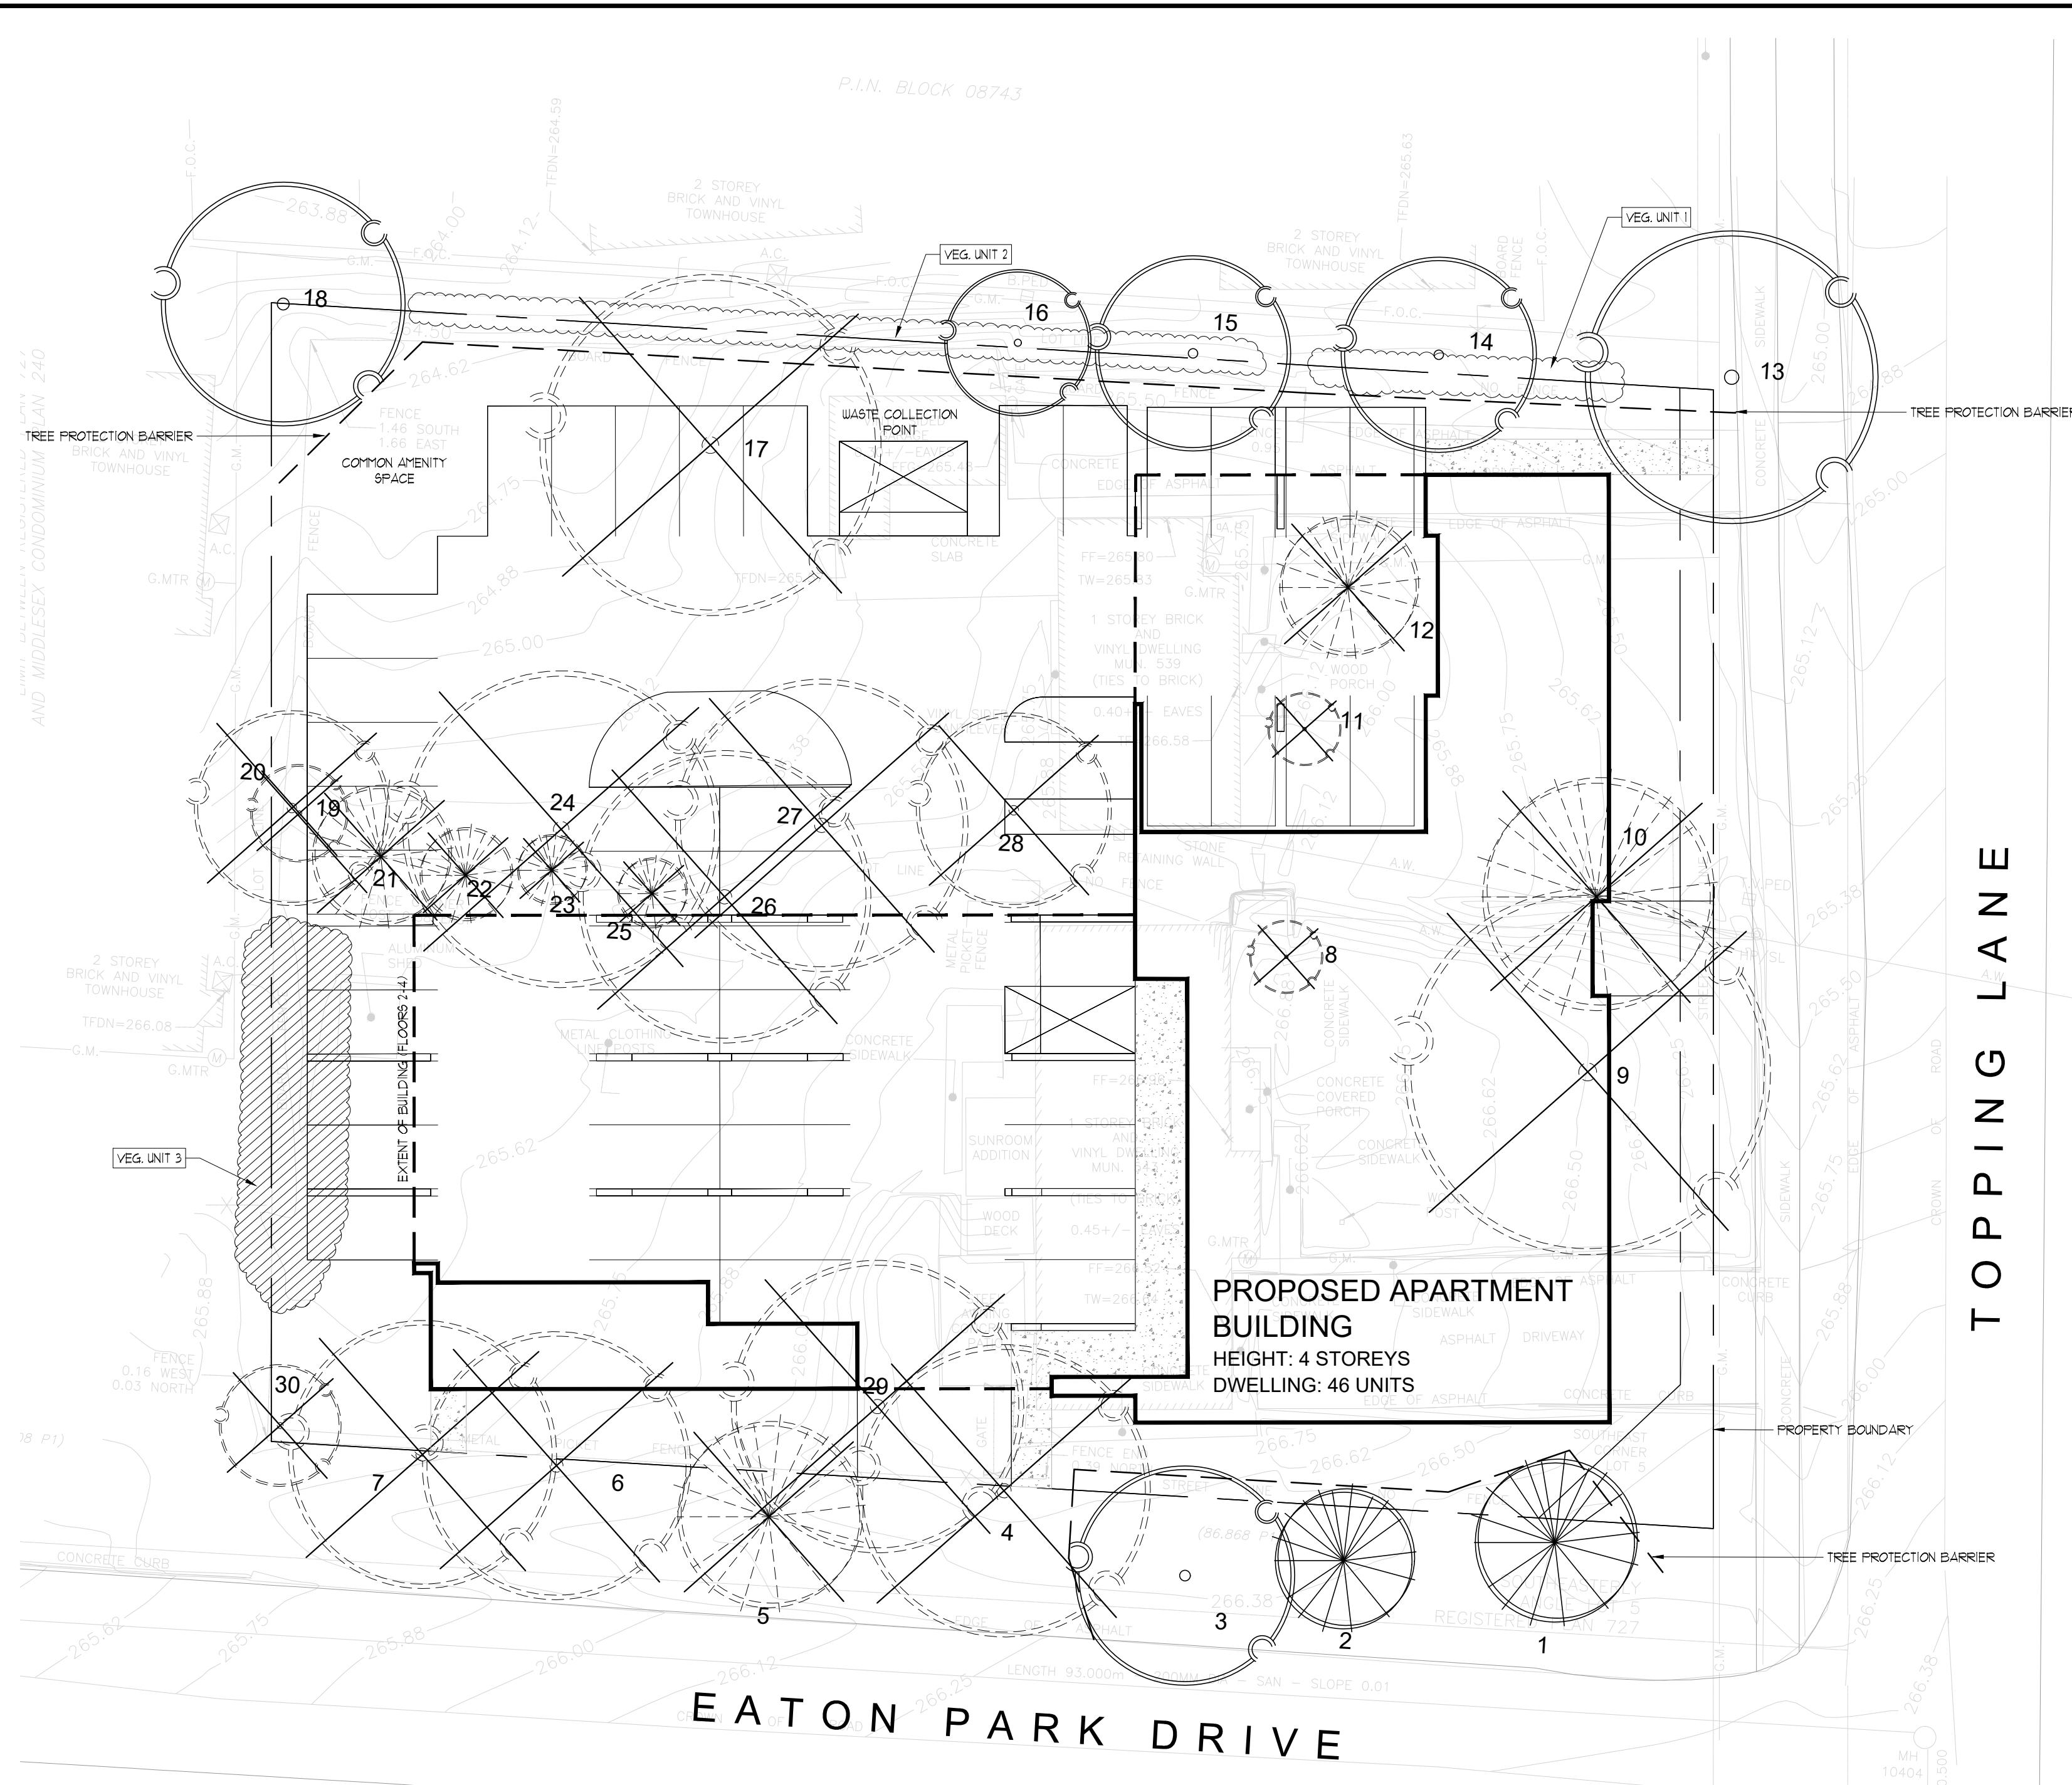
TREE PRESERVATION PLAN
SCALE = 1:200

ID #	GENERAL INFORMATION			SIZE		HEALTH & CONDITION		RECOMMENDATIONS			
	BOTANICAL NAME	COMMON NAME	LOCATION	DBH (cm)	CROWN RADIIUS (cm)	STRUCTURAL DBH	STRUCTURAL INTEGRITY	COMMENTS	EXPECTED CONSTRUCTION IMPACTS	PRESERVE OR REMOVE	IMPACT MITIGATION / CONSENT REQUIREMENTS
1	<i>Picea canadensis</i>	Colorado Spruce	City ROW Eaton Park Drive	34	3.5	4	Good	North canopy dieback, branch to grade	minor expected impacts to critical root zone, to be reviewed with civil plans at the time of SPA	preserve	tree protection barrier
2	<i>Picea canadensis</i>	Norway Spruce	City ROW Eaton Park Drive	33	3	5	Good	Limbed up 2 meters	minor expected impacts to critical root zone, to be reviewed with civil plans at the time of SPA	preserve	tree protection barrier
3	<i>Acer platanoides</i>	Norway Maple	City ROW Eaton Park Drive	38	4.5	5	Fair	Cavities forming in old prune wounds	minor expected impacts to critical root zone, to be reviewed with civil plans at the time of SPA	preserve	tree protection barrier

13	<i>Gleditsia triacanthos</i>	Honey Locust	City ROW Topping Lane	52	8	4	Fair	Deadwood, lean south, bark peeling	minor expected impacts to critical root zone	preserve	tree protection barrier
14	<i>Acer platanoides</i>	Norway Maple	535 Topping Lane	42	4	5	Fair	Minor epicormic growth, canopy heavy south	expected impacts to critical root zone, to be reviewed with civil plans at the time of SPA	preserve	tree protection barrier
15	<i>Acer platanoides</i>	Norway Maple	535 Topping Lane	40	4	5	Fair	DBH approximated due to limited access from board fence, minor deadwood, low primary union	expected impacts to critical root zone, to be reviewed with civil plans at the time of SPA	preserve	tree protection barrier
16	<i>Alnus incana</i>	Horseshoe Nut	535 Topping Lane	30	3	4	Fair	DBH approximated due to limited access from board fence, canopy heavy south, crooked leader	expected impacts to critical root zone, to be reviewed with civil plans at the time of SPA	preserve	tree protection barrier

18	<i>Acer saccharinum</i>	Silver Maple	Boundary - subject site and 535 Topping Lane	65	5	5	Fair	Low primary union, minor deadwood	minor expected impacts to critical root zone	preserve	tree protection barrier
VEG UNIT 1	<i>Thuja sp.</i>	Cedar	Boundary - subject site and 535 Topping Lane	5-10	1	5	Good	Dense, approximate 19 individuals	minor conflict with critical root zone	preserve	tree protection barrier
VEG UNIT 2	<i>Thuja sp.</i>	Cedar	Boundary - subject site and 535 Topping Lane	5-10	1.5	5	Fair	Some parts of hedge sparse, lower part of hedge is hidden from view by existing wood fence	minor conflict with critical root zone	preserve	tree protection barrier

ID #	GENERAL INFORMATION			SIZE		HEALTH & CONDITION		RECOMMENDATIONS			
	BOTANICAL NAME	COMMON NAME	LOCATION	DBH (cm)	CROWN RADIIUS (cm)	STRUCTURAL DBH	STRUCTURAL INTEGRITY	COMMENTS	EXPECTED CONSTRUCTION IMPACTS	PRESERVE OR REMOVE	IMPACT MITIGATION / CONSENT REQUIREMENTS
4	<i>Acer platanoides</i>	Norway Maple	Boundary - subject site and Eaton Park Drive	59	6	5	Fair	DBH taken below primary union, cracks in primary union and bark	conflict with proposed driveway	remove	Consent from the City of London required
5	<i>Pinus nigra</i>	Austrian Pine	City ROW Eaton Park Drive	29	4	4	Fair	Canopy heavy south, lean in trunk, old prune wounds	conflict with proposed driveway	remove	Consent from the City of London required
6	<i>Acer platanoides</i>	Norway Maple	City ROW Eaton Park Drive	57	5.5	4	Fair	Exposed roots, deadwood, epicormic growth, prune wounds	conflict with proposed building and critical root zone	remove	Consent from the City of London required

7	<i>Acer platanoides</i>	Norway Maple	Boundary - subject site and Eaton Park Drive	34	5.5	4	Poor	Major epicormic growth, cavities forming, rubbing branches	conflict with proposed building and critical root zone	remove	Consent from the City of London required
8	<i>Morus alba</i>	Weeping White Mulberry	Subject site	19	15	5	Good	Typical form	conflict with proposed building	remove	
9	<i>Gleditsia triacanthos</i>	Honey Locust	Subject site	89	3.5	5	Fair	Low primary union, minor cavities in branches	conflict with proposed building	remove	
10	<i>Thuja occidentalis</i>	Canadian Hemlock	Subject site	40	5	5	Fair	DBH approximated due to lay on trunk, dead lower, suppressed by tree #9	conflict with proposed building	remove	
11	<i>Morus alba</i>	Weeping White Mulberry	Subject site	15	15	5	Good	Typical form	conflict with proposed building	remove	
12	<i>Picea canadensis</i>	Colorado Spruce	Subject site	46	3	4	Fair	Dead lower, limbed up 4 meters	conflict with proposed building	remove

17	<i>Acer platanoides</i>	Norway Maple	Subject site	60	7	5	Fair	DBH approximated due to play structure constructed around tree, low primary union, deadwood in major limbs	direct conflict with proposed parking	remove	
19	<i>Celtis occidentalis</i>	Hickberry	Subject site	12	2	5	Fair	Cracked trunk, suppressed	direct conflict with proposed parking	remove	
20	<i>Betula sp.</i>	Birch	Subject site	31	4	5	Good	Good	direct conflict with proposed parking	remove	
21	<i>Picea canadensis</i>	Norway Spruce	Subject site	21	3	4	GOOD	Sparsely, gall present	direct conflict with proposed parking	remove	
22	<i>Thuja sp.</i>	Cedar	Subject site	12	2	5	Fair	Good	direct conflict with proposed parking	remove	
23	<i>Thuja sp.</i>	Cedar	Subject site	11	1.5	5	Poor	Low primary union, deadwood, low primary union	direct conflict with proposed parking	remove	
24	<i>Acer saccharinum</i>	Silver Maple	Subject site	55, 50	6.5	3	Poor	Limbed up, major split in stems, major stem snapped off, cavities present, peeling bark	direct conflict with proposed parking	remove

25	<i>Juniperus sp.</i>	Juniper	Subject site	10	1.5	4	Poor	Straggly form, deadwood	direct conflict with proposed parking	remove	
26	<i>Acer saccharum</i>	Sugar Maple	Subject site	56	6	4	Fair	Epicormic growth, deadwood, low primary union	direct conflict with proposed parking	remove	
27	<i>Acer saccharum</i>	Sugar Maple	Subject site	64	6	5	Fair	Lean east, epicormic growth, deadwood, low primary union	direct conflict with proposed parking	remove	
28	<i>Betula sp.</i>	Birch	Subject site	17, 23	4	5	Fair	Limbed up low primary union, old prune wounds, included bark	direct conflict with proposed parking	remove	
29	<i>Gleditsia triacanthos</i>	Honey Locust	Subject site	50	6	4	Poor	Large open seam from base to primary union, prune wounds	direct conflict with proposed parking	remove	
30	<i>Ulmus sp.</i>	Elm	Subject site	24	4	2	Poor	Major limbs removed, cavities forming, epicormic growth, lead lost	minor conflict with critical root zone and poor tree condition	remove

VEG UNIT 3	<i>Thuja sp.</i>	Cedar	Subject Site	5-5	2	3.5	Fair	Stemmed to grade, approximately 22 individuals, suppressed behind shed	conflict with proposed construction	remove

- a) Prior to any construction activity, tree preservation fencing is to be installed as per the attached tree preservation drawings and detail.
- b) Trees approved for removal are to be clearly indicated in the field (marked with spray paint or other agreed upon method) by the project arborist or landscape architect prior to any tree removal operations. All removals to be undertaken by an ISA certified arborist.

- b) Tree preservation fencing is to remain intact as per the tree preservation drawings, and can only be temporarily removed with the express written consent from the project arborist or landscape architect. Should tree preservation fencing be temporarily relocated or moved, it is to be reinstated as per the tree preservation plans as soon as possible.
