TREE PRESERVATION REPORT FOR ZONING BY-LAW AMENDMENT

**553-557 UPPER QUEENS STREET
LONDON, ONTARIO**

Report prepared by
Ron Koudys Landscape Architects Inc

RKLA Project #23-223

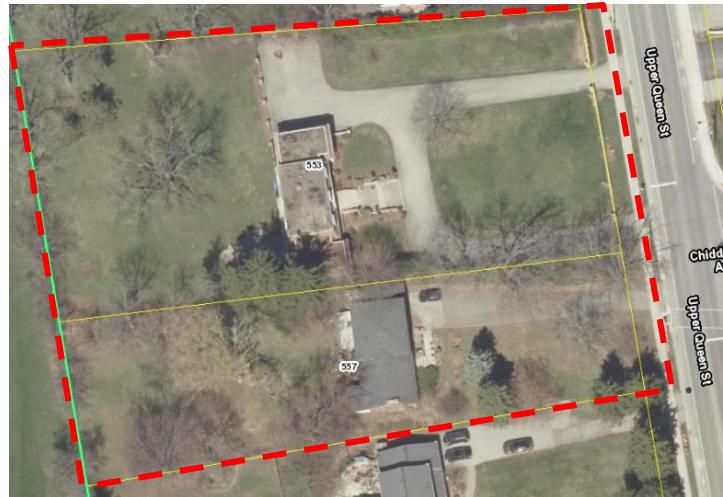
Figure 1 - City of London mapping with 2019 aerial imagery. NTS

Red dashed line - Limit of inventory
