32 Chesterfield Avenue, London

Tree Protection Plan

Project No. 2363 | December 2023
Revised July 2024

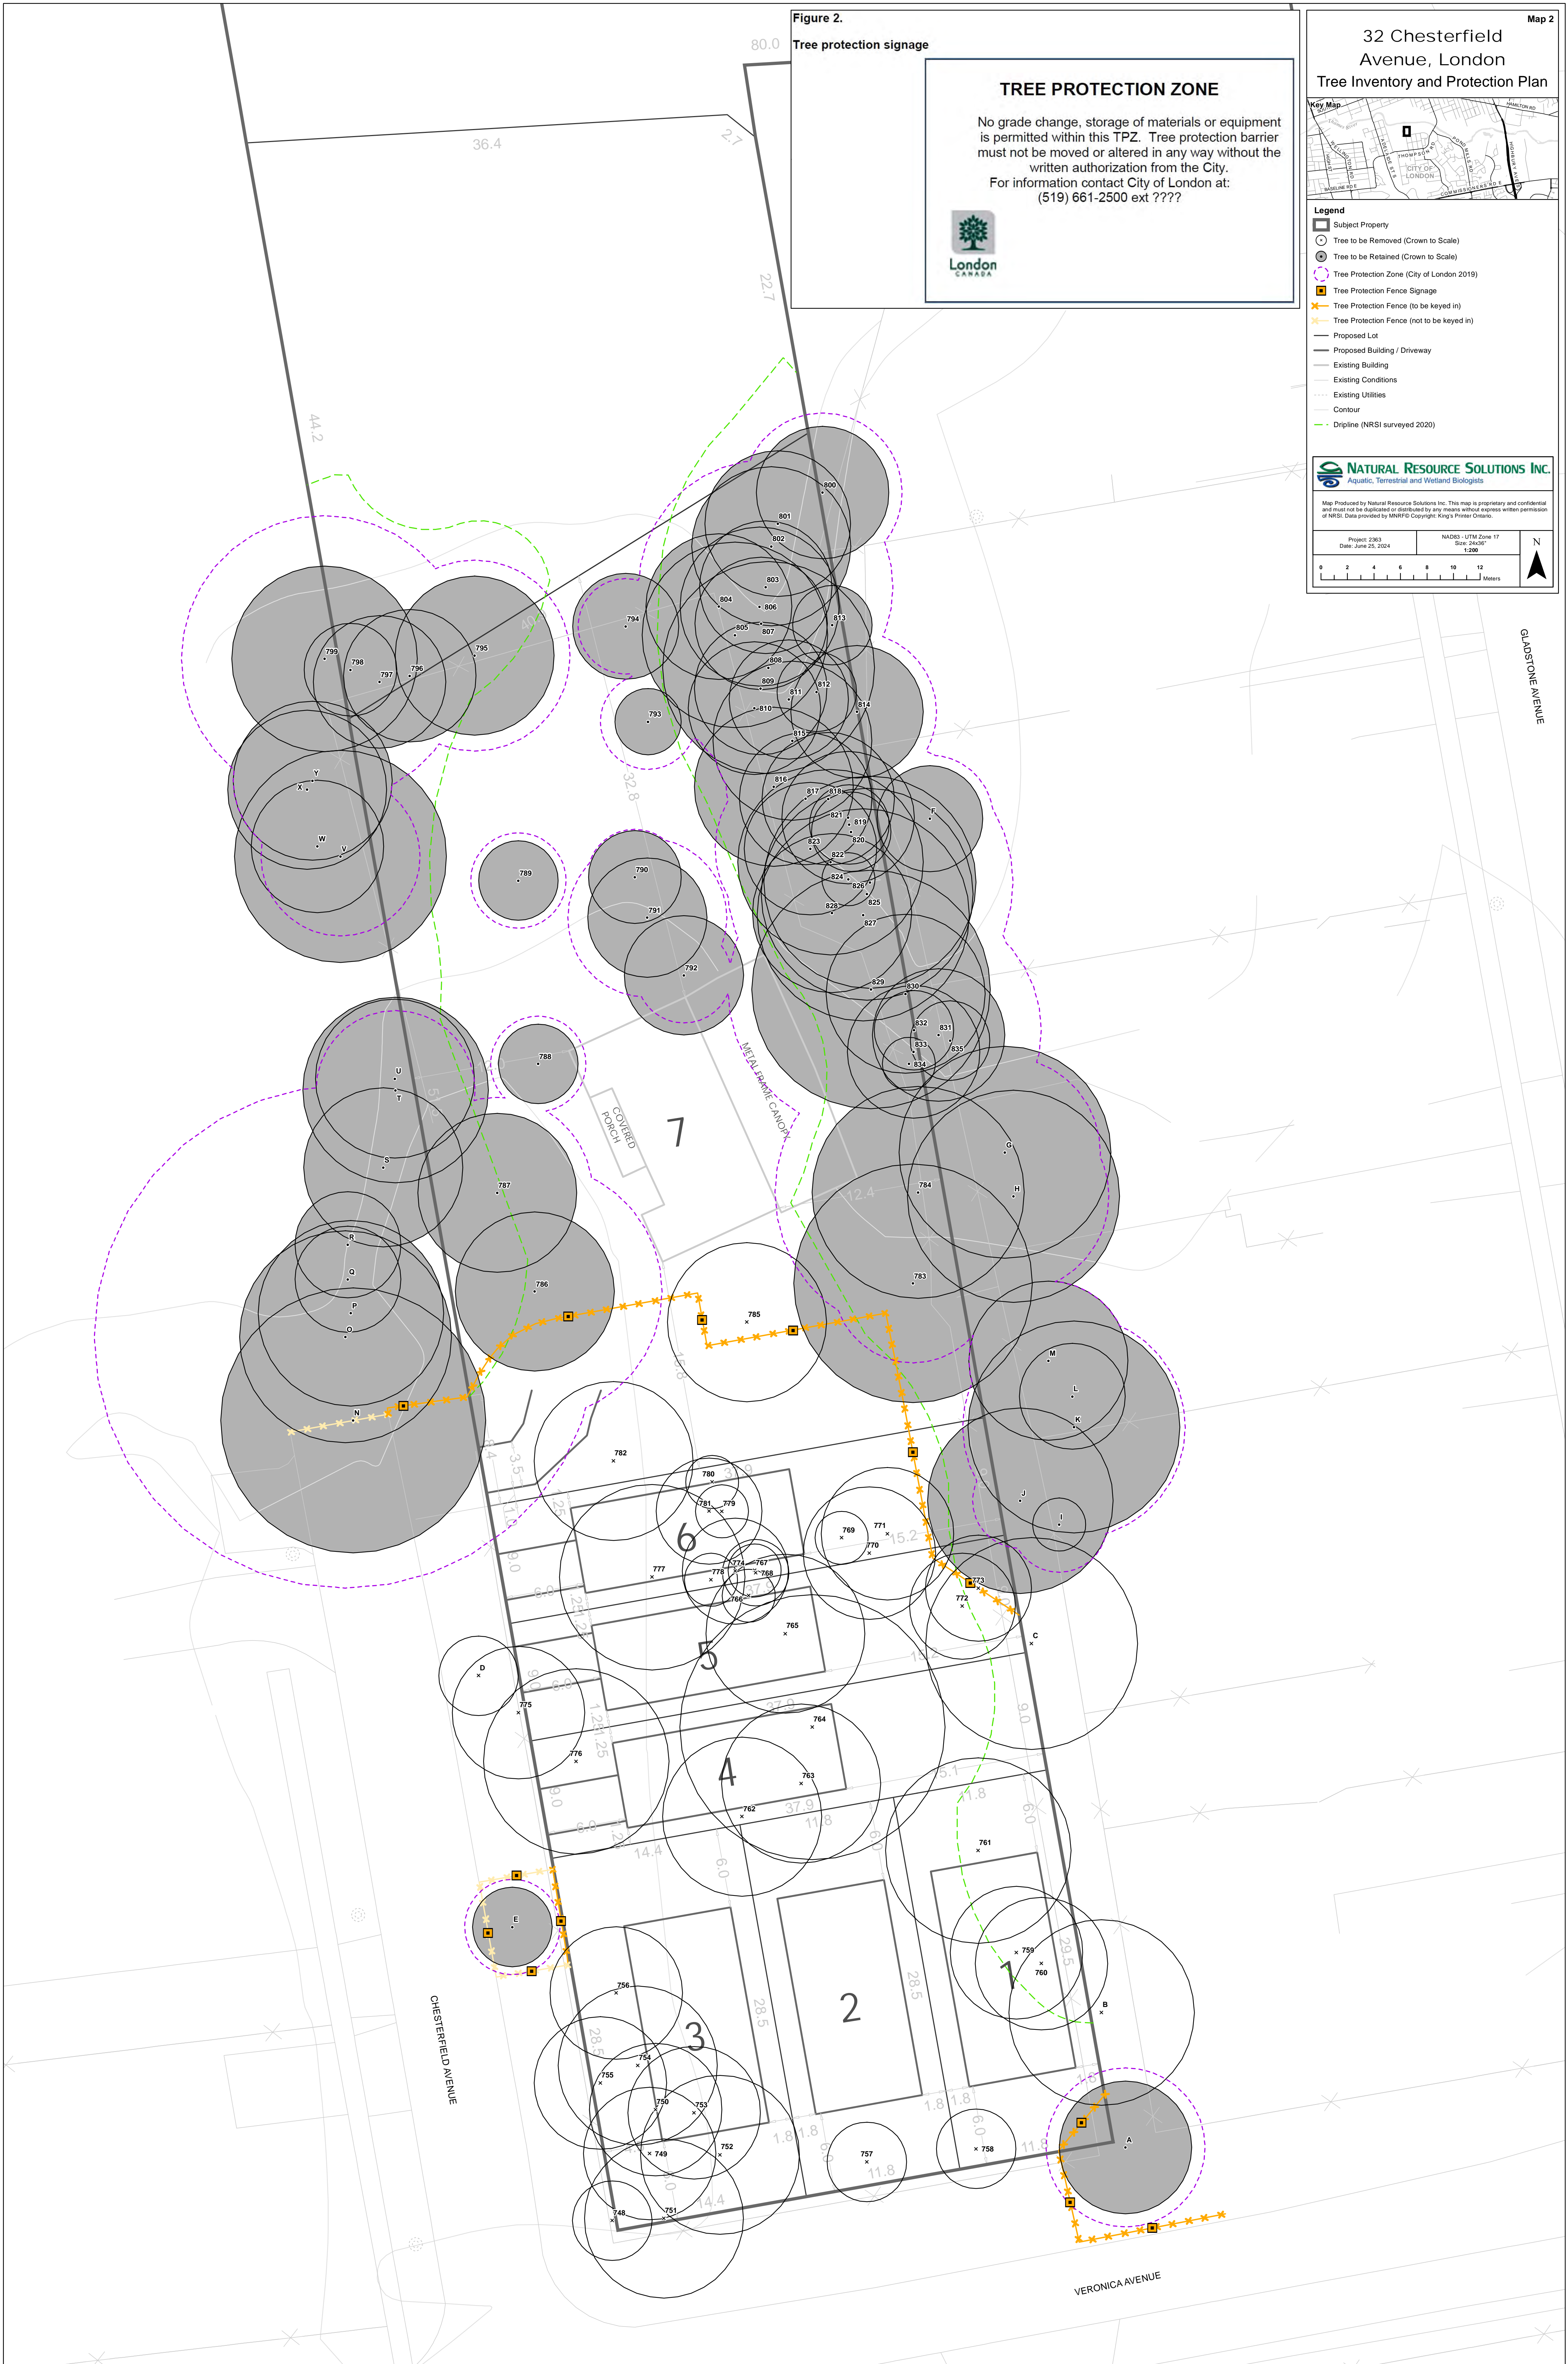
32 Chesterfield Avenue, London Tree Inventory and Protection Plan

The results of this retention analysis (as seen on Map 2 and Appendix I) indicate that 74 inventoried trees have been proposed for retention. Following the boundary measurement standards set by the City of London’s Tree Protection Zone (TPZ) requirements (2019), most of the trees to be retained are anticipated not to be impacted by the proposed development. Several off-property trees to be retained may be impacted, including Tree A, N, and O as their TPZ extends into the proposed development area. As Tree A, N, and O are off the subject property, permission to impact is required by the applicable landowners to approve this plan. This will be provided during the following design stage.

39 of the 113 inventoried trees are anticipated to require removal based on the extent of the proposed development, and/or due to their health and potential for structural failure. The majority of the trees proposed for removal are in fair health with an improbable or possible potential for structural failure, and range in size from 10.2cm to 84.6cm DBH. Two of the trees anticipated to be removed were identified as dead during the tree inventory; one Eastern Red Cedar (*Juniperus virginiana*) and one American Elm (*Ulmus americana*).

Temporary tree protection fencing (TPF) will be situated where trees are adjacent to proposed development as shown on Map 2. A combined sediment and erosion control fence (i.e., silt fence) and TPF is recommended where trees are situated adjacent to the limit of disturbance. This TPF is to take the form of plastic mesh fencing (such as snow fencing), t-bar stakes, heavy duty silt fencing, and topped with 2x4 beams, as outlined in the Design Specifications (City of London 2019). Detailed requirements and a corresponding fencing diagram from the Design Specifications can be found on Map 2.

The TPF will be installed and maintained by the Developer prior to any construction activities (rough grading, vegetation and tree removal). Prior to works commencing on-site, fence installation and location is to be inspected by a Certified Arborist or Registered Professional Forester. Keying in TPF around Tree N and E should be avoided in the areas shown on Map 2, to avoid additional root disturbance to nearby trees. Signage indicating the purpose of protection fencing will be attached to the TPF every 100-150m. Recommended signage, as outlined in the Design Specifications (City of London 2019), and suitable locations, are shown on Map 2.

Section 12.3 of the Design Specifications (City of London 2019) stipulates the minimum size of any TPZ based on the DBH of the protected trees. The TPZ for trees designated for retention are shown on Map 2, applying the protection distances specified for trees within Open Spaces and Woodlands as per the Design Specifications (City of London 2019). For some of the trees designated to be retained, the TPZ will not be possible to maintain to its full extent due to the proposed development plan.
