# **ARBORIST REPORT FOR BY-LAW ZONING AMENDMENT**

**566 SOUTHDALE ROAD & 818 EASY  
STREET, LONDON**

**Report prepared by  
Ron Koudys Landscape Architects Inc**

**RKLA Project #24-192**

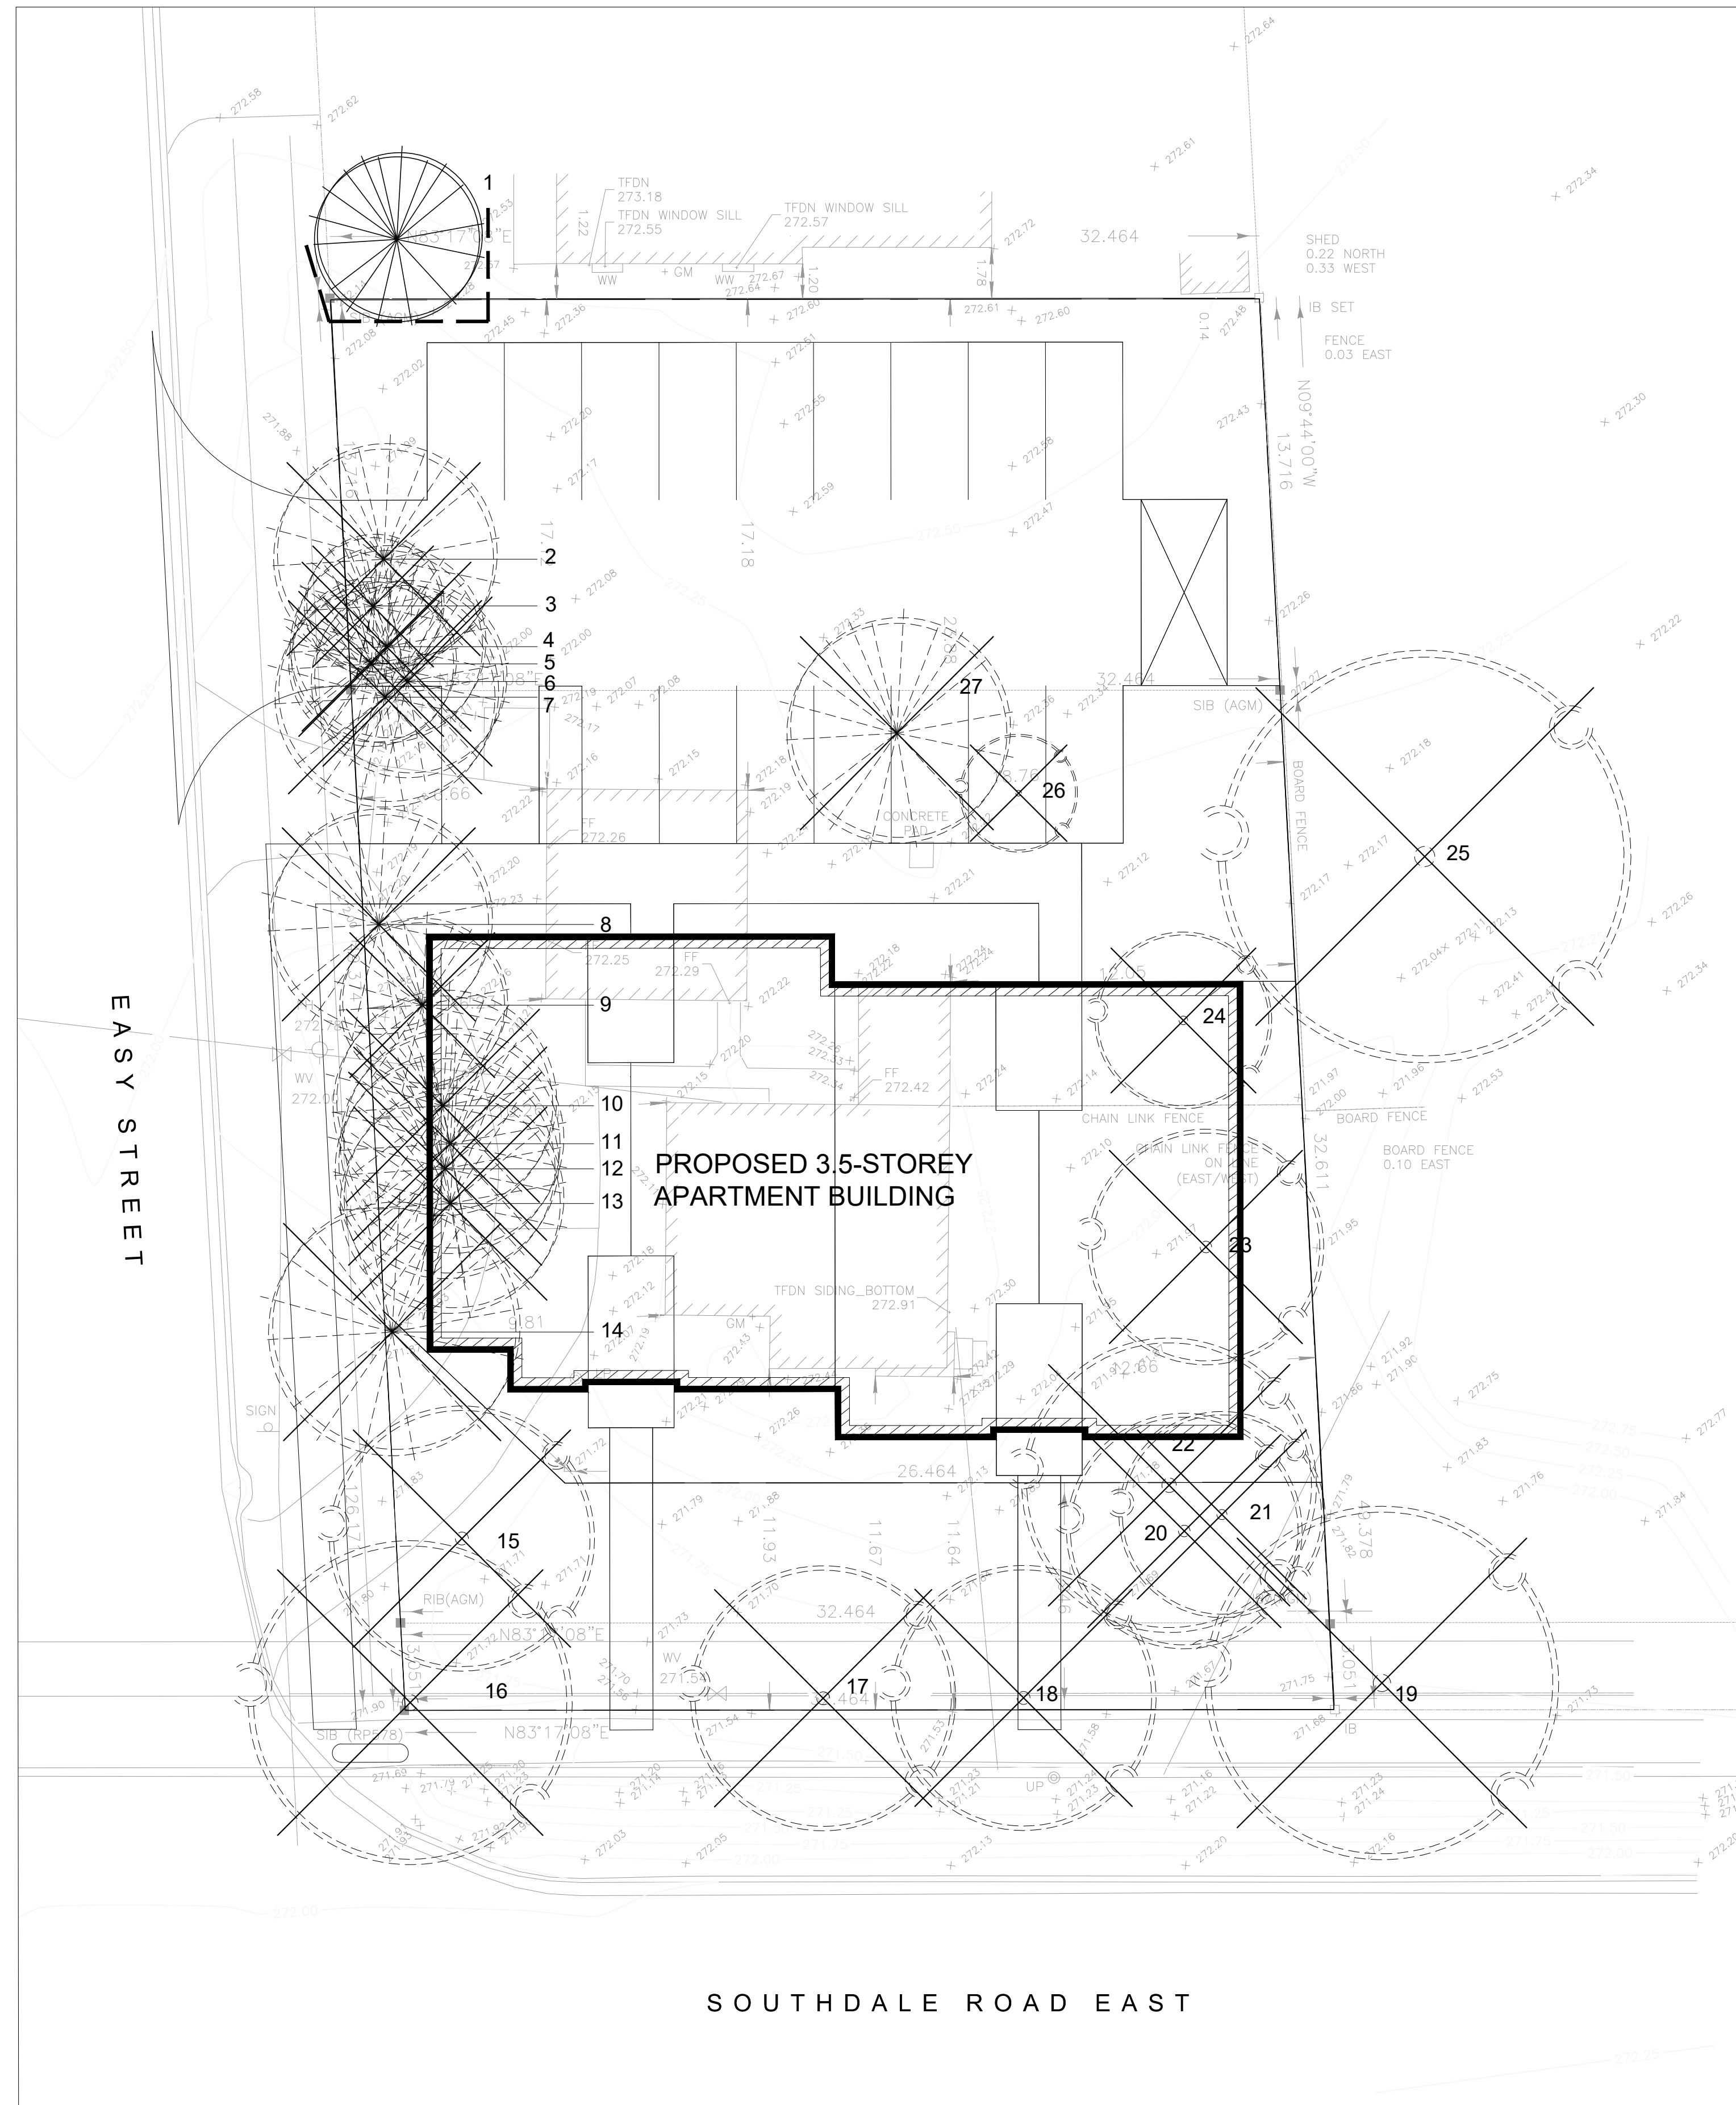
**TREE PRESERVATION PLAN**  
 SCALE = 1:150

ID #	GENERAL INFORMATION		SIZE	HEALTH & CONDITION			RECOMMENDATIONS				
ID #	BOTANICAL NAME	COMMON NAME	LOCATION	DBH (cm)	CANOPY RADIIUS (m)	CROWN CONDITION	STRUCTURAL COPH	STRUCTURAL INTEGRITY	COMMENTS	EXPECTED CONSTRUCTION IMPACTS	PRESERVE OR REMOVE
1	<i>Picea pungens var. glauca</i>	Colorado Blue Spruce	818 Easy Street	-40	3	4	Good	Good	Branch to grade, slightly sparse inner canopy	no anticipated impacts	preserve

ID #	GENERAL INFORMATION		SIZE	HEALTH & CONDITION			RECOMMENDATIONS				
ID #	BOTANICAL NAME	COMMON NAME	LOCATION	DBH (cm)	CANOPY RADIIUS (m)	CROWN CONDITION	STRUCTURAL COPH	STRUCTURAL INTEGRITY	COMMENTS	EXPECTED CONSTRUCTION IMPACTS	PRESERVE OR REMOVE
2	<i>Thuja spp.</i>	Cedar	Subject Site	47.19	5	4	Poor	Fair	Primary union at grade, cavity forming at base	conflict with proposed entrance	remove
3	<i>Thuja spp.</i>	Cedar	Subject Site	21.18	3	3	Poor	Poor	Suppressed, included bark with seam	conflict with proposed entrance	remove
4	<i>Thuja spp.</i>	Cedar	Subject Site	27	4	4	Fair	Fair	Suppressed, epicormic growth	conflict with proposed entrance	remove
5	<i>Thuja spp.</i>	Cedar	Subject Site	22	3	4	Fair	Fair	lean west, suppressed, epicormic growth at base	conflict with proposed entrance	remove
6	<i>Thuja spp.</i>	Cedar	Subject Site	44	4	4	Poor	Fair	lean east, suppressed, major limb broken off, epicormic growth	conflict with proposed entrance	remove

7	<i>Thuja spp.</i>	Cedar	Subject Site	30	4	3	Fair	Fair	lean south, deadwood, epicormic growth	conflict with proposed entrance	remove
8	<i>Picea glauca</i>	White Spruce	Subject Site	51	4	4	Fair	Good	limbed up 3 meters, sparse	conflict with proposed building	remove
9	<i>Picea glauca</i>	White Spruce	Subject Site	30	3	4	Fair	Good	limbed up 3 meters, suppressed	conflict with proposed building	remove
10	<i>Thuja spp.</i>	Cedar	Subject Site	32	4	4	Poor	Fair	Major limb curled west, low union, hydro wires through canopy	conflict with proposed building	remove
11	<i>Thuja spp.</i>	Cedar	Subject Site	31	4	4	Poor	Fair	Union at grade, suppressed, cavity forming at base	conflict with proposed building	remove
12	<i>Thuja spp.</i>	Cedar	Subject Site	29	4	4	Fair	Fair	Major limb removed, lean south	conflict with proposed building	remove
13	<i>Thuja spp.</i>	Cedar	Subject Site	32	4	4	Fair	Fair	lean south, significant epicormic growth	conflict with proposed building	remove

14	<i>Picea glauca</i>	White Spruce	Boundary with City ROW of Easy Street	45	5	4	Fair	Good	limbed up 2 meters, lowers dead, wide flare	conflict with proposed building	remove
15	<i>Salix spp.</i>	Willow	Subject Site	26.25	5	5	Poor	Fair	Low primary union, major epicormic growth	conflict with anticipated grading and poor tree condition	remove
16	<i>Acer saccharinum</i>	Silver Maple	Boundary with City ROW of Easy Street & Southdale Road E.	63	6	3	Poor	Poor	Hydro pruned, deadwood, major cavity on south side	conflict with anticipated grading and poor tree condition	remove
17	<i>Acer saccharum</i>	Sugar Maple	Boundary with City ROW of Southdale Road E.	51	5	3	Poor	Poor	Major oak at 1 meter, south side completely dead	conflict with anticipated grading and poor tree condition	remove
18	<i>Acer platanoides</i>	Norway Maple	Boundary with City ROW of Southdale Road E.	36.25	5	5	Fair	Good	Canopy through hydro wires, low primary union	conflict with anticipated grading/pedestrian	remove

19	<i>Acer platanoides</i>	Norway Maple	574 Southdale Road E.	56	6	5	Fair	Fair	Major epicormic growth, low primary union	to be removed under the 574 Southdale Road East development	remove
20	<i>Betula papyrifera</i>	Paper Birch	Subject Site	32	4	5	Fair	Good	Slight lean south, minor deadwood	conflict with proposed building	remove
21	<i>Betula papyrifera</i>	Paper Birch	Subject Site	20.17	4	4	Fair	Fair	Low primary union, trunk wounds	conflict with proposed building	remove
22	<i>Betula papyrifera</i>	Paper Birch	Subject Site	36.34	5	5	Fair	Fair	Low primary union, epicormic growth	conflict with proposed building	remove
23	<i>Quercus rubra</i>	Red Oak	Subject Site	26	4	5	Good	Good	Minor damage on branches	conflict with proposed building	remove
24	<i>Gymnocladus dioica</i>	Kentucky Coffee Tree	Subject Site	14	3	5	Good	Good	No major damage present, lower branches pruned	conflict with proposed building	remove - permit from the MECP required for removal

25	<i>Acer saccharinum</i>	Silver Maple	574 Southdale Road E.	-70	7	5	Fair	Fair	Low primary union, not completely visible due to tower fence	to be removed under the 574 Southdale Road East development	remove
26	<i>Picea pungens</i>	Colorado Spruce	Subject Site	14	2	4	Good	Good	Slightly sparse on west side of parking	conflict with proposed parking	remove
27	<i>Picea glauca</i>	White Spruce	Subject Site	-40	4	4	Fair	Good	Inner canopy sparse	conflict with proposed parking	remove
