TRICAR - PROPOSED APARTMENT BUILDING

1378-1398 COMMISSIONERS RD WEST LONDON, ONTARIO

TREE PRESERVATION PLAN

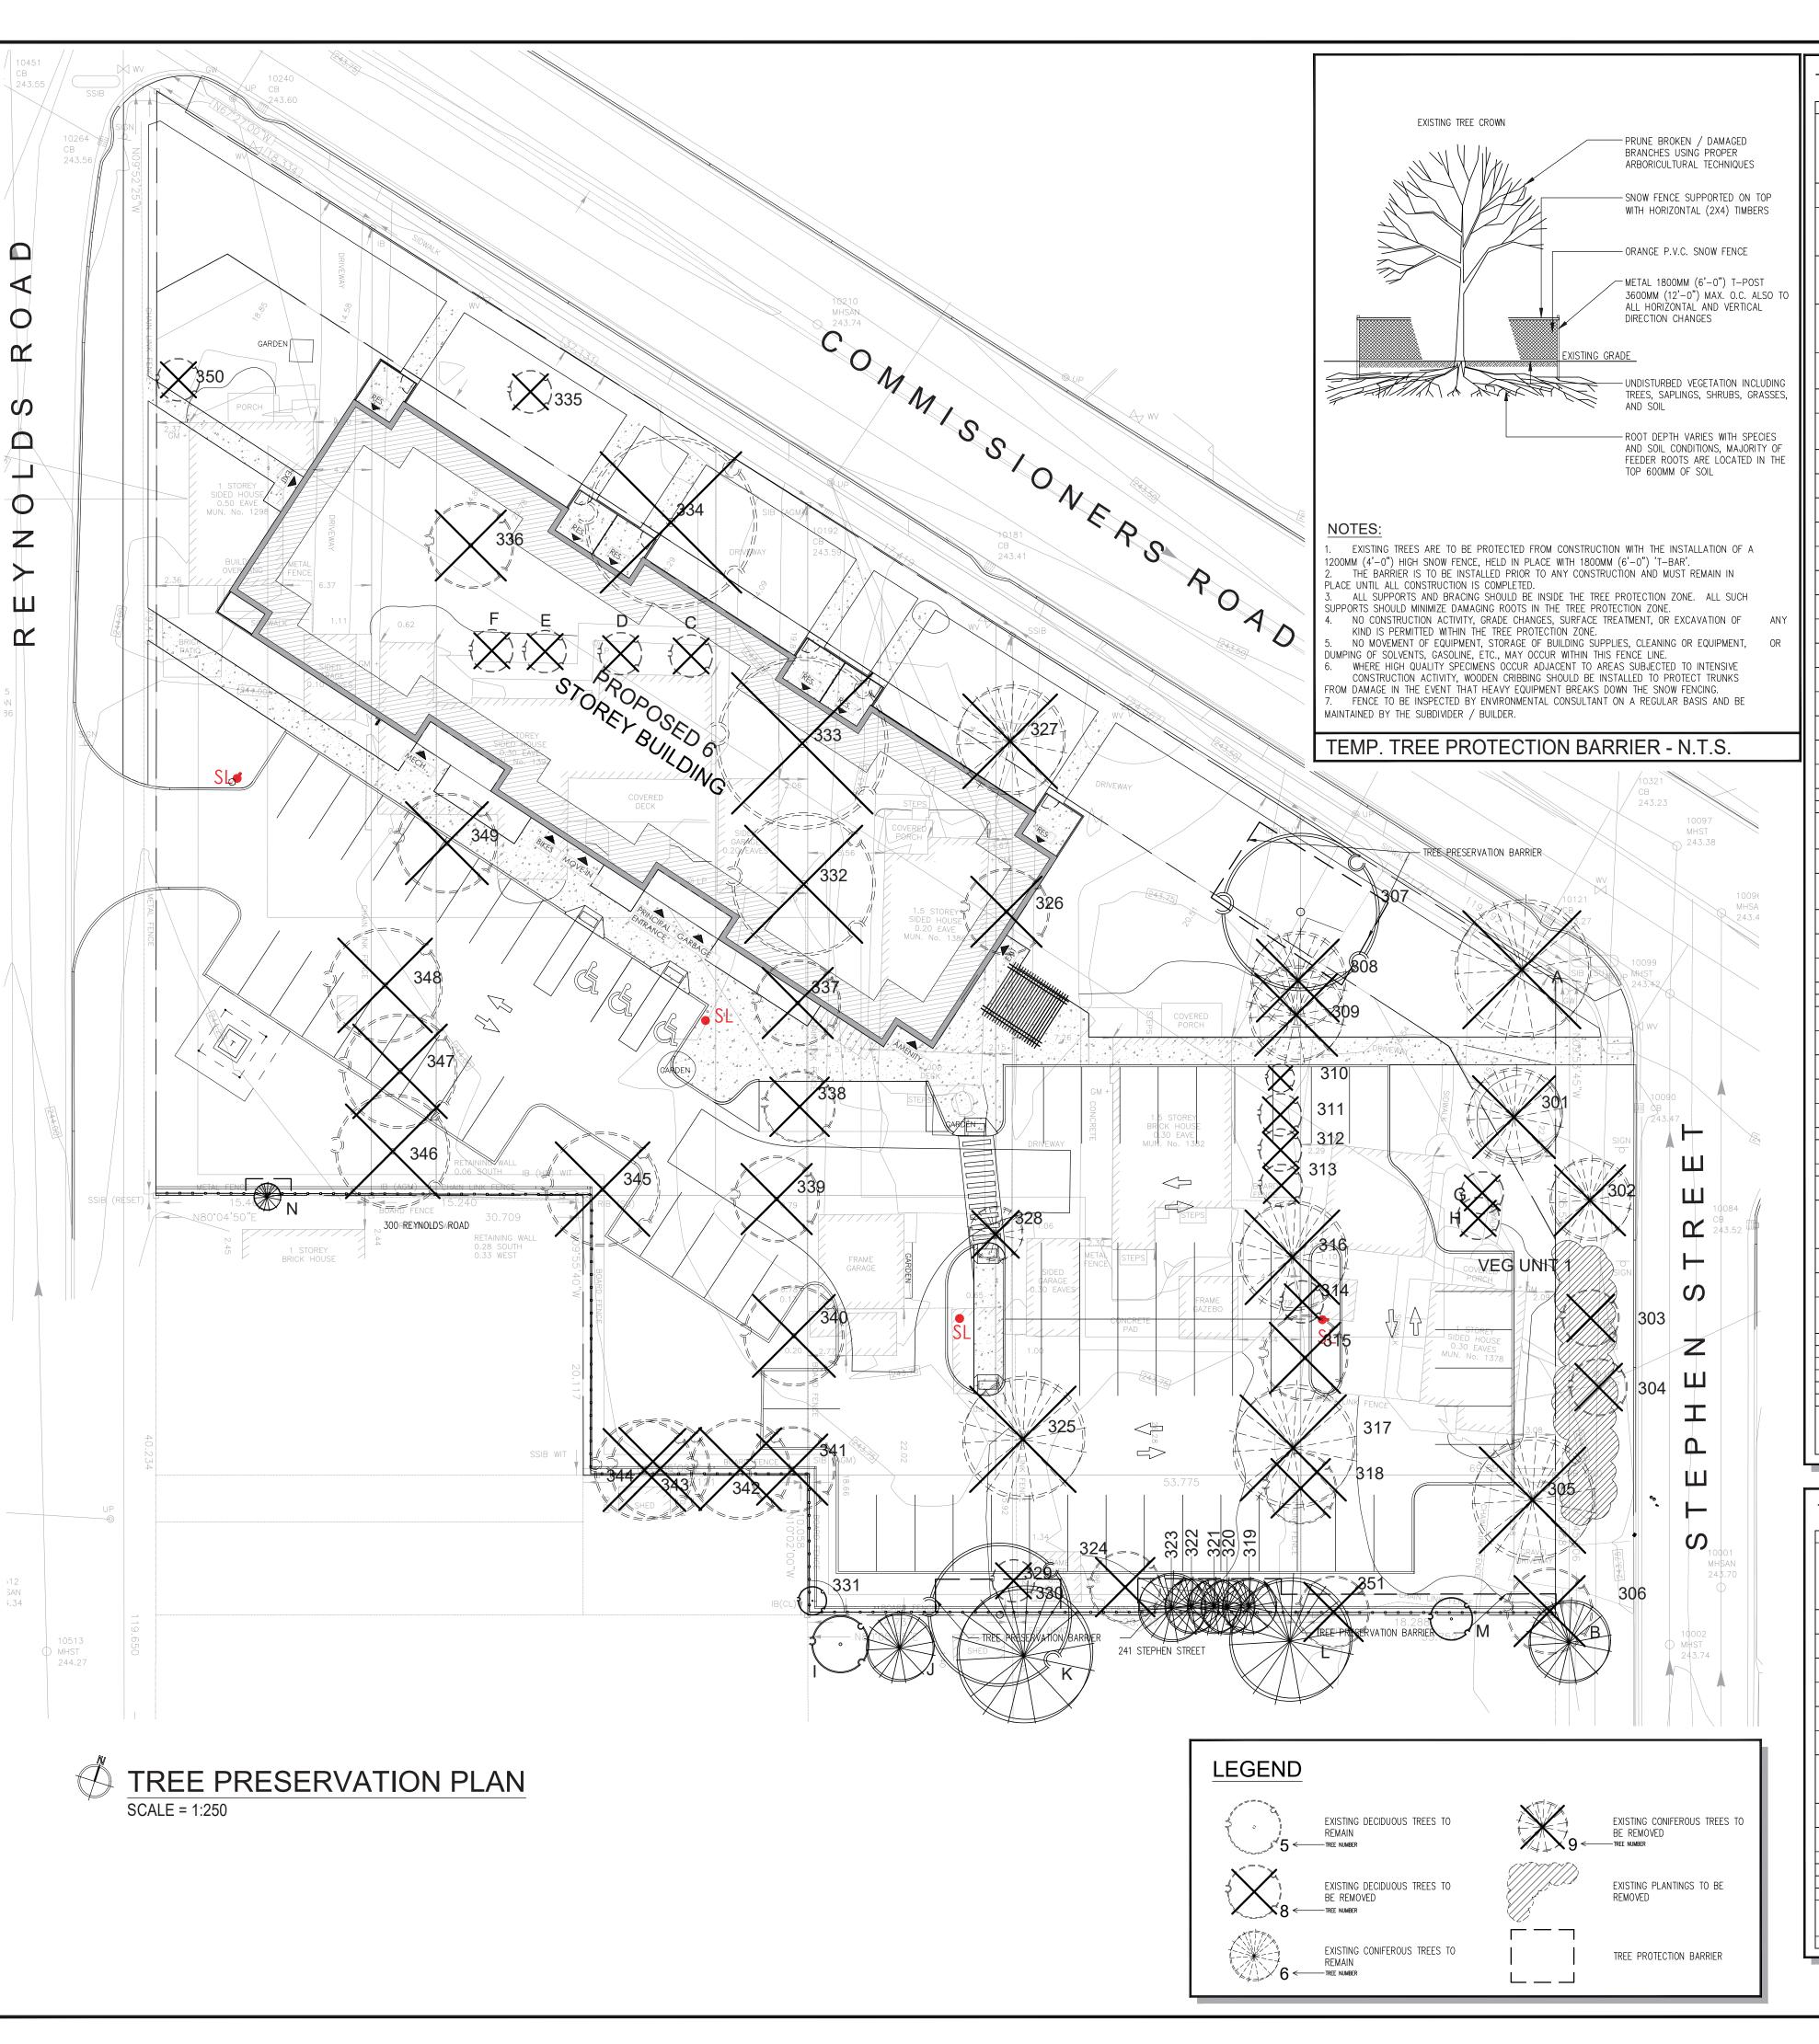
<u> </u>	ENERAL INFORMATION	1	SIZE		L			LTH & CONDITION	RECOM	MENDATIONS	
D#	BOTANICAL NAME	COMMON NAME	LOCATION	DBH (cm)	CANOPY RADIUS (m)	CROWN CONDITION	STRUCTURAL FORM	STRUCTURAL INTEGRITY	COMMENTS	EXPECTED CONSTRUCTION IMPACTS	PRESERVE OR REMOVE	CON REQUIR
301	Picea abies	Norway Spruce	Subject site (within road widening)	59	3.5	3	Poor	Good	canopy dieback, only top part of canopy	conflict with proposed road	remove	N/A
302	Picea pungens	Colorado Spruce	City ROW Stephen Street	68	3	3	Poor	Fair	present, limbed up 3 meters topped for hydro pruning, hydro wires through top of canopy, codominant at 2 meters, exposed roots	widening and poor tree condition poor tree condition	remove	Consent from the London t departn
303	Acer platanoides	Norway Maple	City ROW Stephen Street	21	2	4	Poor	Fair	pruned for hydro, in hedge	poor tree condition	remove	Consent from the London to departr
304	Acer platanoides	Norway Maple	City ROW Stephen Street	21	2	4	Poor	Fair	topped at 2 meters, epicormic growth	poor tree condition	remove	Consent from the London f departn

305	Picea abies	Norway Spruce	Subject site	49	4.5	3/4	Fair	Good	slight trunk lean, limbed up, old pruned wounds not healing, slightly sparse	conflict with proposed parking	remove	N/A
306	Morus alba	White Mulberry	Subject site	17, 13, 5	3	3/4	Poor	Poor	low primary union, deadwood, included bark at union	poor tree condition	remove	N/A
308	Picea abies	Norway Spruce	Subject site	51	3.5	4	Poor	Fair	codominant stems at 2 meters, abnormal primary union, included bark and split at union	1 1 1	remove	N/A
309	Picea abies	Norway Spruce	Subject site	54	3.5	4	Poor	Fair	multi-stem at 2 meters, abnormal primary union	conflict with proposed walkway and parking/ poor tree condition	remove	N/A
310	Salix spp.	Willow	Subject site	6, 5, 5, 3, 2,	1	5	Poor	Good	multi-stem, primary union at grade, 2.5	conflict with proposed walkway and	remove	N/A
311	Salix spp.	Willow	Subject site	2 17	1.5	5	Poor	Fair	meters tall, dead wood major basal wound on east side	parking/ poor tree condition conflict with proposed parking and	remove	N/A

312	Salix spp.	Willow	Subject site	15	1.5	5	Poor	Fair	major basal wound on east side	poor tree condition conflict with proposed parking and	remove	N/A
313	Salix spp.	Willow	Subject site	13	1.5	5	Poor	Fair	minor trunk wounds throughout canopy,	poor tree condition conflict with proposed parking and	remove	N/A
314	Celtis occidentalis	Hackberry	Subject site	10	1.5	5	Fair	Good	deadwood supressed, slight lean west, low	poor tree condition conflict with proposed parking	remove	N/A
315	Acer saccharum	Sugar Maple	Subject site	29	3	4	Fair	Good	epicormic growth supressed, covered in grape vine, minor	conflict with proposed parking	remove	N/A
316	Picea abies	Norway Spruce	Subject site	68	4	4	Fair	Good	wounds and cracks on trunk codominant stems at 3 meters, vines	conflict with proposed parking	remove	N/A
317	Picea abies	Norway Spruce	Subject site	79	4.5	4	Fair	Good	growing up trunk entire trunk covered in english ivy, lower limbs supressed	conflict with proposed parking	remove	N/A

318	Acer platanoides	Norway Maple	Subject site	22, 18	2.5	4/5	Poor	Poor	lean southwest, fence grown, low primary union, supressed	conflict with proposed parking	remove	N/A
324	Malus sp.p.	Apple	Subject site	31	2.5	3/4	Poor	Poor	epicormic growth, major wounds and	minor conflict with proposed	remove	N/A
325	Picea abies	Norway Spruce	Subject site	56	4.5	4	Good	Good	cavities starting vines covering trunk, canopy slightly	parking and poor tree condition conflict with proposed parking	remove	N/A
326	Cercis canadensis	Red bud	Subject site	20, 18, 14	3	4	Fair	Good	1	conflict with proposed building	remove	N/A
327	Picea abies	Norway Spruce	Subject site (within road widening)	54	4	5	Good	Good	lowers pruned, overall full form	conflict with proposed building	remove	N/A
328 329	Picea glauca Rhamnus cathartica	White Spruce Buckthorn	Subject site Subject site	22 13	2 1.5	4	Good Fair	Good Fair	full form grown opportunistically, fence grown	conflict with proposed parking conflict with proposed parking	remove remove	N/A N/A

332	Acer saccharum	Sugar Maple	Subject site	64	5	4/5	Fair	Fair	elevated base, fence gate rubs against trunk base, cavity at 1.5 meters from grade, slight lean west	conflict with proposed building	remove	N/A
333	Acer saccharum	Sugar Maple	Subject site	96	6	4/5	Fair	Fair	codominant at 1.5 meters, wide flare, exposed roots	conflict with proposed building	remove	N/A
334	Catalpa speciosa	Catalpa	Subject site (within road widening)	119	6	4/5	Poor	Fair	cavity forming in centre at primary union, minor canopy dieback, cavities forming at prune wounds	conflict with proposed walkway and poor tree condition	remove	N/A
335	Morus alba Pendula'	Weeping White Mulberry	Subject site (within road widening)	32	1.5	4	Poor	Fair	major wound on east side of trunk, cavity forming and split at union		remove	N/A
336 337	Acer platanoides Acer saccharum	Norway Maple Sugar Maple	Subject site Subject site	65	3	4	Poor Fair	Fair Fair	with frass	conflict with proposed building and poor tree condition conflict with proposed building	remove remove	N/A N/A

ŕ			Ċ			with included bark	, ,	remove	
338 339	Acer saccharum Acer saccharum	Sugar Maple Sugar Maple	Subject site Subject site	25 34	2.5 3	4	Fair Fair	Fair Good	trunk burl at base minor epicormic growth, minor dieback	conflict with proposed parking conflict with proposed parking	remove remove	N/A N/A
340	Ulmus pumilla	Siberian Elm	Subject site	69	3.5	3/4	Poor	Poor	codominant stems at 2 meters, open weeping wound on west side of trunk	conflict with proposed parking and poor tree condition	remove	N/A
341 342	Ulmus pumilla Ulmus pumilla	Siberian Elm Siberian Elm	Subject site Subject site	33	3.5	3/4	Poor	Good Good	epicormic growth, old prune wounds epicormic growth, old prune wounds	conflict with proposed parking and poor tree condition conflict with proposed parking and	remove remove	N/A N/A
343	Ulmus pumilla	Siberian Elm	Subject site	61	3.5	3/4	Poor	Fair	trunk lean, sparse, lower epicormic	poor tree condition conflict with proposed parking and	remove	N/A

344	Ulmus pumilla	Siberian Elm	Subject site	41	3.5	3/4	Poor	Fair		poor tree condition conflict with proposed parking and poor tree condition	remove	N/A
345 346	Juglans nigra Juglans nigra	Black Walnut Black Walnut	Subject site Subject site	54 79	4	5	Fair Poor	Good Fair	canopy dieback, basal burl lower primary union, included bark at	conflict with proposed parking minor conflict with proposed parking and poor tree condition	remove remove	N/A N/A
347 348	Ulmus pumilla Ulmus pumilla	Siberian Elm Siberian Elm	Subject site Subject site	75 46	4	4	Fair Poor	Fair Fair	low union, sparse, included bark	parking and poor tree condition conflict with proposed parking conflict with proposed parking	remove remove	N/A N/A
349	Acer negundo	Manitoba Maple	Subject site	87	3.5	4	Poor	Poor	stem removed tree topped at primary union, entire canopy all epicormic growth, major	conflict with proposed parking	remove	N/A

750	Maliscop	Annie	Subject site	7.4	15	7	Doc-	Fair	cavity at union and down the north side of trunk	conflict with proposed well-	ramair	NI/A
350 351	Malus spp. Tilia cordata	Apple Little Leaf Linden	Subject site Subject site	24 27, 15	1.5 2.5	3	Poor	Fair Fair	epicormic growth, low primary union fence grown, low primary union,	conflict with proposed walkway and poor tree condition minor conflict with proposed	remove remove	N/A N/A
A	Picea abies	Norway Spruce	Subject site (within road widening)	72	5	4	Fair	Good	supressed codominant stems at 3.5 meters with included bark, minor dieback, hydro wire through lower canopy	parking and poor tree condition conflict with proposed road widening and fair tree condition	remove	N/A
(Acer palmatum	Japanese Maple	Subject site	9, 5	1.5	5	Good	Good		conflict with proposed building	remove	N/A
D E	Acer palmatum Acer palmatum	Japanese Maple Japanese Maple	Subject site Subject site	12, 6 10, 9	1.5 1.5	5 5	Good Good	Good Good		conflict with proposed building conflict with proposed building	remove remove	N/A N/A

F G	Acer palmatum Amelanchier spp.	Japanese Maple Serviceberry	Subject site Subject site	11, 9, 6 ~10	1.5 2	5 5	Good Fair	Good Fair	split forming at primary union	conflict with proposed building conflict with proposed building	remove remove	N/A N/A
Н	Pyrus spp.	Pear	Subject site	1.5	4	4	Fair	Fair	all epicormic growth, low primary union	conflict with proposed building	remove	N/A
UNII #1	Syringa spp.	Lilac	City ROW Stephen Street	~5-12	1-2	5	Poor	Fair	all epicormic growth, straggly form, grapevine covering canopy, wounds and cavities forming along trunks	conflict with proposed parking and poor condition	remove	Consent from th London

GENERAL INFORMATION					SIZE			HEAL	TH & CONDITION	RECOMMENDATIONS		
ID#	BOTANICAL NAME	COMMON NAME	LOCATION	ОВН (ст)	CANOPY RADIUS (m)	CROWN CONDITION	STRUCTURAL FORM	Structural Integrity	COMMENTS	EXPECTED CONSTRUCTION IMPACTS	PRESERVE OR REMOVE	CONSENT REQUIREMENTS
307	Juglans nigra	Black Walnut	Subject site (within road widening)	56	5.5	4	Fair	Good	hydro wires through canopy, slight trunk lean	no conflict with proposed site plan	preserve	N/A
319	Thuja spp.	Cedar	Subject site	21	2	4	Good	Good	hedge row, slightly supressed	minor conflict with proposed parking	preserve	N/A
320	Thuja spp.	Cedar	Subject site	23	2	4	Good	Good		minor conflict with proposed parking	preserve	N/A
321	Thuja spp.	Cedar	Subject site	18	2	4	Good	Good		minor conflict with proposed parking	preserve	N/A
322	Thuja spp.	Cedar	Subject site	23	2	4	Good	Good	hedge row, slightly supressed	minor conflict with proposed parking	preserve	N/A

323	Thuja spp.	Cedar	Subject site	32	2.5	4	Good	Good	hedge row, slightly supressed	minor conflict with proposed parking	preserve	N/A
330	Juglans ailantifolia	Japanese Walnut	Boundary between 1386 Commissioners Road (subject site) and 241 Stephen Street	~55	5	5	Fair		fence is attached to the trunk on either side, dbh estimated, codominant stems at 3 meters, large branches have been pruned, prunes healing well	conflict with critical root zone and proposed parking	preserve - review at the time of SPA	Consent to injure required from 24 Stephen Street
331	Ulmus pumilla	Siberian Elm	Subject site	8	1	5	Good	Good	full form, low epicormic growth	minor conflict with proposed construction	preserve	N/A
В	Picea abies	Norway Spruce	City ROW Stephen Street	57	3.5	5	Fair		topped for hydro , DBH taken below primary union, codominant	no conflict with proposed site plan	preserve	N/A
	Acer platanoides	Norway Maple	241 Stephen Street	~12	1.5	5	Good	Good	Limited view from wood fence	no conflict with proposed site plan	preserve	N/A

J	Pinus sylvestris	Scots Pine	241 Stephen Street	~15	2	4	Good	Good	limited view from wood fence	no conflict with proposed site plan	preserve	N/A
K	Picea abies	Norway Spruce	241 Stephen Street	~40	5	4	Good	Good	Limited view from wood fence	no conflict with proposed site plan	preserve	N/A
L	Picea abies	Norway Spruce	241 Stephen Street	~50	5	4	Fair		low codominant stems	no conflict with proposed site plan	preserve	N/A
М	Lonicera spp.	Honeysuckle	241 Stephen Street	~5-12	1.5	4	Poor		low primary union, multiple stems,	no conflict with proposed site plan	preserve	N/A
