# **TREE PRESERVATION REPORT FOR ZONING BY-LAW AMENDMENT**

**459 HALE STREET  
LONDON, ONTARIO**

Report prepared by  
Ron Koudys Landscape Architects Inc

RKLA Project #24-143

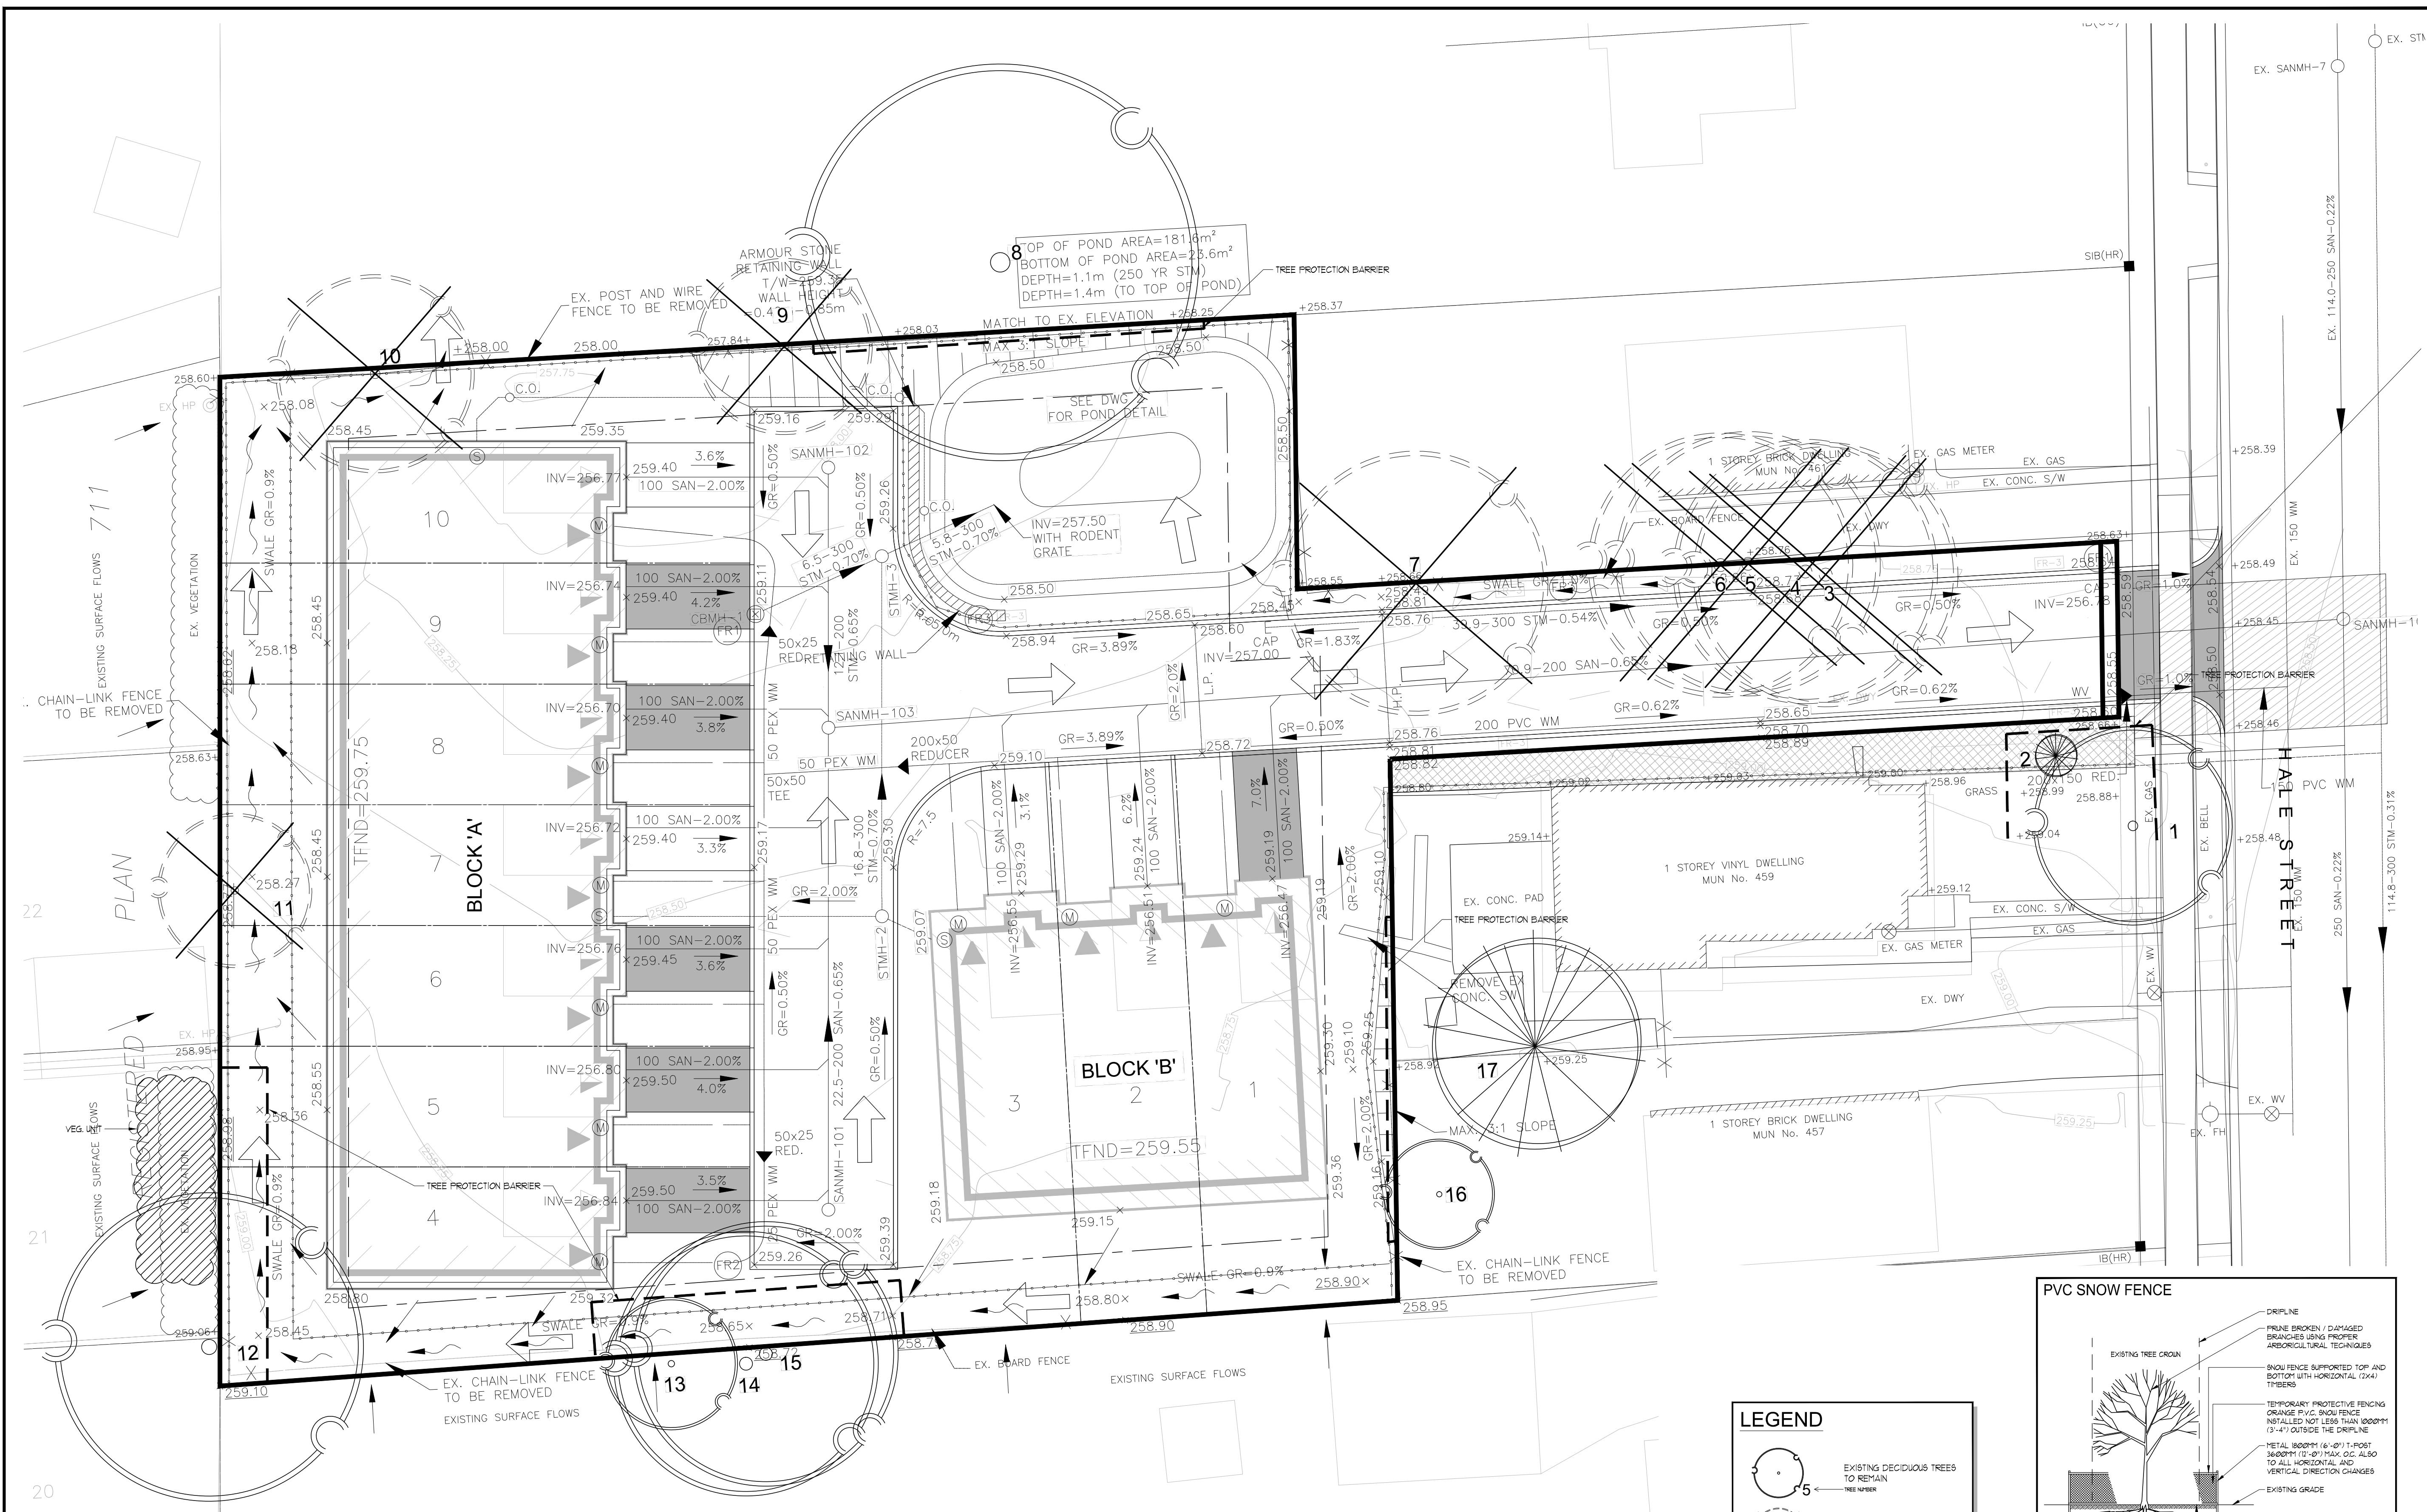
**TREE PRESERVATION PLAN**  
 SCALE = 1:150

GENERAL INFORMATION				SIZE		HEALTH & CONDITION				RECOMMENDATIONS		
ID #	BOTANICAL NAME	COMMON NAME	LOCATION	DBH (cm)	CANOPY RADIUS (m)	CROWN CONDITION	STRUCTURAL FORM	STRUCTURAL INTEGRITY	COMMENTS	EXPECTED CONSTRUCTION IMPACTS	PRESERVE OR REMOVE	IMPACT MITIGATION / CONSENT REQUIREMENTS
1	<i>Gleditsia triacanthos var. inermis</i>	Honey Locust	Boundary - 459 Hale Street and City ROW	30	4.5	5	Good	Good	Full form	no expected impacts	preserve	tree protection barrier
2	<i>Picea glauca 'Conica'</i>	White Spruce	549 Hale Street	25	1	5	Good	Good	Full form	no expected impacts	preserve	tree protection barrier
3	<i>Ulmus pumila</i>	Siberian Elm	Subject site	40	6	4	Fair	Fair	previously a multistem 2 tree - 35 dia. Trunk removed at 60cm from grade. North side of root system covered by asphalt driveway right up to base of trunk	conflict with proposed driveway entrance	remove	
4	<i>Acer negundo</i>	Manitoba Maple	Subject site	40	6	4	Poor	Fair	codominant stems, included bark, epicormic growth, suppressed, open crown. North side of root system covered by asphalt driveway right up to base of trunk	conflict with proposed driveway entrance	remove

5	<i>Acer negundo</i>	Manitoba Maple	Boundary - subject site and 461 Hale Street	30	6	4	Fair	Fair	epicormic growth, uneven crown, suppressed, dead limbs, dramatically curved trunk - significant lean NWW. North side of root system covered by asphalt driveway right up to base of trunk	conflict with proposed driveway entrance	remove	consent from 461 Hale Street required

GENERAL INFORMATION				SIZE		HEALTH & CONDITION				RECOMMENDATIONS		
ID #	BOTANICAL NAME	COMMON NAME	LOCATION	DBH (cm)	CANOPY RADIUS (m)	CROWN CONDITION	STRUCTURAL FORM	STRUCTURAL INTEGRITY	COMMENTS	EXPECTED CONSTRUCTION IMPACTS	PRESERVE OR REMOVE	IMPACT MITIGATION / CONSENT REQUIREMENTS
6	<i>Acer negundo</i>	Manitoba Maple	Boundary - subject site and 461 Hale Street	35	6	4	Fair	Fair	previously a multistem 2 tree - 35 dia. Trunk removed at 30cm from grade. Suppressed, significant lean NWW, epicormic growth along stem and emerging from remaining stump. North side of root system covered by asphalt driveway right up to base of trunk	conflict with proposed driveway entrance	remove	consent from 461 Hale Street required
7	<i>Ulmus pumila</i>	Siberian Elm	Boundary - subject site and 461 Hale Street	110	6	5	Fair	Fair	tree is growing on property line - existing wood fence is cut around the trunk, codominant stems, included bark, low unions, epicormic growth	conflict with proposed driveway entrance	remove	consent from 461 Hale Street required

8	<i>Acer platanoides</i>	Norway Maple	465 Hale Street	85	9	5	Fair	Fair	elevated root plate, low unions, dead limbs in upper centre of crown, broad spreading crown	minor impact to critical root zone	preserve	tree protection barrier
9	<i>Celtis occidentalis</i>	Hackberry	Boundary - subject site and 465 Hale Street	35	4	5	Fair	Good	trunk is touching existing wire fence, low branched	conflict with proposed construction and critical root zone	remove	consent from 465 Hale Street required
10	<i>Ulmus pumila</i>	Siberian Elm	Boundary - subject site and 465 Hale Street	30, 30, 45	4.5	2	Poor	Fair	multistem 3, trunk is touching wire fence, all trunks heavy with moss and showing a pattern of disfigurement, no indication of live growth at time of assessment	conflict with proposed construction and poor tree condition	remove	consent from 465 Hale Street required
11	<i>Acer negundo</i>	Manitoba Maple	Subject site	10, 10, 10	3.5	3	Poor	Fair	multi stem 3, approx. 5 additional stems removed at 80cm from grade, significant epicormic growth from pruned stems, entangled in vine	conflict with proposed construction and poor tree condition	remove

12	<i>Acer negundo</i>	Manitoba Maple	87 Heather Place	10, 15, 20	7	3	Poor	Fair	multistem 3, base of tree is beyond subject site, but all three stems and 95% of the canopy extends into subject site, significant lean, rubbing/damaged branches, wounds	minor impact to critical root zone and canopy	preserve	tree protection barrier - pre-construction canopy pruning
13	<i>Acer platanoides</i>	Norway Maple	456 Hale Street	11	3	4	Fair	Fair	leaning, trunk wounds	minor impact to critical root zone	preserve	tree protection barrier
14	<i>Acer platanoides</i>	Norway Maple	455 Hale Street	35	6	5	Fair	Good	beyond subject site, growing immediately beside tree 17, wound from rubbing branch from tree 17	minor impact to critical root zone	preserve	tree protection barrier

GENERAL INFORMATION				SIZE		HEALTH & CONDITION				RECOMMENDATIONS		
ID #	BOTANICAL NAME	COMMON NAME	LOCATION	DBH (cm)	CANOPY RADIUS (m)	CROWN CONDITION	STRUCTURAL FORM	STRUCTURAL INTEGRITY	COMMENTS	EXPECTED CONSTRUCTION IMPACTS	PRESERVE OR REMOVE	IMPACT MITIGATION / CONSENT REQUIREMENTS
15	<i>Acer platanoides</i>	Norway Maple	455 Hale Street	85	6	5	Fair	Good	beyond subject site, growing immediately beside tree 16, included bark, low union, trunk is pushing up against ex. Fence	minor impact to critical root zone	preserve	tree protection barrier
16	<i>Malus spp</i>	Apple	457 Hale Street	20	3	4	Fair	Good	typical epicormic growth	no expected impacts	preserve	tree protection barrier
17	<i>Pinus strobus</i>	White Pine	459 Hale Street	40	5	5	Good	Good	Full form	no expected impacts	preserve	tree protection barrier
Veg unit 1	<i>Thuja spp.</i>	Cedar	85 Heather Place	10-15	2.5	4	fair	fair	approximately 10 individuals, grapevine covering canopy	no expected impacts	preserve	tree protection barrier

- Removal of 5 trees located beyond the subject site with consent from adjacent landowners. Consent will be acquired at the time of Site Plan Approval.
- Removal of 3 trees from the subject site due to direct conflict with the proposed work.
- Preserve 9 trees and 1 vegetation unit located beyond the subject site.
- Follow pre, during, and post construction recommendations outlined in the Construction Impact Mitigation Recommendations in this report.

- a) Prior to any construction activity, tree preservation fencing is to be installed as per the attached tree preservation drawings and detail.
- b) Trees approved for removal are to be clearly indicated in the field (marked with spray paint or other agreed upon method) by the project arborist or landscape architect prior to any tree removal operations. All removals to be undertaken by an ISA certified arborist.
