# TREE PRESERVATION REPORT FOR ZONING BY-LAW AMENDMENT

219 COMMISSIONERS ROAD WEST,  
LONDON

Report prepared by  
Ron Koudys Landscape Architects Inc

RKLA Project #26-105

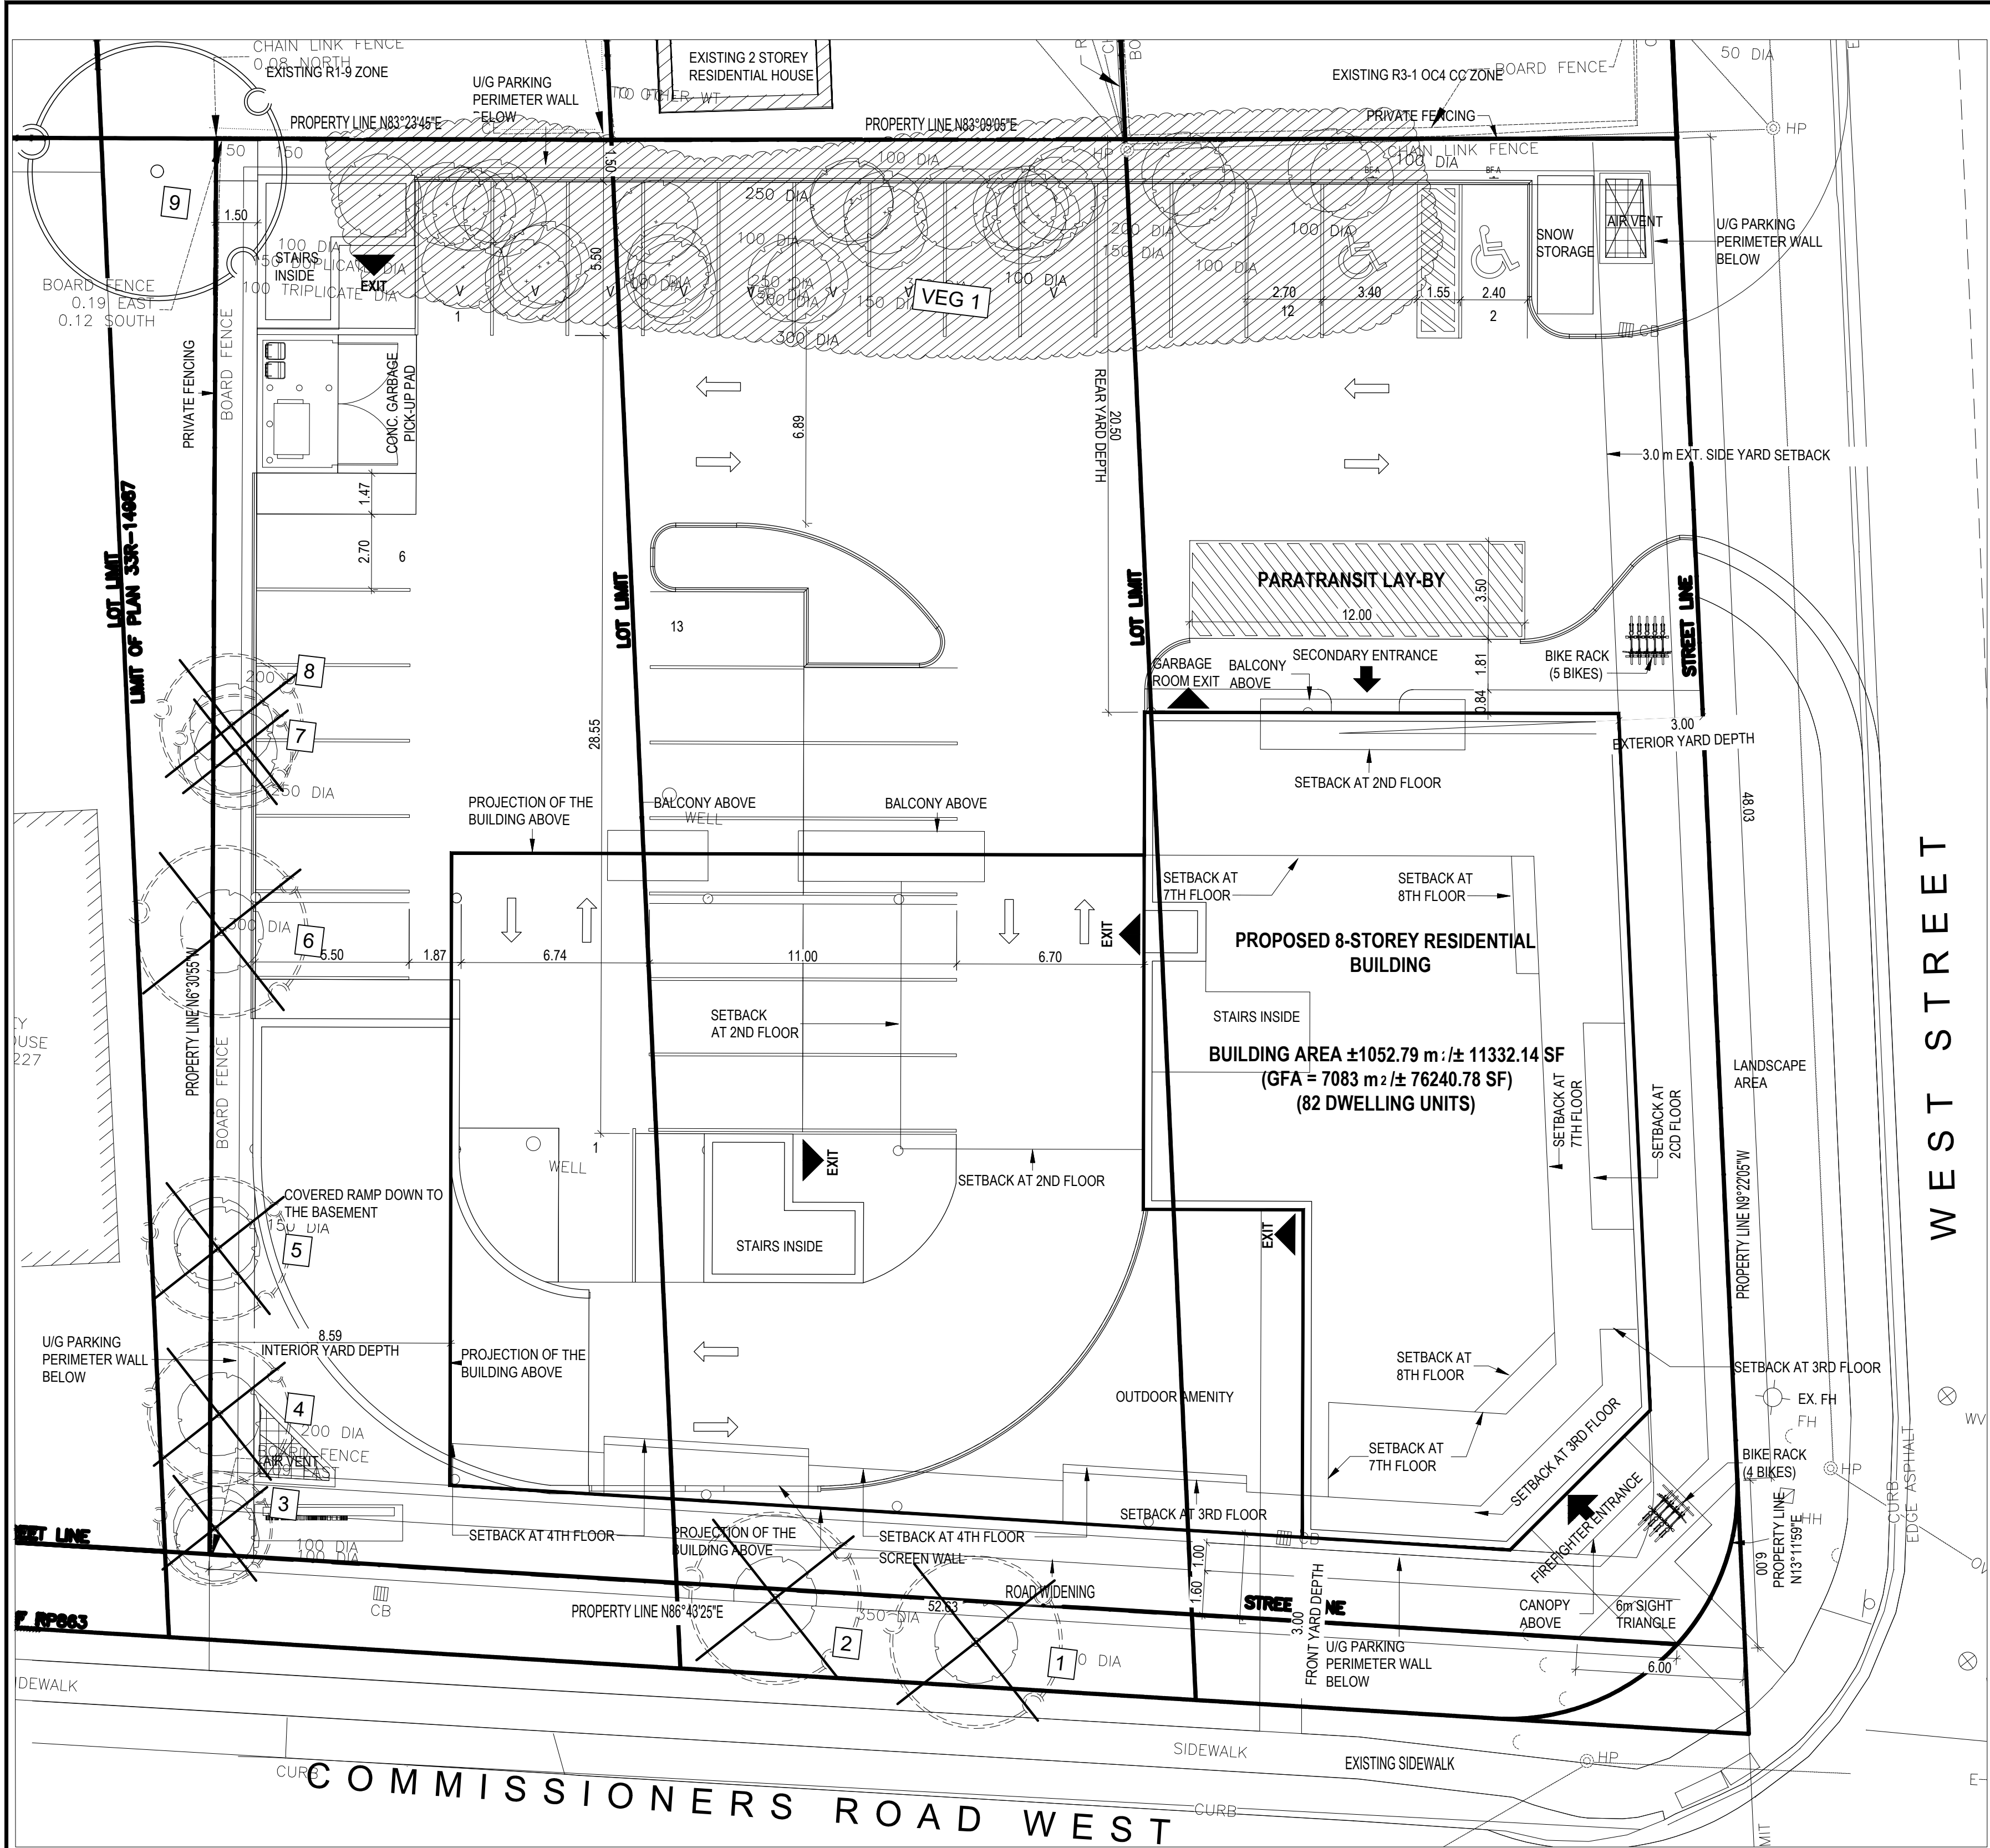
**TREE PRESERVATION PLAN**  
SCALE = 1:150

- Recommended removal of 6 trees and 1 vegetation unit due to direct conflict with the proposed building and/ or parking lot.
- Recommended removal of 2 trees located within the City ROW due to direct conflict with the proposed building and poor tree condition. Approval from the City of London Forestry Department required for removal.
- Recommended preservation of 1 tree located on the adjacent property at 227 Commissioners Road.
- Review Construction Impact Mitigation recommendations in Section 6.0 of this report.

- a) Prior to any construction activity, tree preservation fencing is to be installed as per the attached tree preservation drawings and detail.
- b) Trees approved for removal are to be clearly indicated in the field (marked with spray paint or other agreed upon method) by the project arborist or landscape architect prior to any tree removal operations. All removals to be undertaken by an ISA certified arborist.
