Downtown London

Heritage Conservation District Plan

161401203 **March 2012**

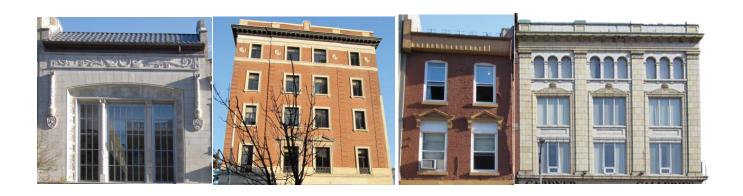
The steep mansard roof of the Mechanic's Institute (left) with its ornately trimmed dormers is an example of a roofline that is character-defining element for both the street and the individual building. The example of Italian Renaissance style architecture is part of what makes the eclectic fabric of the Dundas Street roofscape.

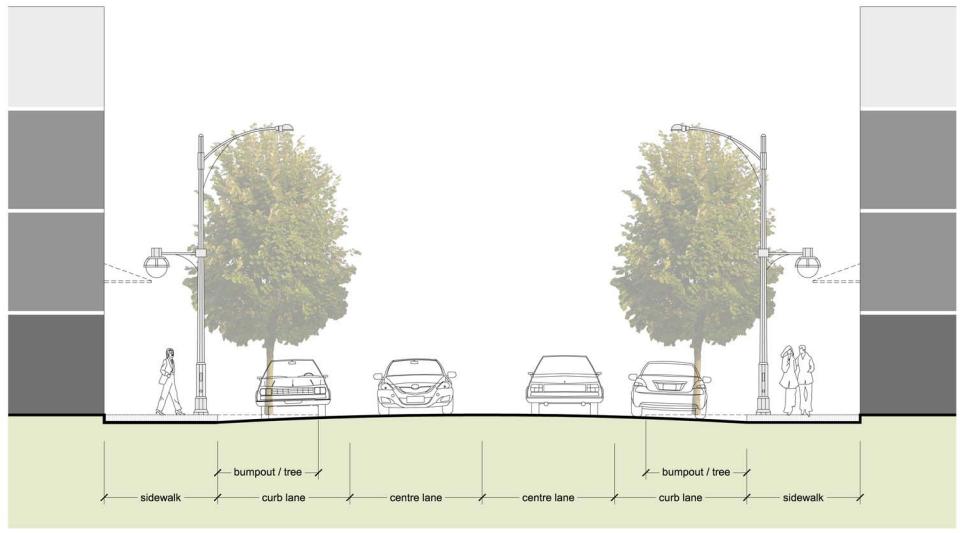
SECTION C-C COMMERCIAL STREET PROFILE
