EAST WOODFIELD HERITAGE CONSERVATION DISTRICT STUDY

HERITAGE CONSERVATION DISTRICT PLAN

Prepared for:
THE CORPORATION OF THE CITY OF LONDON
JULY, 1992

UNTERMAN McPHAIL CUMING ASSOCIATES
WENDY SHEARER LANDSCAPE ARCHITECT LIMITED

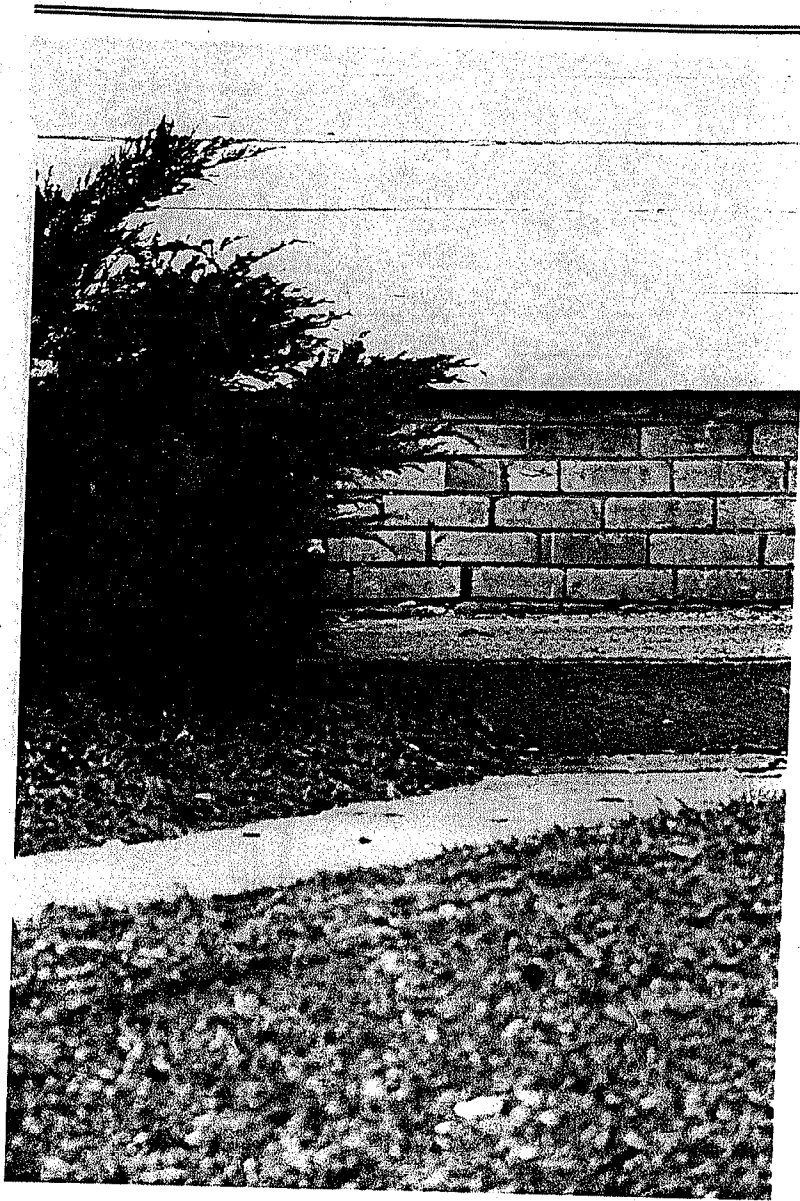
Foundations should be inspected regularly. Brick foundations are generally more susceptible to moisture related damage than their stone counterparts.

Regular inspection: The importance of the regular inspection of basements and foundation walls cannot be overstressed. Regular inspections should be completed at different times of the year and during different weather conditions. Using a flashlight look for signs of moisture, cracks, deflection of structural members, bulging, buckling, crumbling mortar, wood in direct contact with soil and settlement. Settlement may take years to occur and normally does take place during the first years of the structure's life. Often older buildings which have settled reach an equilibrium. However, changes in ground water levels, excessive spring runoff, earth movements, new tree plantings positioned too close to a structure and disconnected downspouts can result in further sub-surface destabilization of the structure and foundation. Basement renovations which may entail underpinning to gain extra ceiling height, new additions and the construction of new buildings on adjacent properties may also contribute to settlement.

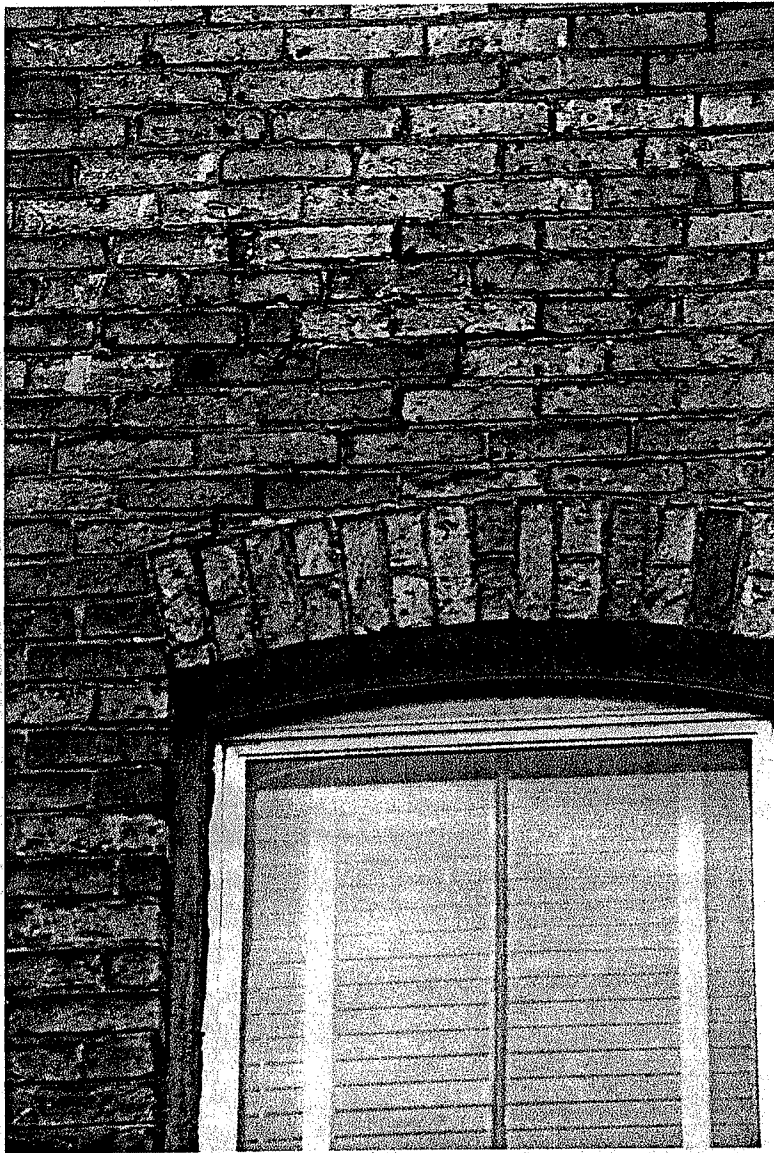
Walls should be examined for cracks and other signs of distress.

Cracks: Not every small crack or fissure in a foundation means trouble. The cracks can be monitored using simple measuring devices and photographs over time to provides information on the degree of movement.

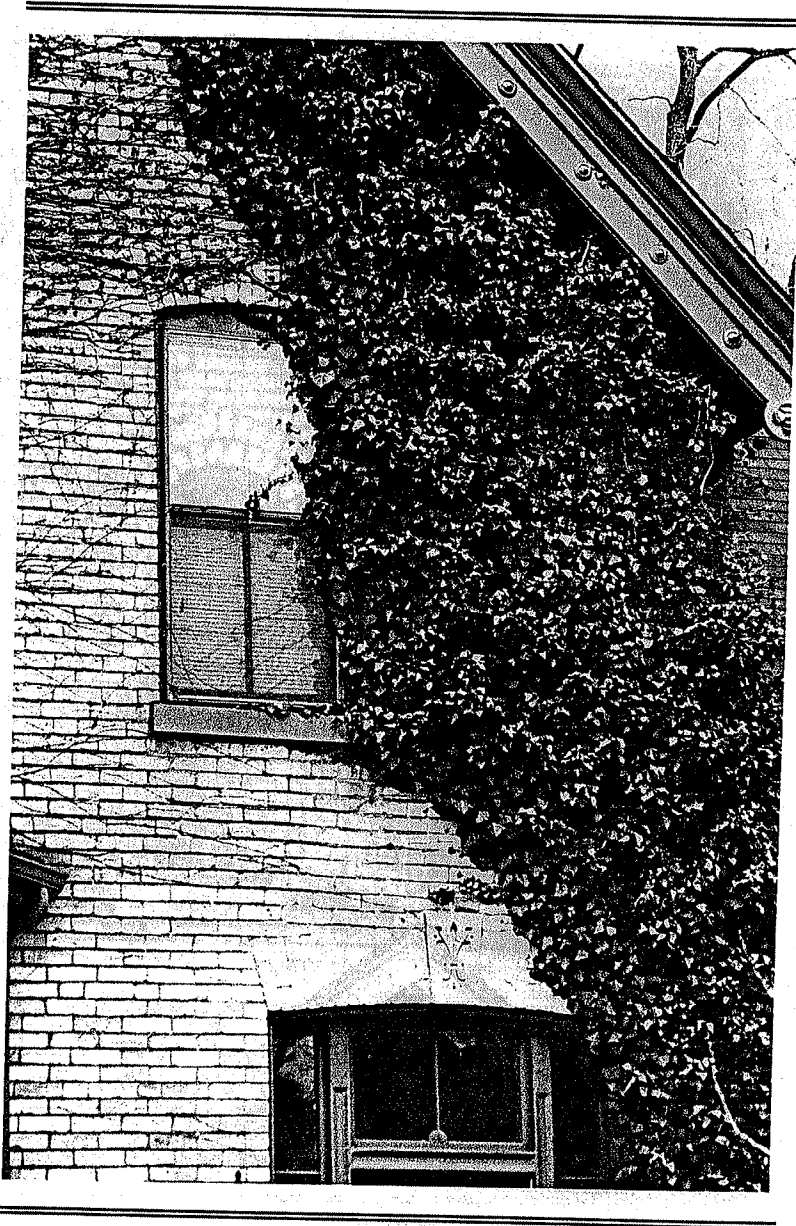
Try to ensure that wall clinging vegetation is not accounting for excessive moisture retention in masonry work or that mortar joints are not being compromised by root growth.

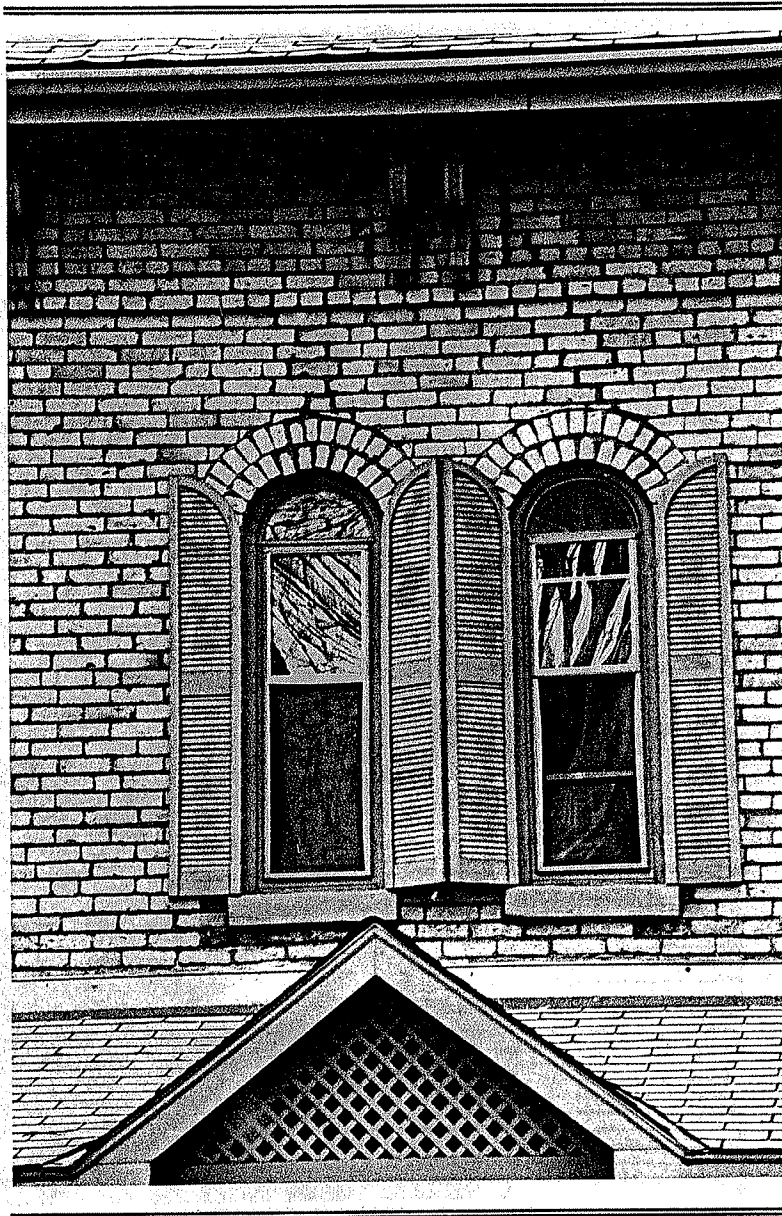
Try to ensure that new mortar in masonry work matches the historic mortar material, usually characterized by a high lime and low cement content.

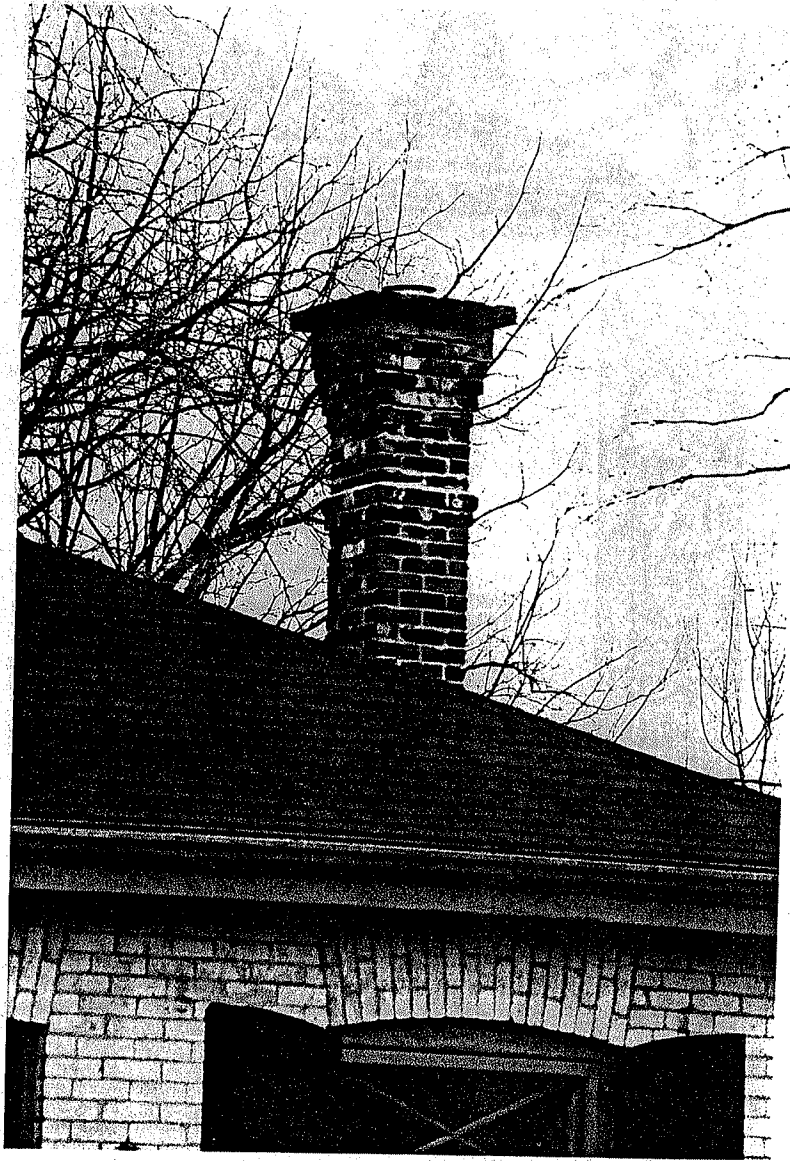
Warming and cooling cycles in heating residences often contribute to the deterioration of chimneys. These are a distinctive feature in the East Woodfield heritage district.

damp. The large decorative chimneys found in the district show signs of deterioration in some situations. These elements are often vulnerable because of the role they play in the heating of the residence. The warming and cooling cycle with associated moisture and the lack of flue liners often contribute to the deterioration of this building feature. Also the exposure to northwesterly winds takes a toll on these elements which because of their size and roof location receive little maintenance until major problems arise. With decorative chimneys it is very important to restore the style and design profile of these features. Chimneys which are no longer in use should be capped with a metal cover instead of removed as they often provide a balance to the design and symmetry of the structure.

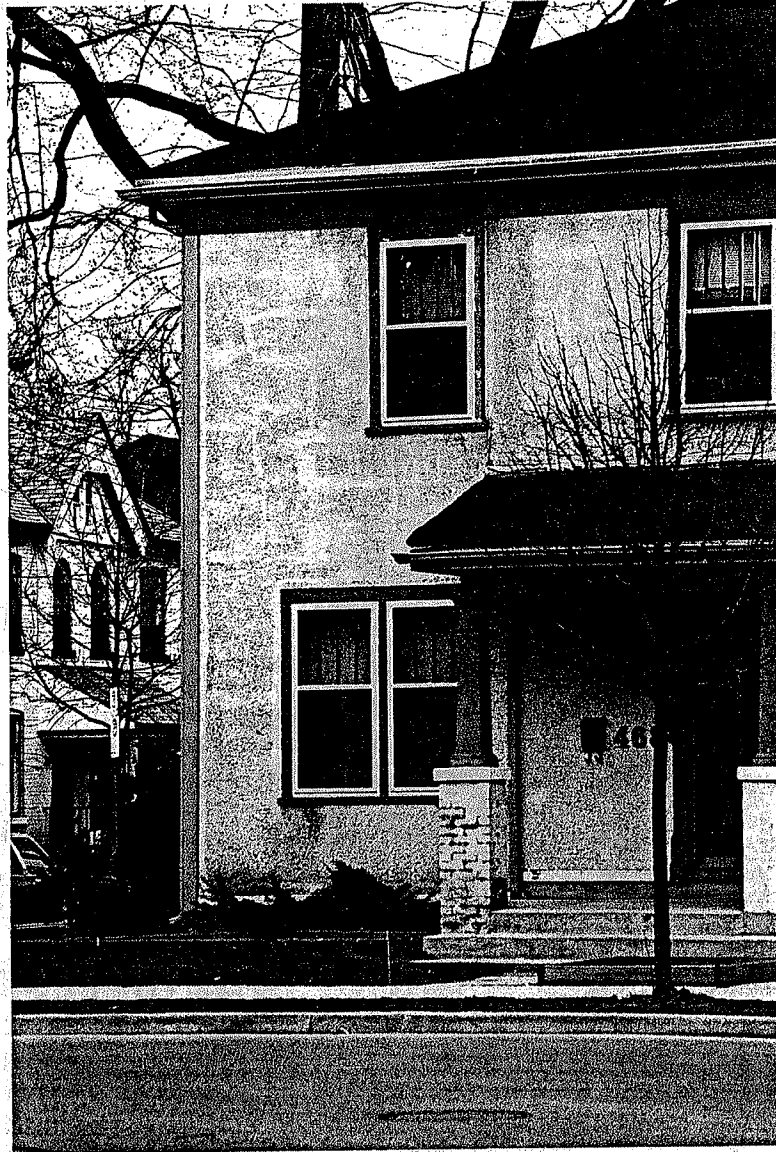
Stucco is used as a wall cladding within the East Woodfield heritage district on a number of residences. Moisture penetration is often a prime cause of stucco failure.

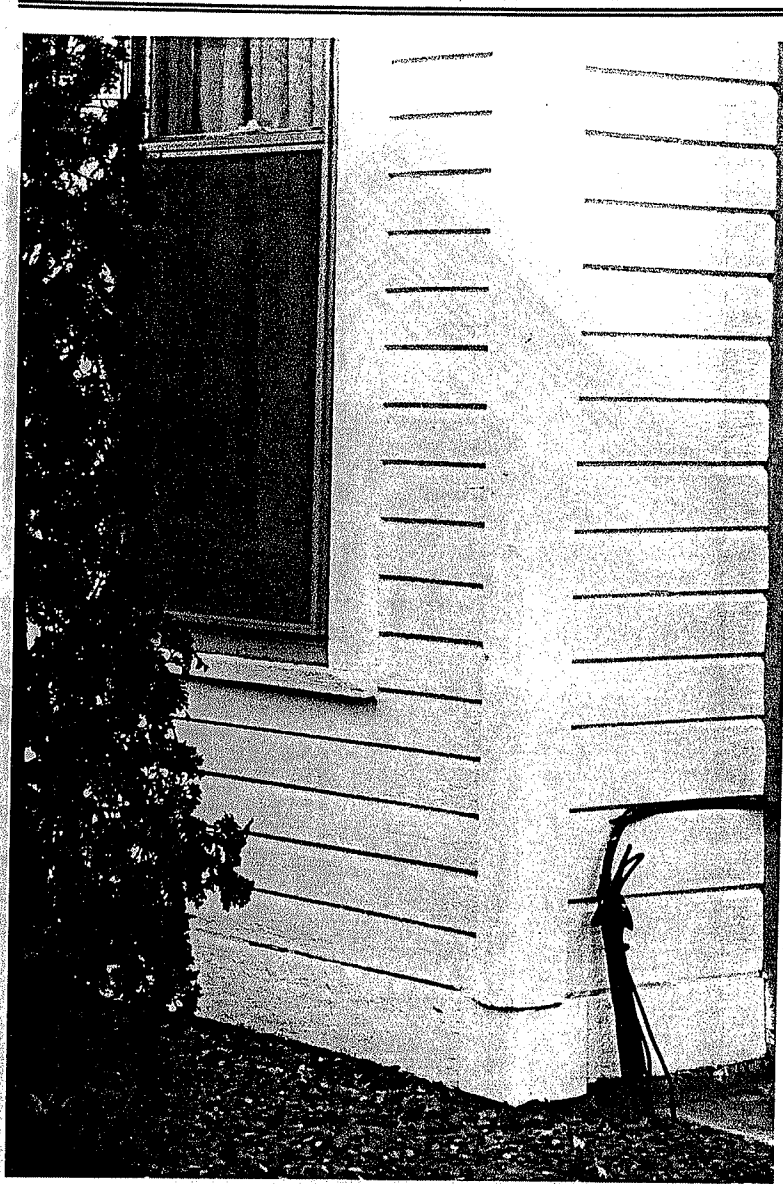
Wooden cladding is found on several residences within the East Woodfield heritage district. Wood siding should be repaired whenever possible as synthetic sidings are often poor and visually unsuitable replacements.

Examples of clapboard siding or horizontal wooden cladding are found in the district as well as some decorative shingle siding. Wood siding should be repaired wherever possible. Small cosmetic repairs or "dutchmen" should be carried out in wood or a combination of wood and glue. New replacement wooden siding should match the original in *form, style, dimension, profile and method of installation*. Three common types of wood siding include; shiplap; tongue-and-groove; and, bevel. Cornerboards should match the original in *dimension and profile*. This may involve the cutting of a new knife for the

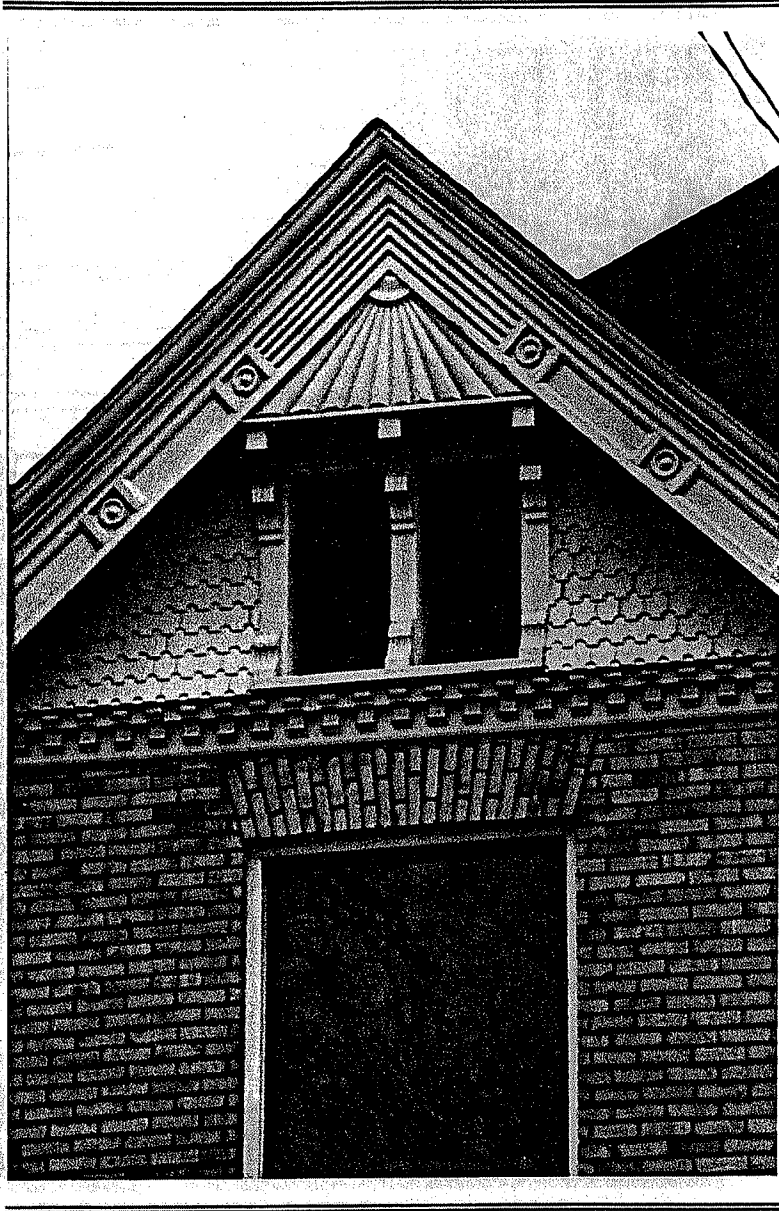
Decorative wooden shingling is evident in district residences and is found on gable ends and roof dormers. Continuing conservation is encouraged.

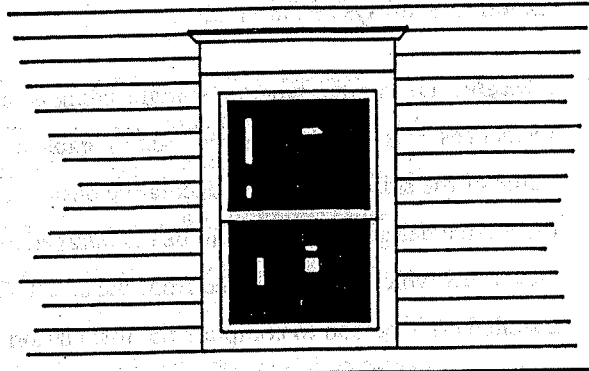
Acceptable

Do not remove window trim when residing or installing new windows

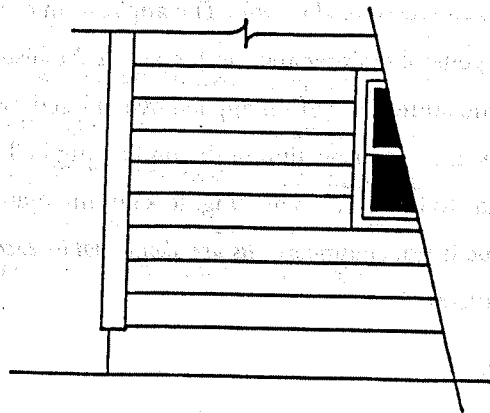
Not acceptable

Original siding width and profile should be maintained when residing

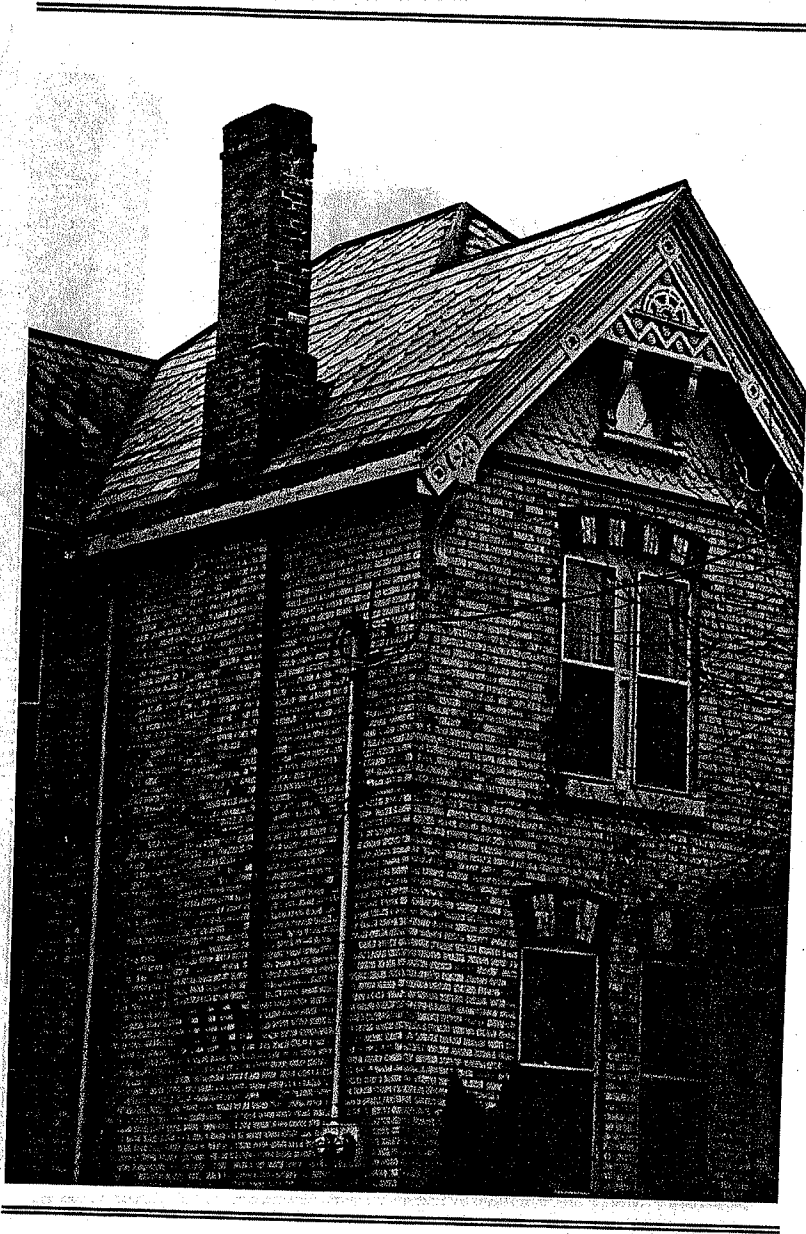
Respect and protect original roof line configurations and materials, including chimneys, dormers, cupolas and cresting.

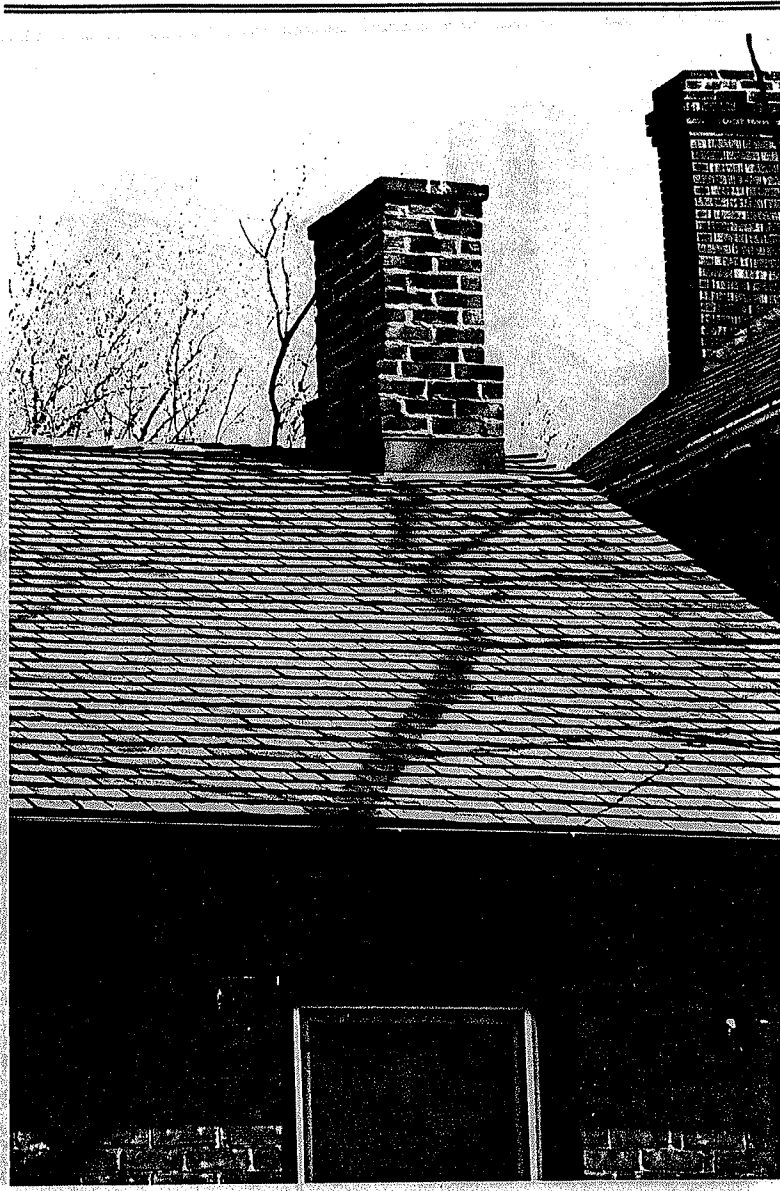
*Areas around chimneys may be subject to failure.
Ensure that flashing is sound.*

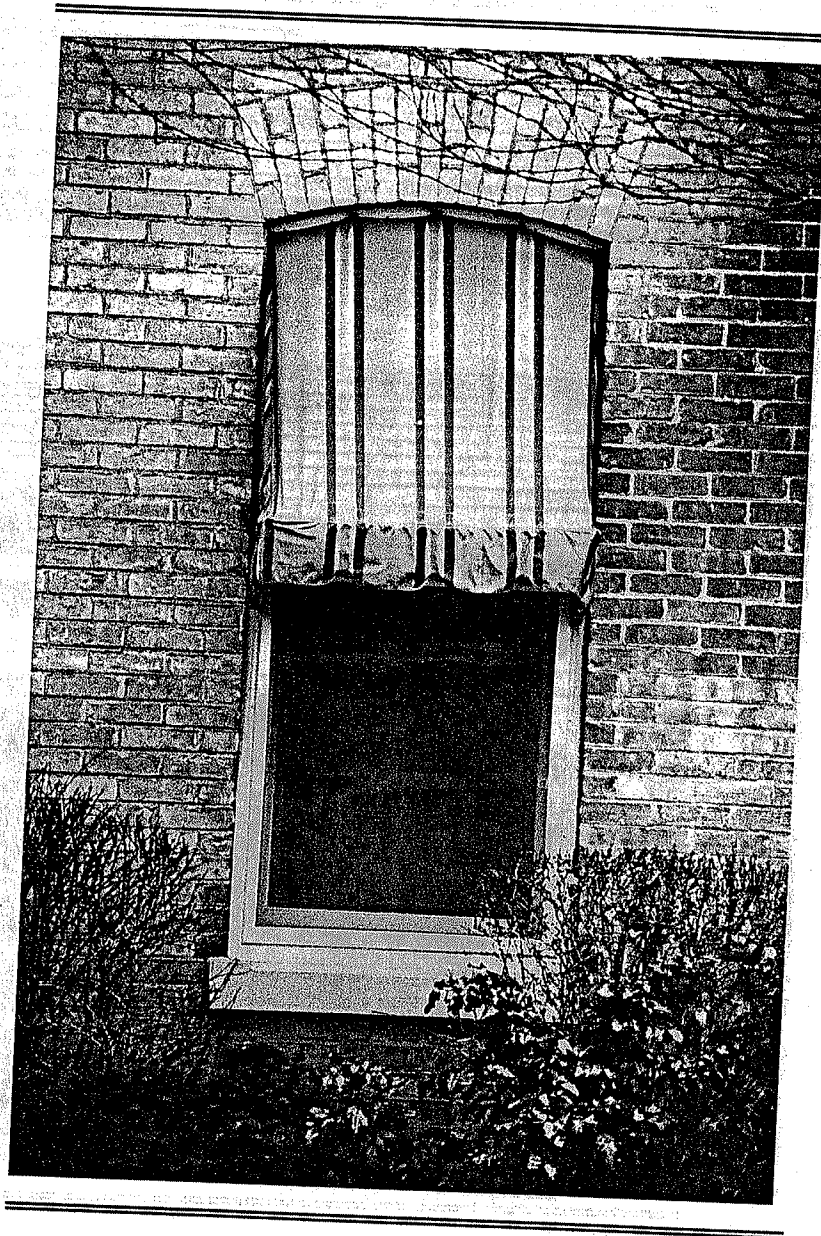
Simple rectangular, canvas canopies were a traditional way to provide shade in summer months in the late nineteenth and early twentieth century. They should be used in preference to the synthetic, clam-shell canopies.

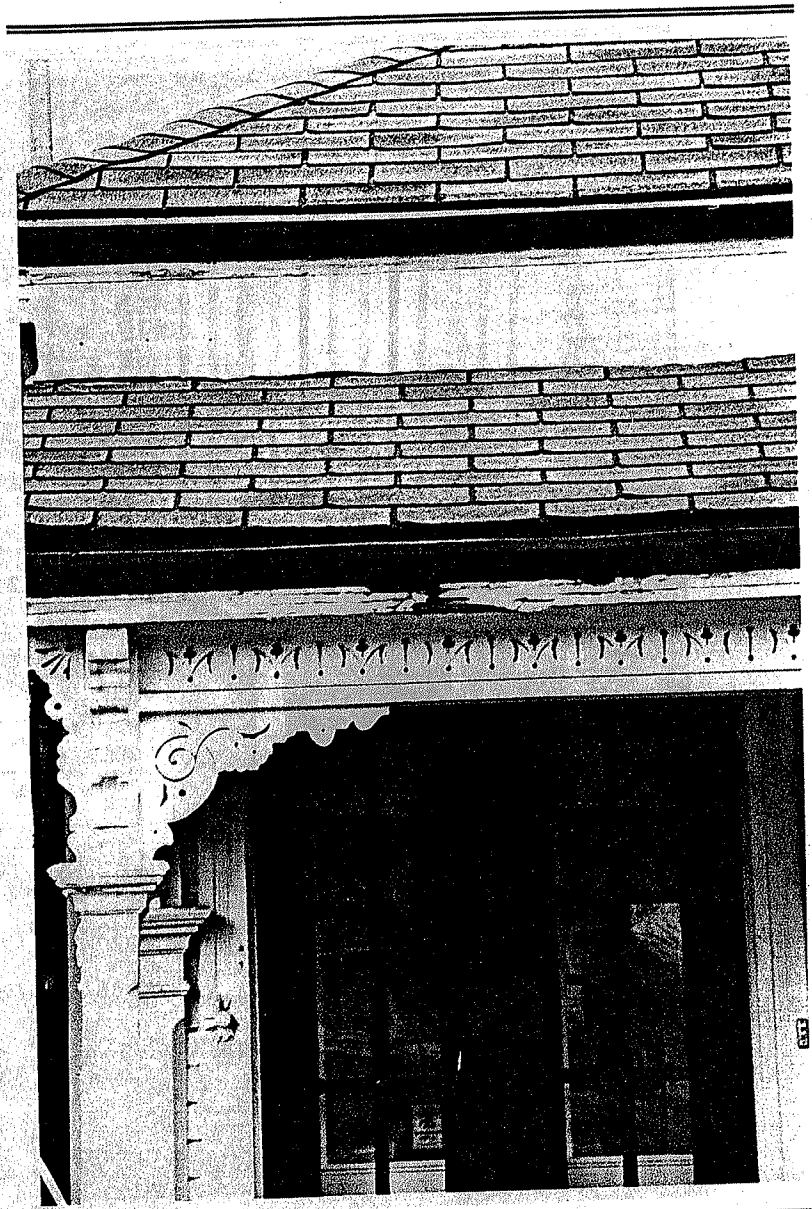
Check eavestroughs regularly to protect against blockages that may result in damage to wood facias and roofing.

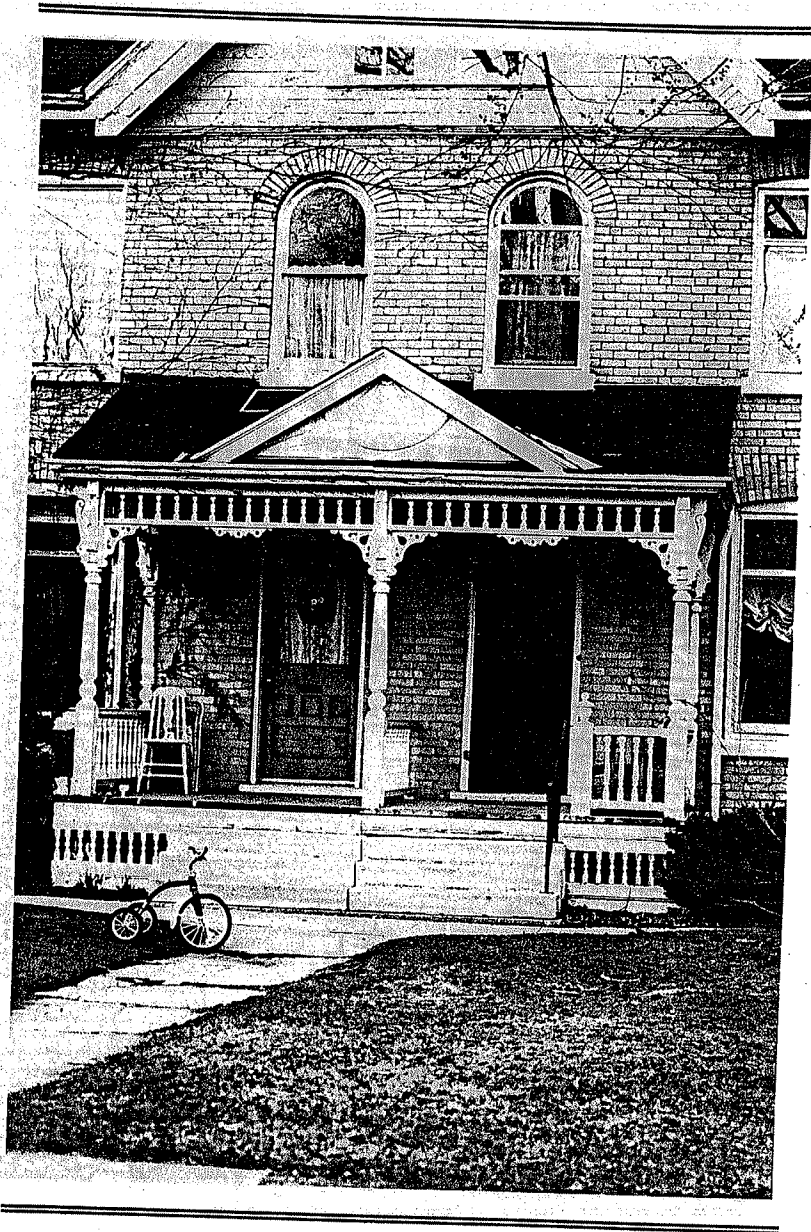
Decorative wooden detailing on porches, verandahs, scrollwork and brackets are integral to a building's character and should be conserved.

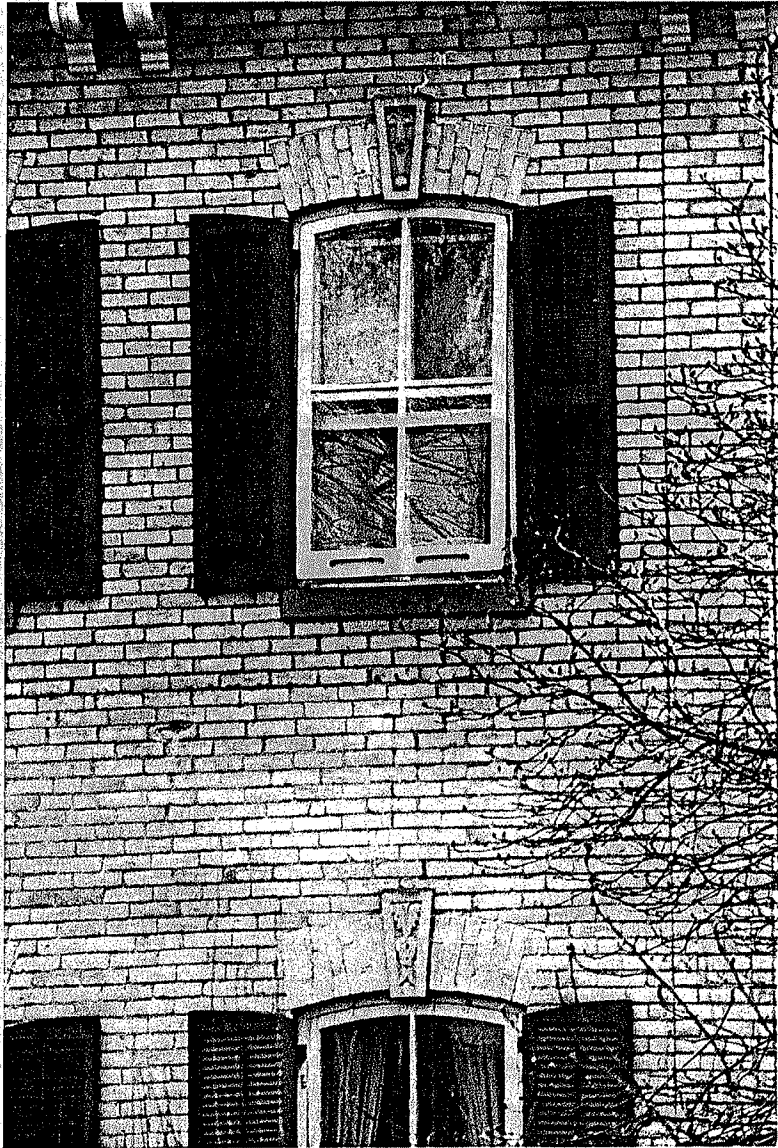
Shutters, wooden storm windows and original windows should be repaired and maintained rather than replaced.

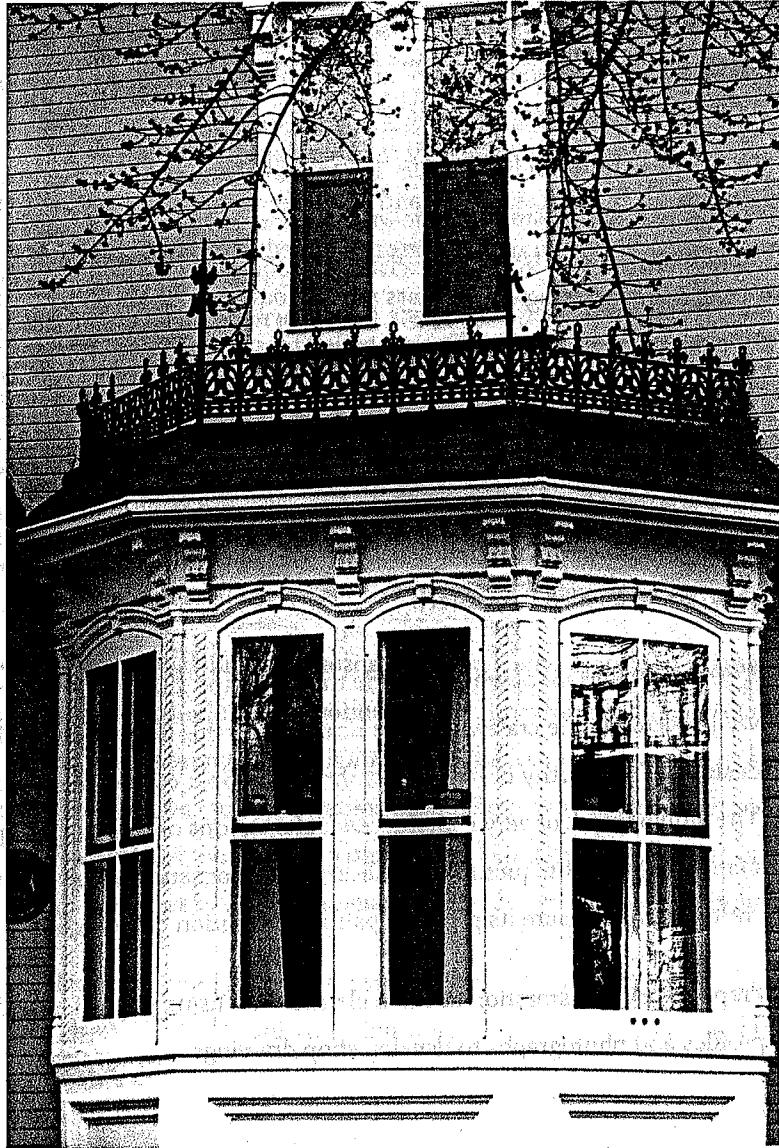
This decorative bay window with well crafted wooden detailing, storm windows and cresting all add distinctive character to this residence.

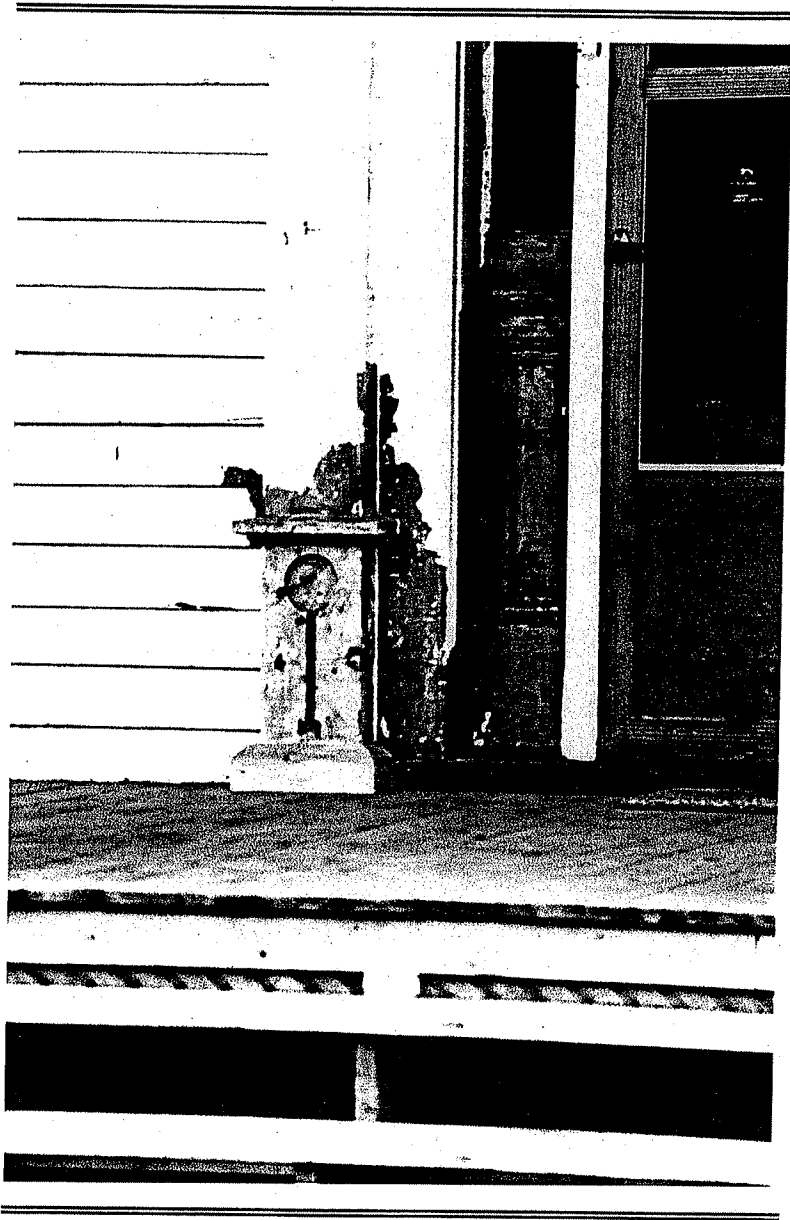
Painting is the most common form of maintenance and decorative work undertaken by owners. Original paint colours may be determined through analysis of previous coats by a professional or informed property owner.

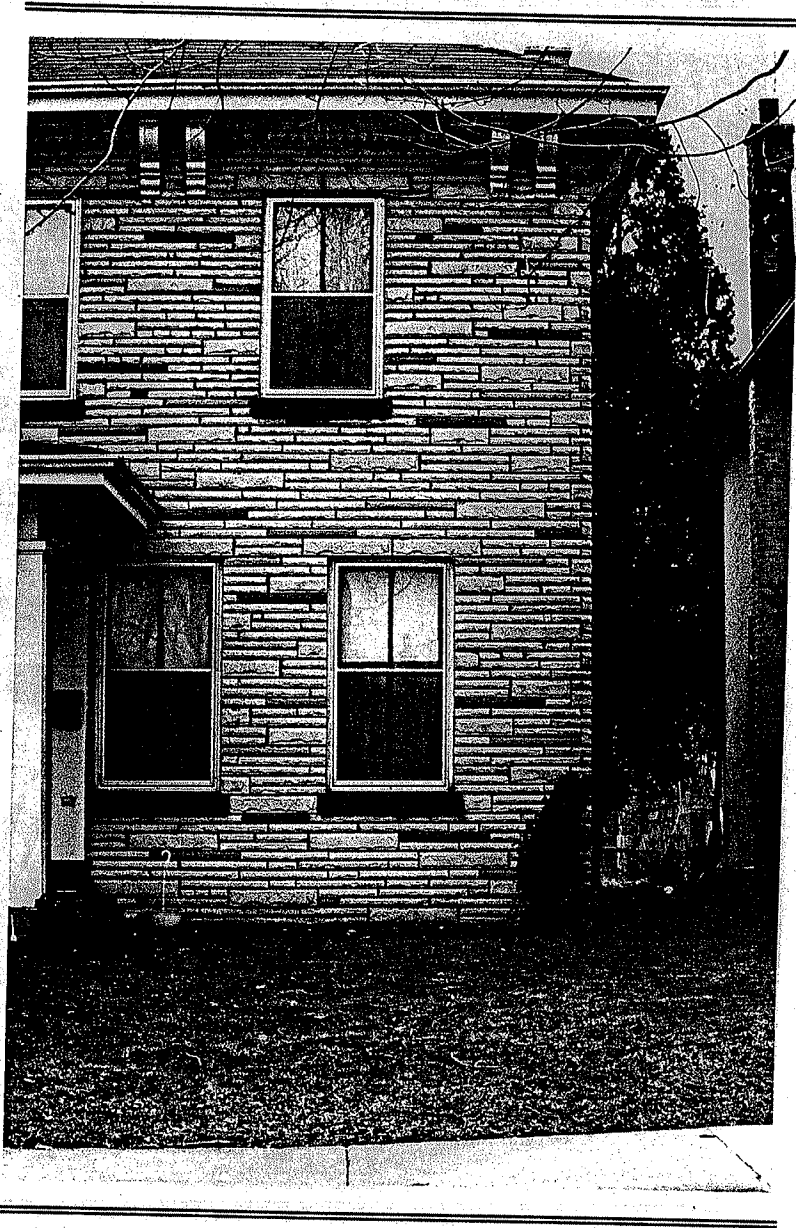
Avoid alterations, such as the application of new wall claddings, that may permanently damage existing heritage building fabric.

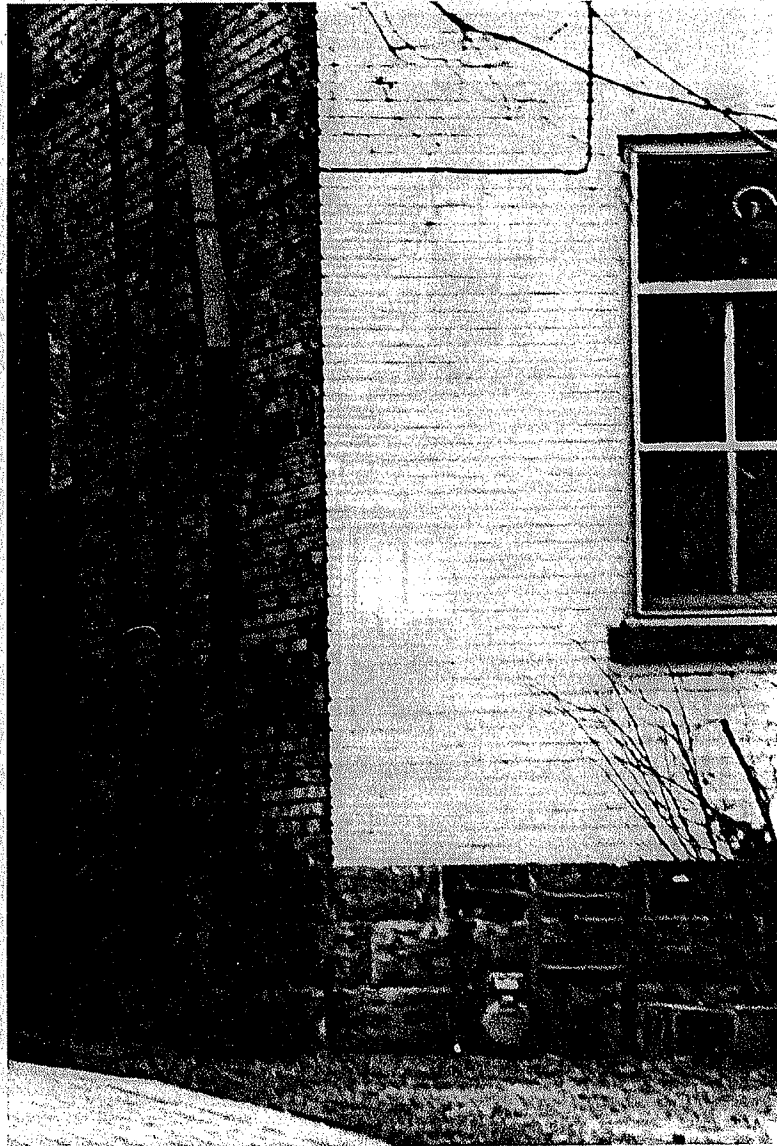
Painting masonry surfaces is inadvisable as it often detracts from the patina of an original wall surface and may cause further conservation problems later on.

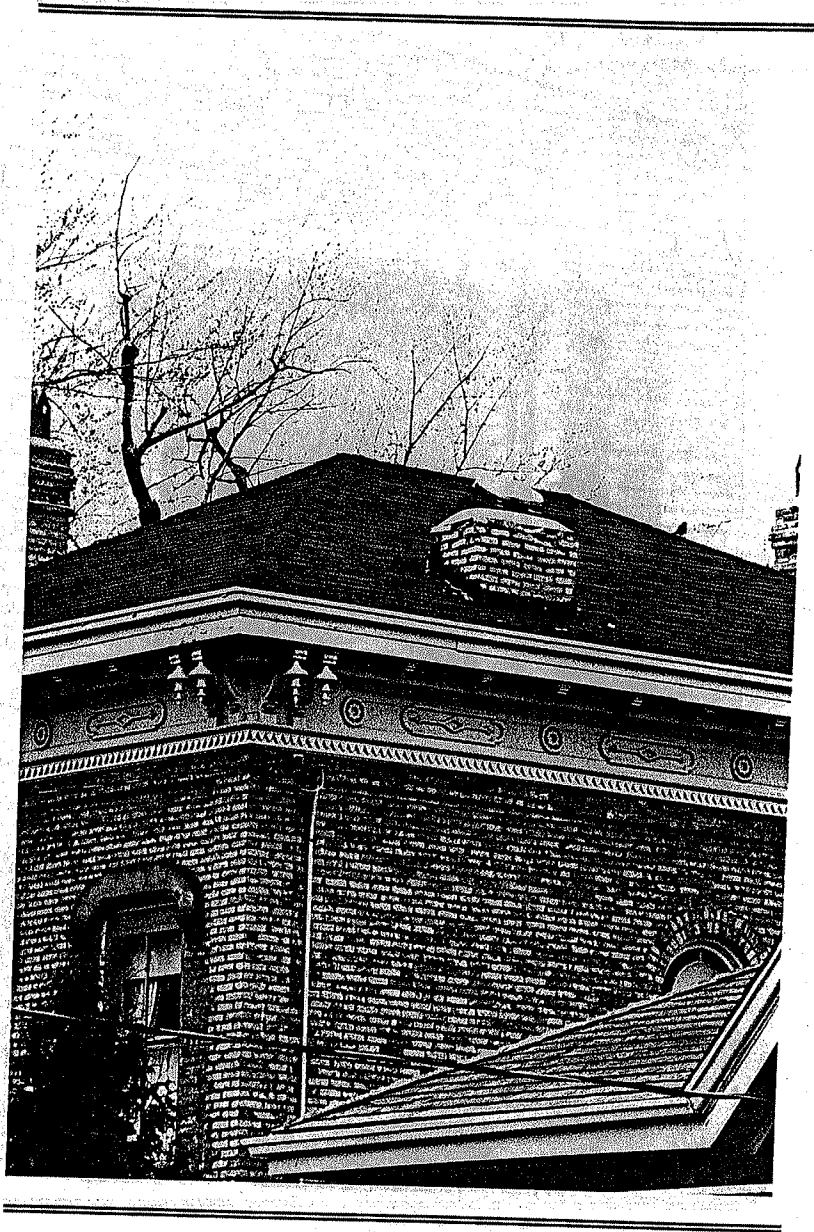
Masonry chimneys should be repaired rather than removed or partially demolished.

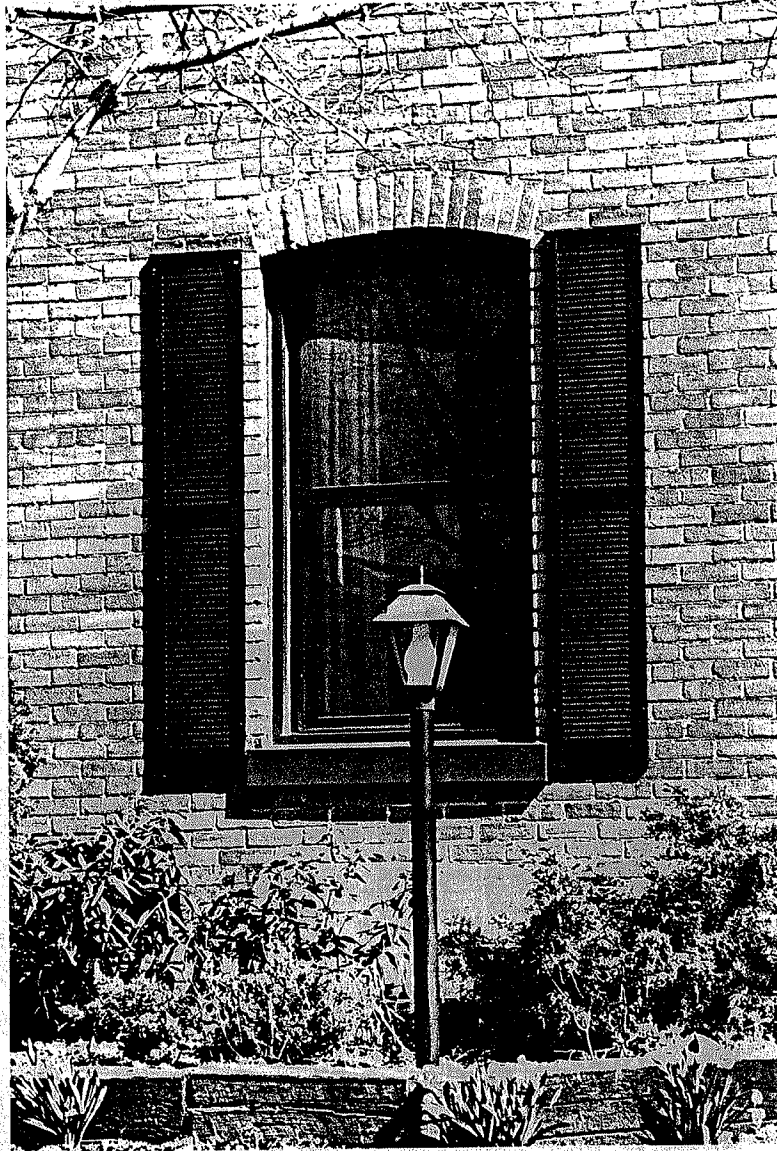
If applying non-operable shutters to an existing window ensure that they appear to cover the window in height, width and profile.

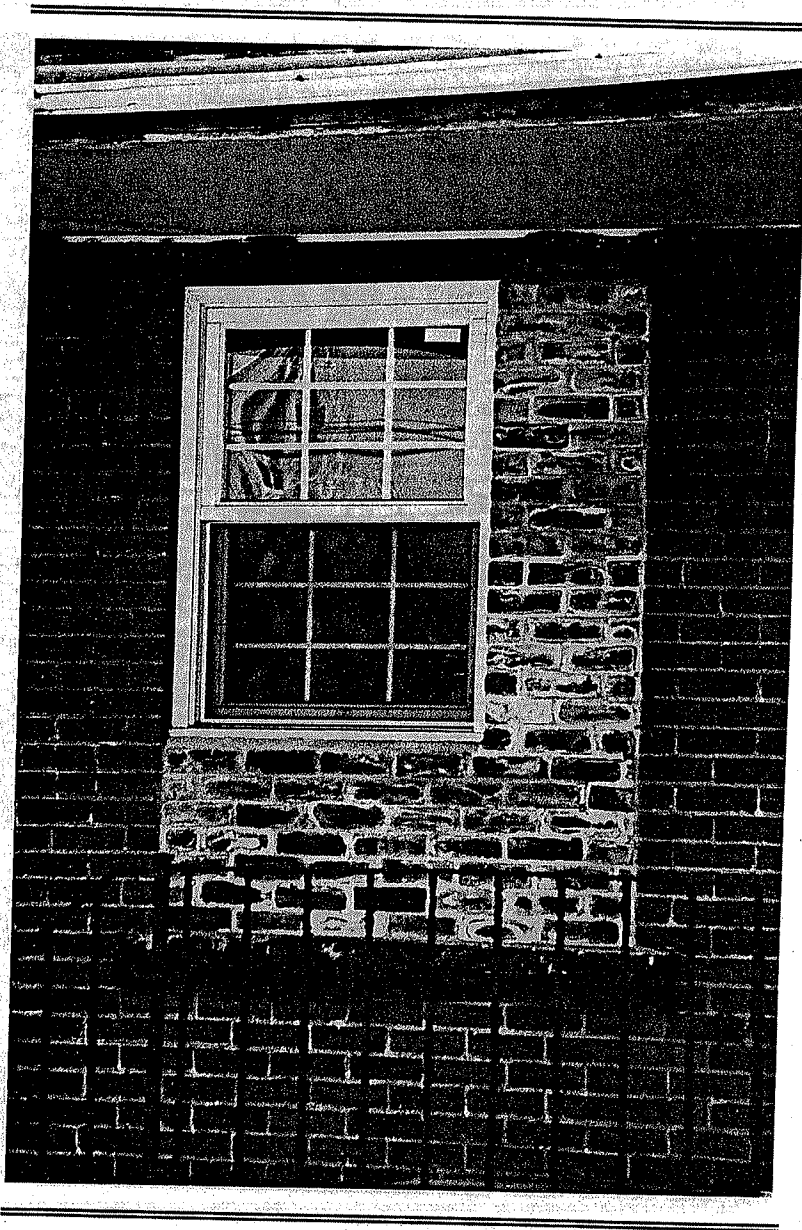
Windows are particularly vulnerable to unsympathetic treatment. On principal facades ensure that windows are not replaced by sealed modern synthetic units that are out of keeping with existing heritage fabric.

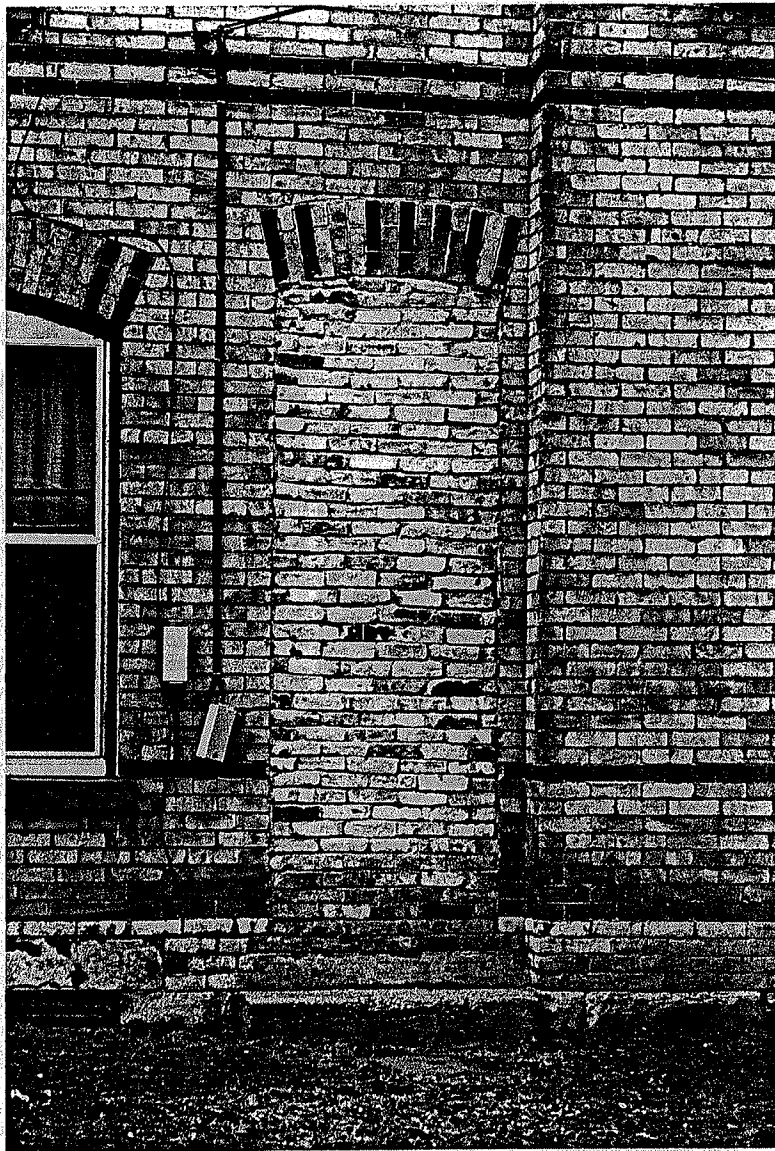
Try to avoid the blocking up of doors and windows.
