EAST WOODFIELD HERITAGE CONSERVATION DISTRICT STUDY

HERITAGE CONSERVATION DISTRICT PLAN

Prepared for:
THE CORPORATION OF THE CITY OF LONDON
JULY, 1992

UNTERMAN McPHAIL CUMING ASSOCIATES
WENDY SHEARER LANDSCAPE ARCHITECT LIMITED

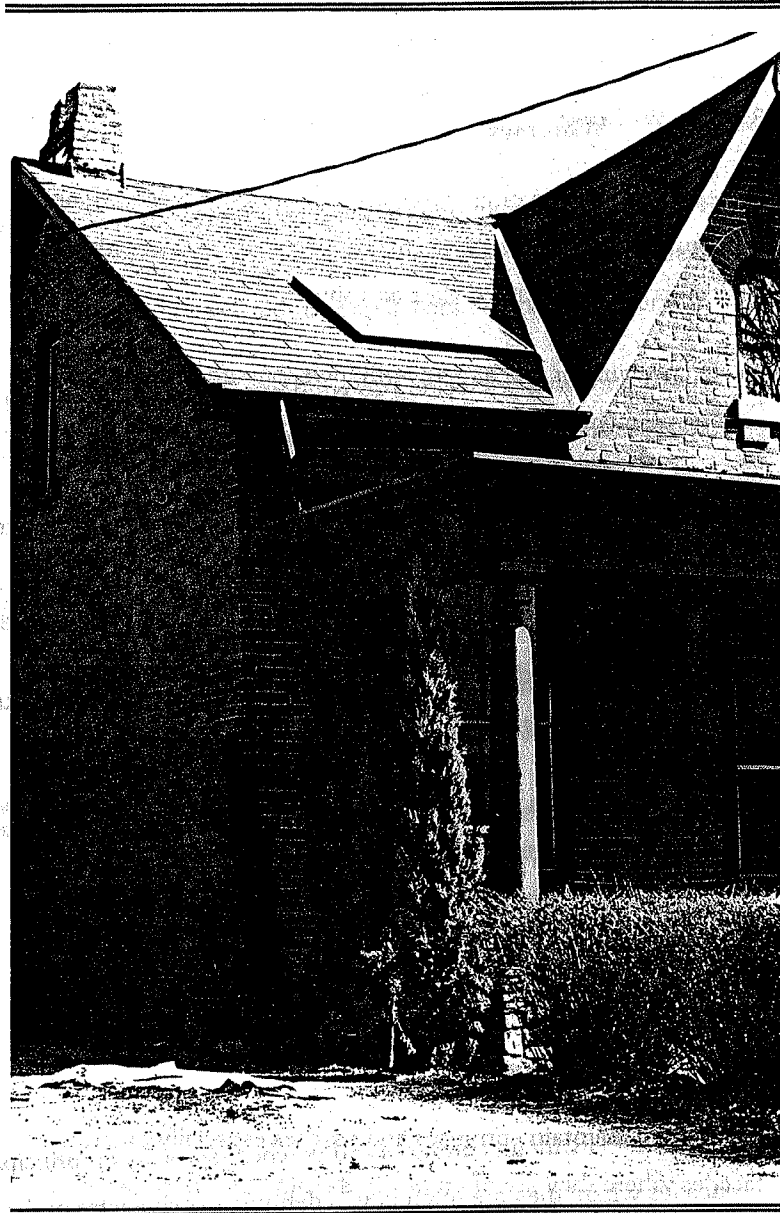
Attempt to locate skylights and other alterations in places other than on principal facades.

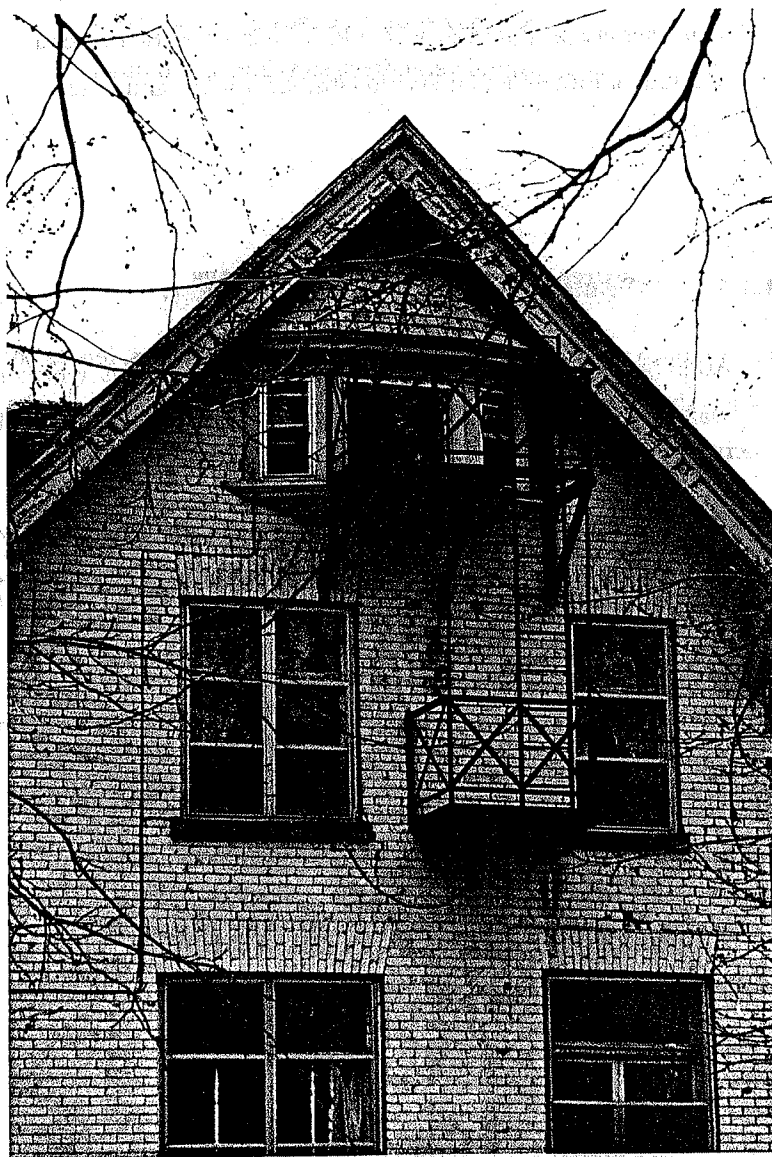
External staircases are best placed at the side or rear of buildings.

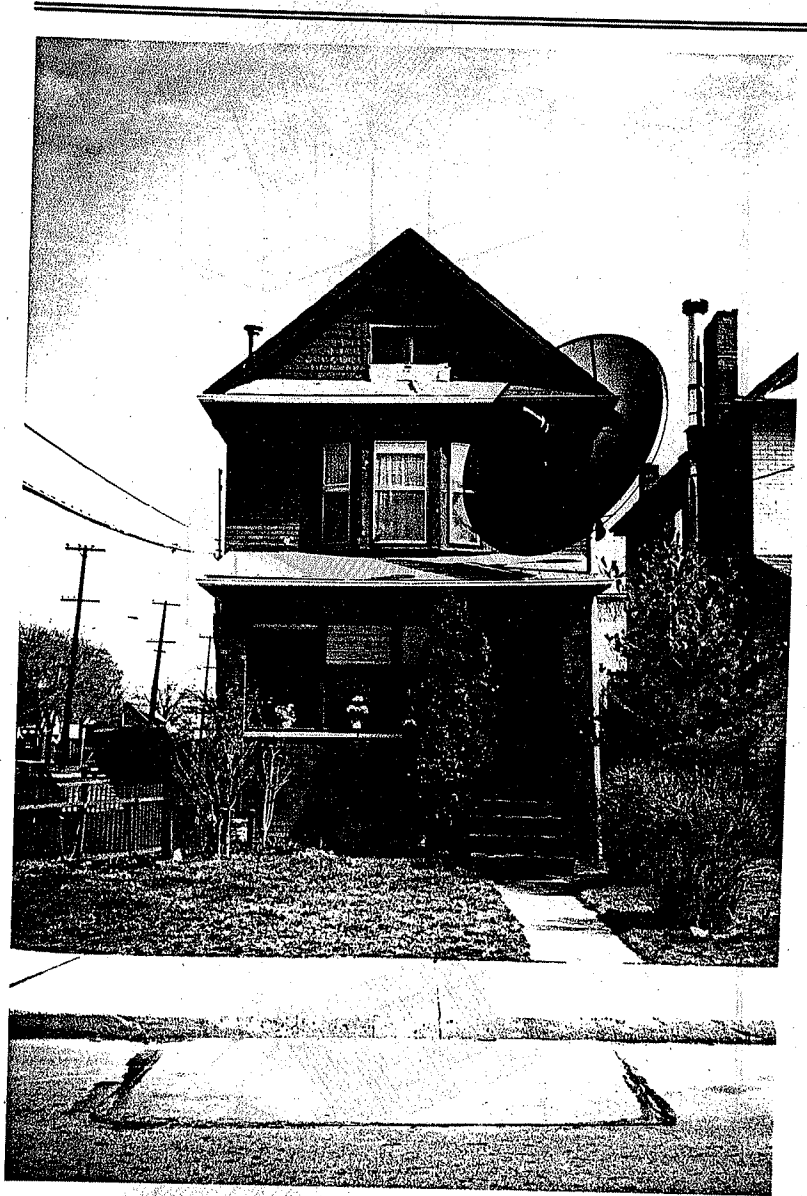
Satellite dishes should be placed at the rear of buildings rather than obstructing the front yard.

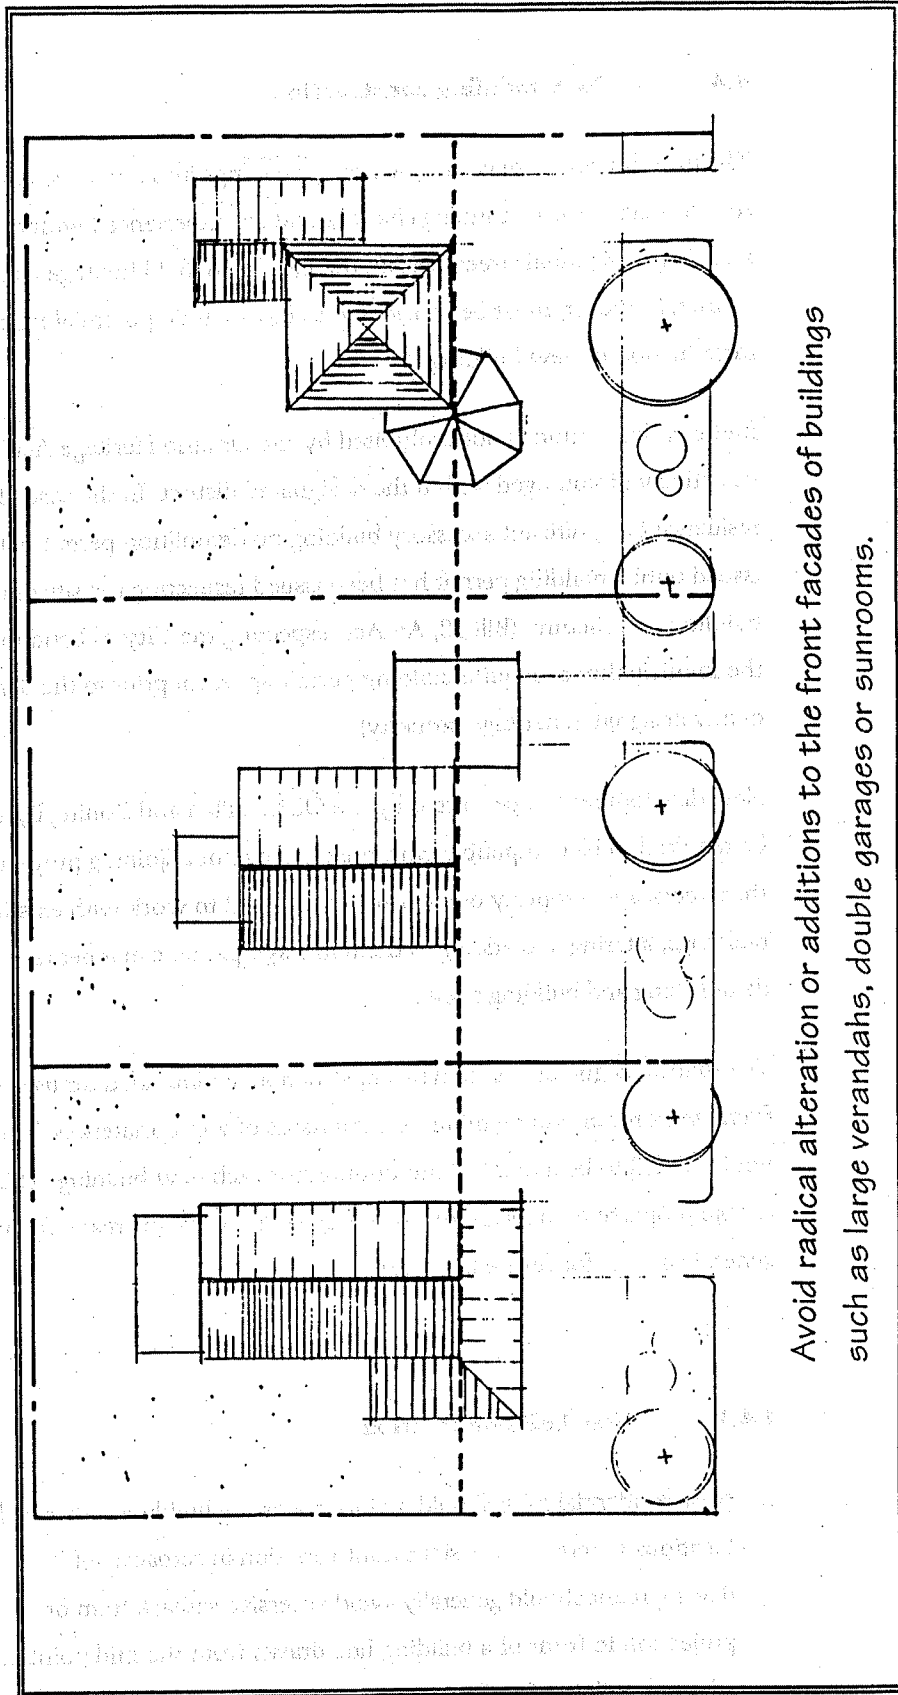
Avoid radical alteration or additions to the front facades of buildings
such as large verandahs, double garages or sunrooms.

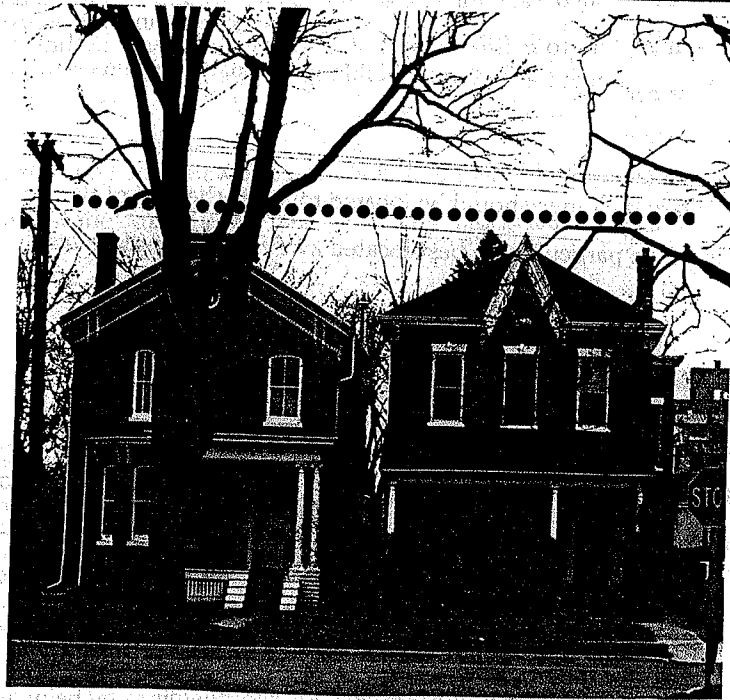
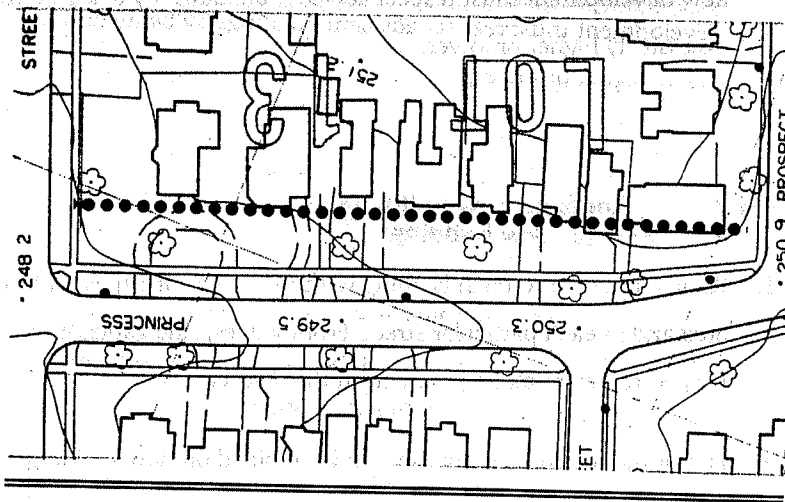
Existing building heights and established building lines will determine the maximum extent of new construction.

1. New residential infill should maintain existing building setbacks. In locations where there is significant variation in setbacks infill development should generally avoid excessive setback from or projection in front of a building line drawn from the mid point of adjacent building facades.

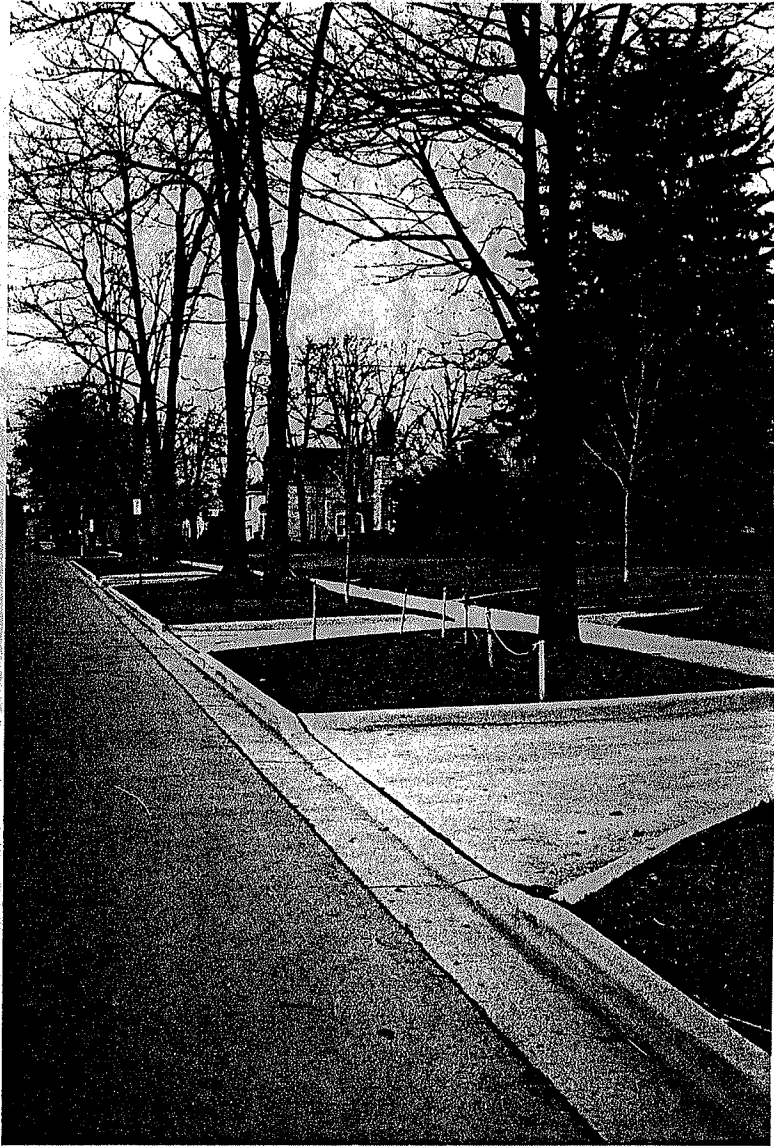
Boulevards provide the settings for street trees and are particularly susceptible to incursions by new driveways. As with street trees, boulevards must be carefully protected and maintained.

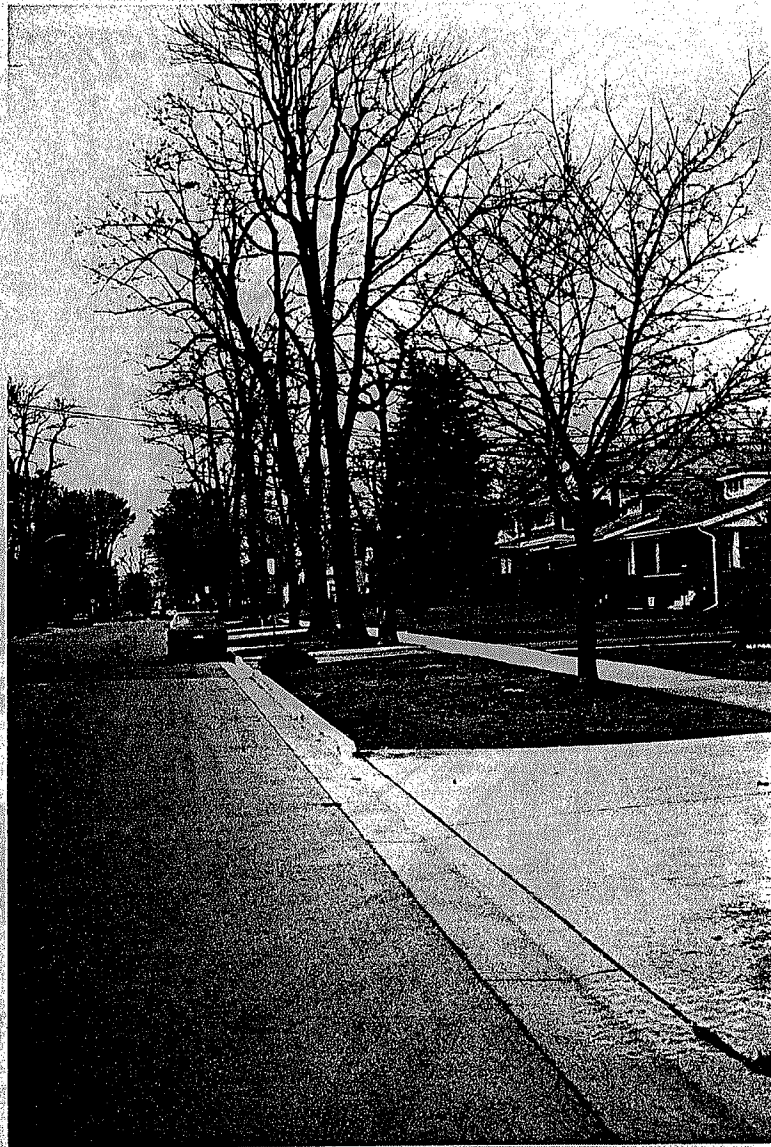
Street trees are a distinctive and important feature within the East Woodfield heritage district. They are worthy of continued care and maintenance.

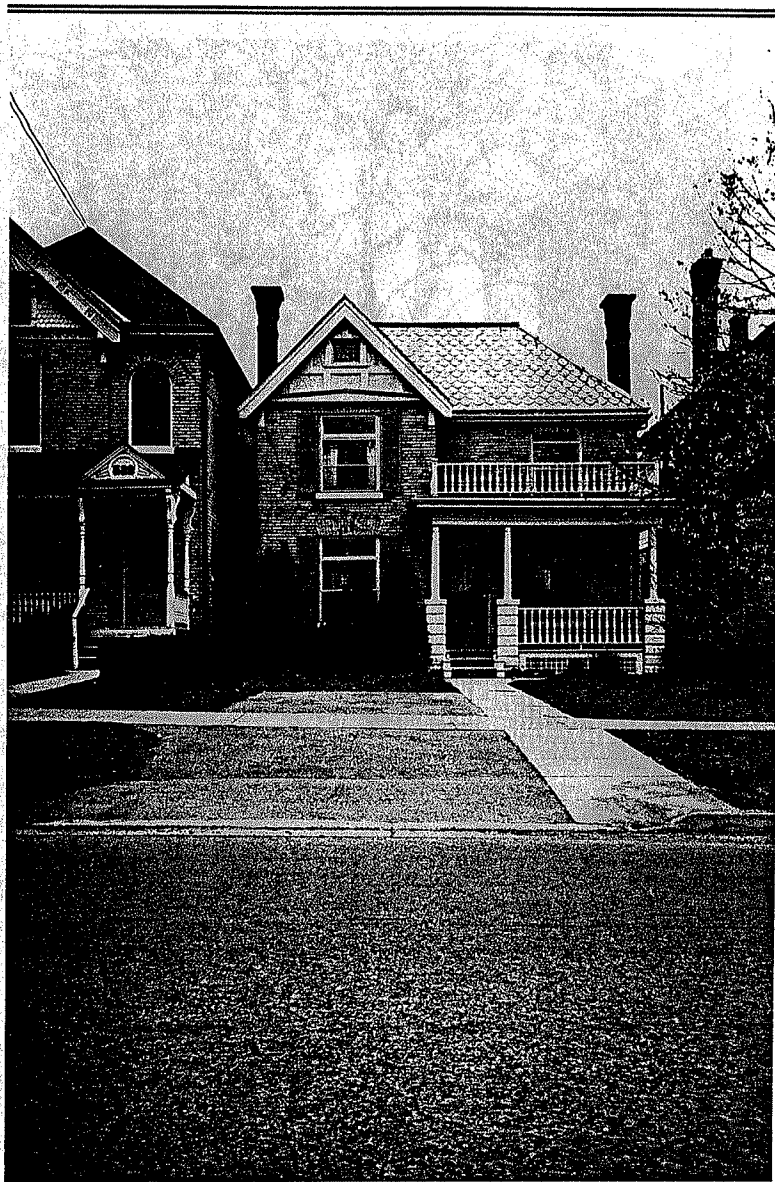
Front yard parking should be avoided wherever possible as it results in the loss of soft landscaping and degrades the building setting.

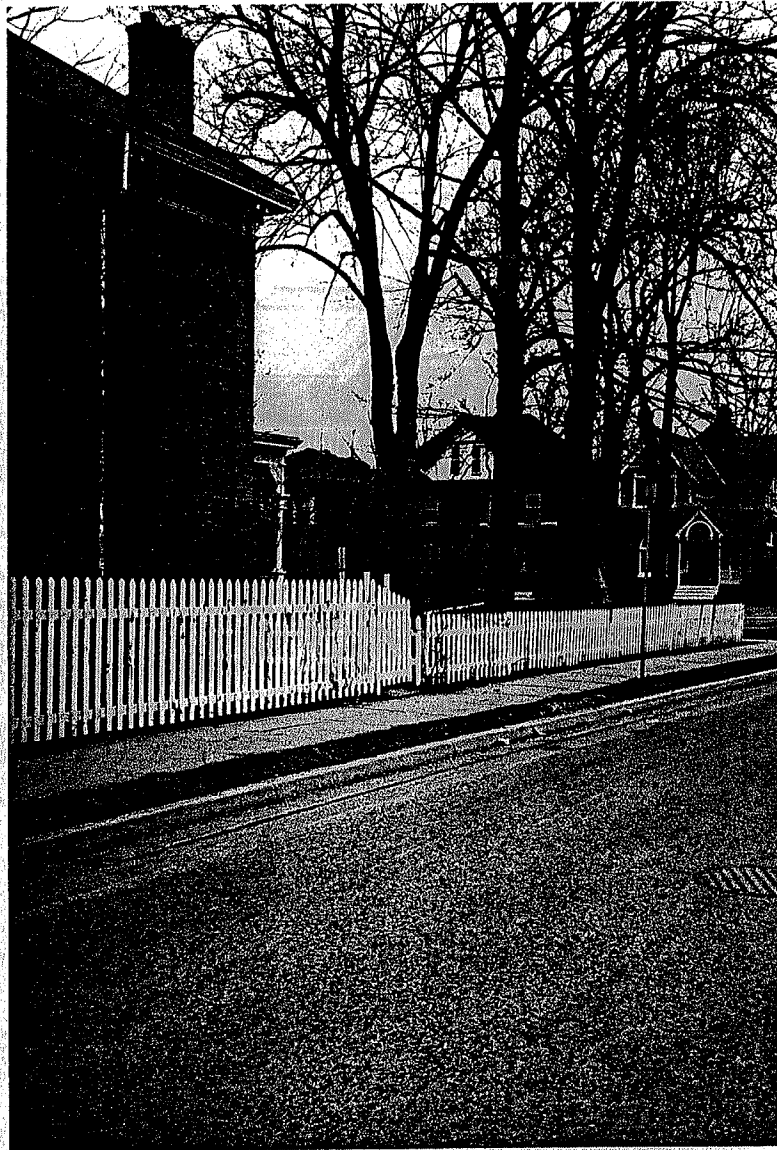
Fences and hedges assist in defining public, semi-public and private spaces. Existing fences should be preserved.

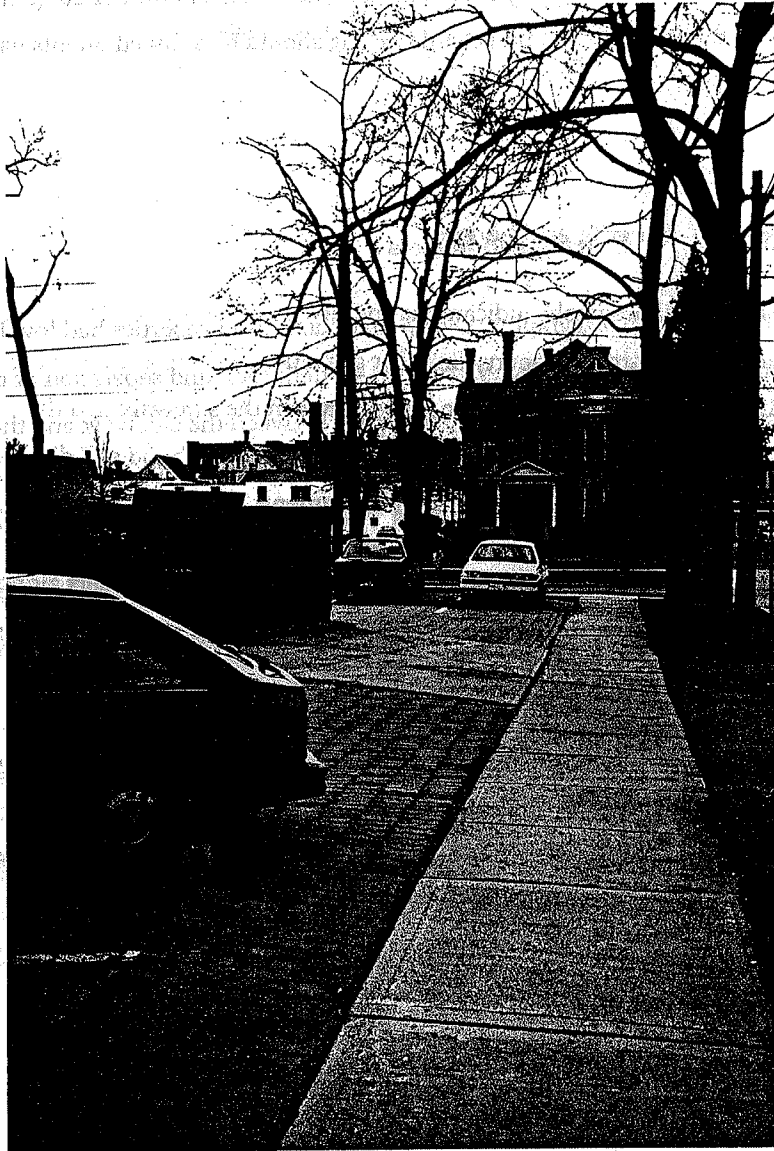
The reintroduction of fence lines and/or hedges at certain locations will lessen the visual impact of parking and service activities and soften the otherwise hard surfaces that flow from private to public space.
