Hydrogeological Assessment

Proposed Apartment Complex
1470 – 1474 Highbury Avenue North
London, Ontario

KCH-00260285-A0

Final Report

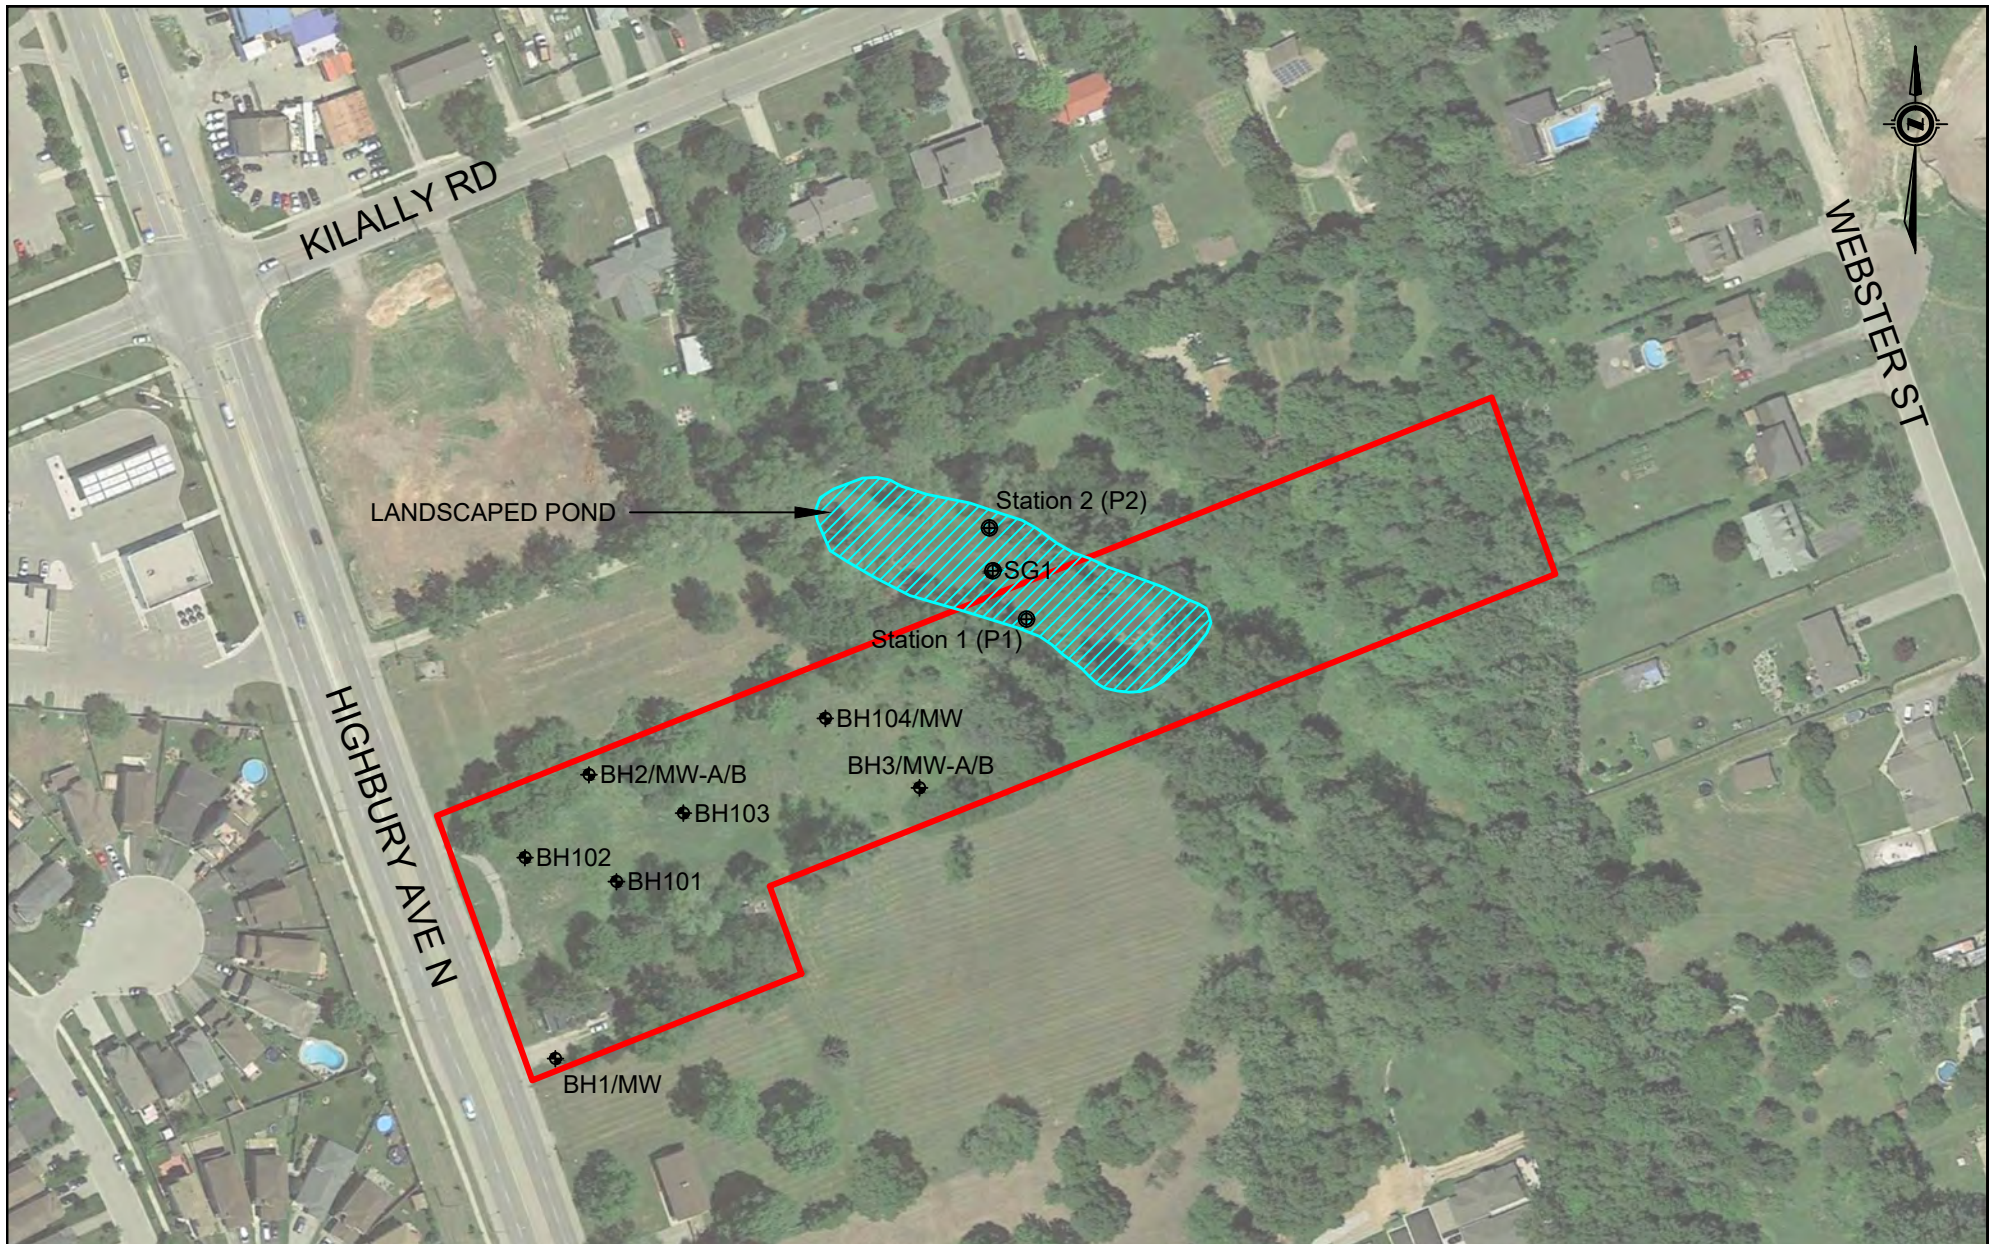
CLIENT Copia Developments			
TITLE Borehole Location Plan			
Prepared By: J.M.		Reviewed By: H.B.	
 		EXP Services Inc. 15701 Robin's Hill Road, London, ON, N5V 0A5	
DATE JUNE 2021	SCALE 1:2,000	PROJECT NO. KCH-00260285-A0	DWG. 2

- ◆ BH1/MW Approximate Borehole Location (June, 2020)
- ⊕ P1 Approximate Piezometer Location
- ⊕ SG1 Approximate Staff Gauge Location
- Approximate Site Boundary
- ◆ BH101 Approximate Borehole Location (March, 2021)

The purpose of the assessment was to examine the subsoil and groundwater conditions at the Site by advancing a series of boreholes and installing monitoring wells at the locations chosen by EXP and illustrated on the appended Borehole Location Plan (**Appendix A, Drawing 2**).

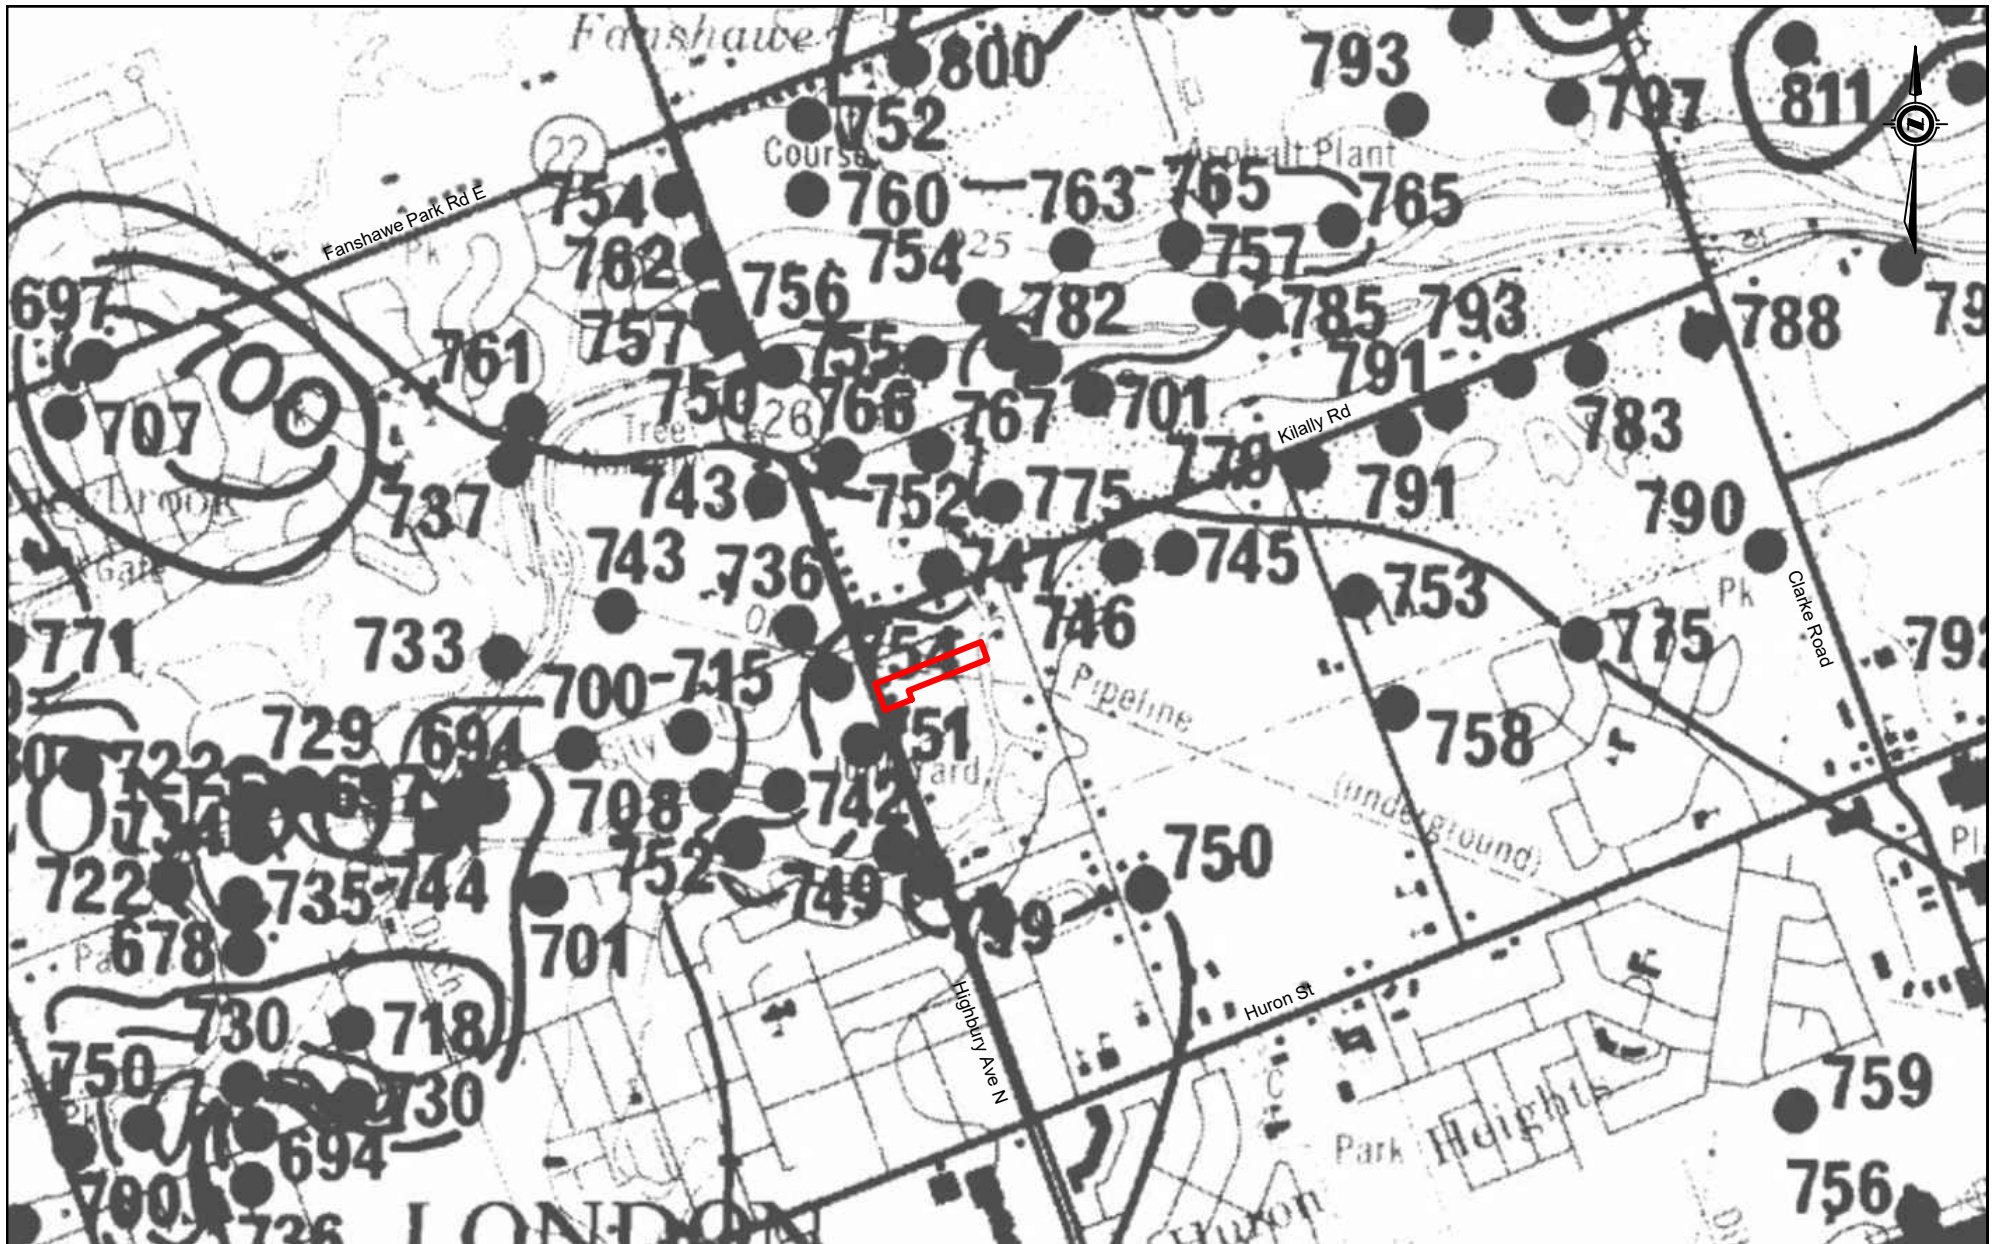
CLIENT Copia Developments	
TITLE Bedrock Topography	
Prepared By: E.B.	Reviewed By: H.J.
EXP Services Inc. 15701 Robin's Hill Road, London, ON, N5V 0A5	
DATE AUGUST 2020	SCALE 1:20,000
PROJECT NO. KCH-00260285-A0	DWG. 5

- ▬ Approximate Site Boundary
- 751 Bedrock Surface Elevation in a Well or Test Hole (feet)
- 700— Contours on Bedrock Surface (feet)

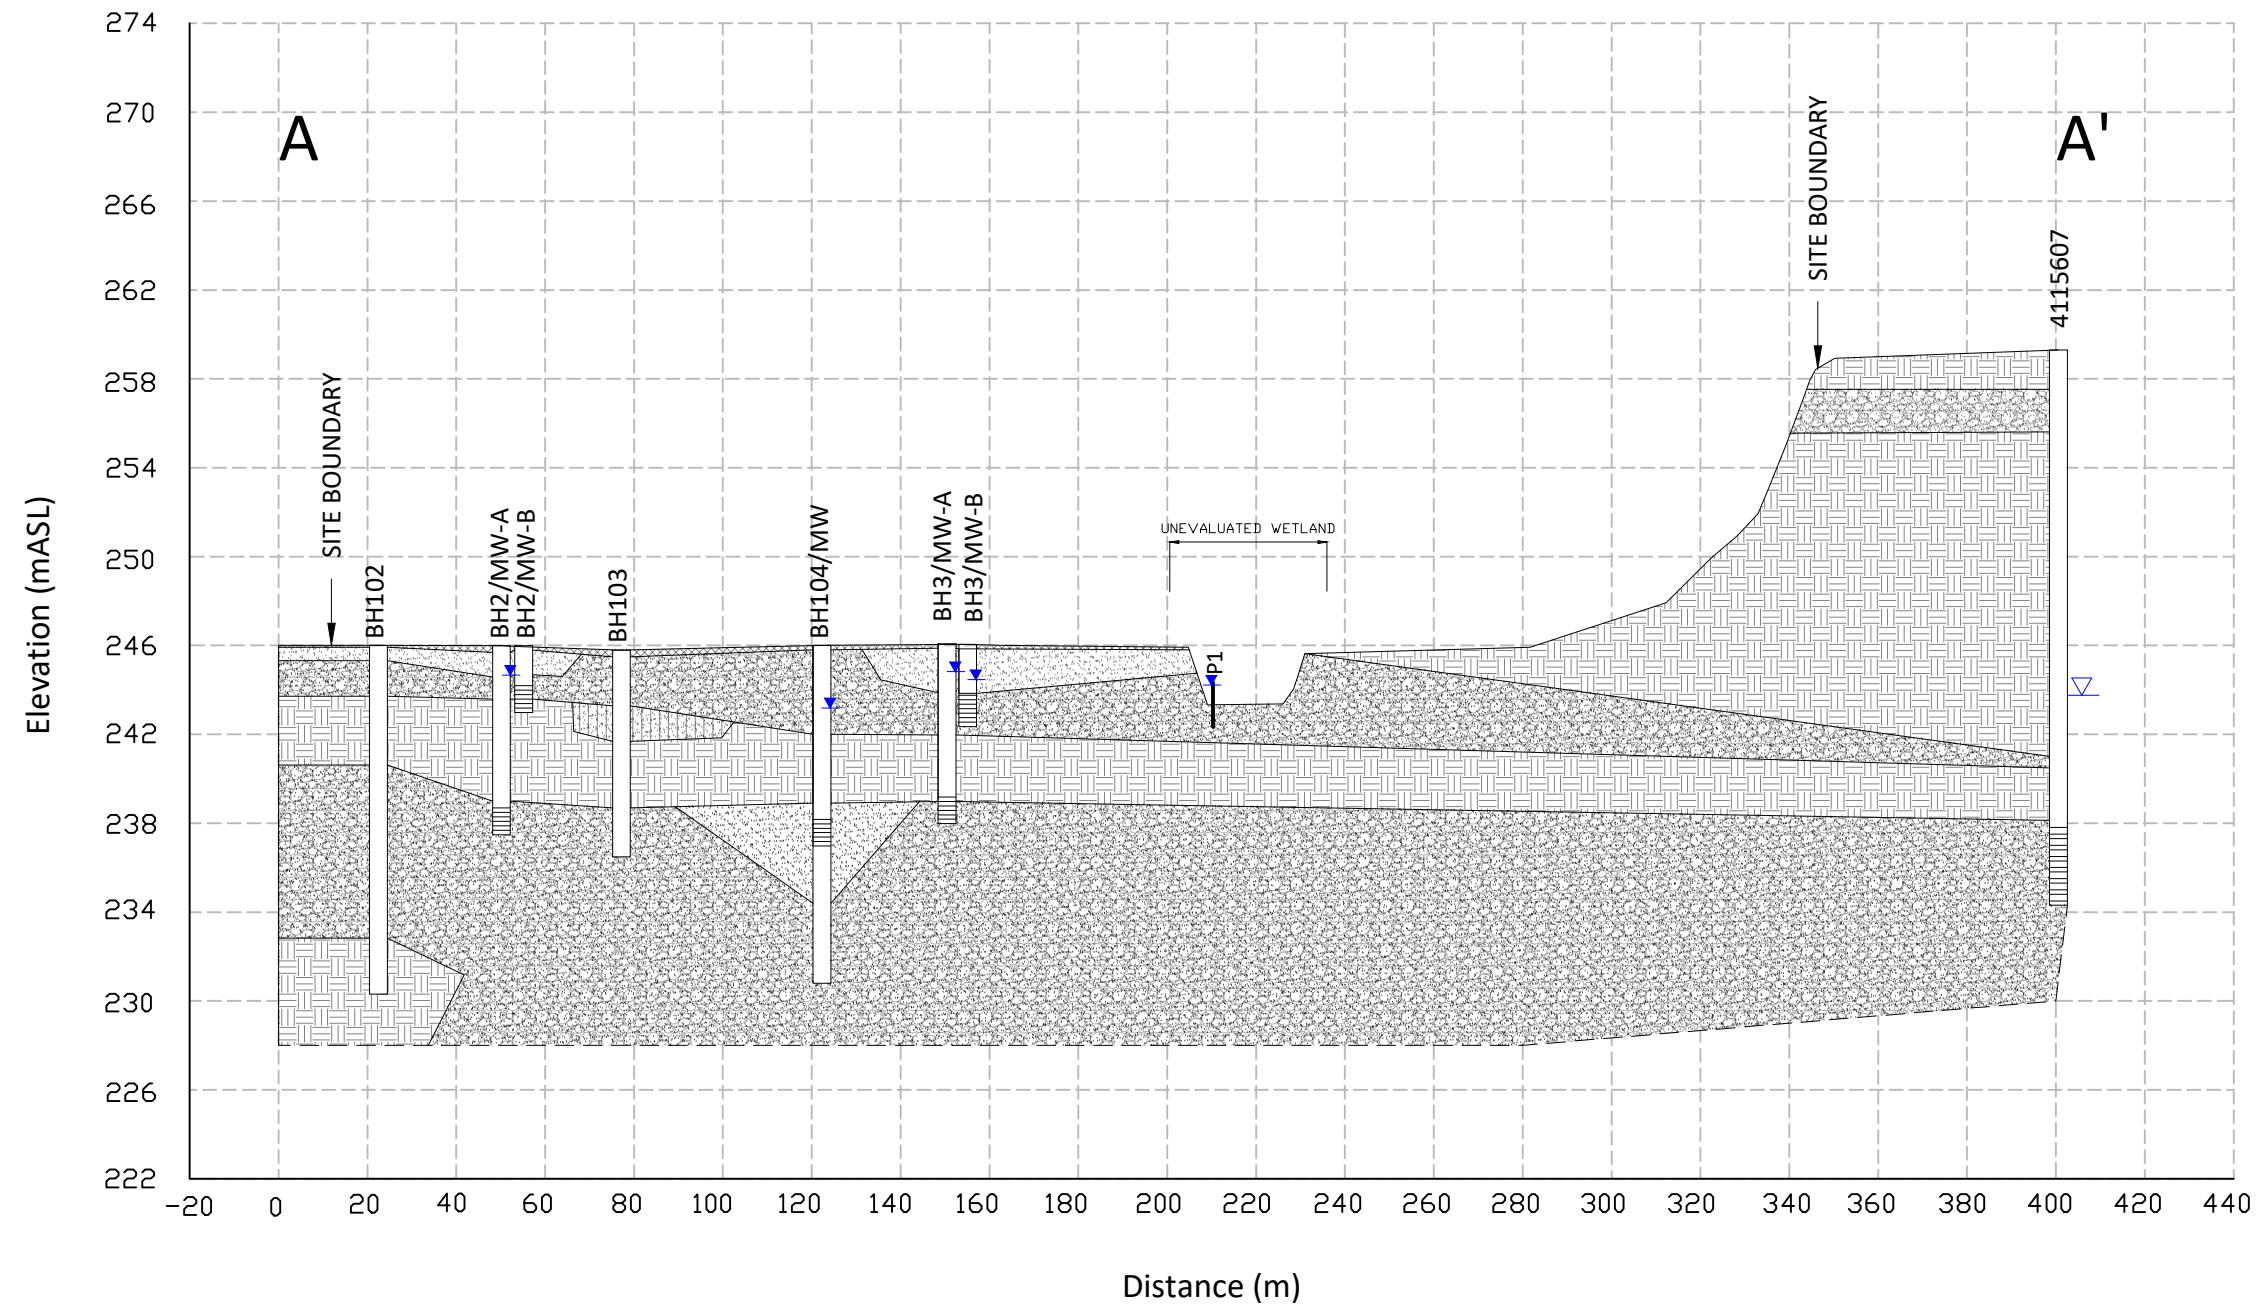
CLIENT Copia Developments		
TITLE Cross Section A - A'		
DRAWN BY: J.M.	REVIEWED BY: H.B.	DATE: June 2021
		EXP Services Inc. 15701 Robin's Hill Road London, ON, N5V 0A5
SCALE: H=1:1500, V=1:300 (11x17)	PROJECT NO. KCH-00260285-A0	DWG. 11

Groundwater Measurement March 2021
	Groundwater Measurement MECP Well Log
	Topsoil
	Sand
	Clayey Silt Till
	Sand & Gravel
	Sand Silt

A generalized stratigraphic cross section through the Site, as shown in **Drawing 10**, is provided as **Drawing 11**. The cross section includes a private well to the east of the property from the MECP Water Well Records (WWR). The surficial geology of the Site is characterized as having an unconfined sand aquifer overlying the majority of the Site and continuing under the landscaped pond feature. The east side of the Site and the slope consist of clayey silt till with a sand and gravel unit on top. Below the unconfined sand aquifer found across the Site is a clayey silt till confining layer. This confining layer ranges in thickness from approximately 2.5 to 4.5 m across the Site. Underlying the confining till is a confined sand and gravel aquifer.

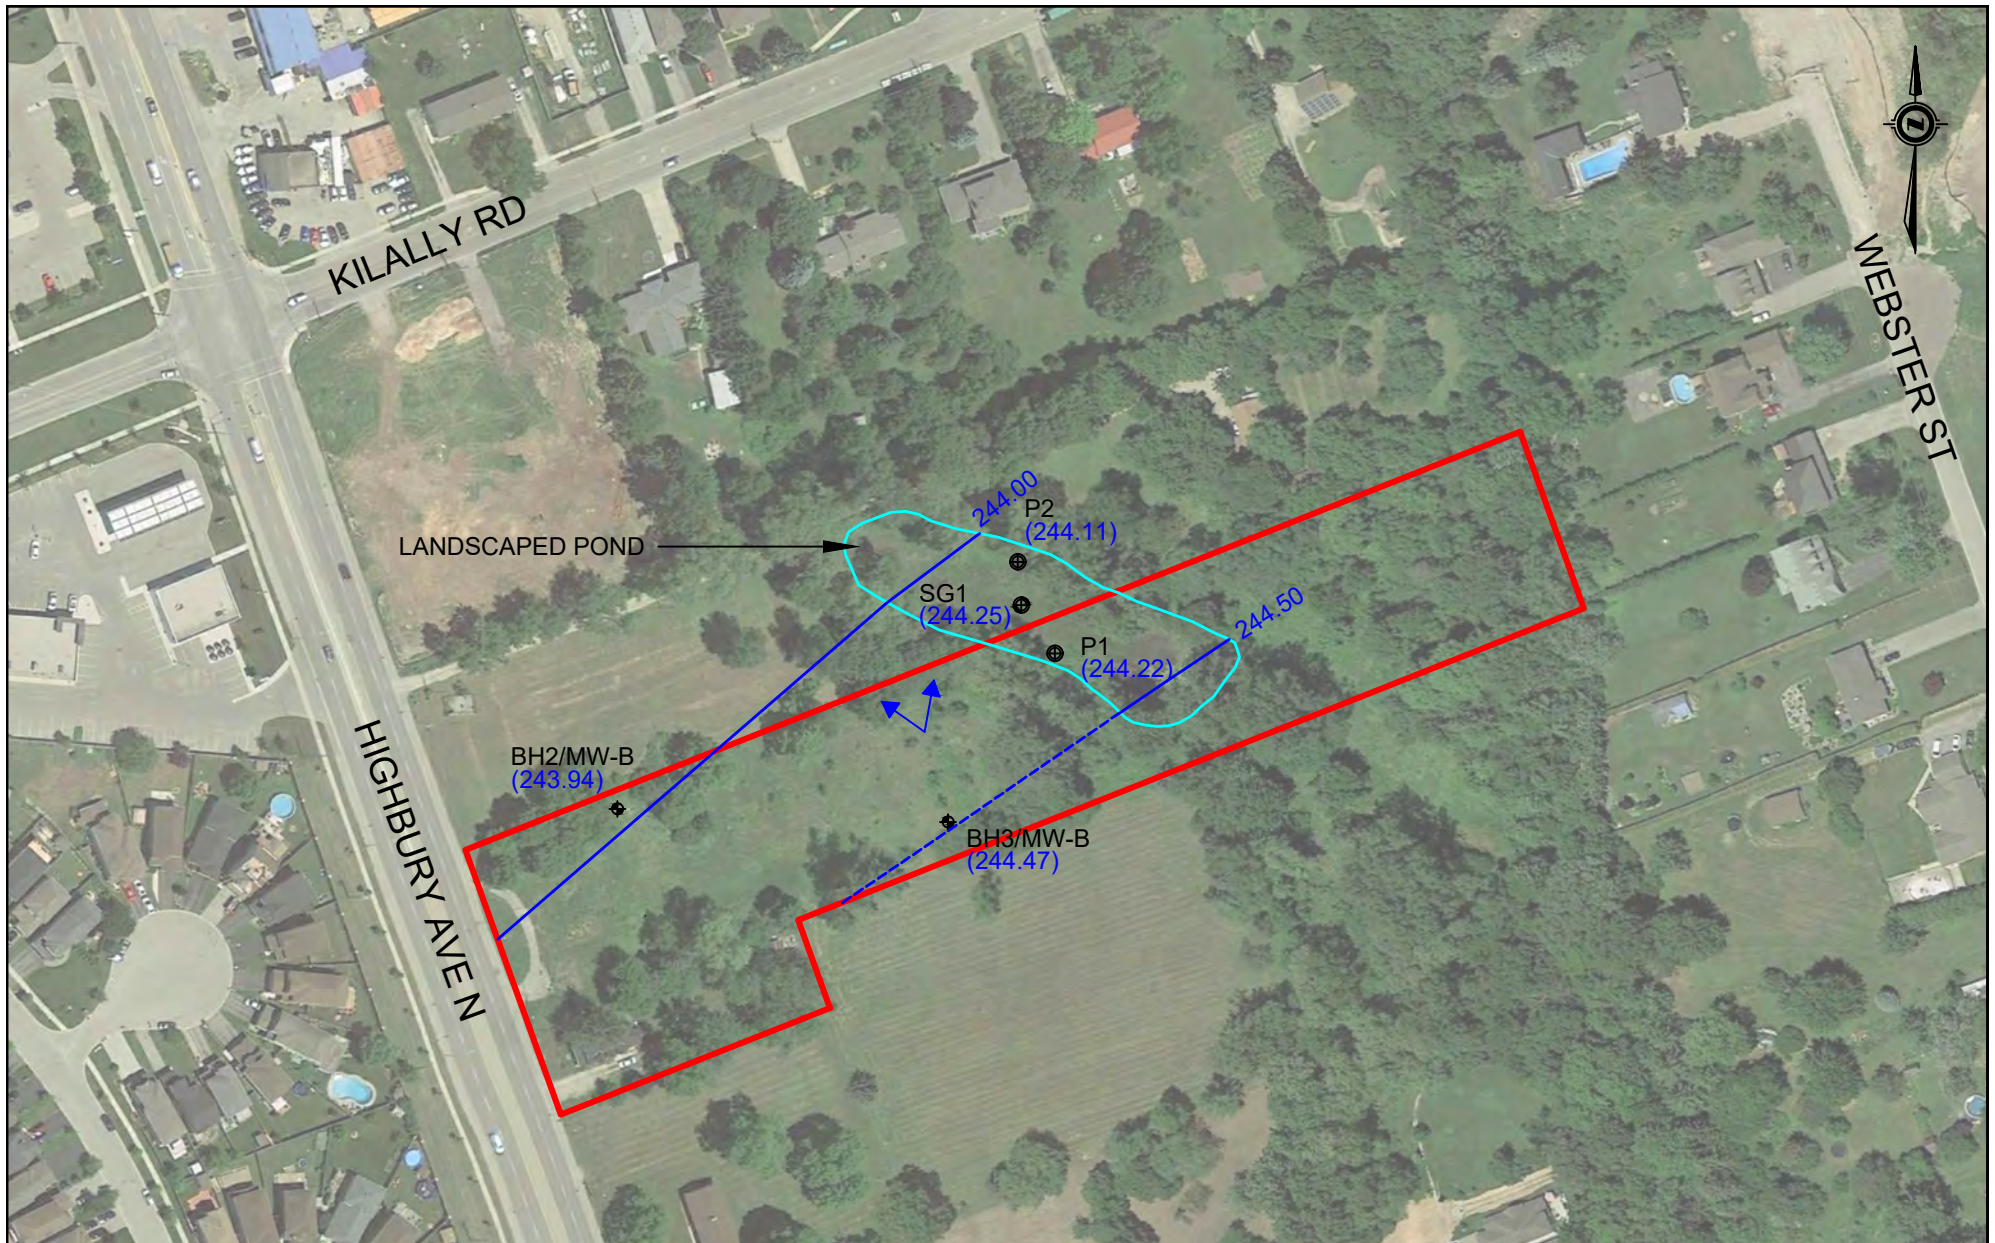
CLIENT Copia Developments	
TITLE Shallow Groundwater Flow Plan	
Prepared By: J.M.	Reviewed By: H.B.
EXP Services Inc. 15701 Robin's Hill Road, London, ON, N5V 0A5	
DATE July 2021	SCALE 1:2,000
PROJECT NO. KCH-00260285-A0	DWG. 13

- ◆ BH1/MW Station 1
- ⊕ Surface Water Station Location
- Approximate Site Boundary
- (244.47) Shallow Groundwater Elevation (mAMS), March 17, 2021
- Groundwater Equipotential Lines
- ➔ Inferred Groundwater Flow Direction

The horizontal hydraulic gradient across the Site will vary due to the range in topography and resulting range in groundwater elevations. The hydraulic gradient is found to be approximately 0.01 m/m across the Site.

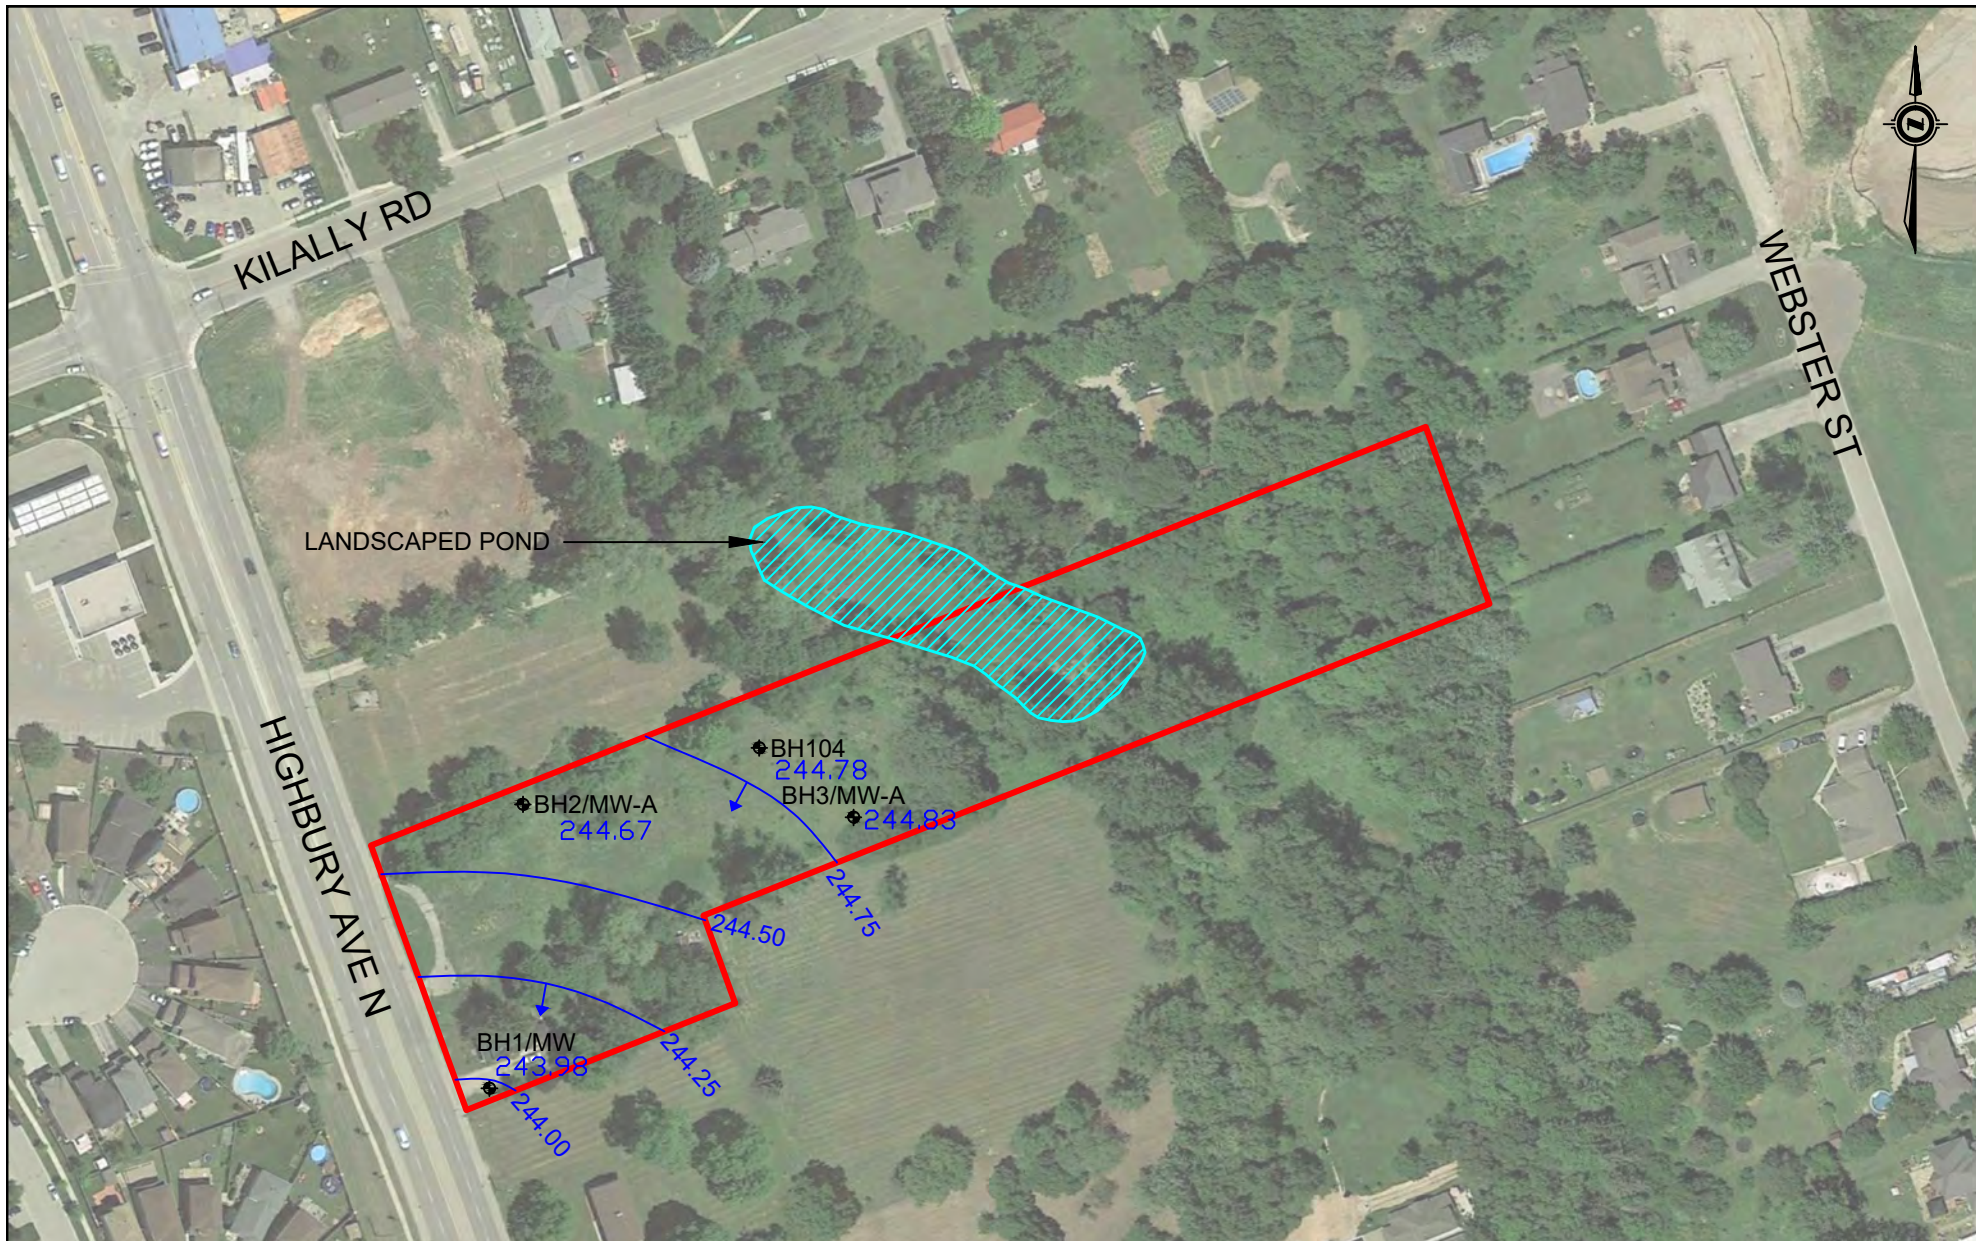
CLIENT Copia Developments	
TITLE Deep Groundwater Flow Plan	
Prepared By: J.M.	Reviewed By: H.B.
EXP Services Inc. 15701 Robin's Hill Road, London, ON, N5V 0A5	
DATE July 2021	SCALE 1:2,000
PROJECT NO. KCH-00260285-A0	DWG. 14

- ◆ BH1/MW Approximate Borehole Location
- ⊕ Station 1 Surface Water Station Location
- Approximate Site Boundary
- (243.98) Deep Groundwater Elevation (mAMSL), March 17, 2021
- Groundwater Equipotential Lines
- Inferred Groundwater Flow Direction

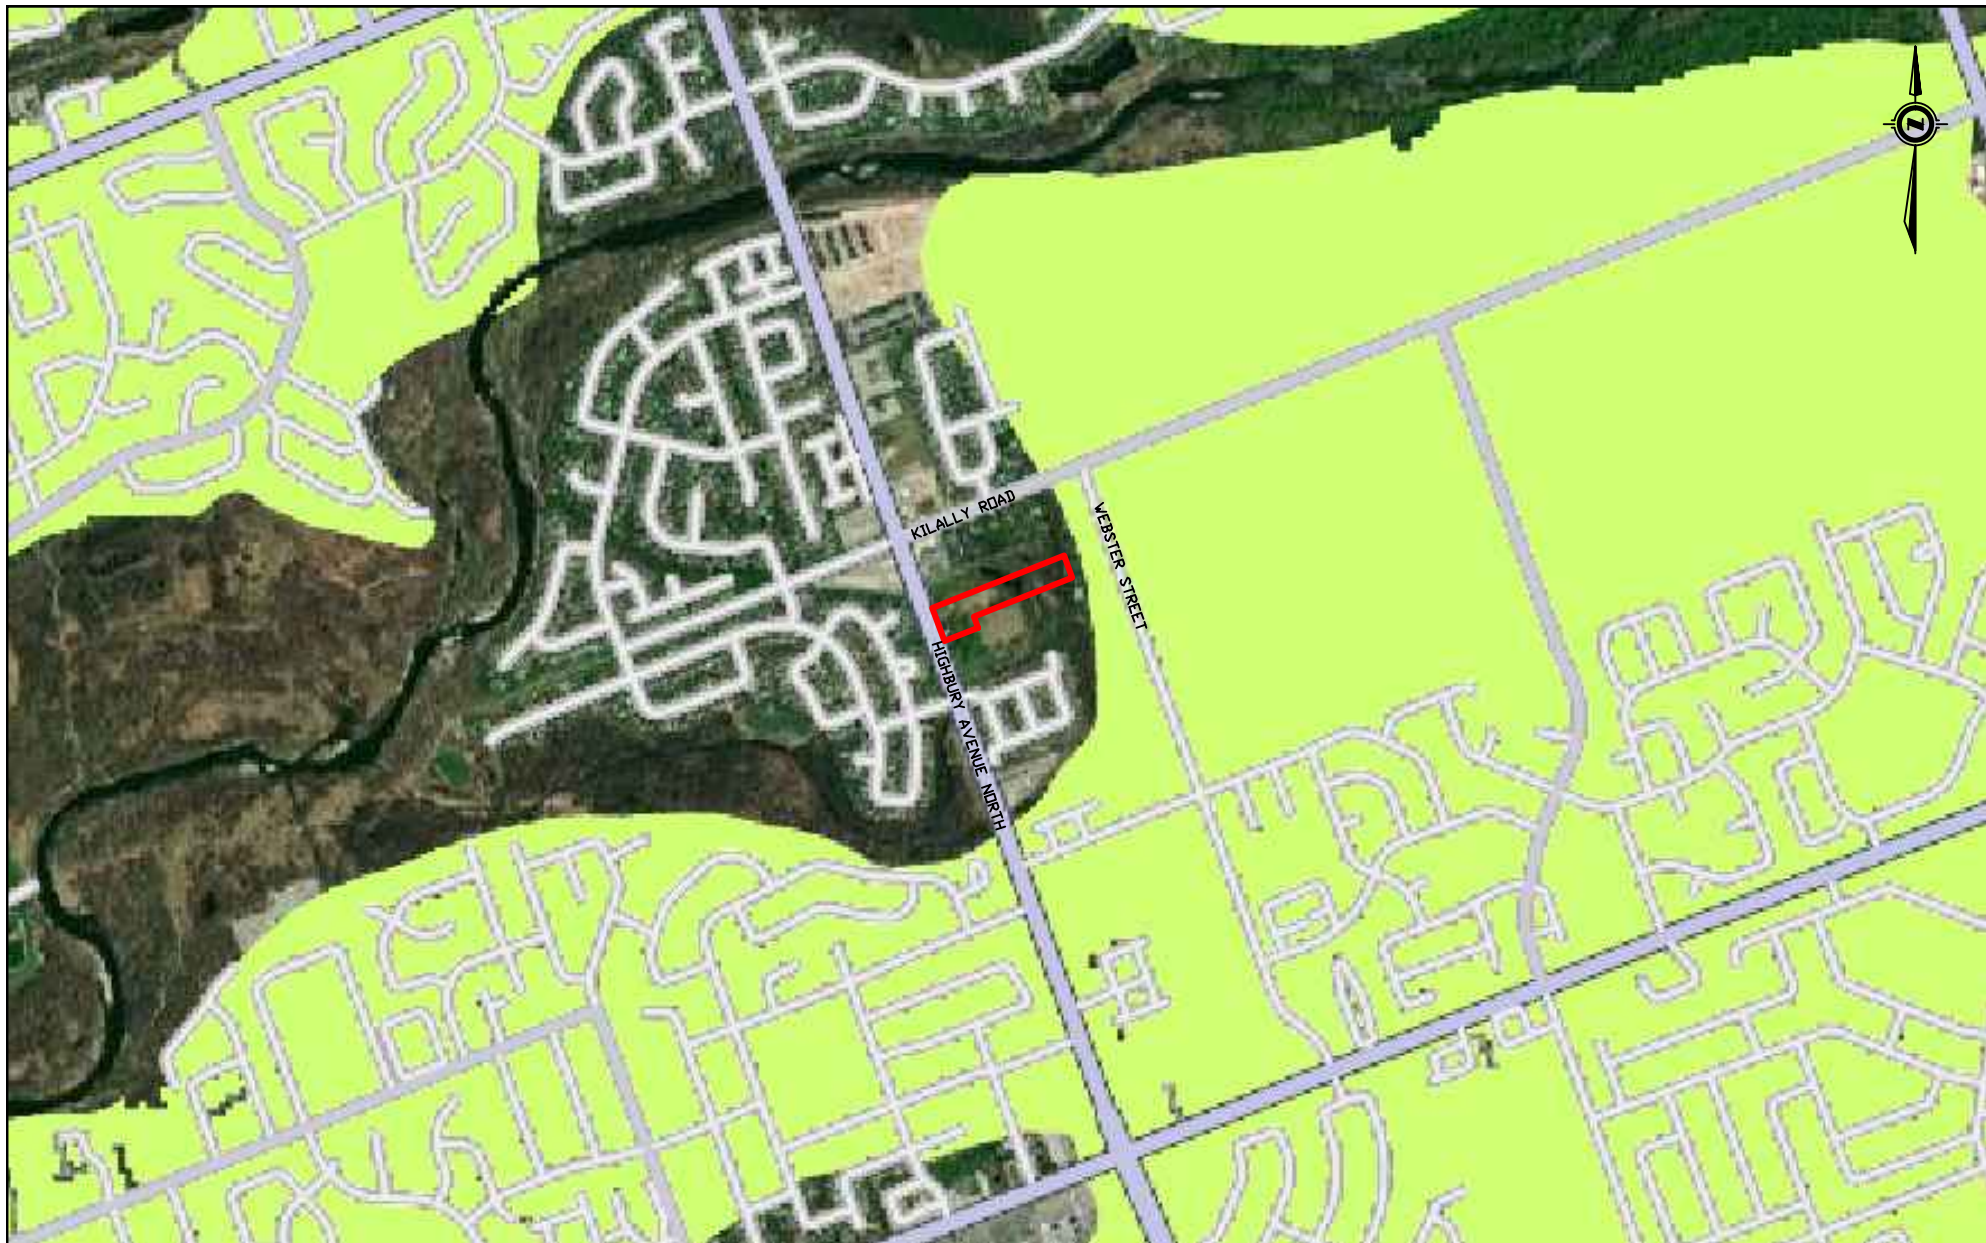
CLIENT Copia Developments			
TITLE Schoeller Diagram for Water Quality - Minor Ions			
Prepared By: K.D.		Reviewed By: H.B.	
exp		EXP Services Inc. 15701 Robin's Hill Road, London, ON, N5V 0A5	
DATE June 2021	SCALE NA	PROJECT NO. KCH-00260285-A0	DWG. 16b

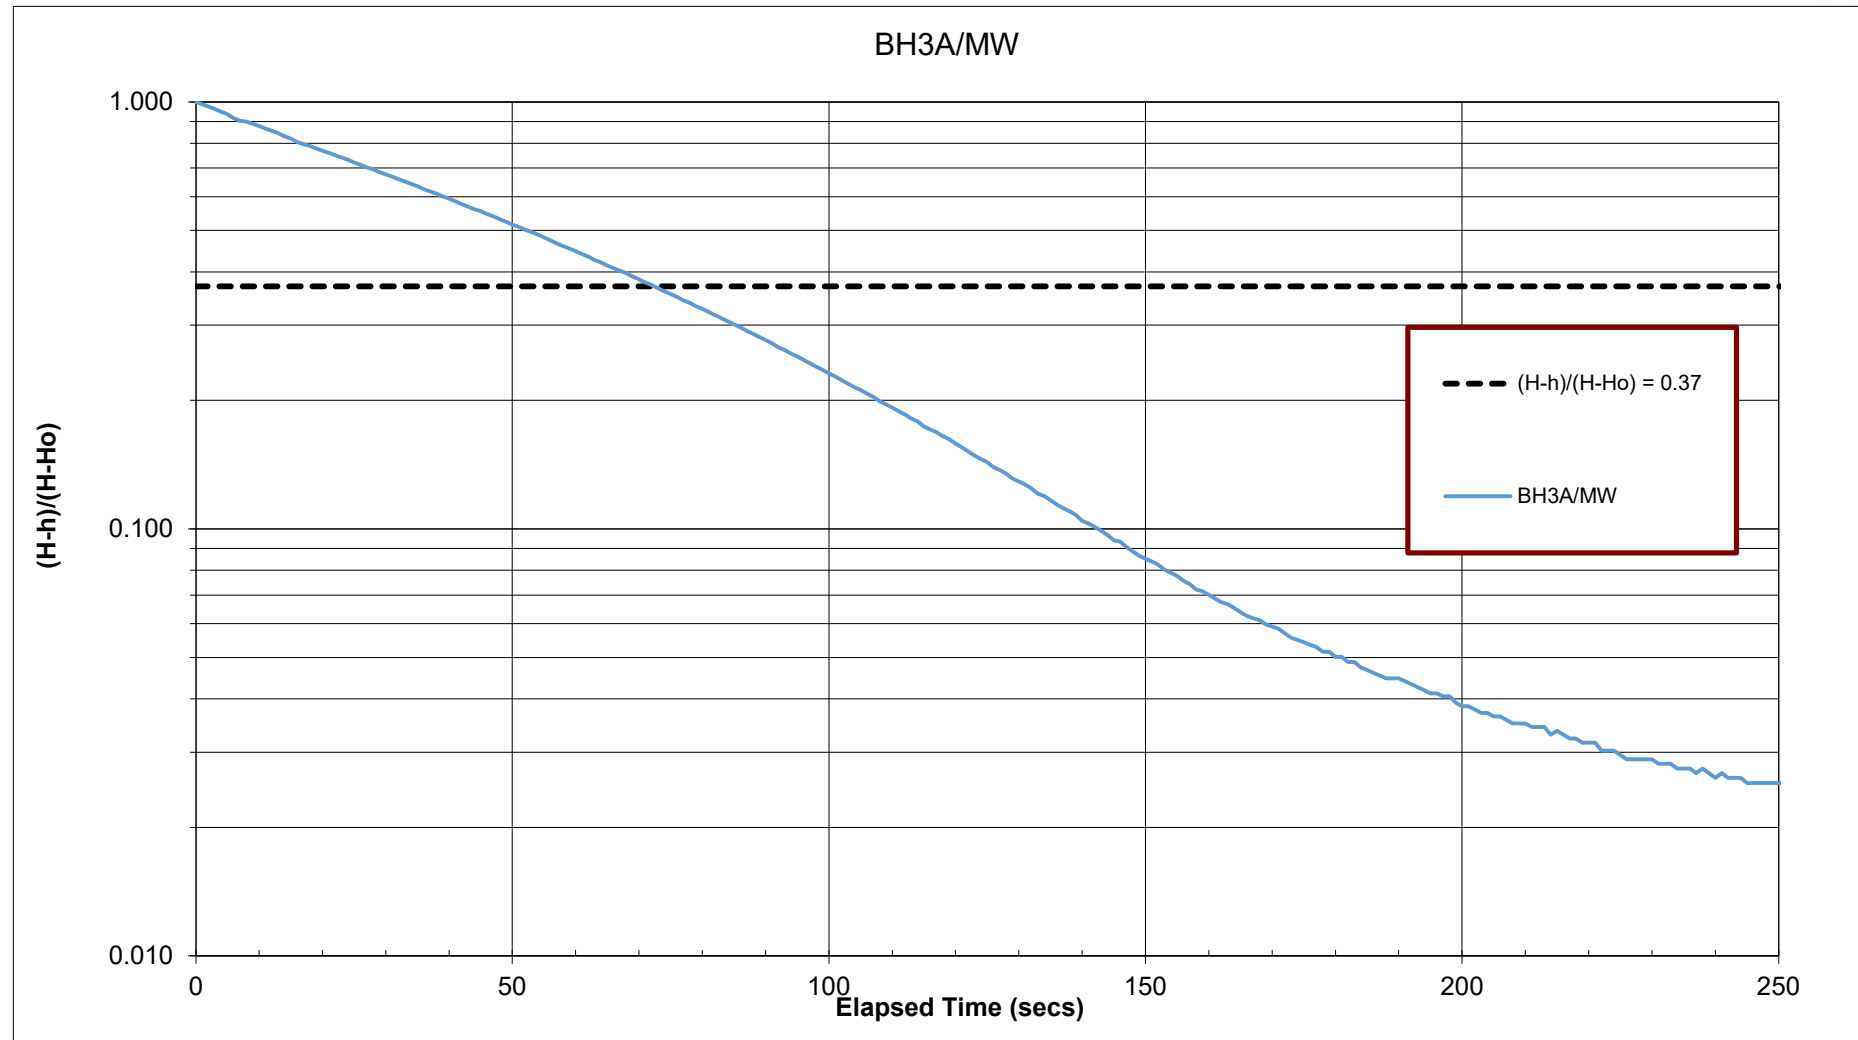
Recovery Testing - Hvorslev Method (1951)

Initial Water Level 1.63 m bgs
 Maximum Drawdown 1.46 m

r (m) = 0.0254
 L (m) = 1.52
 R (m) = 0.1080
 T₀ (sec) = 72

Based on these tests the hydraulic conductivity of the upper sand and gravel was found to be 4.2×10^{-5} m/s and the underlying sand and gravel unit was found to be 7.8×10^{-6} m/s. Literature values for hydraulic conductivities range from 10^{-5} to 10^{-2} m/s for sand (Table 2.2, Freeze and Cherry; 1979). The underlying sand and gravel unit is therefore slightly below this typical range.

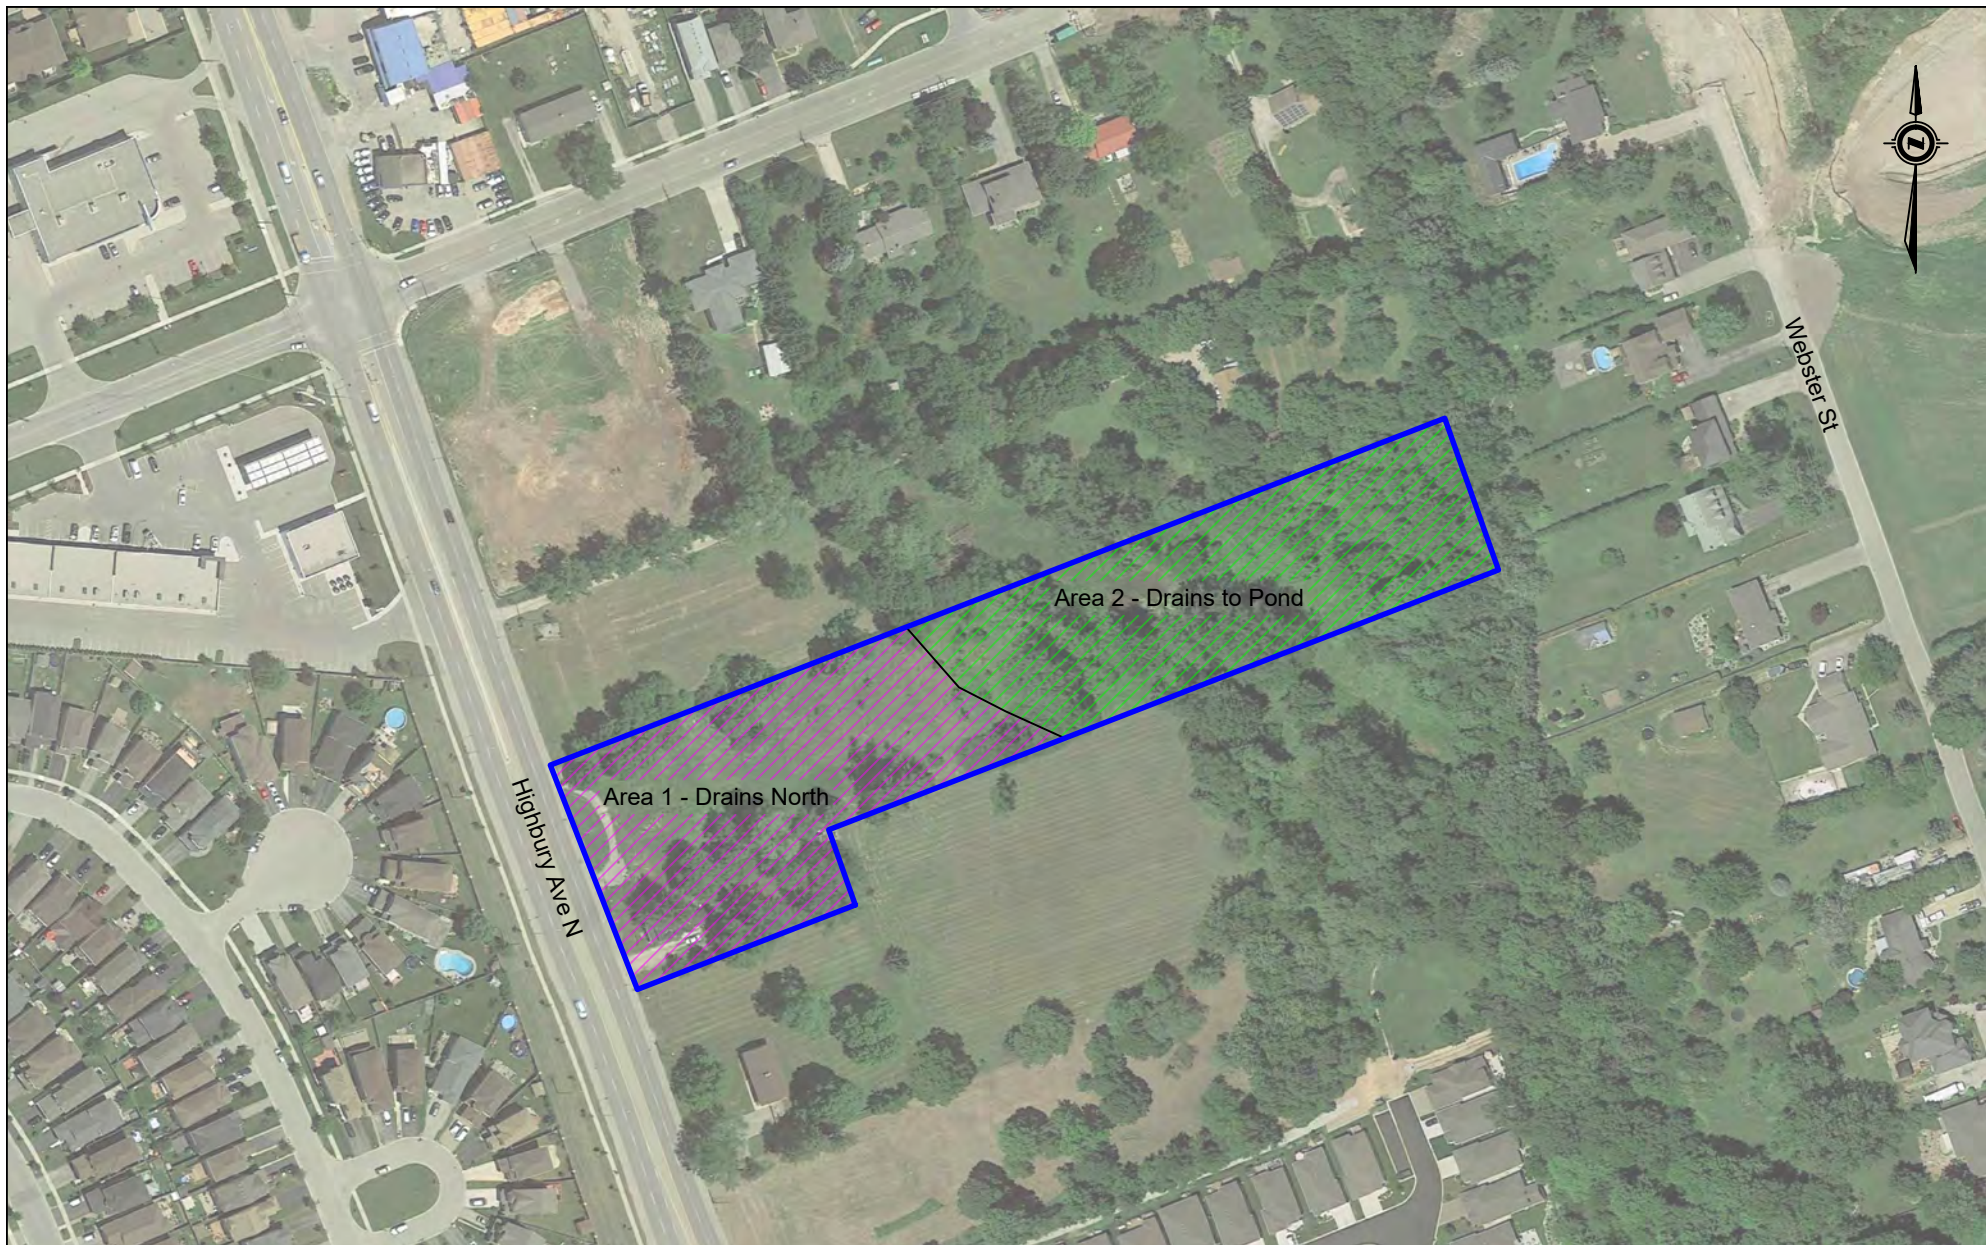
- Approximate Site Boundary (15974 sq m)
- Area 1 (8036 sq m)
- Area 2 (7938 sq m)

The soil water holding capacities and infiltration rate were determined using values presented in Table 3.1 of the MOE Stormwater Management Planning and Design Manual (MOE, 2003) based on the vegetative cover and the hydrologic soil group. The weighted values based on the Site conditions are presented in the calculation sheets provided in Appendix K.
