Slope Stability and Geotechnical Investigation

Proposed Development
2624 Woodhull Road
London, Ontario

LON-21002656-AO

Final Report

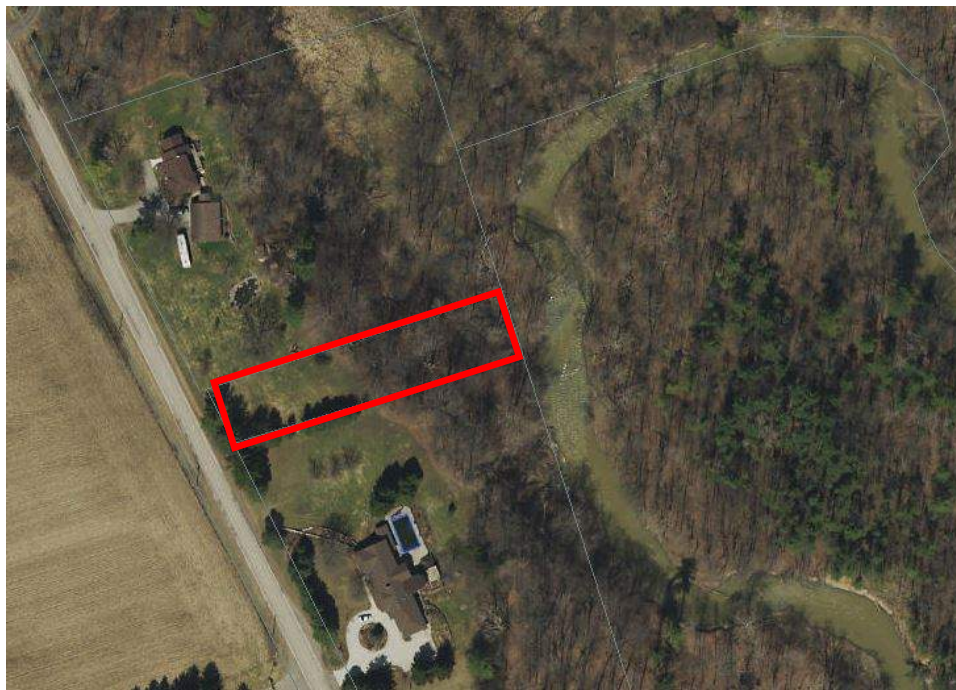
The site for the proposed development (see **Drawing 1**) is located on the east side of Woodhull Road within the property of MN2624 in London, Ontario. The site is bounded by a slope on the east side, neighbouring residential properties on the north and south sides, and an agricultural field on the west side of Woodhull Road. A narrow side channel (~1.7 m width) of Dingman Creek is located beyond the base of the slope on the east side of the site. A map of the site location (taken from MNR Maps March 2021) is provided below.

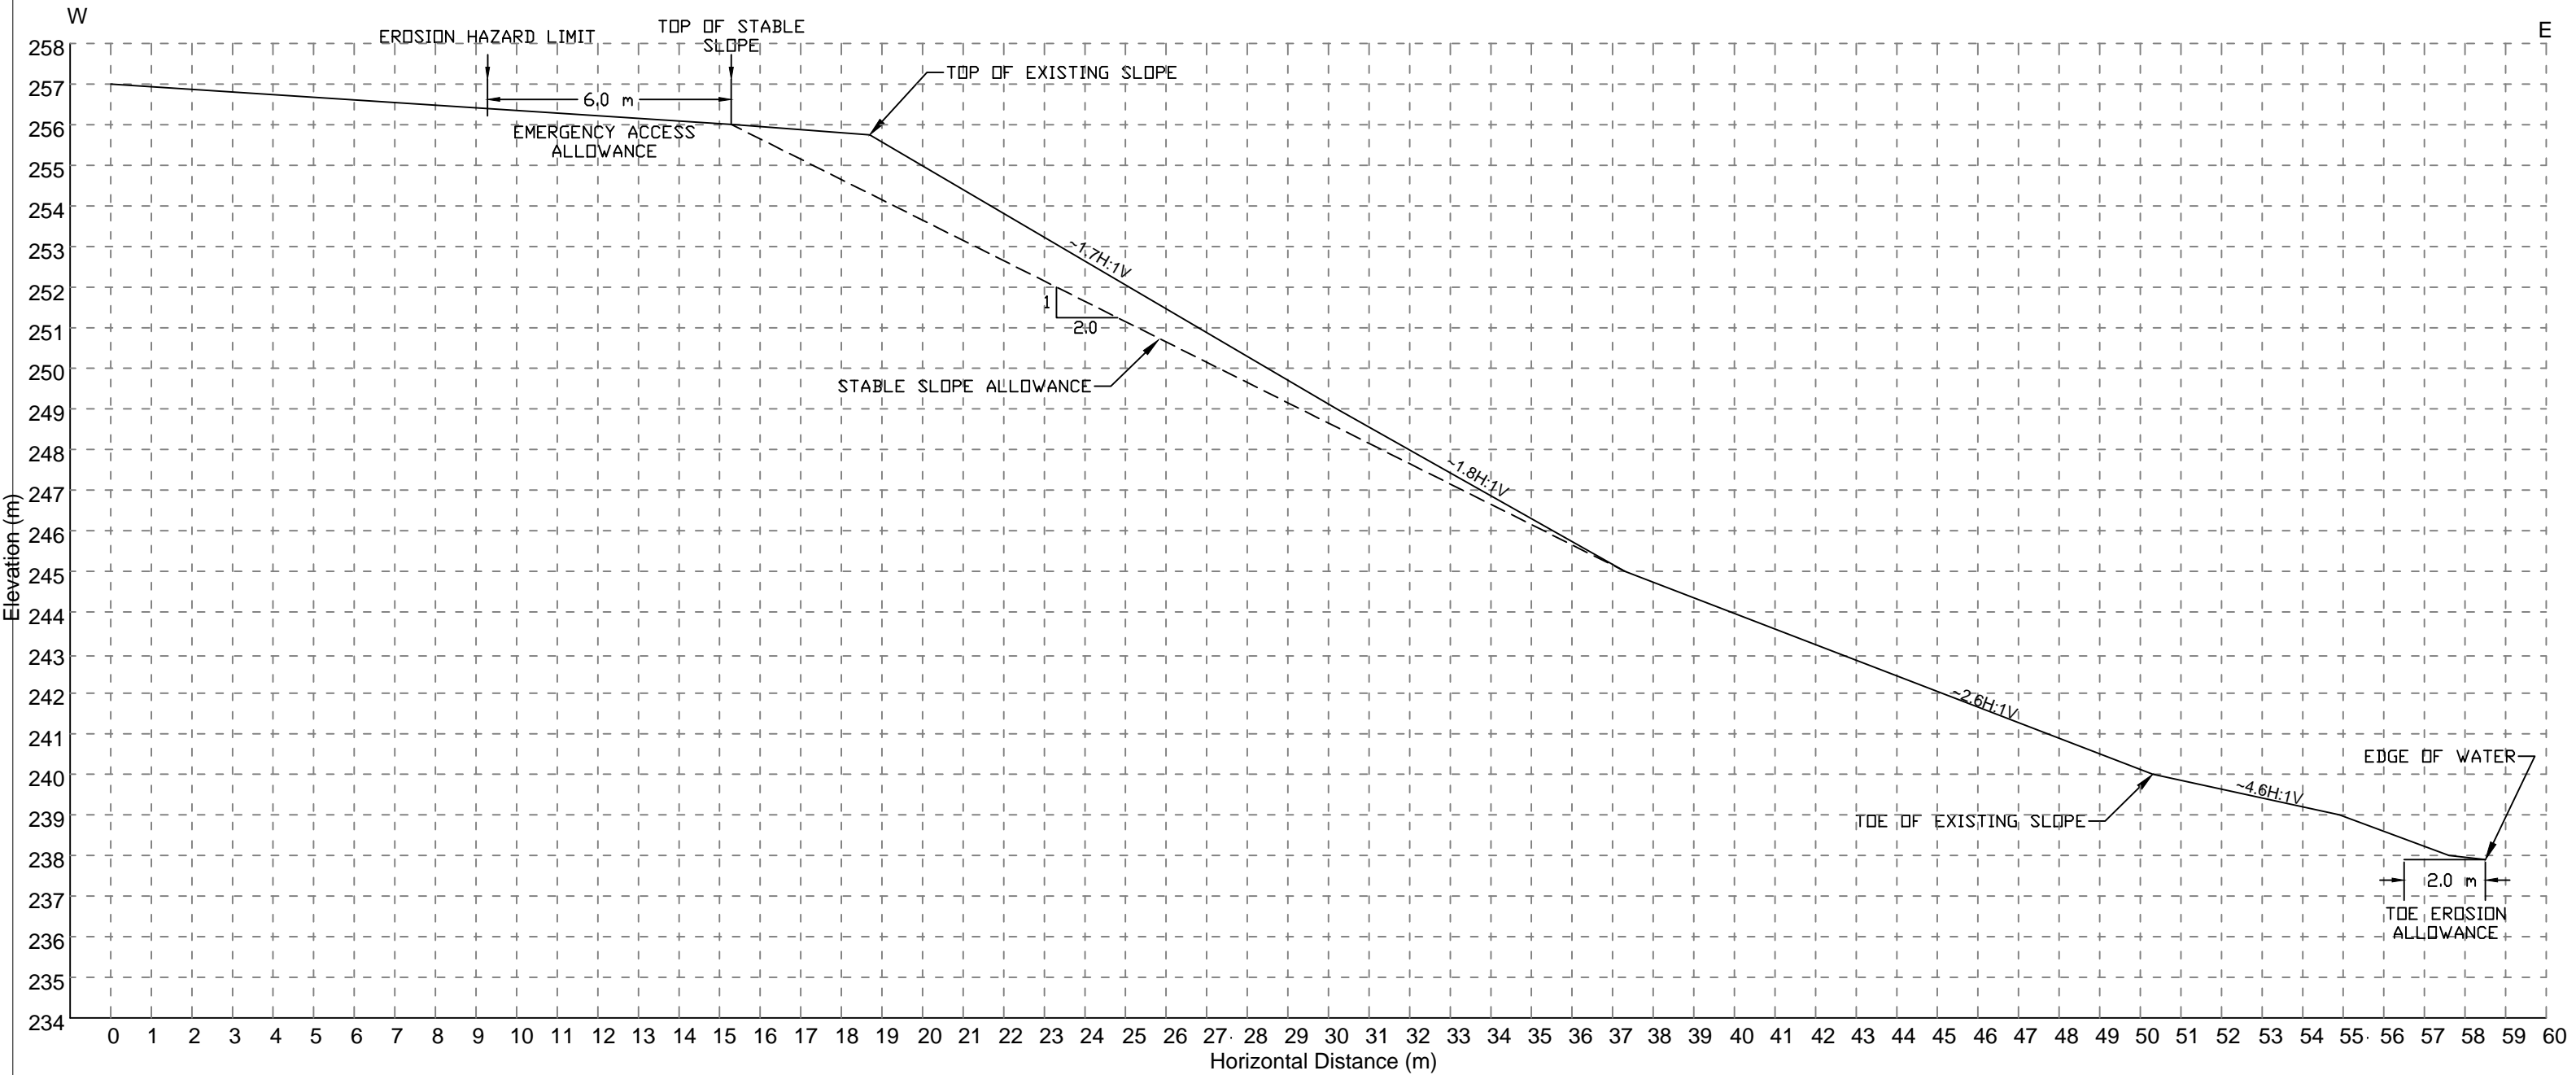
Cross Section A - A'

1. The cross section should be read in conjunction with EXP Report LON-21002656-A0.

The setback distance from the slope crest varies slightly along the slope, based on the overall slope height and inclination, and the type and amount of toe erosion at the base of the slopes. A cross section (Cross Section A-A') has been shown on **Drawing 1** along the existing slope profile and was used for establishing the location of the Erosion Hazard Limit. Additionally, the inferred location of the Erosion Hazard Limit, top of slope line, top of stable slope line, toe of slope and toe erosion allowance are also provided on **Drawing 1** and on cross sectional **Drawing 2**.

The failures at the cross section consisted of shallow depth failures and deep rotational failures throughout the depth of the slope. After completing the computerized stable slope analysis on the cross section, the minimum calculated factor of safety (FOS) under the existing conditions at Cross Section A-A’ was 1.46. These FOS are an indication of long-term safe slope conditions.

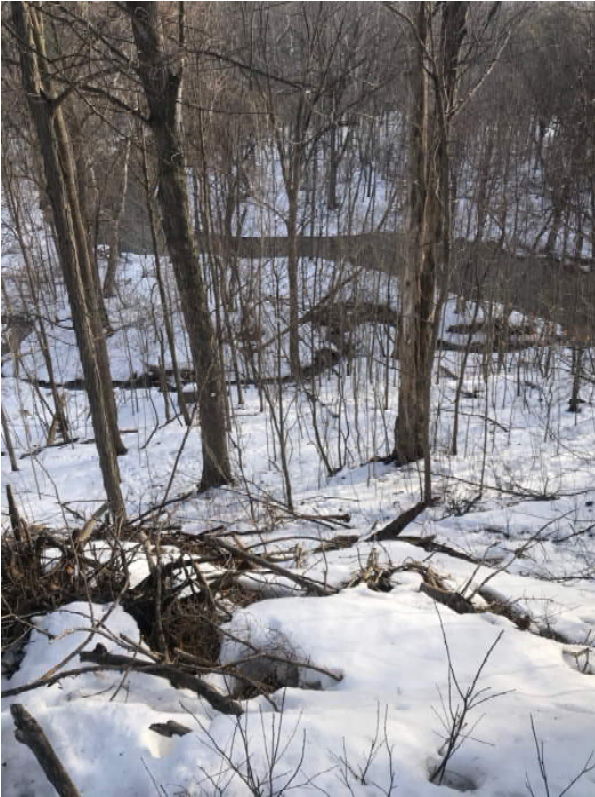
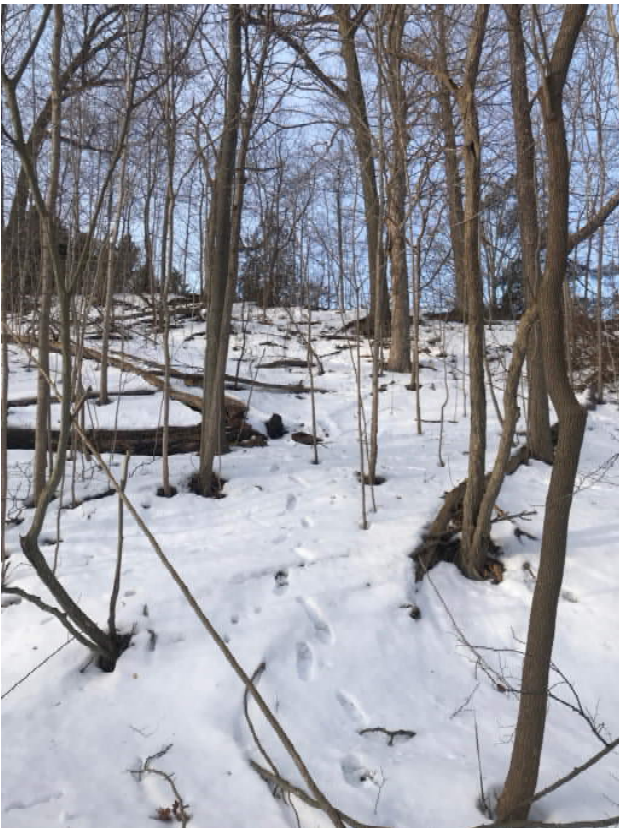
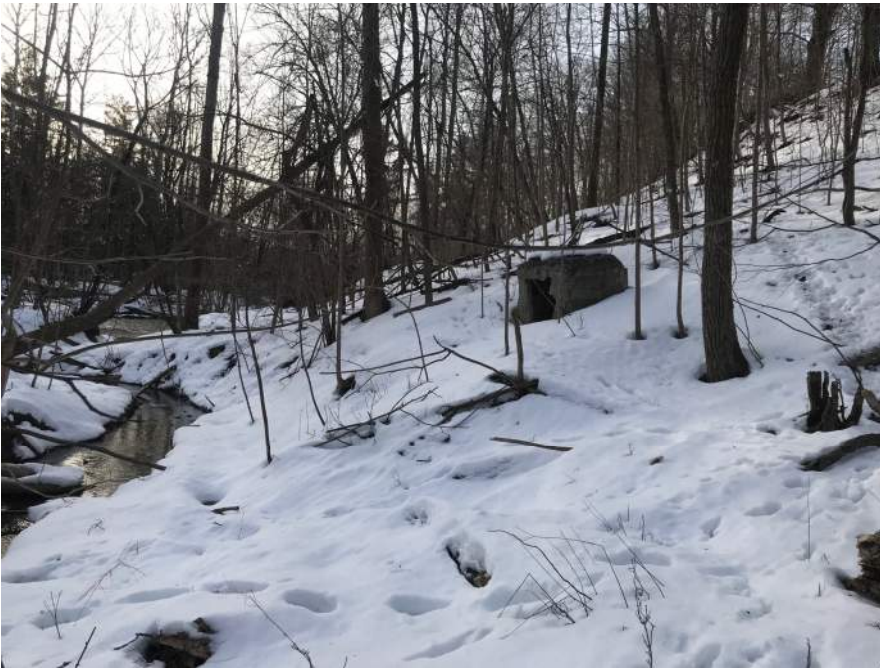
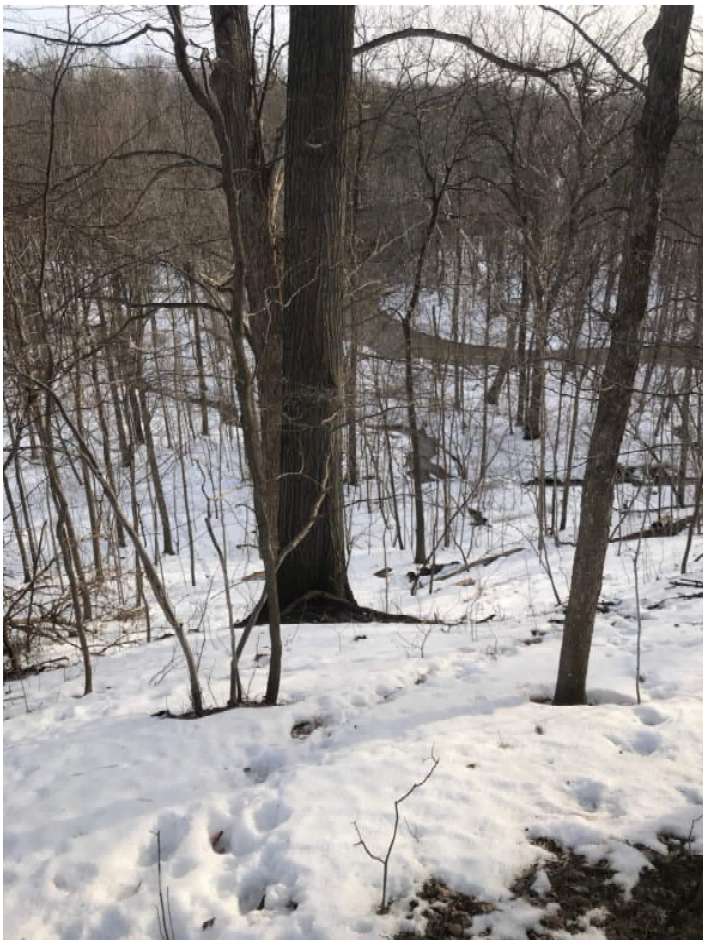
At the time of the investigation, the slope surface was typically well vegetated with heavy shrubs and mature trees. No previous surficial sliding failures or drainage over the slope were observed. Selected photos of the slope are presented in **Appendix D**.

The slope has a height of approximately 16.0 m, is well vegetated throughout, and the mature trees do not show any signs of rotational movement or failure. There were also no signs of water seepage along the slope face.
