Talbot Village Phase 8

Subject Lands Status Report and Environmental Impact Study (SLSR/EIS)

3095 Bostwick Road, City of London, ON

MTE Consultants Inc.
123 St. George Street
London, ON N6A 3A1

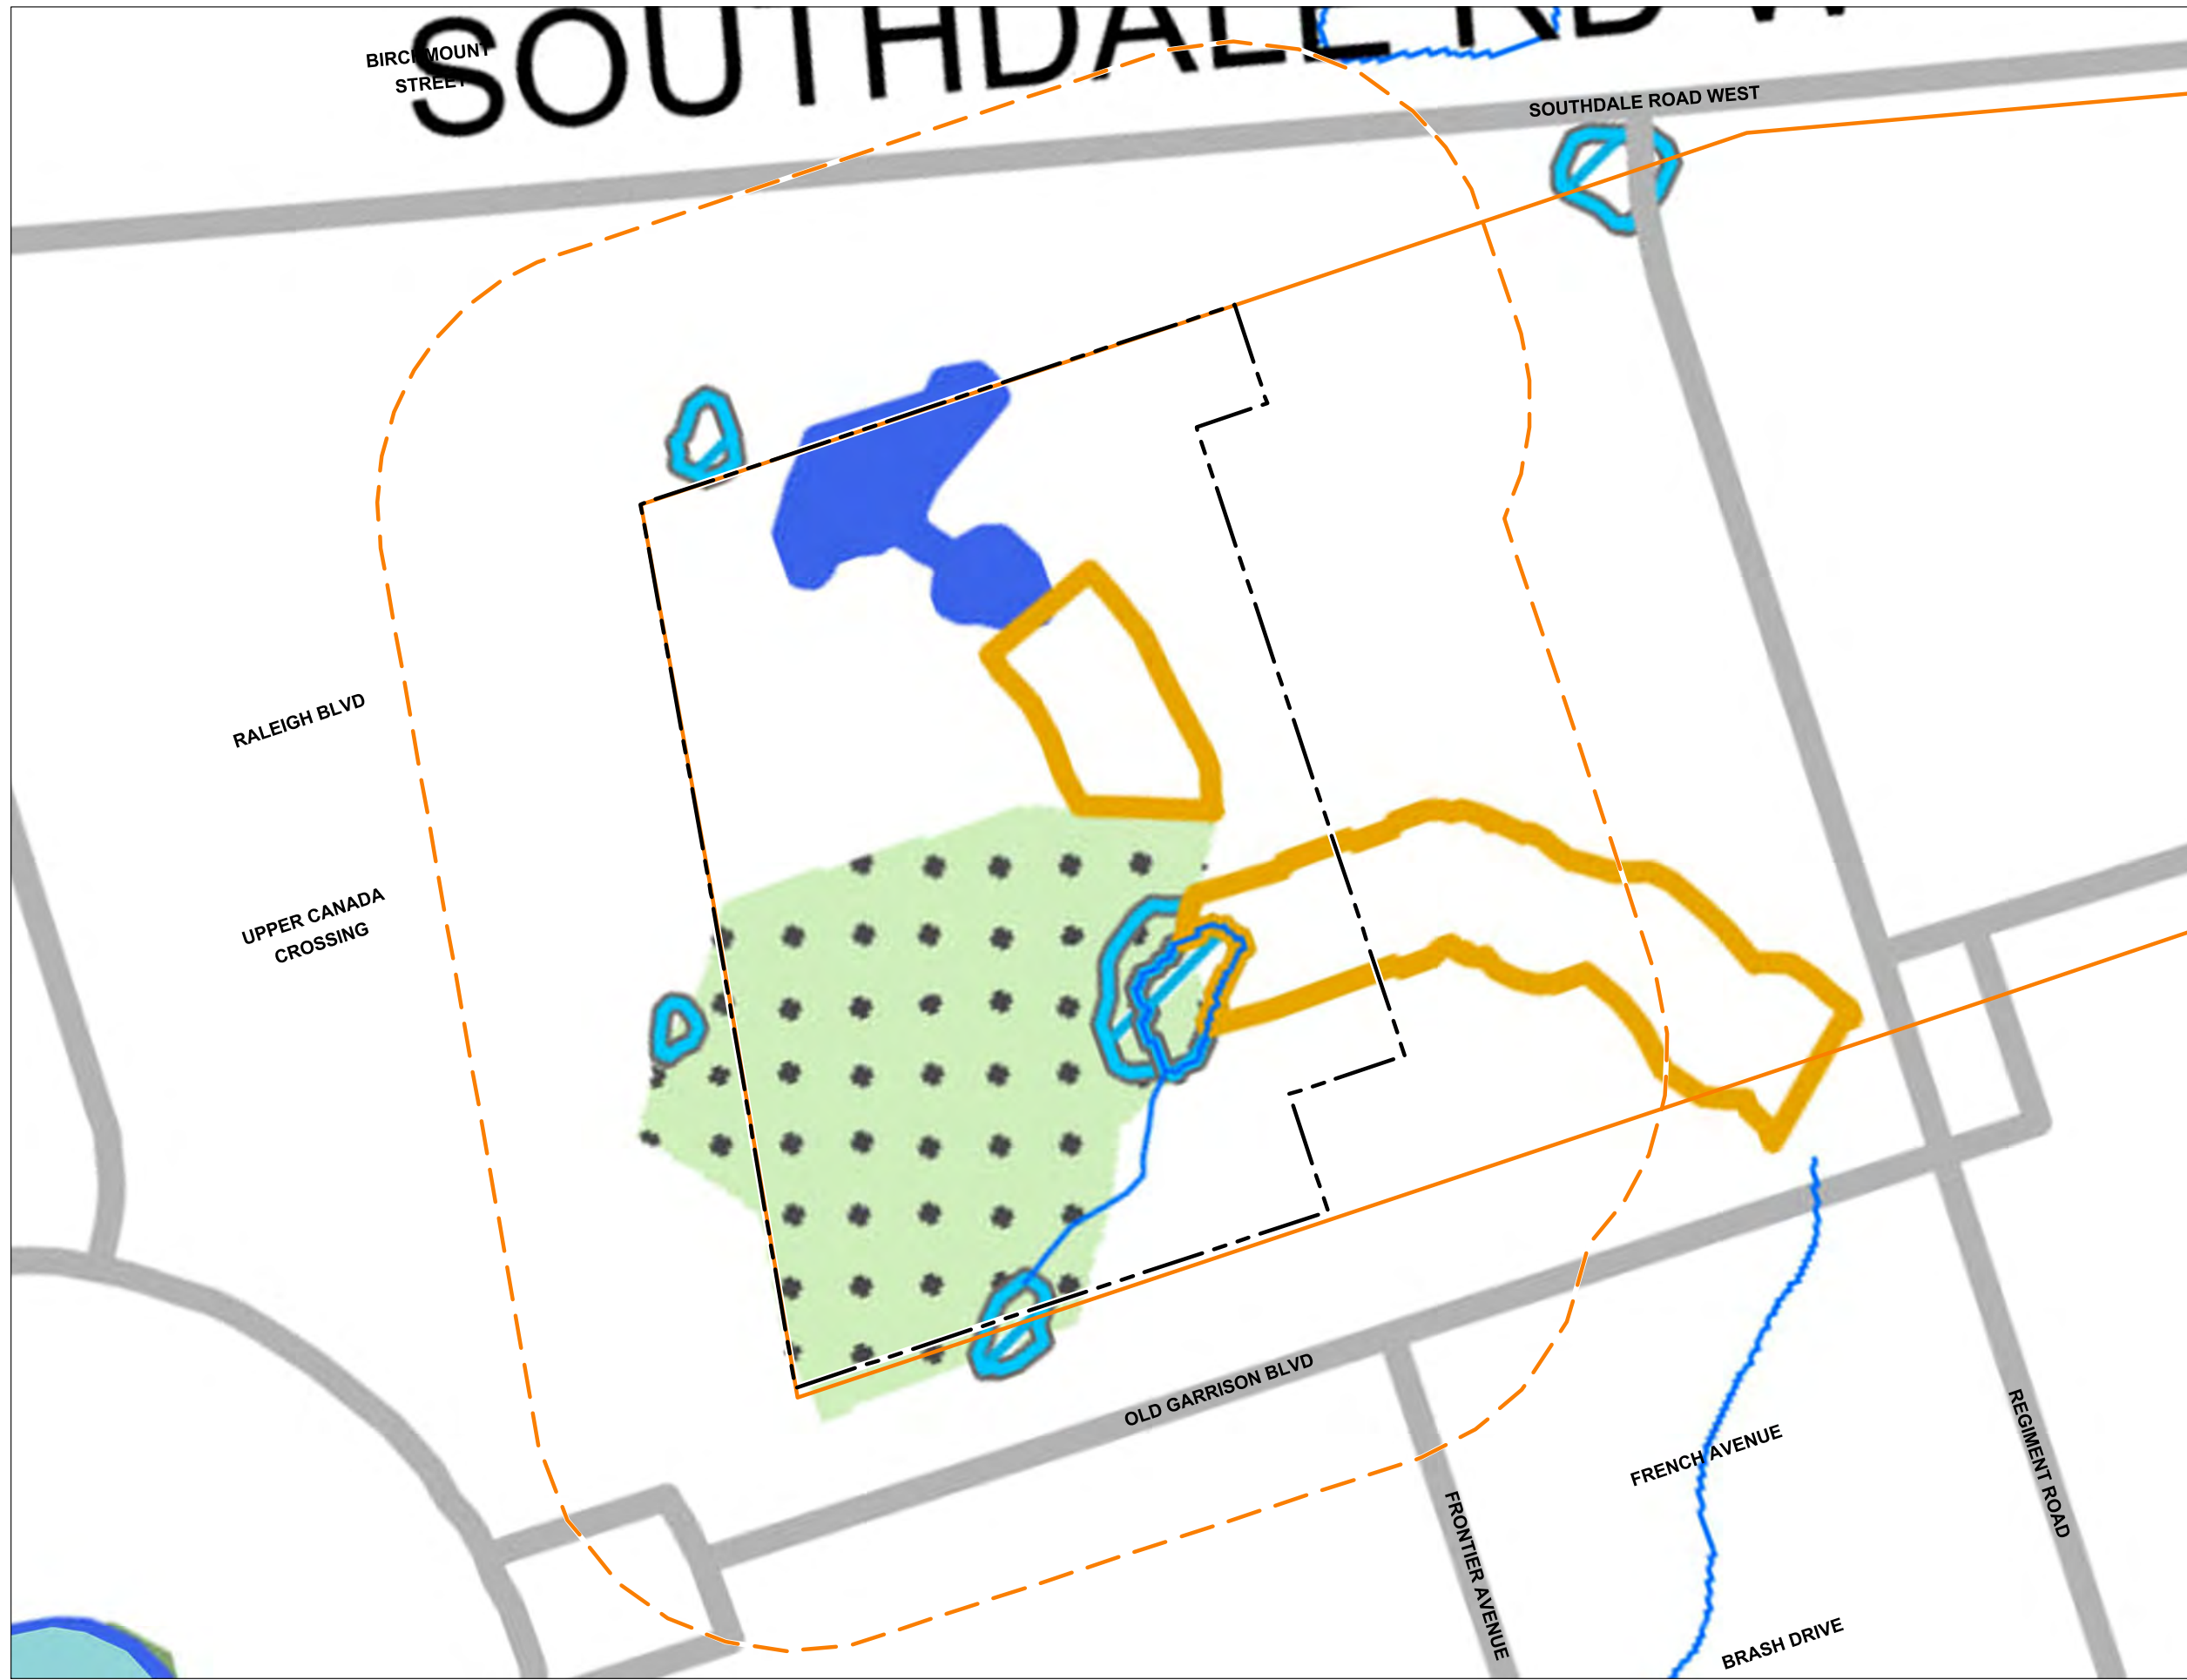
Drawn	DCH	Scale	1:3,000	Figure 3
Checked		Project No.	46666-100	
Date	2024-08-14	Rev No.	0

- SUBJECT LANDS
- STUDY AREA
(120m from Subject Lands)
- LEGAL PARCEL
- PROVINCIALY SIGNIFICANT WETLAND
- STREET
- UNEVALUATED VEGETATION PATCH
- UNEVALUATED WETLAND
- VALLEYLAND
- WATERCOURSE/POND

TITLE
**NATURAL HERITAGE
 THE LONDON PLAN**
