801 Sarnia Road

Tree Preservation Report

October 21, 2021

Revised: November 25, 2024

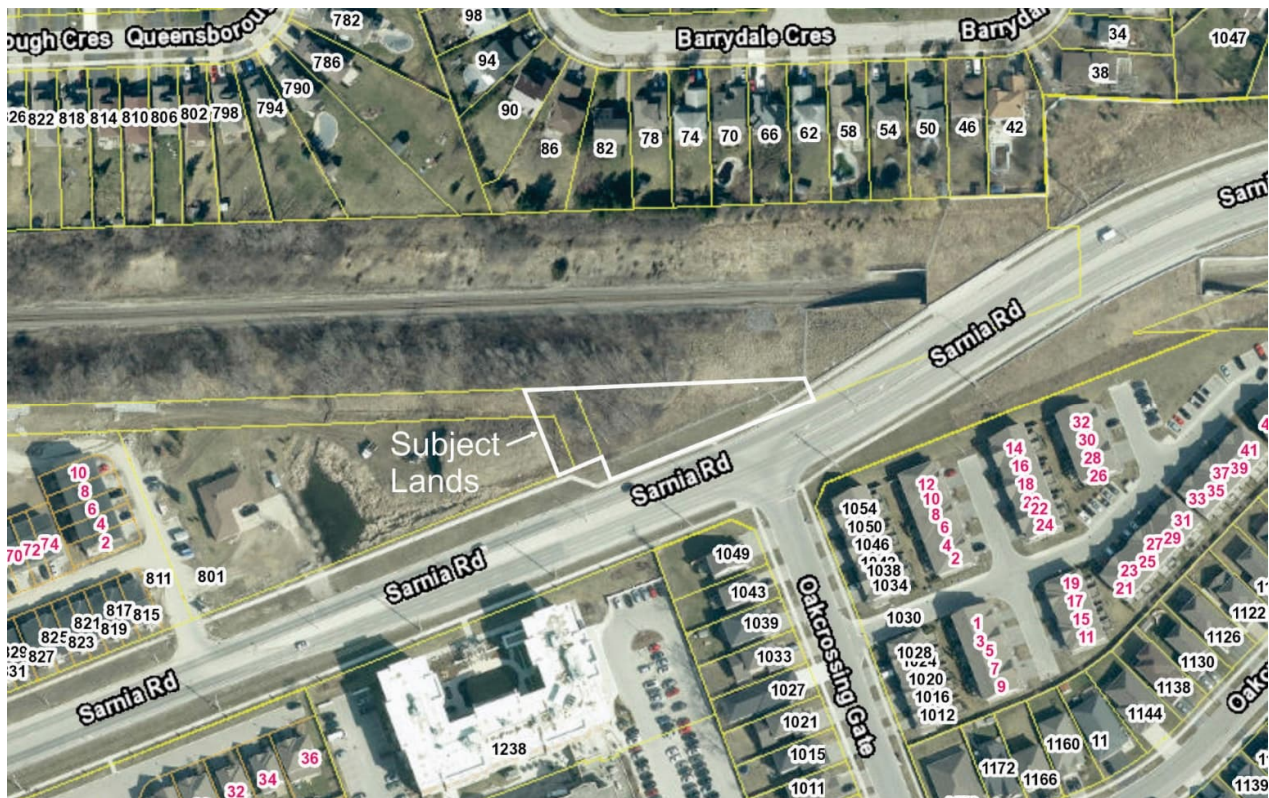
Site Location

MTE Consultants Inc. (MTE) was retained by Royal Premier Homes to complete the Tree Preservation Report for the 11-level, 182-unit apartment building to be constructed at 801 Sarnia Road in the City of London [Figure 1].

The Subject Lands is a triangular piece of land at the east end of 801 Sarnia Road and part of it is within the rail line corridor that bounds the north and east edge of 801 Sarnia Road.

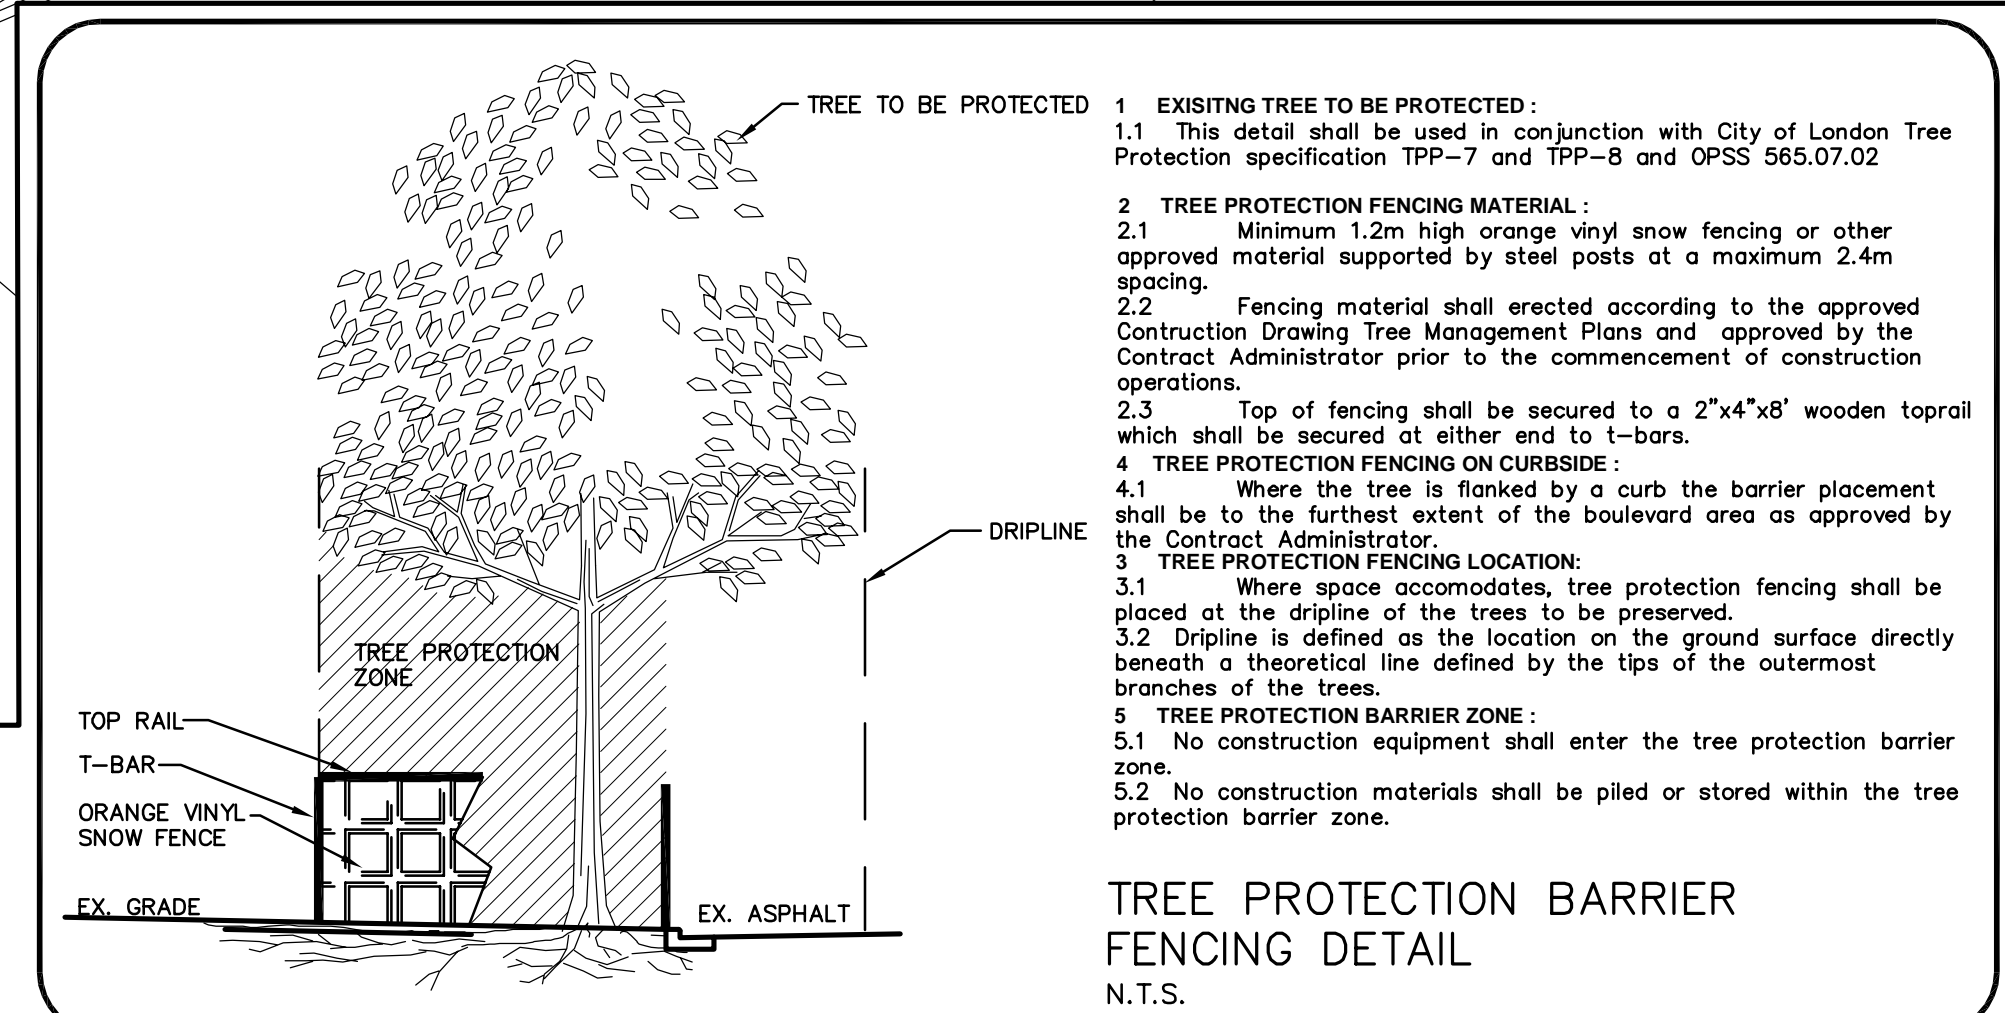
- EXISTING TREE TO BE PROTECTED:**
 - This detail shall be used in conjunction with City of London Tree Protection specification TPP-7 and TPP-8 and DPSS 565.07.02

- TREE PROTECTION FENCING MATERIAL:**
 - Minimum 1.2m high orange vinyl snow fencing or other approved material supported by steel posts at a maximum 2.4m spacing.

- Top of fencing shall be secured to a 2"x4"x8" wooden top rail which shall be secured at either end to t-bars.
- TREE PROTECTION FENCING ON CURBSIDE:**

- TREE PROTECTION FENCING LOCATION:**
 - Where space accommodates, tree protection fencing shall be placed at the dripline of the trees to be preserved.

- Dripline is defined as the location on the ground surface directly beneath a theoretical line defined by the tips of the outermost branches of the trees.
