# Cultural Heritage Evaluation Report / Heritage Impact Assessment

1589 Fanshawe Park Road East, London, Ontario

1433506 Ontario Inc.

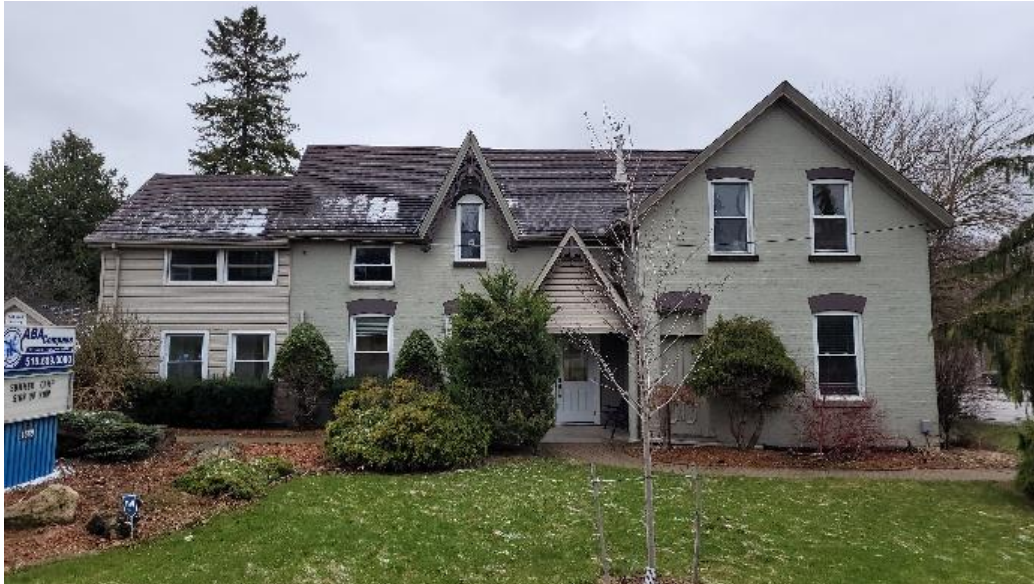
**Photograph 10: View of the north elevation of the farmhouse (AECOM, 2025)**

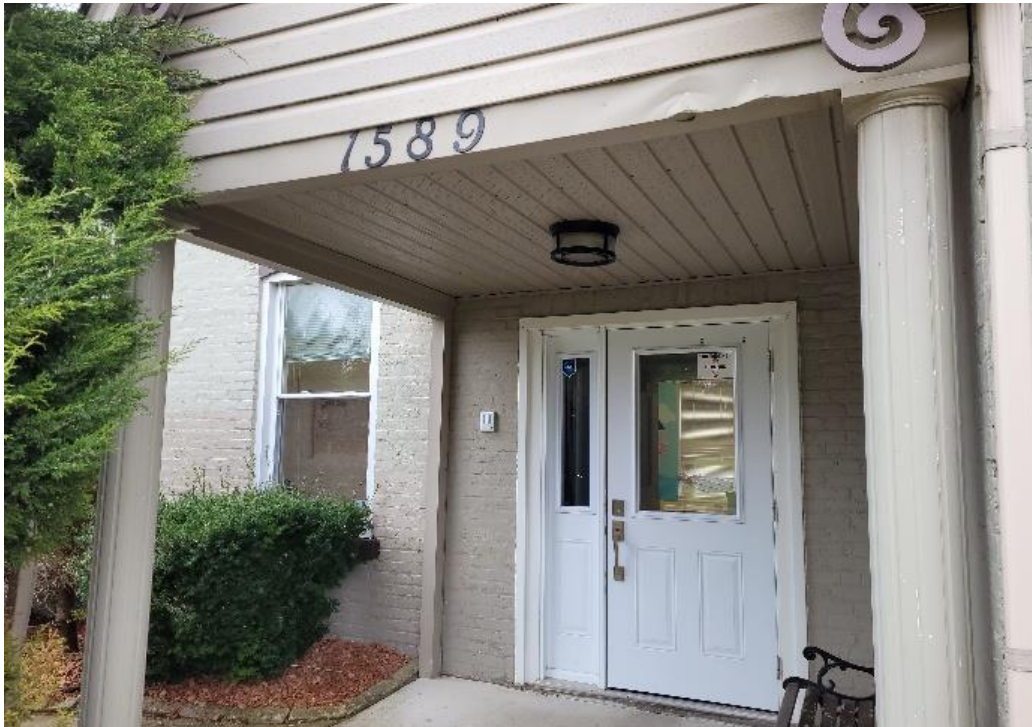
The east side of the elevation is recessed from the west wing. On the west corner of the elevation is the main entrance to the farmhouse. The entrance is a metal door with a half window and two-panels in a metal and vinyl frame (**Photograph 15**). A sidelight is east of the door and consists of a window in the top half and a metal panel below. The entrance is covered by a portico that is not original to the farmhouse. The portico has a gable roof with decorative bargeboard on the gable end and is clad in vinyl siding (**Photograph 16**). This bargeboard is believed to be a reproduction of the original bargeboard still present in the centre gable on this elevation (see below). The roof of the portico is aluminum with two metal columns holding the portico up. The construction materials of the portico indicate it is a recent addition to the farmhouse, however, it is not clear if it replaced an older portico over the entrance. East of the entrance on the first storey are two windows. Both windows are one-over-one sash windows in vinyl frames with segmentally arched brick voussoirs (**Photograph 17** to **Photograph 18**). On the west window, the brick voussoir is laid using headers instead of stretchers, indicating this may have originally been an entrance into the farmhouse in the centre of the east side (**Photograph 17**). The second storey of the east side features a gable end in the centre with a one-over-one sash window in vinyl frame within the gable end (**Photograph 19**). The window has a segmentally elliptical brick voussoir with wood sill. The gable end features decorative wood bargeboard that matches the design of the bargeboard on the portico. The bargeboard appears to be original to the farmhouse as its design matches decorative features shown in the historic photograph of the farmhouse (**Image 1**). The wooden fascia of the gable end is believed to be original. A second window is located east of the gable and consists of a one-over-one sash window in vinyl frame with rusticated concrete sill and no brick voussoir (**Photograph 20**).

**Photograph 15: View of the main entrance to farmhouse on north elevation (AECOM, 2025)**

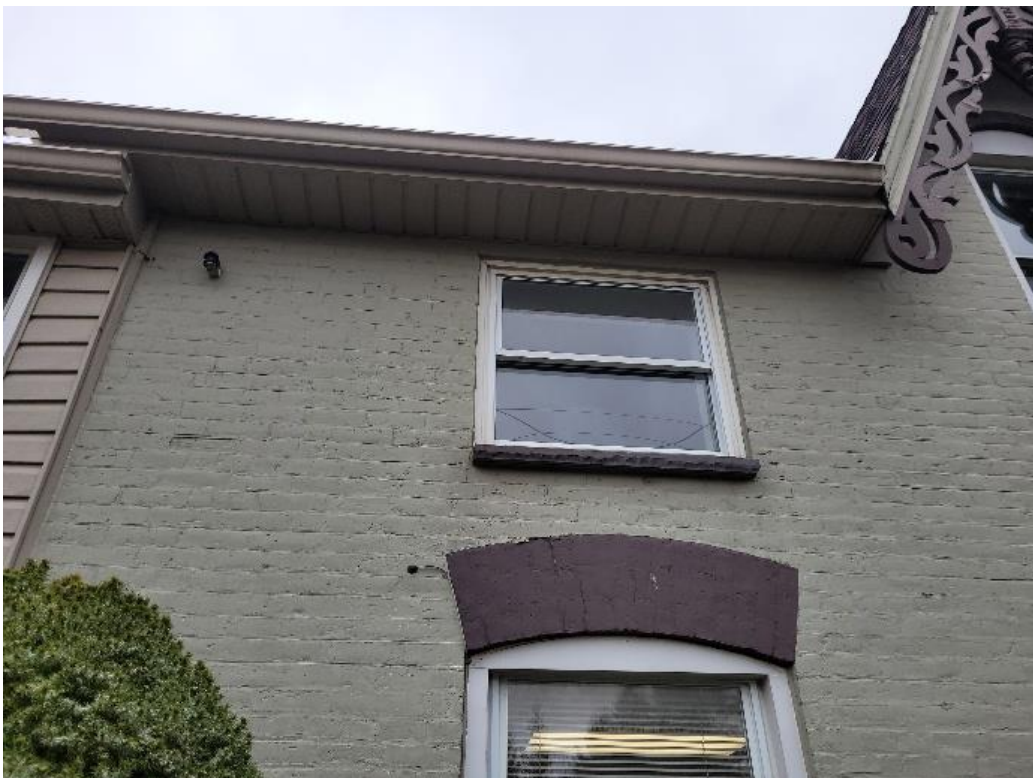
**Photograph 20: View of the east window on second storey of the north elevation (AECOM, 2025)**

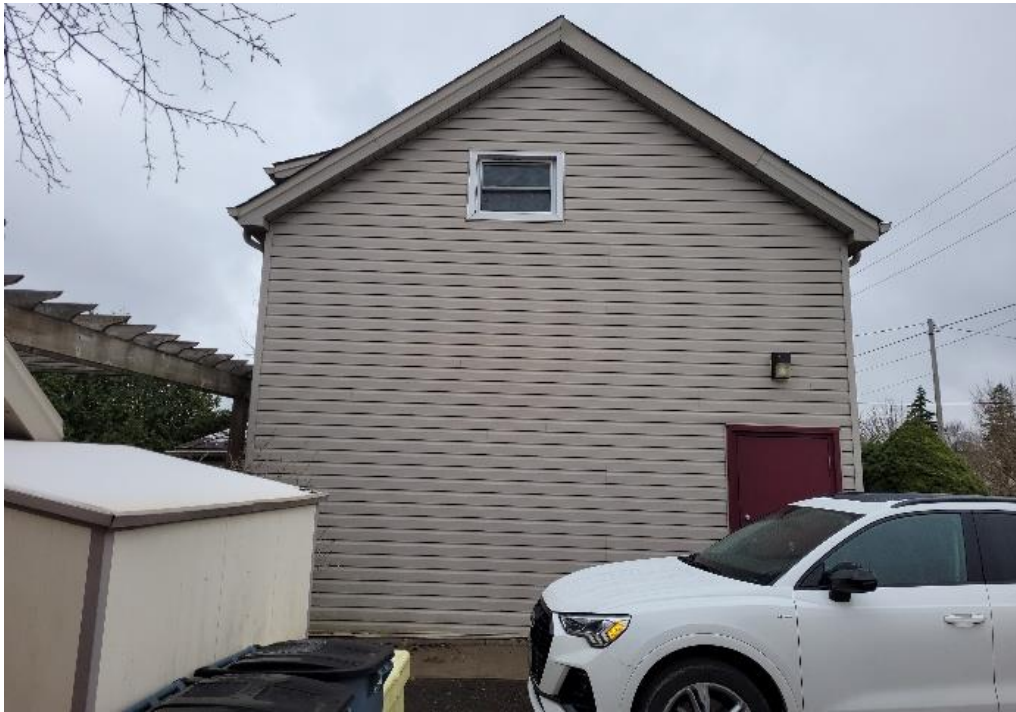
**Photograph 24: View of the east elevation of the east addition (AECOM, 2025)**

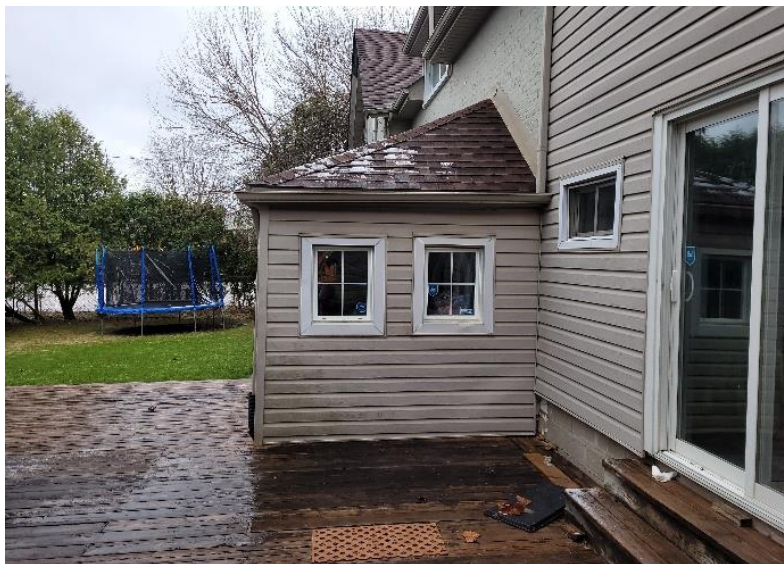
The one-storey addition off the south elevation is clad in vinyl siding and features two identical windows (**Photograph 28**). They are both casement windows in vinyl frames with muntins between the four panes of glass. The roof of the addition is half-hipped and clad in brown asphalt shingles. The foundation is obscured as a wood deck wraps around the addition.

**Photograph 28: View of the east elevation of the one-storey addition off south elevation (AECOM, 2025)**

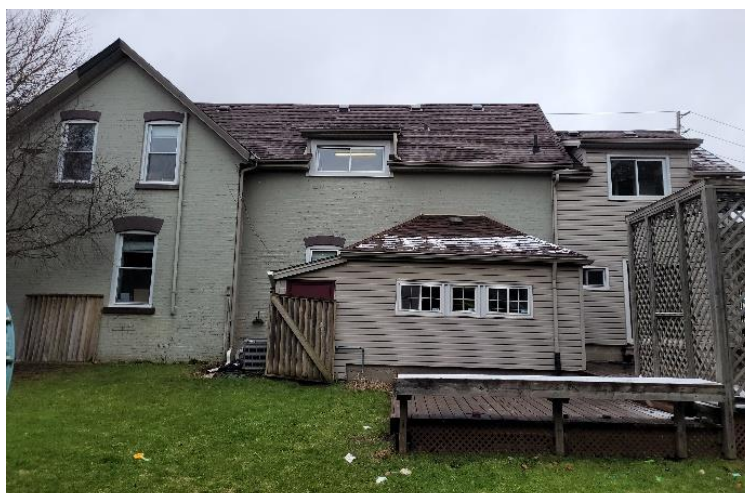
The south elevation of the farmhouse consists of the original farmhouse, the east addition, and the one-storey addition (**Photograph 29**).

**Photograph 29: View of the south elevation of the farmhouse (AECOM, 2025)**

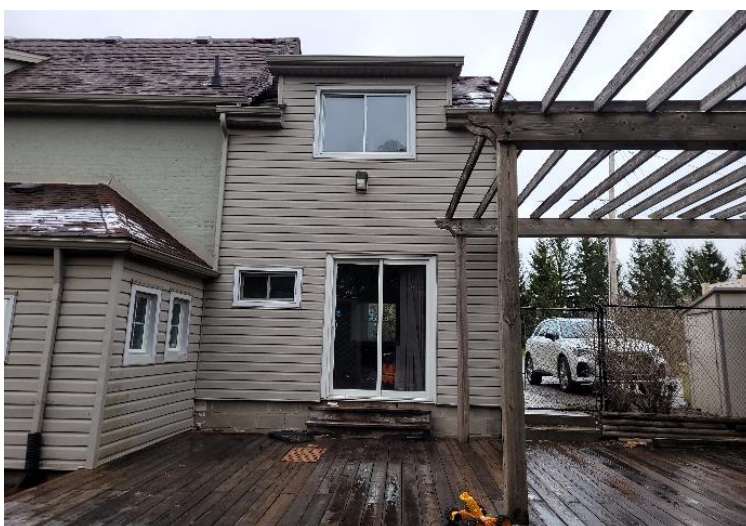
The east addition is located off the east corner of the original farmhouse (**Photograph 30**). The foundation is exposed on this elevation, revealing concrete block construction. The first storey features a sliding door located approximately in the centre of the east addition (**Photograph 31**). The sliding door is in a vinyl frame with a set of wood steps up to the door. A horizontal sliding window in a vinyl frame is located west of the door. An exterior light is located above the door, between the first and second storey. The second storey features a dormer with a horizontal sliding window in the dormer (**Photograph 32**). The window is in a vinyl frame. The overhanging eaves on the addition and the dormer have aluminum soffits with a gutter along the edge.

**Photograph 30: View of the south elevation of the east addition (AECOM, 2025)**

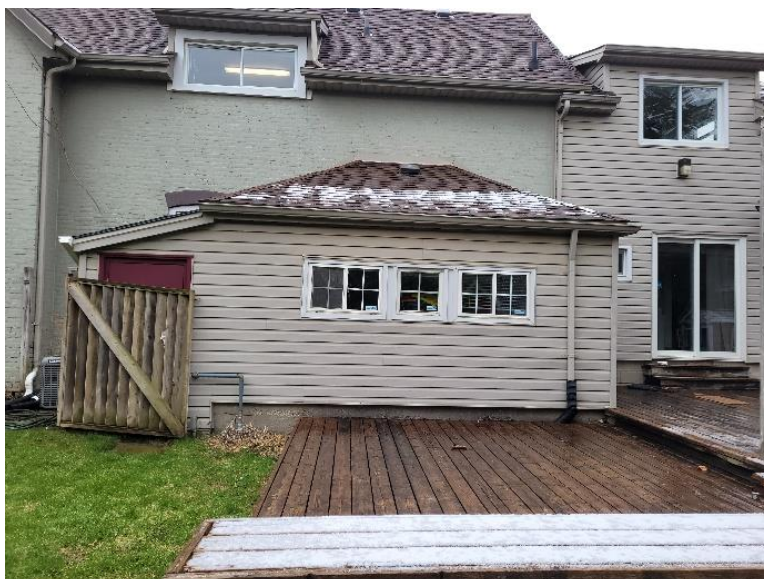
The one-storey addition is located off the south elevation of the original farmhouse in approximately the middle of the south elevation (**Photograph 33**). The foundation of the addition is poured concrete, and the addition is clad in vinyl siding. Three windows are located in the middle of the addition with mullions between the windows. The centre window is a casement window with muntins between the panes. The windows flanking the centre casement window are both one-over-one sliding windows with muntins between the panes. All three windows are in vinyl frames. To the west of the windows is a red metal door that is partially obscured by a wood gate. The door leads to the basement of the farmhouse (**Photograph 34**). The roof of the addition is half-hipped and clad in brown asphalt shingles.

**Photograph 33: View of the one-storey addition on south elevation (AECOM, 2025)**

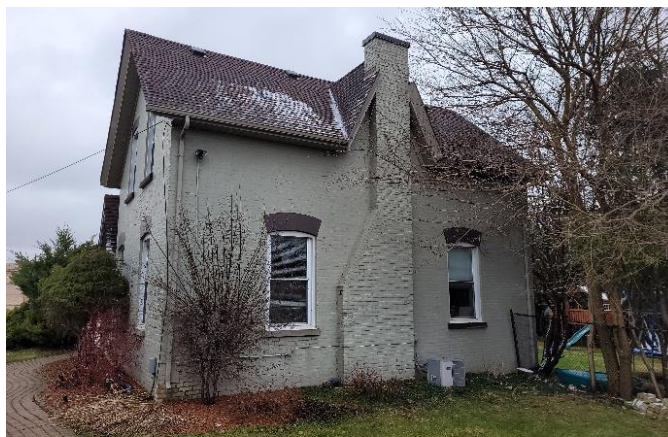
The west elevation consists of the original farmhouse and the one-storey addition off the south elevation. Full views of the elevation are obscured by a row of cedar trees growing south of the farmhouse. The original farmhouse features a brick chimney up the centre of the elevation, narrowing as it goes up the elevation. The roof of the farmhouse extends to the chimney, creating a gable with the chimney on the gable end that supports the top of the chimney (**Photograph 40**). Bricks on the chimney have been replaced with stone or concrete that has since been painted beige like the rest of the bricks on the farmhouse. On the first storey, flanking either side of the chimney, are identical one-over-one sash windows set in vinyl frames (**Photograph 41** and **Photograph 42**). Both windows feature segmentally arched brick voussoirs and concrete sills. A chain-link fence begins near the south corner of the elevation, enclosing the backyard area of the farmhouse.

**Photograph 39: View of the west elevation of the farmhouse (AECOM, 2025)**

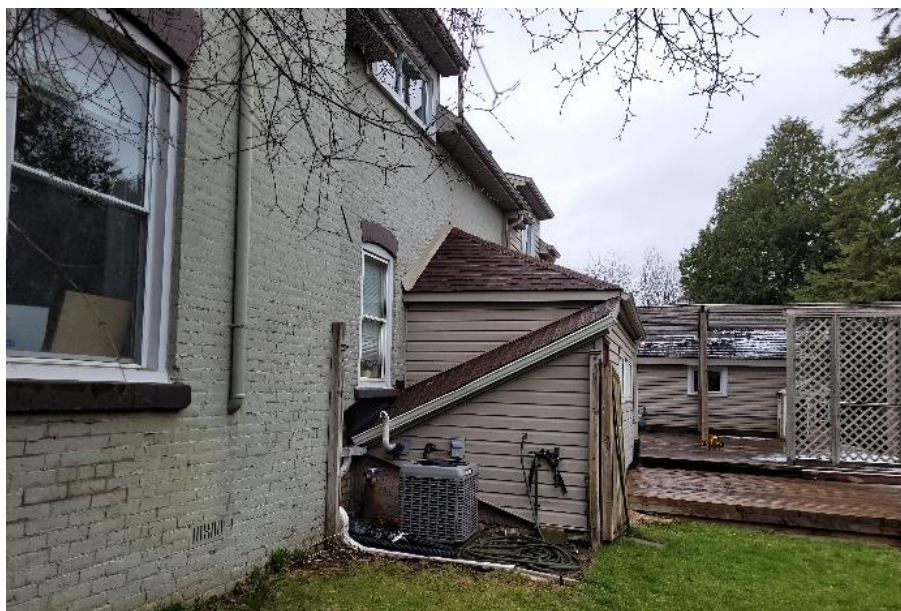
The west elevation of the one-storey addition reveals the basement access associated with the door on the south elevation, as the roof slopes toward the farmhouse, suggesting a stairwell behind the door (**Photograph 43**). The roof is angled to the west, with a gutter at the corner draining the water off the roof and away from the farmhouse. The foundation of the addition is poured concrete with the addition clad in vinyl siding.

**Photograph 43: View of the one-storey addition's west elevation (AECOM, 2025)**

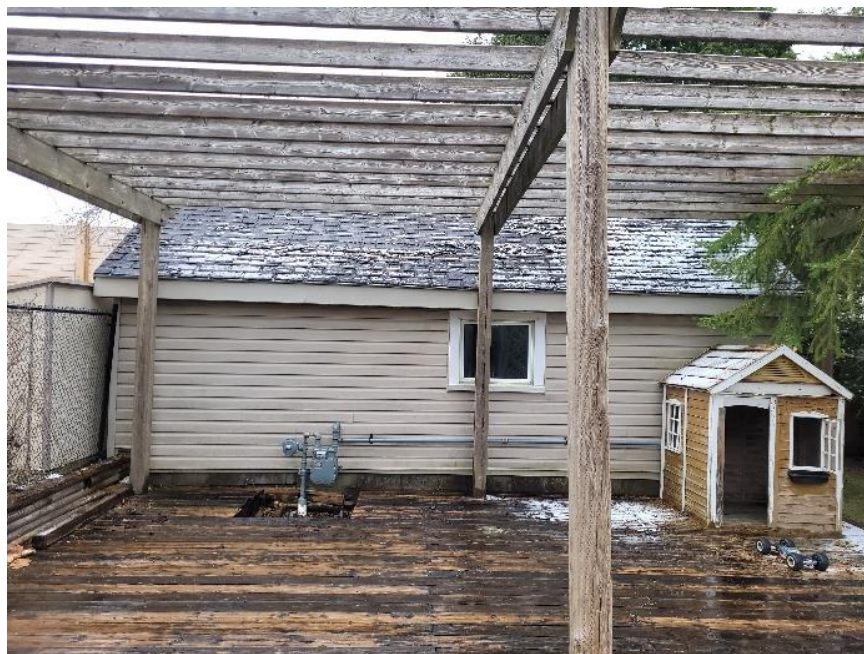
The west elevation is partially obscured by a deck with a pergola and a children's play hut positioned along this side of the farmhouse (**Photograph 47**). At the center of the elevation is a square picture window set in a vinyl frame with a wood sill. A gas line runs along the base of the wall, leading to the meter located on the north side of the elevation. The roof shingles above this elevation are showing visible signs of deterioration.

**Photograph 47: View of the west elevation of the shed (AECOM, 2025)**

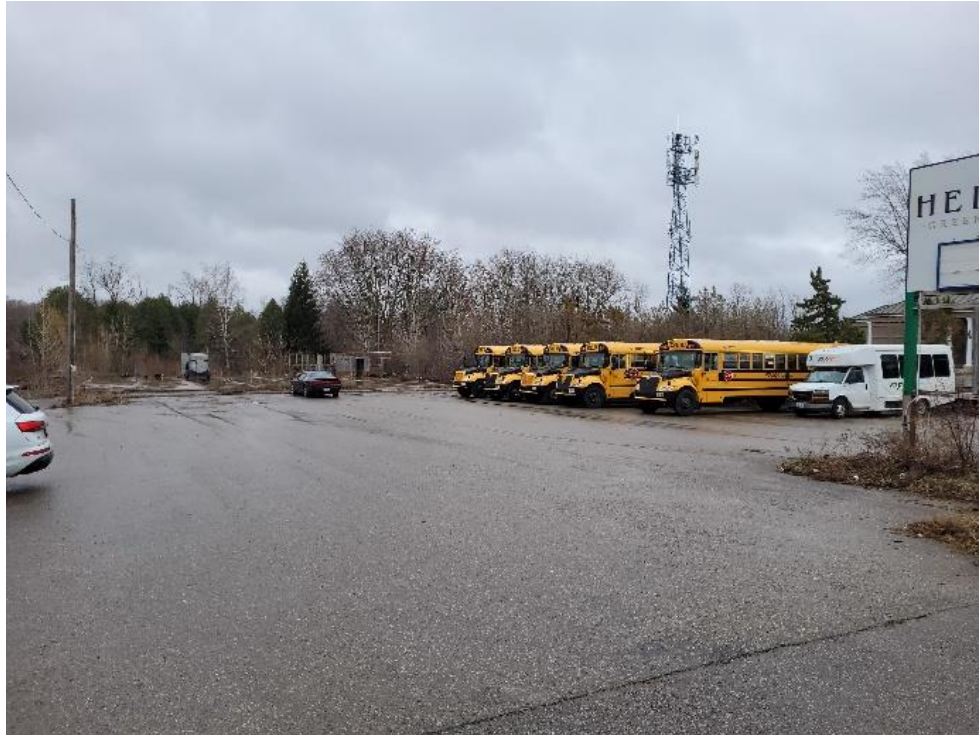
The remains of the former garden centre are located in the northern section of the Subject Property, positioned to the west and south of the farmhouse. The parking lot, west of the farmhouse, is paved in asphalt (**Photograph 55**). Between the two driveways onto the parking lot is a sign for the garden centre (**Photograph 56**). South of the parking lot is a poured concrete pad that was the foundation of the greenhouses for the garden centre (**Photograph 57** and **Photograph 58**). On the north end of the pad is an electrical panel that serviced the garden centre (**Photograph 59**). East of the concrete pad are the remains of greenhouses and the outdoor section of the garden centre (**Photograph 60** and **Photograph 61**). The area is a mix of dirt and gravel, with black canvas underneath. Refuse has been scattered throughout the area. On the eastern boundary of the property is a double furrow plough (**Photograph 62**).

**Photograph 55: View of the parking lot west of the farmhouse (AECOM, 2025)**

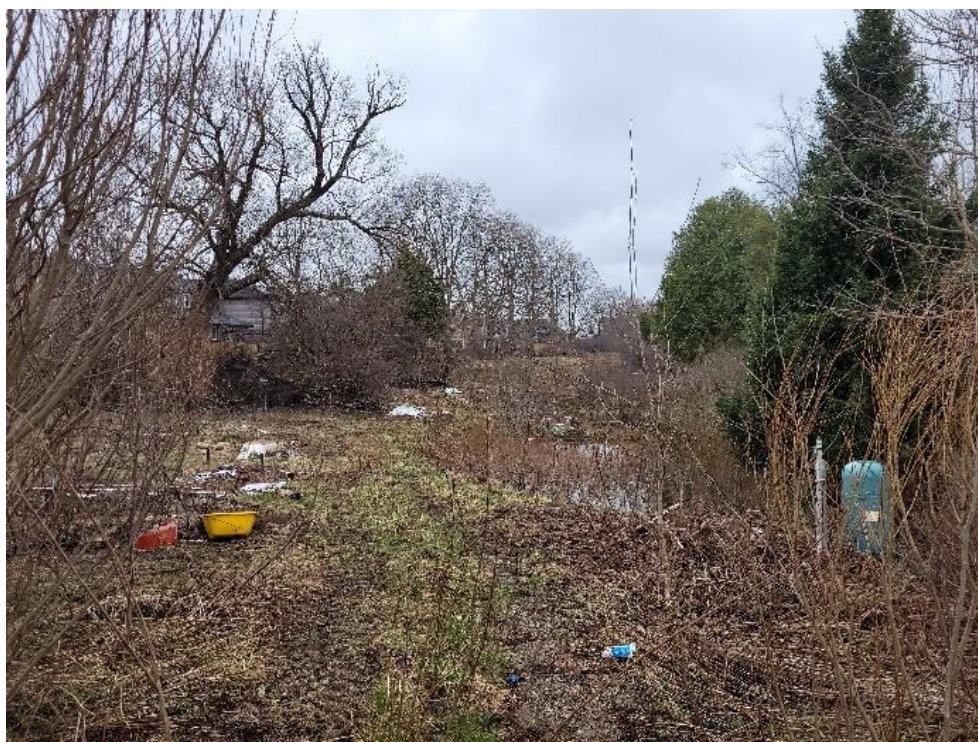
The remains of the golf course are located in the southern section of the Subject Property. Access to the remains of the golf course was limited due to the naturalized state of the area and the poor ground conditions at the time of the field review to safely access the area (**Photograph 63** and **Photograph 64**). Photographs from a distance reveal that while the area is no longer maintained, the shape of the golf course holes can still be seen (**Photograph 65**). The landscaping of the golf course, with trees lining the old fairways. Aerial imagery shows that the outlines of the other holes are still visible, with evidence of refuse through the area. The area appears to be still in use with evidence of vehicle tracks leading into the area.

**Photograph 63: View to the south of the Subject Property with vehicle tracks (AECOM, 2025)**
