517 - 525 FANSHAWE PARK ROAD EAST
LONDON, ONTARIO
TREE ASSESSMENT REPORT
FOR REZONING APPLICATION

PREPARED BY: RON KOUDYS LANDSCAPE
ARCHITECTS INC

DATE: JANUARY 2022

RKLA PROJECT #: 21-115

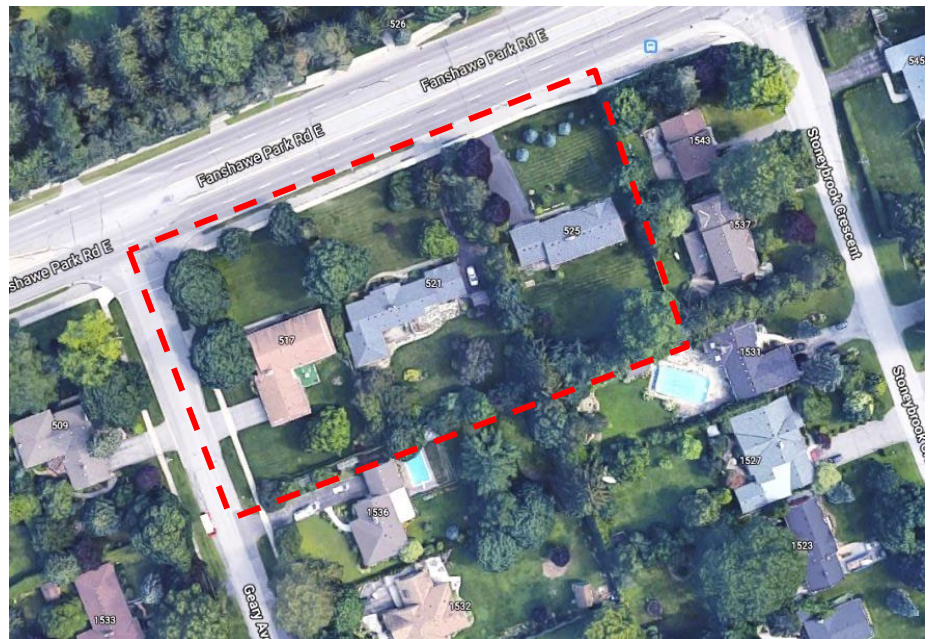
Figure 1 - Image capture from Google
Red dashed line - limit of tree inventory
