16 WETHERED STREET
LONDON, ONTARIO
TREE ASSESSMENT REPORT FOR REZONING

PREPARED BY: RON KOUDYS LANDSCAPE
ARCHITECTS INC

DATE: NOVEMBER, 2020

RKLA PROJECT #: 20-233

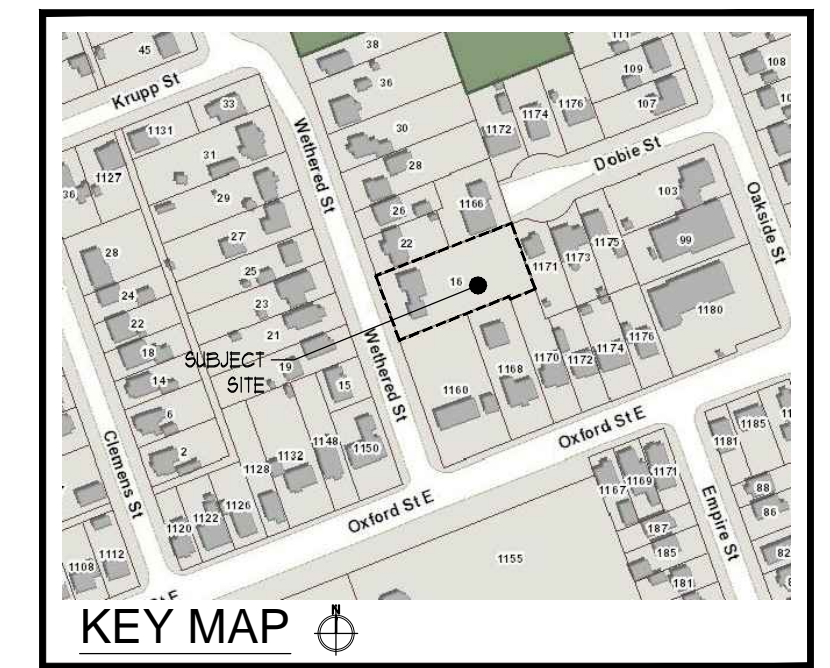
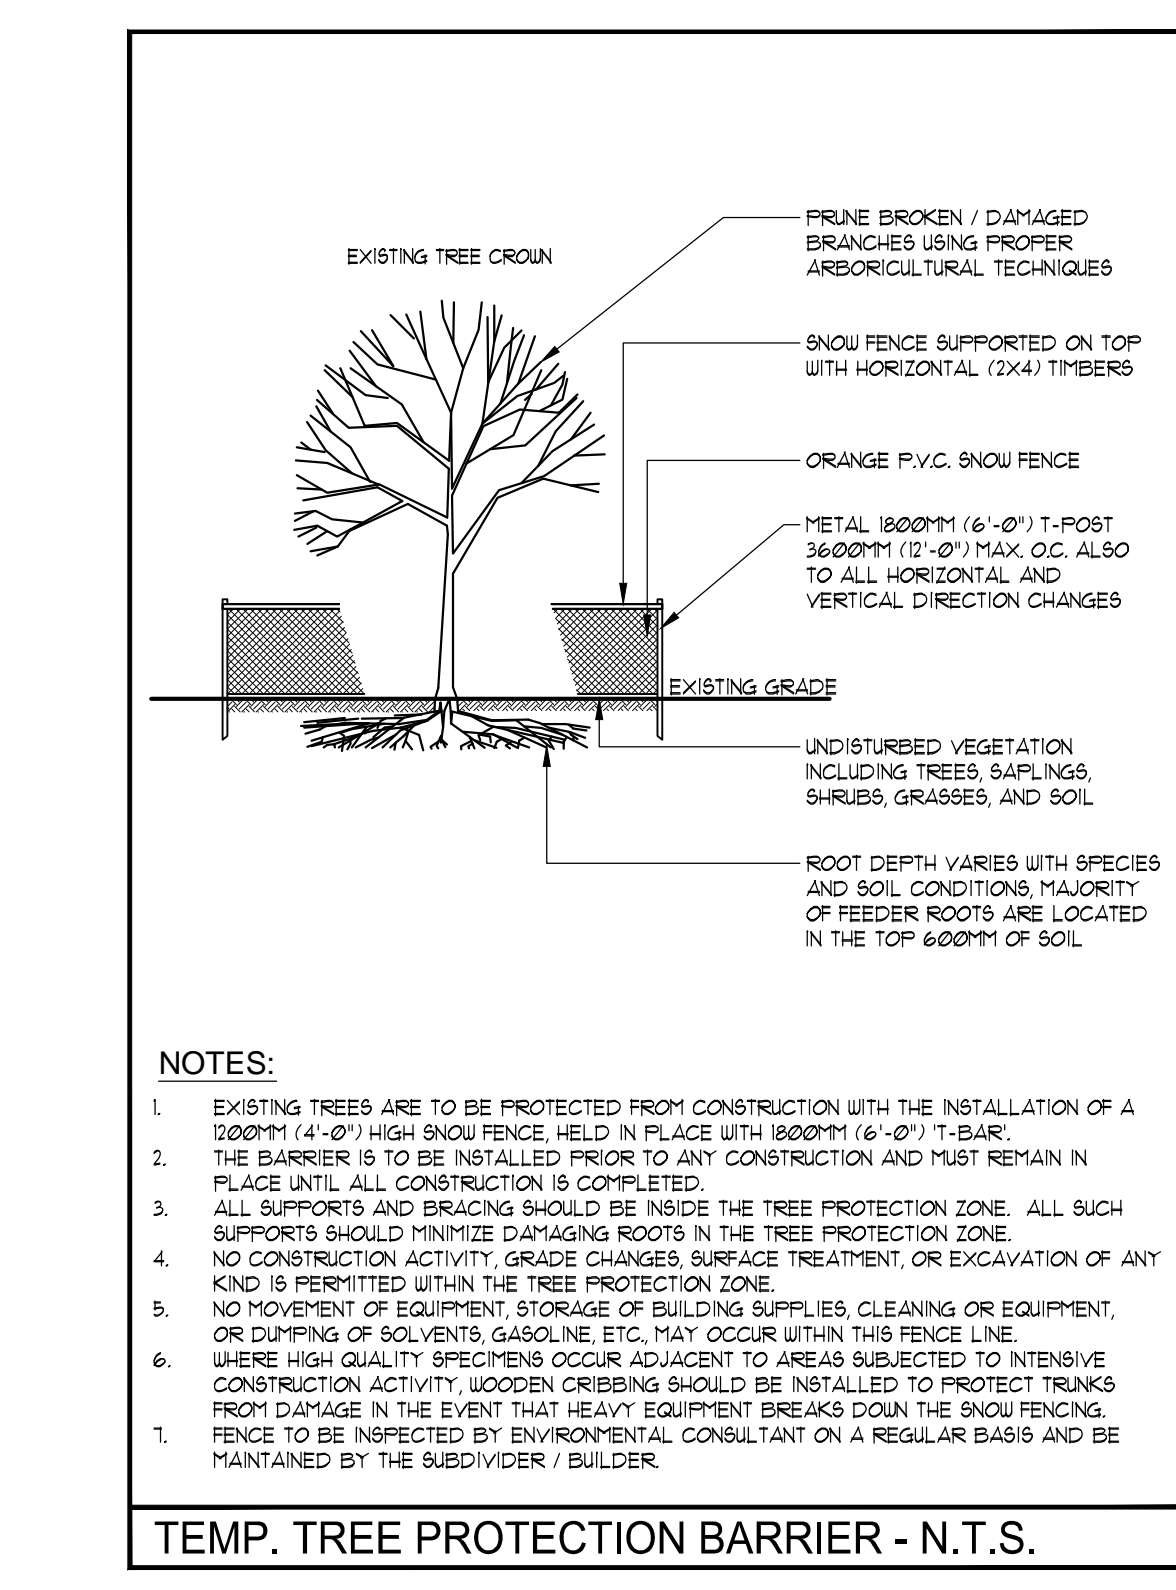
TREE PRESERVATION PLAN
SCALE = 1:200

NOTE THAT THE FOLLOWING TREES ARE BOUNDARY TREES, AND REQUIRE WRITTEN CONSENT FROM THE SHARED OWNER TO BE REMOVED: TREE #S 2, 23, 24, 30, 31 & 32

VEGETATION UNITS RECOMMENDED FOR REMOVAL (1)										
Vegetation Units		SIZE		HEALTH		RECOMMENDATION				
VI	Common Name	DBH (cm)	Canopy Radius (m)	Crown Condition	Structural Condition	Comments	Proposed Action	Rationale	Consent for Removal Required	
VI	White Cedar	Subject site	20-30	4	4	good	11 individuals, soil piled high on a few individuals	remove	conflict with proposed laneway	NO

- PRE-CONSTRUCTION RECOMMENDATIONS**
- PRIOR TO ANY CONSTRUCTION ACTIVITY, TREE PRESERVATION FENCING IS TO BE INSTALLED AS PER THE ATTACHED TREE PRESERVATION DRAWINGS AND DETAIL.
