2060 DUNDAS STREET
LONDON, ONTARIO
TREE ASSESSMENT REPORT
FOR REZONING APPLICATION

DATE: JULY 2021

REVISED: MAY 2022

RKLA PROJECT #: 20-245

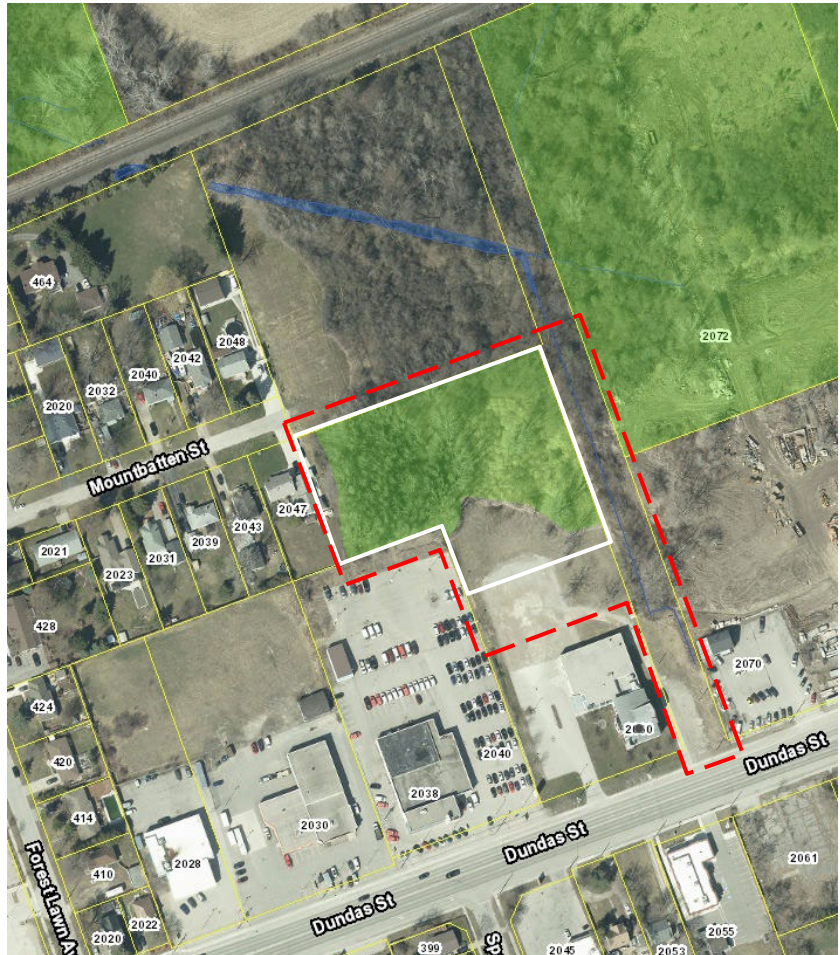
Figure 1 - Image capture from City of London mapping with 2020 imagery
White line - subject site
Red dashed line - scope of tree inventory
