**Legacy Village Strategic
Conservation Plan – 850
Highbury Avenue North,
London ON**

November 16, 2022

File: 160940807

LEGACY VILLAGE STRATEGIC CONSERVATION PLAN – 850 Highbury Avenue North, London ON

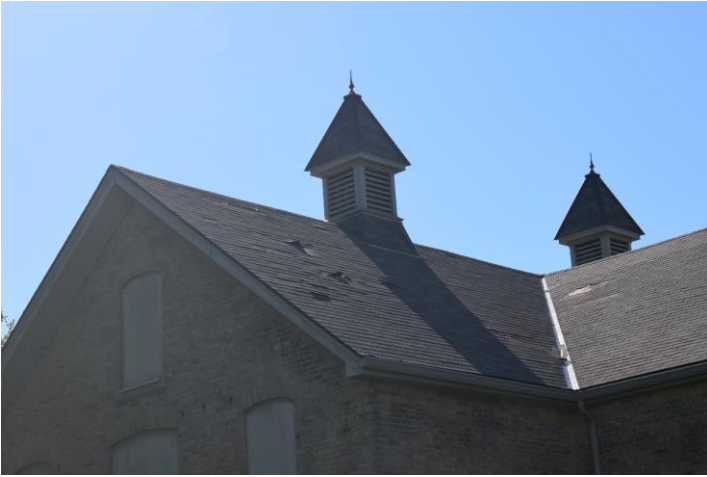
Photo 7: Horse Stable north elevation roof with lifting shingles

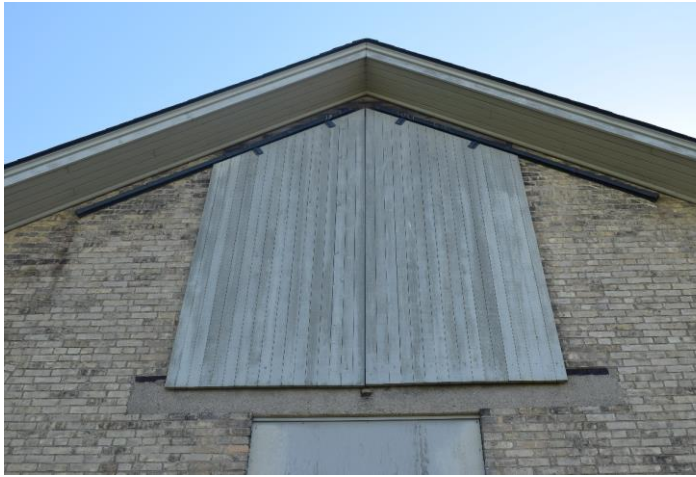
Photo 13: Horse Stable west elevation boarded-up hay loft door

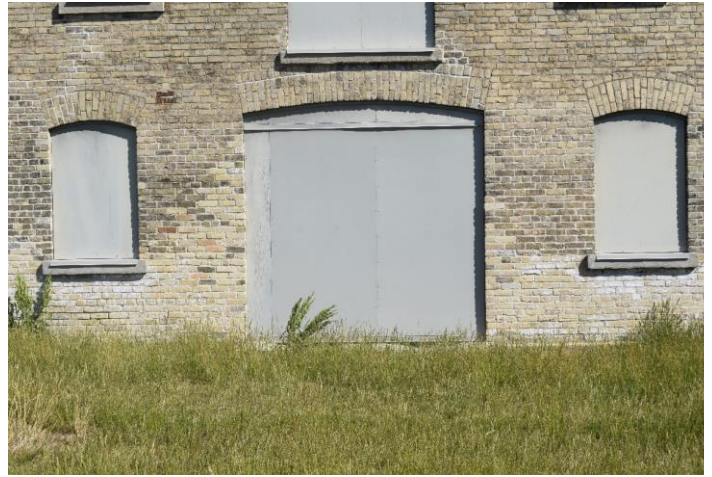
Photo 14: Horse Stable south elevation boarded-up entry door and windows

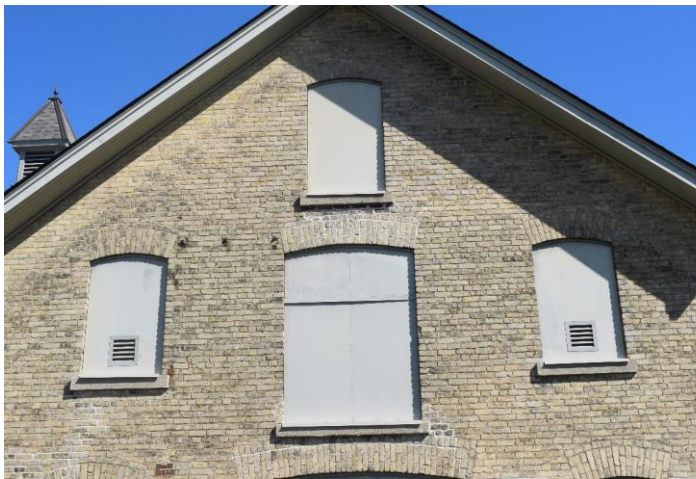
Photo 15: Horse Stable south elevation gable with boarded-up windows with venting

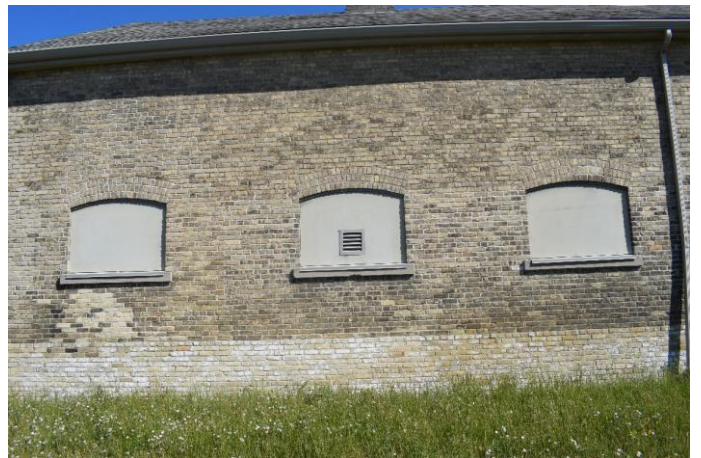
Photo 16: Horse Stable south elevation boarded-up windows with venting

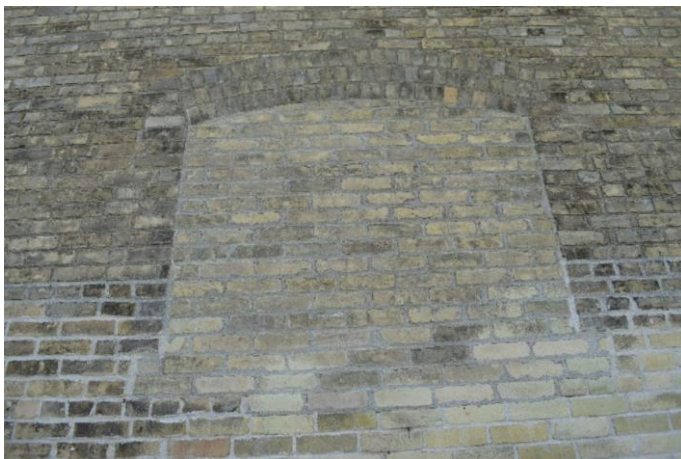
Photo 17: Horse Stable close-up of infill window

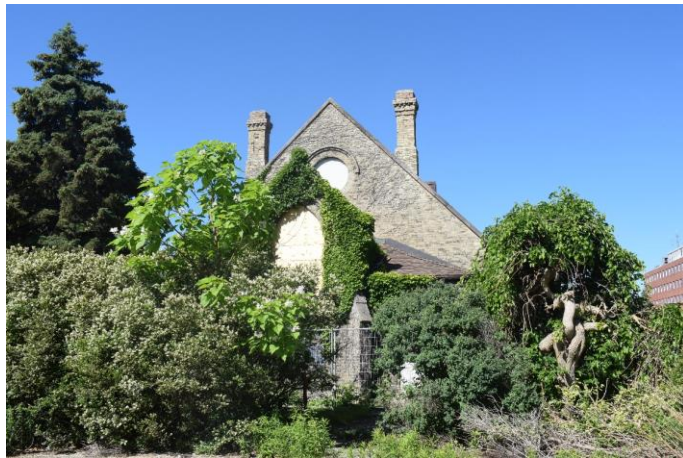
Photo 20: Chapel of Hope rear elevation with vegetation overgrowth, looking west

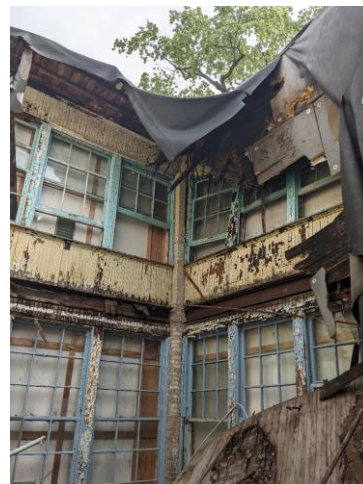
Photo 47: Infirmary east elevation porch end looking northwest prior to porch collapse

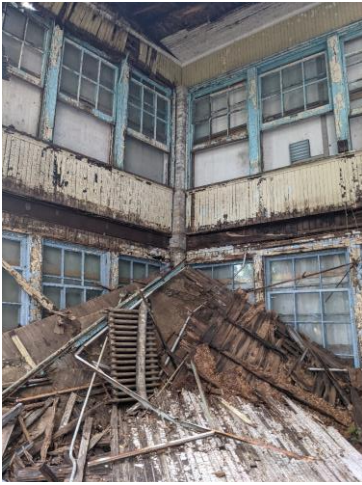
Photo 48: Infirmary east porch roof collapse, photo provided by Old Oak from June 25, 2021

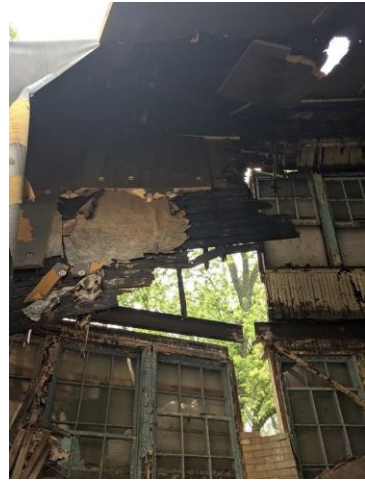
Photo 49: Infirmary east porch roof collapse, photo provided by Old Oak from June 25, 2021

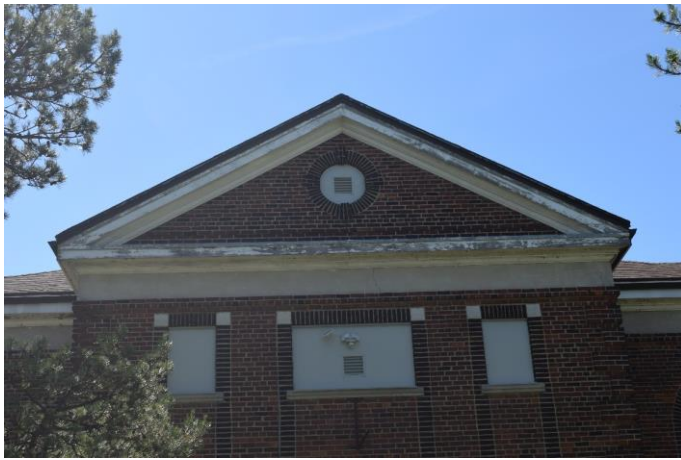
Photo 60: Recreation Hall front elevation boarded-up windows

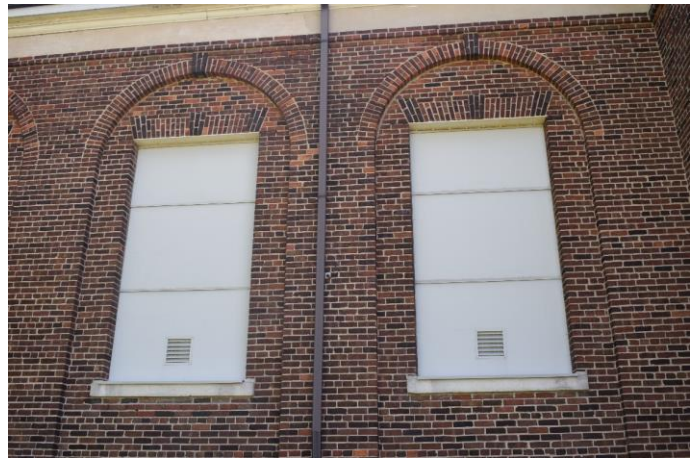
Photo 61: Recreation Hall entrance pediment with boarded-up windows

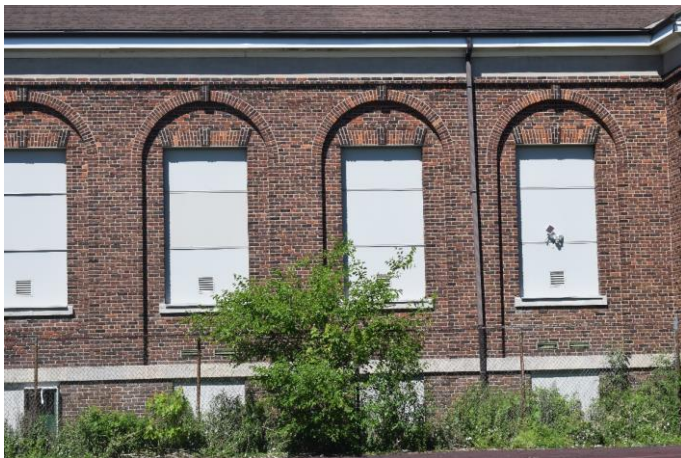
Photo 62: Recreation Hall west elevation boarded-up windows with venting

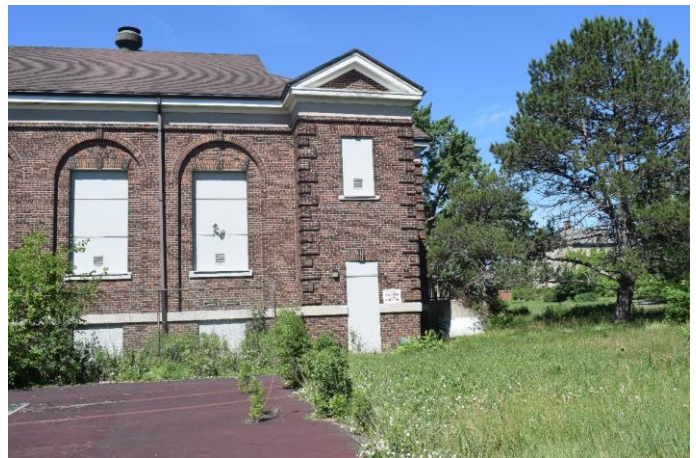
Photo 63: Recreation Hall east elevation boarded-up windows with venting

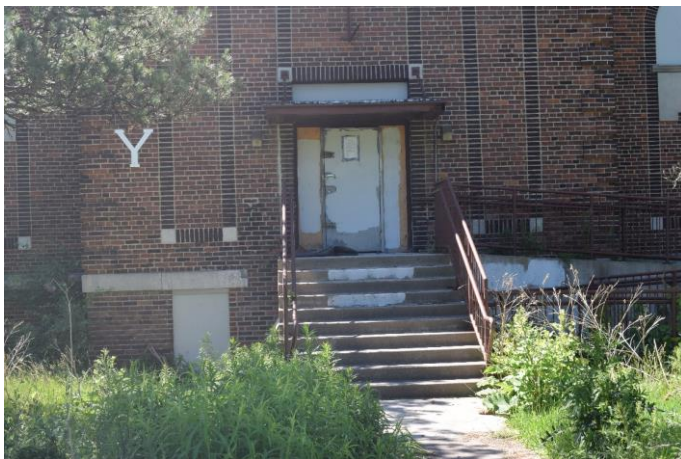
Photo 64: Recreation Hall east elevation boarded-up window and door on projecting bay

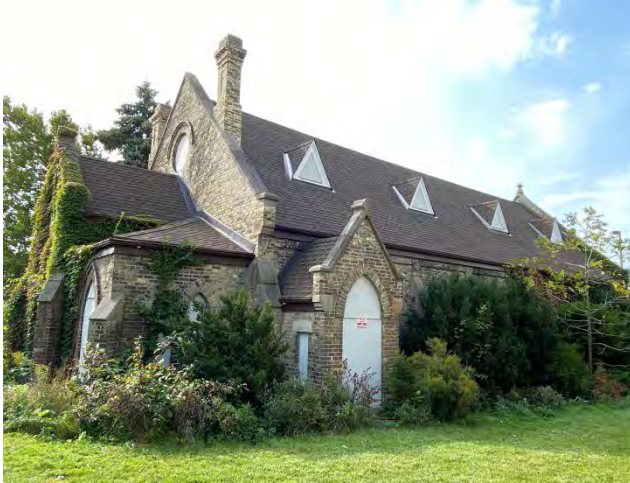
Figure No. 6: North Roof Shingles (Photo No. 5.0)

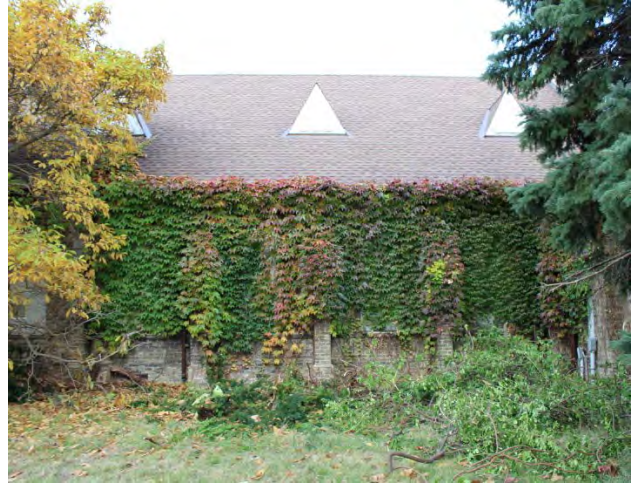
Figure No. 7: South Roof Shingles (Photo No. 7.0)

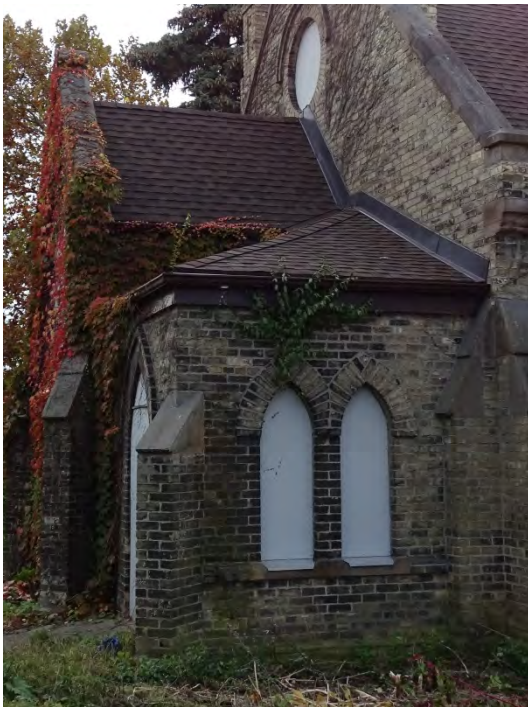
Figure No. 8: East Elevation – Sanctuary and North Entrance Wing Roof Shingles (Photo No. 6.0)

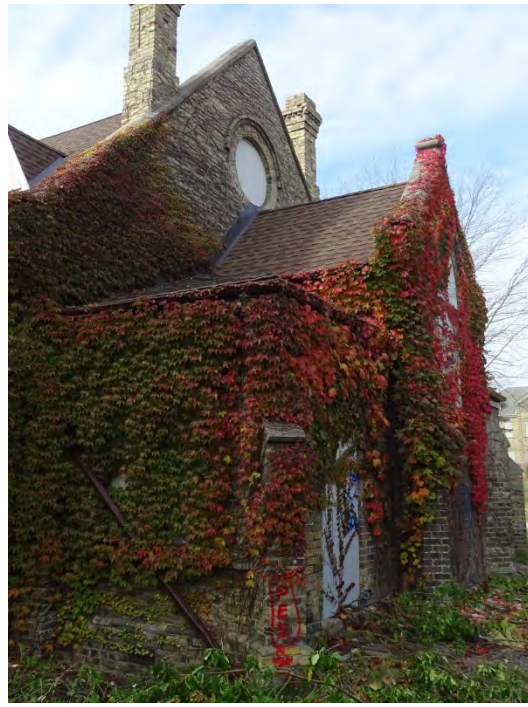
Figure No. 9: East Elevation – Sanctuary and South Entrance Wing Roof Shingles (Photo No. 6.1)

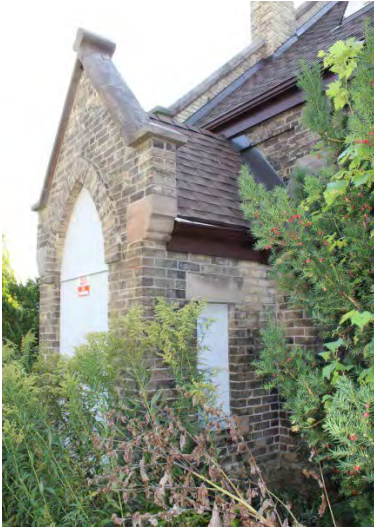
Figure No. 10: West Elevation – North Transept (Photo No. 8.1)

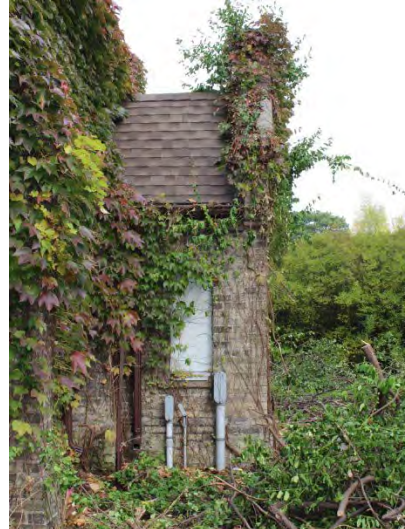
Figure No. 11: West Elevation – South Transept (Photo No. 8.2)

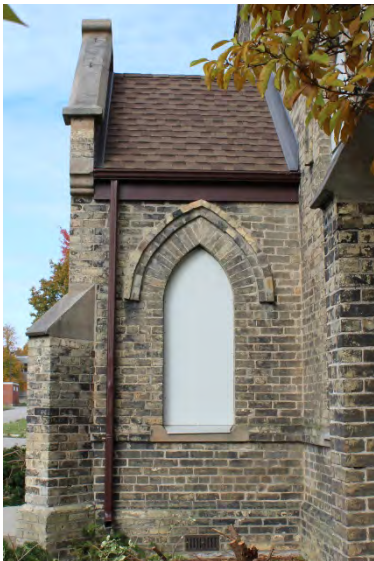
Figure No. 12: South Elevation – Main Entrance (Photo No. 7.1)

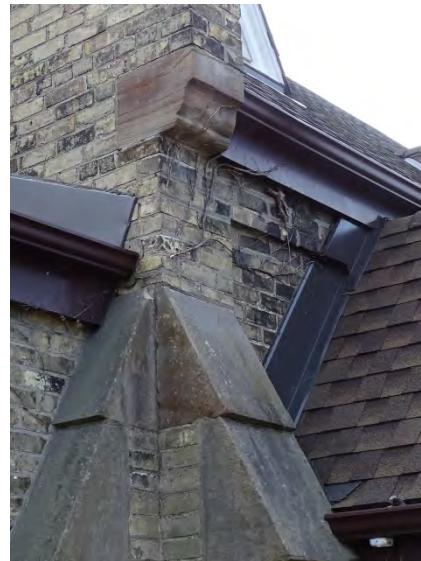
Figure No. 13: North Elevation – North Transept Fascia (Photo No. 9.1)

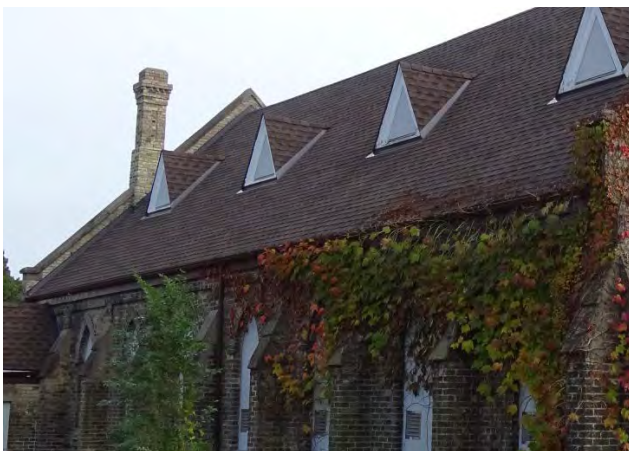
Figure No. 14: North Elevation – Nave Fascia (Photo No. 9.3)

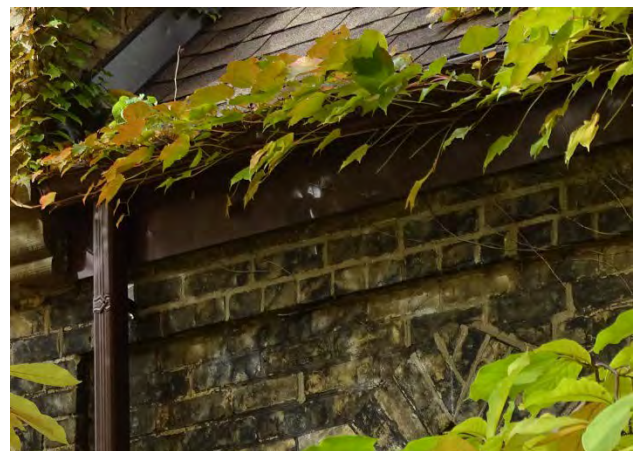
The pre-painted brown metal capped fascia boards along the south side of the Chapel, inclusive of the Main Roof, Sanctuary and hipped roofs flanking the Altar, and the South Entrance have excessive vegetative growth. Accordingly the condition of the fascia boards is unknown. The fascia board on the south side of the West Entrance is in good condition with no vegetative growth.

Figure No. 15: South Elevation – Nave Fascia (Photo No. 11.2)

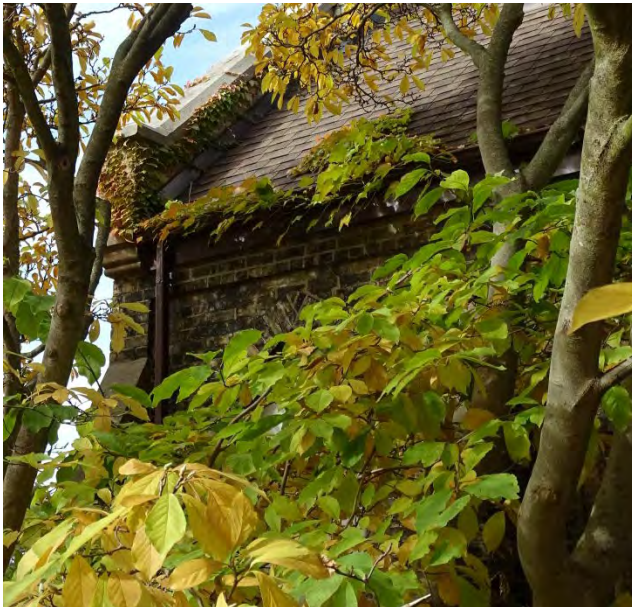
Figure No. 18: South Elevation – Main Roof Gutter and RWL (Photo No. 15.1)

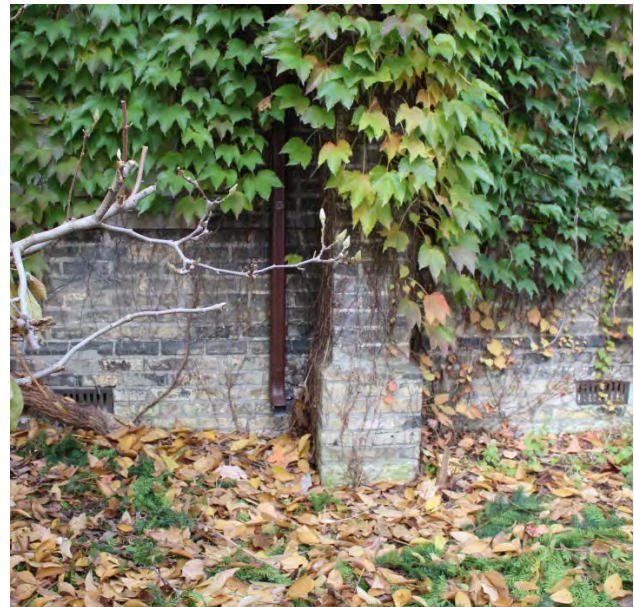
Figure No. 19: South Elevation – Main Roof RWL Detail at Grade (Photo No. 15.3)

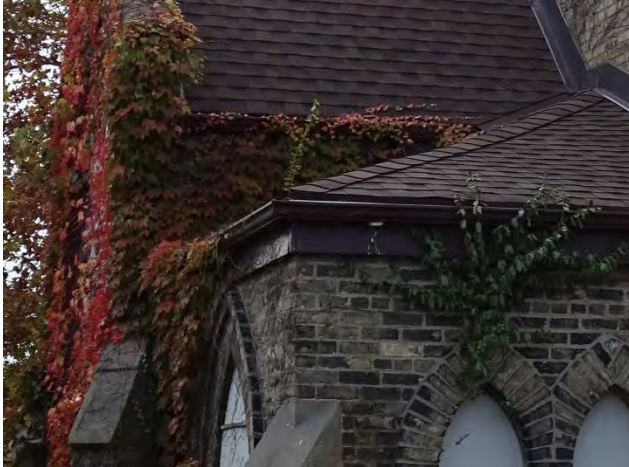
Figure No. 20: North Elevation – Sanctuary Gutter (Photo No. 13.4)

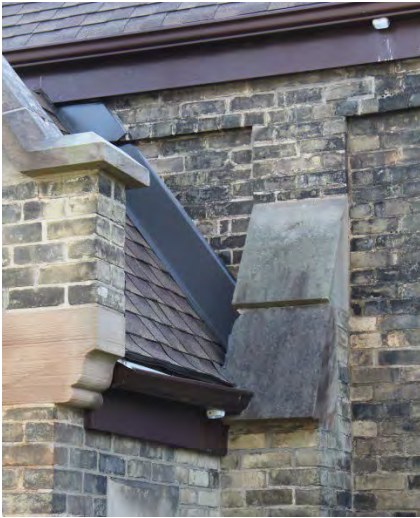
Figure No. 22: West Elevation – North Transept Gutter and Missing RWL (Photo No. 16.0)

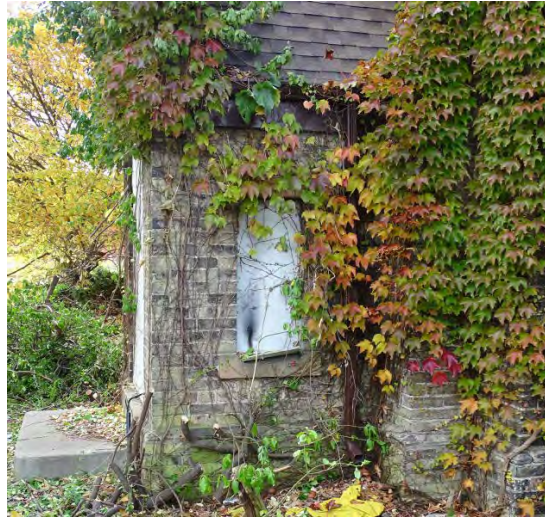
Figure No. 23: East Elevation – South Transept Gutter and RWL (Photo No. 14.4)

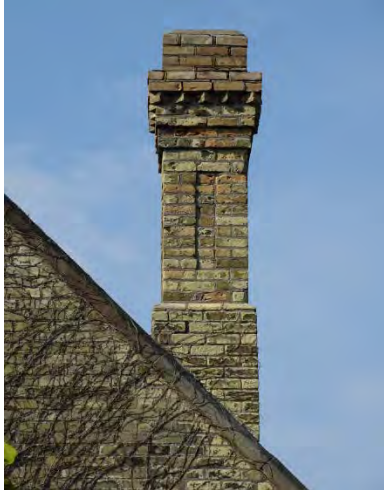
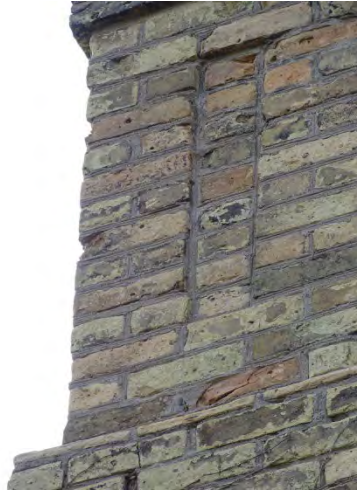
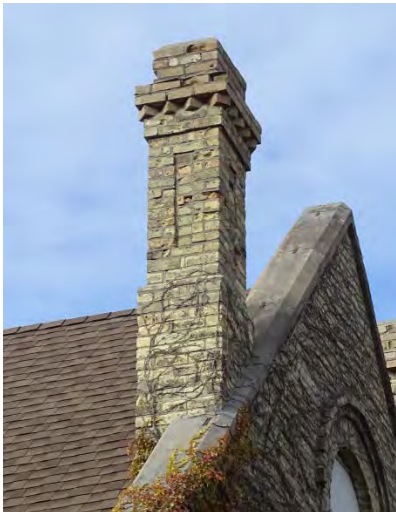
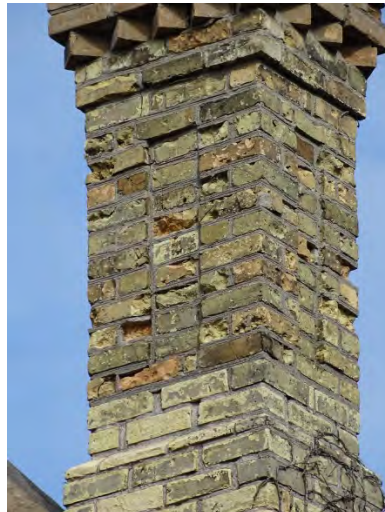
2 Chimneys on East Gable/Elevation (Figure No. 26, 27, 28 and 29)

Both chimneys have deteriorated/spalled or even missing brick and open joints. The metal flashings at the base of the chimneys where they intersect the roof are not stepped with the brick coursing. The base section of the chimney on the south side has ivy/vegetative growth.

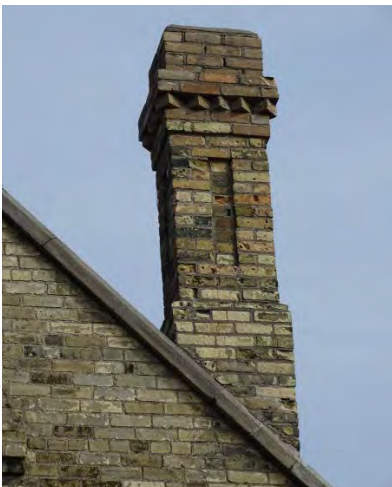
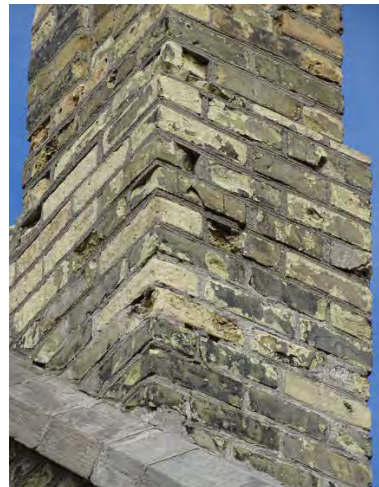
Chimney on West Gable/Elevation (Figure No. 30 and 31)

The entire chimney has deteriorated/spalled brick and open joints. The metal flashing at the base of the chimney where it intersects the roof is not stepped with the brick coursing.

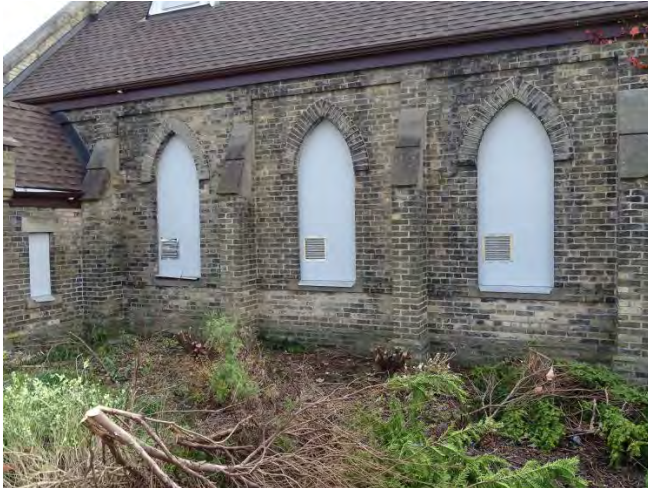
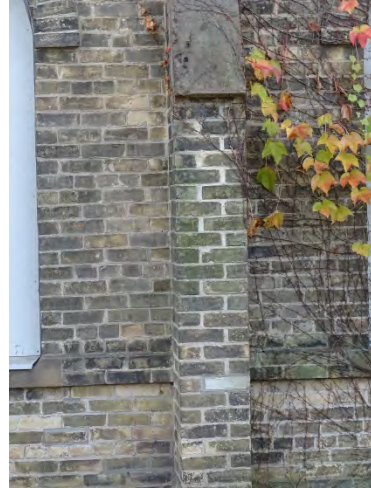
Central Section/Nave - North Elevation (Figure No. 32 and 33)

The masonry walls are generally in fair condition with what is believed to be original beaded mortar joints. Discrete areas of masonry repointing and broken stone capping is evident, primarily at the masonry buttresses. Along the base of the walls, where the brick masonry extends to grade, green lichen or organic staining is evident along the bottom 5 to 6 courses of brick as well as at the interior corners. Black atmospheric staining, to various degrees, is evident on the original buff masonry as well as at areas of brick adjacent to grade that have been mechanically impacted.

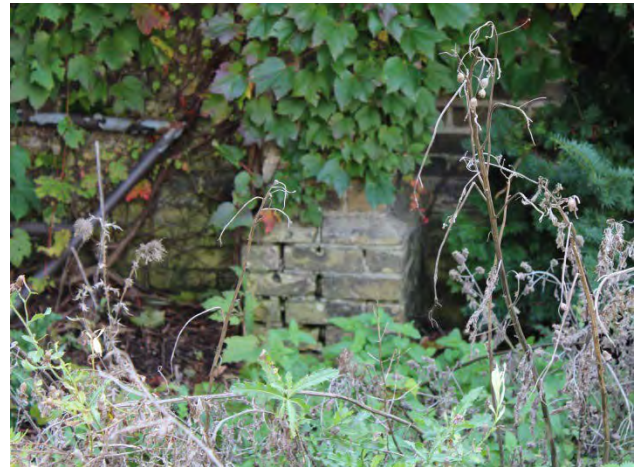
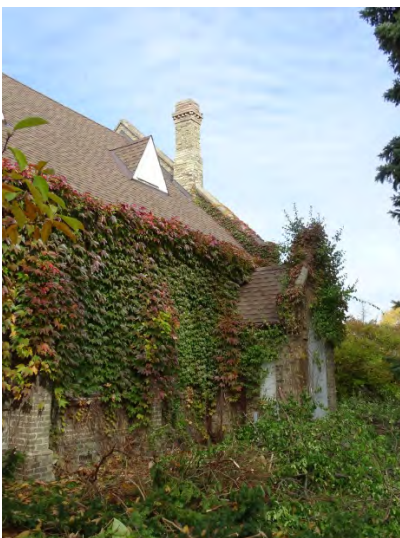
Central Section/Nave - South Elevation (Figure No. 34, 35 and 36)

As previously noted the masonry walls on the south elevation have excessive vegetative overgrowth thereby limiting a visual review. However unlike the north elevation the brick masonry bears on atleast one course of stone with metal vents set above. The masonry around the vent on the south elevation of the Main Entrance appeared to be in good condition however open and cracked mortar joints were evident at several other vents.

Where visible, areas of open joints were evident in addition to damaged stone and black atmospheric staining. On the south elevation large stalks for the ivy, are growing in close proximity to the base of the walls.

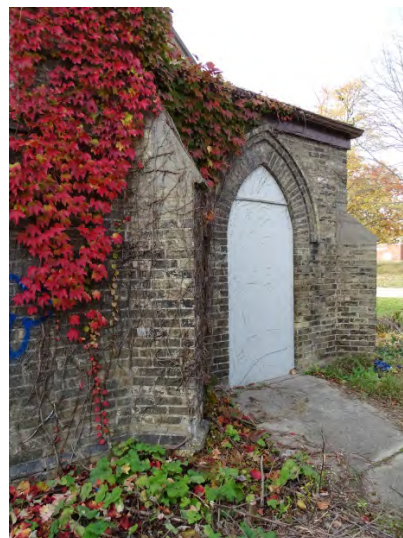
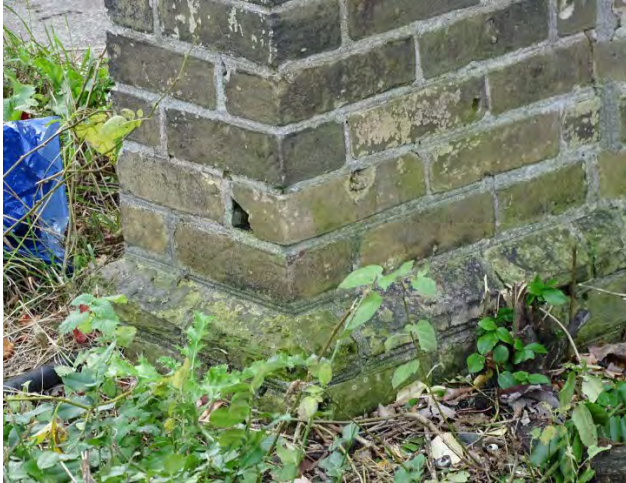
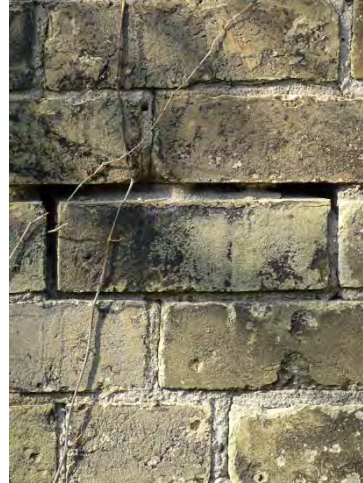
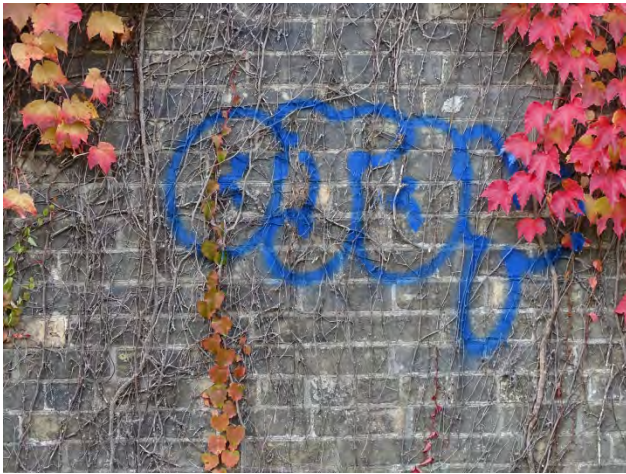
Sanctuary and Flanking Entrance Wings - East Elevations (Figure No. 37 - 40)

The extent of vegetative growth on the Sanctuary and flanking entrance wings increases from the north towards the south elevation, thereby limiting a visual review with growth on the north entrance wing was fairly limited compared to the Sanctuary and south entrance wing. Similarly to the other elevations along the base of the walls, where the brick masonry extends to grade, green lichen or organic staining is evident along the bottom 5 to 6 courses of brick as well as at the interior corners where the main walls intersect projecting walls/elements. Black atmospheric staining, to various degrees, is evident on the original buff masonry as well as areas of brick adjacent to grade that have been mechanically impacted and discrete open mortar joints are evident. On the south flanking wing graffiti is evident on both the brick masonry and plywood enclosures for the doors.

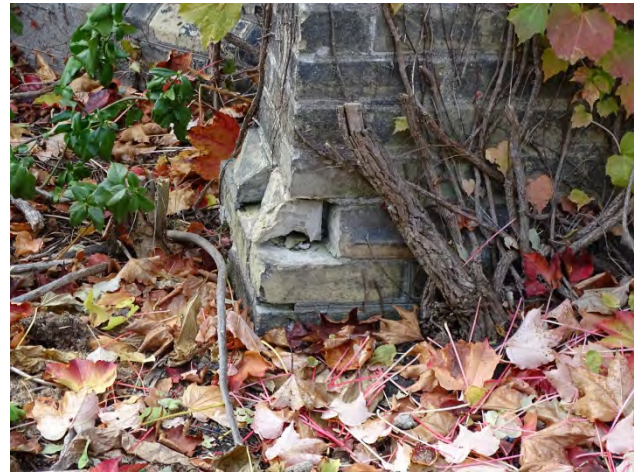
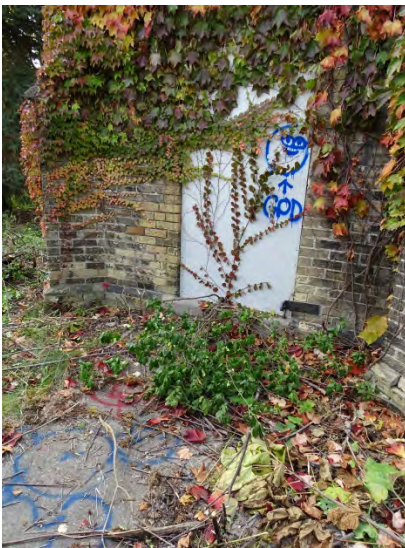
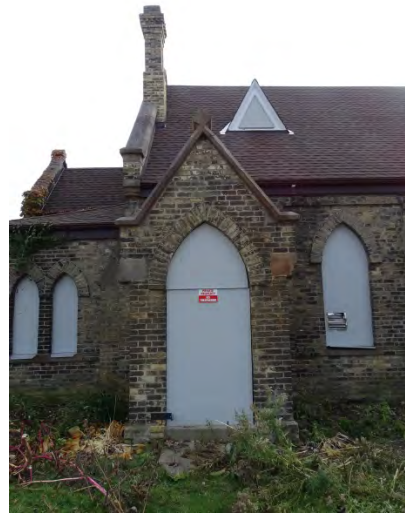
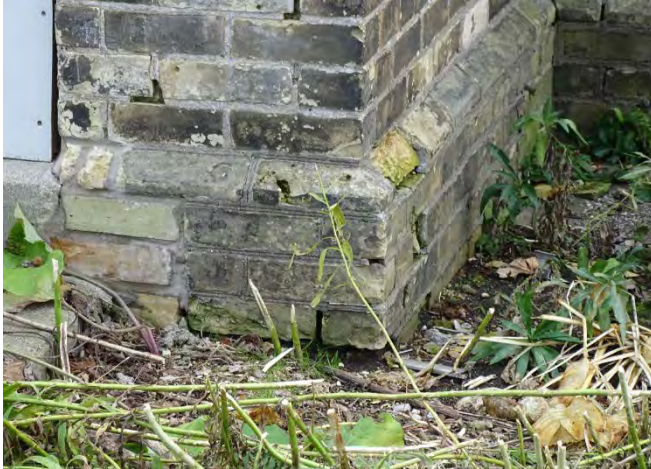
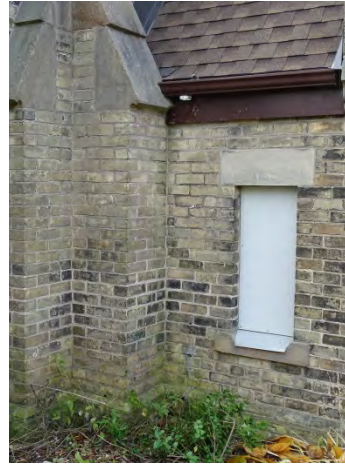
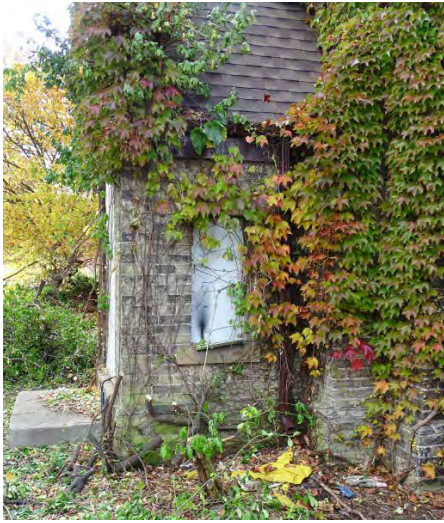
North and South Transepts (Figure No. 41 - 46)

The masonry walls, inclusive of brick and stone detailing, is generally in fair condition with the exception of discrete areas of open mortar joints and areas adjacent to grade that have been mechanically impacted or affected by snow/ice and salt. As previously noted where the downspouts are missing the brick within these areas is starting to show algae growth.

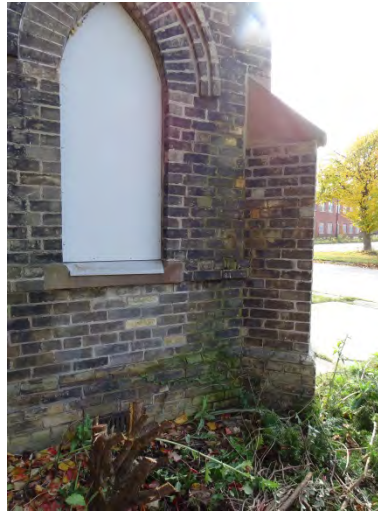
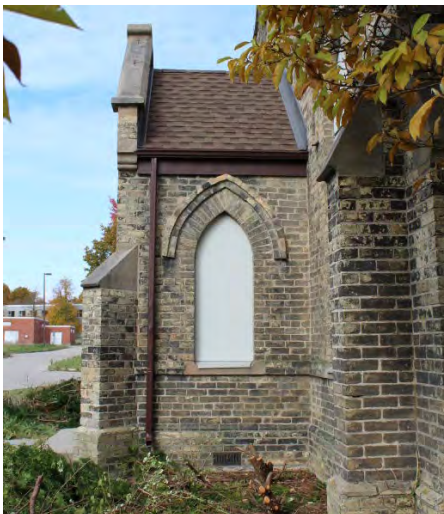
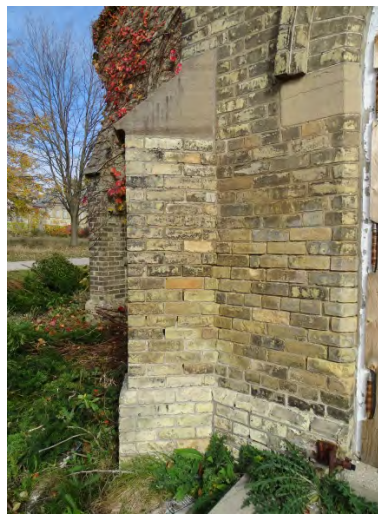
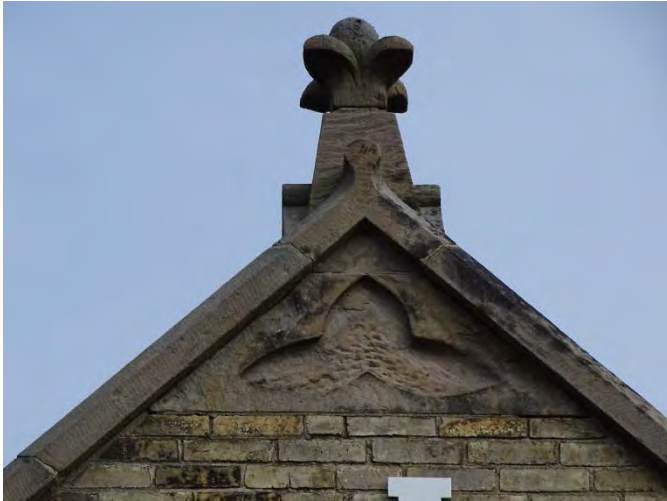
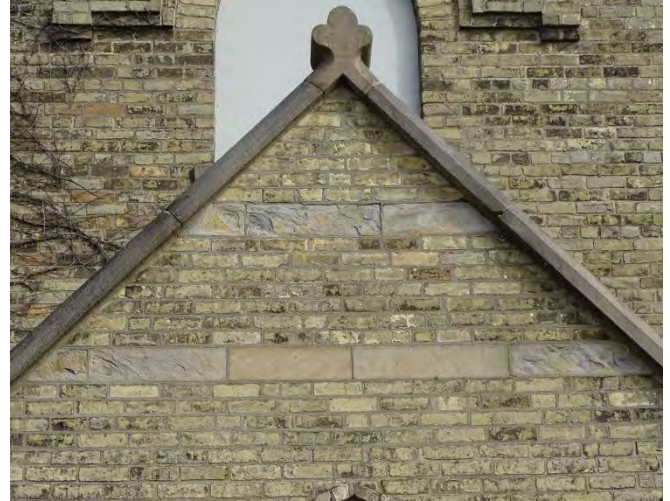
West/Main Entrance – West Elevation (Figure No. 47 - 51)

The masonry walls are generally in fair to good condition with what is believed to be original beaded mortar joints. There is limited vegetative growth on the west gable and on the one storey gable entrance and flanking north and south sides walls. Along the base of the wall on the north side, where the brick masonry extends to grade and the rainwater leaders are missing, green lichen or organic staining is evident along the bottom 5 to 6 courses of brick. The brick is relatively clean with atmospheric staining to a lesser degree than the adjacent elevations.

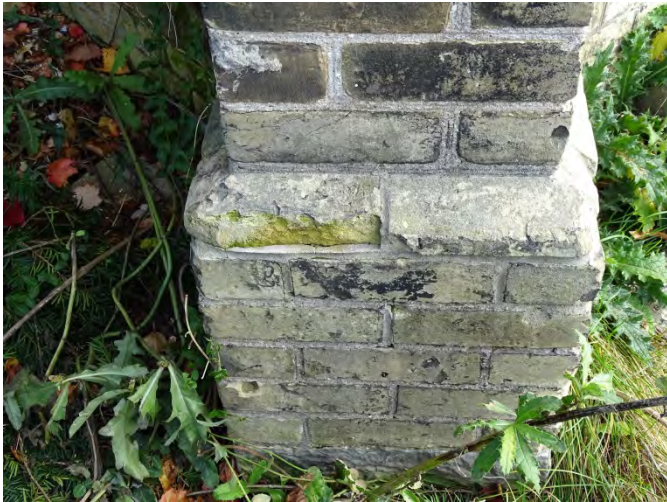
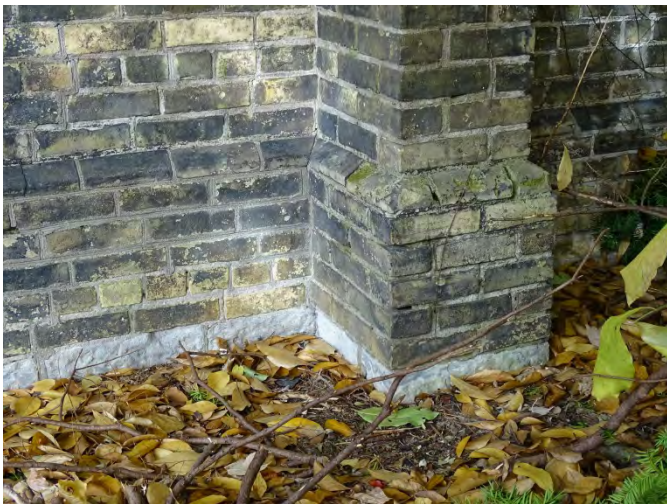
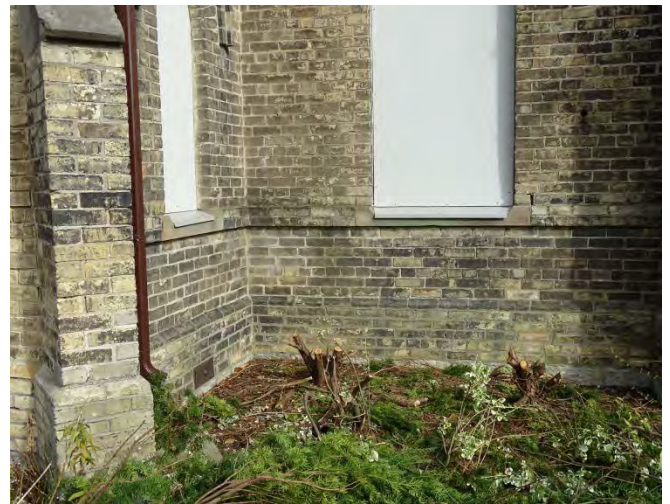
Foundation Walls (where visible above grade)**Description and Condition: (Figure No. 52, 53, 54 and 55)**

As previously noted the brick extends to grade with the exception of along the south elevation and south side of west elevation where one course of stone is visible above grade. Along the east elevation of the Sanctuary, it is assumed that the brick course above or the stone foundation itself is deteriorated which has created a void in the wall.

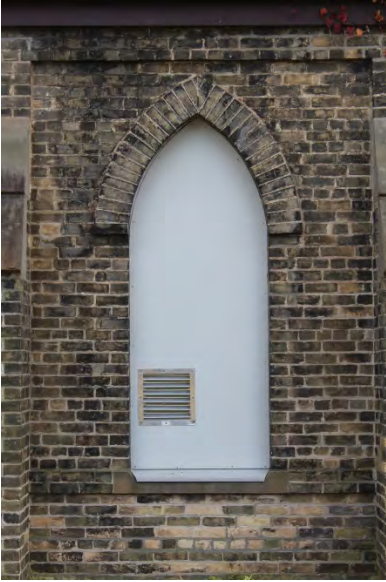
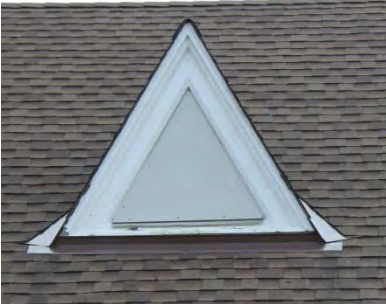
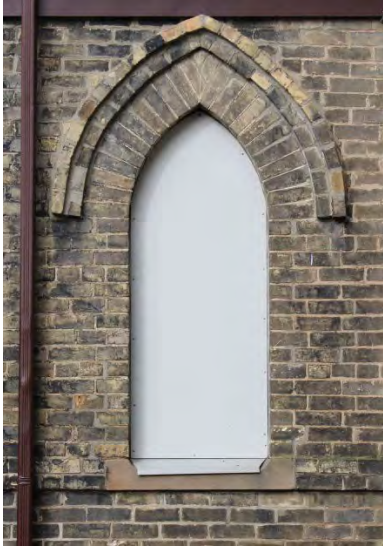
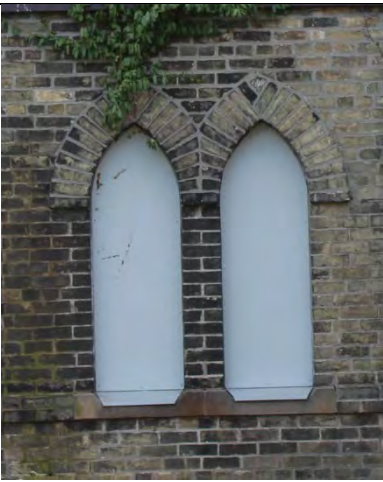
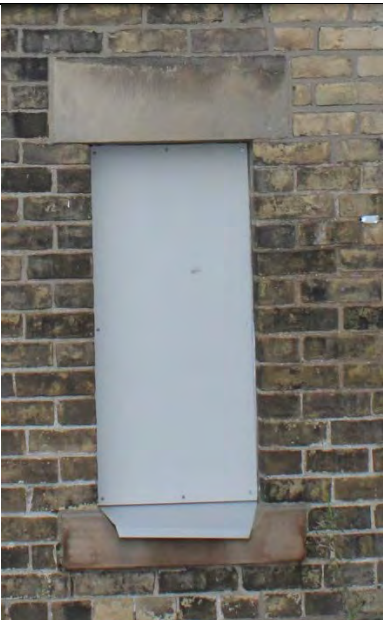
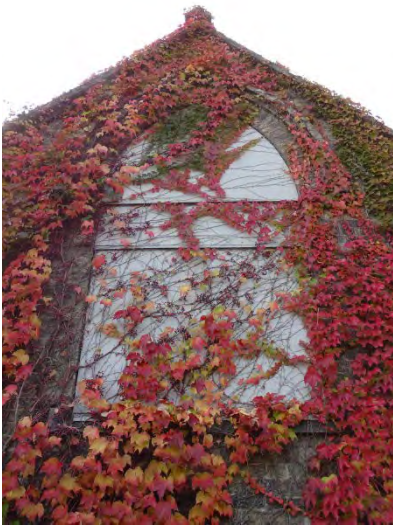
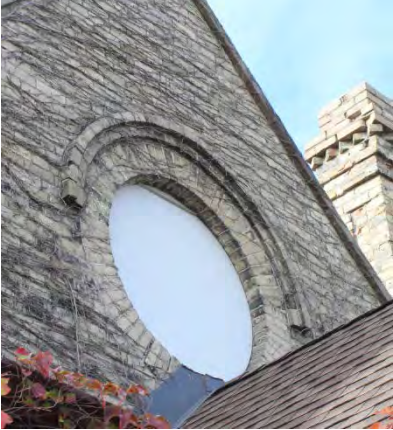
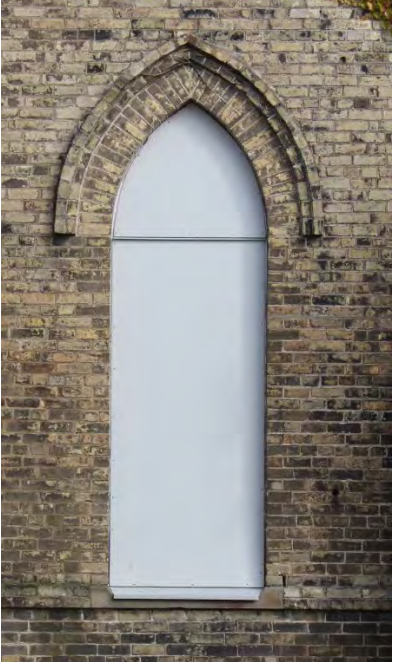
Description and Condition: *(Figures No. 56 - 64)*

Peeling paint was noted around the exposed woodwork around the roof dormers on both the north and south elevations.

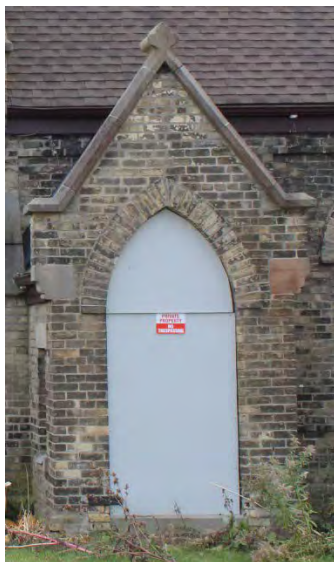
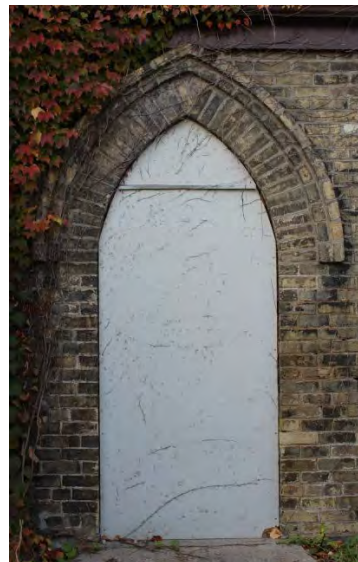
Description and Condition: *(Figures 65 - 72)*

In similar fashion to the windows the doors were boarded as part of the mothballing of the structure and there was no interior access. There are 5 exterior doors to the Chapel of Hope; the main entrance on the west gable with a set of double wood doors with an arched transom above (Door W-D1), 2 single arch headed wood doors at the North and South Transepts (Door N-D1 and Door S-D1) and 2 single arch headed doors at the Entrance Wings flanking the Sanctuary (Door E-D1 and Door E-D2).

No documentation was provided as part of the Baseline Documentation Report to confirm the condition of these doors prior to mothballing, accordingly detailed descriptions and condition assessments of the doors is not possible. The main doors were the only exception as they were not totally covered by plywood and weathered wood was evident at the head of the doors as well as hinges on both sides. Vegetative growth was evident at the concrete threshold as well as single step/landing adjacent to the doors.

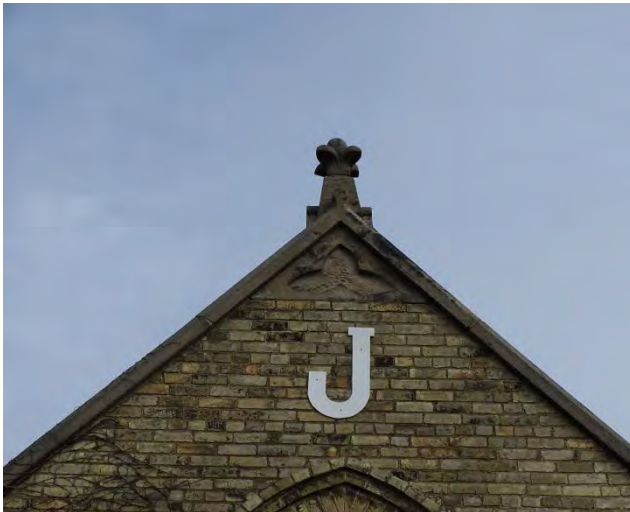
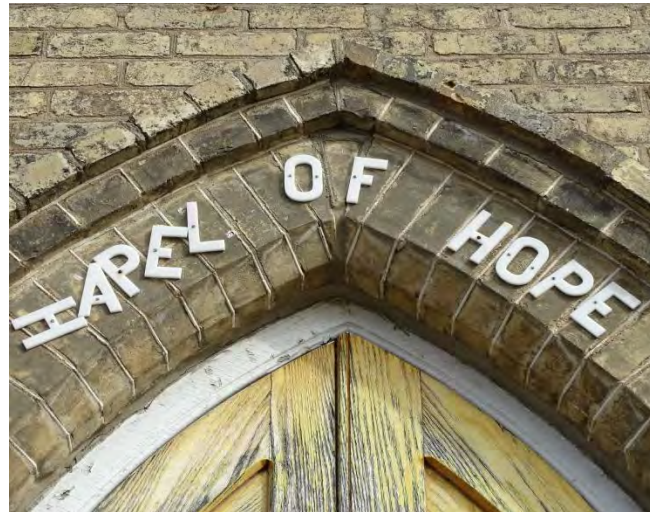
Condition: (Figure No. 73 and 74)

The signage identifying *Chapel* are missing the C with the remaining letters skewed.

Figure No. 73: West Elevation – West/Main Entrance – Letter "J"
(Photo No. 34.0)

Figure No. 74: West Elevation – West/Main Entrance – "Chapel of Hope"
(Photo No. 34.1)

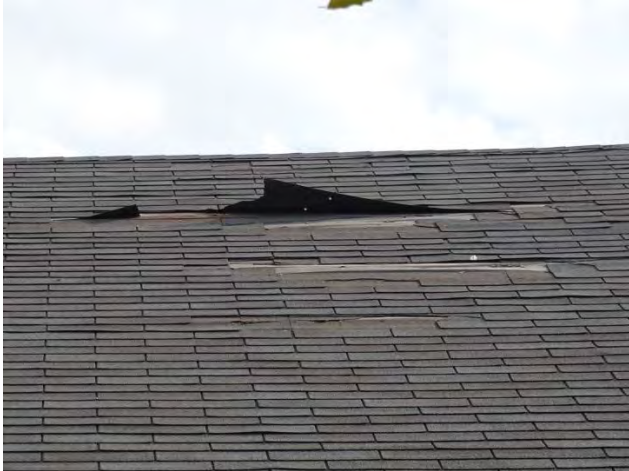
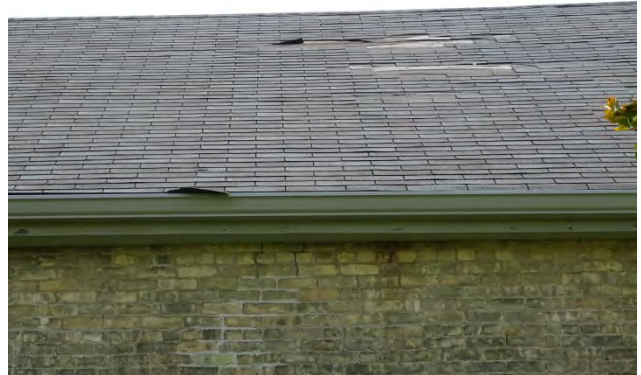
Figure No. 76: North Elevation Shingles Detail (Photo No. 5.2)

Main Roof - North Elevation (Figure No. 76 and 77)

The Conservation Plan, London Psychiatric Hospital, London, Ontario (December 2008) noted that the slate roof of the Horse Stable was in poor condition and had started to leak. The current asphalt shingles are believed to have been installed to address this issue as a stabilization measure. Generally the grey asphalt shingles appear to be in good condition with the exception of discrete areas on the north side that have lifted and some shingles have fallen off possibly due to high winds.

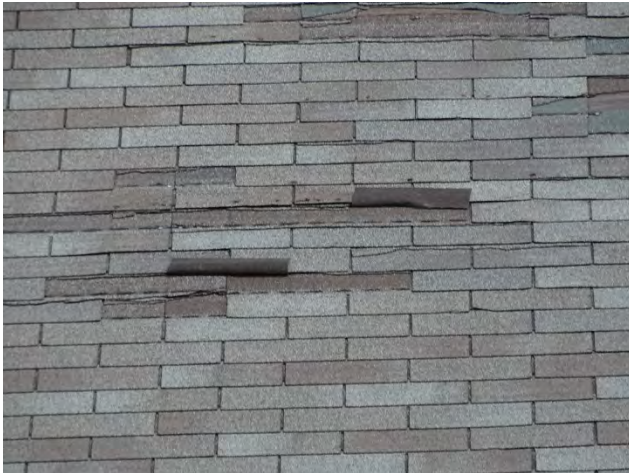
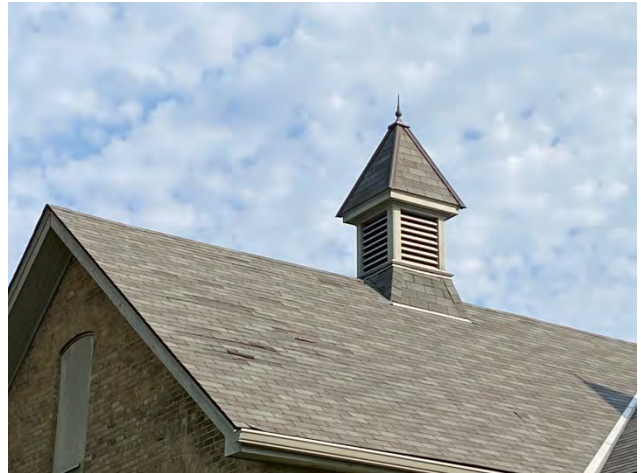
Figure No. 78: South Elevation Shingles Detail (Photo No. 6.3)

Main Roof - South and West Elevations (Figure No. 78 and 79)

Generally the grey asphalt shingles appear to be in good condition with the exception of discrete areas that have lifted and some shingles have fallen off possibly due to high winds.
