**Legacy Village Strategic
Conservation Plan – 850
Highbury Avenue North,
London ON**

November 16, 2022

File: 160940807

LEGACY VILLAGE STRATEGIC CONSERVATION PLAN – 850 Highbury Avenue North, London ON

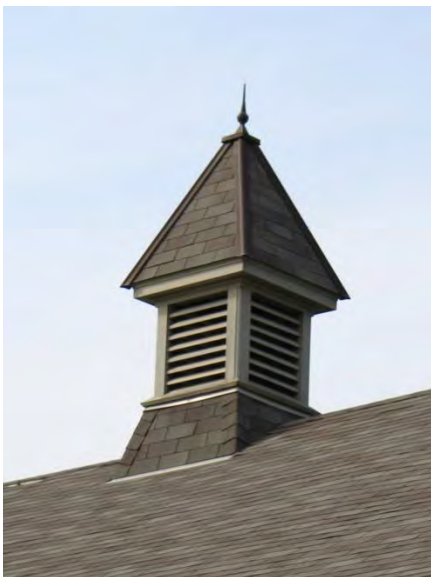
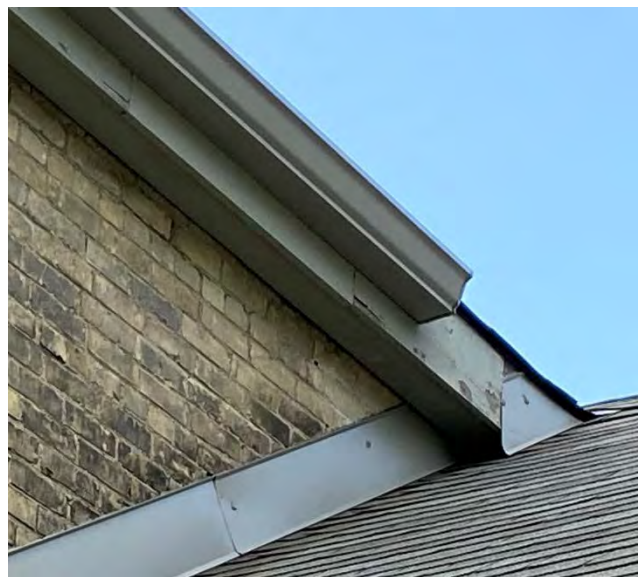
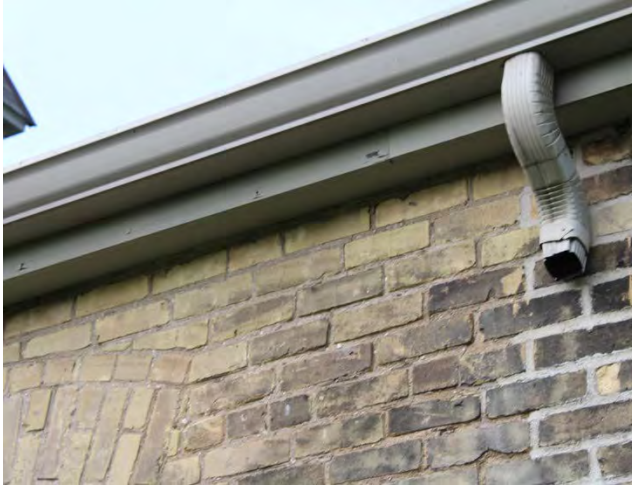
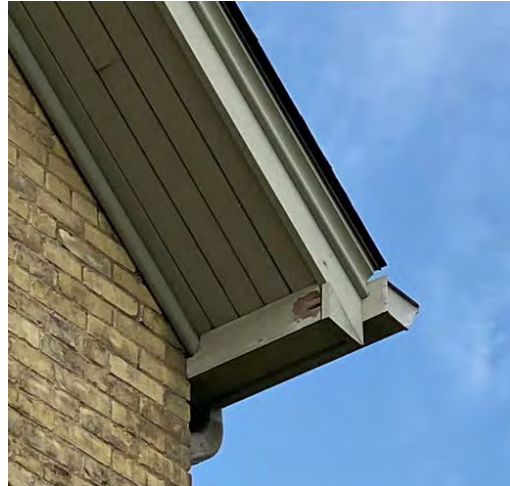
Condition:***Main Roof – Both Sides (Figure No. 80, 81, 82 and 83)***

The Conservation Plan, London Psychiatric Hospital, London, Ontario (December 2008) noted that both the detailing around the ventilators and the condition of the ventilators themselves were in poor condition. The ventilators are believed to have been repaired/restored since 2008 as part of the building stabilization measures. The ventilators are in good condition. The soffits, fascias and ogee moldings appear to be in good condition with the exception of a damaged area on the south side of the west gable.

Figure No. 80: Ventilator (Photo No. 15.0)

Figure No. 81: East Elevation Fascia Detail (Photo No. 8.0)

Figure No. 82: One Storey South Elevation Fascia (Photo No. 9.0)

Figure No. 83: West Elevation Soffit Detail (Photo No. 10.0)

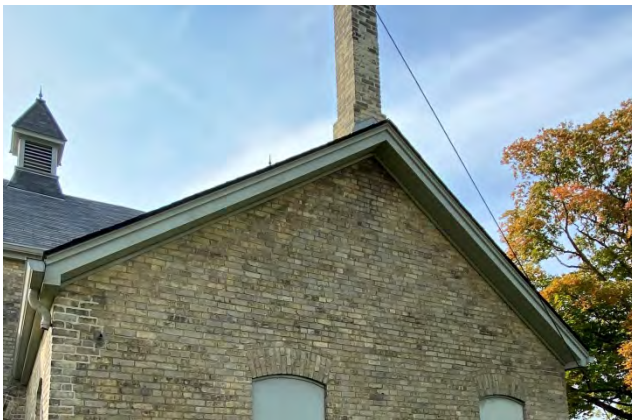
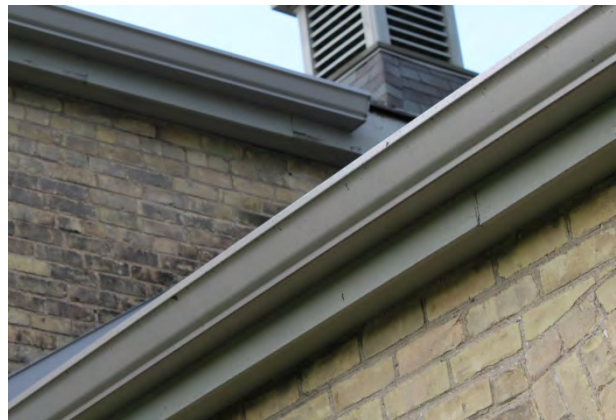
Figure No. 84: East Elevation Fascia (Photo No. 7.0)

Condition:***One Storey Wing (Figure No. 84 and 85)***

The fascias and ogee moldings appear to be in good condition

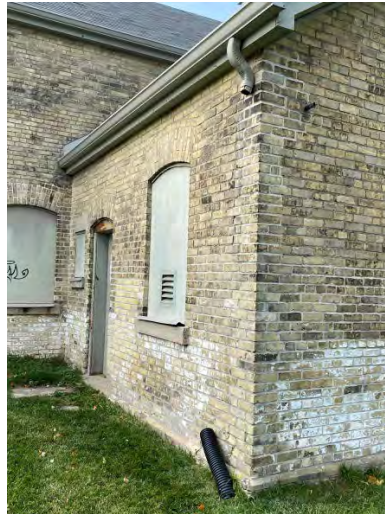
One-Storey Roof (Figure No. 89)

The gutters of the one-storey gable roof are in fair to good condition however the rainwater leader on the south corner is missing.

Figure No. 89: South Elevation Missing RWL (Photo No. 12.0)

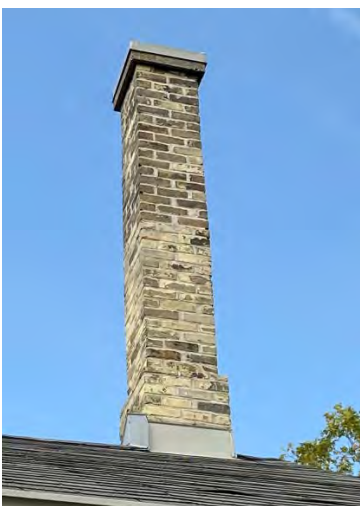
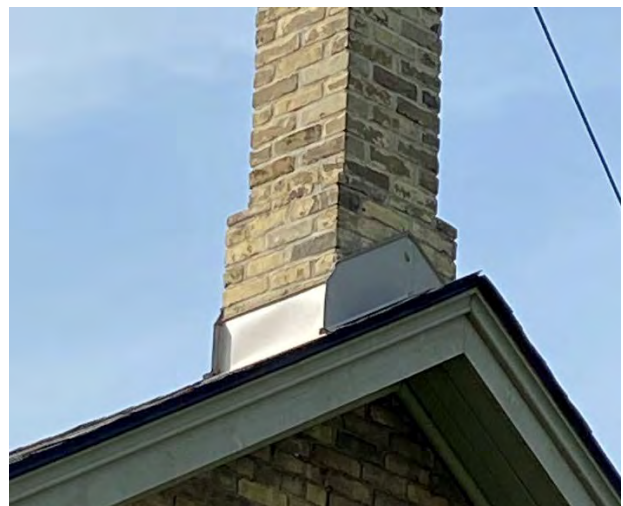
Figure No. 90: Chimney (Photo No. 14.0)

Condition: (Figure No. 90 and 91)

The upper half of the chimney appears to have been rebuilt as there are distinctive brick differences and areas of masonry repairs are evident. A metal flashing with rain diverters at each side is evident at the base of the chimney. The chimney appears to be in fair condition.

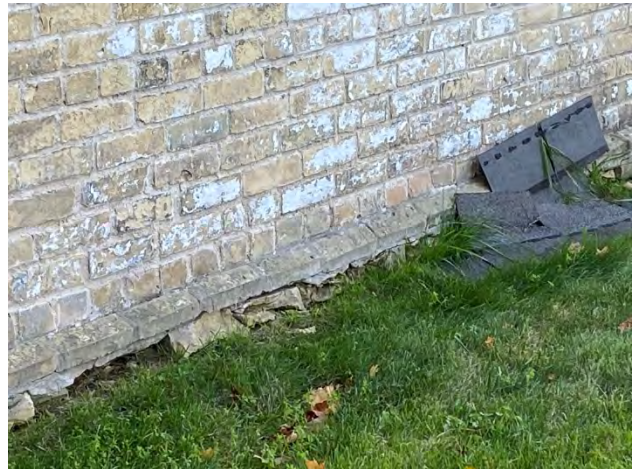
Figure No. 95: North Elevation Foundation (Photo No. 20.1)

The Heritage Assessment of ORC Mental Health and Developmental Services Facilities, N00014 – Regional Mental Health, London Site-Specific Report (September 2004) noted that the Horse Stable had a parged stone foundation. With the exception of a damaged window well on the north elevation where stone was evident the brick masonry extended to grade as of the 2020 site visit. As noted on the north gable the base of the buff brick masonry sits on a three course high brick base proud of the wall above. The stone foundation may exist but has been covered by the changes in grade over time. **Refer to Walls (above foundation).**

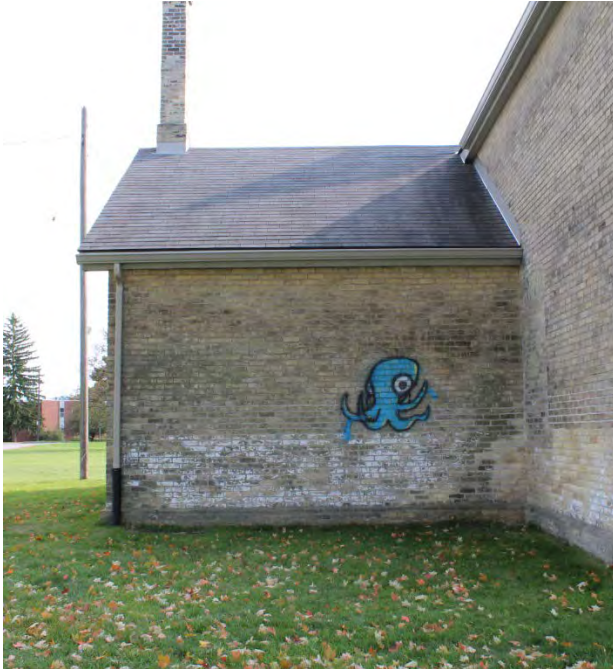
Figure No. 102: Graffiti and White Wash (Photo No. 16.0)

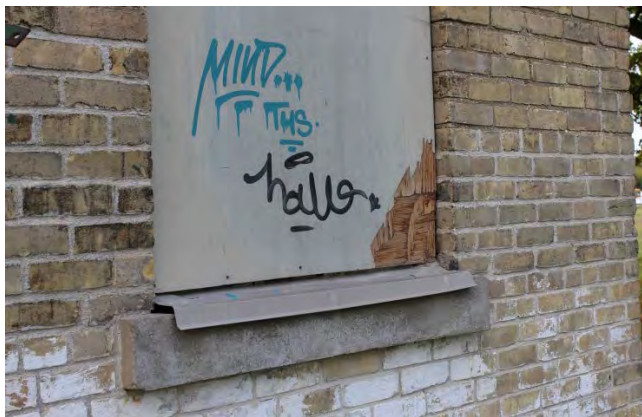
Figure No. 117: Damaged Window Protection (Photo No. 24.13)

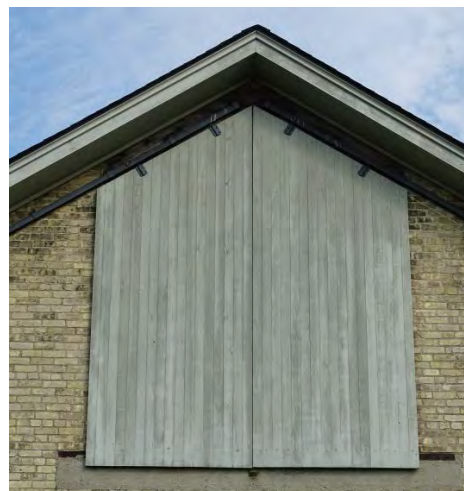
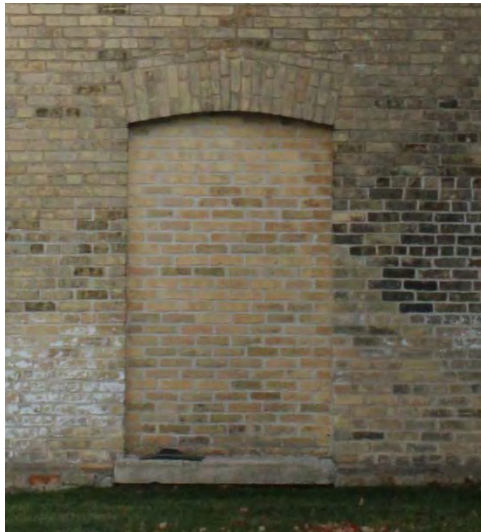
No documentation was provided as part of the Baseline Documentation Report to confirm the condition of these doors prior to mothballing, accordingly detailed descriptions and condition assessments of the doors is not possible. The hay loft door was visible and appeared to be in good condition.

Figure No. 123: Door W-D2 – Hayloft Doors (Photo No. 25.5)

Figure No. 124: Door W-D3 – Hayloft Doors (Photo No. 25.6)

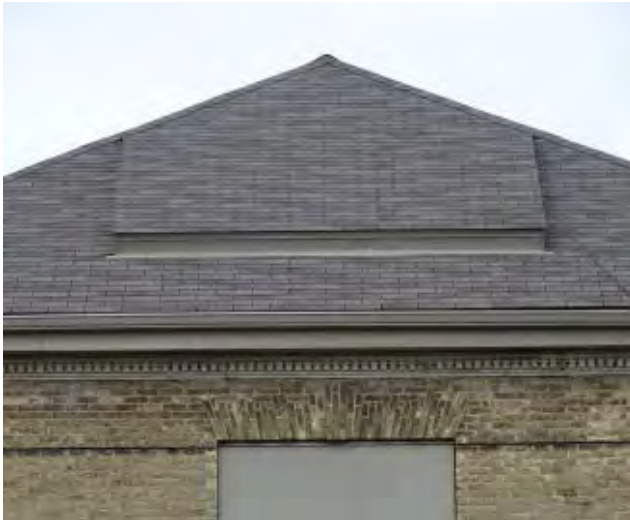
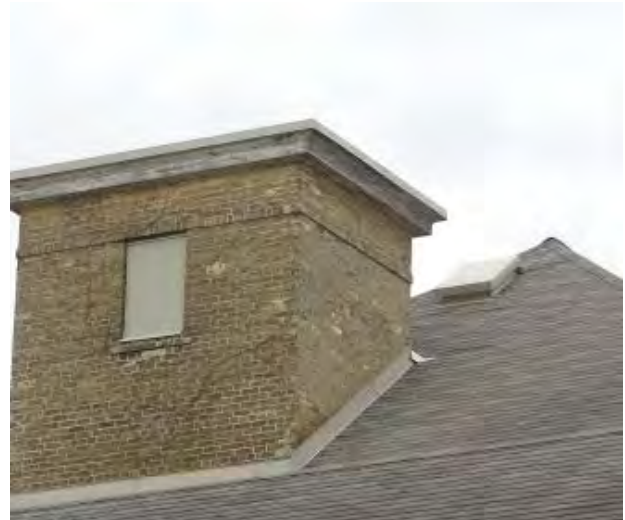
The Conservation Plan, London Psychiatric Hospital, London, Ontario (December 2008) noted that the hipped roof of the Infirmary was in poor condition with major roof leaks having resulted in damage to the interiors and the complete collapse of the wood structure on the west sunroom (believed to be a typo in the conservation plan and should have noted east sunroom). The current asphalt shingles on all the roofs; inclusive of the Central Administration Block, the Central Pavilion and Corridors and the East and West Wings, are believed to have been installed to address this issue as a stabilization measure.

Generally, the grey asphalt shingles appear to be in fair condition with some discoloration throughout the hipped roofs. The large skylight above the operating room on the south elevation of the Central Administration Block may have been covered in plywood at the time the reroofing was completed though no documentation was provided to confirm this assumption. The Conservation Plan, London Psychiatric Hospital, London, Ontario (December 2008) specially made reference to this heritage attribute noting that the large skylight had an interior sash with ribbed glass in the operating room ceiling though there were no remnants of any operational sash there was evidence of casement swing arms that may have been used to direct light from the mirrors.

On the north side is a prominent brick element (possibly a service shaft) with a boarded window opening and a contemporary roof vent. The prefinished metal flashings appear to be in good condition but are not stepped within the masonry coursing of the brick service shaft nor at the 2 brick chimneys.

Figure No. 128: Central Administration Block – South Elevation – Skylight Detail (Photo No. 23.1)

Figure No. 129: Central Administration Block – North West View of Roof (Photo No. 21.1)

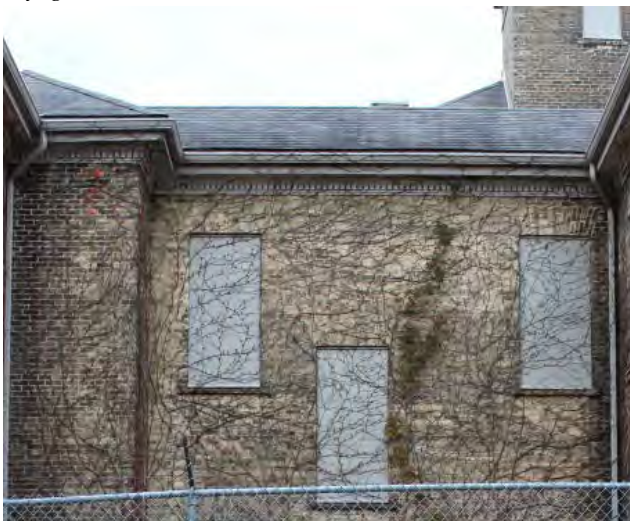
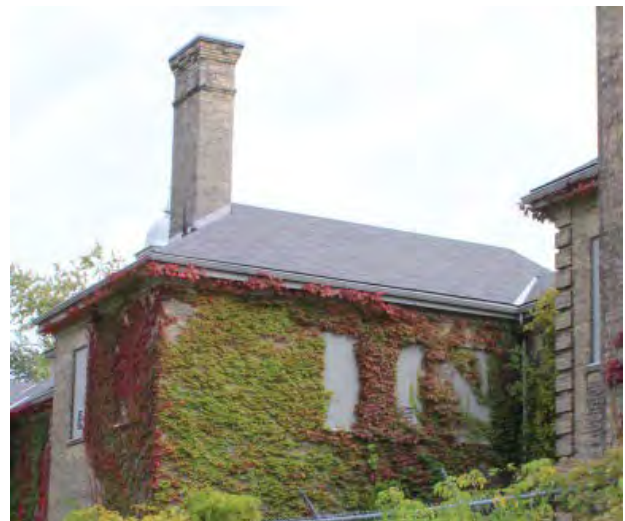
Generally, the grey asphalt shingles appear to be in fair condition with some staining/discoloration. The prefinished metal flashings appear to be in good condition but are not stepped within the masonry coursing of brick chimney located along the north side.

Figure No. 130: East Corridor– North Elevation (Photo No. 25.1)

Figure No. 131: Central Pavilion – West Elevation (Photo No. 27.0)

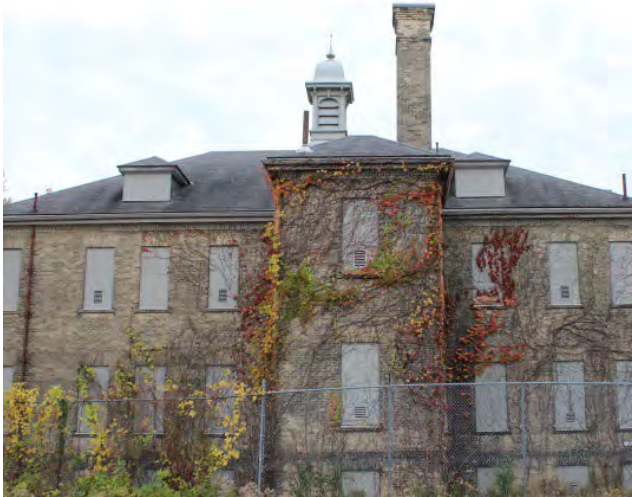
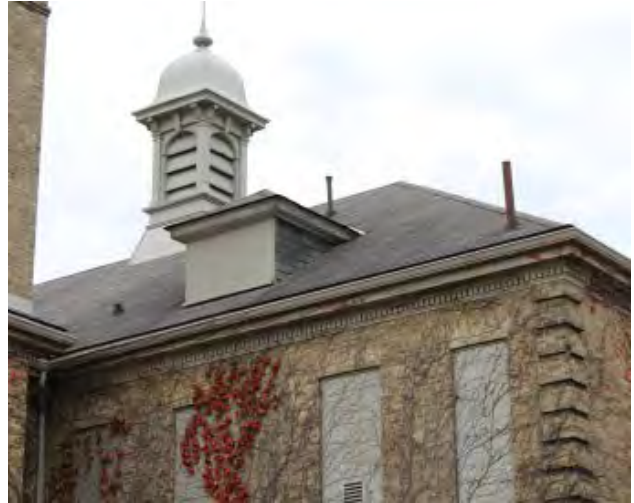
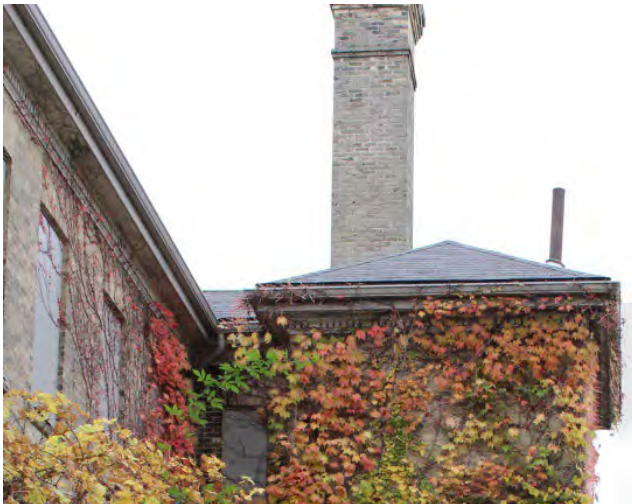
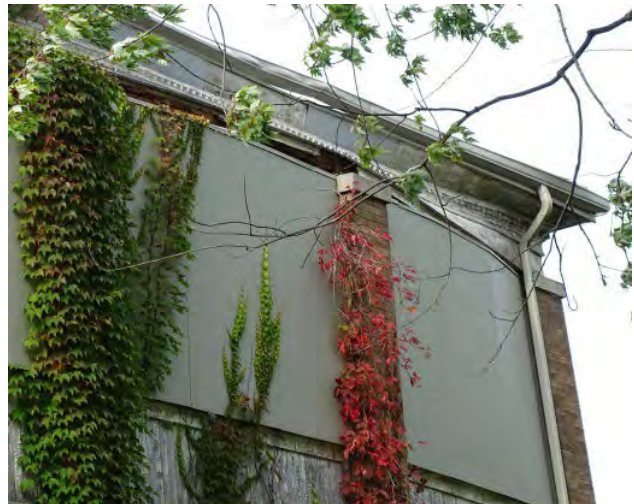
Generally, the grey asphalt shingles of the east wing, exclusive of the east porches, appear to be in fair condition. The condition of the east porches, cited in the Conservation Plan, London Psychiatric Hospital, London, Ontario (December 2008), has further decayed and the entirety of the porch structure has pulled away from the east wing and is in an advanced state of structural collapse.

Figure No. 132: East Wing – North Elevation
(Photo No. 29.0)

Figure No. 133: East Wing – North Elevation – West Side of Stair Tower Detail
(Photo No. 29.1)

Figure No. 134: East Wing – Stair Tower – East Elevation
(Photo No. 30.0)

Figure No. 135: East Wing – Porches – East Elevation Detail
(Photo No. 101.2)

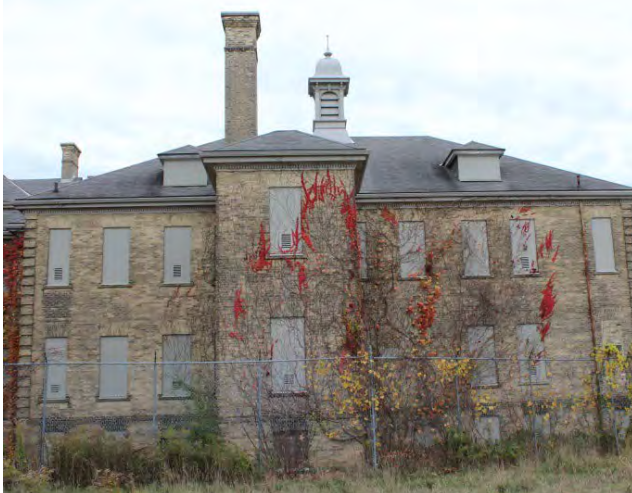
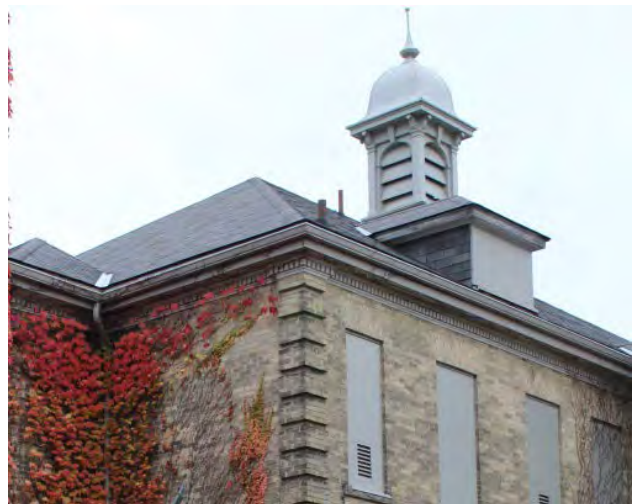
Generally, the grey asphalt shingles of the west wing, exclusive of the west porches, appear to be in fair condition. The west porches have fared better than those on the east elevation however the condition of their roof could not be seen from grade nor was interior access possible to confirm if water penetration is occurring from the low sloped roof.

Figure No. 136: West Wing – North Elevation (Photo No. 33.0)

Figure No. 137: West Wing – East Elevation Detail
(Photo No. 34.0)

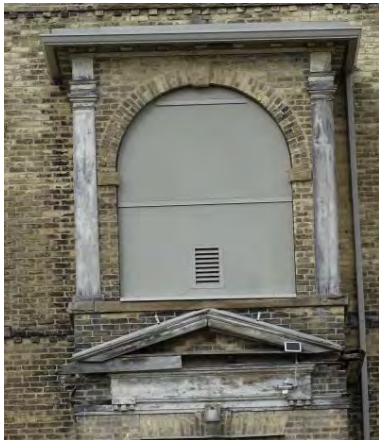
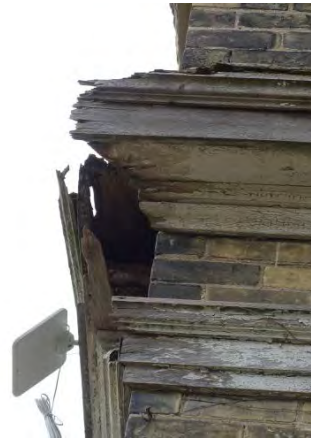
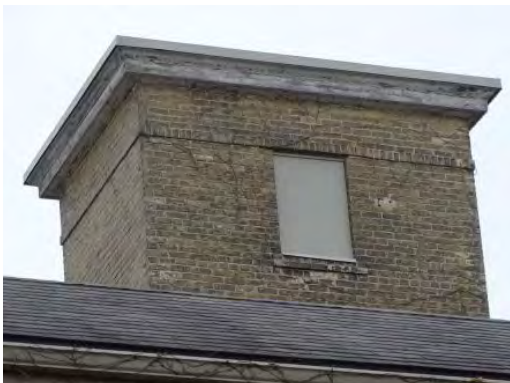
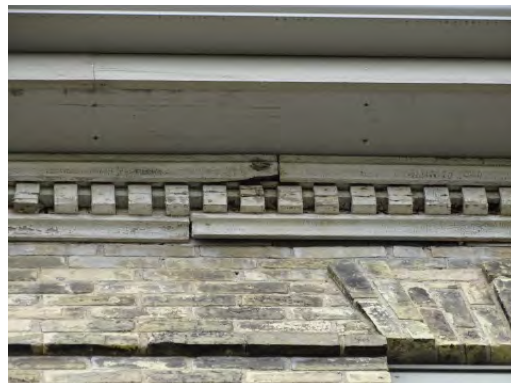
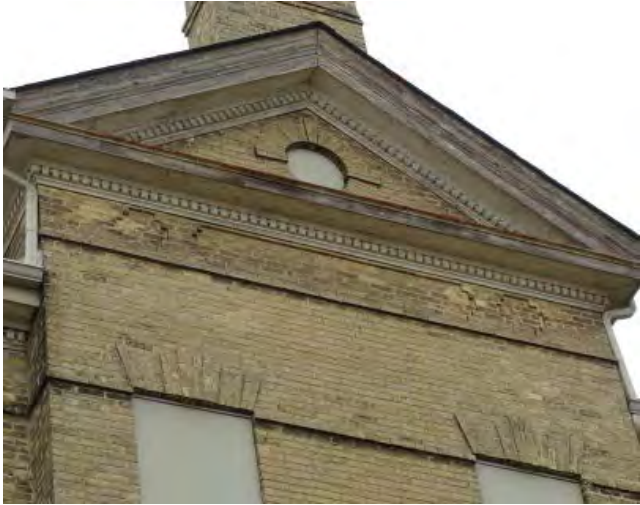
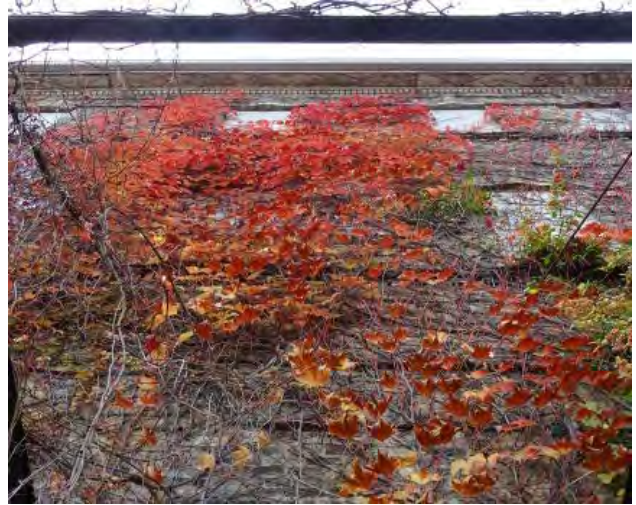
With the exception of the dentillated wood cornice, the woodwork at the south facing entrance of the Central Administration Block is very poor or missing primarily at the wood detailed pediment and pilasters above the main entrance. The remaining wood is weathered and grey.

The wood fascia and soffits at the top of the brick service shaft have peeling paint or areas with limited paint. The continuous dentillated cornice, fascia and soffits at the base of the hip roof generally appear intact though the paint is peeling with areas of bare wood evident. On the south side wood trim at the soffits is damaged, lifting and openings evident. It appeared that the dentils also were beginning to have horizontal cracking.

Figure No. 138: Central Administration Block – Entrance – South Elevation (Photo No. 41.1)

Figure No. 139: Central Administration Block – East Elevation – Entrance Detail (Photo No. 41.8)

Figure No. 140: Central Administration Block – Service Shaft – North Elevation (Photo No. 37.1)

Figure No. 141: Central Administration Block – South Elevation Detail (Photo No. 39.3)

Figure No. 142: Central Administration Block – West Elevation – West Pediment Detail (Photo No. 40.1)

Figure No. 143: Central Administration Block – East Elevation (Photo No. 38.3)

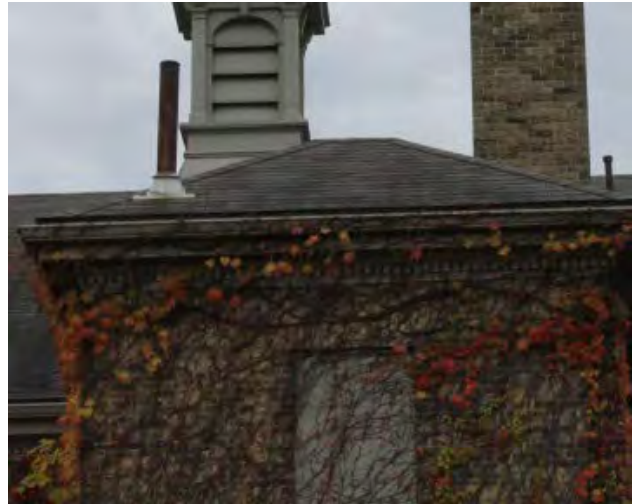
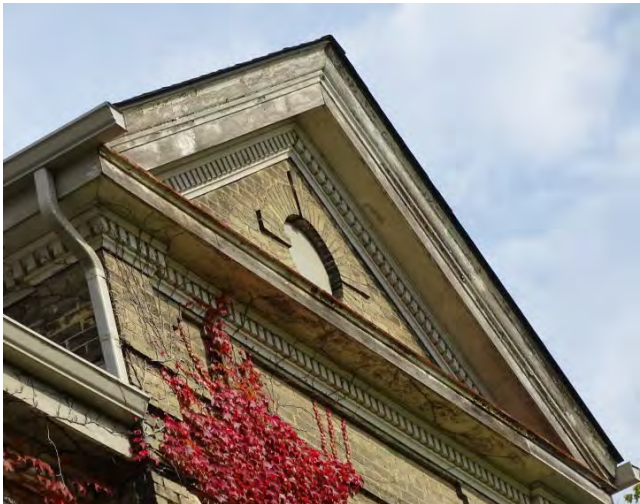
Figure No. 145: East Wing – Stair Tower – North Elevation (Photo No. 46.4)

Figure No. 146: East Wing – South Elevation – South Pediment (Photo No. 48.5)

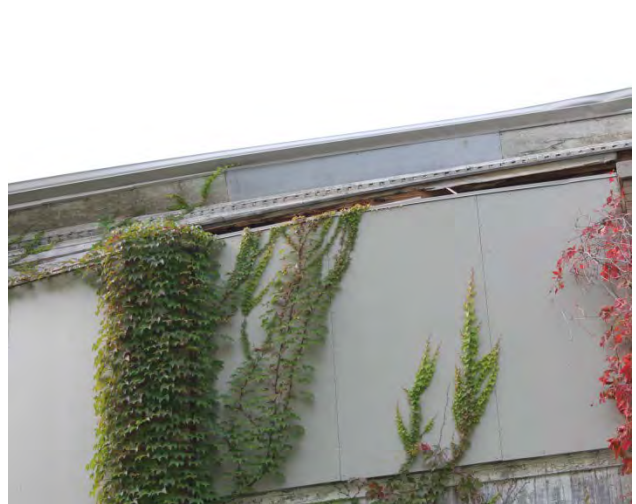
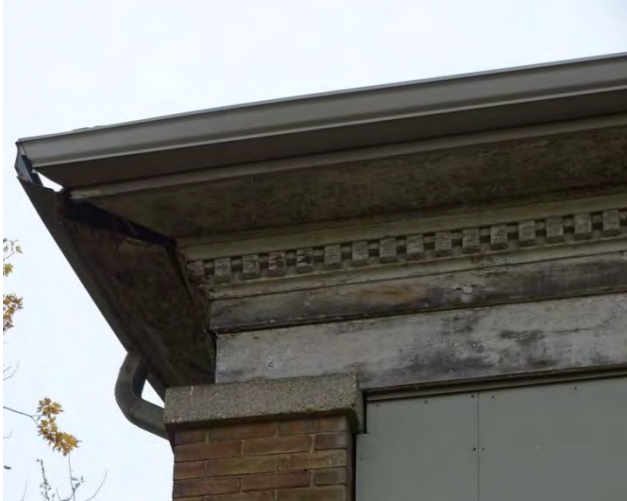
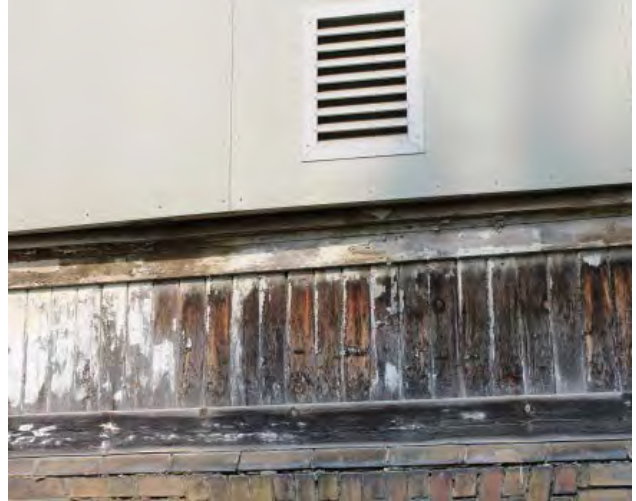
The condition of the east porches, cited in the Conservation Plan, London Psychiatric Hospital, London, Ontario (December 2008), has further decayed and the entirety of the porch structure,

Figure No. 147: East Wing – Porches – East Elevation (Photo No. 101.5)

Figure No. 148: East Wing – Porches – North Elevation Detail
(Photo No. 100.3)

Figure No. 149: East Wing – Porches – South Elevation Detail
(Photo No. 102.4)

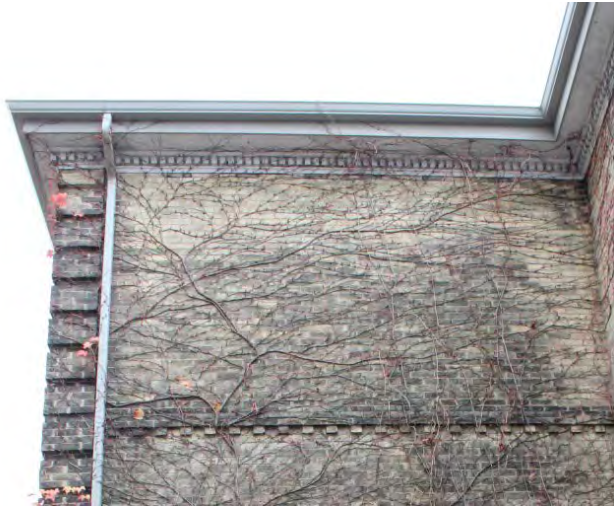
The continuous dentillated cornice, fascia and soffits at the base of the hip roof generally appear intact though openings in the soffit were noted. Ivy has typically grown up the elevations of the West Wing and extends over the wood cornice to the line of the roof gutters. In some areas the ivy growth is beginning to extend onto the shingled roofs.

There is limited or no paint on the south elevation's projecting central bay's wood detailed pediment and the existing wood is grey and weathered.

The west porches have fared better than those on the east wing however limited or no paint remains and the dentillated cornice, fascias, soffits and vertical tongue and groove siding are grey and weathered. The roof soffit on the west elevation has been covered with a cement board.

Figure No. 150: West Wing – East Elevation Detail
(Photo No. 51.3)

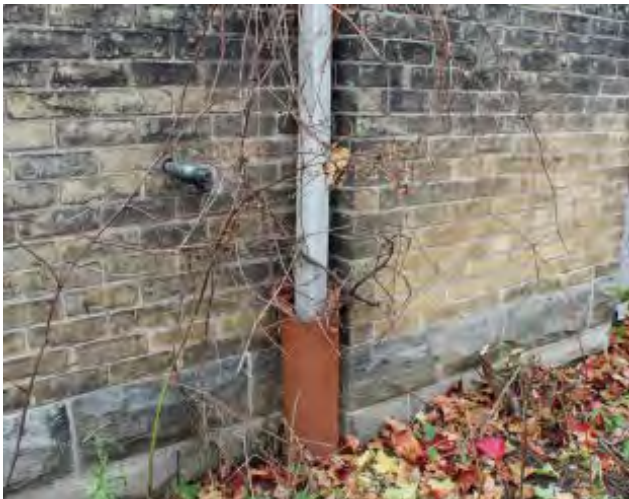
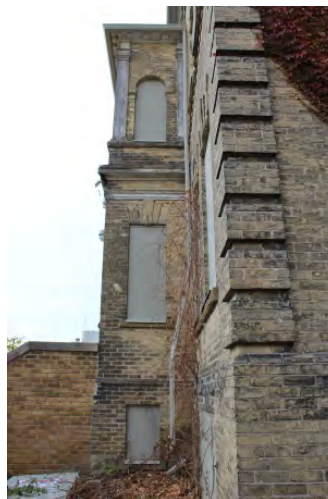
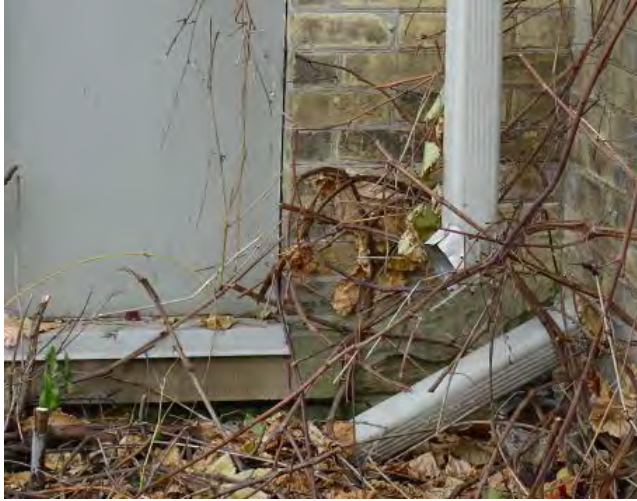
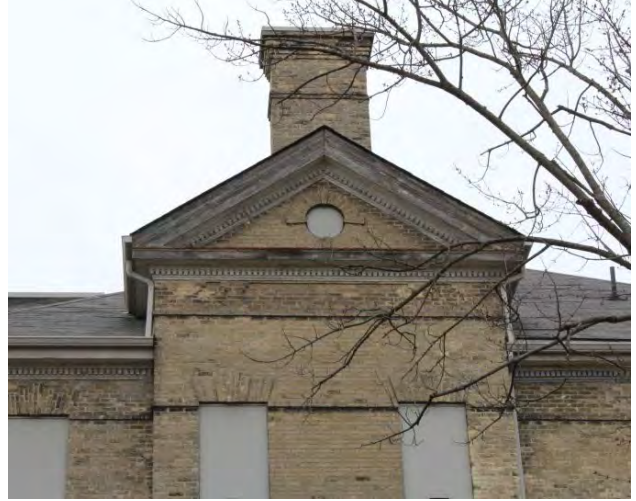
Central Administration Block (Figure No. 154, 155, 156 and 157)

The gutters and rainwater leaders are in fair to good condition however some of the clay pipes are broken or are not visible at grade. The base of the downspout on the east side of the main entrance is broken.

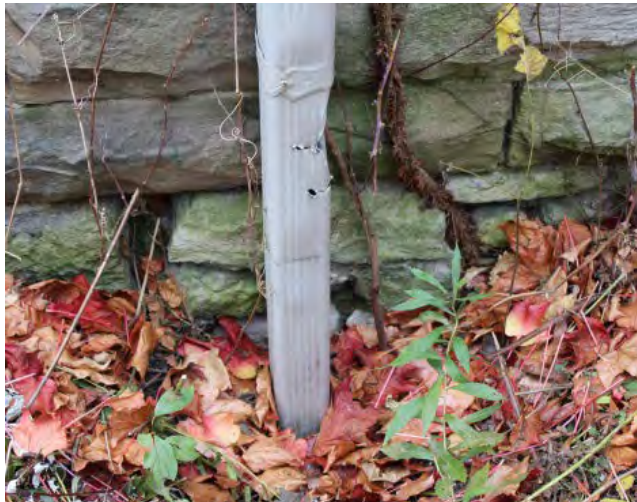
Figure No. 158: West Corridor – South Elevation – Detail at Grade (Photo No. 60.1)

The gutters and rainwater leaders are in fair to good condition however some of the clay pipes are not visible at grade.

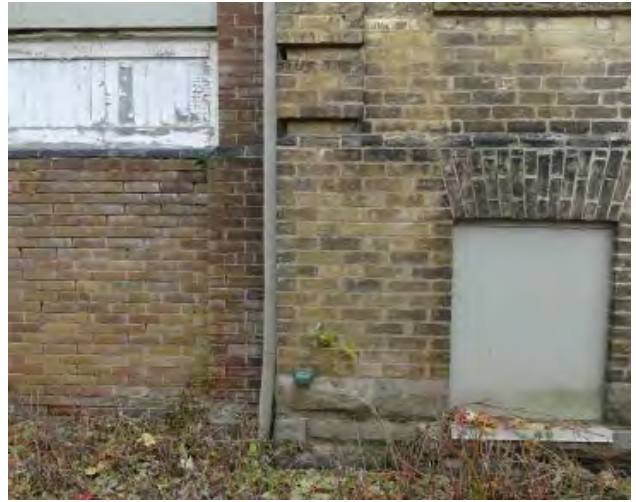
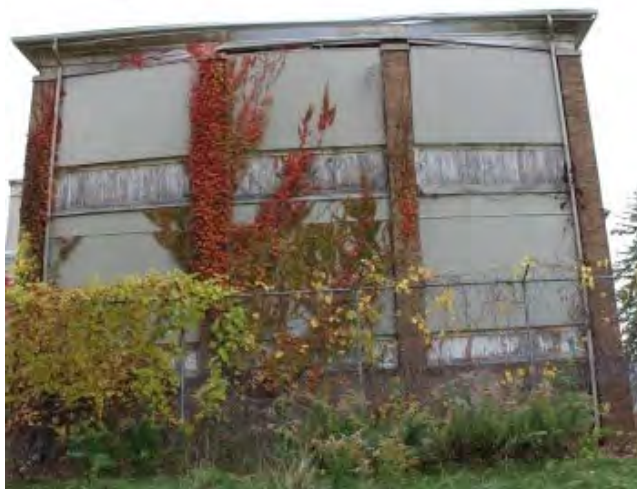
East Wing and Porches (Figure No. 159 - 160)

The gutters and rainwater leaders are in fair to good condition however some of the clay pipes are not visible at grade and others have been disconnected and rerouted to drain to grade. 2 downspouts are located on the east elevation of the porches.

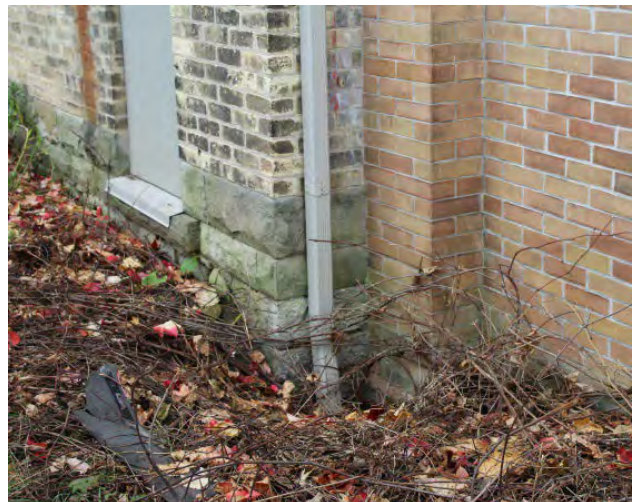
Figure No. 161: West Wing – North Elevation – West Wing/Porch Connection – Detail at Grade (Photo No. 66.4)

The gutters and rainwater leaders are in fair to good condition however some of the clay pipes are not visible at grade and others have been disconnected and rerouted to drain to grade. 2 downspouts are located on the east elevation of the porches.

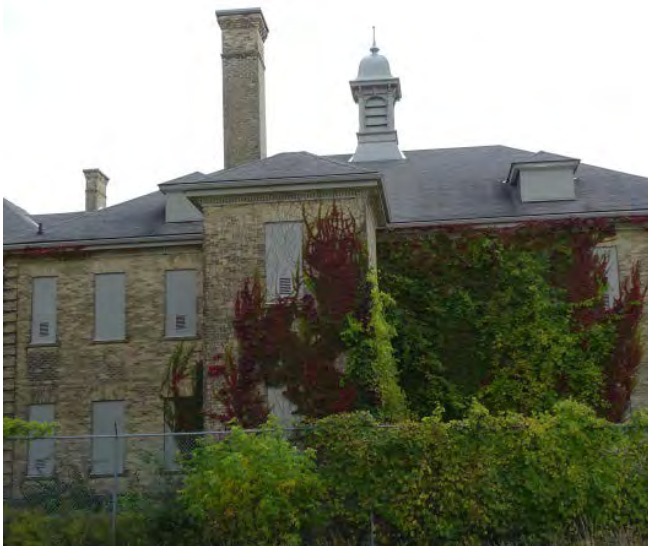
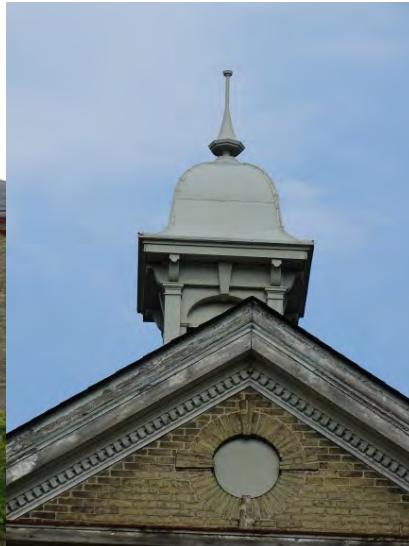
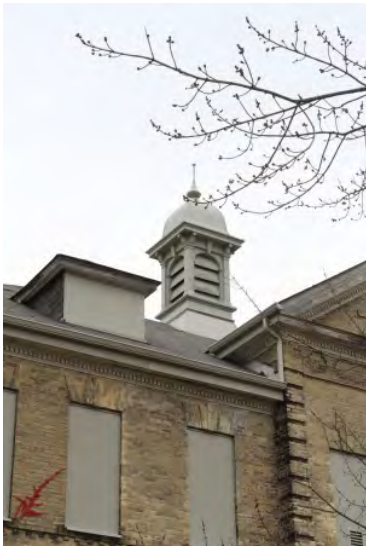
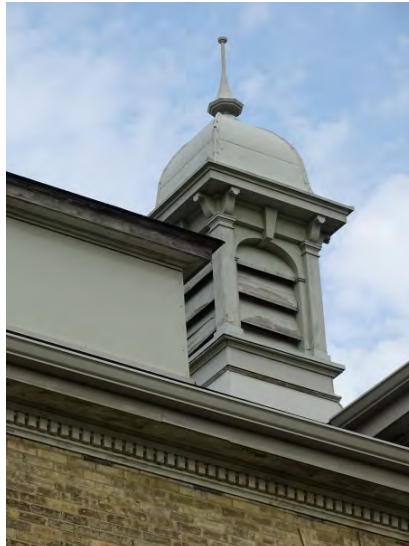
Condition: (Figure No. 162, 163, 164 and 165)

The existing bellcast cupolas/roof ventilators (2) along the rood ridge of the East and West Wings are in good condition with the exception of the louvered slates where the painting is peeling.

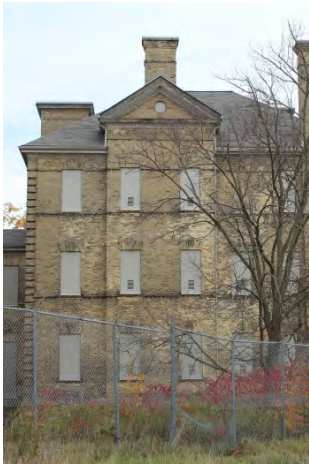
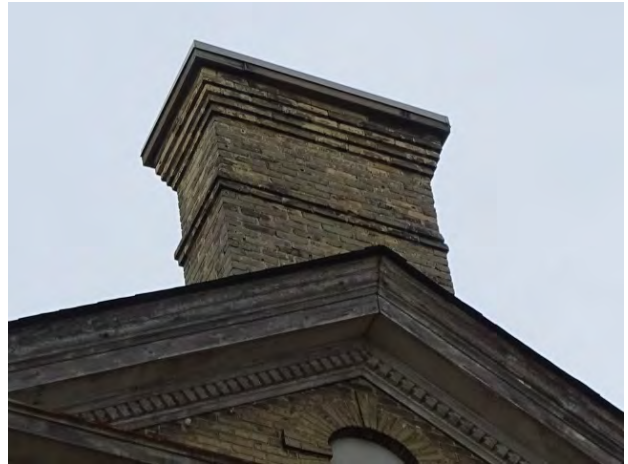
Figure No. 166: Central Administration Block – West Chimney – West Elevation (Photo No. 70.0)

The 3 buff brick chimneys were simply detailed with concrete/stone cap stones. The chimneys appear to be capped with prefinished metal. Some atmospheric staining is evident on the brick.

The west chimney is in fair condition and the metal flashings at the base of the chimney, where they intersect the roof are not stepped with the brick coursing. There are some open joints and spalled brick primarily on the west elevation of the upper half of the chimney.

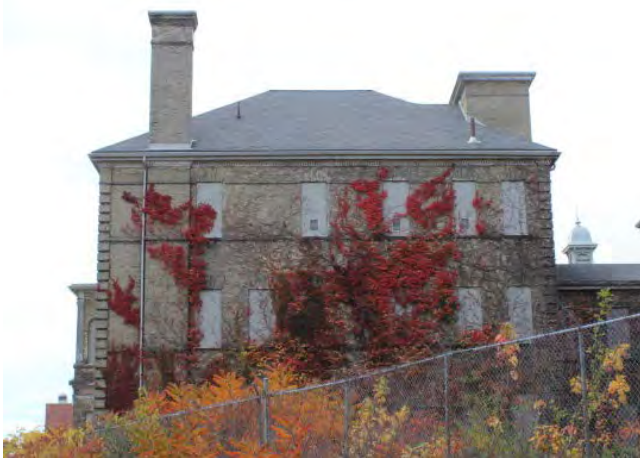
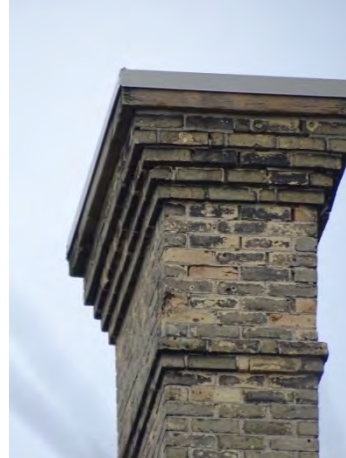
Figure No. 168: Central Administration Block –South East Chimney – East Elevation (Photo No. 71.0)

The south east chimney is in poor to fair condition and the metal flashings at the base of the chimney where they intersect the roof are not stepped with the brick coursing. There are open joints and spalled brick primarily on the south elevation of the upper half of the chimney above the mid-point decorative 2 courses of brick.

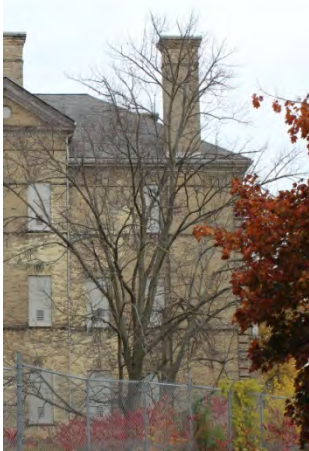
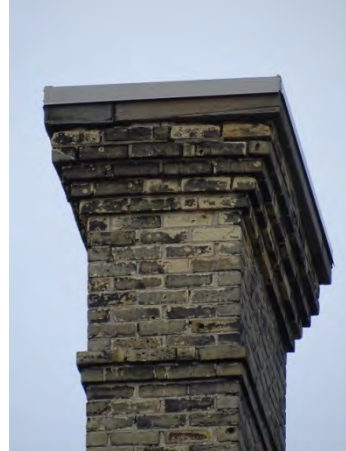
Figure No. 170: Central Administration Block – South West Chimney – West Elevation (Photo No. 72.0)

The south west chimney is in fair condition and the metal flashings at the base of the chimney where they intersect the roof are not stepped with the brick coursing. Masonry repairs/repointing appears may have been completed on the north elevation of the upper half of the west chimney above the mid-point decorative 2 courses of brick. The upper courses of brick on the west side appears to be damaged and brick missing below the cap stone.

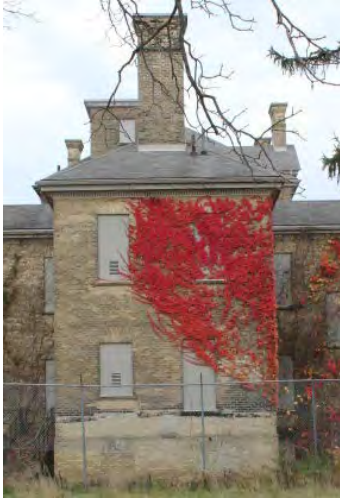
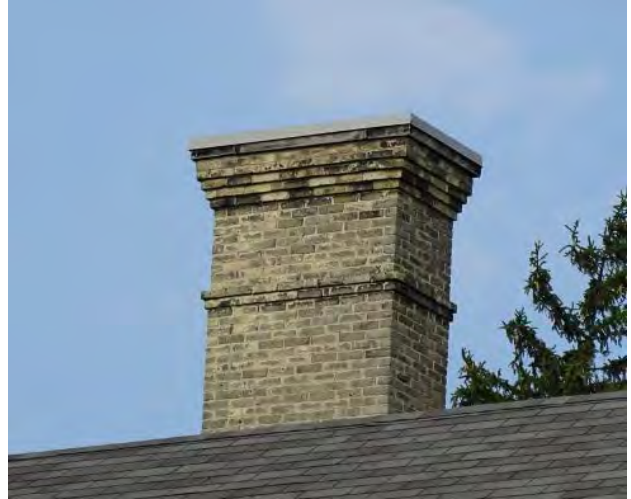
Chimney on the Central Pavilion and Corridors (Figure No. 172 and 173)

The buff brick chimney on the north side of the Central Pavilion was similarly detailed to those on the Central Administration Block and there are open joints and spalled brick primarily above the mid-point decorative 2 courses of brick.

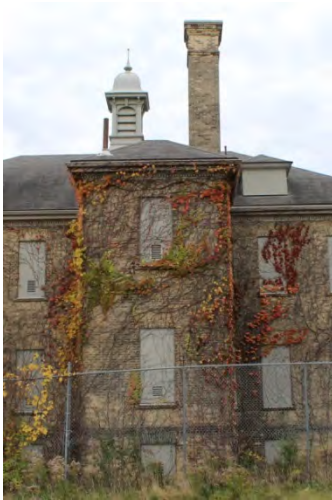
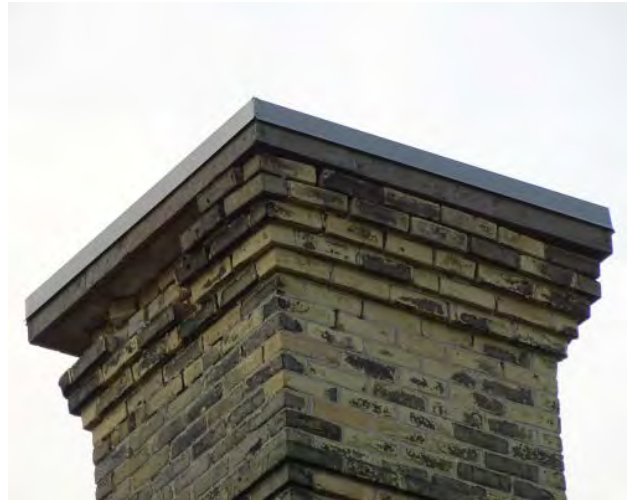
Chimneys on the East Wing (Figure No. 174 and 175)

The buff brick chimney on the East Wing Stair Tower was similarly detailed to those on the Central Administration Block and the chimney is in poor condition. The upper 5 courses have missing brick, open joints and fairly dark atmospheric staining. There are open joints and spalled brick primarily above the mid-point decorative 2 courses of brick.

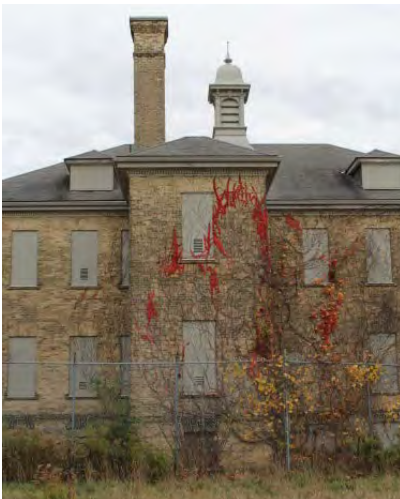
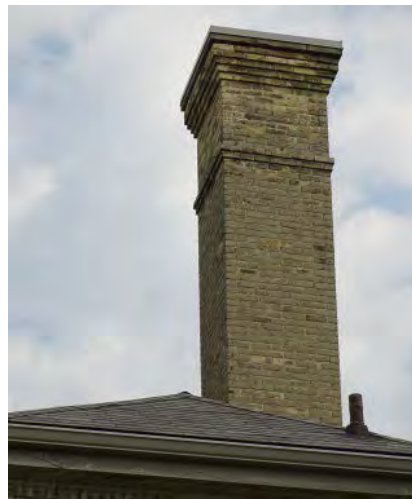
Chimneys on the West Wing (Figure No. 176 and 177)

The buff brick chimney on the West Wing Stair Tower was similarly detailed to those on the Central Administration Block and the chimney is in poor condition. The upper 5 courses have

missing brick, open joints and fairly dark atmospheric staining. There are open joints and spalled brick primarily above the mid-point decorative 2 courses of brick.

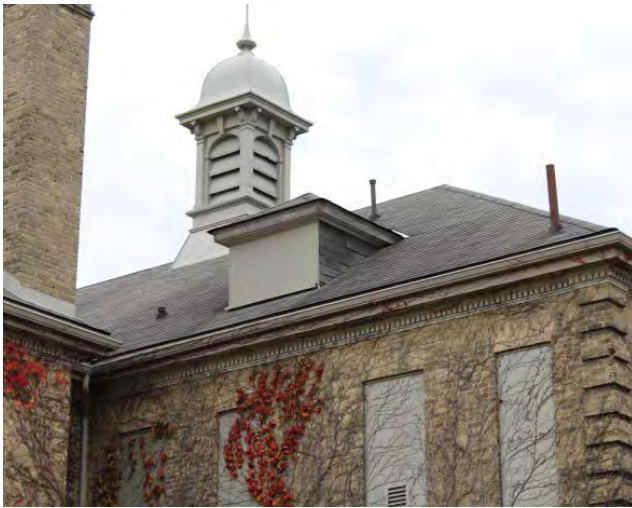
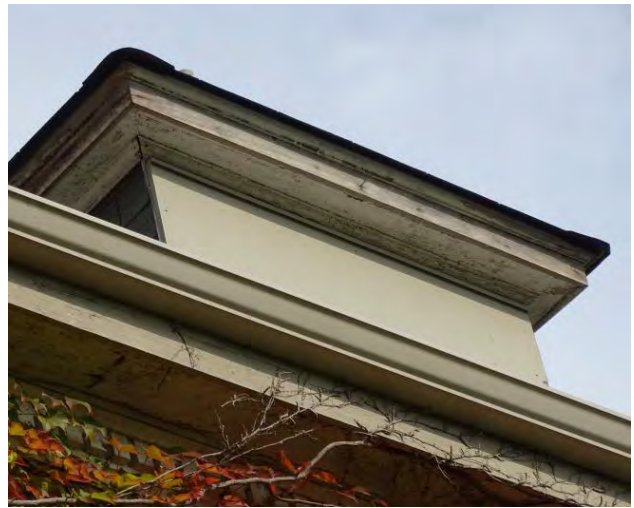
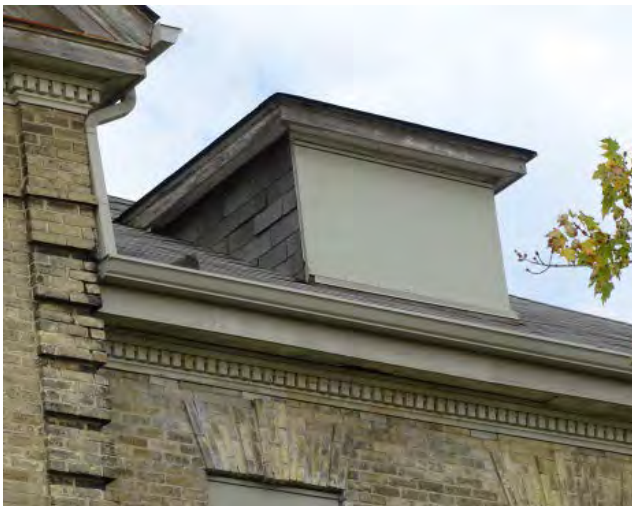
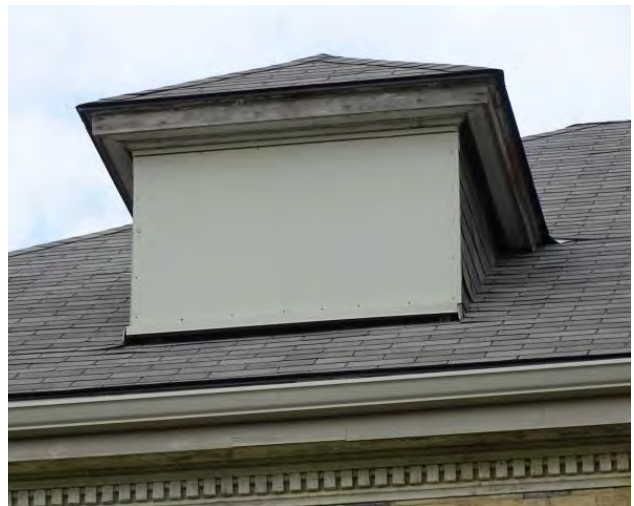
Condition: (Figure No. 178, 179, 180 and 181)

The existing dormers along the ridge of the East and West Roofs are in fair condition with the some lifting of the shingles along the return sides. The front faces have been covered with plywood with an integral metal flashing/sill at the base. There is generally no paint left on the fascias and the wood is grey and weathered. The paint on the soffits has been protected beneath the fascia overhang.
