**Legacy Village Strategic
Conservation Plan – 850
Highbury Avenue North,
London ON**

November 16, 2022

File: 160940807

LEGACY VILLAGE STRATEGIC CONSERVATION PLAN – 850 Highbury Avenue North, London ON

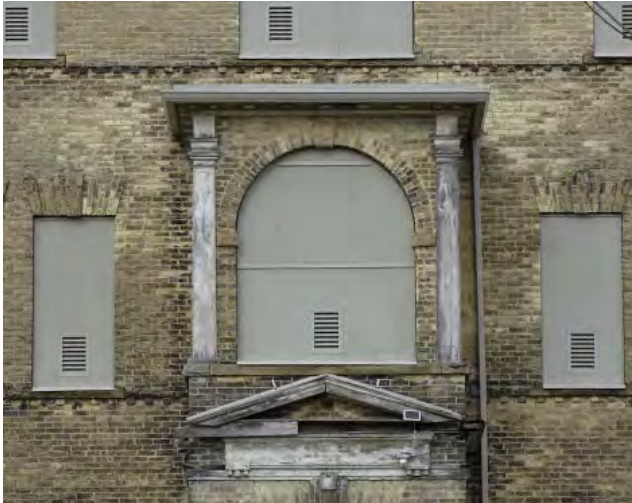
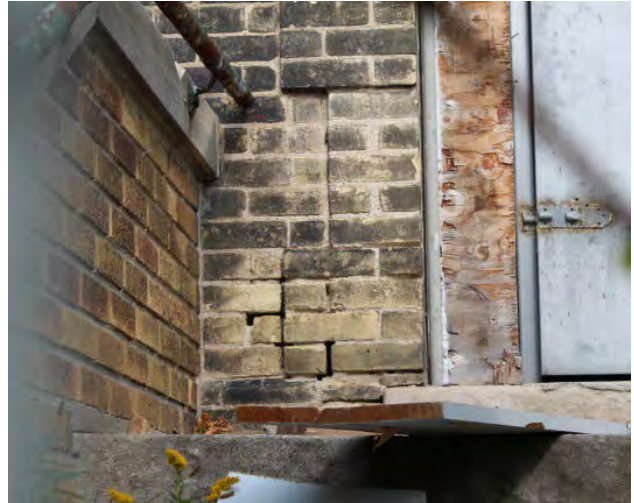
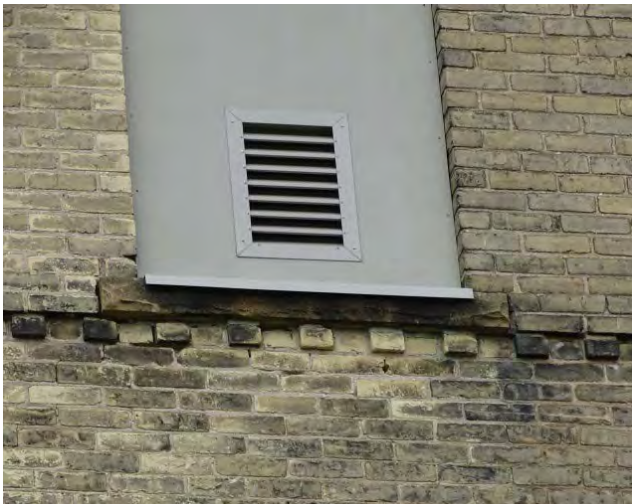
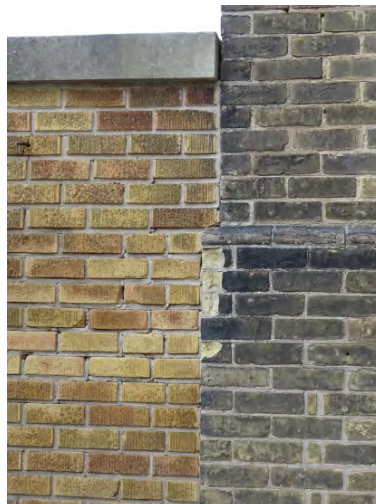
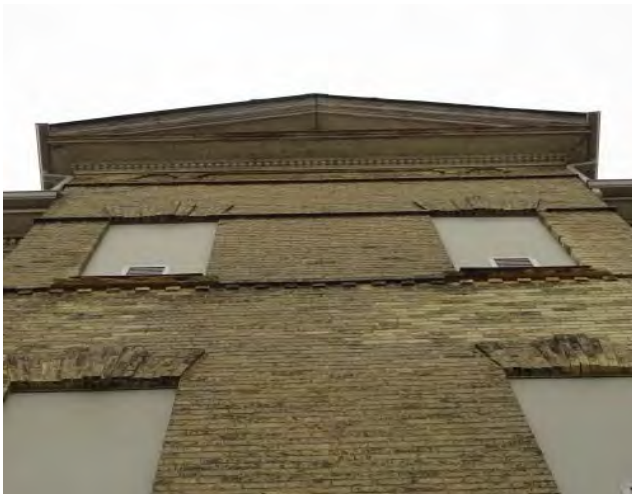
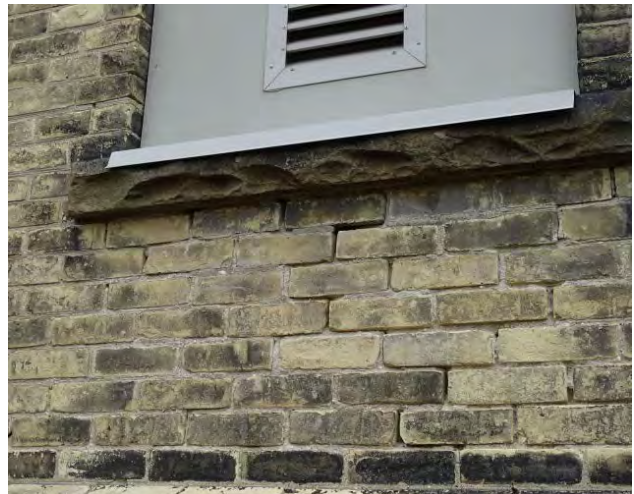
Central Administration Block (Figure No. 182 - 187)

The brick masonry at the main front/south entrance has fared the worse with damage at the missing wood elements and at areas with uncontrolled rainwater control. Within this area there is significant atmospheric staining, open and cracked masonry joints within the brick masonry and damaged/missing brick masonry. Brick masonry on the east side has mechanical damage with the faces of several of the bricks, adjacent to the main entrance staircase, missing. The stonework has discrete open joints and is stained.

The entirety of the main entrance staircase masonry, not original, is in very poor condition with open joints and spalled and missing brick. **Refer to Ramp and Stairs.**

With the exception of the area surrounding the front entrance the masonry walls are generally in fair condition with what is believed to be original mortar joints. Discrete areas of open and cracked masonry joints, often in the areas below the window openings and within the brick lintels, quoining and decorative brick banding exists. Where fittings were removed, openings within the brick have not been repaired. Black atmospheric staining, to various degrees, is evident on the original buff bricks and the rough faced stone sills.

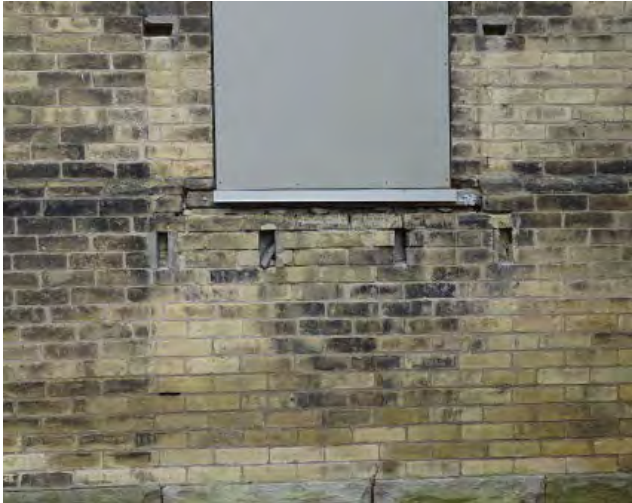
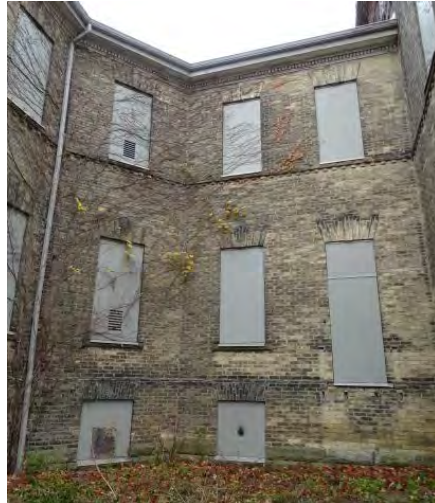
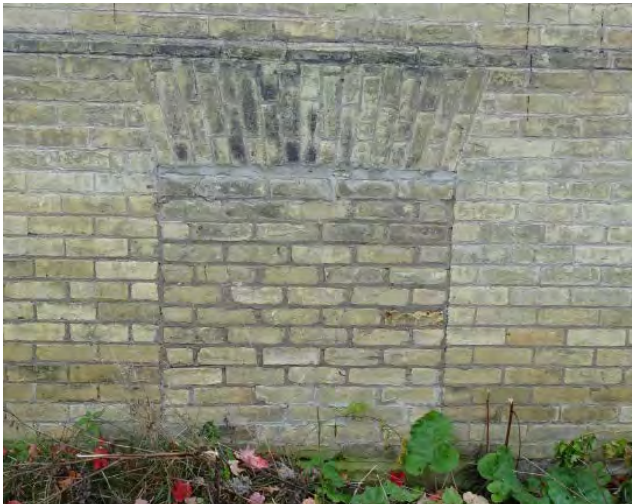
Central Pavilion and Corridors (Figure No. 188 - 193)

A former entrance stair was removed along the west elevation of the South Corridor and the pockets, for the former structure, within the brick masonry remain open and the surrounding mortar joints are open. Openings with the adjacent grade suggests that the supports for the previous stairs/ramp were removed and the areas were not infilled. The staining of the stone courses is primarily organic/green staining.

Several grade level masonry openings on the north elevation of the Pavilion have been infilled with brick. The brick matches the original however the joints' width, mortar, execution and alignment with the original masonry coursing do not. Stains, appearing to be residual asphalt, remain where a former structure/roof was removed on the north side.

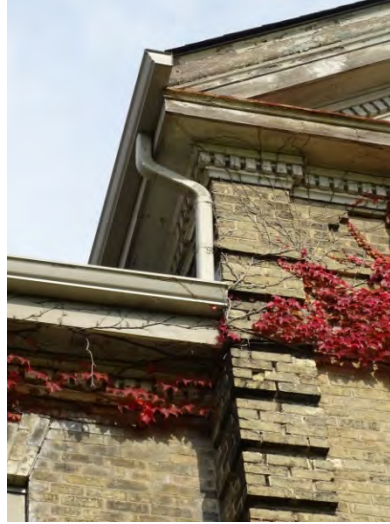
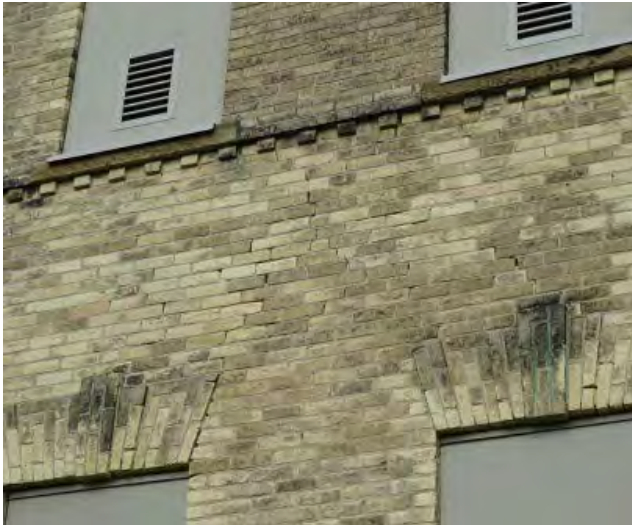
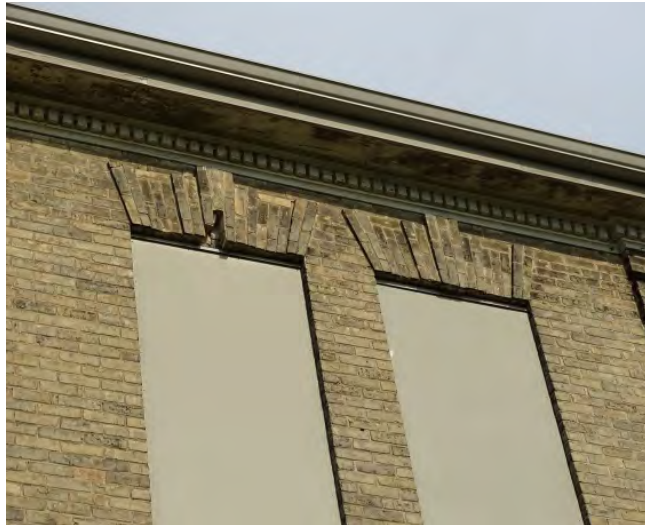
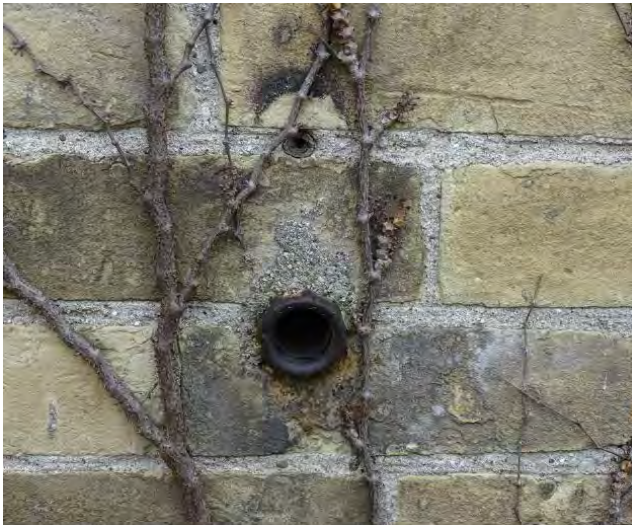
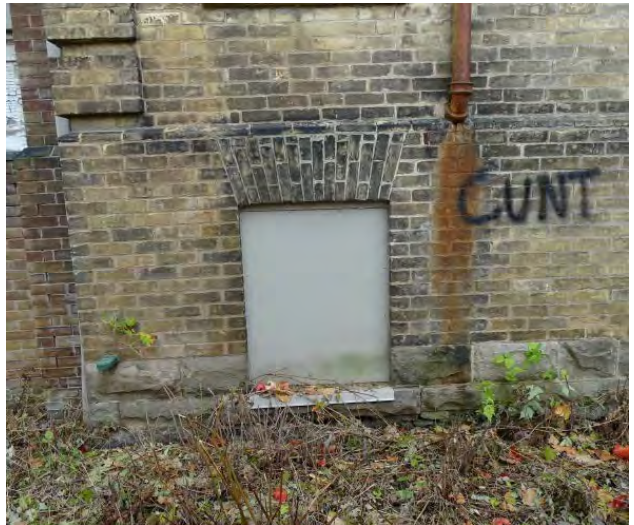
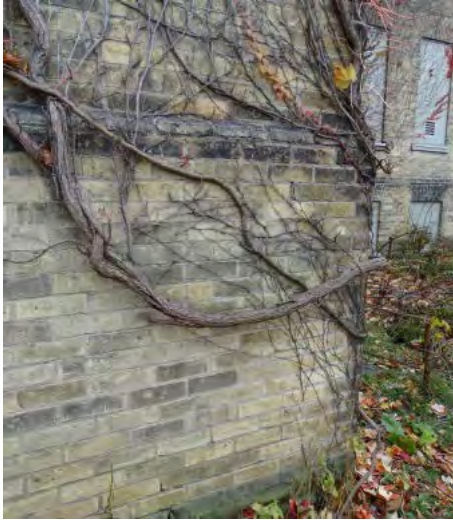
Where fittings were removed or still exist, openings within the masonry have not been repaired. Black atmospheric staining, to various degrees, is evident on the original buff bricks, brick watercourse, brick lintels and the rough faced stone sills.

Areas of rust staining are evident beneath a ferrous pipe on both the brick and stone masonry on the north elevation, adjacent to the east porches.

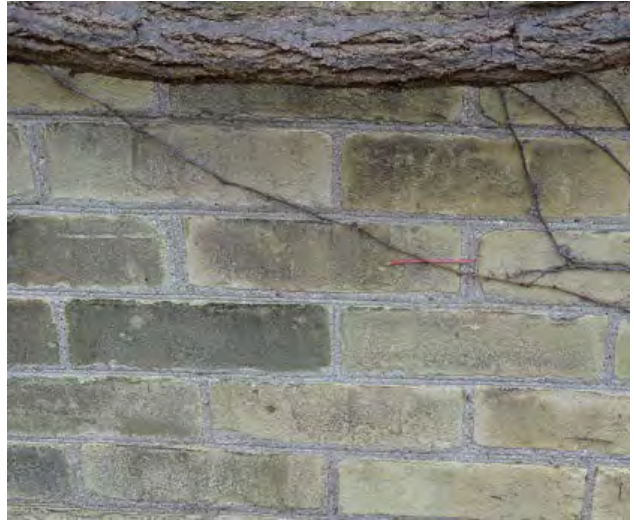
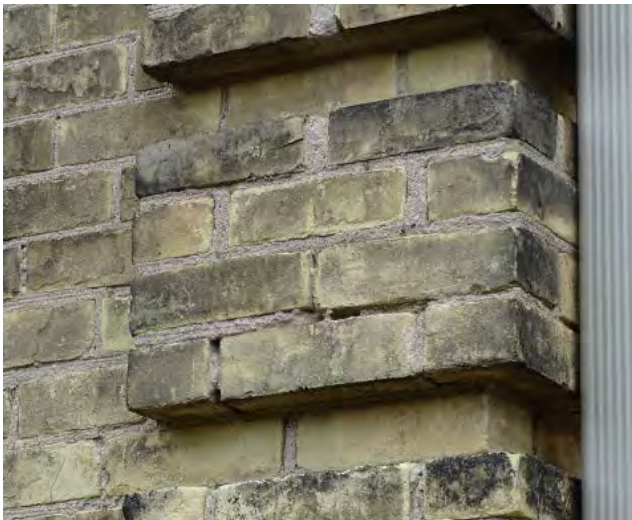
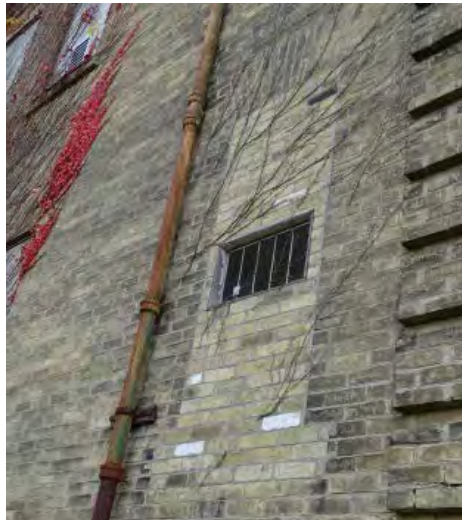
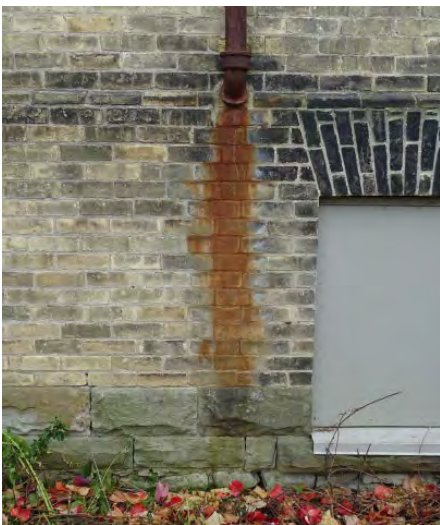
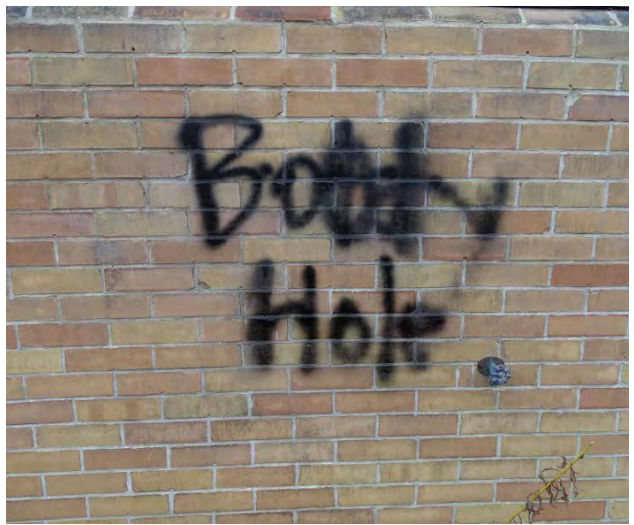
Given the extent of ivy growth along the north and south elevations the review of the masonry was sometimes limited. The masonry walls appear to be generally in fair condition with what is believed to be original mortar joints. Discrete areas of open and cracked masonry joints, often in the areas below the window openings and within the brick lintels, quoining and decorative brick banding exists.

Areas of rust staining are evident beneath a ferrous pipe on both the brick and stone masonry on the north elevation, adjacent to the east porches. Graffiti is evident on the west elevation of the west porches.

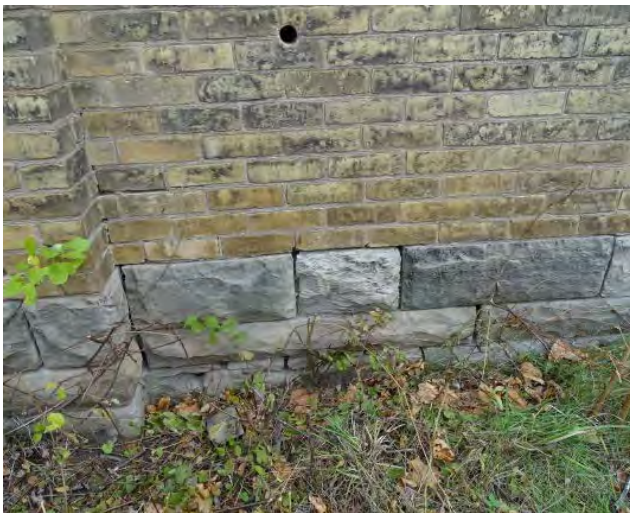
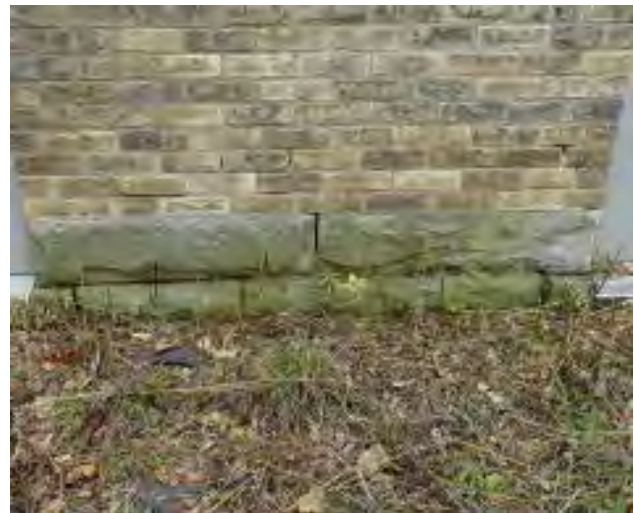
Figure No. 206: Central Administration Block – West Elevation (Photo No. 90.2)

Generally many of the mortar joints are cracked or open within the bottom exposed courses of stone. The broken downspout at the juncture of the main entrance stair and east side of the Central Administration Block has resulted in the greening/organic staining on both the brick and stone masonry. Similarly areas along the west side have both areas of vegetative and atmospheric staining.

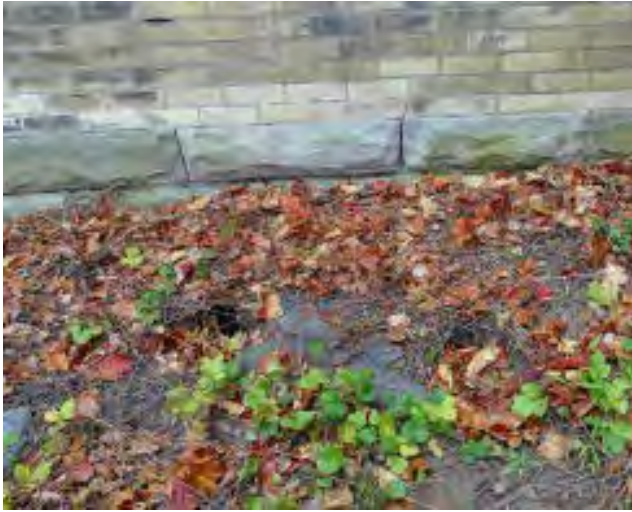
Figure No. 208: Central Pavilion and Corridors – South Corridor – West Elevation (Photo No. 92.1)

Generally many of the mortar joints are cracked or open within the bottom exposed courses of stone. The staining of the stone courses is primarily organic/green staining.

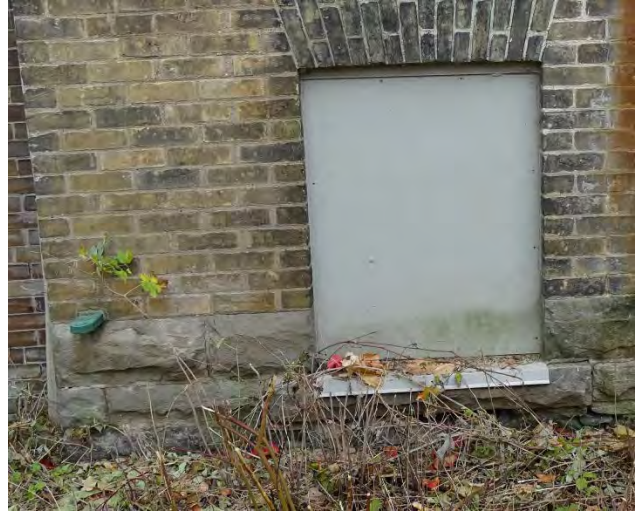
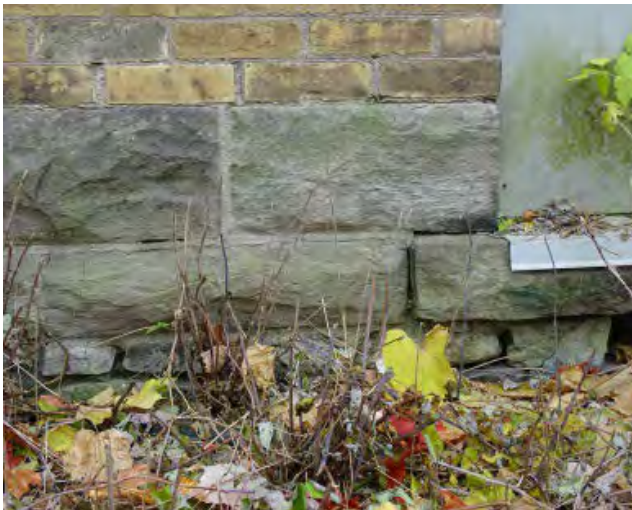
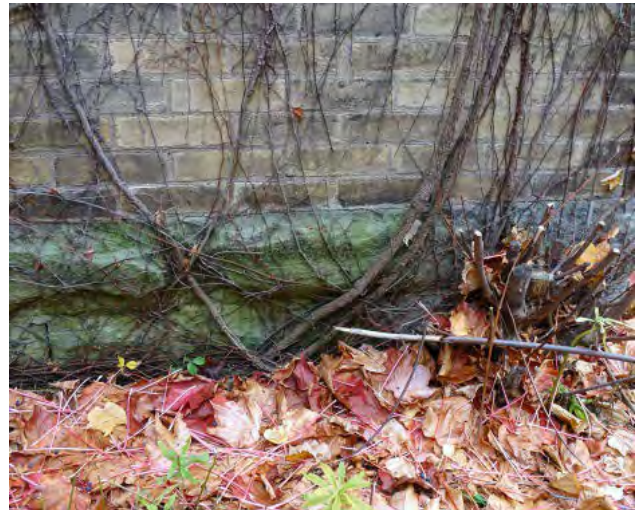
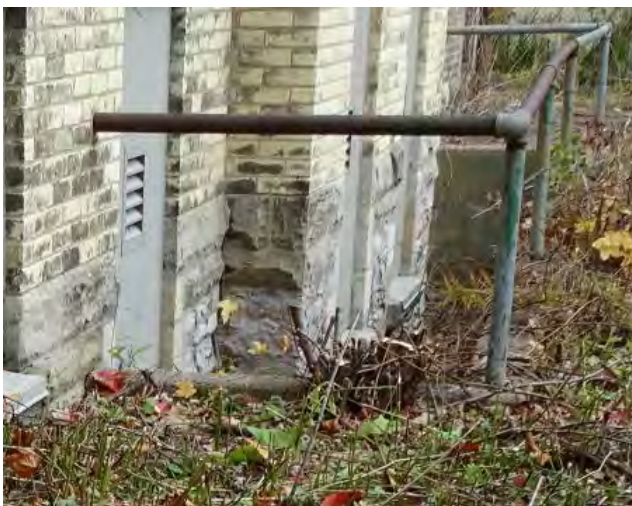
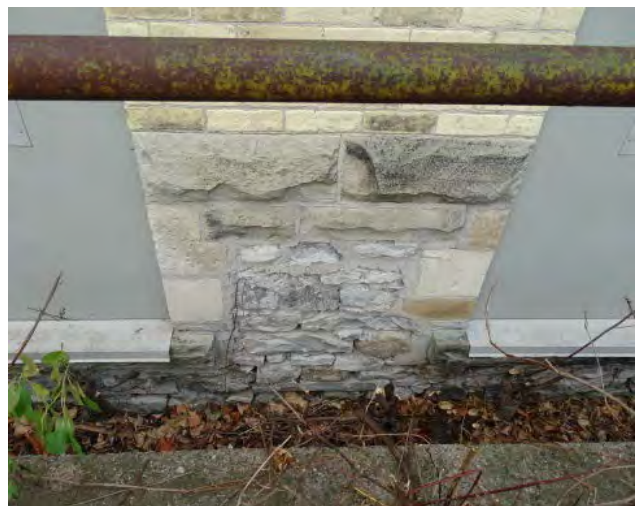
Given the extent of leaves and overgrowth along the north and south elevations the review of the stone base courses was not always feasible. However where viewed many of the mortar joints are cracked or open within the bottom exposed courses of stone and portions of the rubblestone foundation are missing. The substantial trunks of the ivy growth, in close proximity to the base of the structure, has resulted in damage and discrete areas of displaced stonework. The staining of the stone courses is primarily organic/green staining.

Areas of rust staining are evident beneath a ferrous pipe on both the brick and stone masonry on the north elevation, adjacent to the east porches.

A window well on the south elevation, surrounded by a metal guard at grade, shows the original rough stone coursing, dressed/smooth faced quoining at the masonry openings and open joints within the rubblestone foundation.

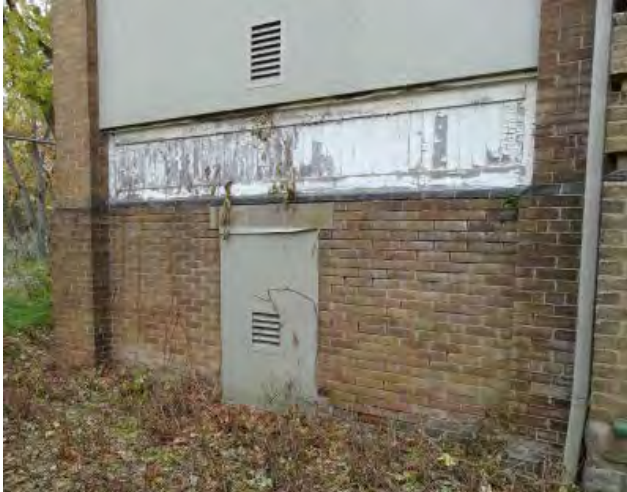
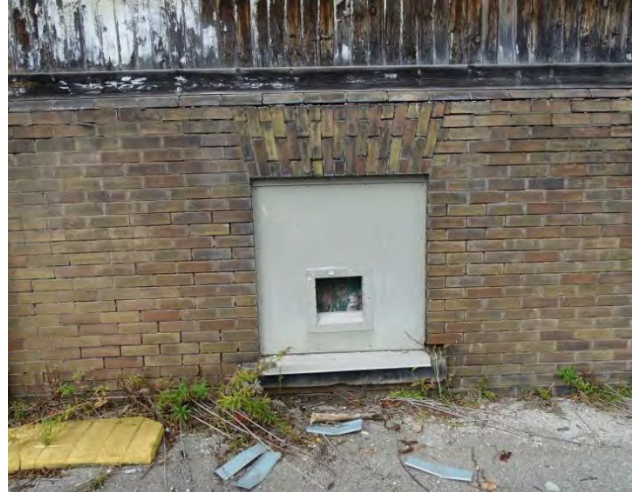
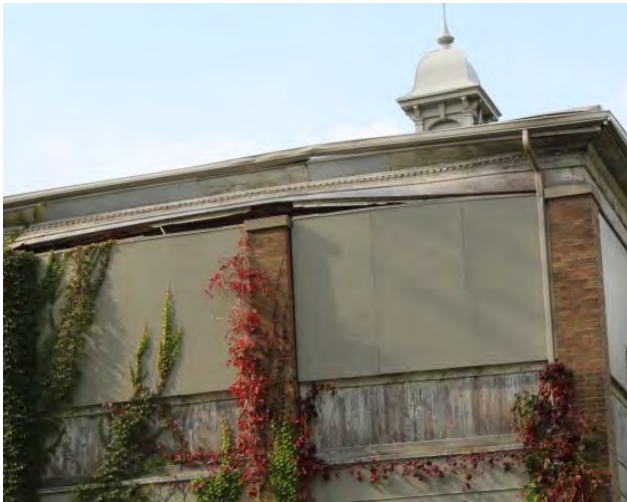
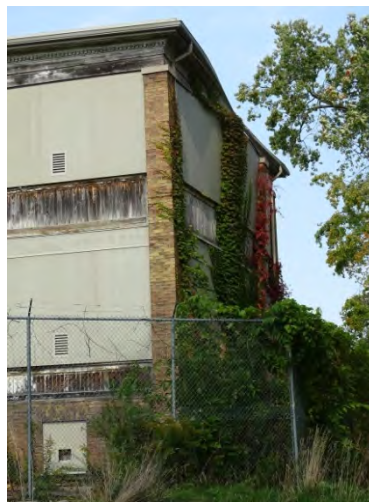
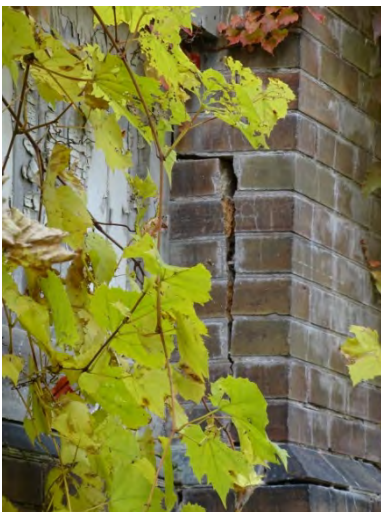
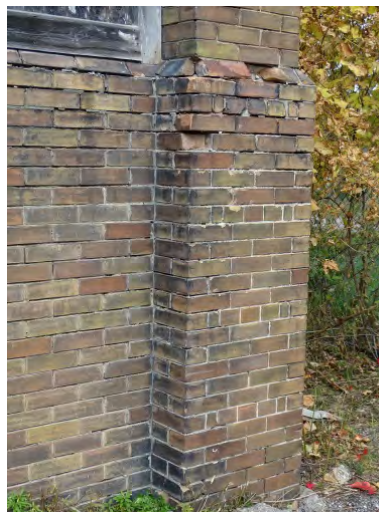
The brick generally extends to grade at the east porches. The condition of the east porches, cited in the Conservation Plan, London Psychiatric Hospital, London, Ontario (December 2008), has further decayed and the entirety of the porch structure, inclusive of masonry and wood elements, has pulled away from the east wing and is in an advanced state of structural collapse. The masonry has open joints and spalled, missing and displaced masonry.

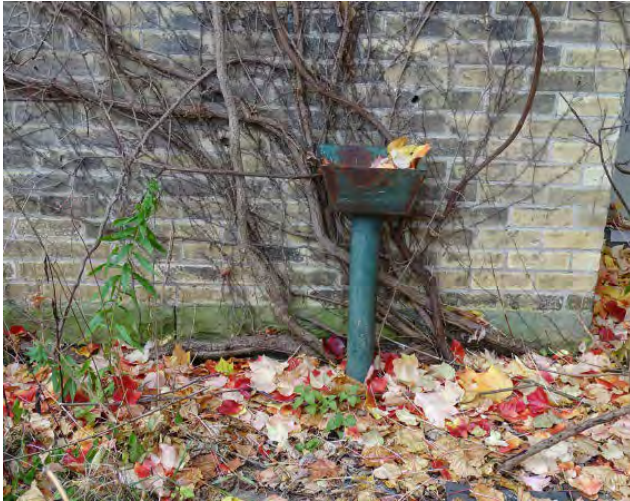
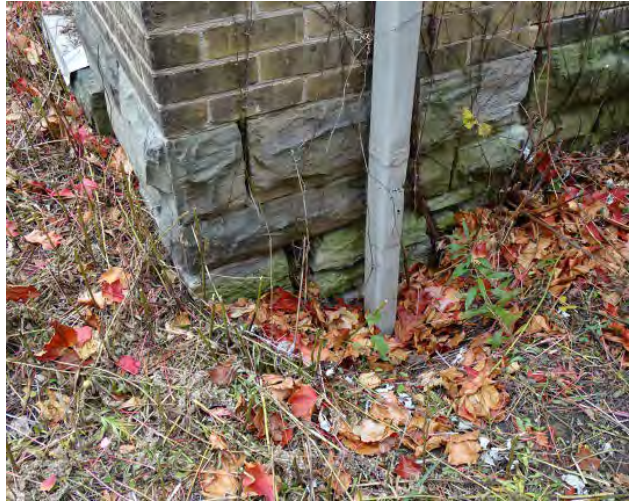
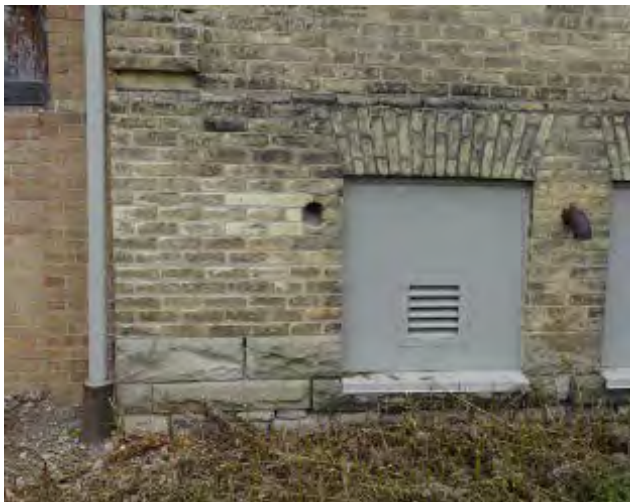
Given the extent of leaves and overgrowth along the north and south elevations the review of the stone base courses was not always feasible. However where viewed many of the mortar joints are cracked or open within the bottom exposed courses of stone and portions of the rubblestone foundation are missing. The substantial shoots of the ivy growth in close proximity to the base of the structure has resulted in damage and discrete areas of displaced stonework. The staining of the stone courses is primarily organic/green staining.

A former basement entrance on the north elevation, surrounded by a metal guard at grade, shows the original rough stone coursing, open joints within the rubblestone foundation and both organic (green) with some indication of efflorescence (white) staining.

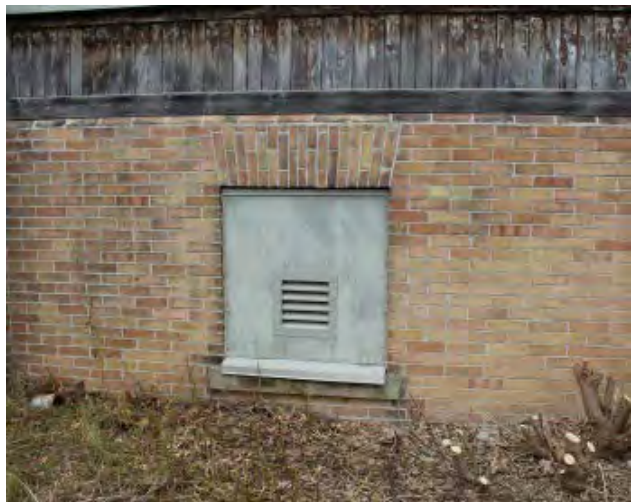
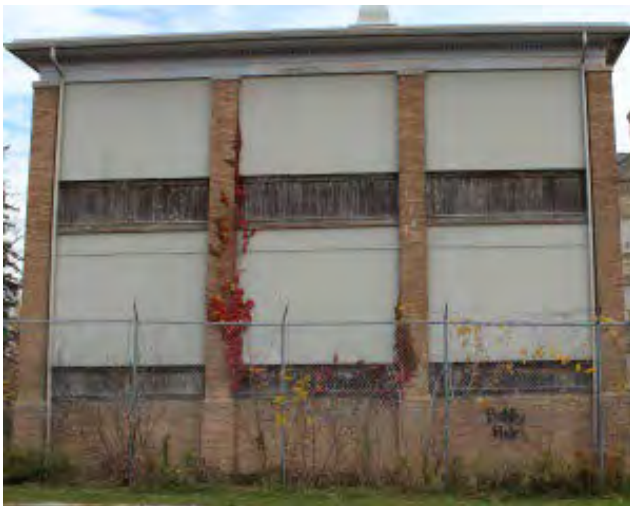
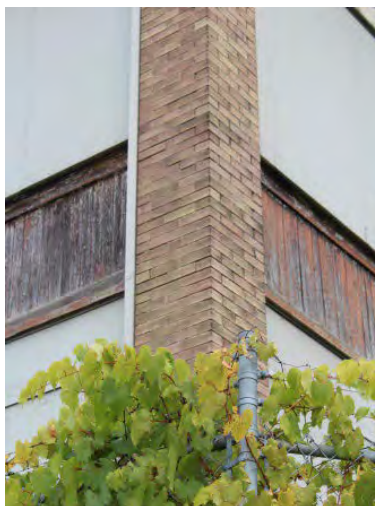
The brick generally extends to grade at the west porches. The west porches have fared better than those on the east wing with generally no open masonry joints or masonry damage adjacent to grade.

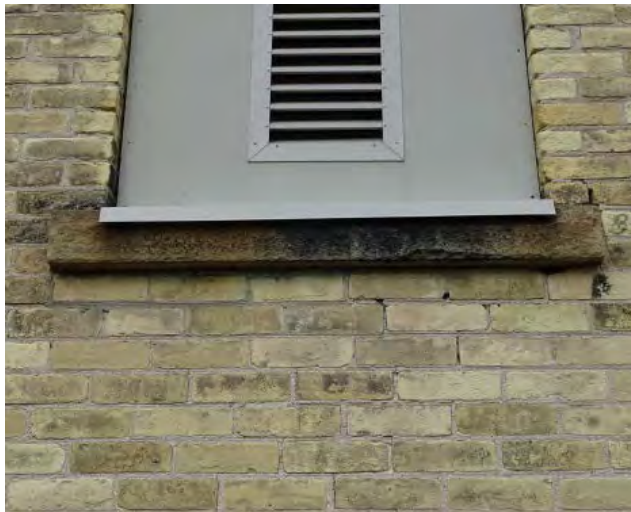
Figure No. 260: Stained Sill Detail (Photo No. 106.34)

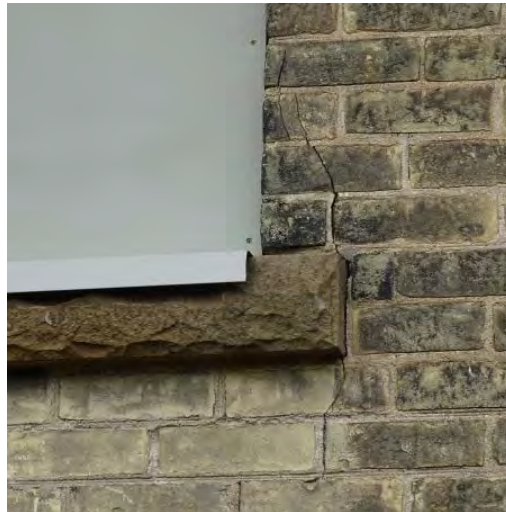
Figure No. 261: Crack at Sill (Photo No. 106.35)

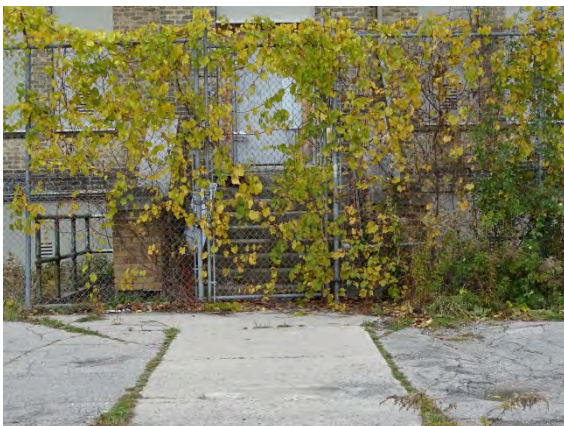
Figure No. 272: Central Administration Block – Entrance – South Elevation (Photo No. 108.0)

The front entrance staircase, complete with a basement entrance, is not original to the structure and was constructed with concrete steps with yellow brick walls topped with stone capstones. A single light remains above both the basement and main entrance. As previously noted the entirety of the main entrance staircase is in very poor condition.

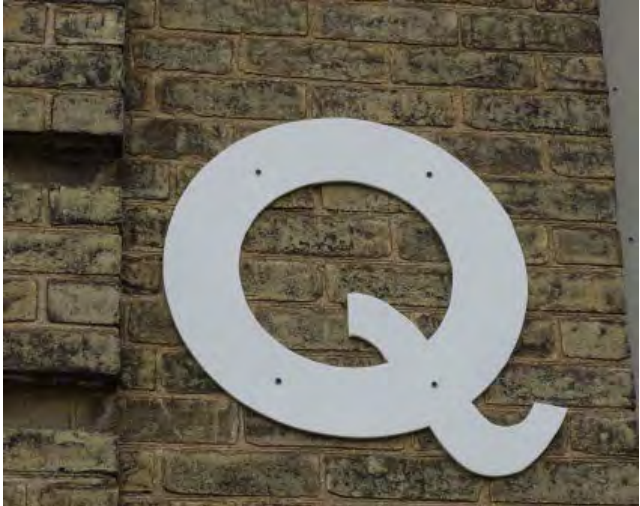
Figure No. 280: Central Administration Block – South Elevation (Photo No. 113.0)

The Infirmary has 2 type of signages: a letter Q located on the south elevation beside the front entrance (typical building signage on the site) and a no parking sign. The Q signage is in fair condition while the no parking is weathered and faded.

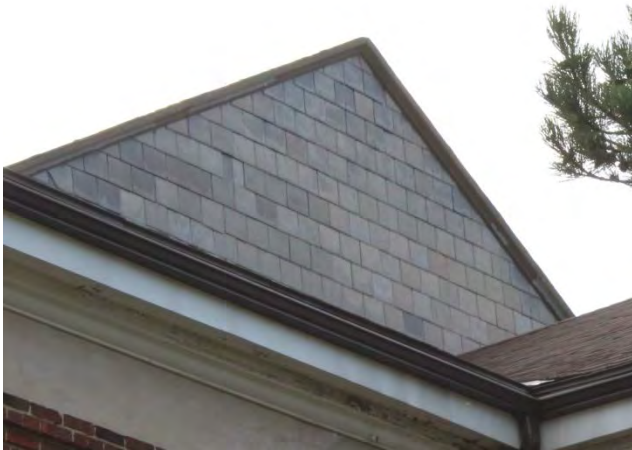
Figure No. 283: North Gable Slate Detail (Photo No. 5.1)

Tucked behind the central block frontispiece the north facing gable has what is believed to be the last remaining area of original slate roofing. The slate appears to be intact and in fair condition.

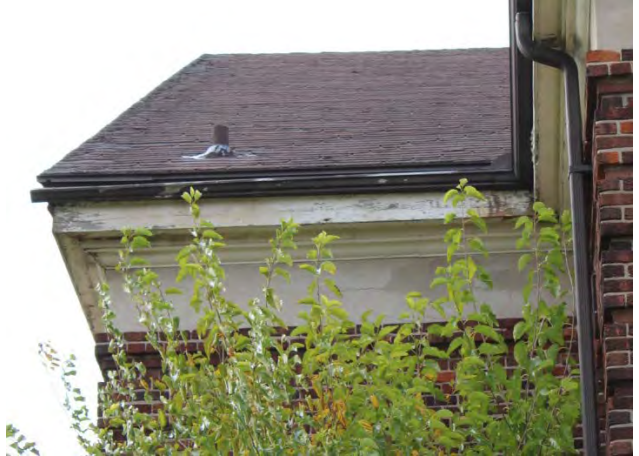
Figure No. 284: East Elevation Main Roof South of Rear East Wing (Photo No. 6.3)

The age of the brown asphalt shingles is not known. The shingles on the east side of the main roof and the frontispiece are in poor to fair condition and showing signs of loss of the top surface and the shingles are beginning to curl.

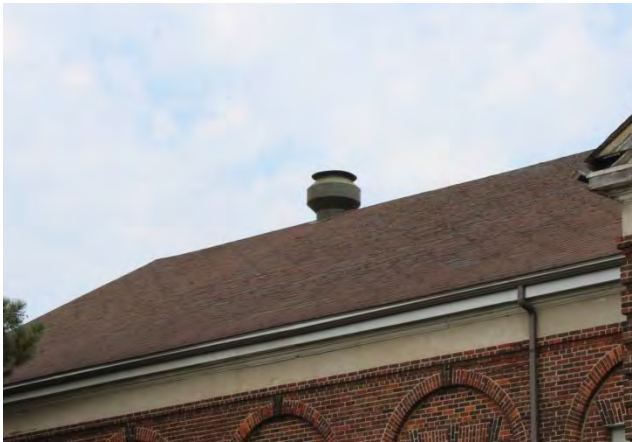
Figure No. 285: West Elevation Main Roof (Photo No. 8.1)

The age of the brown asphalt shingles is not known. The shingles on the west side of the main roof and the frontispiece are in poor to fair condition and showing signs of loss of the top surface and the shingles are beginning to curl.

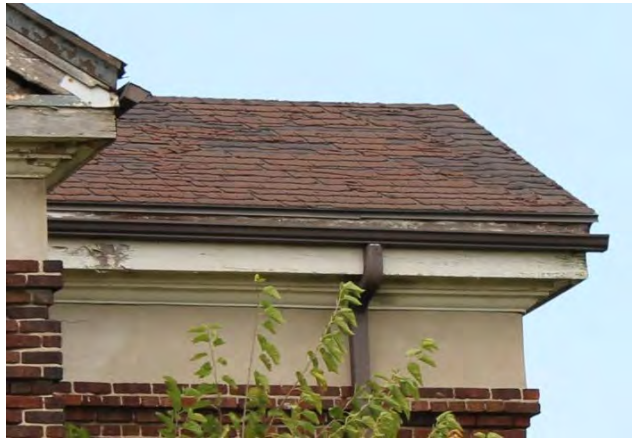
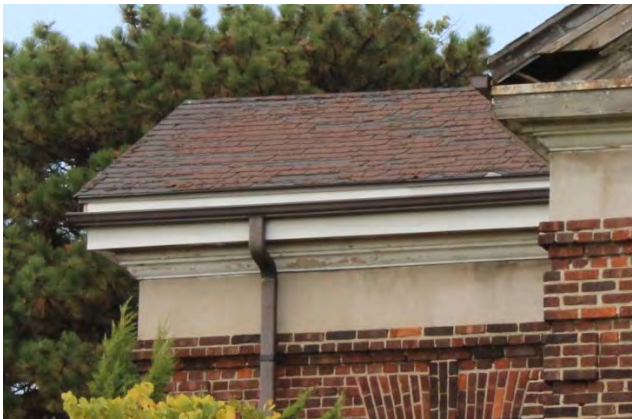
The age of the brown asphalt shingles is not known. The shingles on the front and rear flanking wings are in poor to fair condition and showing signs of loss of the top surface and the shingles are beginning to curl.

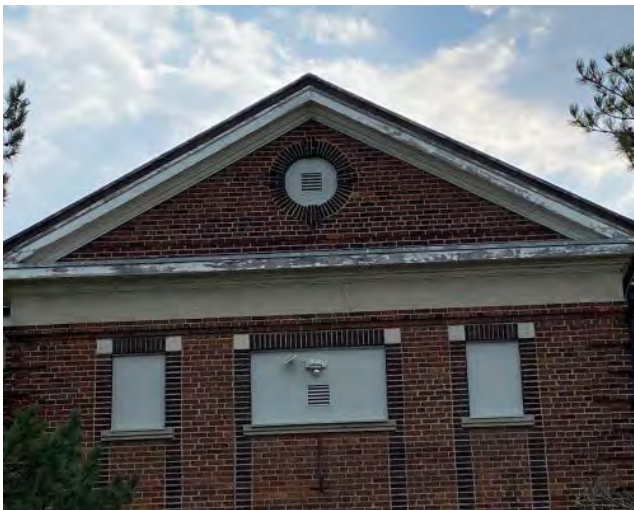
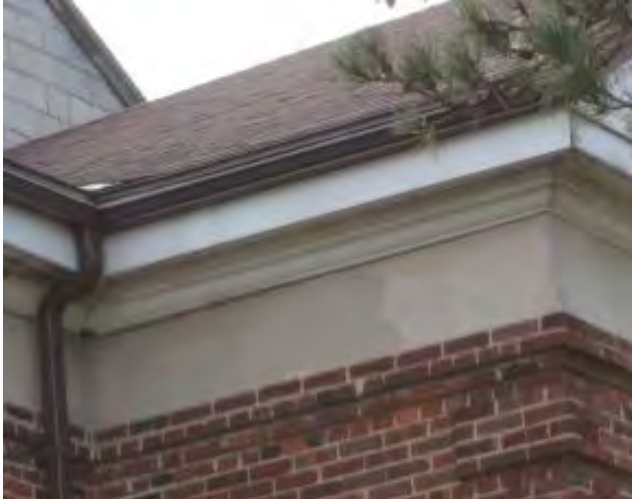
Generally the wood fascia board appears to be intact and in fair condition. Staining and damage is generally limited to the underside of the wood soffit and along the intersection of the soffit and decorative plaster band on the east elevation of the main roof. A section of the wood trim above the decorative plaster band has started to lift. The decorative plaster band appears to be in fair condition.

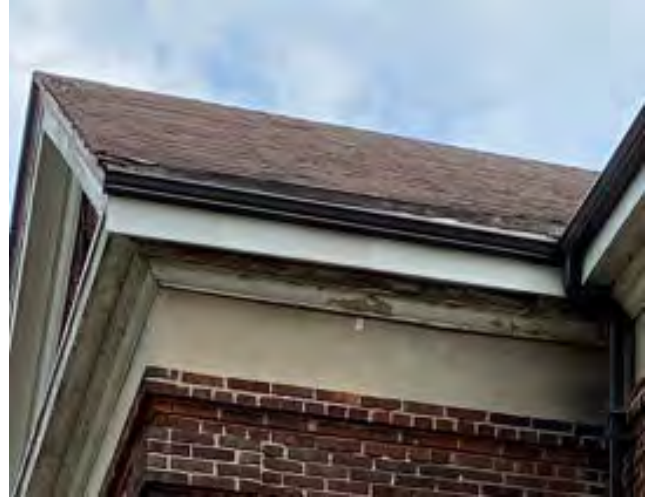
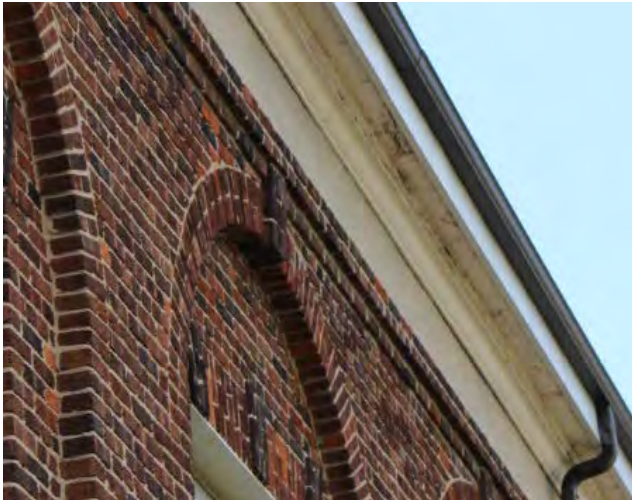
Generally the wood fascia board appears to be intact and in fair condition. Staining and damage is generally limited to the underside of the wood soffit and along the intersection of the soffit and decorative plaster band on the west elevation of the main roof. At the intersection of the front flanking wing and the west elevation a portion of the soffit is missing and there are pine needles within the gutter above. A section of the wood trim above the decorative plaster band has started to lift.

The decorative plaster band appears to be in poor condition with hair line and larger cracking, surface pitting and discolouration.

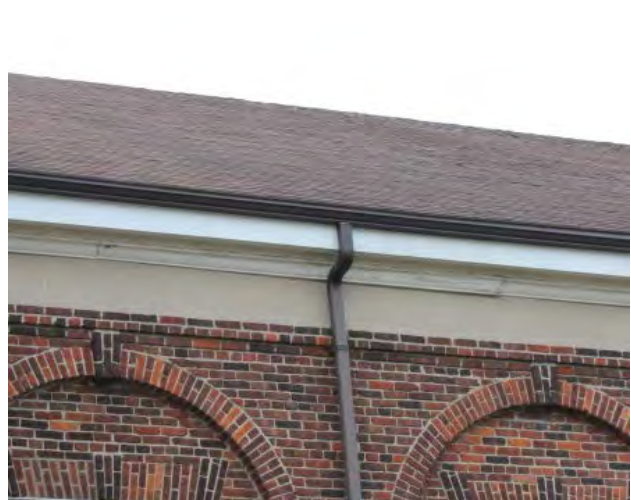
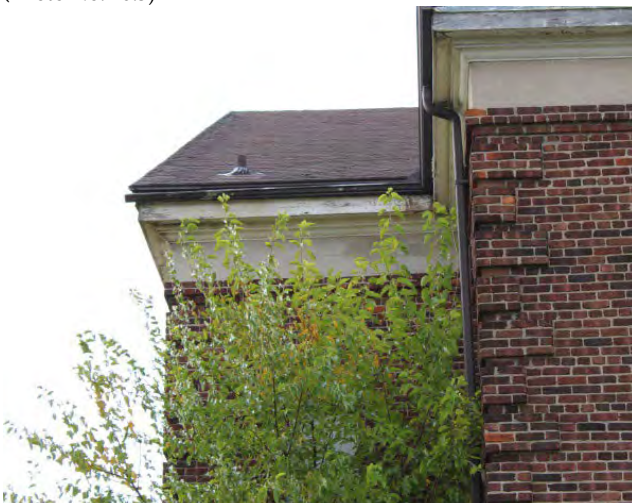
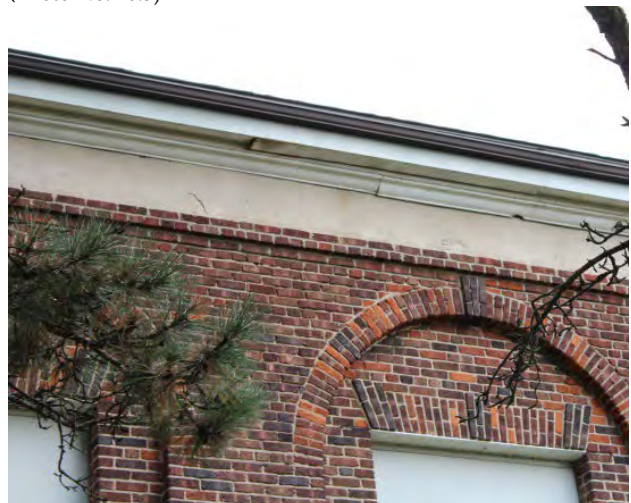
The wood fascia and bargeboard on the south gable have little or no paint and are in poor condition. On both the east and west sides where the wood detailing on the gable ends ties into the horizontal returns the fascias are open and both fascia and soffits are missing. The adjacent metal flashing that caps the horizontal wood detailing is rusted and the fascia boards have little or no paint and are grey and weathered.

The decorative plaster band at each horizontal return appears to be in fair condition though some discolouration and surface pitting on the west side is evident.

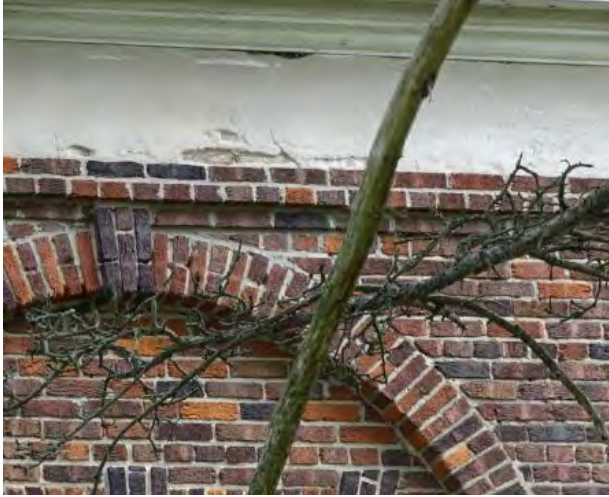
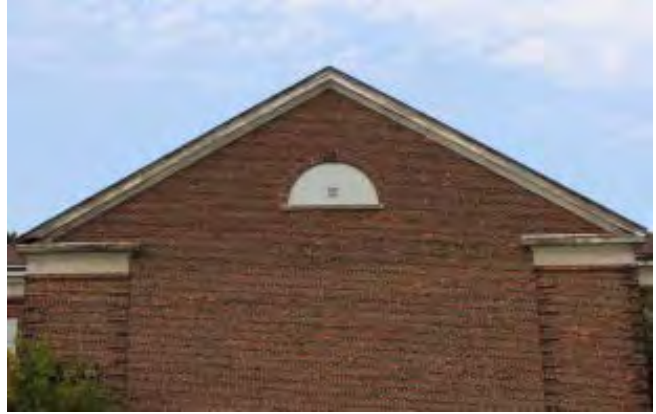
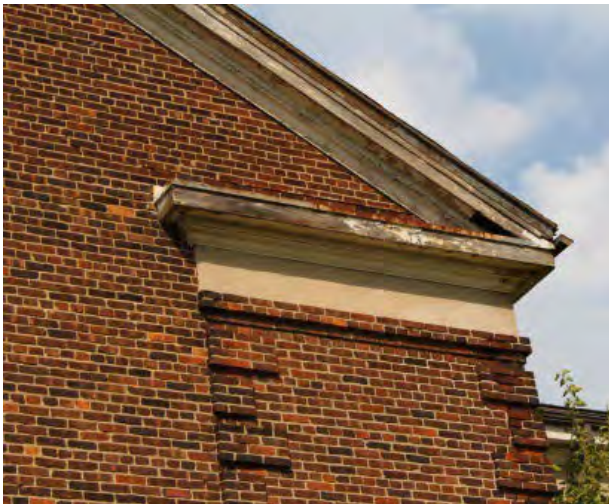
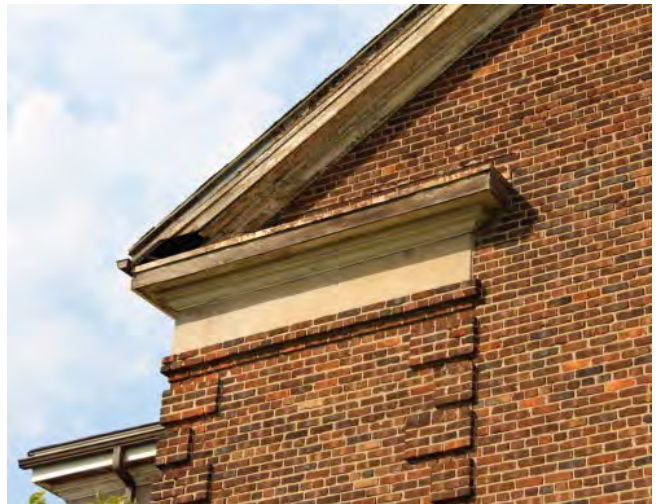
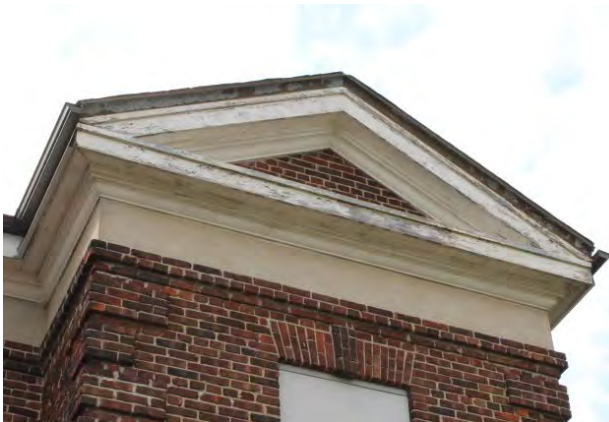
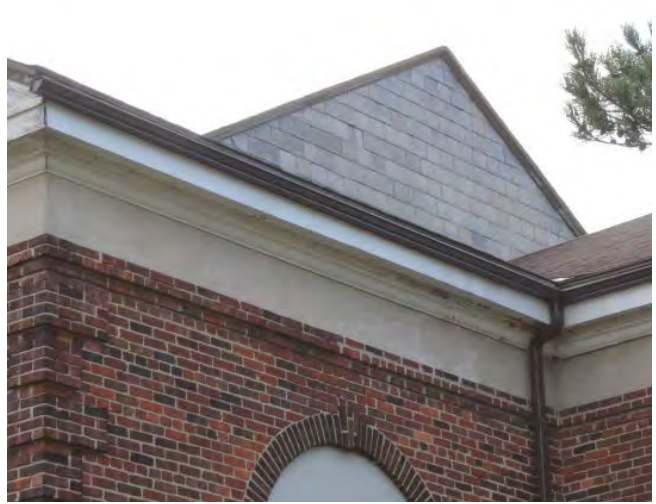
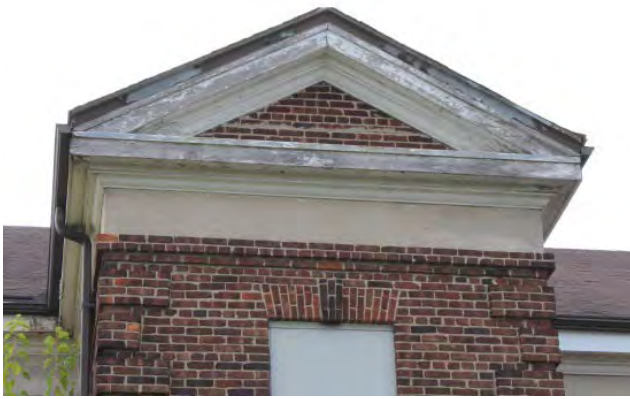
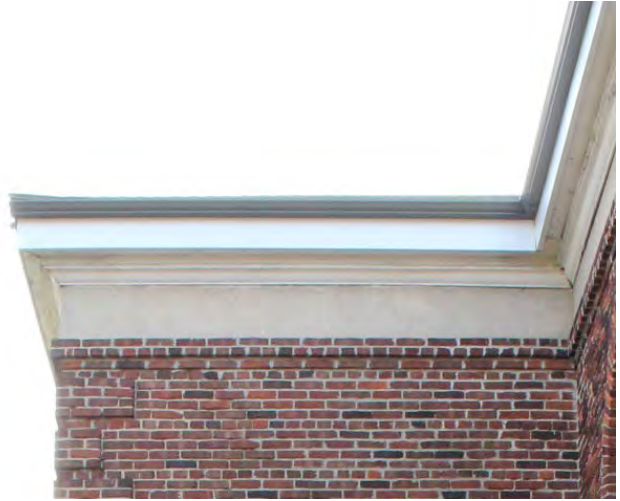
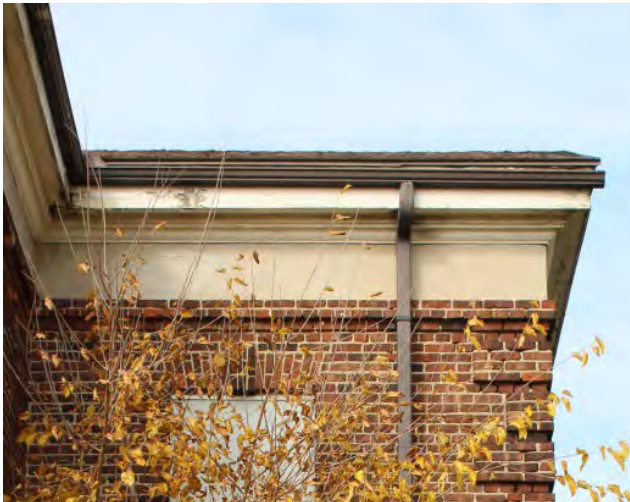
Generally the woodwork, fascias and soffits on the east facing pediments of the front and rear flanking wings appears to be intact though the majority of the paint appears to be weathered and starting to show exposed woodwork. The protected fascia boards (beneath the gutters) on the return sides of the wings appears to be in fair condition. The decorative plaster band appears to be in fair condition with some discolouration.

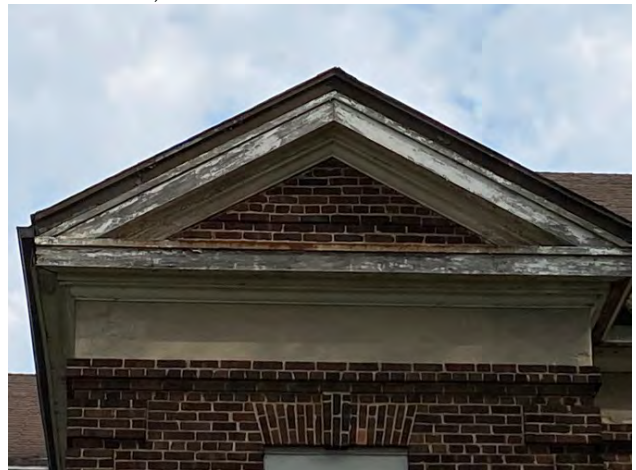
Figure No. 308: Frontispiece West Wing West Pediment (Photo No. 12.1)

The wood fascia and bargeboard on the west pediment of the front flanking wing have little or no paint and are in poor condition. The adjacent metal flashing that caps the horizontal wood detailing is rusted and the adjacent fascia boards have little or no paint and are grey and weathered. The decorative plaster band appears to be in fair condition with some discolouration.

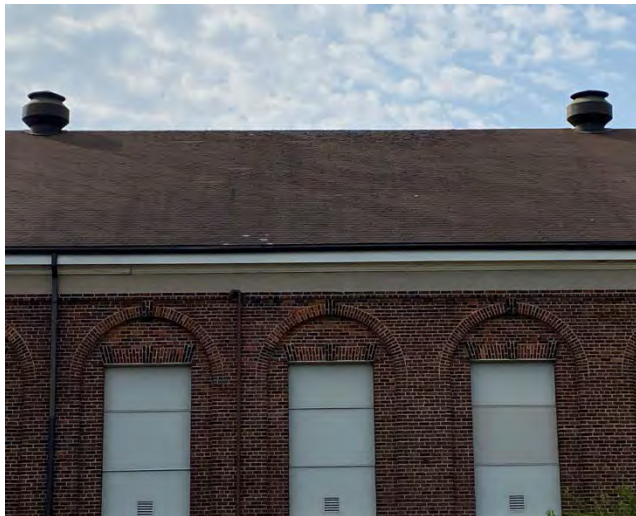
Figure No. 313: Ventilator (Photo No. 17.0)

The existing roof ventilators (2) along the ridge of the main roof appear to be in fair to good condition.
