**Legacy Village Strategic
Conservation Plan – 850
Highbury Avenue North,
London ON**

November 16, 2022

File: 160940807

LEGACY VILLAGE STRATEGIC CONSERVATION PLAN – 850 Highbury Avenue North, London ON

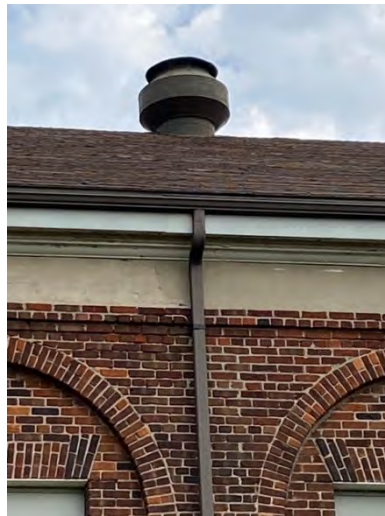
The existing roof ventilators (2) along the ridge of the main roof appear to be in fair to good condition.

Figure No. 314: Ventilator Detail (Photo No. 17.1)

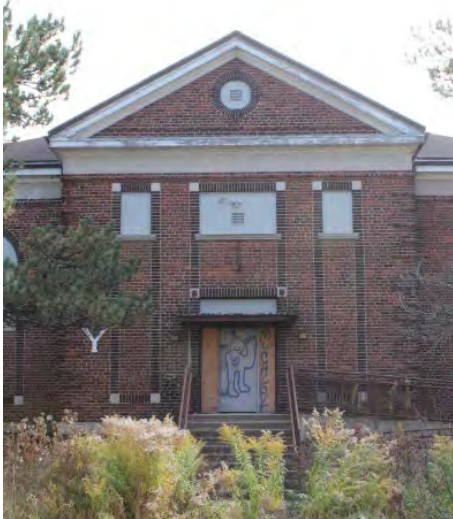
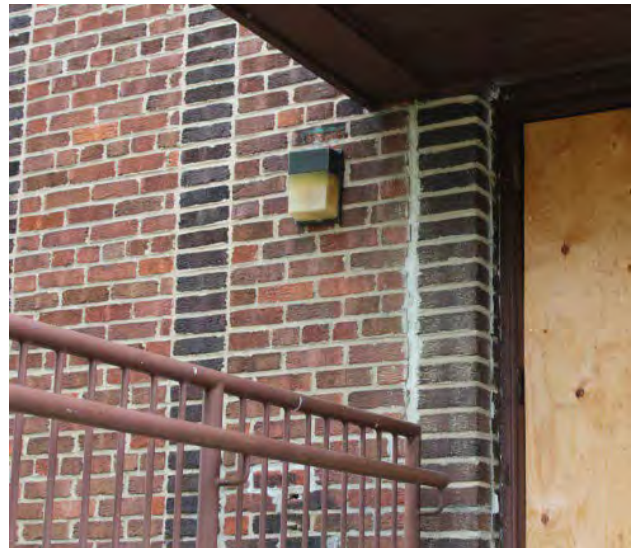
The masonry walls on the north elevation are generally in good condition. Though the edges or arrises of the bricks are rough and some of the corners of the bricks are missing the adjacent mortar generally appears undisturbed and possibly the bricks were imperfect when originally laid within the walls. Discrete areas of repointing are visible including an area of vertically stacked brick/stretchers to the east of the front entrance.

Figure No. 315: North Elevation Frontispiece, Front Entrance (Photo No. 18.0)

Figure No. 316: North Elevation Frontispiece, Front Entrance Detail (Photo No. 18.1)

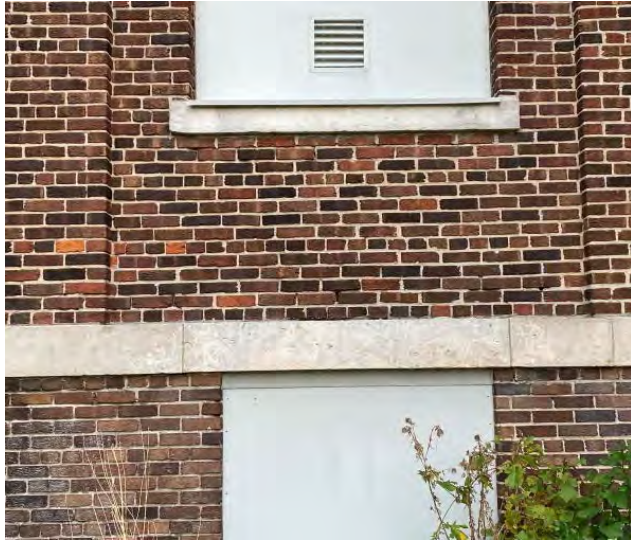
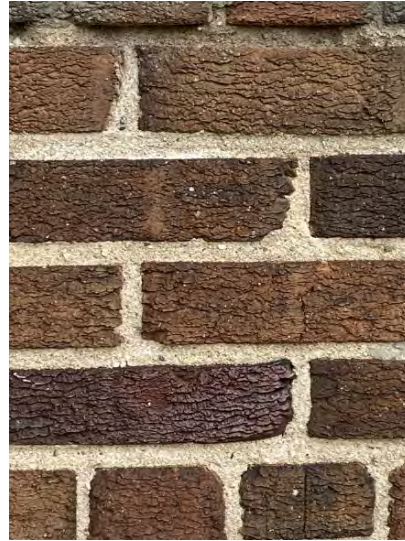
The masonry walls on the east elevation are generally in good condition. Though the edges or arrises of the bricks are rough and some of the corners are missing the adjacent mortar generally appears undisturbed and possibly the bricks were imperfect when originally laid within the walls. Discrete areas of open joints were noted within the flat headed brick arches and steel lintels above the windows and adjacent to the downspout towards the north side.

The stone sills beneath the windows on the east elevation are in poor condition and consistently have cracked horizontally though some also have vertical cracks. Light spalling of the face of the horizontal band of stone above the basement windows has occurred. Discolouration/staining of the stone band is consistent on all elevations.

Figure No. 317: East Elevation Stone Band Detail (Photo No. 19.1)

Figure No. 318: Typical Brick Coursing and Mortar (Photo No. 19.4)

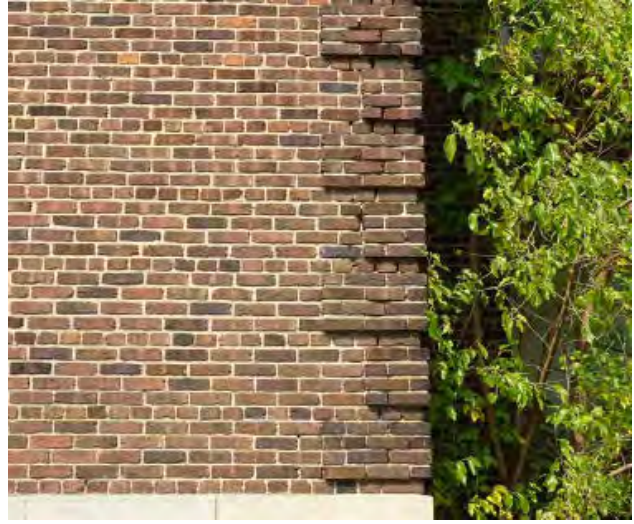
The masonry walls on the south elevation are generally in fair to good condition with the exception of the east corner brick quoining where there are open and cracked mortar joints, displaced/shifted masonry, a rusted metal fitment and an open penetration thru the masonry.

Figure No. 324: South Elevation East Corner Brick Quioning Detail (Photo No. 20.4)

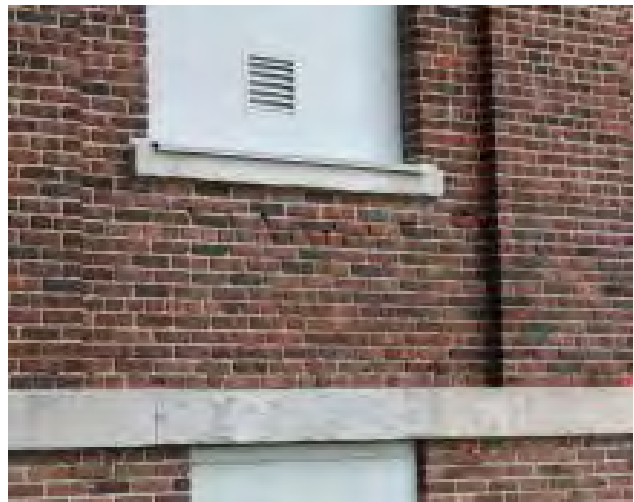
The masonry walls on the west elevation are generally in fair to good condition with the exception of the brick masonry adjacent to the rain water leaders/ below the stone band, brick

Figure No. 326: West Elevation (Centre) Stone Band Detail (Photo No. 21.3)

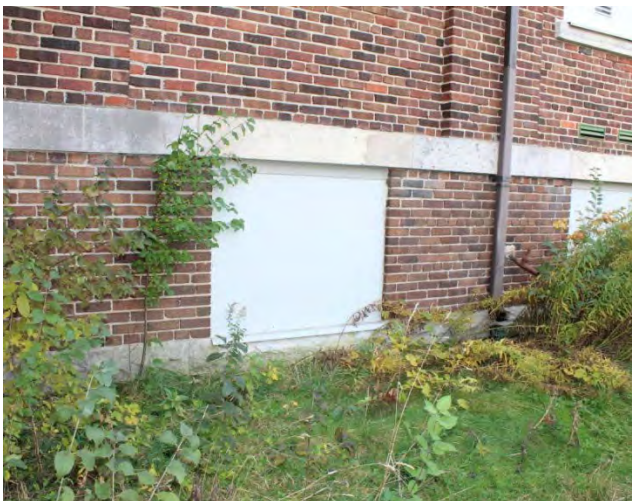
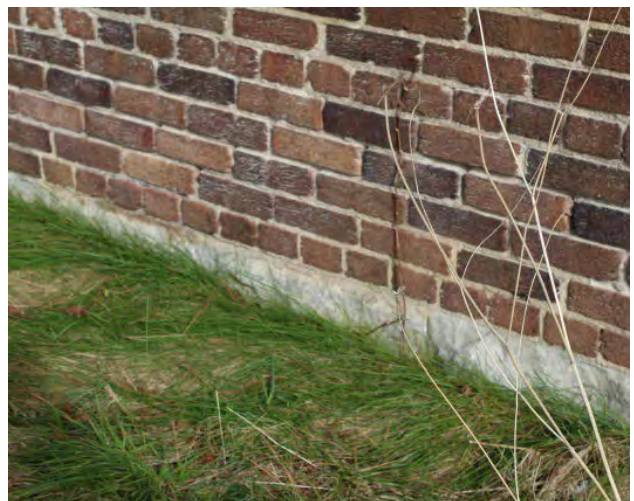
The single course of rough faced stone, where visible at grade, is in good condition on all elevations.

Figure No. 327: East Elevation Foundation (Photo No. 23.0)

Figure No. 328: West Elevation Foundation (Photo No. 25.0)

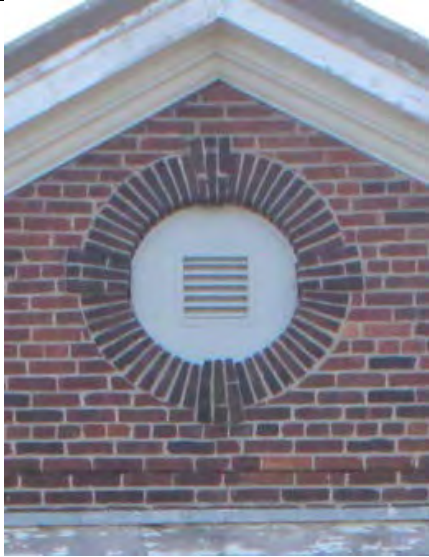
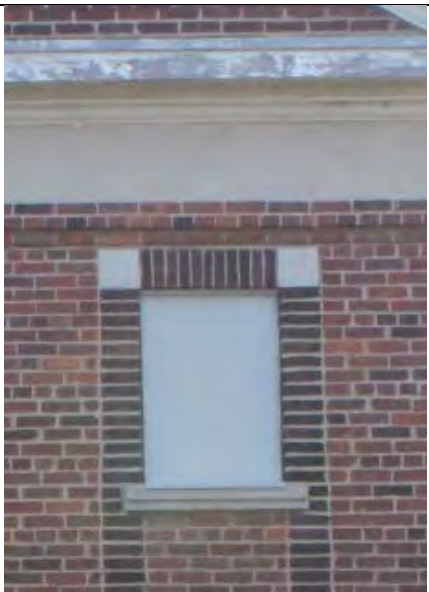
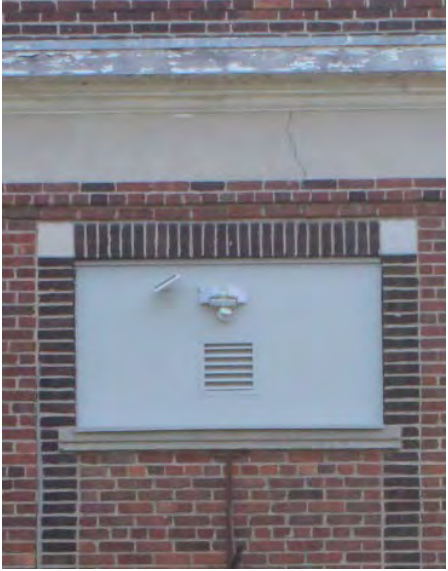
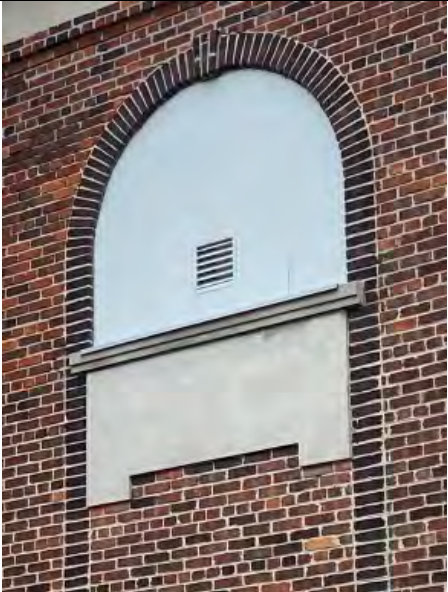
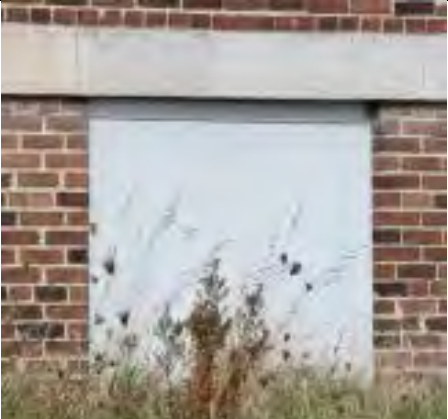
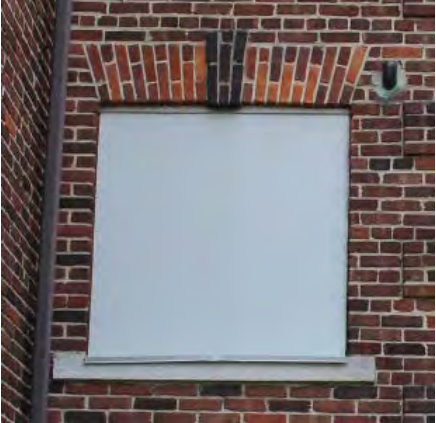
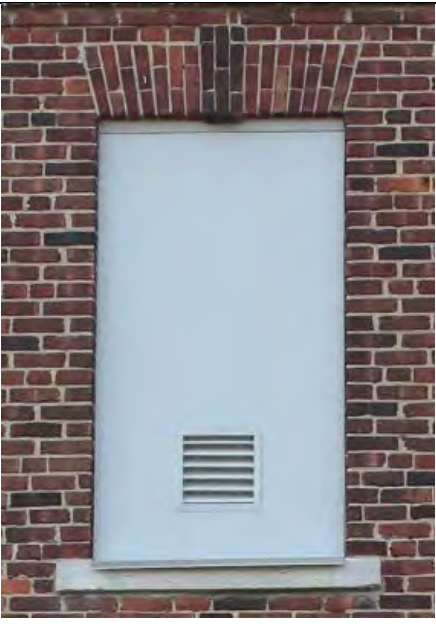
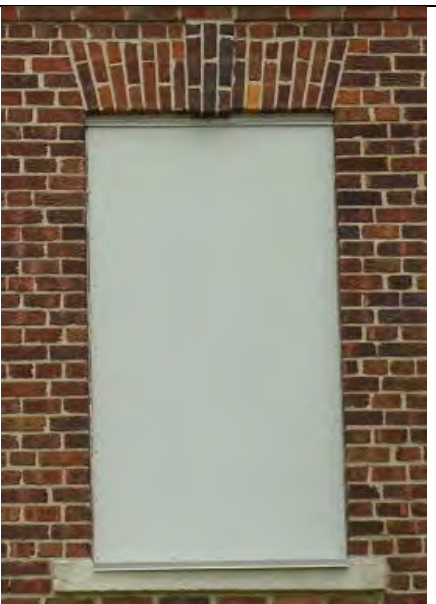
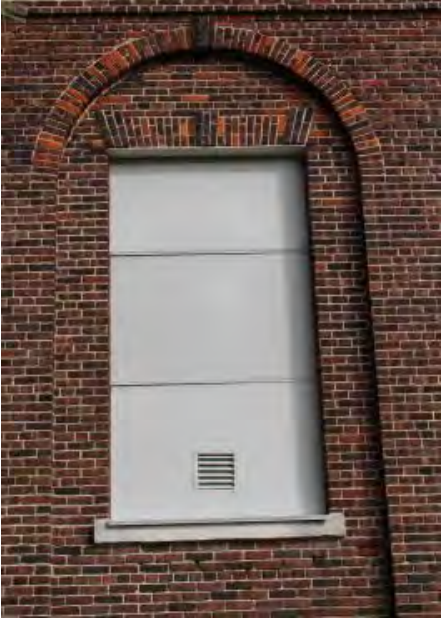
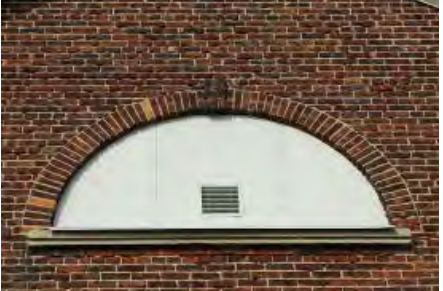
The following table has broken down the windows into various types, elevation where located and number of the specific windows per type. Given that the windows had been previously boarded during the mothballing of the structure and access to the interior was not possible detailed descriptions and condition assessments of the windows is limited and/or non-existent.

One plywood opening appeared to have been pried open and was reported at the time of the site visit.

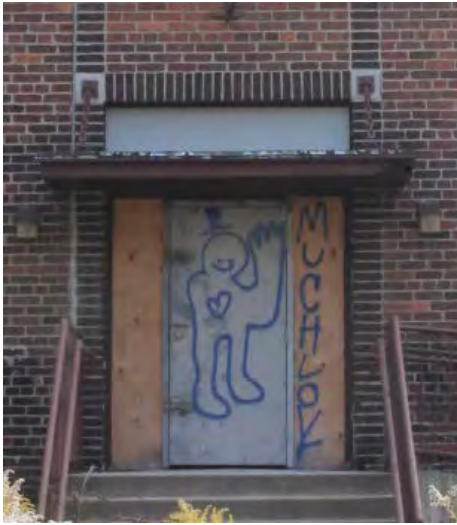
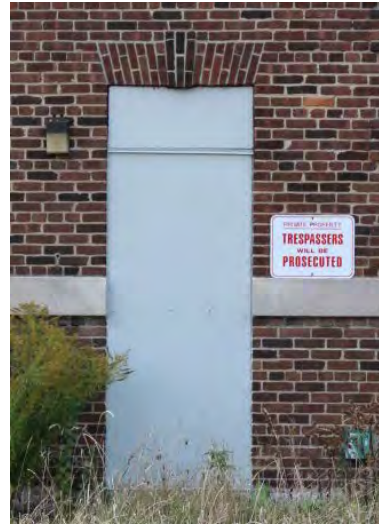
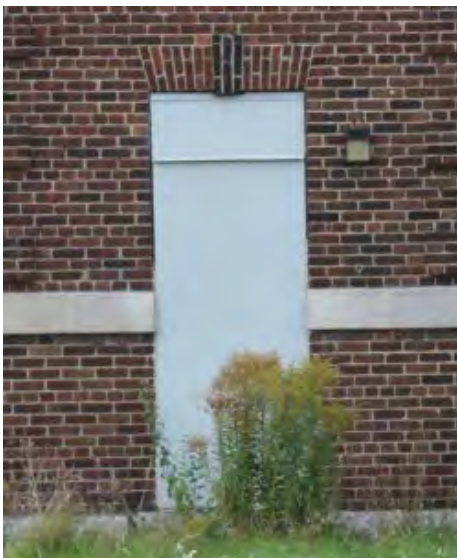
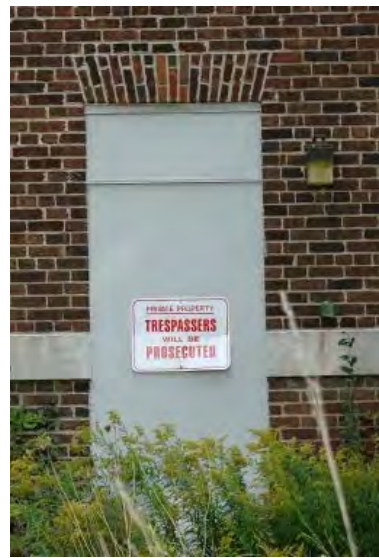
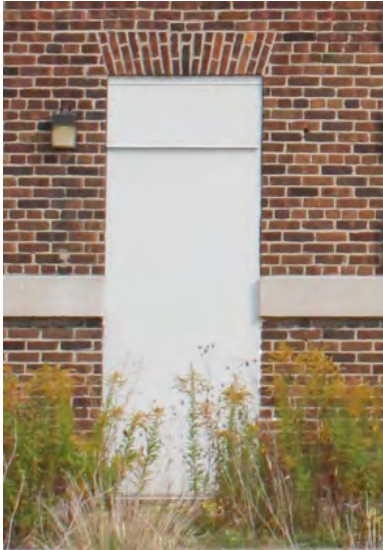
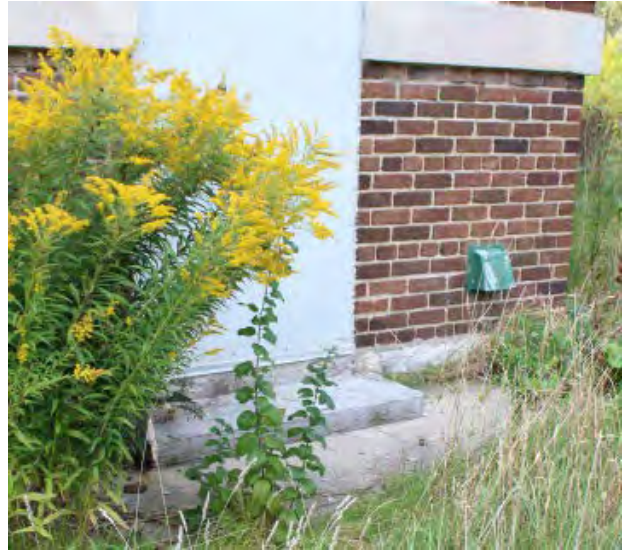
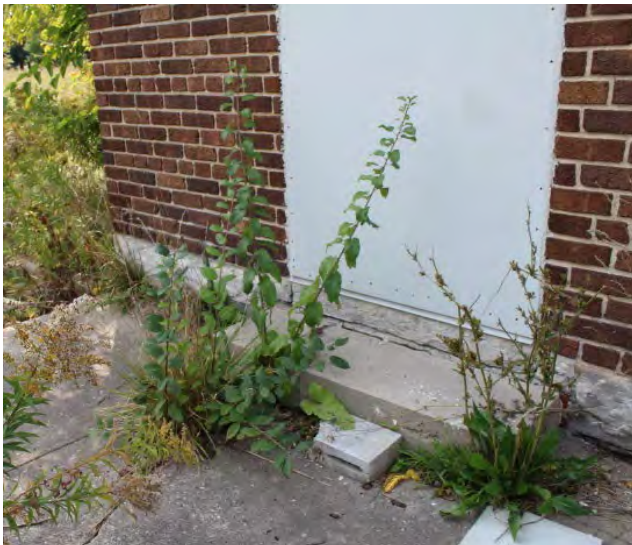
In similar fashion to the windows the doors were boarded as part of the mothballing of the structure and there was no interior access. There are 5 exterior entrances to the Recreation Hall; the main door on the north elevation (Door N-D1) and two single doors on each of the front and rear flanking wings east (Door E-D1 and Door E-D2) and (Door W-D1 and Door W-D2) elevations.

No documentation was provided as part of the Baseline Documentation Report to confirm the condition of these doors prior to mothballing, accordingly detailed descriptions and condition assessments of the doors is not possible. The temporary front entrance door and adjacent plywood infill had graffiti.

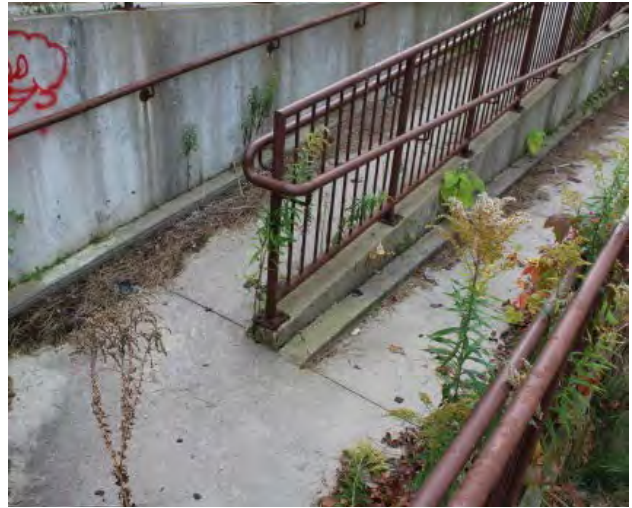
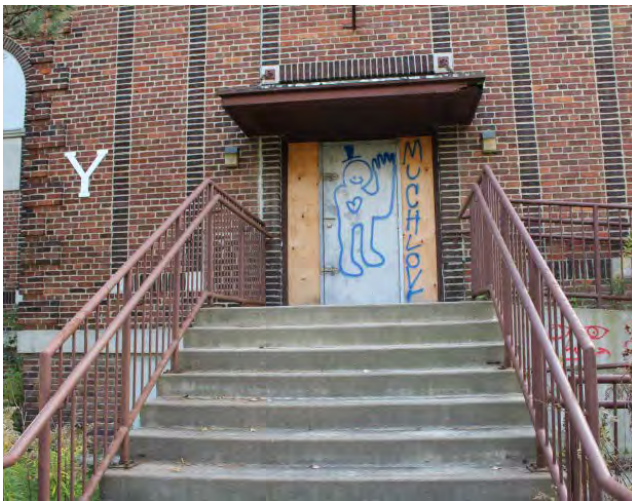
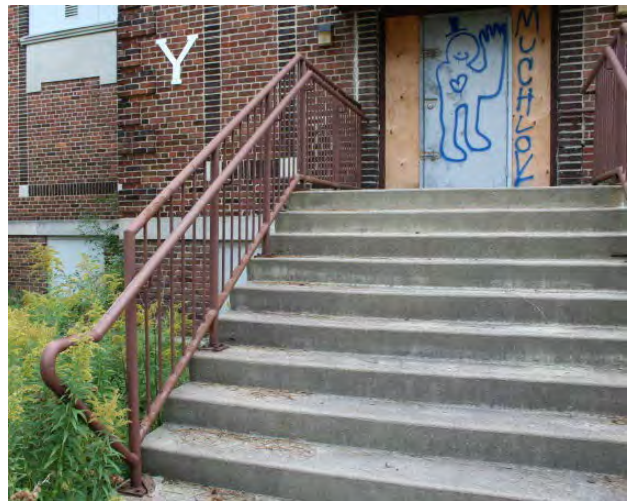
The front concrete entrance stairs and ramp were stained and had areas of vegetative growth. The retaining walls around the ramp had graffiti. The round metal handrails, posts and anchorage generally appeared intact though chipping and peeling paint was noted.

Figure No. 347: North Elevation, Ramp Detail (Photo No. 28.4)

Figure No. 348: North Elevation, Stairs (Photo No. 29.0)

Figure No. 349: North Elevation, Stair Detail (Photo No. 29.1)

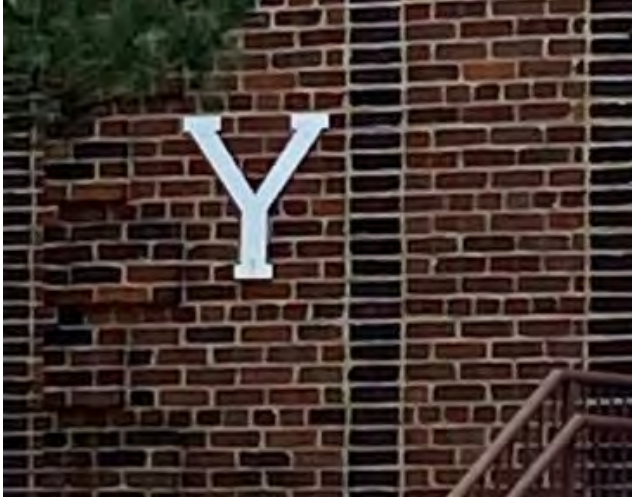
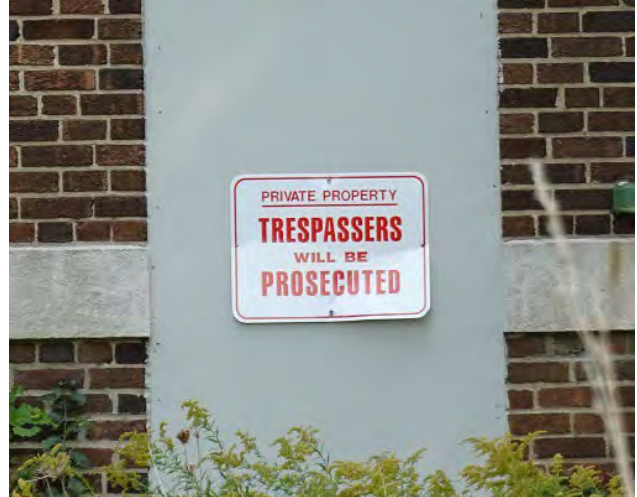
The Recreation Hall has 1 type of signage: a letter Y located on the north elevation beside the front entrance (typical building signage on the site). The signage is in fair condition. There are also multiple private property signs noting trespassers will be prosecuted.

Figure No. 350: Original Signage (Photo No. 31.0)

Figure No. 351: Signage (Photo No. 31.1)

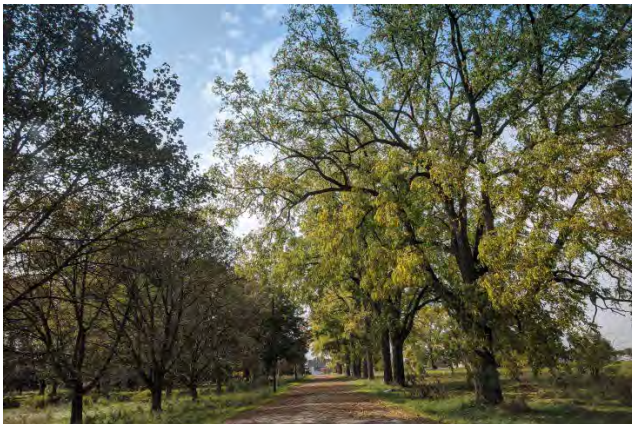
- Primarily gravel with some areas of failed asphalt surfacing with grass shoulders either side

Figure No. 355: View to west along Section 3, poor condition paving, grass shoulders, tree lines both sides (Photo No. 2.0)

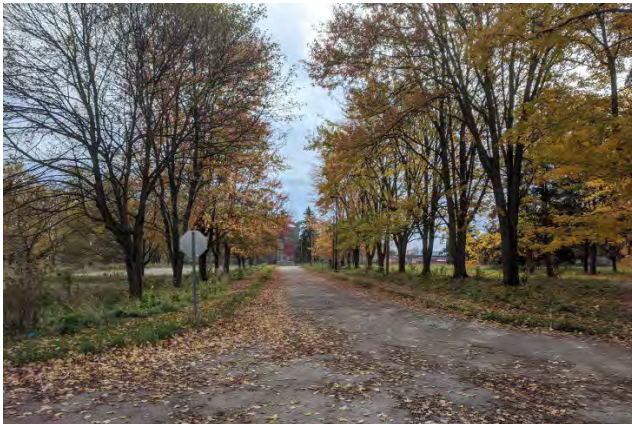
Figure No. 357: View to south along Section 4 to north elevation of Infirmary, asphalt with curb on west side, tree lines both sides, paved parking lot on east side (Photo No. 2.3)

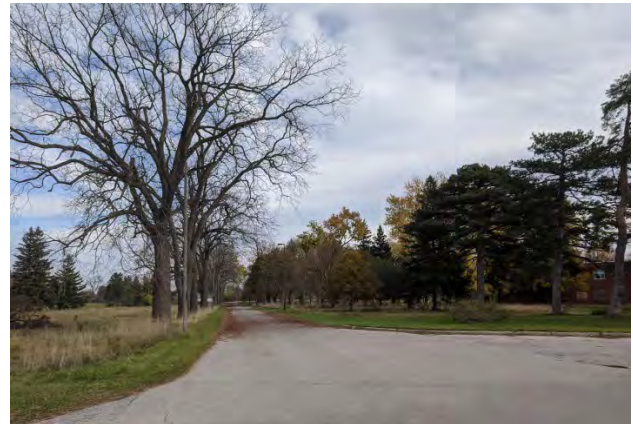
Figure No. 358: View to east at intersection of Section 2 and 1, concrete curb on east side of Section 1 (Photo No. 2.4)

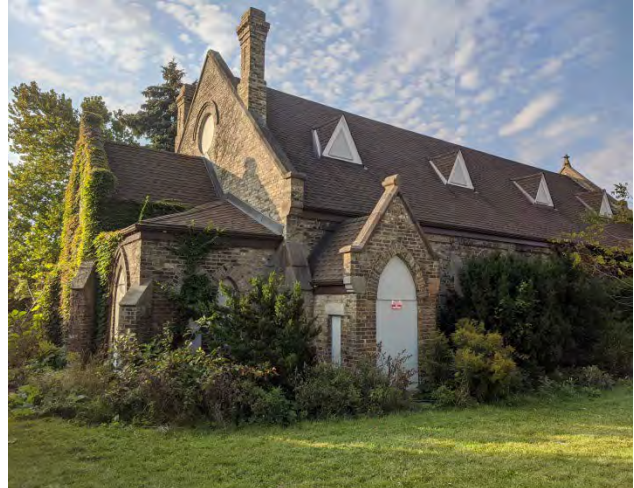
Figure No. 361: View from south at east west road by Chapel of Infirmary (Photo No. 3.4)

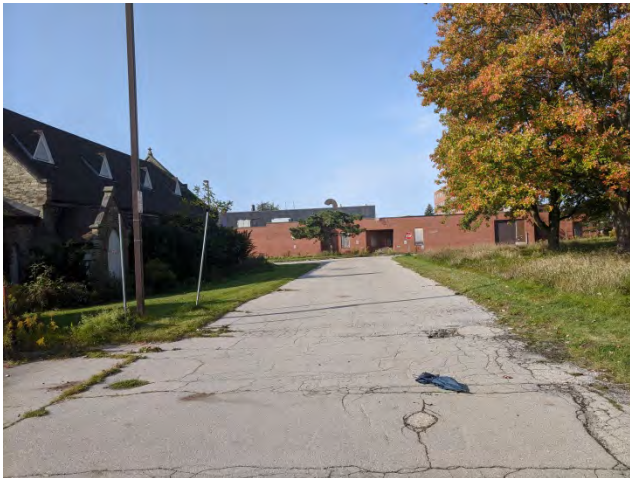
Figure No. 362: View of north elevation of Chapel before brushing out (Photo No. 3.5)

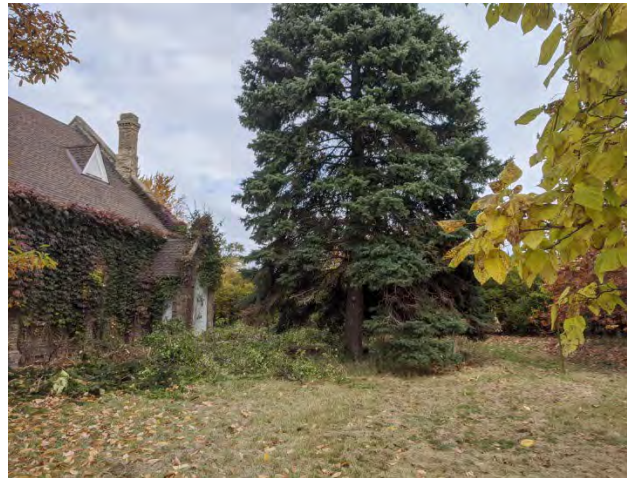
Figure No. 363: View of east west road along north side of Chapel (Photo No. 3.7)

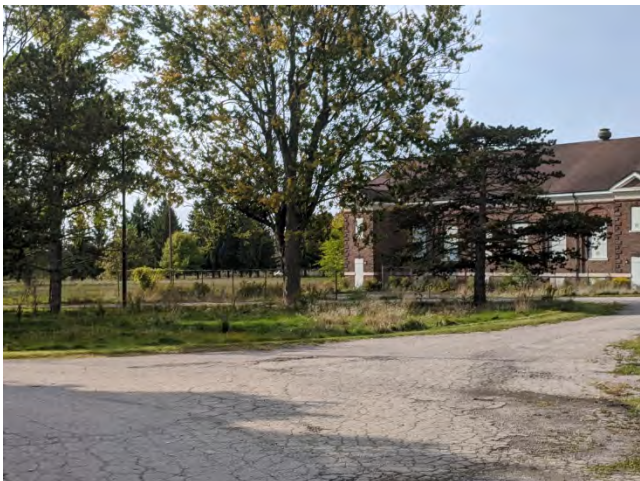
Figure No. 365: View from the east of open lawn with specimen trees (Photo No. 4.1)

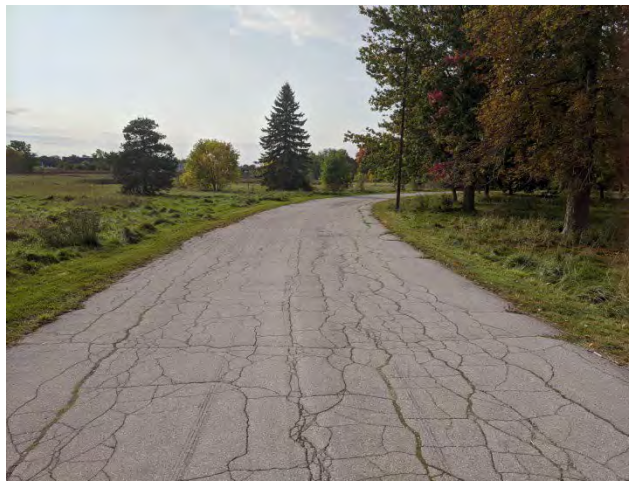
Figure No. 366: View to the south along the perimeter road, informal planting of mature trees in open lawn on west side (Photo No. 4.7)

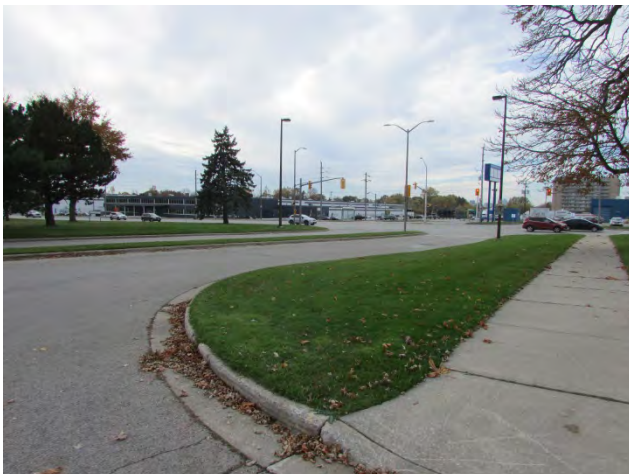
Figure No. 367: View to west of entrance drive (Photo No. 5.0)

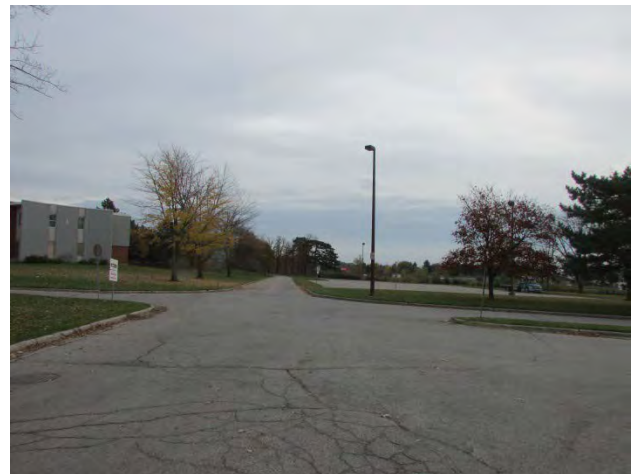
Figure No. 368: View to south along perimeter road at entrance drive, parking area on west side of entrance (Photo No. 5.1)

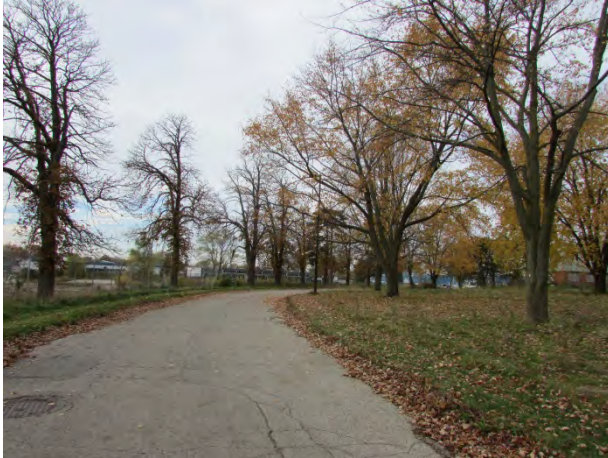
Figure No. 369: View to north along curvilinear road of treeline on west side primarily horse chestnut trees (Photo No. 6.2)

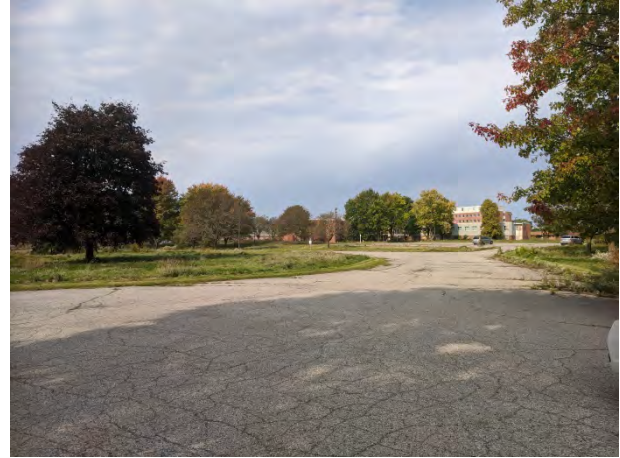
Figure No. 370: View to north from edge of centre island of large parking lot (Photo No. 6.3)

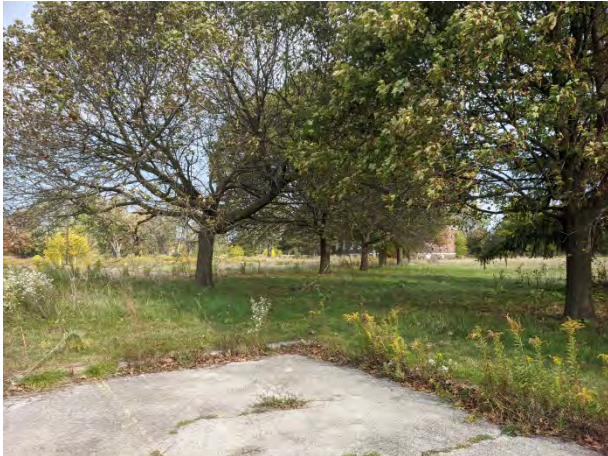
Figure No. 371: View to north east towards Recreation Hall of tree line along driveway (Photo No. 6.8)

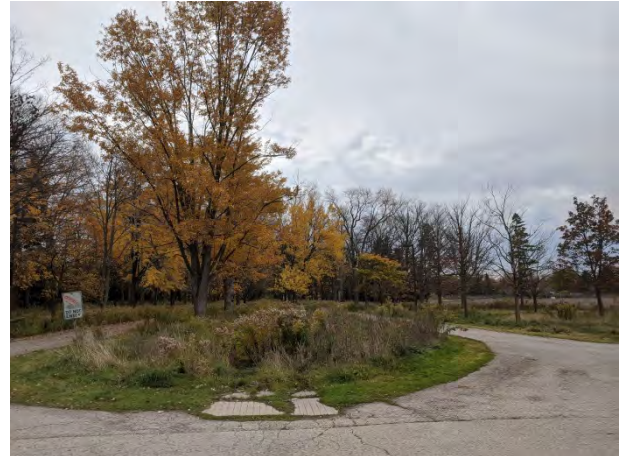
Figure No. 372: View to south of walkway landing and entrance to treed allee walkway from south road at centre island (Photo No. 6.11)

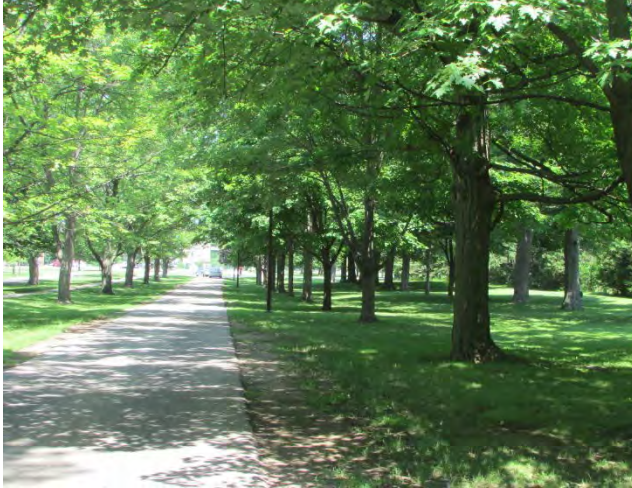
Figure No. 373: Date of Photo 2008, View to north within treed alley along east roadway (Photo No. 7.2)

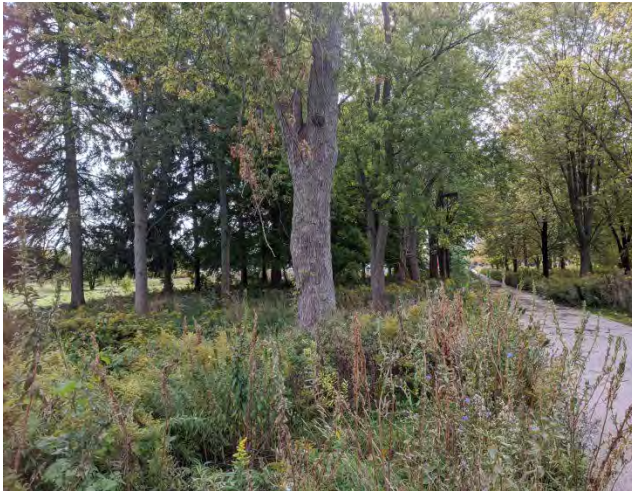
Figure No. 375: View to south of east side of treed alley, conifers along west edgedrive (Photo No. 7.6)

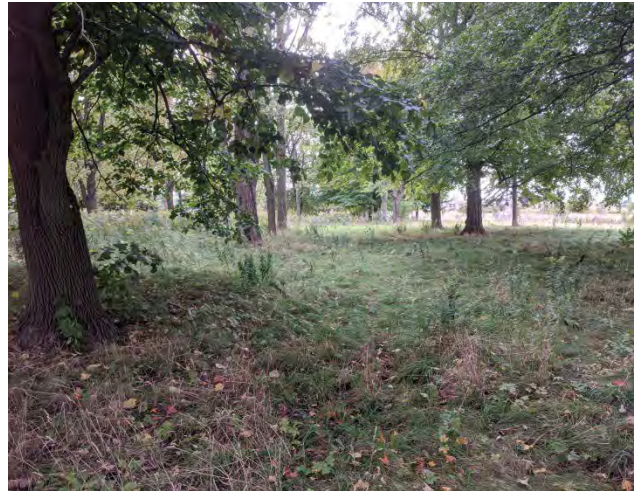
Figure No. 376: View within treed alley east side, unmaintained turf (Photo No. 7.8)

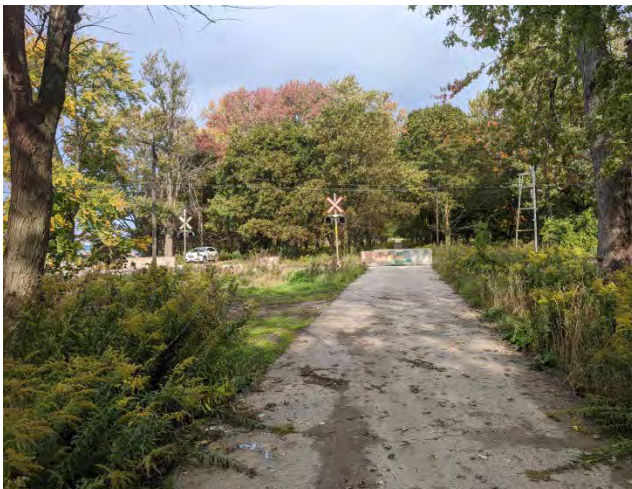
Figure No. 377: View to south of railway crossing with barricades, west road (Photo No. 7.10)

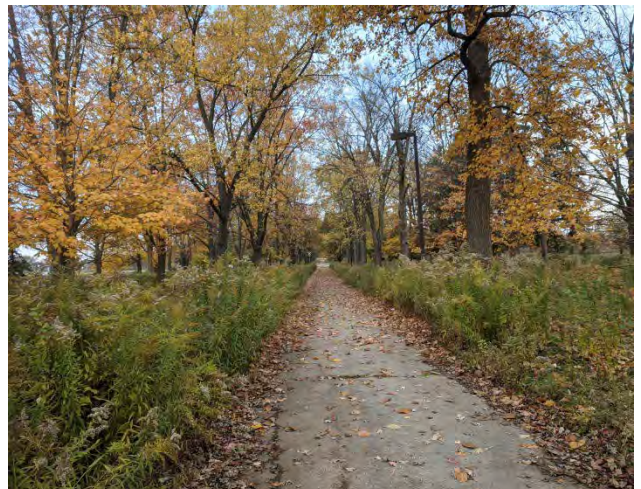
Figure No. 378: View to north along east roadway (Photo No. 7.11)

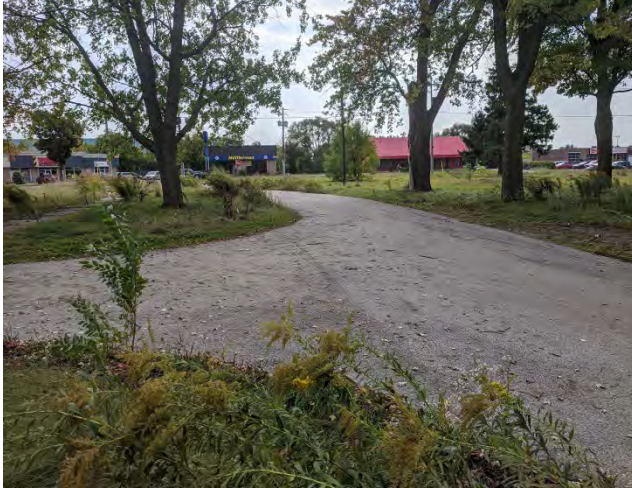
Figure No. 379: View to south toward Dundas Street (Photo No. 8.0)

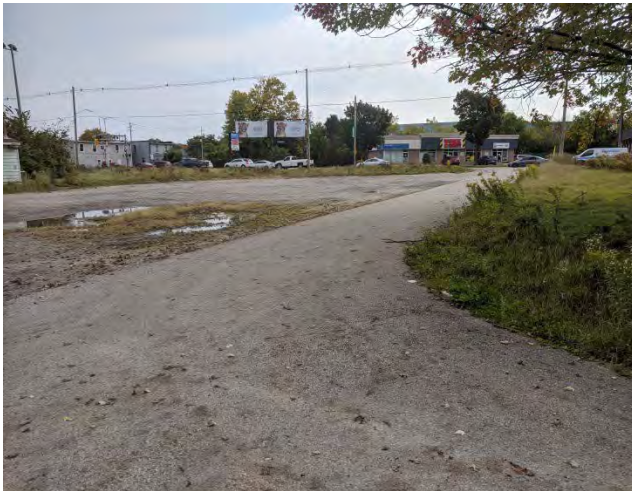
Figure No. 381: View to south of gravel driveway, parking area on east side (Photo No. 8.2)
