TREE PRESERVATION REPORT FOR ZONING BY-LAW AMENDMENT

**1982 COMMISSIONERS ROAD EAST
LONDON, ONTARIO**

Report prepared by
Ron Koudys Landscape Architects Inc

RKLA Project #23-155

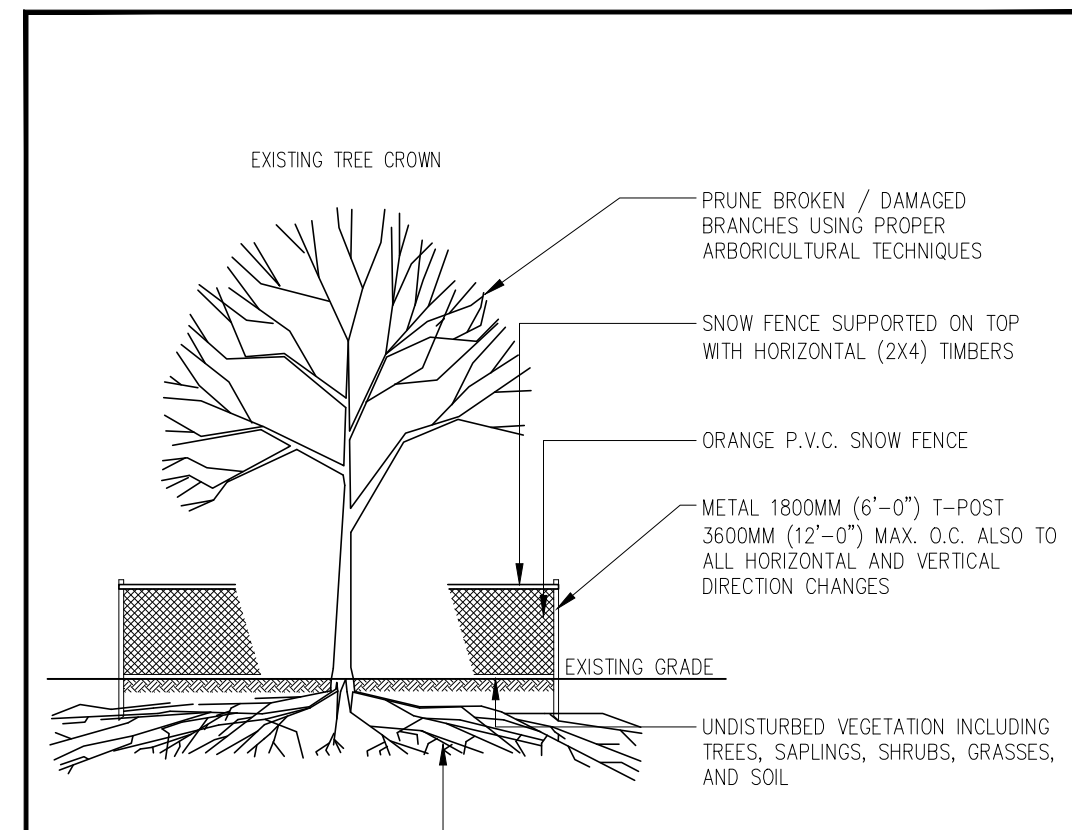
TREES RECOMMENDED FOR PRESERVATION (2)

GENERAL INFORMATION			SIZE		HEALTH & CONDITION			RECOMMENDATIONS				
ID #	BOTANICAL NAME	COMMON NAME	LOCATION	DBH (cm)	CANOPY RADIUS (m)	CROWN CONDITION	STRUCTURAL COMB	STRUCTURAL INTEGRITY	COMMENTS	EXPECTED CONSTRUCTION IMPACTS	RESERVE OR REMOVE	IMPACT MITIGATION / REMOVAL RATIONALE
6	<i>Acer negundo</i>	Manitoba Maple	1990 Commissioners Road East	75, 10	3	5	Fair	Good	Multi-stem 2, low primary union	possible impacts from grading requirements	preserve	tree preservation barrier
7	<i>Acer saccharum</i>	Sugar Maple	Subject Site	34	45	4	Good	Good	Full form	possible impacts from grading requirements	preserve	tree preservation barrier

- NOTES:**
- EXISTING TREES ARE TO BE PROTECTED FROM CONSTRUCTION WITH THE INSTALLATION OF A 1200MM (4'-0") HIGH SNOW FENCE, HELD IN PLACE WITH 1800MM (6'-0") T-BAR.

- THE BARRIER IS TO BE INSTALLED PRIOR TO ANY CONSTRUCTION AND MUST REMAIN IN PLACE UNTIL ALL CONSTRUCTION IS COMPLETED.
 - ALL SUPPORTS AND BRACING SHOULD BE INSIDE THE TREE PROTECTION ZONE. ALL SUCH SUPPORTS SHOULD MINIMIZE DAMAGING ROOTS IN THE TREE PROTECTION ZONE.
