TREE PRESERVATION REPORT FOR ZONING BYLAW AMENDMENT

**934 OXFORD STREET WEST LONDON,
ONTARIO**

Report prepared by
Ron Koudys Landscape Architects Inc

RKLA Project #23-160

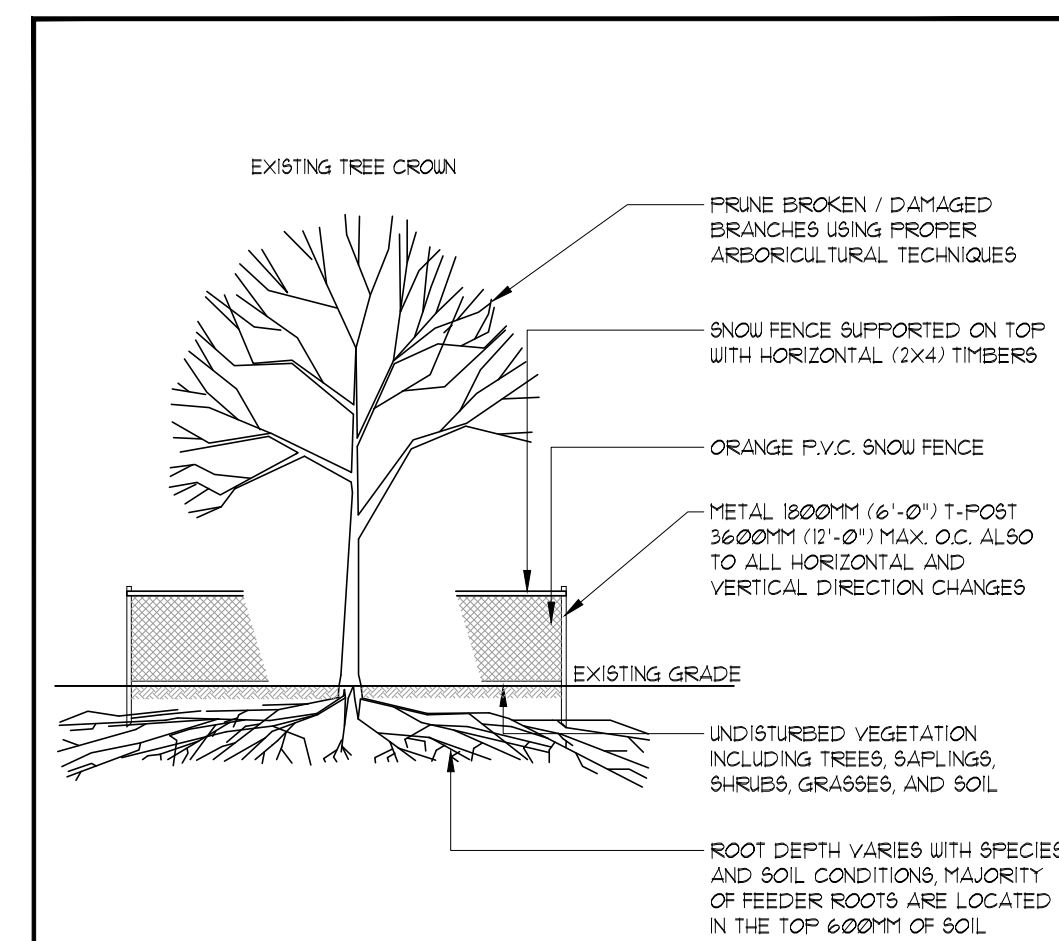
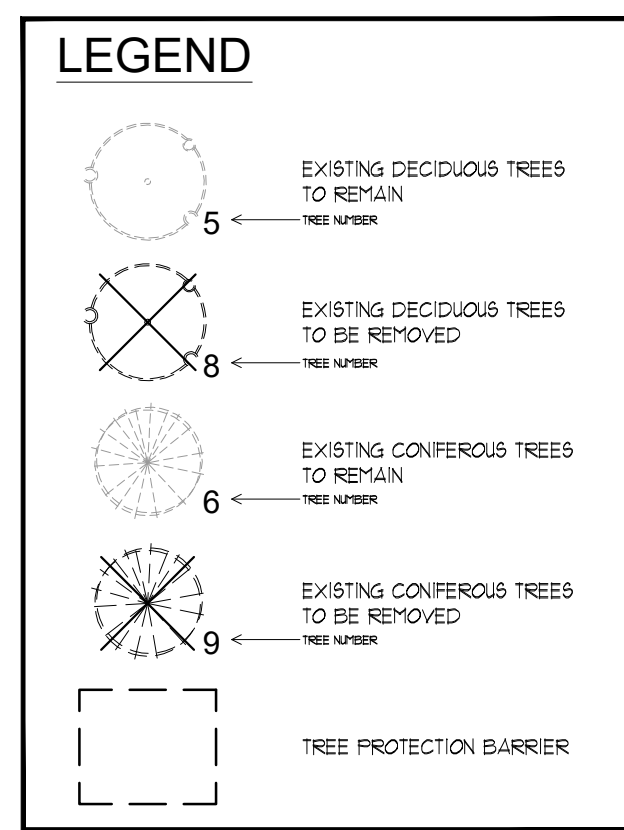
DRAWING TITLE:
TREE PRESERVATION PLAN

ID #	GENERAL INFORMATION			SIZE	HEALTH & CONDITION	RECOMMENDATIONS
	BOTANICAL NAME	COMMON NAME	LOCATION			
10	<i>Picea abies</i>	Norway Spruce	940 Oxford Street West	-15	2 - 4 Good	Lower suppressed canopy. No conflict. Preserve. Tree protection barrier.
11	<i>Juglans x intermedia</i>	Hybrid Walnut	Boundary Subject site and 940 Oxford Street West	-18	4.5 - 5 Good	Hooked leader towards east, lower suppressed branching. No conflict. Preserve. Tree protection barrier.
12	<i>Celtis occidentalis</i>	Hackberry	Boundary Subject site 175 Deer Park Circle	-45	6 - 5 Fair	Girdling roots, minor dead wood, fence grown. Minor conflict with proposed parking - potential retention, require upon grading. Preserve. Tree protection barrier.
14	<i>Rhamnus cathartica</i>	Buckthorn	175 Deer Park Circle	25	4 - 3 Poor	Stk taken below primary union. Minor potential conflict with grading. Preserve. Tree protection barrier.

15	<i>Rhamnus cathartica</i>	Buckthorn	175 Deer Park Circle	18	3 - 3 Poor	Minor dieback, multiple minor trunk wounds. Minor potential conflict with grading. Preserve. Tree protection barrier.
16	<i>Acer saccharum</i>	Sugar Maple	Boundary Subject site 175 Deer Park Circle	26	4 - 5 Fair	Growing in fence, suppressed branching, slightly suppressed. Minor potential conflict with grading. Preserve. Tree protection barrier.
18	<i>Picea abies</i>	Norway Spruce	175 Deer Park Circle	-40	4 - 4 Good	Good. No conflict. Preserve. Tree protection barrier.
29	<i>Picea abies</i>	Norway Spruce	175 Deer Park Circle	-40	4 - 4 Good	Good. No conflict. Preserve. Tree protection barrier.
