TREE PRESERVATION REPORT FOR ZONING BY-LAW AMENDMENT

**1458 HURON STREET,
LONDON, ONTARIO**

Report prepared by
Ron Koudys Landscape Architects Inc

RKLA Project #23-247

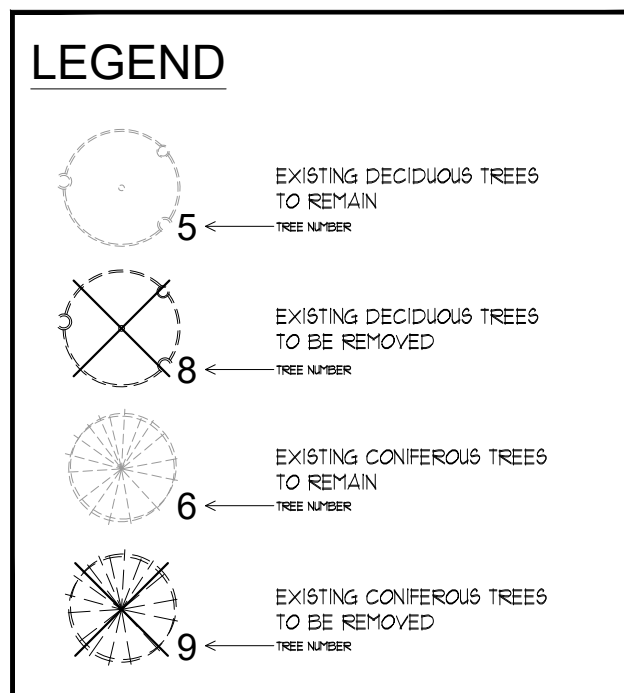
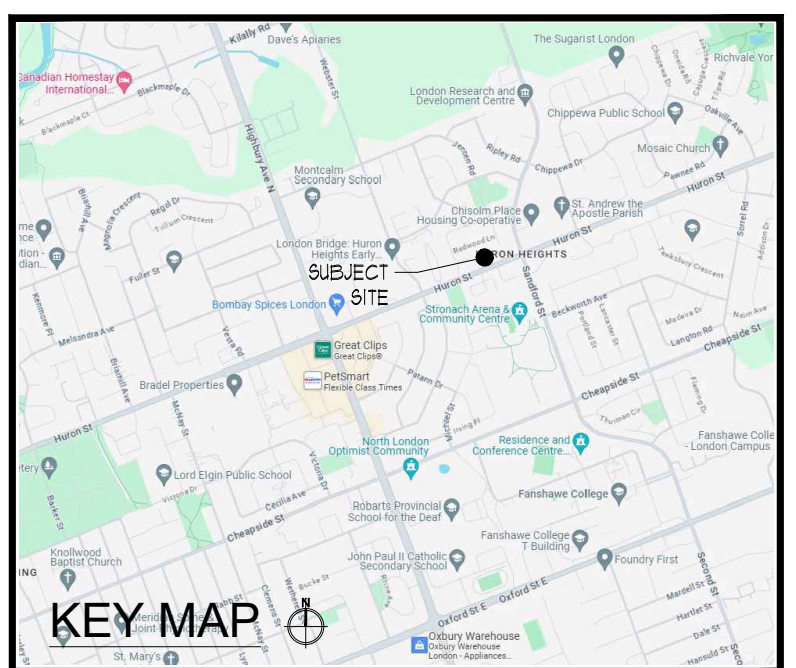
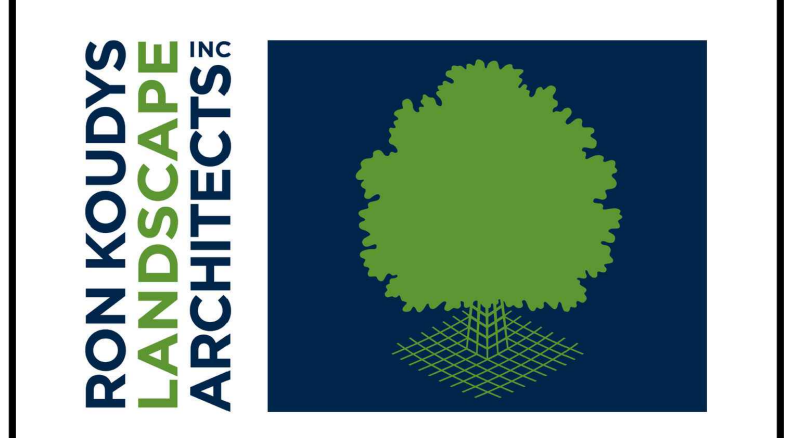
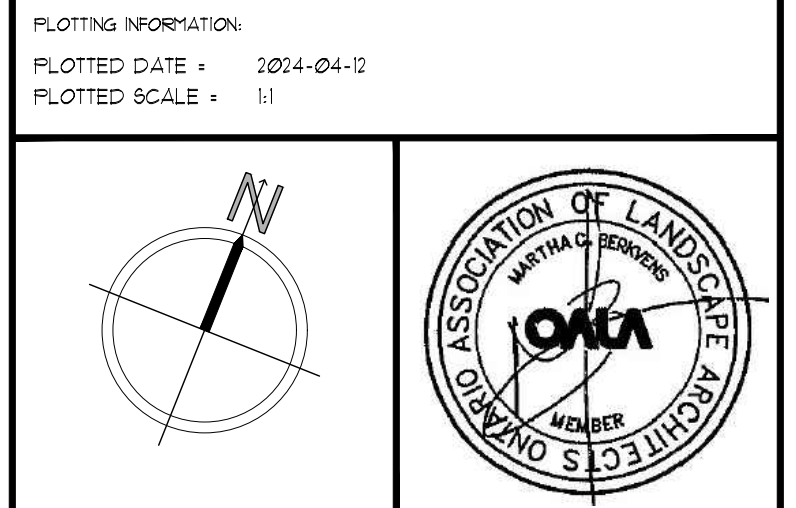
DRAWING TITLE:
TREE PRESERVATION PLAN

12	<i>Morus alba</i>	White Mulberry	Boundary - Subject site & 1335 Basswood Place	14, 14, 12, 5	2.5	4	Fair	Poor	Multistem 4, fence grown, epicormic growth	potential conflict with proposed grading	preserve	tree protection barrier
14	<i>Acer platanoides</i>	Norway Maple	1338 Basswood Place	40	4	5	Fair	Fair	Low primary union, lower half not visible due to wood fence	minor impact to critical root zone	preserve	existing wood fence to act as tree protection barrier
15	<i>Acer platanoides</i>	Norway Maple	1338 Basswood Place	35	3	5	Fair	Good	Lower half not visible due to wood fence	minor impact to critical root zone	preserve	existing wood fence to act as tree protection barrier
16	<i>Tilia spp.</i>	Linden	1338 Basswood Place	35	3	5	Good	Good	Lower half not visible due to wood fence	N/A	preserve	existing wood fence to act as tree protection barrier
29	<i>Juglans nigra</i>	Black Walnut	Boundary 1458 Huron Street & 1242 Basswood Road	31	3	5	Fair	Good		potential conflict with proposed grading	preserve	tree protection barrier

34	<i>Viburnum</i>	Little Leaf Linden	Subject Site - 39 Redwood Lane	25	3	5	Good	Good		N/A	preserve	tree protection barrier
38	<i>Picea abies</i>	Norway Spruce	35 Redwood Lane	35	4	5	Good	Good	Lower half not visible due to wood fence	potential for removal to be reviewed with civil plans at the time of SPA	review
