Technical Memorandum

То:	Stephen Romano, P.Eng. Environmenta	al Services Engi	neer	Page 1		
CC	Aaron Rozentals, Jake Helm, John Haa	sen				
	City of London: Arva Pumping Station Municipal Class Environmental Asse			ransmission Main		
Subject	Technical Memorandum – Long Term Alternative Conceptual Design					
From	Bander Abou Taka, P.Eng.					
		Project				
Date	March 30, 2021	Number	6061950	03

The City of London (City) retained AECOM to perform a Municipal Class Environmental Assessment Master Plan (MCEAMP) of a twinned 1,050 mm dia. Prestressed Concrete Cylinder Pipe (PCCP) transmission main from the Arva Pumping Station to Fanshawe Park Road, and a single 1,050 mm dia. PCCP transmission main between Fanshawe Park Road and Huron Street. Refer to **Figure 1.1.**

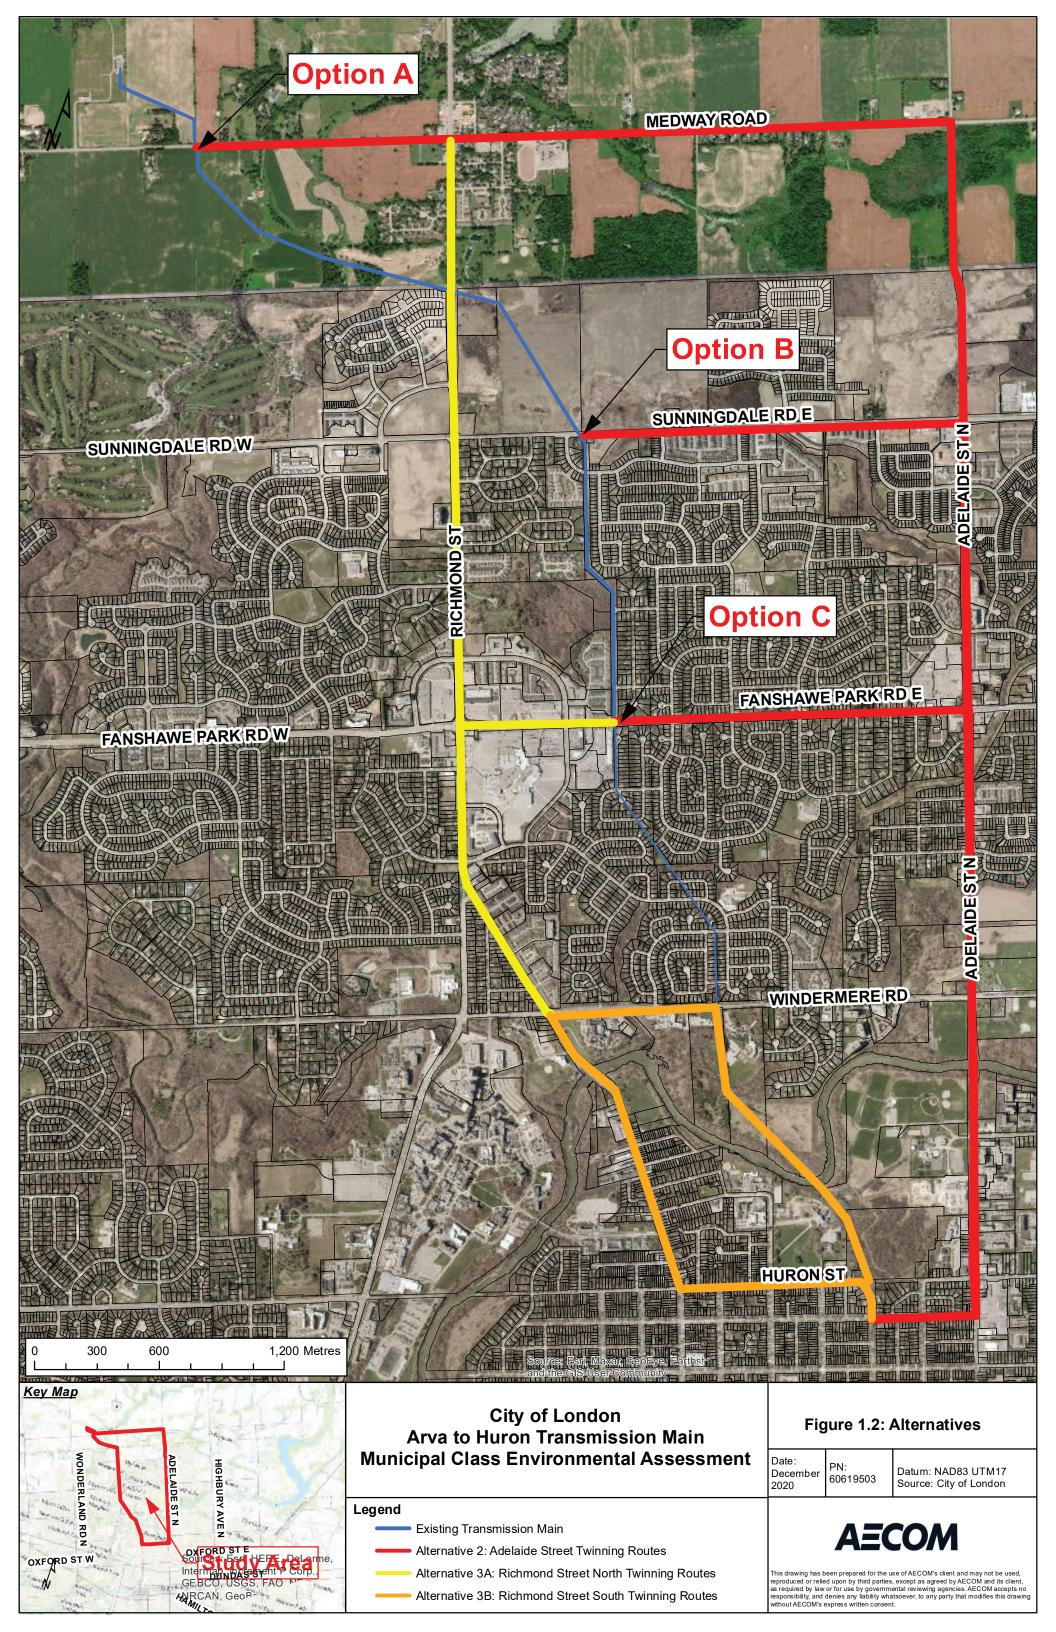
Figure 1.2 illustrates the twinning alternatives evaluated and considered by the City.

Alternative 2, Option C twinning along Adelaide Street, and connecting to the existing transmission mains via Fanshawe Park Road and Regent Street, was identified as the preferred alternative, and is the basis for the conceptual design discussed in this technical memorandum. Future modeling and master planning for the City as whole to better serve Northeast London may modify or add connection points to one of the other options on Medway Road or Sunningdale Road.

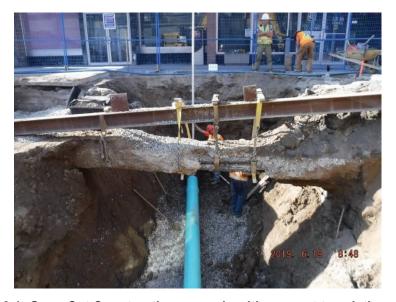
Figure 3.1: Open Cut Construction example with support to existing utilities

Figure 3.1 illustrates the open cut method while **Figure 3.2** illustrates what is involved with the HDD method. **Figures 3.3** and **3.4** provides an example of recent projects where Jack and Bore construction methods were utilized under major roadways and/or a watercourse. As a minimum, these approaches would be required for the Thames River and Stoney Creek crossings.

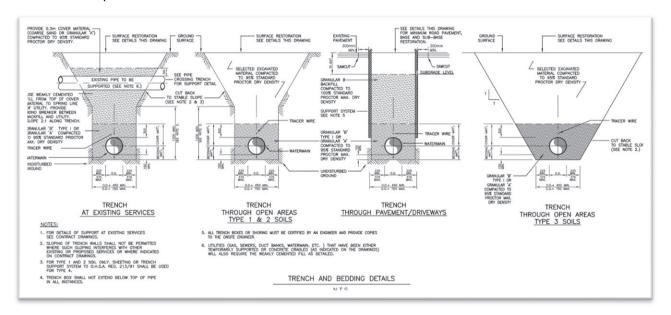
Figure 3.5: Typical Trench & Bedding Details

For most of the transmission main routing, the installation will be within an existing roadway or boulevard where appropriate, to avoid other utilities in the ROW or to be near or within City owned property to allow more room for construction equipment. For the open cut construction method, soil type will dictate the width of the open trench required to minimize cave in and rolling of material down the slope. Soils are identified by geotechnical engineers based on borehole or test pit inspections. Soils are categorized into four types. For Type 1 and 2 soils, or relatively good soils, the trench can be cut back at an angle of 1 to 1, or one meter back for each meter up. Walls should be sloped to within 1.2 meters of the trench bottom. For Type 3 soils, the trench walls should be cut back to the bottom of the pipe elevation in a 1 to 1 slope. For Type 4 soils, or bad soils, the slope should be cut back in a 1 to 3 slope, or 3 meters back for every 1 meter up from the trench bottom. Figure 3.5 illustrates the various trench slopes for each soil type. Based on the Geotechnical work completed as part of the project, along the existing transmission main north of Fanshawe Park Road, the soil type is classified as Type 2 or 3, and a 1 to 1 slope ratio is assumed for all open cut construction work along Fanshawe Park Road, Adelaide Street and Regent Street. Additional geotechnical investigation will be required to confirm soil types at all locations during preliminary/detailed design. Therefore, for a single 1,050mm main, and assuming 2 meters of depth, a 7-meter width is required for clearance and sloping. An additional 3 meters of space is required for construction equipment allowance for a total width of 10 meters. If two transmission mains are to be installed, then an additional 3 meters would be required for a minimum width of 13 meters.

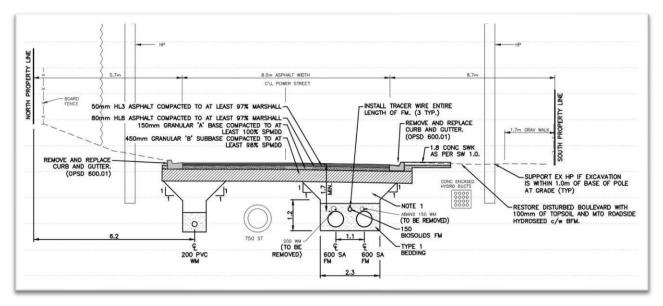
Figure 3.6: Typical Trench & Bedding Details for multiple mains in a road

For two transmission mains in the same trench, Figure 3.6 provides a typical installation from a similar project in the City of London using two mains in the same trench. The details shown in the figures are typical for under pavement construction and shows clearances from other utilities in the ground.

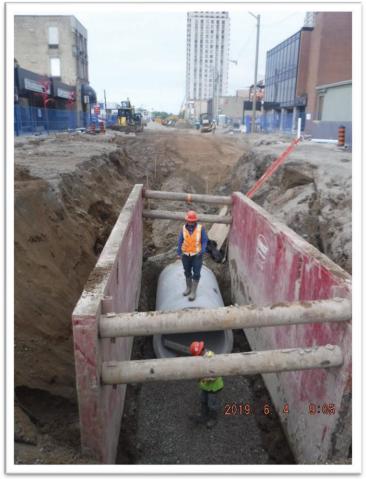
Figure 3.7: Trench Box and Shoring

Where the required 10-13 meters of spacing cannot be achieved, the contractor can utilize removable trench boxes that provide engineered support to the trench walls at a 90° angle without the need to slope the trench. This system is meant to protect the workers in case of cave-ins. In some cases, additional shoring or support of the trench box would also be required to prevent movement of the trench box walls. This is usually used to prevent the movement of soils, protect underground utilities nearby, and protect nearby roads and building foundations. Refer to Figure 3.7.

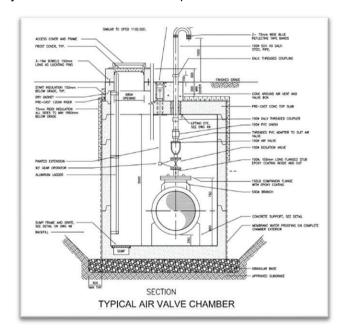
Figure 3.8: Typical Air Valve Chamber

These chambers can range from single manholes with one or two valves to a multi-valve complex structure where various valves and instruments are required to connect to the existing transmission main(s). **Figures 3.8** and **3.9** are examples of typical chambers that would be used for this transmission main. **Figure 3.10** provides an example of multiple transmission mains interconnecting inside a single chamber to control flow direction. The chamber for this project would be much larger to allow for the installation of five isolation valves in addition to any other air or drain valves required.

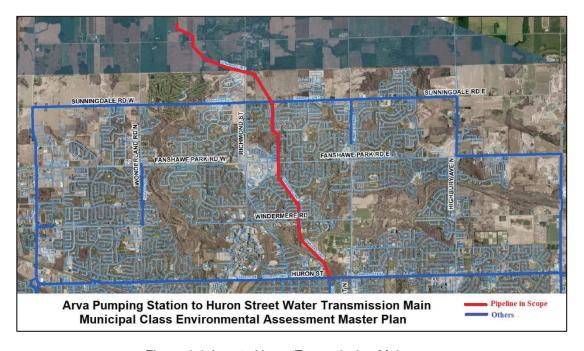
Figure 1.1 Arva to Huron Transmission Main

The City of London (City) retained AECOM to perform a Municipal Class Environmental Assessment Master Plan (MCEAMP) of a twinned 1,050 mm dia. Prestressed Concrete Cylinder Pipe (PCCP) transmission main from the Arva Pumping Station to Fanshawe Park Road, and a single 1,050 mm dia. PCCP transmission main between Fanshawe Park Road and Huron Street (Figure 1.1).

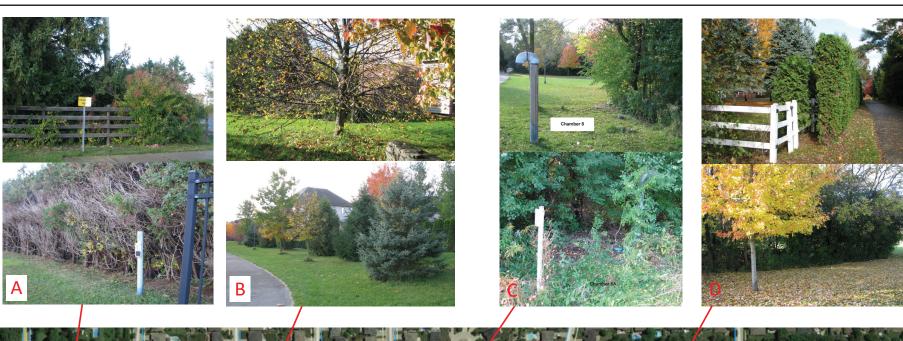
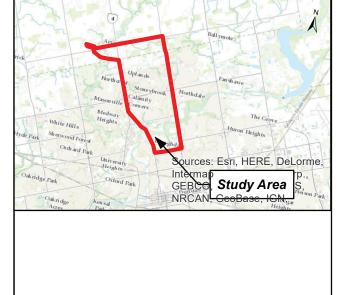
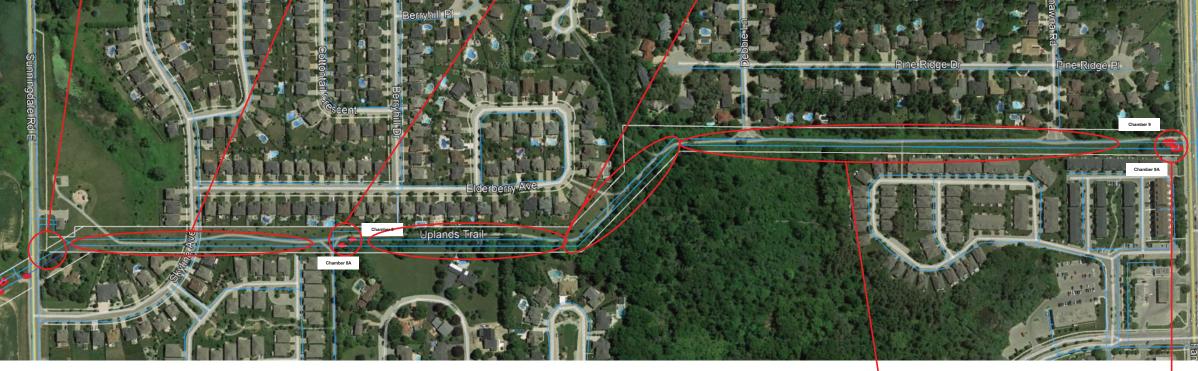
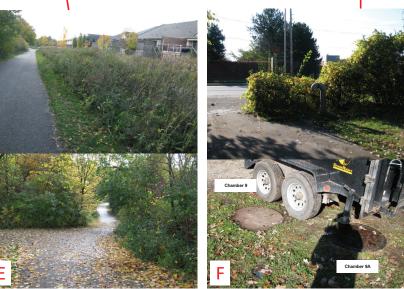
Figure 3.2

Sunningdale Road to Fanshawe Park Road

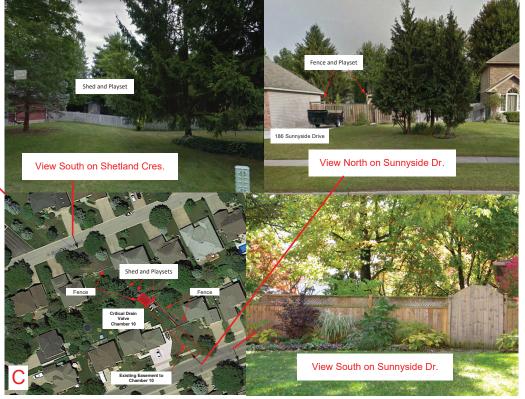
Fanshawe Park Road to Sunnyside Drive

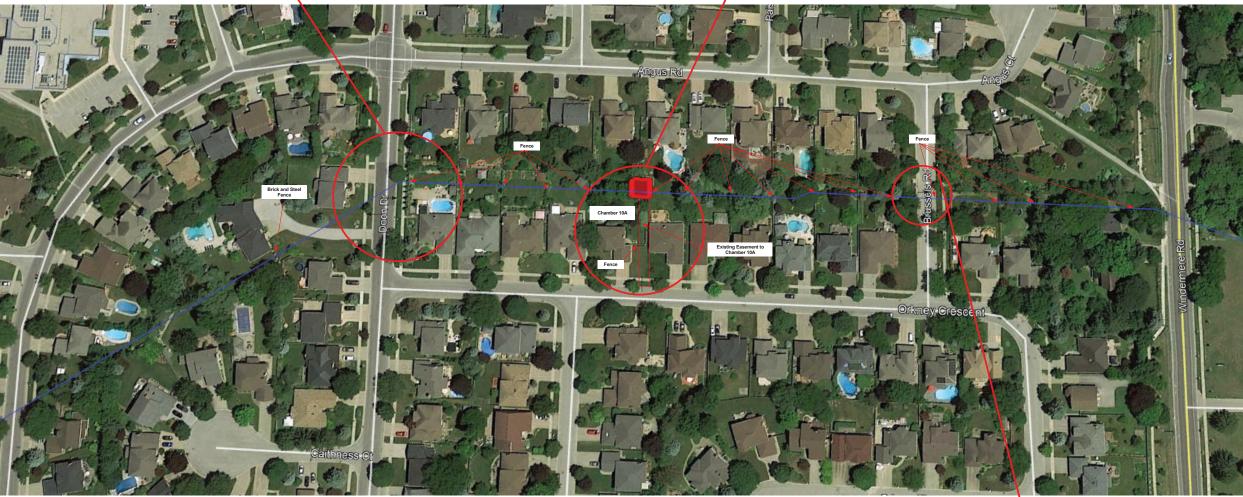
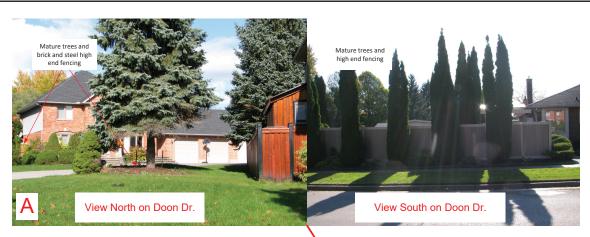
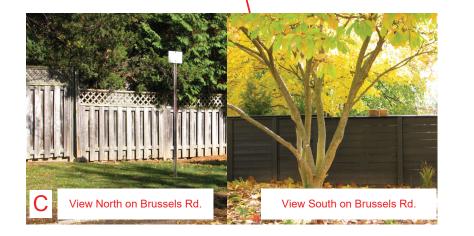
Sunnyside Drive to Windemere Road

Refer to Figure 3.4 A. The transmission main enters and exists several properties between Sunnyside Drive and Windermere Rd.: 199, 203 Sunnyside Dr., 27 Caithness Crt., and 126 Doon Dr. Several manmade and natural	Medium	Recommend reviewing the sites and assess the need to remove trees and other obstacles to reduce risk of damage by tree roots, and to allow for maintenance and/or monitoring access.

Pipe / Chamber ID	Site Condition	Risk Level	Recommendations
	obstacles such as playsets,		
	sheds, fencing, concrete pads,		
	trees and shrubs are on top of		
	the transmission main within		
	the City's easement.		
Chamber 10A	Refer to Figure 3.4 Transmission main continues between Doon Dr and Windermere Rd through several properties on Orkney Cres., and Windermere Rd: 127,131,139, 143, 147, 151, 155, 159, 163, 167, 171, 175, 179 Orkney Cres., and 542 Windermere Rd. Refer to Figure 3.4 B. Chamber 10A is an air release chamber located on 163 Orkney Cres. The City owns an easement on the property to access the chamber going through the south end of the property.	Medium	Recommend removing all obstacles around the chamber within the easement and widen the existing gate in the fencing for the 163 Orkney Cres. property, where Chamber 10A is located to allow City maintenance trucks to enter the property when required for repairs.

Pipe / Chamber ID	Site Condition	Risk Level	Recommendations
	obstacles such as playsets, sheds, fencing, concrete pads, trees and shrubs are on top of the transmission main within		
Chamber 10A	the City's easement. Refer to Figure 3.4 Transmission main continues between Doon Dr and Windermere Rd through several properties on Orkney Cres., and Windermere Rd: 127,131,139, 143, 147, 151, 155, 159, 163, 167, 171, 175, 179 Orkney Cres., and 542 Windermere Rd. Refer to Figure 3.4 B. Chamber 10A is an air release chamber located on 163 Orkney Cres. The City owns an easement on the property to access the chamber going through the south end of the property.	Medium	Recommend removing all obstacles around the chamber within the easement and widen the existing gate in the fencing for the 163 Orkney Cres. property, where Chamber 10A is located to allow City maintenance trucks to enter the property when required for repairs.

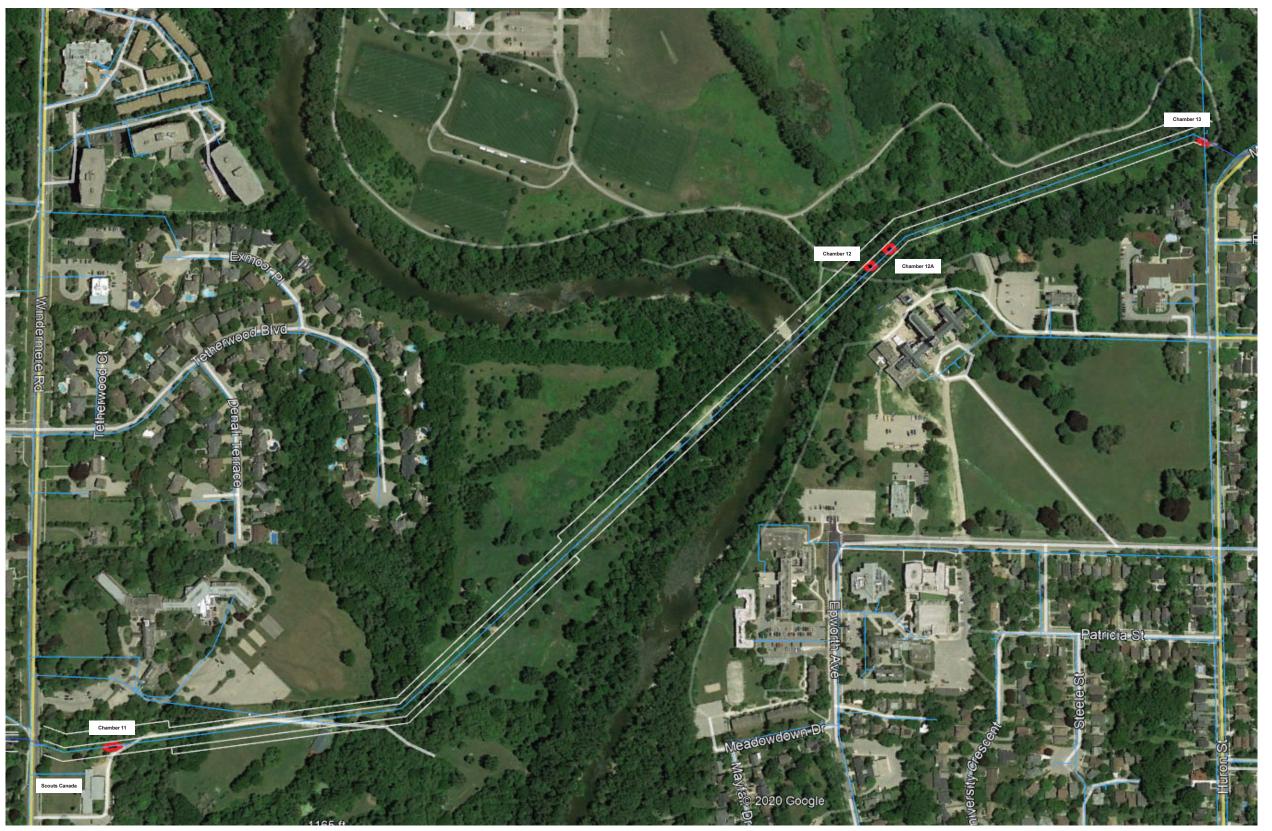
Windermere Road to Huron Street

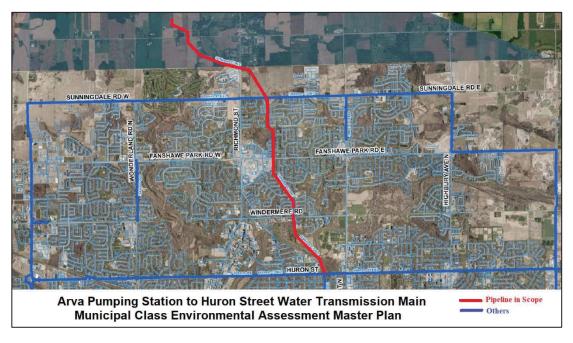
Figure 1.1 Arva to Huron Transmission Main

The City of London (City) retained AECOM to perform a Municipal Class Environmental Assessment Master Plan (MCEAMP) of a twinned 1,050 mm dia. Prestressed Concrete Cylinder Pipe (PCCP) transmission main from the Arva Pumping Station to Fanshawe Park Road, and a single 1,050 mm dia. PCCP transmission main between Fanshawe Park Road and Huron Street (Figure 1.1).
