St George-Grosvenor Heritage Conservation District Study

Volume IV Appendix F, [2016]

APPENDIX F: INVENTORY OF CULTURAL HERITAGE RESOURCES

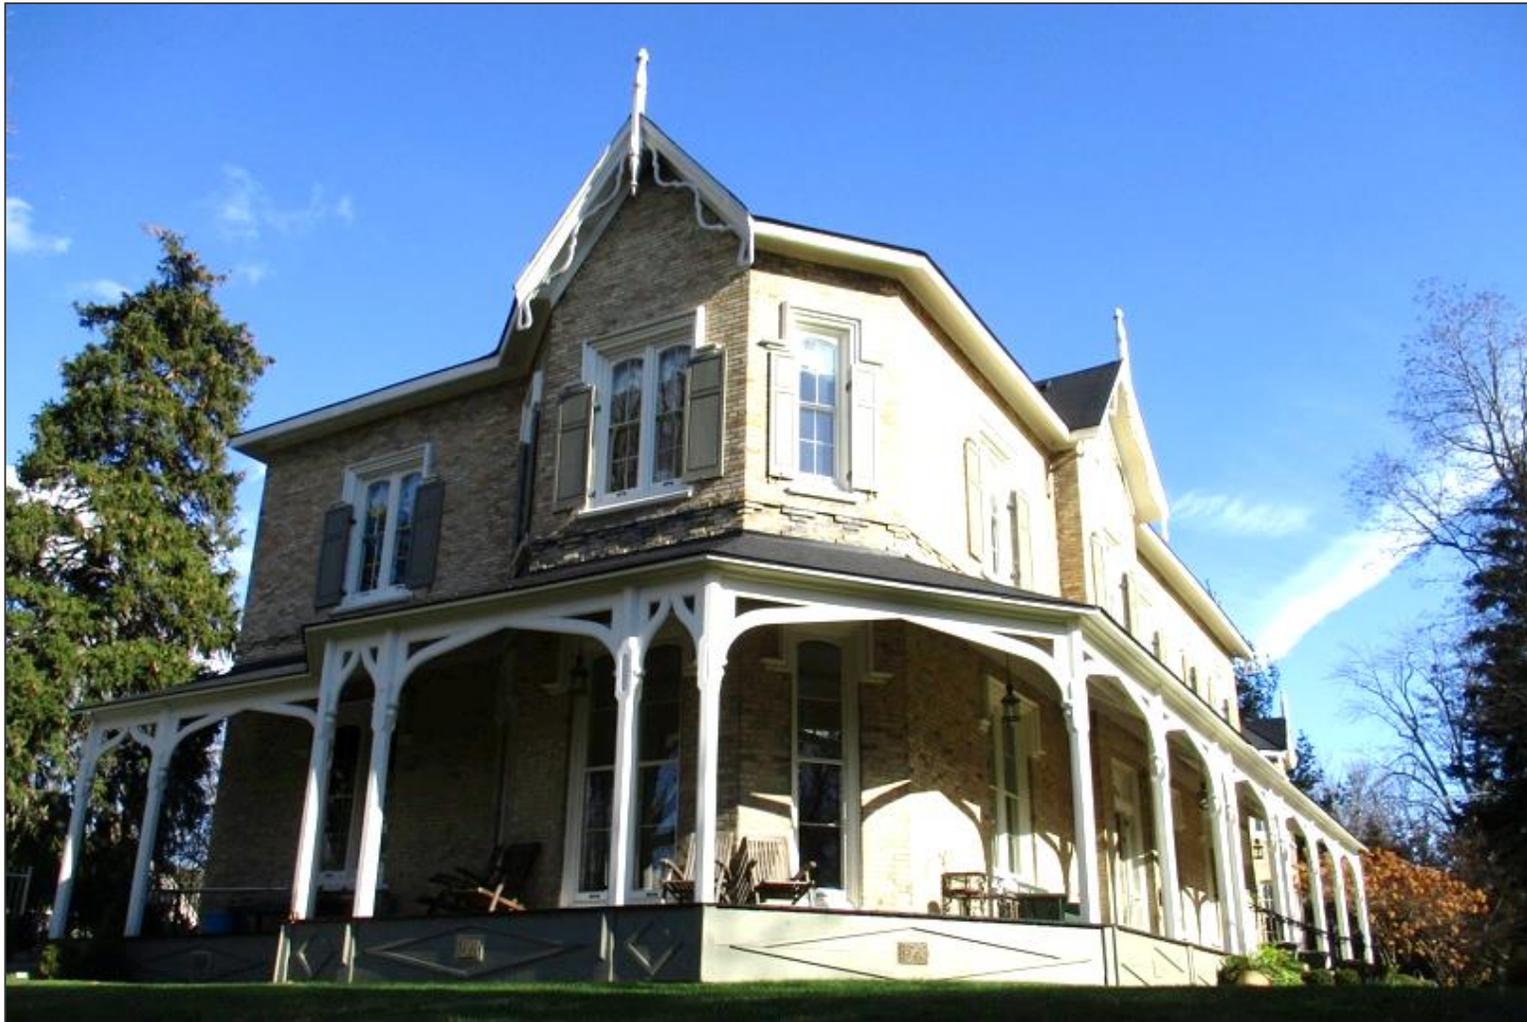
Image H1: Thornwood (329 St. George Street), viewed from the southwest. Each gable has robustly carved bargeboard lining the eaves, with relatively plain fascia between gables, 2015

Thornwood, built by H.C.R. Becher in 1852, is the oldest still standing building in the Study Area, and a discussion of its style is therefore a good place to begin considering the architecture of the Study Area. The building is an excellent example of mid-nineteenth-century Gothic Revival architecture. Gothic Revival architecture, based on medieval prototypes, became popular during the period because of two movements, A.W.N. Pugin's ecclesiological arguments that medieval churches offered the only true expression of the religious impulse, and a more secular enthusiasm for the Middle Ages brought about by literary interpretations of the Middle Ages. The architectural forms inspired by the Gothic Revival were greatly varied, ranging from churches with their lancet arches and high spires to a crenelated courthouse or a house featuring carved bargeboards or Gothic arches. Because of its varied and often irregular forms, Gothic architecture also came to be associated with the concept of the Picturesque. Thornwood exemplifies the more secular tradition, using medieval forms, not with any idea of religious or historical propriety, but with the apparent aim of creating a picturesque and somewhat romantic edifice.

details of the house, such as the fine mouldings around the front door, the drip moulds over the windows, and the arches of the verandah, are drawn from the late medieval, or Tudor, period.

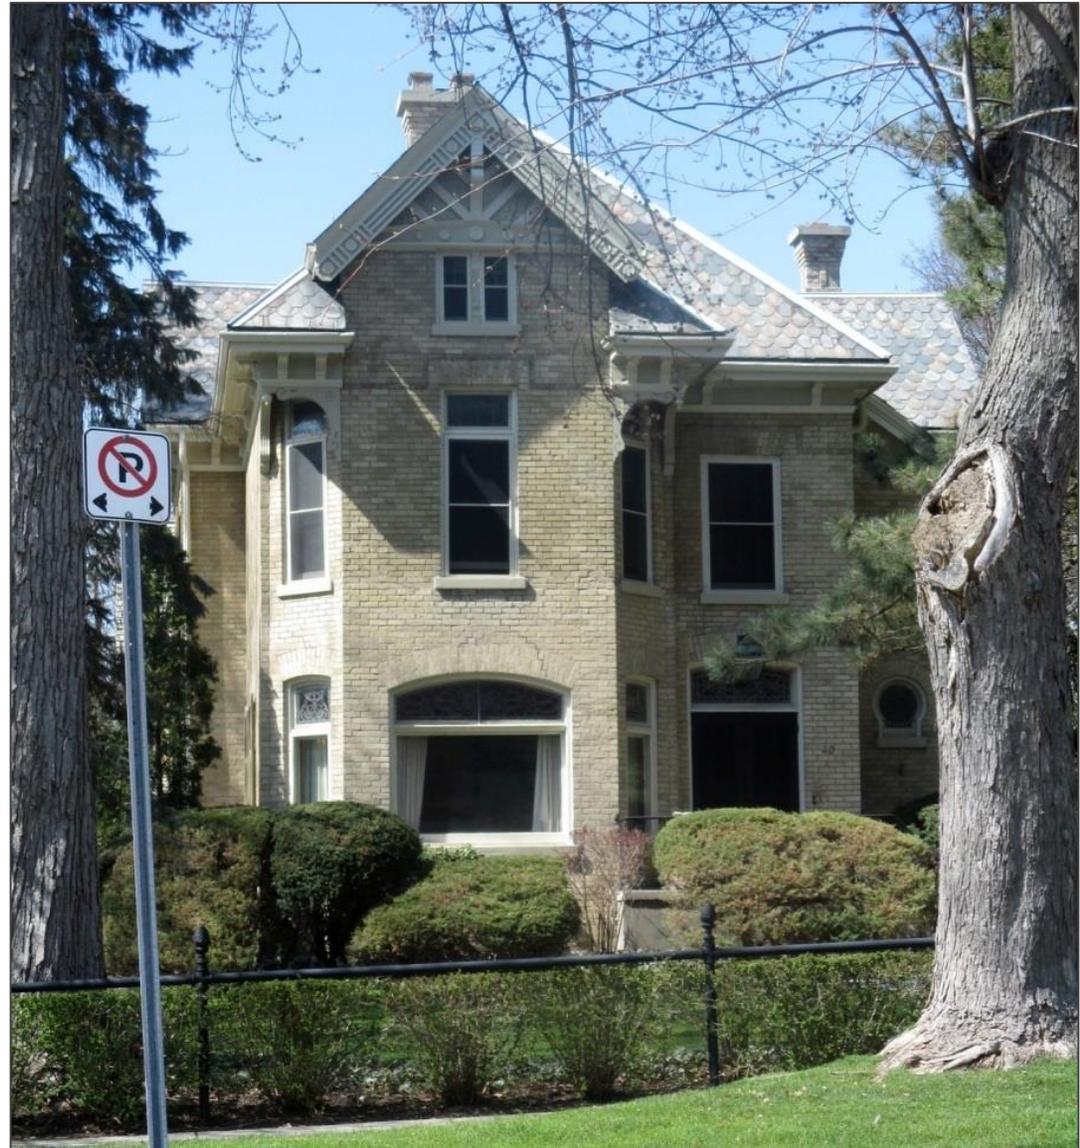
Image H9: 20 Grosvenor Street, 2015

The house at 20 Grosvenor Street (Image H9), built in 1892 as the Rectory for the Church of St. John the Evangelist east of Richmond Street, exemplifies the protruding and receding wall planes of the style, the typical picturesque roofline with high corbelled chimneys, the slate roof with patterned tiles, the stained glass windows, the boxed decorative bargeboard, and the elaborately ornamented gable. It also reveals Italianate influence in the brackets and broad eaves.

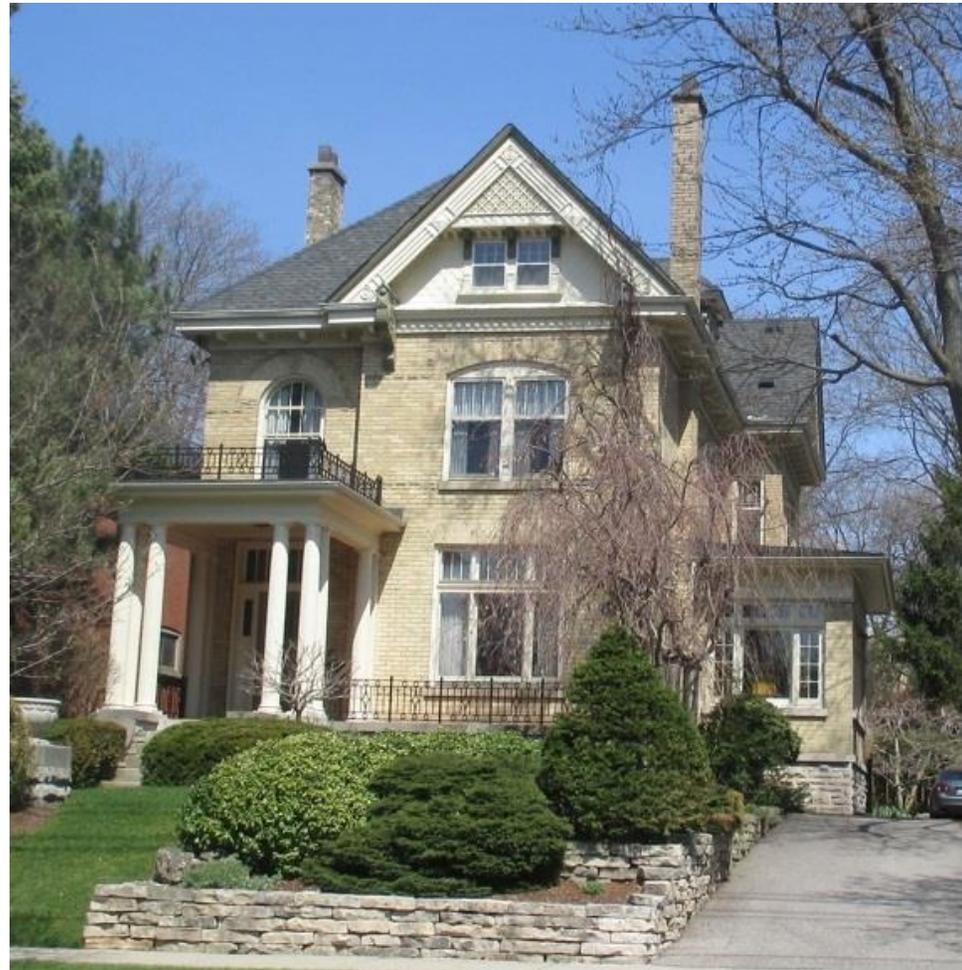
Image H12: 322 St. George Street, 2015

The house features a simpler footprint than, say, one finds at 20 Grosvenor Street, but it still retains a plethora of ornamental detail on the facade: the boxed bargeboard, the brackets supporting a decorative panel in the apex of the gable, shaped wood shingles, contrasting voussoirs, to name some of the more obvious. To this is added a handsome porch supported at each outer corner by a grouping of three fluted Doric columns.

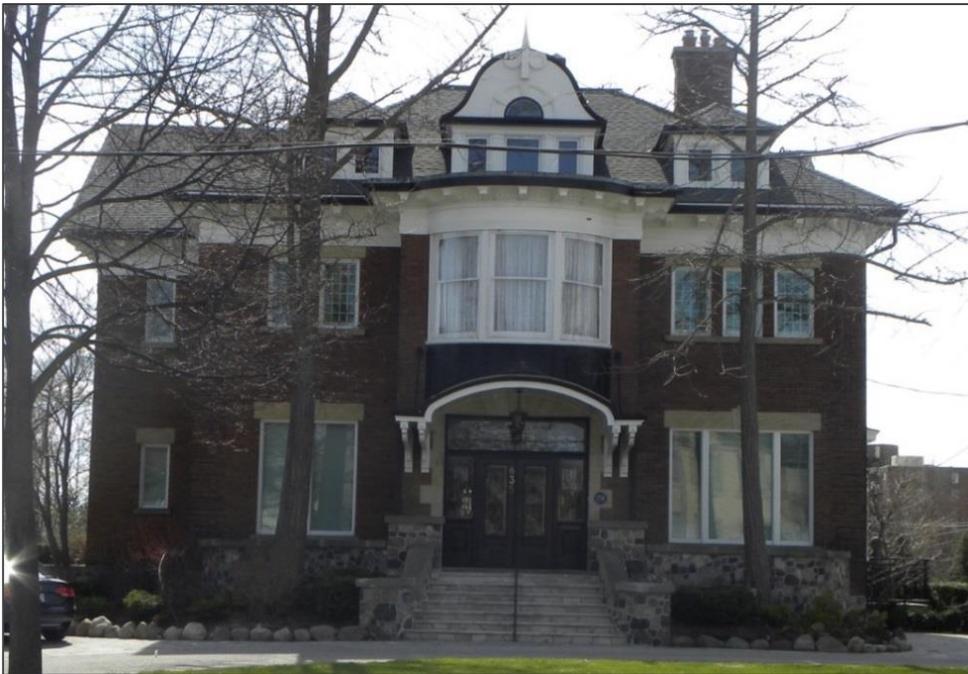
Image H13: 835 Richmond Street, 2015

A more unique interpretation of Edwardian Classicism is found at 835 Richmond Street (Images H13 and H14). While the modillions under the eaves are a prominent feature of the design, the classicism relies more heavily on near symmetry and on geometrical shapes for its impact. The bulbous oriel window above the front entrance is echoed by a broad rounded bay on the south side of the building. The posts of a brick wall that once surrounded a courtyard terminate in stone spheres.

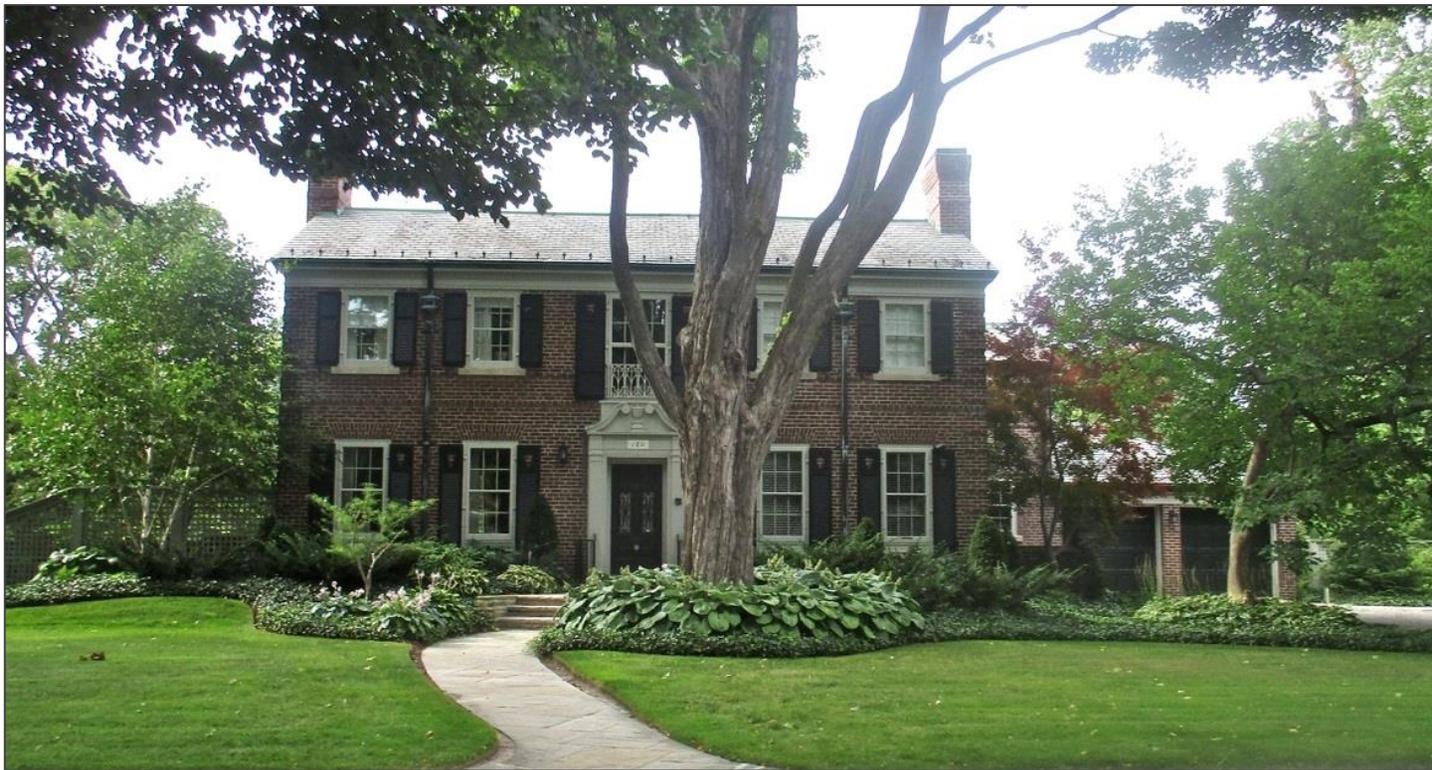
Image H18: 180 Cheapside Street, 2015

The term "Colonial Revival" is a term originating in the United States to describe a revival of pre-Revolutionary War buildings. The term is therefore somewhat meaningless in Canada, and is often replaced by "Georgian Revival." The buildings erected here during the 1920s and 1930s were strongly influenced by their southern neighbours, however, and the "Colonial/Georgian" buildings of the period were in fact somewhat imaginary mixtures of elements that had not existed before. The house at 180 Cheapside Street (Image H18), is conscientious in its effort to imitate early Georgian features (the symmetry), the five bays, the small-paned windows, the shallow gable roof), but the heavily moulded broken pediment above the front door would not have been combined with such primitive features as the common garden bond found in the brickwork. Like the between-the-wars buildings of the Tudor Revival, those of the Colonial Revival were largely imaginative inventions in a new style.

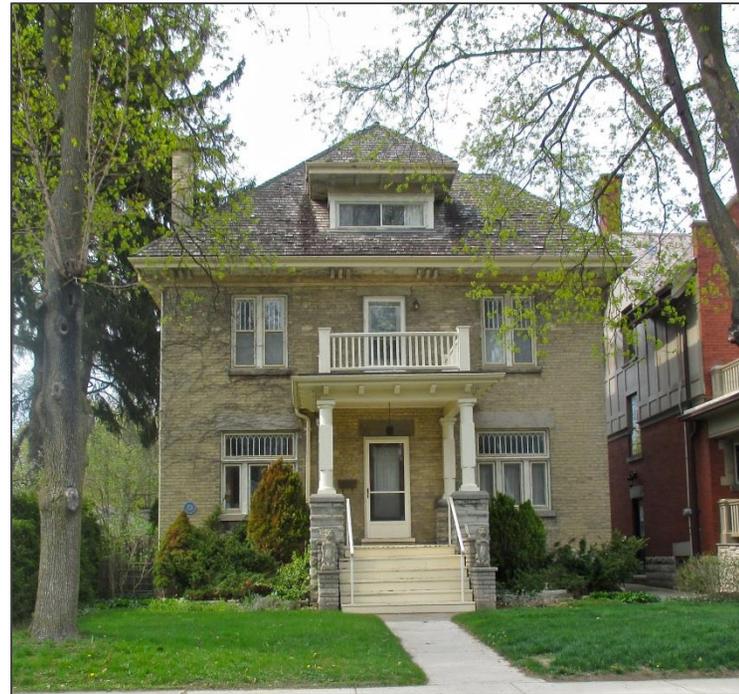
The 2-and-1/2 storey, buff brick house is one of several four-square houses on the block. Typically, it has a hipped roof, here with hipped roof dormers on the front and the east side. Like the original roof, these are covered in wood shingles. Their broad eaves appear to be supported with shallow modillions, evenly spaced along the deep soffits of the dormers and the porch roof, and gathered in groups of three along the broad eaves of the house itself. The symmetrical facade has three bays. The ground floor windows in the outside bays feature three lights, surmounted by transoms that feature narrow panes shaped into lancets by their wood muntin bars; a row of small dentils separate the transom from the lights below. More elongated lancet shapes appear in the upper sashes of the two-light windows above, on the second-storey. A high, 18-inch deep foundation, faced with rusticated stone, surrounds the house; the same rusticated stone forms courses alternating with those with a smooth surface to form the thick bases of the porch posts. Possibly the most striking feature of the house are the unique, heavy wood posts: their long middle section, with its square profile, seems to suggest the raw material from which the elegant round sections above and below have been fashioned. The front porch serves as an entranceway to the front door, mainly composed of glass within a moulded wood frame. Above, a door leads from the second floor onto the porch, surrounded by railings whose spindles also have a square profile. The front porch has a wood deck and five wooden steps. All windows and doors are surmounted by a slightly rusticated, thick sandstone lintel; the windows also feature sandstone sills. Though a later addition to the house, the stone lions that guard the front steps provide an appealing welcome. The wood front door contains a large glass panel.

Bridport is a narrow street, but the house sits approximately 8 metres from the front property line and 14.5 metres from the edge of the street. A two-car garage opens from the laneway behind the house, where a board fence topped by a wooden trellis also serves to separate the lane from the back garden.

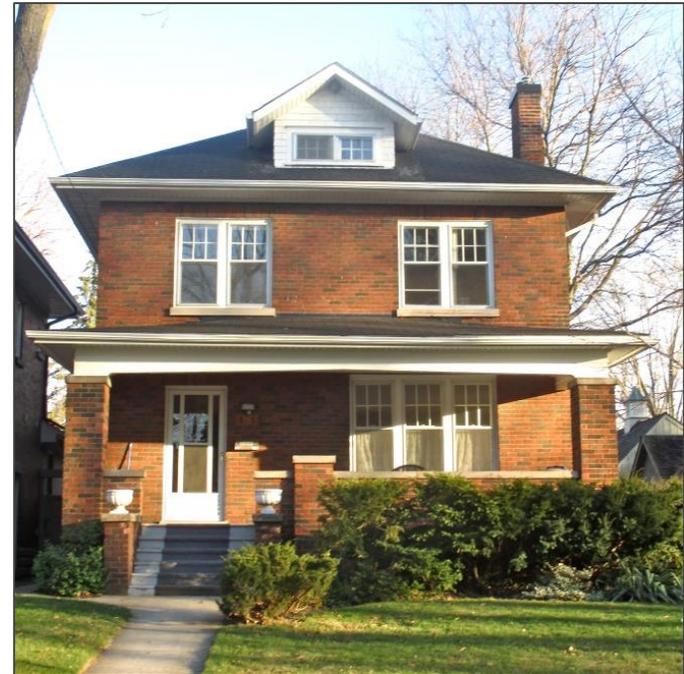
Numerous Craftsman-Style elements are incorporated into the design, such as the flattened arch on the veranda that spans the width of the facade, the use of brick for the "balustrade" (which has been sympathetically extended to accommodate a narrower set of front steps and features stone copings) , and the broad, square, brick columns, supporting the veranda roof. The house has a fundamental symmetry that is somewhat contradicted on the first storey by an offset front door and triple window. On the upper storey paired windows are placed symmetrically. All front windows are original 6/1 sash windows, and all windows, as well as the front door, are topped by brick voussoirs and have stone sills. The porch has a very shallow hipped roof; its fascia board and eaves are unadorned, as are the main roof eaves. The dormer features two six-paned windows and a wood shingle bargeboard cladding the gable dormer. The roofs are now clad with asphalt shingles. A tall chimney rises along the west side of the house.

At the back of the house there is a two-storey addition clad in board-and-batten. Laneways lead along the west side of the house and across the back; both are lined behind the house with chain link fences and rows of cypress trees. A board-and-batten one-car garage opens off the back lane. The front of the house is approximately 5 metres from the front property line and approximately 11.5 metres from the edge of the street.

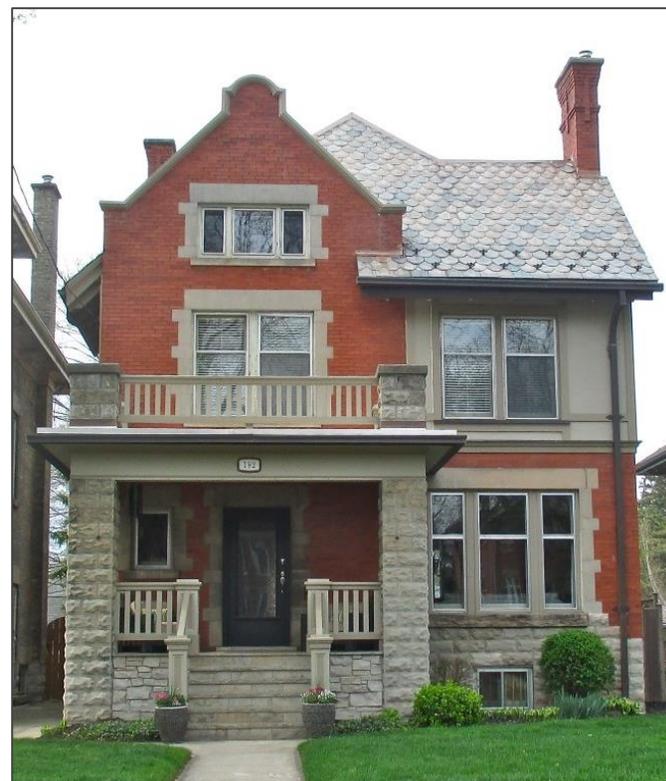
The two and a half storey red pressed brick and half-timbered house presents a striking, late version of the Queen Anne Revival style, dealing with that style in a restrained manner influenced by the Richardsonian Romanesque and Craftsman movements. Its most dramatic feature is the stone-capped, brick pediment gable that rises above roughly the west half of the facade; it contributes to a restrained picturesque roofline combining a pointed hipped roof with a west gable. The scalloped slate tiles with which the roof is clad and the high corbelled chimneys make a significant contribution to the picturesque effect. The ground floor and the area

beneath the gable are faced with brick, the second storey and east gable with a simplified half-timbered pattern derived from the Craftsman Style. Also reflective of that style are the rafters under the overhanging eaves. The prominent Richardsonian influence is felt in the high rusticated stone foundation, which rises to encompass the first-floor window sill and to form the thick stone block posts of the porch and the balustrade above; the square profile of the balusters echoes that of the posts. Smooth stone slabs top the front door all windows within the parts of the facade faced with brick. In a manner typical of the period, most windows are grouped, to form a triple window in the gable, paired sash windows on the second floor, and a triple-light window on the ground floor. A small single stained-glass window, given the full treatment of stone lintel, sill, and quoins, sits west of the front door, overlooking the porch. The front doorway comprises a large glass panel within a wood frame.

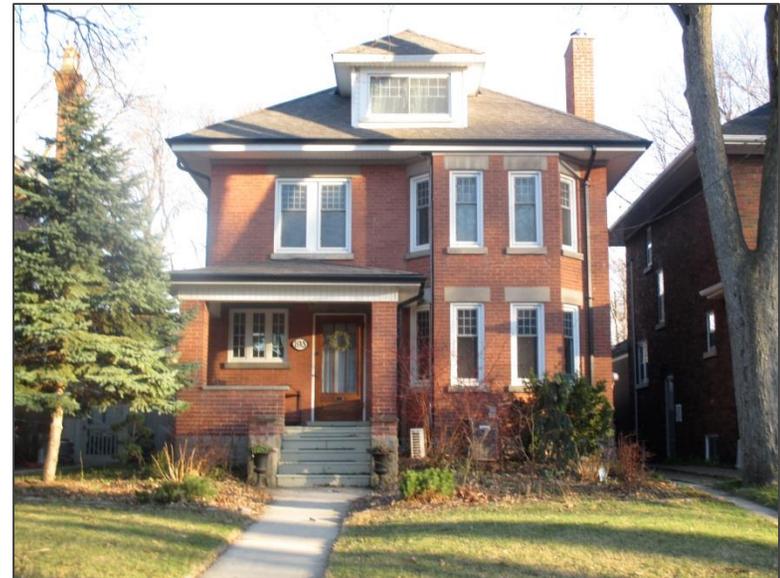
The facade of this four-square brick house is dominated by a broad two-storey protruding bay on the west side that spans slightly more than half the frontage. The squared-off bay is notable for its unusual brickwork, where the front face extends slightly beyond the angled side walls. Windows are placed symmetrically within the bay, two across the front section and one on each side on both storeys. Paired sash windows of the same length are found on the second floor, above a square porch that extends half way across the facade. With all of these windows, the upper sash has been divided into very small panes by wood muntin bars. The porch has brick columns, flanking a low brick wall, surmounted by a stone coping, across its sides and part of its front. The porch encloses the front door and a smaller triple window, also featuring small panes. As is typical of four-square houses, the roof is interrupted by a hipped dormer, here with small paired windows. The house, dormer, and porch roofs all have hipped roofs. The house has a rusticated cement block foundation. All windows feature stone sills and heavy stone lintels surmount all windows and the front door. The roof is now clad with asphalt shingles. This house has a brick chimney on the west side.

Like other houses along Bridport Street, this house is separated from the street by a rather shallow boulevard, a sidewalk, and a moderately sized front garden. The front of this house is approximately 5.5 metres from the front property line and 11.75 metres from the edge of the street. A two-car brick garage opens off the laneway, where a board-and-batten fence also assures the privacy of the back garden.

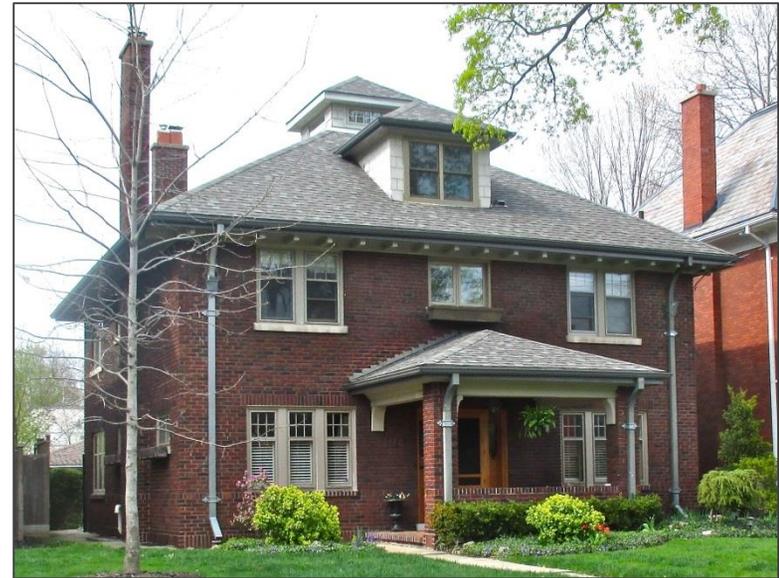
The two and a half storey brick house has a Craftsman-like profile and details that lend it the look of a large cottage. The basic symmetry of the rather horizontal structure is maintained by the common lines of the various roof structures: the hipped roofs of the house, the centred dormer, and the centre porch. The front of the roof is interrupted by a central dormer with a hipped roof. This dormer has a double window in front and is clad in white siding. The windows are grouped in triples on the first floor and on the second; the pair over the front porch is smaller to allow for the height of the roof. All of the longer windows have upper sections featuring six small panes. The second-storey windows are outlined with a substantial, flat wood trim, and they have concrete lintels and sills that are finished to look like stone. The first-floor windows are topped with brick soldier courses and have sills formed with brick headers, which continue as a course of headers around the building, intersecting other sills in the process; the low foundation line is also accented with a soldier course of brick. The brick facing of the house is of variegated hues, ranging from red to black and giving an overall impression of a dark red. This brick is also used to form the solid square posts of the porch. Thick, shallow, plain, wood spandrels provide a transition between the porch, posts, and wall. Like the purlins beneath the broad eaves, they allude to the Craftsman character of the building. The unique front entranceway comprises a door a wood door and two large sidelights filled mainly with the same wood, but all three units feature a short window, flat at the top and forming a deep V at the bottom. The front porch is accessed on the side and a single step above grade. A belvedere, a relatively recent addition to the building, sits at the peak of the roof. This house has a tall brick chimney on the west side and a second tall brick chimney on the back near the northwest corner of the house.

This house, like its neighbours, sits comfortably distanced from the boulevard and sidewalk. The front of this house is approximately 8 metres from the front property line and 14.5 metres from the edge of the street. Behind the house, a two-car garage leads off of the laneway at the rear of the property; a high board fence adjoining the garage provides additional privacy to the back garden.

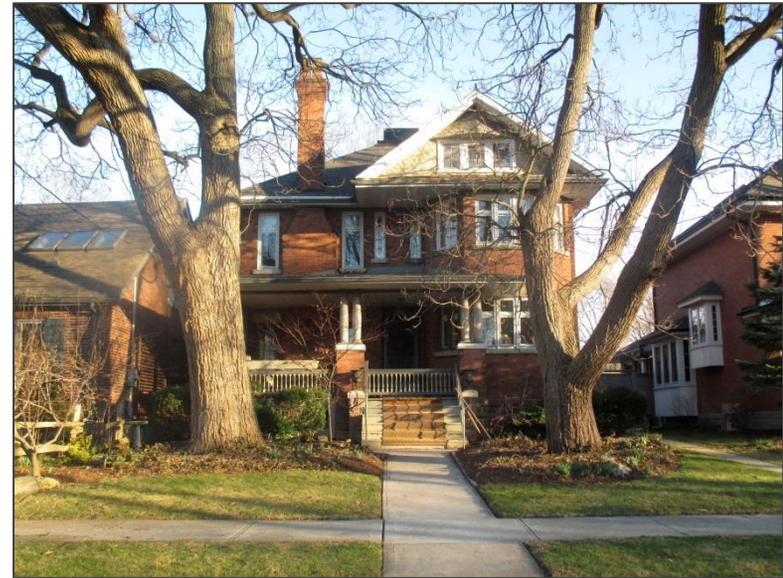
W.G. Murray was a competent and adventurous architect, but the home he seems to have designed for himself sticks relatively close to the Edwardian norm, looking forward in some subtle ways. The most prominent departure from the typical was in his use of the large cantilevered front gable, which overhangs not only octagonal bay, but also the area above the front door, distinguished by two narrow windows on the second floor. This impressive weight on the west part of the facade is balanced to some extent by the porch reach across much of the east side. The house is clad in pressed brick, popular during the period, but the brick has the orange/red to black range in colour that became common with the more textured brick of the next decade. The house sports a considerable variety of window sizes. Windows of the same size are symmetrically placed around the bay: a group of three on each storey in the front, and pairings along the sides on each storey. The two windows on each storey near the eastern side of the front façade are

longer and spaced to emphasize the wall space between them. All of these windows are divided into a long lower section and a small upper pane, the latter probably once displaying stained glass. All windows except the three currently in the dormer have stone sills, and droved ashlar stone slabs form the lintels of the ground-floor apertures. The squat, slightly bulging Doric columns of the porch, sit on top of thick, square stone piers; a single column is on the east pier and groups of two dignify the approach to the front entrance. Classically shaped spindles form a balustrade between the posts. The front wood door is panelled with a 6/6 window in its upper half; what appears to be an original storm door provides added protection. The front gable features large scalloped shingles, both next to its three-light window and in the protruding apex, where the shingles form a prow-like structure. The hipped roof is now clad in asphalt, and the house appears to have a rusticated concrete block foundation

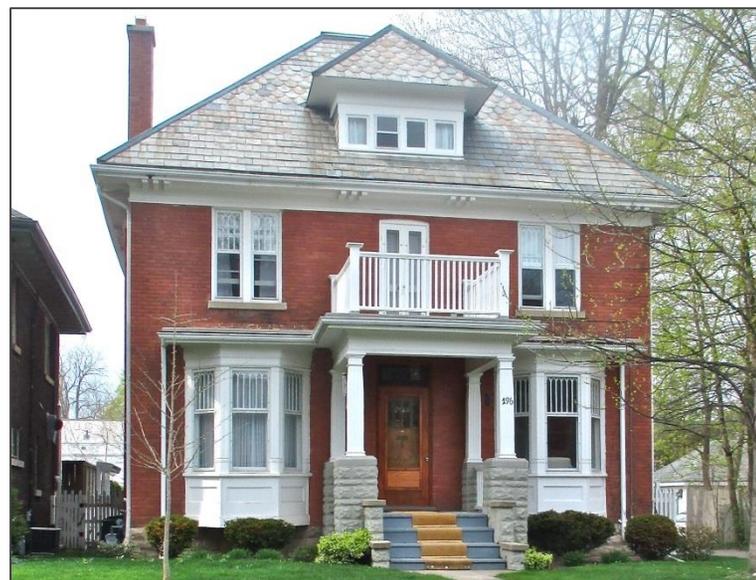
The houses at 196 and 190 Bridport Street are so similar that they may have been designed by the same builder or architect. They share the same square footprint; hipped roof and dormer structures; high brick chimney on the west side; broad eaves supported by groupings of three modillions; a three-bay symmetrical facade with window pairings on the second floor with groups of three windows on the first floor below; narrow lancet-shaped panes in the upper sashes of the windows; and a square centre porch leading to a front

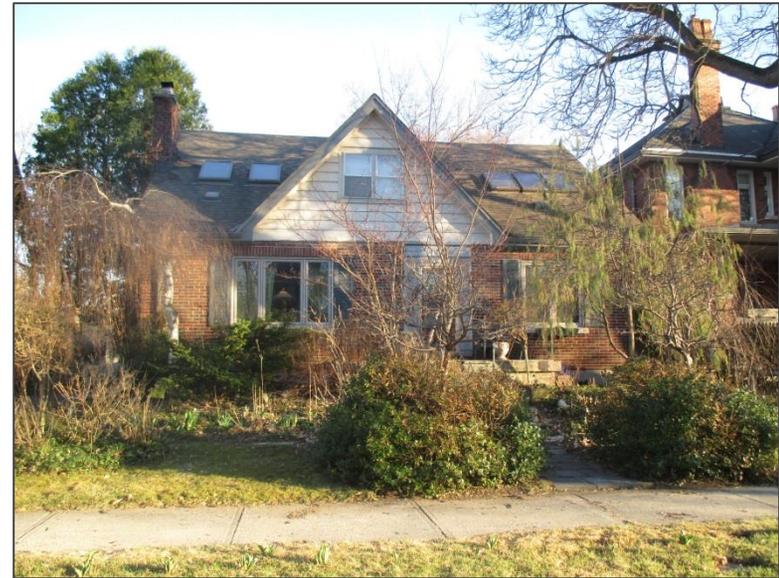
The gable-roofed house at 157 Bridport is a relatively late addition to the streetscape and shares some attributes with wartime housing, such as the very shallow eaves. The brick-clad ground floor has a three-bay symmetrical facade, with triple windows to each side of the central front door. The windows are topped with brick soldier courses and are flanked by ornamental wood shutters; they have stone sills. The front door, with a leaded glass panel, is flanked by two fluted pilasters that give apparent support to a relatively plain lintel. The side gables have upper-storey windows, and a large off-centre front gable, holding paired windows and faced with wood siding, now, with numerous skylights. There is also a new dormer addition at the back. The house is supported by a concrete foundation, and a concrete stoop leads to the front door. All windows are now aluminum framed.

This house, like its neighbours, sits comfortably distanced from the boulevard and sidewalk. The front of this house is approximately 5 metres from the front property line and 11.5 metres from the edge of the street. Stone steps lead by stages to the front concrete stoop. The back garden is protected by a partly trellised fence; a two-car garage leads off the back laneway.

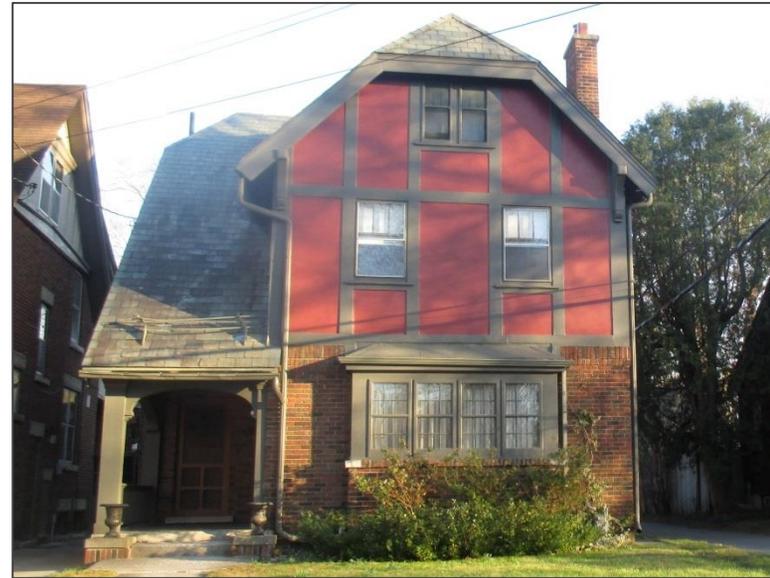
This two and a half-storey house presents a striking example of Arts and Crafts influence. It has a hipped gabled roof with half-hipped treatments at the gable ends. It has a simple pattern of half-timbering on the second storey combined with brick cladding on the first storey. This house has a wide, shallow front bay with a row of four 6/6 sash windows, and a hipped roof. The Arts and Crafts influence can also be seen in the angle of the roof, seen in this photo at the end of a dramatic downward sweep along the east side of the house. The porch is recessed under the main roof, and supported by heavy square wood posts and a simple by equally heavy arch. The roof is covered with slate tiles in a variety of hues. The rug brick blends colours ranging from an orange/red to black. A brick soldier course runs around the base of the building; protruding courses of vertical headers and stretchers finish the top of the ground-floor brick cladding. The sill of the bay windows is formed of headers, with stone accents at the corners. A brick chimney rises to the level of the roof peak. The front door features a long, leaded glass panel set into a wood frame.

This house, like its neighbours, has a moderately sized front garden, owing in part to the narrowness of the boulevard separating the road from the sidewalk. The front of this house is approximately 4.75 metres from the front property line and 11 metres from the edge of the street. A one-car pebble-dash garage opens from the laneway along the west side of the house. A partly trellised wood fence separates the back yard from the lane.

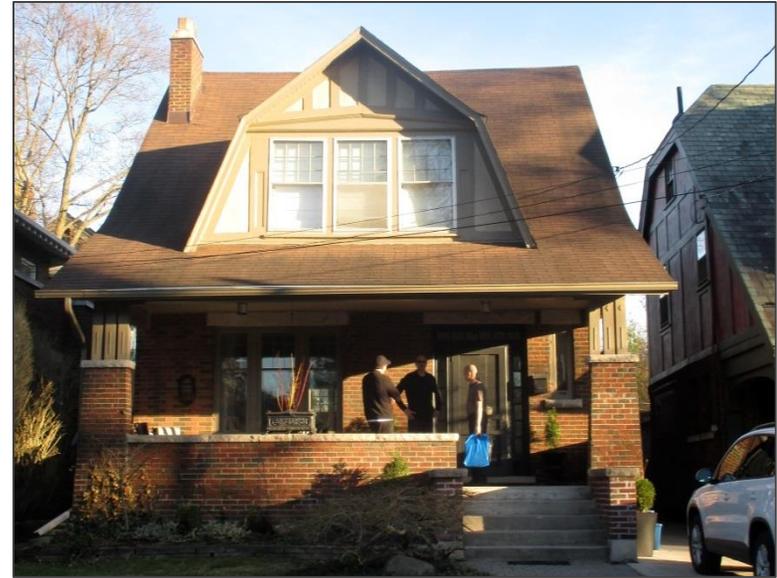
This house, like other Bungalow style homes, gains almost a full second storey through the broad dormer in its front- sloping roof and the length of its side gables, although this roof is unusual for the style in that the roof becomes shallower over the front porch. This house features a brick-clad ground storey with half-timbering above. Here the brick is a rug brick ranging in colour from an orange-red to black; it wraps around the house to envelop the front porch walls and posts. The half-timbering, like other features in the house, shows considerable Craftsman-style influence. Of particular interest here are the stone-capped, tapered porch posts, narrowing at the top, where a combination of five squat, square, wood posts transitions to the roof above. Also of interest is the framing of the row of 12/6 dormer windows, with partially panelled members along each side and a pediment-shaped board above, the shape outlined by a protruding moulding. The ground-floor facade features a triple window, also with small panes in its upper section, and a short, narrow window west of the handsome front door, which exhibits small bevelled panes within a larger wood frame. A deep, narrow chimney, terminating at the height of the roof crests, emerges above the east wall.

This house, like its neighbours, has a moderately sized front garden, owing in part to the narrowness of the boulevard separating the road from the sidewalk. The front of this house is approximately 3 metres from the front property line and approximately 9 metres from the edge of the street. A driveway runs along the west side of the house towards a one-car garage attached to the rear corner.

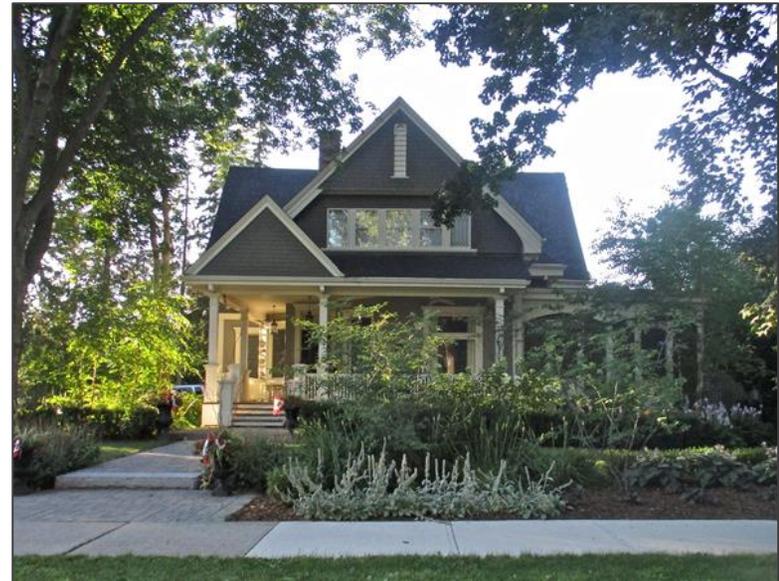
The building's footprint comprises numerous projections and setbacks that allow for the picturesque plan typical of Queen Anne cottages. It shares other attributes of the Queen Anne style: the mixture of Elizabethan/Tudor motifs and classical motifs, such as, respectively, the small-paned windows and the Palladian window in the west window with its elegant shell motif. Shingle Style influence was mainly felt in the copious use of wood shingles on the steep roof, in the high, broad gables, and in a deep first-storey, slightly flared cornice. When seen two-dimensionally, as in the elevation shown above, the house suggests something of the Edwardian classicism evident in a symmetrical, balanced design, but with this building there is a tension the Edwardian orderliness and more irregular Queen Anne qualities: the walls widen at different points on east and west sides of the building. The wide front gable extends well over the recessed doorway and broad bay window below. While keeping the windows and most of the window, door, and porch trim of the original house design, a recent remodelling has substantially changed the character of the building by eliminating much of the texture that was formerly created through the use of shingles and the local buff-coloured brick cladding. Stucco was applied to the exterior of the house. Wood corner boards have been added that appear to frame the building. The asphalt shingles in the gables and cornice are now laid in a smooth sheet that further minimizes the sense of texture.

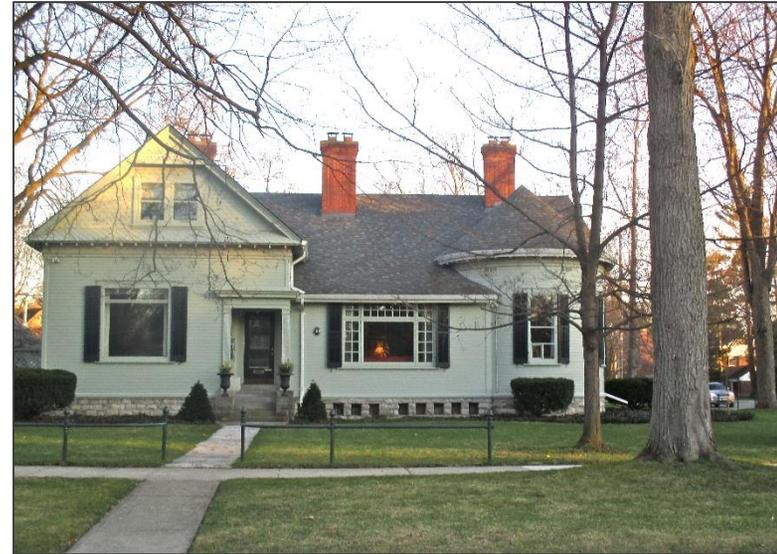
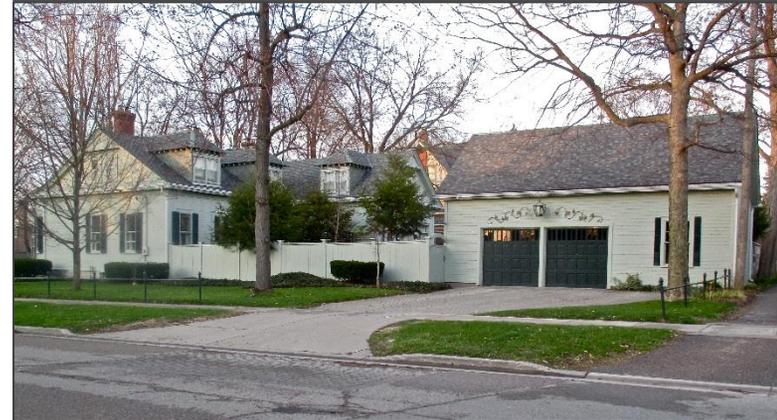
Two features of this house make it unique and especially noteworthy: (1) its one-and-one-half-storey interpretation of a Queen Anne Revival form usually found in two-storey versions, and (2) the tongue-and-groove siding that curves smoothly around the corner tower. A common Queen Anne Revival format calls for a gable, usually over a protruding wall plane, at one end of a facade, with a tower at the other end, and with a front door and porch in between, the porch often extending towards one corner of the facade. Here one finds a broad gable, over a once-protruding wall, at the east end of the front facade, with a conical roof defining a greatly shortened tower at the west end. The one-time porch between these two elements has been made, reputedly by Cora Tracey Goepel in the early 1940s, into an enclosed room with a wide front window surrounded by small panes. Despite its Queen Anne Revival allusions, there are other elements of the facade that seem to be at least a decade or two ahead of the building's apparent **Date of Construction**: the gable decorations, consisting only of shaped wood shingles and paired windows with a fluted surround and corner blocks, are simple for c. 1900; the front door is recessed within the gable wall, underneath the half storey above; and the decorative purlins are found under the broad eaves, even those of the dormers visible from the St. George Street side of the house. The narrow tongue-and-groove siding is laid horizontally around the entire house, including its large back wing; corner and foundation boards and a cornice of layered wood mouldings frame the building's structural divisions. The sash windows that are found on the short tower, the back and sides of the house and the garage are now flanked by ornamental shutters. Three wide, panelled, and corbelled red brick chimneys are placed symmetrically just north of the roof ridge, forming a striking addition to the building's front facade.

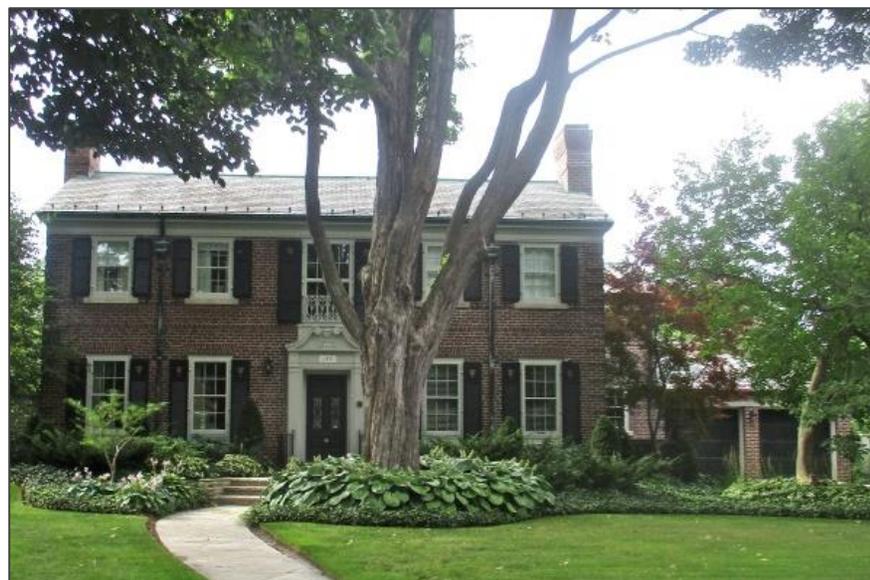
The large 2-storey house re-creates a Georgian Revival or early Colonial impression in a number of ways: through the symmetrical five-bay format with a centre door, the shallow gable roof, the placement of the upper-storey windows against the cornice, the 6/6 window, working shutters, and the use of red brick facing with the wide applications of mortar, brick quoins, brick voussoirs and the tall end chimneys that are on either end of the house. In addition, several unique and subtle features introduced here make the house a particularly interesting and refined version of its style: the introduction of a bond row in every fifth brick course, even though the brick is actually a veneer, the use of protruding and recessed bricks in the sill and floor courses to create the impression of a broad brick band encasing the house, a soldier course along the foundation, an intersecting saw-tooth design in the wood cornice, and elaborate stone mouldings in the spandrels beneath the ground floor windows. An impression of a frontispiece is created by the

centre complex of door and window: a heavily moulded broken pediment above the front door, housing an urn, backs against a wooden spandrel that forms the base of the elongated window above. Windows in the front door are decorated with a wrought iron design that echoes that in the ironwork of the ornamental balcony above.

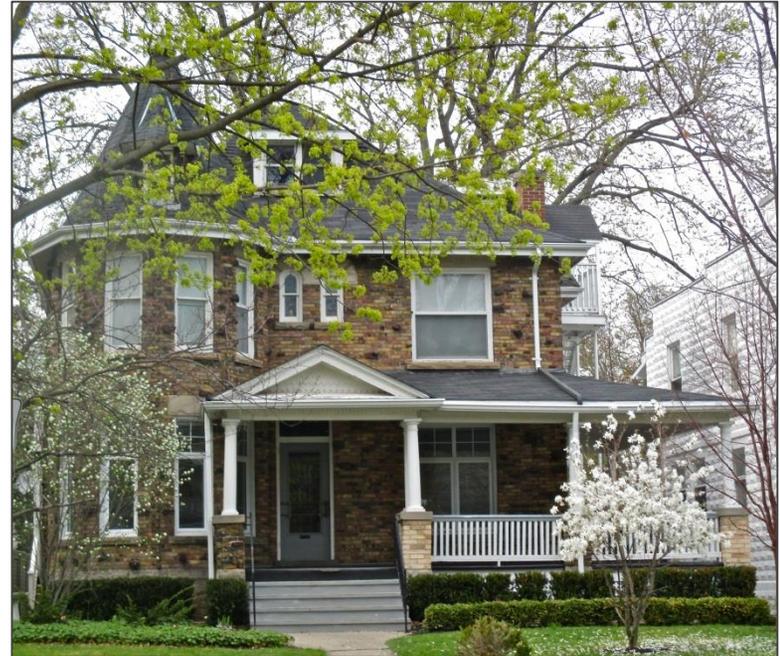
This house has the trademarks of Edwardian Classicism within its London environment, but it also possesses a number of distinctive features that give it a very distinctive character. Typical characteristics include the tower, the steeply pitched hipped roof with a cross gable, the large porch, classical details (such as the Doric columns, a classical pediment over front steps, and the dentils around the cornice of the porch), the decorative wood shingles within the pediment, and the rusticated stone foundation. Among the unusual features are the brick facing, the shape of the tower, and the composition of the facade in terms of balance. Most evident is the unusual brick used: rather than the usual local white brick or imported red pressed brick, this building is faced with a unique, moderately rough brick including shades of yellow, gray, and a pale orange, its textural quality enhanced by projecting clinker bricks interspersed over all parts of the wall. This highly palpable surface treatment looks forward to the emerging Craftsman Style, as do the high bases of the shortened columns. The tower is unusual in being decagonal, with a high, pointed, hipped, decagonal roof; each front plane of the tower has long, narrow windows at both the first- and second-storey levels. Examples of Edwardian Classicism usually exhibit a near-symmetry, but here, while the front door and the small, paired, round-arched windows above are centrally positioned in the facade, the complex, projecting planes of tower, emphasized by the eight windows, presents a relatively crowded image balanced less by the broader window arrangements on the east side than by the wide eastern extension of the porch roof, with its hipped roof, and the projecting, hexagonal, bay window under the east gable. Each of the windows (the eight in the tower, the paired windows over the front door, the paired lights east of the front door, and the square sash window above) has a rock-faced stone sill and broad, more shallowly rusticated stone lintels or voussoirs; all ground-floor windows on the front facade have four small panes in the upper

section; all second-floor windows are sashes. A shed-roofed dormer with two sash windows now lights the attic floor, as does a window placed in an ingenious hexagonal miniature tower emerging from the front side of the decagonal tower roof. A stucco-faced, two-storey, rear addition has quoins of brick similar to that of the original house; it interrupts the bay window on the east side of the house, where a stairway leads to an attic apartment.

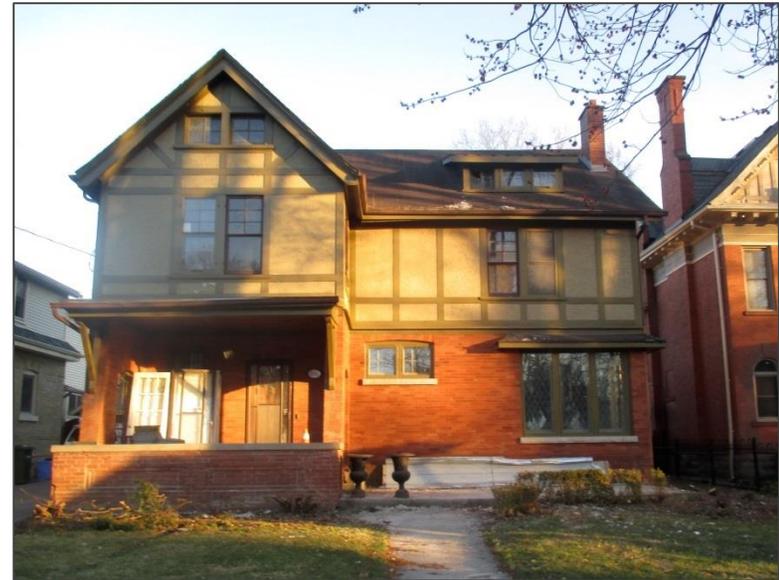
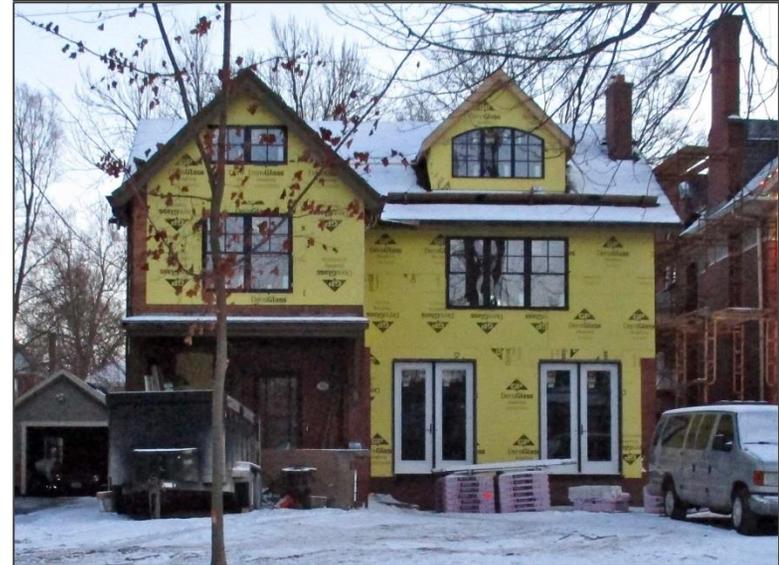
This house was a notable example of homes showing certain Arts and Crafts influences: from the Stickley style of the American Midwest and the Morris and Voysey schools in Britain. Illustrative features were the half-timbering, the porch partially embedded under the roof, and row of small-paned windows on the ground floor, with their own shallow shed roof, and in the dormer, with its fitting and unusual flat roof, the porch overhang "supported by striking diagonal brick piers and heavy diagonal wood braces," and "the emphasized freedom from symmetry and even conventional ideas of balance, evident . . . in the central portion of blank wall." It is clear that several of these features have been removed during the renovation (in progress at the time of writing), but is uncertain just how much the final result might resemble the original. The unique dormer and the rows of windows are gone, along with the blank wall spaces responsible for much of the first facade's original character. It appears, however, that much of the protruding wing on the east may remain, including the shape of the partly recessed porch, with its front and side arches, and the diagonal piers

The upper photograph (April 2015), shows the house much as it must have looked when Stanley first took up residence there. The lower photograph (January 2016) shows the house under renovation.

and heavy braces beneath the projecting porch roof.
