St George-Grosvenor Heritage Conservation District Study

Volume IV Appendix F, [2016]

APPENDIX F: INVENTORY OF CULTURAL HERITAGE RESOURCES

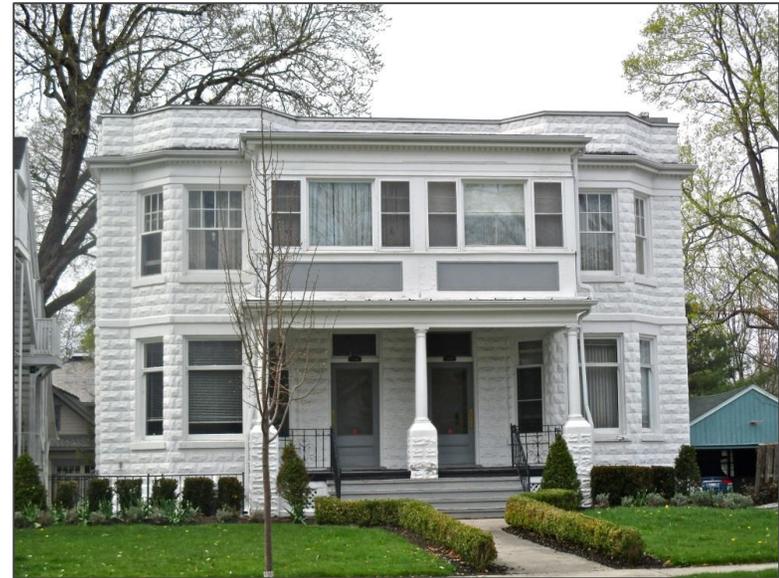
The double house at 194 and 196 Cheapside Street is almost entirely faced with rock-faced concrete blocks, now painted white; exceptions are the plain smooth concrete courses at the floor levels and the deep cornice beneath projecting eaves, and the wood sun- or sleeping room now located over the front porch. The two front doors are centrally located, with a hexagonal, two-storey bay window to each side; the cornice, with a deep dentil frieze, and the eaves intersect those of sun or sleeping rooms above the projecting front porches of both units. Above the cornice, a parapet wall, capped with what appears to metal coping, runs around the bay windows but behind the sun rooms. The porch roof and the rooms above are supported by abbreviated Doric columns set on concrete bases, the latter comprised of alternating smooth and rock-faced courses. The second-floor windows within the bays feature 6/1 sashes on each projecting side. The first-storey sashes have a single plate glass window in the lower window, and, now, a transom-shaped sheet of plain glass in the upper sections, though it is likely that these originally held stained or bevelled glass; the rail between two parts of these windows features a row of small dentils. The windows have smooth concrete sills and lintels, except for those on the second floor, where the lintels are formed by the lower section of the wood cornice. The front doorways hold wood doors, each with a single fielded panel towards the bottom and a long window insert above it, and, separated from the door by a dentilled lintel, a glass transom at the top of the complex. Each of sun rooms above the porch has three windows in front: an approximately square sheet of plate glass with narrower 1/1 sashes to each side. A single moulded panel underlines each grouping.

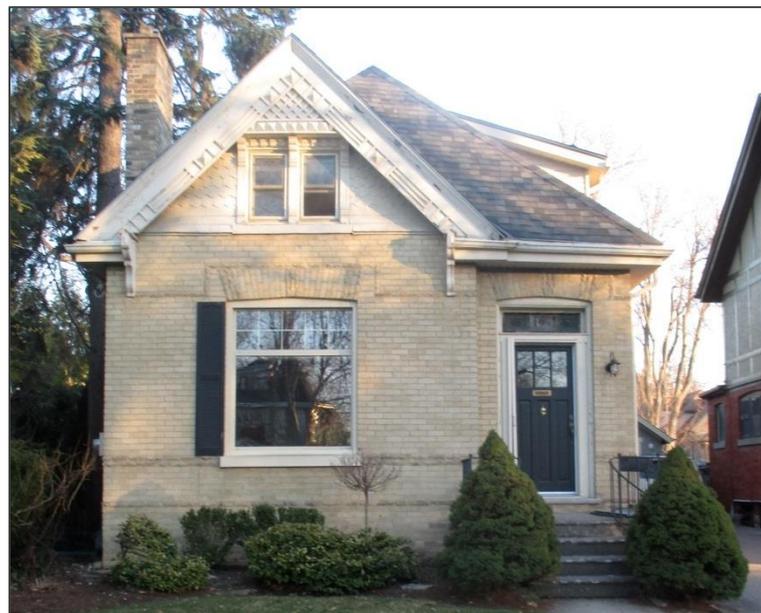
This one-and-one-half-storey house has a rectangular footprint and a hipped roof, with a cross gable facing the front of the house and culminating in a highly decorated gable over a shallow projection in the front wall. (A dormer along the west side of the roof appears to be an addition to the original house. A deep brick chimney rises along the east wall. The front gable sports a wide box bargeboard decorated with applied parallel and perpendicular wood strips and pointed, pyramidal motifs. In the protruding apex is a wooden checkerboard design, finished with a row of further pyramidal motifs across the bottom; the entire apex board is supported by three decorative console brackets attached to the jambs of the paired windows below, as well as a smaller row of brackets in between. Scalloped wood shingles fill the surrounding field. At the outer corners of the gable are triangular brackets" with bevelled ends and carved sides. The walls of the house are made of local buff-coloured brick. Sets of three rusticated buff bricks at the outer edges and in the middle of the voussoirs over the windows and doors, and a row of these rusticated bricks outlines the voussoirs and forms continuing courses at the lintel, sill, and threshold levels. The large sash window beneath the gable has a single pane of glass in its lower panel, a shallow stained glass window above, and a wood sill. The front doorway, on the western side of the facade,

features stained glass in its transom; the present door has vertical panels surmounted by three vertical glass panes. The house has a brick foundation.

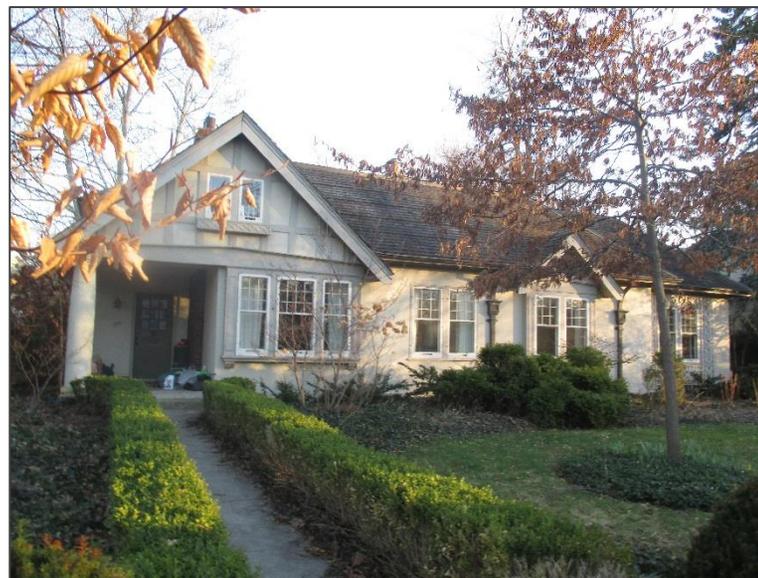
The one-storey, stucco-clad cottage built for Walker's family c. 1925 was relatively small, and J.M. Moore & Co.'s design used a number of devices to give it the distinctly picturesque quality of an imagined English cottage: a high hipped roof, a suggestion of a small addition at the west end, and, particularly, the large gable over a shallow projecting wing that covers over half the breadth of the house. The gable and the area beneath it catch the eye because of the half-timbering and the angled base board in the gable, the recessed doorway beneath the east half of the gable and the stout, slightly tapered Tuscan column supporting the northeast

corner of the house, and the three-light window, flanked by moulded panels and featuring a sill bracketed at the ends. The picturesque quality is emphasized in the front elevation by the trellis the draughtsman has placed against the front wall, suggesting the surrounding flower garden that will complete the cottage. The cottage was substantially expanded in 1940, so that the new house was approximately twice as wide as the old, deeper, and made room for a maid's room and bath in the expanded attic space. Interestingly, the extra space on the main floor was generally devoted to increasing the size of the main spaces (with the possible exception of the kitchen) rather than creating more rooms. The house still had two bedrooms, a dining room, and a living room, though most of these became larger. The single additional kind of space was a sunroom at the back. An extra brick chimney was also added at the rear. The extra length of the facade is accommodated by the addition of a secondary gable and by a shallow setback of the room at the west end of the house. Though much smaller, the new gable reflects the earlier one, protruding over the eaves (though not over a projected wall plane), featuring stucco and wood half-timbering in the simplified Craftsman style, and shielding paired windows with a surround similar to the three-light window further east. "Mailbox" downspouts to each side of this gable further break up the wall. Except for the smaller-paned windows now in the main gable, all windows are 9/1 or 12/1 sashes. The elaborate trellis that now surrounds the paired windows at the west end of the facade echoes the suggestion of the 1925 draughtsman for a cottage draped in picturesque flora.

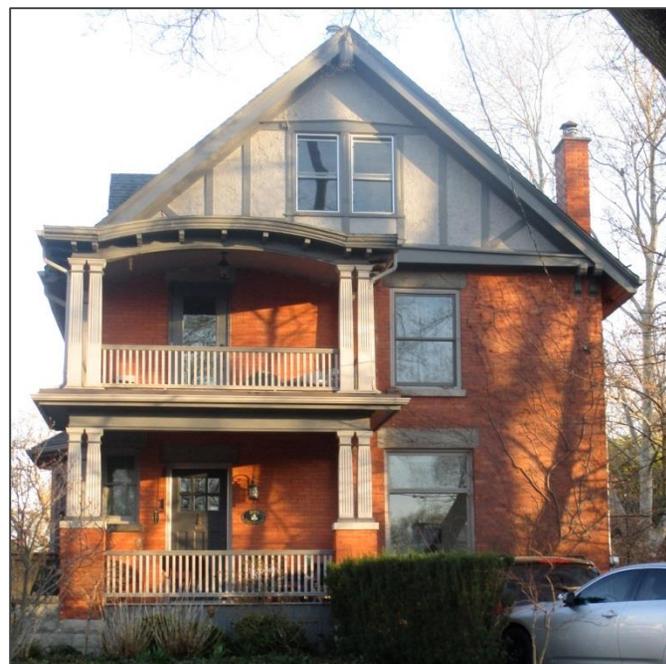
This house has a gable roof, while the other two homes have hipped roofs, and the gable, thus extending across the entire facade, is given prominence by the bold, Stickley-style half-timbering surrounding the paired 1/1 sash windows. The brick walls of the sides and back of this house vary in hue from the orange-red of the front to a near black, the darker colours often caused by what appear to be mechanized scrapings on the brick. The front wall holds two asymmetrical columns of apertures: that towards the west holds

two sash windows (a 1/1 sash on the top and, below that, a larger window with a single pane in the lower panel and a shallower window above, with a row of small dentils between the two sashes); that on the east contains two doors, one opening onto the porch on each floor, and, on the ground floor, a small 1/1 sash next to the door. All openings on the facade are surmounted by deep, rusticated stone lintels; the windows have concrete sills. Both porches are supported by fluted, slightly tapered columns with square profiles; that on the lower level is shorter, sitting on a high brick base. Railings with simple, square spindles line the edges of both porches. The lower porch features a deep, straight architrave, while the architrave and roof of the upper porch are gently bowed, with purlins decorating the deep overhang. The hipped roof of the bay window extending from the east wall features the same purlins below its eaves. The doorway on the west side of the house matches the front door. A gable roof supported by moderately thick braces overhangs the door.

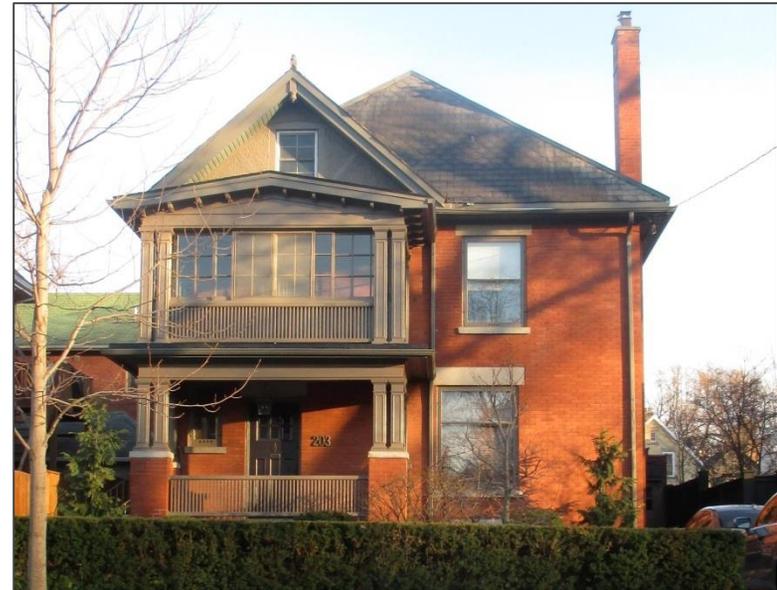
The house at 203 Cheapside has a high, hipped roof, covered with rectangular and scalloped slate tiles and with a steep cross gable over the two-storey porch. The gable holds a single sash window and a half-timbered field, with a heavy pendant and finial at the apex. The front wall holds two asymmetrical and uneven columns of apertures: that towards the west holds two sash windows (a 1/1

sash on the top and, below that and somewhat to the east, a larger window with a single pane in the lower panel and a shallower window above; that on the east would originally have contained two doors, one opening onto the porch on each floor, and, on the ground floor, a small 1/1 sash next to the door. All openings on the facade are surmounted by deep concrete lintels; the windows have concrete sills. Both porches are supported by paired pilasters with square profiles; the pilasters on the lower level are shorter, sitting on a high brick base. Railings with square spindles line the edges of both porches, suggesting that the sun porch now occupying the upper porch may be a later addition. The roof over the porches has a shallow gable, with purlins decorating the deep overhang along all three sides. Period lanterns hang from the roof of the lower porch and over the door on the west side of the house.

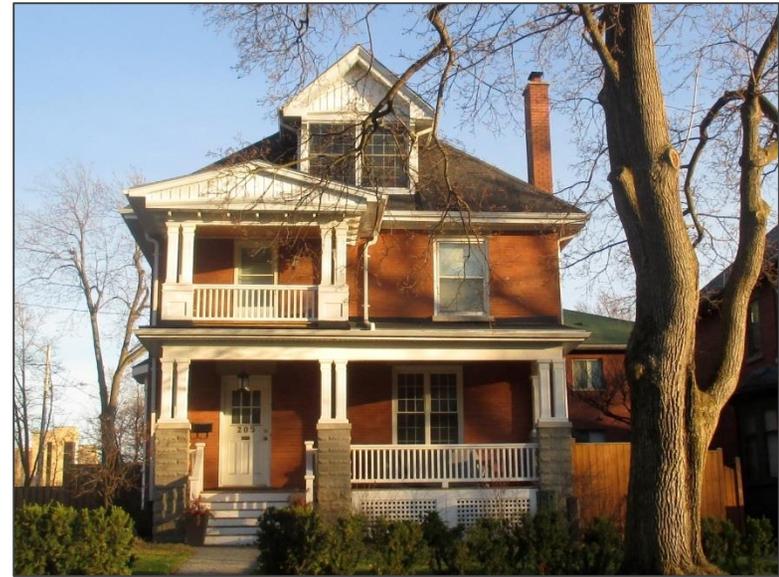
None is completely identical to its neighbour, however. The house at 205 Cheapside has a high, hipped roof and a large gable-roofed dormer in front that may be a recent addition. The facade of each storey holds a window or window complex in the west bay and a door opening onto a porch in the east bay. The second-storey window is a generously sized 1/1 sash. On the ground storey are paired sash windows. All openings on the facade are surmounted by concrete lintels; the windows have concrete sills. The most obvious difference between this house and its neighbours is that the first-floor porch extends all the way across the facade, while that

on the second floor extends only across the east half. Both porches are supported by paired pilasters with square profiles; all pilasters are short, those on the upper storey porch sitting on panelled wood pedestals and those on the first floor on high bases comprising alternating courses of wide, smooth, concrete blocks and narrower, rock-faced concrete. Railings with simple, square spindles line the edges of both porches. The ground-floor porch has a shallow hipped roof, while the second-storey porch has a very shallow gable roof, with purlins decorating the deep overhang along all three sides.

The house has been renovated to accommodate separate upper-storey apartments. An addition has been added at the rear, and a flight of wooden stairs on the west side of the house provides access to the higher apartment(s).

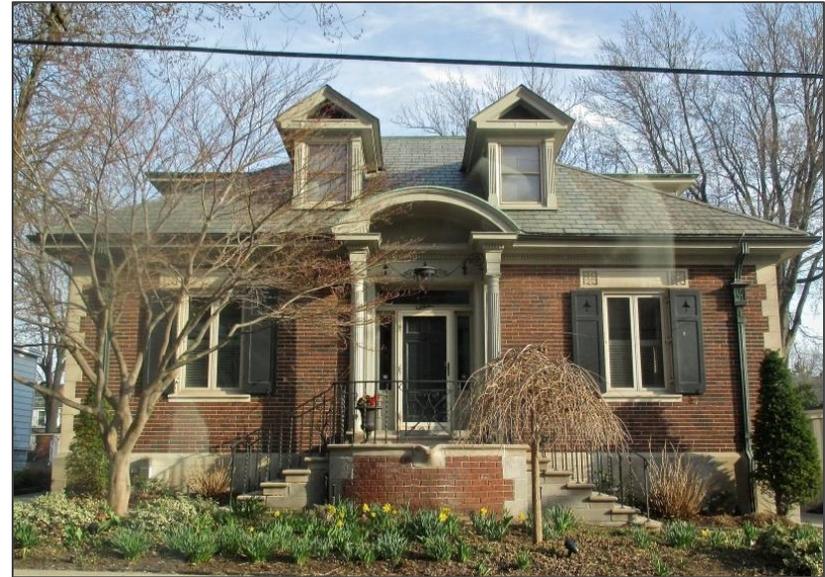
Georgian Revival Ontario Cottage. Technically a one-storey, brick-veneer building according to the 1958 Fire Insurance Plan, Moore's house adopts the form of an Ontario Cottage, with a hipped roof, a three-bay symmetrical facade with centre door, and a rectangular footprint defining the main block of the building. However, the several dormers in the "attic," the high foundation, and a narrower back wing allowed the building to stretch so as to encompass a wide centre hall, a living room, dining room, kitchen, pantry, two "dens," a sunroom, three bedrooms, a maid's room, a nursery, and a play room, along with bathrooms and closets. The external finishes reflect the care taken with the house throughout. While the exterior brick walls project an overall red colour, the individual bricks mix red and black hues in a way that, with their rough surface, gives the walls a strong sense of texture. The brick is recycled; Moore paid for it by trading the one-storey wood cottage that formerly stood on the site (Letter to Moore from Hyman S. Leff, March 27, 1931). The rounded base of the front porch is clad in a less emphatically mottled brick textured with an unusual, random collection of pits and bulges; a sculpted drip stone collects and releases water from the floor of the front porch. Stone quoins mark

the corners of the house and porch. The foundation of the front facade is composed of fossiliferous limestone, as are the lintels, sills, and quoins; the stone lintels of the front windows feature square corner rosettes. The high, ashlar stone foundation is replaced by a brick soldier course and chamfered cement blocks along the side. One approaches the front doorway under a shallow roof supported by two stylized, fluted Doric columns and two fluted pilasters; the tight wood dentils of the porch cornice reach around the cornice of the house. The recessed doorway has a panelled reveal; it has sidelights and transom in a traditional manner, but instead of wood muntins, it features decorative ironwork. Wrought ironwork also forms the railings of the front porch and the steps leading off the porch from each side, as well as a carriage light hanging from the porch roof. The main-floor windows are flanked by working wood shutters pierced near the tops with a stylized tree motif. The roof and the sides of the dormers are covered with subtly multi-hued slate. The windows of the front dormers are recessed beneath projecting gable roofs and flanked by pilasters reminiscent of those at the front entrance; the rows of dormer windows along the sides of the house are surmounted by hipped roofs and also flanked by pilasters. The shallow porch roof is clad with copper. A copper drainpipe along the west side of the facade displays the date "1931" on its "mailbox." While the house retains most of its original features, modern windows have replaced the original 8/8 sash windows, and a metal and glass storm door has been fitted over the original panelled wood door.

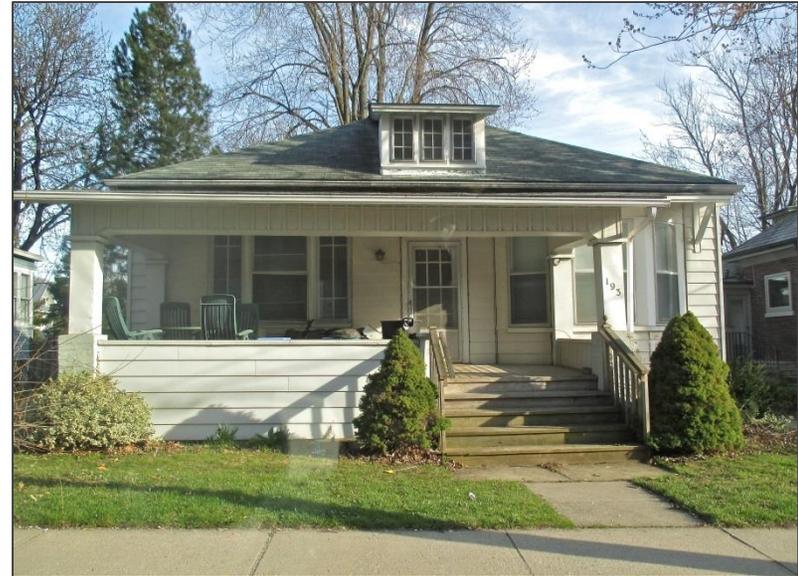
The appealingly broad one-storey cottages at 193 and 195 College Avenue are near reverse twins, though some differences have accrued over time. At 193 College Avenue, the original wood siding, the upper parts of the porch posts, the window and door frames, the porch balustrades, and all soffits have been covered with aluminum siding. The west side of the facade is nearly filled with a generous bay window featuring 1/1 sash windows on its angles and a somewhat wider 1/1 sash window in the middle. This is balanced by a Venetian window on the west and a porch extending from the middle of the bay to the west end of the house. A muntin down the centre of the side panels of the Venetian window and rails near the top and bottom define smaller panes, which are echoed in the window divisions of the central front door. A row of three six-paned windows fills the front. The porch roof is supported by square piers surmounted by square wood posts (now covered with aluminum). The house has a hipped roof, with a deep eaves

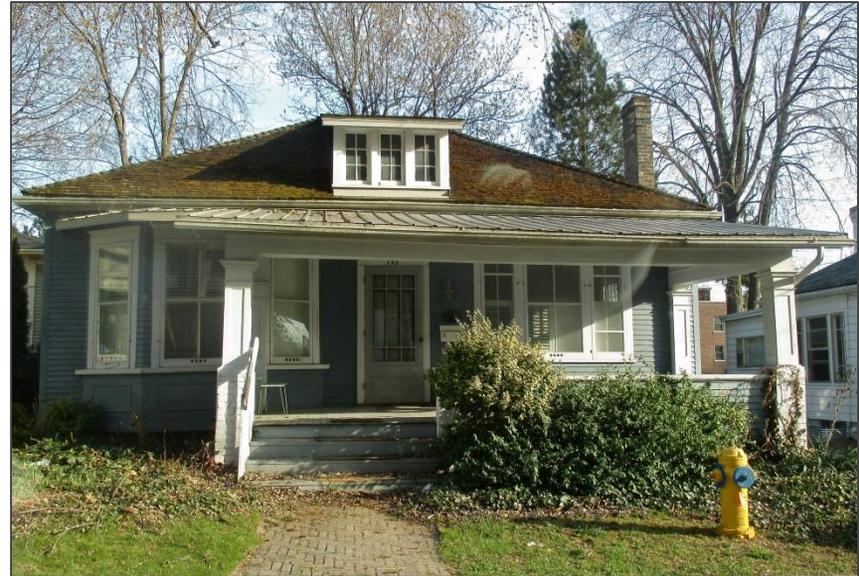
The appealingly broad one-storey cottages at 193 and 195 College Avenue are near reverse twins, though some differences have accrued over time. That at 195 College Avenue retains its original narrow, bevelled board siding, with well-defined corner boards and a narrow board cornice. The east side of the facade is nearly filled with a generous bay window featuring 1/1 sash windows on its angles and a somewhat wider sash window in the middle, with a 2/2 storm window that may reflect the configuration of the window it covers; all windows have their original storms, and all share a common wood sill, over panelled spandrels beneath. This is balanced by a Venetian window on the west and a porch extending from the middle of the bay to the west end of the house. A muntin down the centre of the side panels of the Venetian window and rails near the top and bottom define smaller panes, which are echoed in the window divisions of the central front door. The porch roof is supported by square piers surmounted by square panelled wood posts; the porch is bordered with short narrow, bevelled board walls, and a plain fascia runs across the front. The house has a

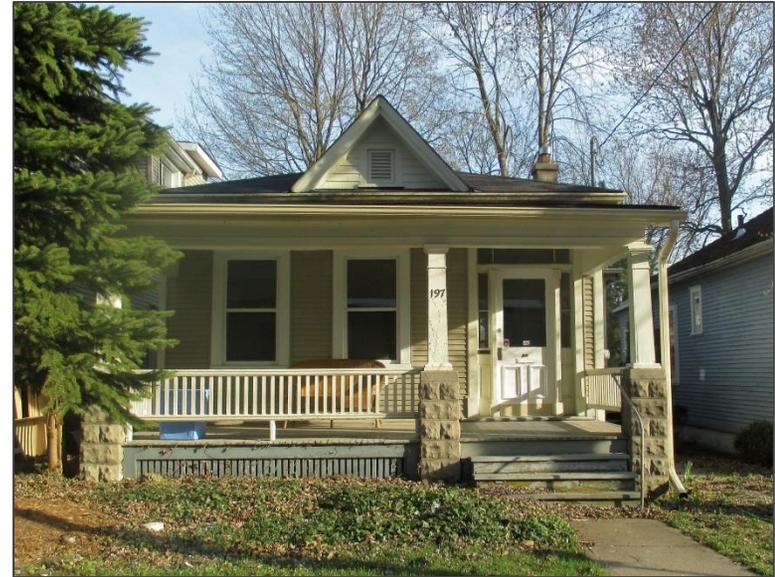
The shallow hipped roof of this 1-storey, side-hall plan cottage, its relatively broad eaves, the Greek Revival entranceway with its sidelights and transom, and the flat tops of the windows and transom together suggest a building from the late 1860s or early 1870s. The original cladding of the house has been covered with vinyl siding. The windows and the entranceway, however, retain their original wood surrounds. The 1/1 sash windows have simple plank surrounds. The unique, somewhat primitive Greek Revival entranceway is remarkably intact: important features include the wood plinth at the base of the pilasters, the transom with its original muntins and the sidelights with their original rails and delicate panelling beneath, and the doorway itself with what appear to be the original two panels beneath a glass inset that has now been inserted. The small gable, now holding a vent, and the front porch with its rusticated concrete block piers and wood posts and balusters, all with a square profile, represent later additions to the house, the porch probably dating from the decade following World War I. Another door, with a transom above, faces the front of the building and opens from a westward projection towards the back of the house. A concrete chimney rises slightly above the roof.

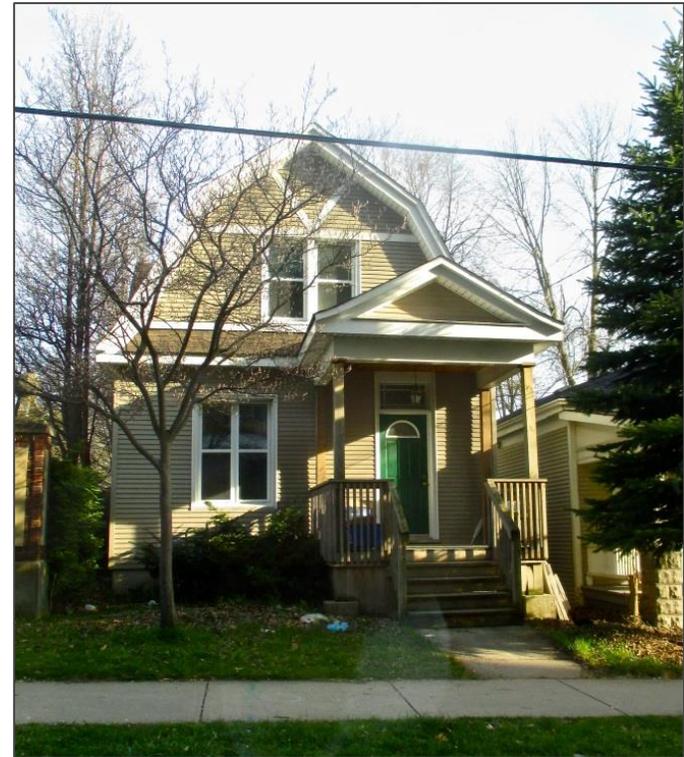
The wood walls and trim are now faced with vinyl; the suggestion of half-timbering in the upper part of the gable may reflect one aspect of the former gable decoration. Two-light sash windows occupy the front gable and part of the front wall below. The front door is surmounted by a transom with muntin bars creating a decorative border. A front porch may retain what was its original roofline, pediment shape, and cornice. A rear addition now adds extra living room.

Like other buildings along College Street, the house sits close to the road, separated from a sidewalk by a narrow front garden. This house is approximately 0.25 metres from the front property line and approximately 6 metres from the edge of the street. A parking area behind the house is now reached from the parking lot at the rear of the property at 835 Richmond Street, and is separated from the house by a tall fence and gate.

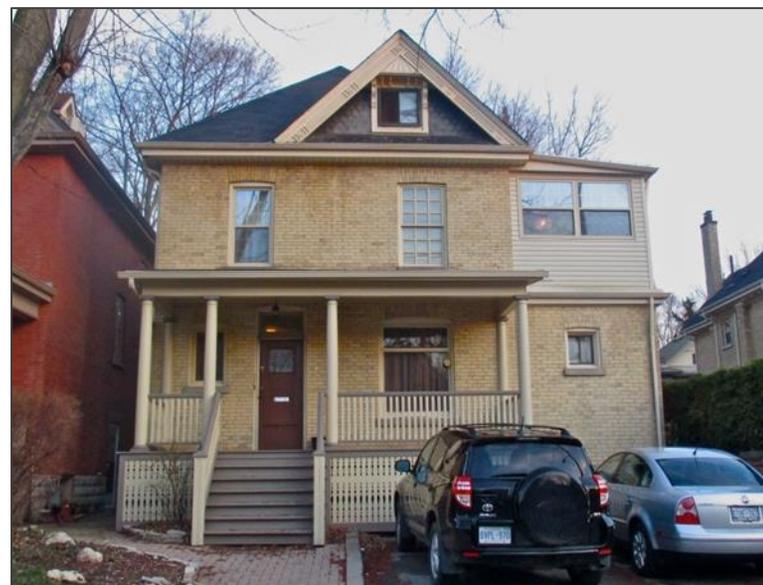
Cromwell is one of the narrower streets in the Study Area, and the houses along both sides sit relatively close to the street, behind modest front gardens, a sidewalk, and a narrow boulevard. The house is approximately 3.5 metres from the front property line and

7.5 metres from the edge of the street. Because all but three very recent buildings were erected within the decades between about 1895 and 1920, and because the buildings are all of similar scale, most of the street possesses a harmoniously unified character.

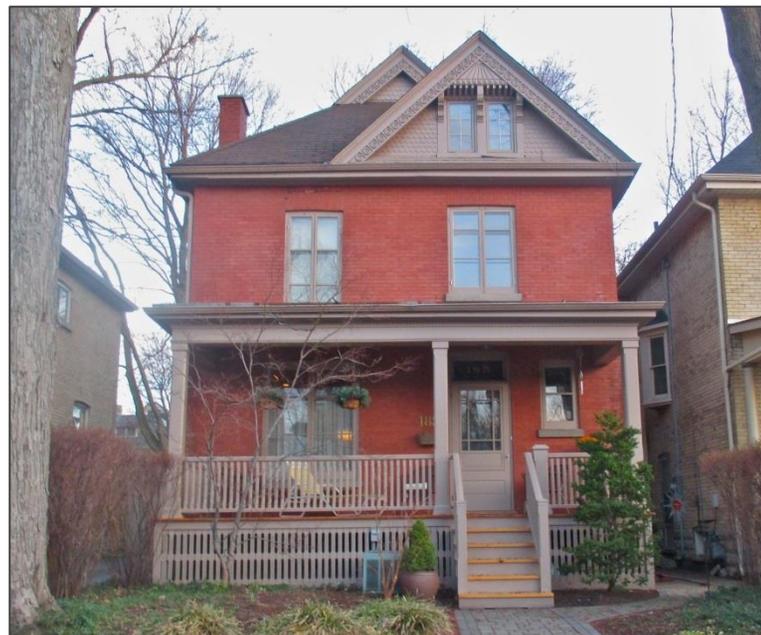
Otherwise, however, it reflects the relative simplicity typical of late Edwardian buildings. Both gablet and gable have box bargeboards ornamented with rows of roundels and fields filled with scalloped wood shingles. The gable contains paired windows with wood jambs and sills; rising from each jamb is a large console bracket, fluted on the outside edge that supports a projecting board in the apex that features a sunburst design. The house is faced with red bricks set with a red mortar to retain a smooth surface. The two symmetrically placed windows on the second-storey facade and the east window on the ground floor have sash windows with a single pane in the lower panel and leaded glass panels above; the west second-floor window, however, has a higher interior panel, however, allowing the lower sash to be raised enough for one to step through. This feature presupposes a one-time two-storey porch or a balustrade around the top of a ground floor porch. Beneath the upper-storey east window, on the ground floor, is a wider plate glass window with a leaded glass transom. Roughly beneath the upper-storey western window is the front door, with horizontal panels in its bottom sections and a glass insert, divided by muntins and rails bordered with bevelled glass; a leaded glass transom above shows the address in gilt numbers. All windows are surmounted by brick voussoirs, set in straight lines, that consist of alternating stretchers and headers, and all windows have wood sills. The present flat-roofed porch across the front (a sympathetic

replacement for the original, is supported by square, bevelled posts; its entablature features shallow moulding at the top and bottom, with a row of dentils along the cornice. A brick chimney rises along the east side of the house.

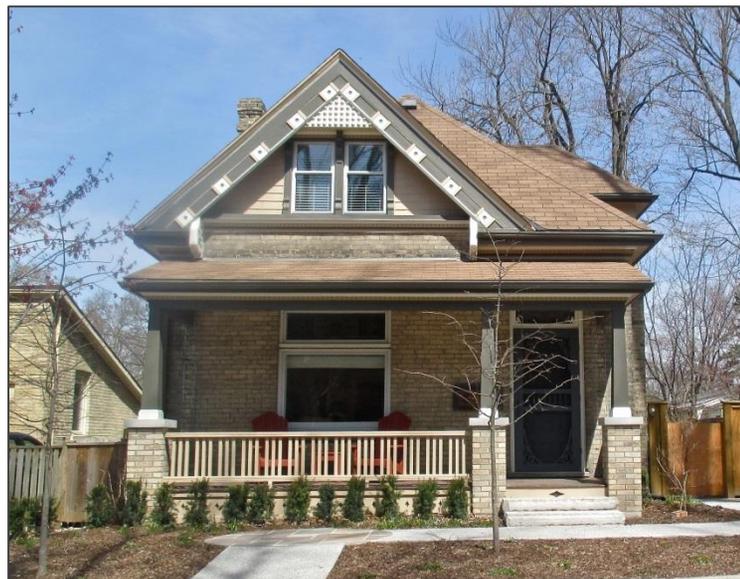
Except for the front and back porches, the house next door, at 190 Cromwell Street, is a mirror image of this house, built at approximately the same time for a fellow butcher. The by-law designating 190 Cromwell Street claims that the twin buildings were constructed for members of the same family; this study has not, however, determined the nature of that relationship.

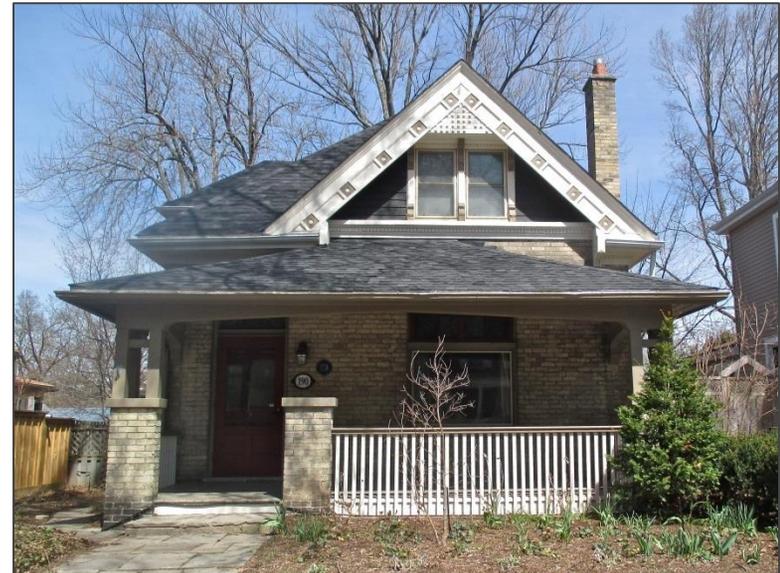
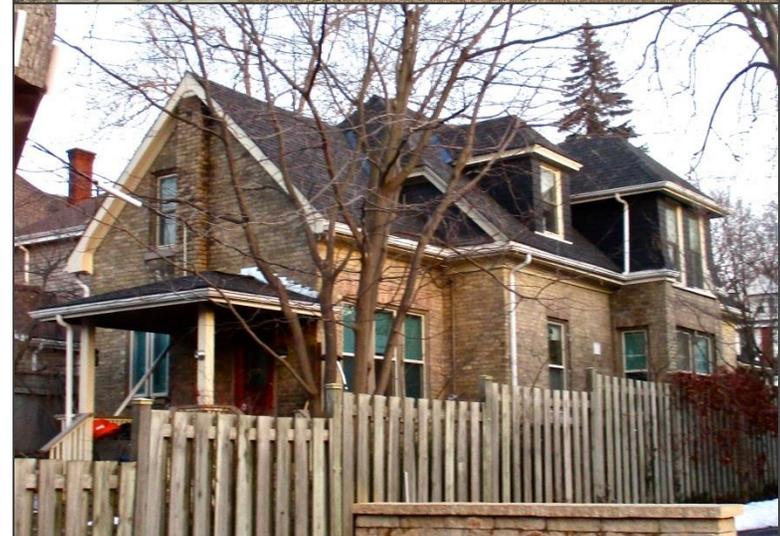
Built at the time when Queen Anne Revival cottages in London boasted their most elaborate footprints and rooflines, the two one-and-one-half buff brick cottages at 186 and 190 Cromwell Street excel in unexpected angles and protuberances. From the front of each house, one can discern a central hipped roof, with a cross gable resulting in a front-facing gable and, surmounting a protruding wall plane at the side, a wall dormer with a hipped roof and flared sides. From the rear (see above), one can see an additional hipped roof dormer, a half-hipped gable at the rear of the main block, with a gable-roofed wing extending in an unusual fashion from the half-hip. Each front gable sports a wide box bargeboard decorated at equal intervals with simple applied square designs. In the protruding apex is a wooden checkerboard design, the spaces filled with half spheres. Just below are paired sash windows with moulded jambs and wood sills. Flat wood shingles fill the surrounding field. At the outer corners of the gable are

triangular "brackets" with bevelled ends and carved sides; a row of dentils reaches across the bottom of the gable and around the cornice of the house. On the ground floor facade is a plate glass window and a panelled door with a glass insert, both surmounted by stained glass transoms. A stained glass window also decorates the outer wall of the entrance hall beyond the door. The dormers hold one or two 1/1 sash windows respectively, and others provide light in the side walls. Those in the brick walls feature brick voussoirs outlined with red mortar. Both buildings have stone foundations. The porch that spans the front of the building was added in 1935. It has a hipped roof, supported by high brick bases and sets of three relatively thick square posts, linked near the top by a horizontal member. A shallow wooden Tudor arch sits on the posts, just below the roof, and a railing features straight spindles with a square profile. According to the designating by-law, the tall chimney and the fireplace that requires it were built in 1974, "in the location indicated in the original plans".

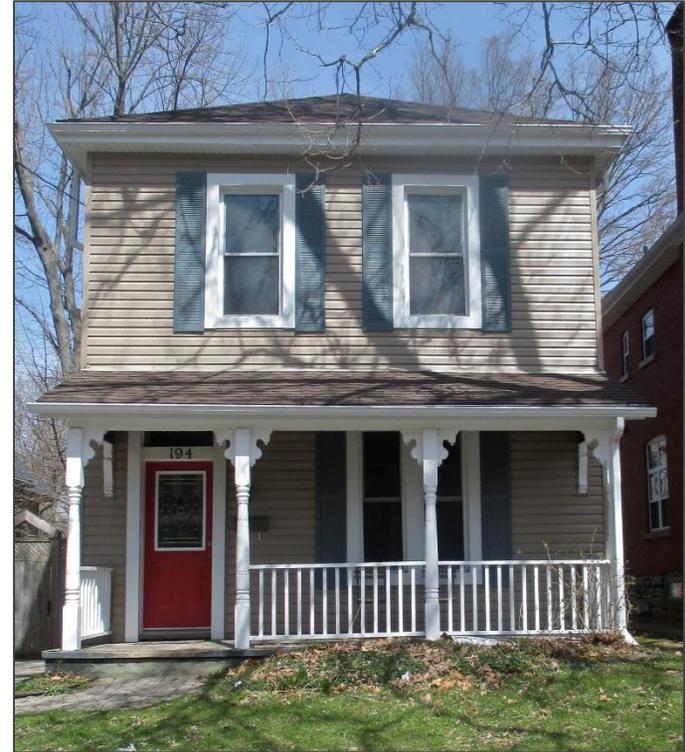
194 Cromwell Street is a two storey house clad in siding with a hip roof. The house has a front veranda spanning the width of the house with a shed roof. The veranda roof is supported by four wooden posts. The front elevation of this house consists of a door and large window on the first floor and two sash windows on the second floor. Windows have shutters and are surrounded with plain white trim. This house has apparently had siding, windows and doors replaced. The front door is one step above grade. The front door is topped with a transom window.

Cromwell is one of the narrower streets in the Study Area, and the houses along both sides sit relatively close to the street, behind modest front gardens, a sidewalk, and a narrow boulevard. This house is approximately 4.5 meters from the front property line and 8.5 metres from the edge of the street. Because all but three very recent buildings were erected within the decades between about 1895 and 1920, and because the buildings are all of similar scale, most of the street possesses a harmoniously unified character.

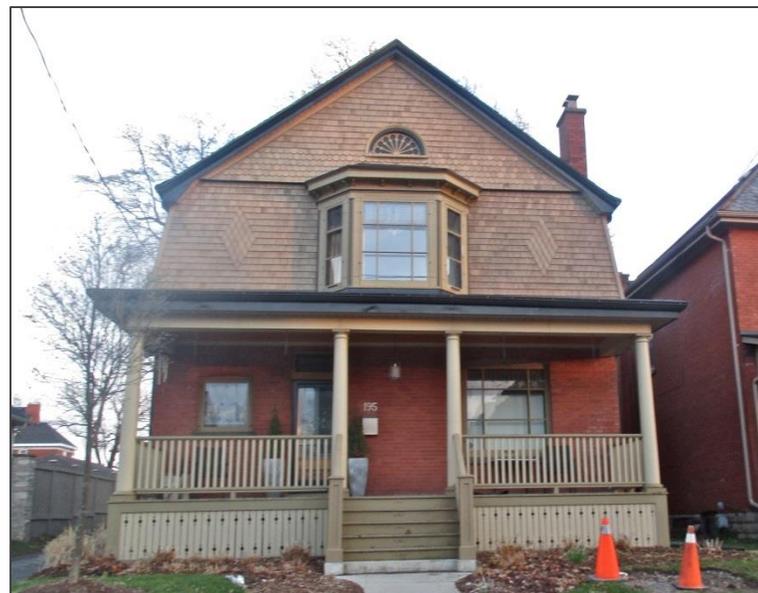
What makes this house particularly striking is the shape and facing of what appears to be the second storey. The house has what is in effect a mansard roof, but, while the top slope is now covered with asphalt shingles, the lower slope, like the front gable, is covered with wood shingles (now quite new, replacing older ones); most are rectangular, with the exception of five rows of scalloped shingles near the bottom of the gable and some diamond-shaped tiles, laid to form larger diamond shapes, placed at intervals on the gable and the east wall of the house. A dormer on each side wall rises straight from a point a few courses above the bottom eaves and is surmounted by a tiny cross-gable; the face of each dormer is trapezoidal in shape and contains a single 1/1 sash window. At centre front of the second storey is a three-sided bay with a flat roof; each of the angled outer sides holds a narrow three paned window, the panes shortest at the top and widest at the bottom. Rails separated the wider centre window into panes that also increase in size towards the bottom of the window, while muntin bars form narrower panes along the sides. A semicircular window, with intricately shaped, radiating dividers, is placed so as to create the illusion of a very stylized Palladian window when the entire complex is viewed from below. The importance of this complex is stressed by the organization of the first-storey facade, where the red pressed brick wall in the centre of the facade is left dramatically blank, though framed by the front steps and centre columns of the porch, thus

drawing the eye upward. A window to the west exhibits the same divisions as those found in the middle section of the bay window above. The front door is offset to the east, along with a small window to its side; the transom features a common design for leaded glass windows, with narrow vertical panes assuming a diamond shape at each end, but the leading is narrower than the norm and the leading finer. The small eastern window features a double layer of the same design. The front porch has a very shallow hipped roof, radiating from the bay window above and supported by Doric columns. The porch has a railing with plain square spindles and a decorative wood cover over the space beneath the porch floor. The house features a rusticated concrete block foundation, and two tall brick chimneys rise on the west side and the rear wall respectively.

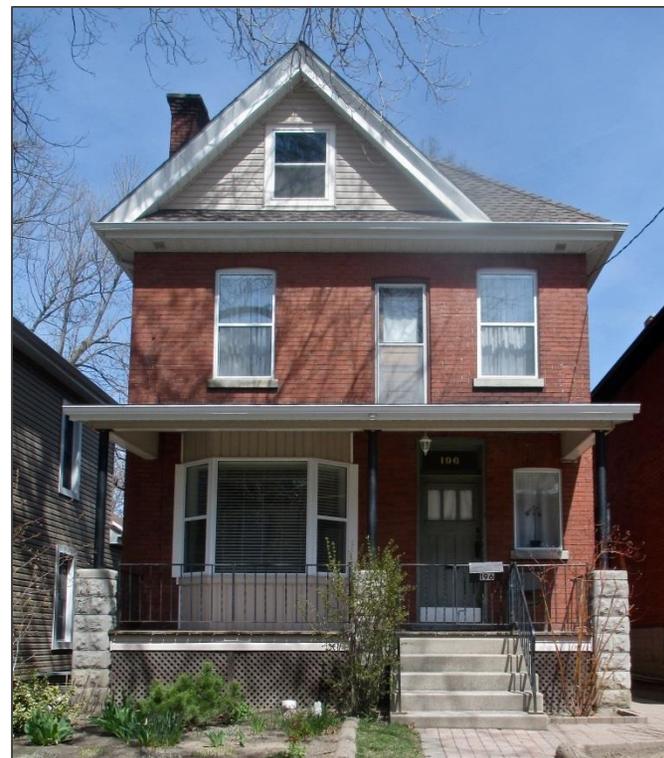
196 Cromwell Street is a two storey red brick house. This house has a hip roof with off centre front gable and a small centred rear gable. The house has a brick chimney on the west side. This house has a front veranda spanning the width of the house with a flat roof. The veranda roof is supported by three round steel posts. The front elevation of this house is asymmetrical. The first floor consists of a large bay window on the west side and a front door in the centre of the eastern half of the elevation and a smaller front window near the east corner. The front door is topped with a transom window. The bay window appears to be a relatively recent change to the front of the house. The second floor on the front elevation consists of two vertically oriented sash windows with segmented arched tops and a door with segmented arched top that opens onto the veranda roof. Window sills appear to be plain concrete. The front gable has a single central sash window and is clad in siding. The brick quality suggests that the one-storey hipped-roof wing at the back of the house is either part of the original building or an early addition. Parking is accessible off the rear laneway. There is no fence separating the back yard from the laneway.

Cromwell is one of the narrower streets in the Study Area, and this house is setback approximately 7.5 metres from the edge of the street and approximately 3.5 metres from the front property line. The house is behind modest front gardens, a sidewalk, and a narrow boulevard. Because all but three very recent buildings were erected within the decades between about 1895 and 1920, and because the buildings are all of similar scale, most of the street possesses a harmoniously unified character.

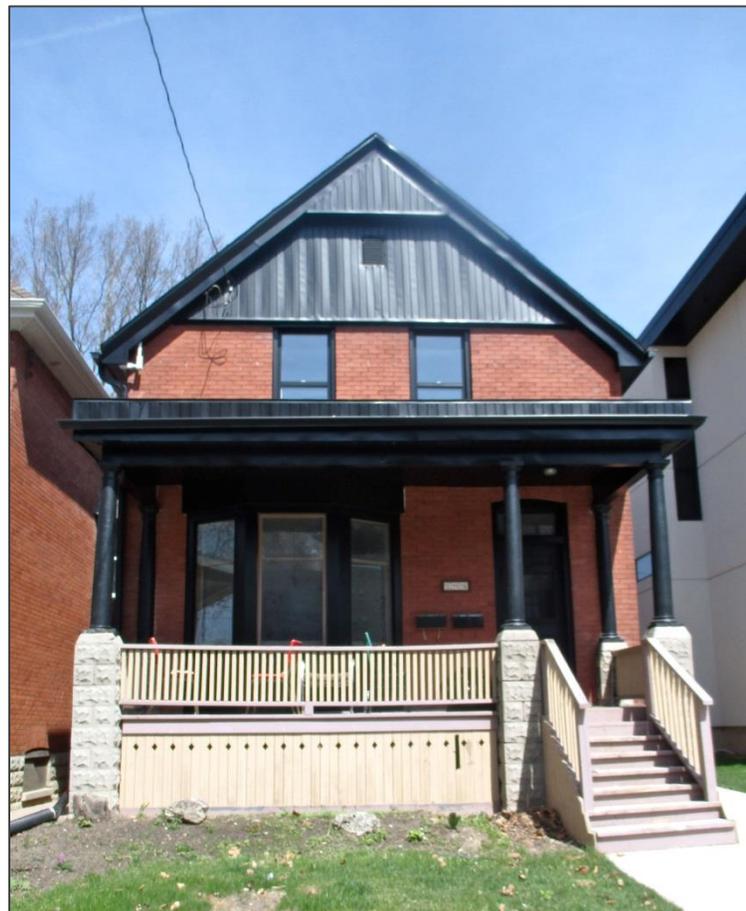
The house at 198 Cromwell Street is a two storey red brick building. The house is rectangular with the short end facing Cromwell Street. The roof is a medium gable covered in shingles. The roof has projecting eaves with a flat soffit. The roof projects from the front of the house with a plain fascia. The front end of the gable is clad in what appears to be a metal flashing that looks like vertically oriented tongue and groove boards with a central rectangular attic vent in the front.

A veranda spans the front of the house. The veranda is approached up eight steps leading to the front door of the house. The veranda has a flat roof supported by three round columns in the front and two half columns against the building. The columns are tapered and sit on square plinths made from rusticated concrete blocks. The plinths extend from the ground to just above the top of the veranda railing. The railing consists of a top rail, bottom rail and square balusters.

The front elevation of the house on the first floor consists of a front door topped with a transom window and a bay window. The front door opening is a segmented arch. The second floor front elevation consists of two sash windows.

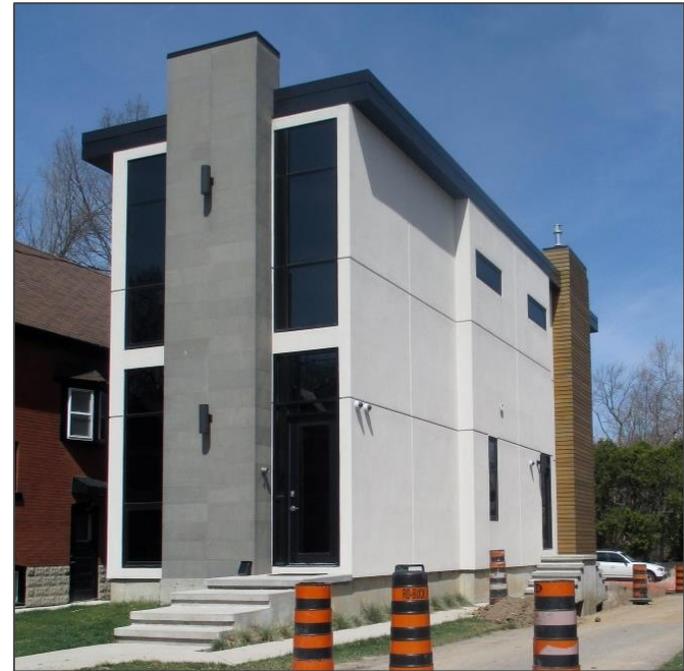
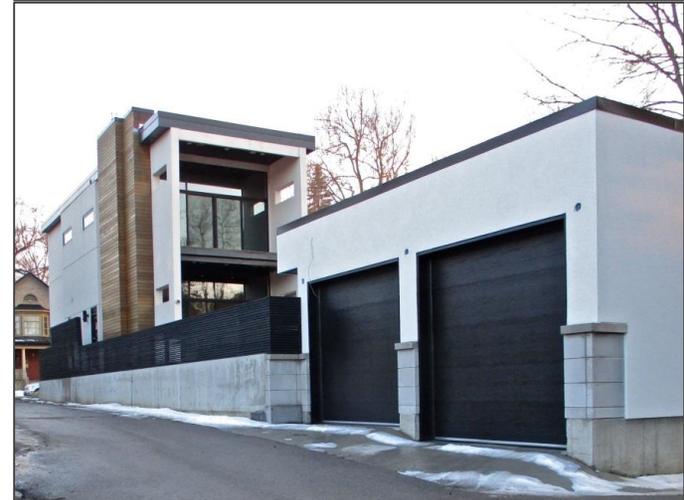
This Modern structure maintains a simple form while also showcasing and contrasting a variety of new and efficient materials. It possesses a sleek, two-storey cuboid shape with glass walls at front and back and long side walls faced with Styrofoam covered with stucco. A thick stone-clad pier bisects the front facade, with the metal-and-glass-front door to one side. The chimney, towards the north end of the east side, is surrounded by horizontal cedar boards. At the north end, the side walls extend beyond the northern walls, to create a ground-floor porch and an upper-floor balcony. The laneway along the east side of the house descends to a two-car garage, separated from the house by a fence with black horizontal members that blend into the general black and white colour scheme of the complex. Between house and garage, a concrete deck surrounds a hot tub and swimming pool. House, garage, and side wall feature concrete foundations. Concrete blocks climb the east walls of the garage to the height of the retaining wall beneath the fence.

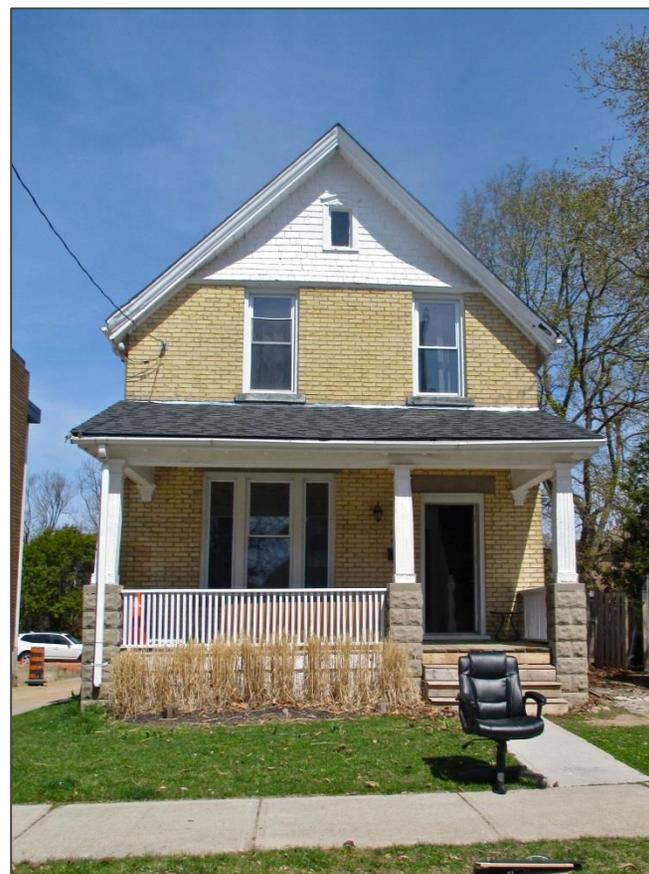
A veranda spans the front of the house with a shed roof. The veranda is four steps above grade. The veranda roof is supported by three tapered square columns on rusticated concrete block plinths. The columns are fluted. The plinths extend from the ground to just above the top of the veranda railing. The railing consists of a top rail, bottom rail and square balusters. The veranda deck is wood boards.

The front elevation of this house on the first floor consists of a front door topped with a concrete lintel and a larger three bay window, also topped with a concrete lintel. The second floor on the front elevation has two sash windows with plain concrete sills. The window on the western side of the house is directly above the centre of the window on the first floor and the eastern window on the second floor is directly above the front door.

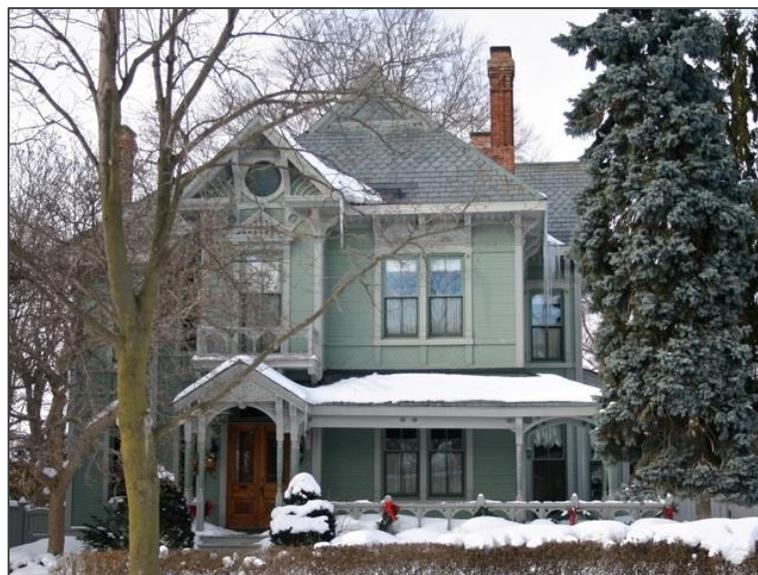
The house is an excellent, even extravagant, example of the Stick Style, a form that grew out of the common use of wood in American buildings in combination with the exuberance of the Queen Anne Revival style. As is typical of the Stick Style, the two-and-one-half-storey frame house at 26 Grosvenor Street reveals its skeleton on the outside through the horizontal and vertical stripping at lintel, sill, and floor levels and adjacent to apertures. The exterior trim explores the many uses and decorative effects of wood, including scalloped shingles, delicately turned porch posts, diagonal boarding, and intricately pierced designs in the pediments, brackets, and spandrels. The picturesque roofline, punctuated with multiple gables, chimneys and combining different

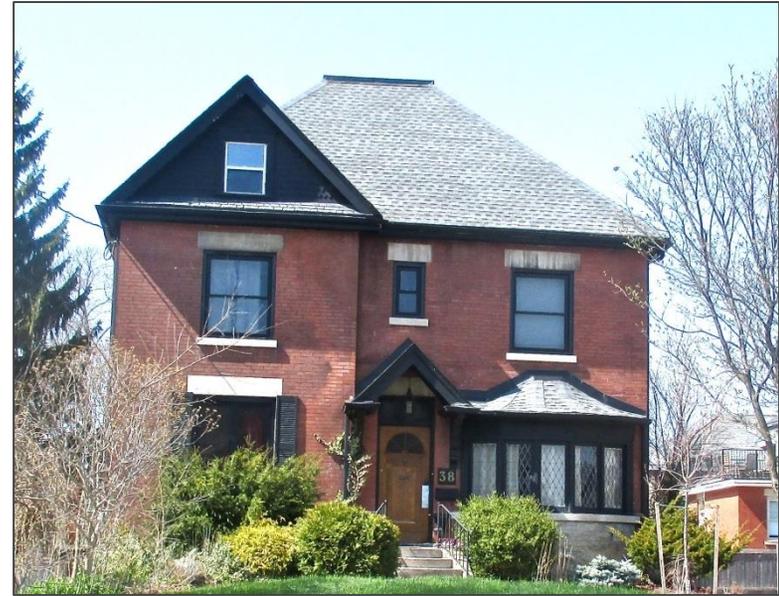
This house is part of a distinguished streetscape of late Victorian and Edwardian houses that grew along Grosvenor Street across from the one-time gardens of the Mount Hope Orphanage and the House of Providence (see the inventory entries for 200 College Avenue, 21 Grosvenor Street, and section 3.4.2.4 of the Study). The institutional growth of what is now the Mount Hope Centre for Long-Term Care has deprived this block of its pastoral setting, but the institutional setback still allows an excellent view of the block, and this has made it one of the City's most admired older streetscapes. The two-storey house at 38 Grosvenor Street was the last component of the streetscape to be built, and it differs from its neighbours in exhibiting the restrained, relatively simple elements of the late Edwardian era.

transom and a stone lintel are placed above the door, along with a simple gable roof with return eaves. (It is tempting to suspect that this roof is a later addition to the house, as it obscures part of the lintel and collides rather awkwardly with the roof of the bay window.) All other windows, sash or solid glass, have smooth stone lintels and sills. The ground-floor window west of the front door is now decorated with louvred shutters. The house has a cut stone foundation.

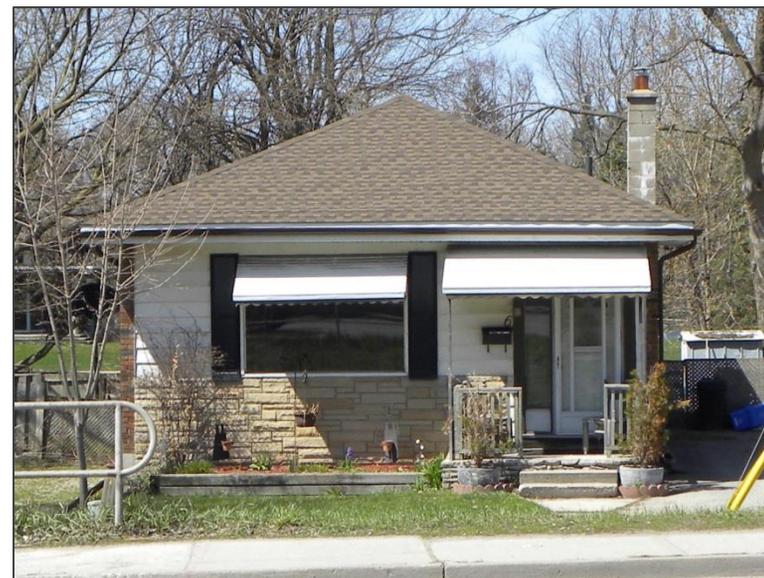
This house at 6 Oxford Street is a one storey vernacular cottage with a hip roof and combination of white siding and stone cladding. The front consists of an off centre door over a small concrete porch and under a veranda and a large off centre window. The front door has a single sidelight. The house is centred on its lot. A brick and concrete chimney is on the east side of the house. The sides of the house are clad in red brick.

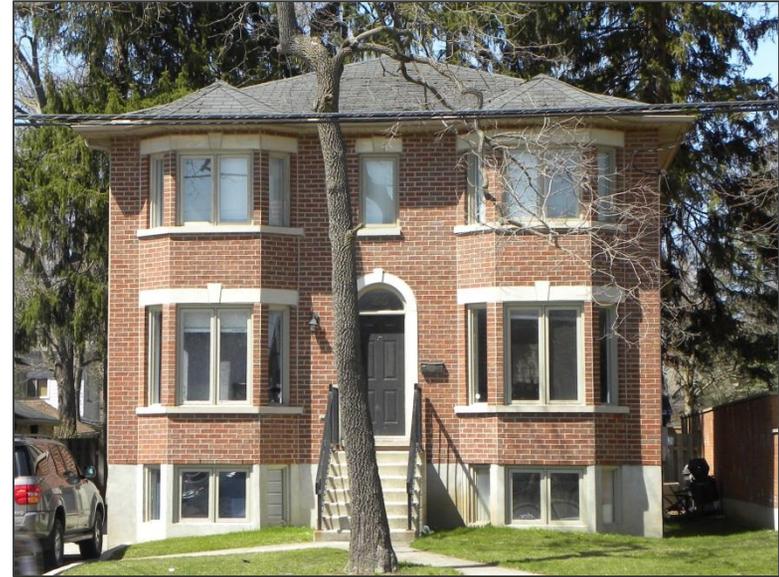
The front elevation has two bay sections, extending the height of the building on either side of the door. These bays have a central double window flanked by single windows. Sills and lintels wrap around the bays under the windows. Each lintel has a central keystone.

This house is on a busy arterial street with a moderate setback from the road. The house is set back slightly more than neighbouring buildings, it is approximately 1.5 metres from the front property line and 12 metres from the edge of the street. The driveway is on the west side of the property, the house is set towards the east side of the property.
