St George-Grosvenor Heritage Conservation District Study

Volume IV Appendix F, [2016]

APPENDIX F: INVENTORY OF CULTURAL HERITAGE RESOURCES

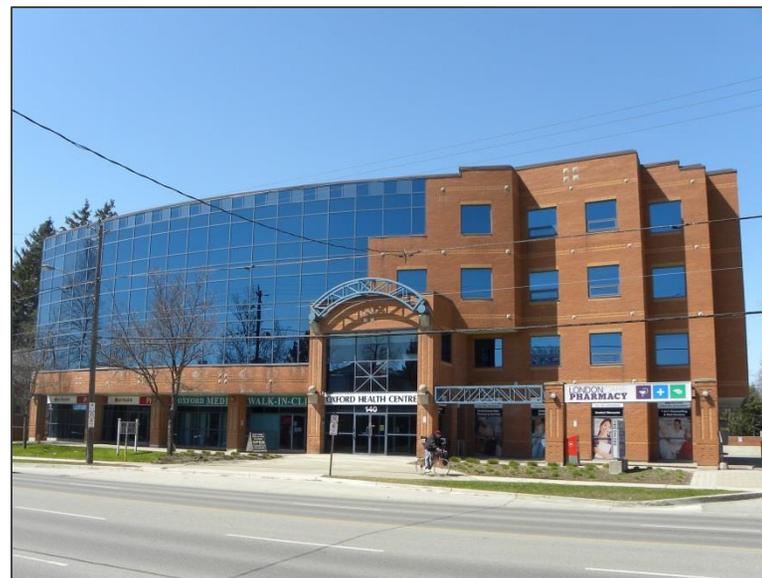
The building at 140 Oxford Street is an irregular shaped four storey commercial building clad in red brick and glass. The main entrance to this building is a two storey front atrium with glass front. The eastern third of the front façade is red brick with large square windows and the western two thirds of the building is glass. This building has a flat roof and has a covered portico at ground level. The building has some concrete decorative elements built into the façade including concrete squares at changes in floor level and a decorative metalwork arch over the front entrance.

The building at 140 Oxford Street East has a moderate setback from a busy arterial road. The front of the building is almost on the front property line and is set back approximately 11 metres from the edge of the street. This commercial building has parking beside to the east and behind the building.

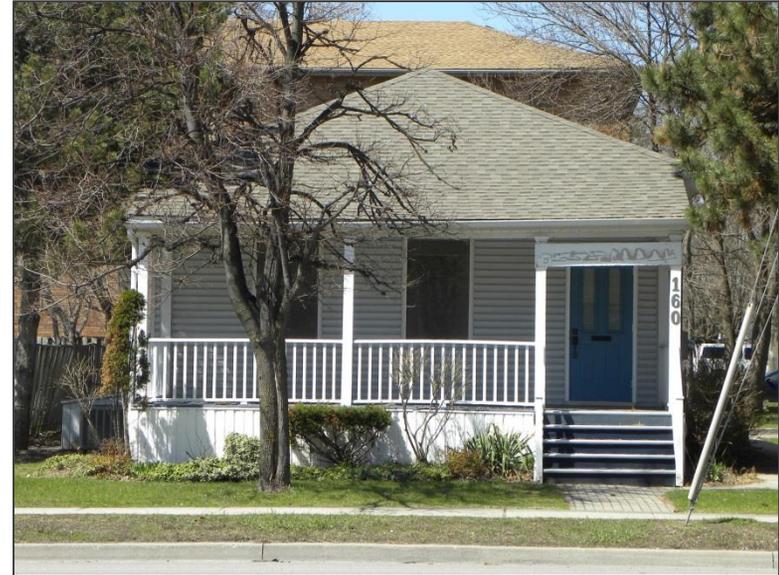
This house at 160 Oxford Street is a single storey vernacular cottage with a hipped roof and front porch along the entire front of the building. The front door is off centre on the east side of the building. The front elevation has two tall windows, one in the centre of the elevation and one on the west side of the front elevation. The front porch is five steps above grade. The roof extends over the porch on the front of the house. This house is clad in vinyl siding.

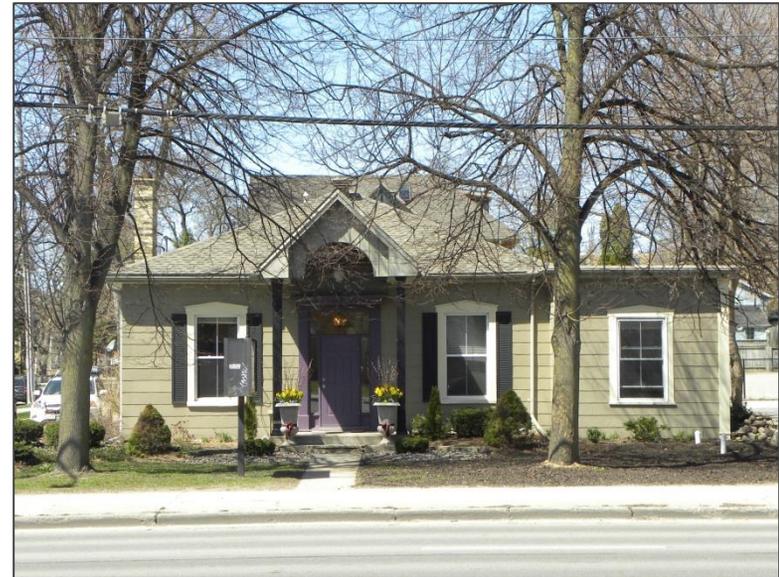
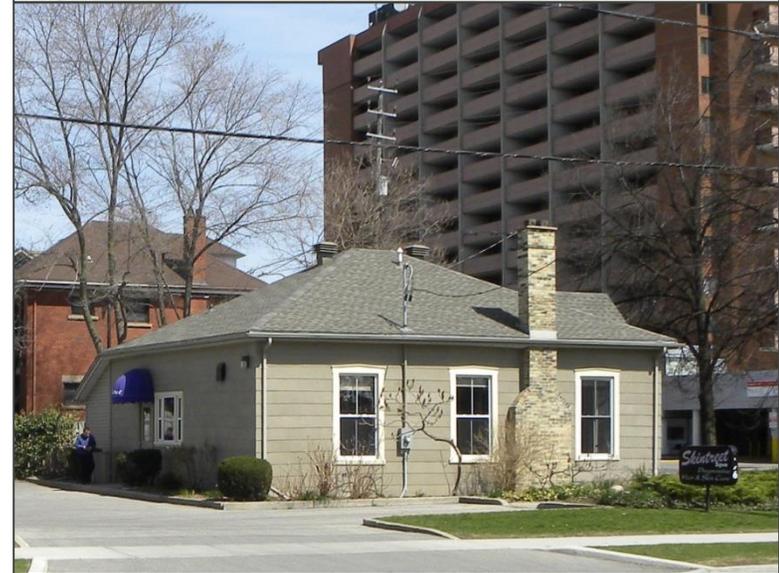
The house at 176 Oxford Street East is a single storey Ontario Cottage with a hipped roof and centrally located gable peak roof over the front door. An addition has been built out the east side of the building which projects slightly towards Oxford Street. The addition has moved the front elevation from being centred on the door to off-set. The façade of this addition is partially a false front. The roof of the building extends over the addition without changing its slope. The roof meets the outer eastern wall approximately $\frac{3}{4}$ of the way up the front wall.

The front door of his house is framed with two sidelight windows and a transom light above the door. The door is topped with entablature trim. The roof above the front door is supported by square posts. The front door is two steps above grade and above a concrete stoop.

Trim around the door and windows is fairly plain. Top trim above each window is shaped coming to a peak in the centre. Windows have modest sills. Windows have vinyl shutters.

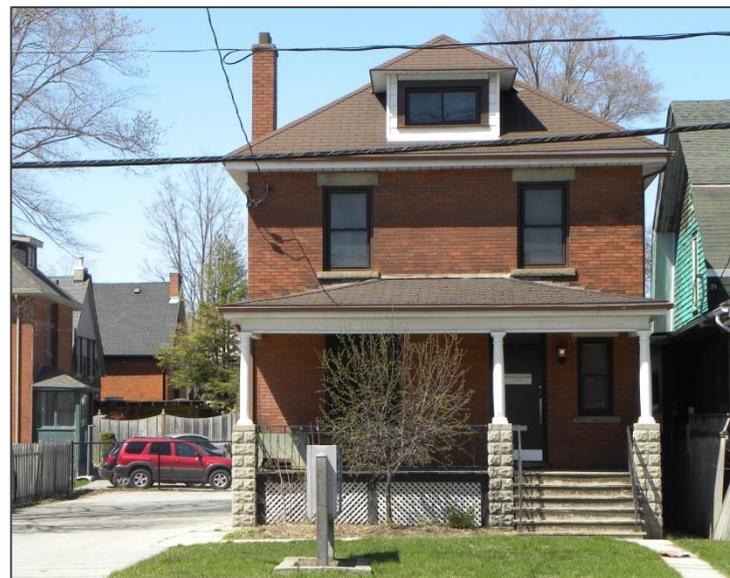
The building at 184 Oxford Street East is a two storey red brick house with a hipped roof and dormer in the attic on the front of the house. The house has a tall chimney on the west side and a front porch that covers the width of the front of the house. The steps to the front porch are off centre towards the east side of the porch. The porch roof is supported by three gently tapered smooth columns on concrete bases. The front door is off centre towards the east side of the front elevation and a small tall window east of the door. A larger window is set west of the front door approximately centred between the door and west wall of the house. The second floor has two windows on the front elevation and the attic dormer has a single window.

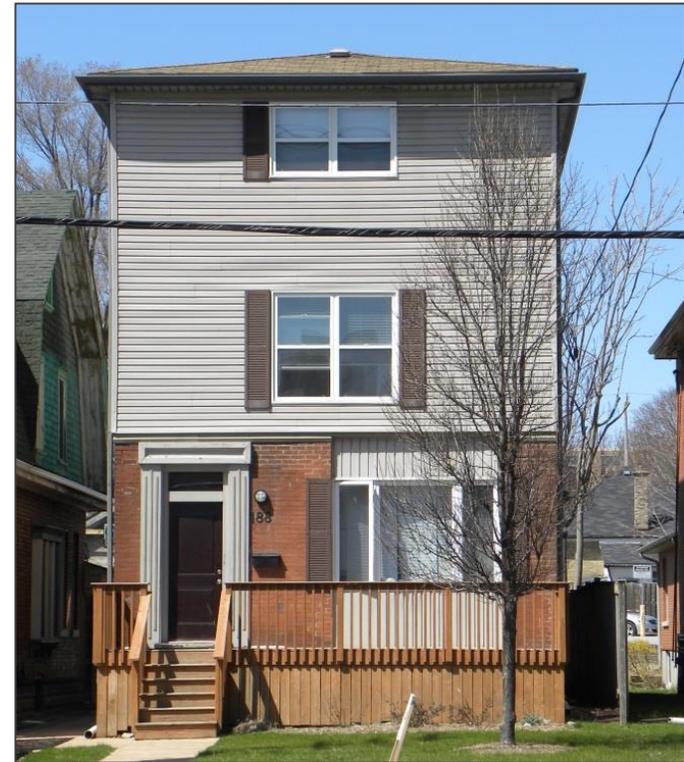
This is a three storey house with partially hipped roof (front and sides). The house has an open front porch with single door and single large window opening with a bay window in it on the first floor. The second and third floors each have a centrally located window. The first floor of this house is clad in brick on the front while the upper floors are clad in siding. The front door of this house has a transom window. This house sits on a narrow, deep lot on a busy arterial street. Parking is in the rear off a rear laneway. The house is set back from the front property line just under 3 metres and is approximately 14 metres from the edge of the street.

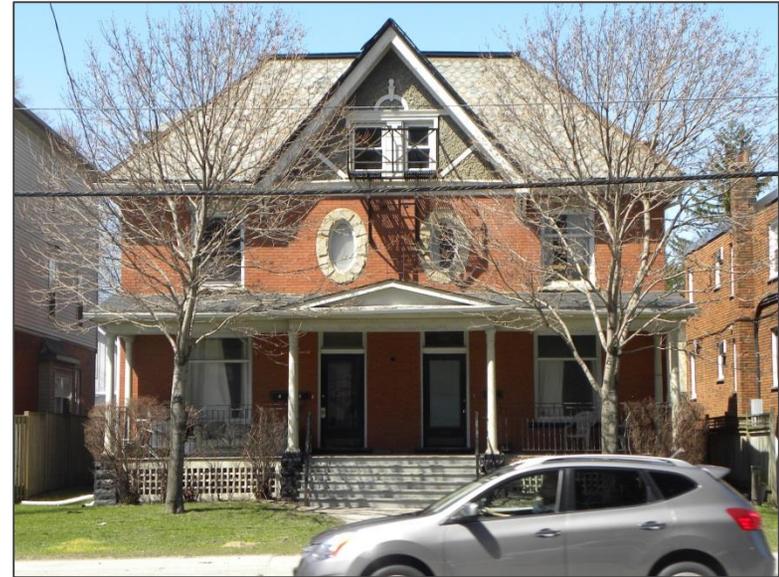
The house at 190-192 Oxford Street East is a duplex. It is a two and a half storey, red brick building with central gable peak. This house has a front porch that spans the width of the building with a pediment (added after 1992) over the front steps. The porch is supported with six plain columns on individual stone bases.

Front doors are in the centre of the front elevation and are topped by glass transom lights. The front elevation has a single large window for each half of the property on the first storey between the front door and exterior side walls of the building. The second storey of the building has four windows on the front elevation, a rectangular window on each side with two oval windows in the centre, above the front doors. The oval windows are surrounded with stone moulding. The third storey is in the roof, the front gable

has two windows, one for each unit. The front of the gable has decorative panelling and an iron fire escape ladder. The roof is a mansard style with fish scale shingles. Dormers project out each side and the back of the roof. (Clemens 2014: 10). A single storey modern addition projects out the rear of this house.

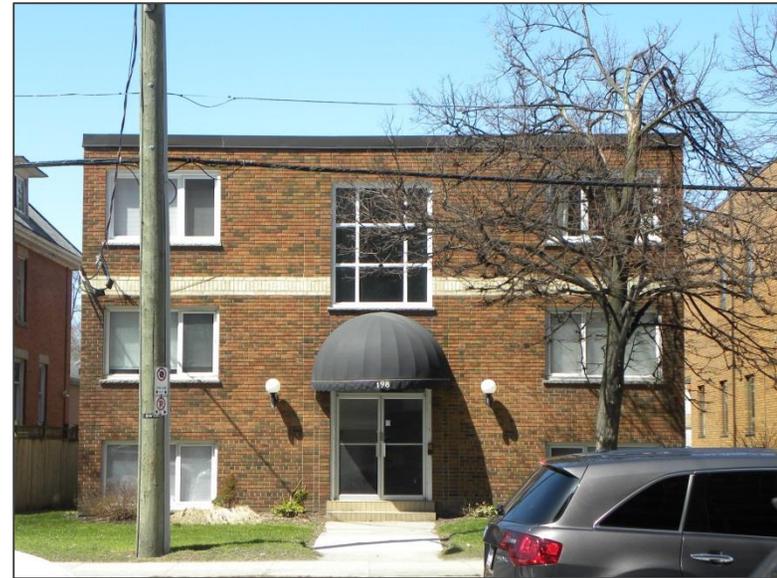
The contemporary building at 198 Oxford Street East is a three storey apartment building. This building is clad in brown brick. The front elevation is symmetrical with a central double door topped with a half dome awning and large central window. The door and central window are flanked by horizontally oriented three section windows on each of the buildings three levels. The lowest level is partially sunk. The building has a band of white or white painted brick between the second and third levels. This building displays elements of modern architectural style with clean lines and horizontal orientation. This building has a flat roof.

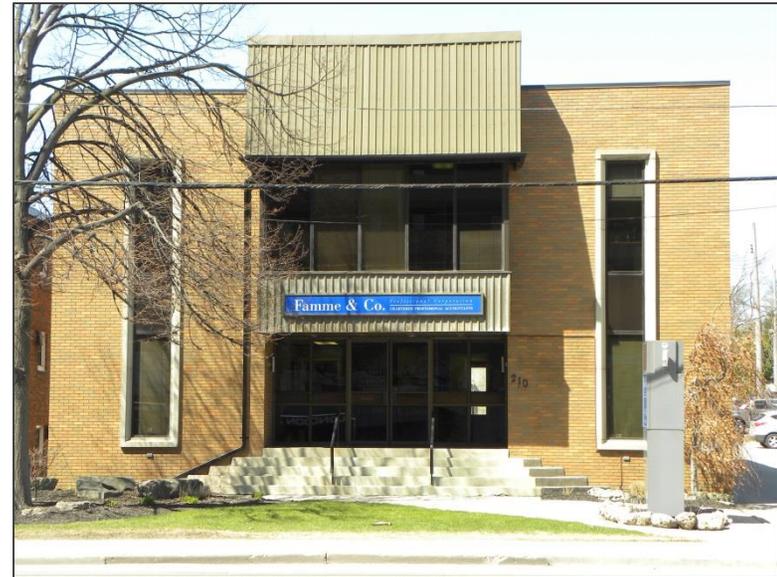
This commercial building is a two storey, yellow brick structure with a flat roof. The front door is approached by a large set of concrete steps. The front door is a double door flanked by sets of large glass windows that match the doors in appearance. Above the front door on the second level is a set of five large vertically oriented windows. The front elevation also has a pair of large multi-storey vertically oriented windows, one on either side of the building.

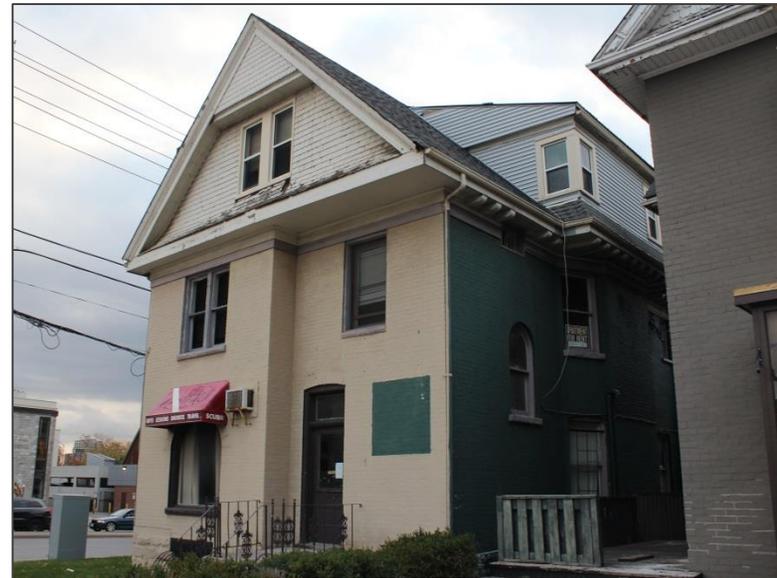
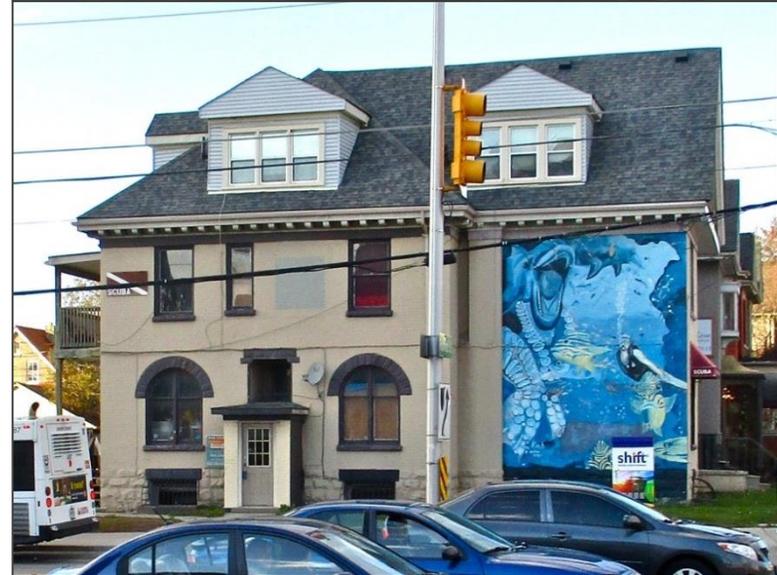
The building at 753 Richmond Street is a two and a half storey brick house with an “L” shape footprint. The brick has been painted in different colours; green on the north side and a brown/tan on the other sides, the house also has a large mural on the south wall. The roof of this house is broken up with two larger gabled dormers on the south side, two small gabled dormers on the west side and a shed dormer on the north side. The south side facing Oxford Street East and the east side facing Richmond Street both read as fronts on this house. This house has a stone foundation and stone window sills.

The Oxford Street East elevation is more elaborate than the Richmond Street elevation. The Oxford Street East elevation of this house has a central door in a small closed porch this appears to be a more recent addition to the building. The door is under an opening which may have been part of the original entry to the building. The door is centred between two arched windows topped with stone voussoirs. The second

floor on the Oxford Street holds three vertically oriented sash windows, two matching ones on either side of the elevation and a third smaller slightly off centre window. Gabled dormers on the Oxford street side of the building hold three windows each and are clad in siding.

The Richmond Street elevation of this house is divided into two bays (split down the centre of the building). The northern half of the elevation is set back. This section holds the door topped with a transom window and a single second storey window. The southern half of this elevation holds two windows, one on each floor. The first floor window is arched with painted stone voussoirs, like the windows on the south side. The gable overhangs the Richmond Street elevation and has imbrication on its end. The gable also has two sash windows in it.

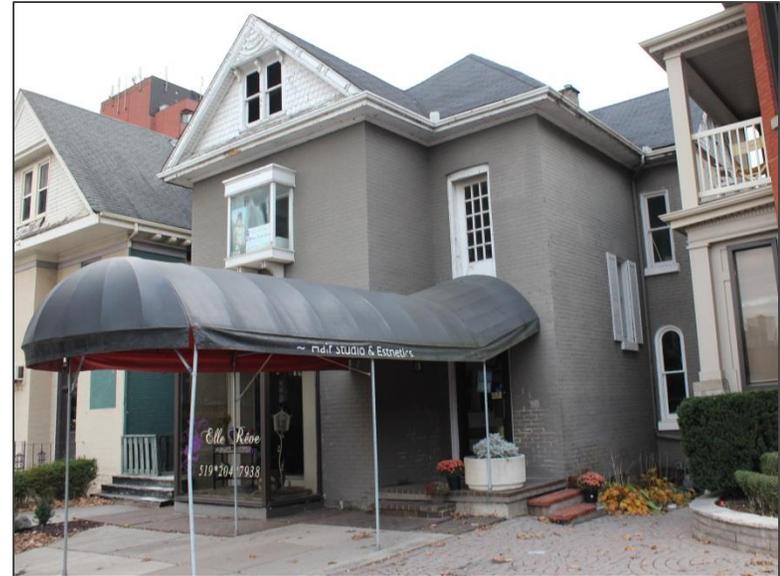
The building at 757 Richmond Street is a two and a half storey brick building with irregular footprint. The brick is painted grey. This house displays influences from the Queen Anne Revival style with complex massing, but is subdued in many respects. The front elevation has a front door and porch set back from the front of the building topped with a vertically oriented window on the second floor. A large square bay window is on the front of the building on the first floor and a smaller square bay window supported by brackets is on the second floor. The gable end on the front of the house has two windows. The gable is clad in fish scale painted wood siding and it topped with decorative woodwork. The fascia is bargeboard with square patterning.

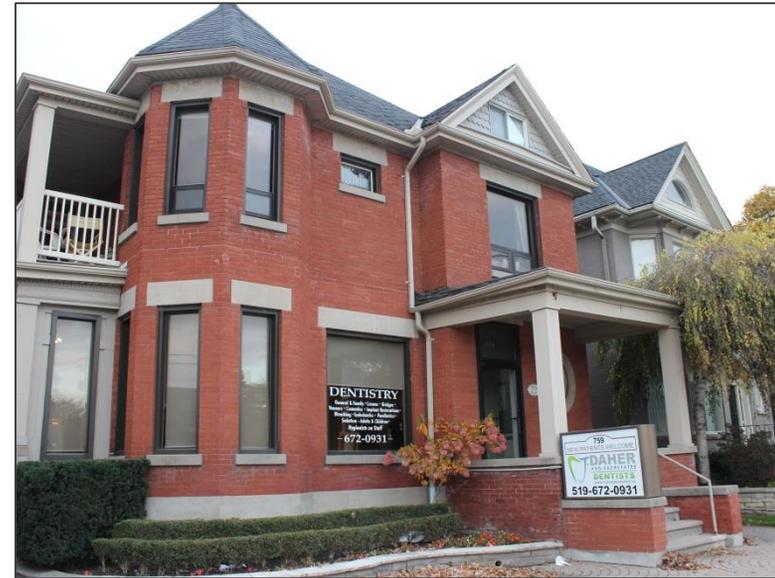
The building at 759 Richmond Street is a two and a half storey red brick building. The building has an irregular footprint. This building demonstrates elements of a Queen Anne Revival style in the irregular footprint, numerous porches, the octagonal tower on the south east corner, the variety of window openings and the heavy concrete lintels on the building. The building has subdued decoration.

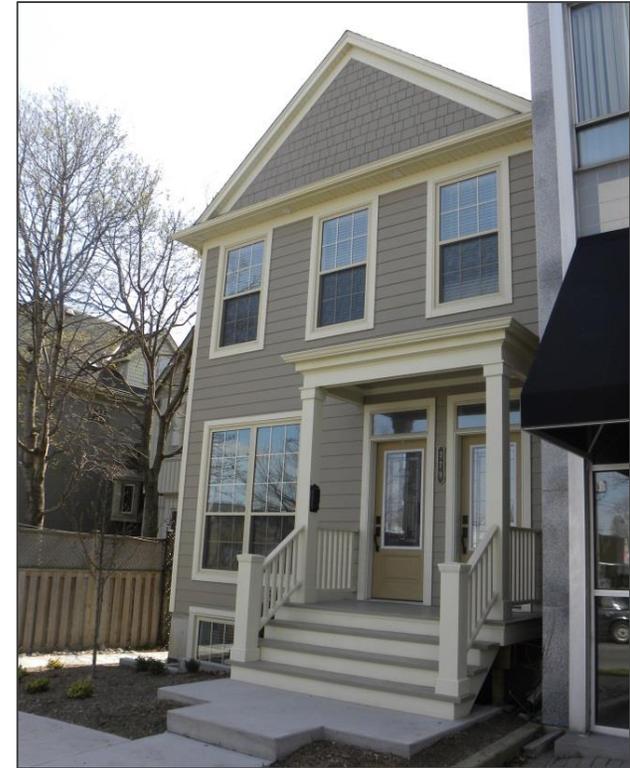
The building at 779 Richmond Street is a two storey frame structure housing several apartments. The building is narrow and long. It has a covered front porch with two doors on the front. The porch is supported by two square pillars. The first floor also has a large front window. The second floor has three evenly spaced windows. All windows are framed in plain trim. This building is clad in siding and appears to have a poured concrete foundation.

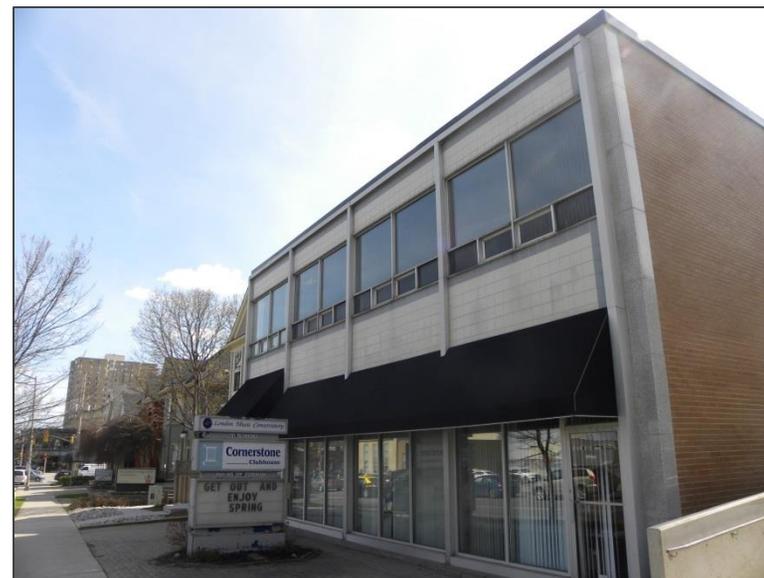
The building at 781 Richmond Street is a two storey rectangular building. The front façade of this building is divided into four bays. It consists of a set of double doors in the southern bay of the building and a single door near the northern bay. The rest of the first floor consists of large floor to ceiling glass windows. The second floor has large windows in each bay spanning the width of the building.

Sections of the building façade that are not windows are clad in what appears to be grey and cream tile. The sides of the building are clad in brown brick. This building consists of elements of horizontal and vertical lines.

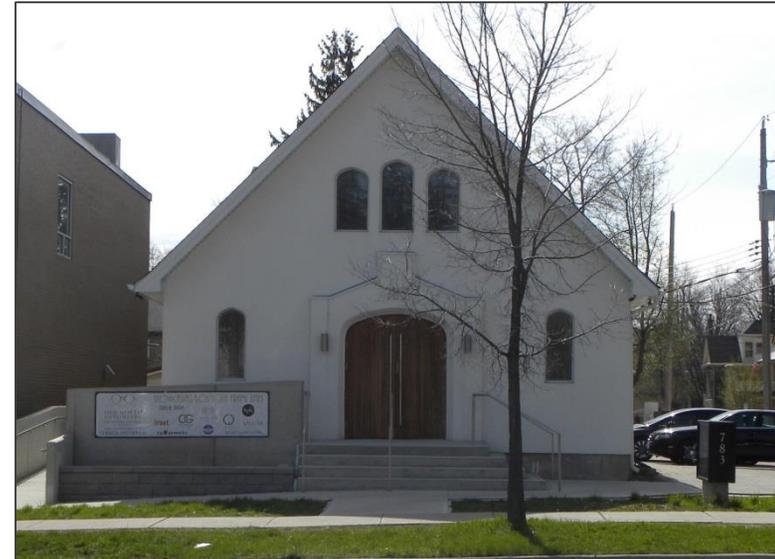
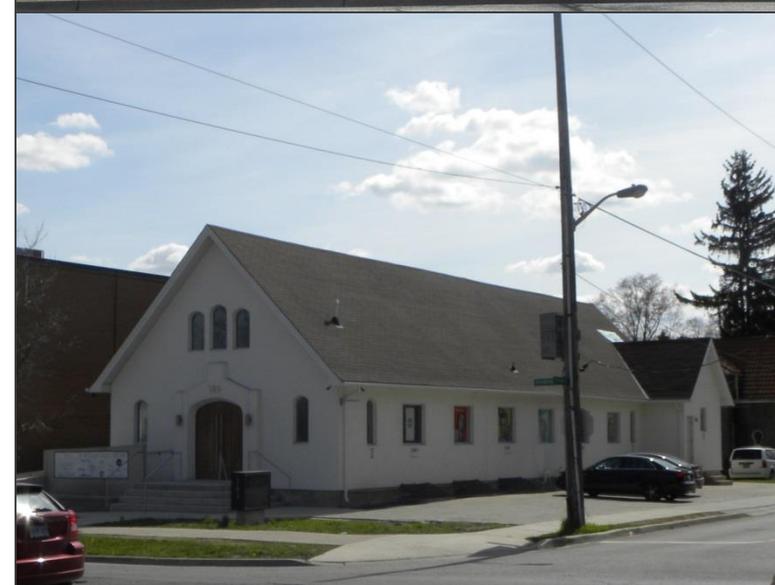
This building is a long narrow structure. It is a single storey ecclesiastical building with steeply pitched gable roof. A small wing extends out the north side near the back of the building. This wing has a gable roof and is clad in white stucco.

The front elevation of this building consists of a double door with two narrow arched windows on the ground floor level and three windows above the door. The north elevation has eight windows, a narrow arched window near the corner with the front of the building six square windows along the side and another narrow window near the rear wing of the building. The front door is approached up four concrete steps to a stoop. The door is laminated vertical wood and is arched. An arched surround frames the front door. It is white stucco like the rest of the building and protrudes from the front of the building.

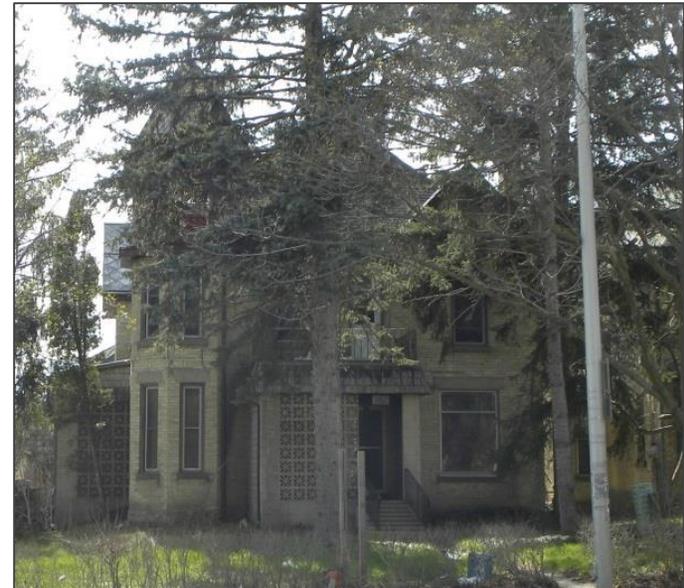
The south side of the building has an enclosed porch area with flat roof.

787 Richmond Street is at the northwest corner of Richmond Street and Sydenham Street. The house has a moderate setback from each street, and has a number of mature trees on the property obscuring the view of much of the building. This house is set back just under 3 meters from the front property line and just under 15 metres from the edge of the street. The property parking area is in the back yard accessed off Sydenham Street. A walkway extends from the steps of the front door to the sidewalk on Richmond Street.

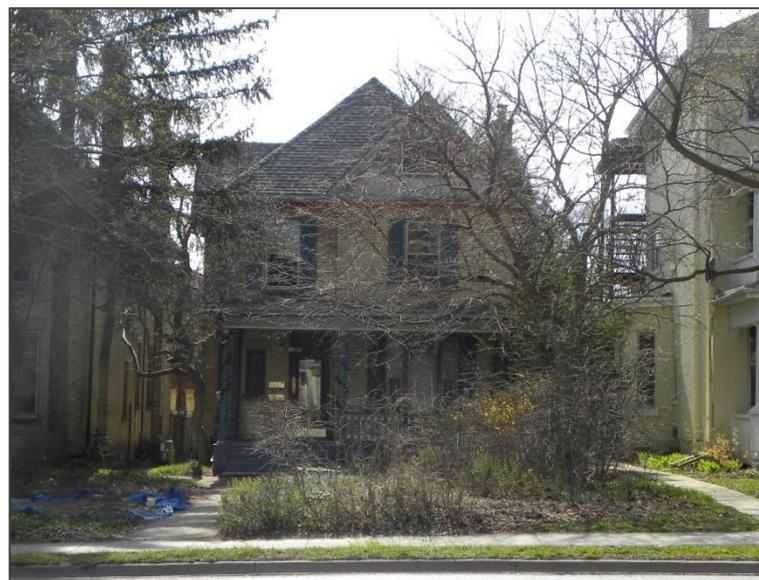
The building at 789 Richmond Street is a two and a half storey white brick house. This house has a rectangular footprint with small extension out the south side. The house has an off centre front gable and gable roof over the south extension.

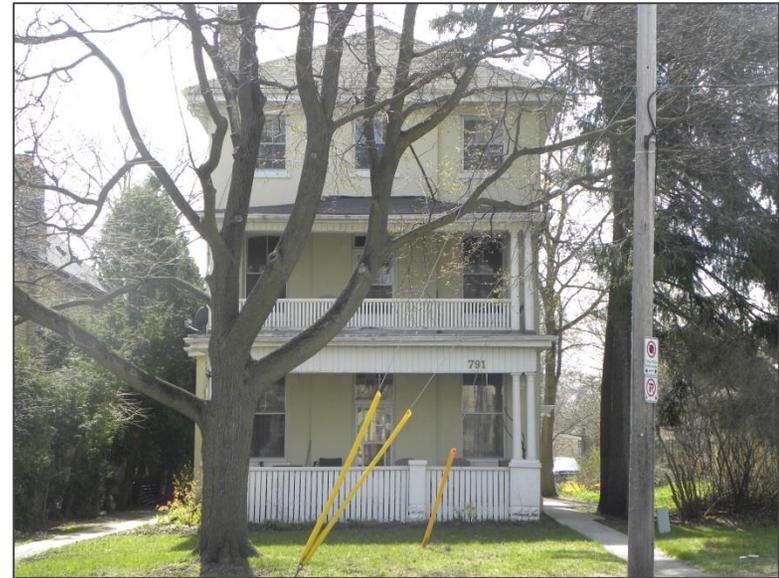
The front elevation of this house has a two storey veranda. The veranda is supported by paired smooth tapered columns in each corner. The first floor section of the veranda has plinths supporting the columns and the second storey veranda columns are full height. The second floor balcony is hipped. The second floor balcony has a low railing with square spindles between the corner columns.

The front elevation first floor has a central front door with a transom window. Each side bay has a vertically oriented window. The second floor front façade has a central door to the balcony with transom window with vertically oriented windows on each side of the façade. The third floor has three vertically oriented windows, one in each section of the façade. These third floor windows are shorter than the windows on each lower floor. This building is symmetrical.

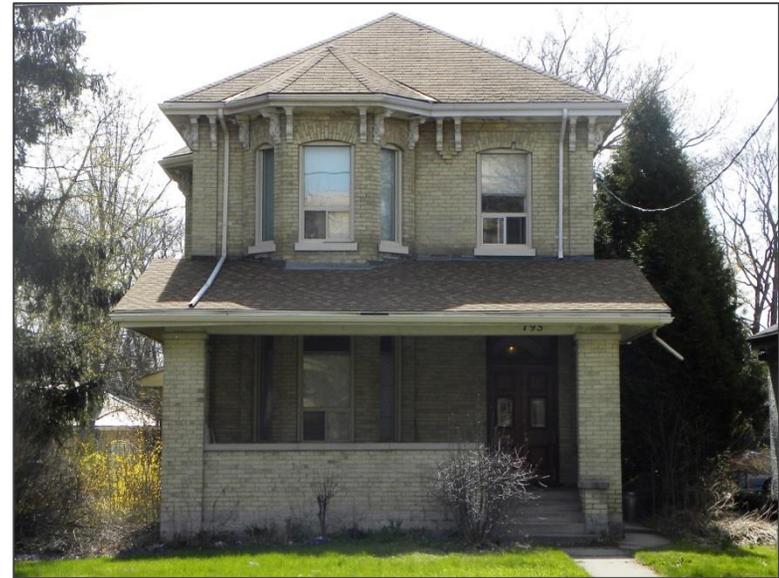
The building at 795 Richmond Street demonstrates some Italianate style influences. This is a two storey white brick house with hip roof. The front of the house has a large covered veranda, which appears to have been added at a later date. The front door is a wood double door with a transom window. Each half of the door consists of three panels with a glass window in the central panel.

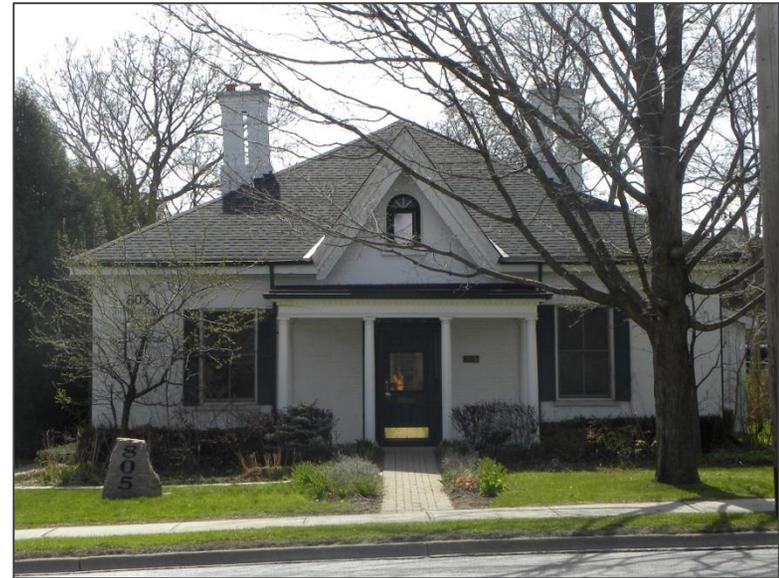
This house is an Ontario Cottage. The building is a single storey with hip roof and a central front gable over the front door. The front gable has a small rounded window in it. The fascia in the front gable has some decoration on it. The front of this house is symmetrical with central front door and two large windows, one on either side of the house. The windows openings have a segmented arch on top and plain sills. The windows have shutters.

The portico is flat and is supported by four smooth tapered columns. Two engaged columns on the face of the house support this roof at the joint of the house. The fascia of this roof includes dentils under the cornice. This house has two linked top chimneys coming out of the roof. The chimneys are symmetrically arranged on the building.

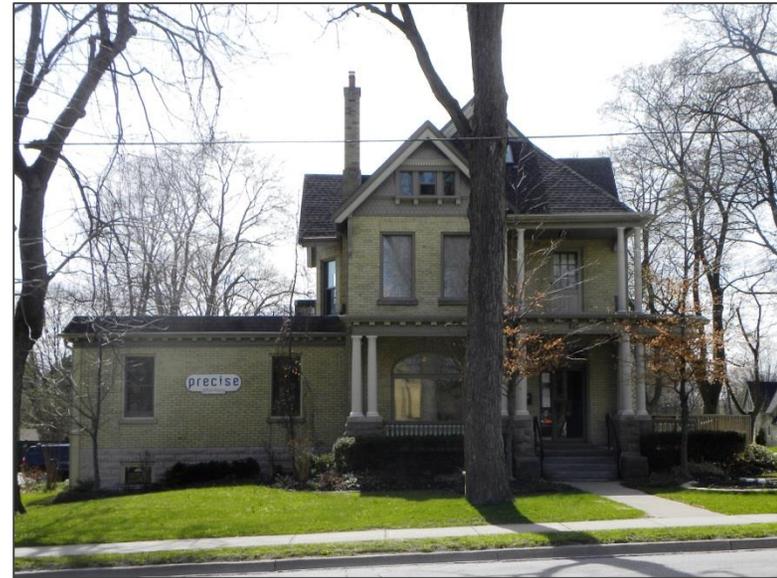
The house at 813 Richmond Street reflects some stylistic influences of the Queen Anne style. This house is a two and a half storey white brick house with a single storey addition out the south side. This main house has a hip roof with several gable dormers. The south side addition has a flat roof. This addition may have been added on to the building around 2003 (air photos). The footprint of this building is irregular with a front porch that spans the front of the two and a half storey section of the building and wraps around to the north side of the building. Part of the second floor extends over the south side of the veranda. The veranda roof is a balcony accessible from the second floor. The veranda roof/second floor balcony are supported by four sets of paired smooth tapered columns which are supported on rusticated concrete block plinths. The cornice of the veranda roof and roof of the single storey, south wing have large dentils.

The front door of 813 Richmond has a single sidelight on the south side of the door and a transom window above the door. The front façade on the first floor also has a large arched window with brick voussoirs. The front elevation on the second floor, above the veranda has two rectangular windows. The balcony above the veranda is accessed by a single door. The roof above this balcony is supported by two sets of paired smooth tapered columns. The front gable in the roof has a triple section window with square and scalloped wood siding and a plain fascia. This gable window has a fixed single pane on each side and a 1/1 sash window in the centre separated by mullions.

Windows on the north side of the building (visible from St. James Street) are rectangular with plain sills. The north gable has some decorative woodwork.

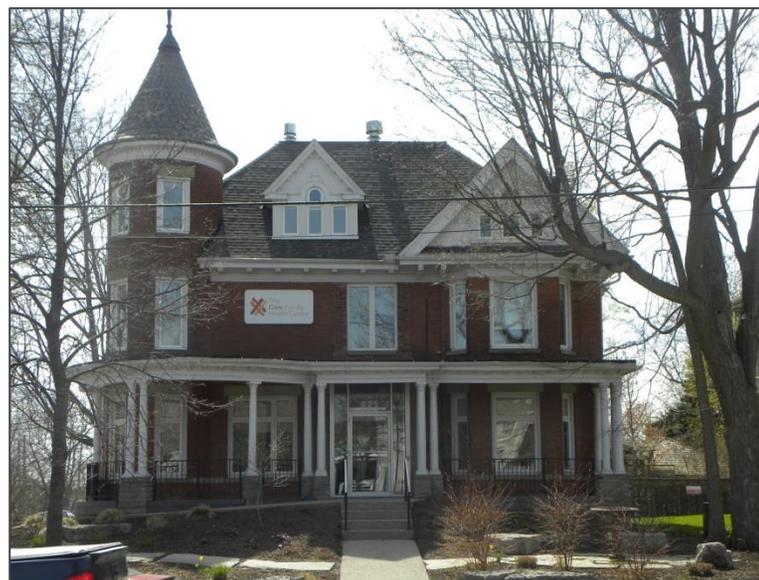
This “large late Victorian red brick dwelling was designed to enhance its raised elevation on a corner property. Anchored by a circular tower, topped by a conical roof, the architecture features a steeply pitched, slate roof, a sweeping classical columned verandah and an array of gables, dormers and bays” (Lutman 1982: 18).

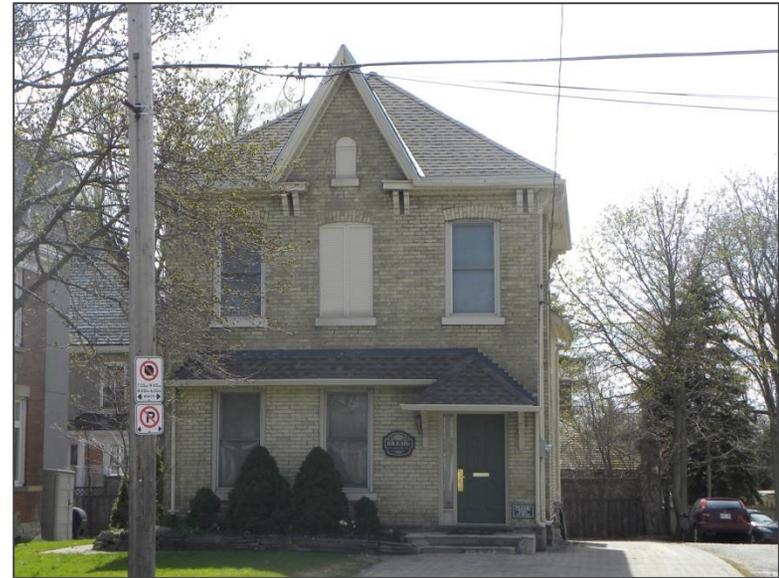
The building at 827 Richmond Street is a two and a half storey white brick building that demonstrates some Italianate stylistic features. This house has a hip roof with a central front gable. The front gable has a steep pitch. This front gable holds an arched attic vent with plain stone sill. Decorative brackets support the eaves. The second floor on the front elevation has three windows evenly spaced across the façade. The central window has blind shutters. Windows openings are arched with brick voussoirs.

The first floor front elevation consists of a front door and two windows. The front door has panelled sidelights on either side. Each window opening is vertically oriented with a segmented arch with brick voussoirs. Windows in this building have been replaced with modern windows. The windows appear to be single pane casemate windows.

The central gable in the roof contains a single fixed pane square window centred on the gable. The gable window opening has a segmented arch with brick voussoirs.

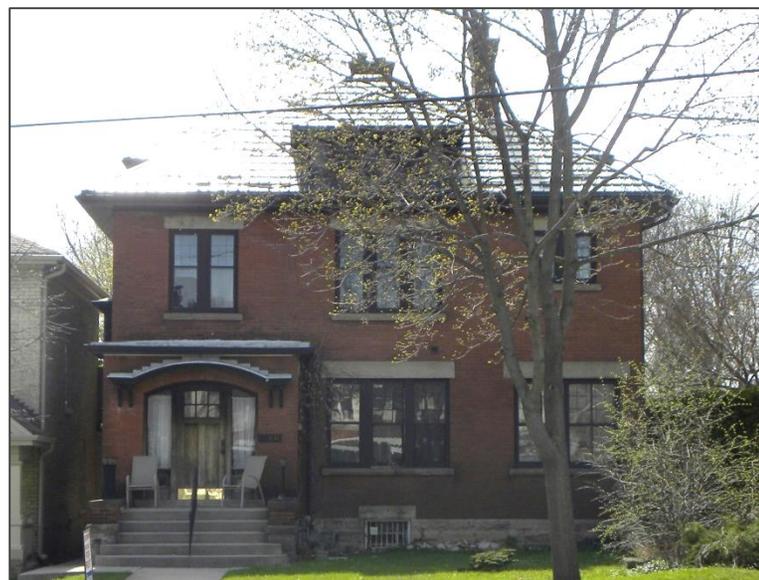
The building on 831 Richmond Street is a two and a half storey red brick building. This building has a nearly square layout and stone foundation. This building has a hip roof. The roof has a central hip dormer with a window in it on the front of the house. The north and south sides of the house have central hip dormers and the rear of the house has a large central gable dormer.

The front elevation of this building can be divided into three bays. The first floor has the front door in the south bay and windows in each of the other bays. The second floor has windows in each bay, all of different sizes. The front door is approached over a raised porch, six steps above grade. The front door and entry way extends out from the front of the building, which was an addition added between 1915 and 1922. The front door is arched with large sidelight windows on each side. The front entryway has a flat roof. The front door is wood with a six pane window in it.

Windows on the front elevation are in sets of two or three. This house has prominent lintels above all windows. It has large window openings. On the first floor the central bay has a three section window divided by mullions, each separate window is a 9/1 pane sash window. The northern bay on the first floor has a two section window. The second floor south bay has a double casemate window. The central bay has a three section window separated with mullions. The northern bay has a small double casemate window.

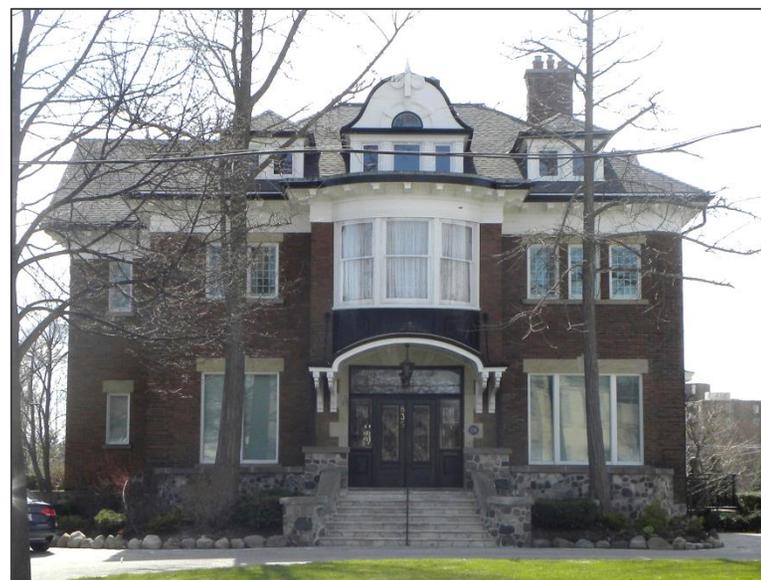
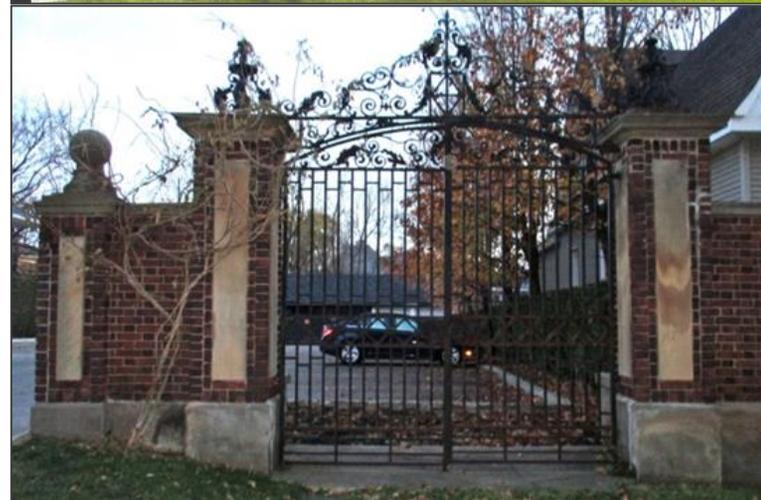
The building at 835 Richmond Street is a two and a half storey apartment building that reflects elements of the Edwardian Classicism style of architecture. While the modillions under the eaves are a prominent feature of the design, the classicism relies heavily on near symmetry and on geometrical shapes for its impact. The bulbous oriel window as part of the frontispiece above the front entrance is echoed by a broad rounded bay on the south side of the building. The posts of a brick wall that once surrounded a courtyard terminate in stone spheres.

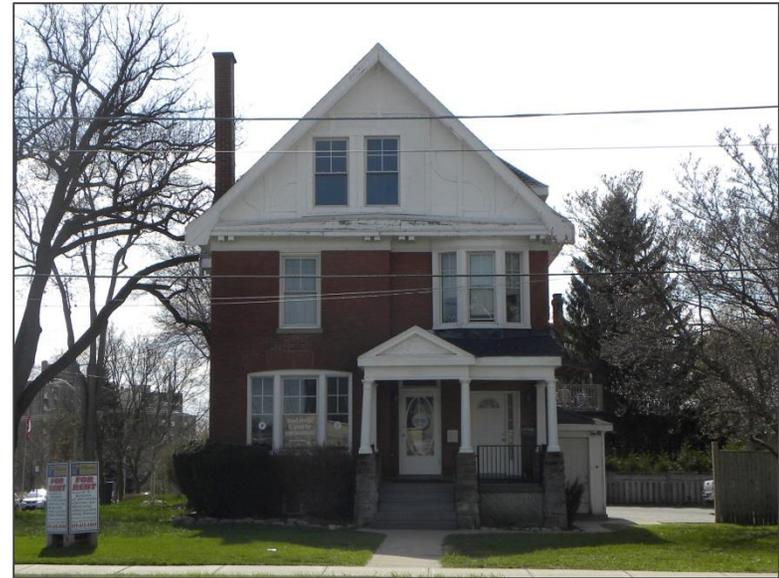
The house at 887 Richmond Street is a two and a half storey red brick home with gable roof. This house has a gable facing south on the south side of the roof. It has a shed dormer on the north side of the roof. This house displays some stylistic influences from the Edwardian Classical styles of architecture. Edwardian Classical elements are the most pronounced and include the scale and massing with a covered porch with pediment over the front door, modillions supporting the eaves and division of the facade into symmetrical halves. Some influence of the Queen Anne Revival style are found in the bay window and various projecting sections of the house and in the lightly irregular roofline, especially around the back of the house as seen from Grosvenor Street.

The front porch roof with pediment over the front steps is supported by five smooth tapered columns. These columns rest on square bases on rusticated concrete block plinths. The columns have plain square capitals. A plain iron railing surrounds the porch between the concrete block plinths. The porch deck is wood.

The south wall of this house holds a chimney and a two storey bay with gable roof.

- Two and a half storey scale and massing
- Modillions supporting the front eaves
- Arch above first floor window on the front elevation
- Pediment over the front steps on the porch roof
- Tall brick chimney on the buildings south side
- Covered front porch with pediment over the front steps
- Round tapered columns on rusticated concrete block plinths
- Iron railing around the front porch

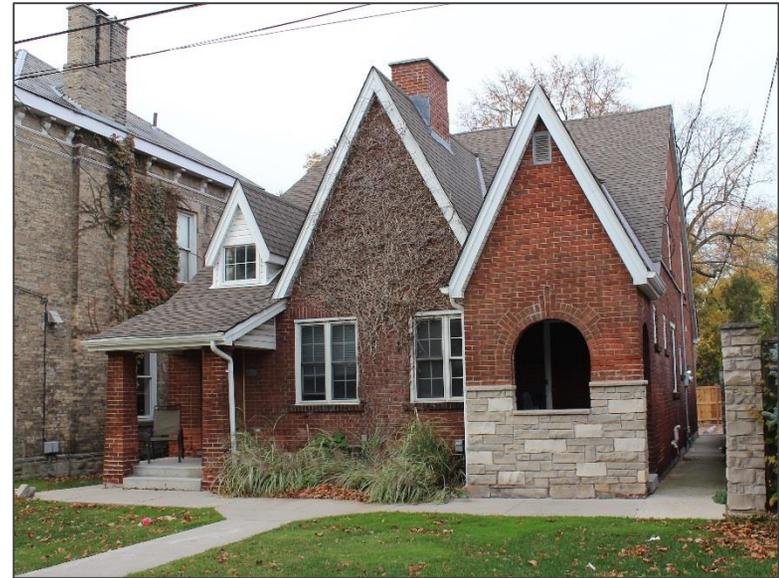
The building at 897 Richmond Street is a one and a half storey red brick building. This house displays some elements of Tudor Revival style architecture in the steeply pitched gables and arched opening in front of one front door on the front elevation of the house. This house has a side gable roof.

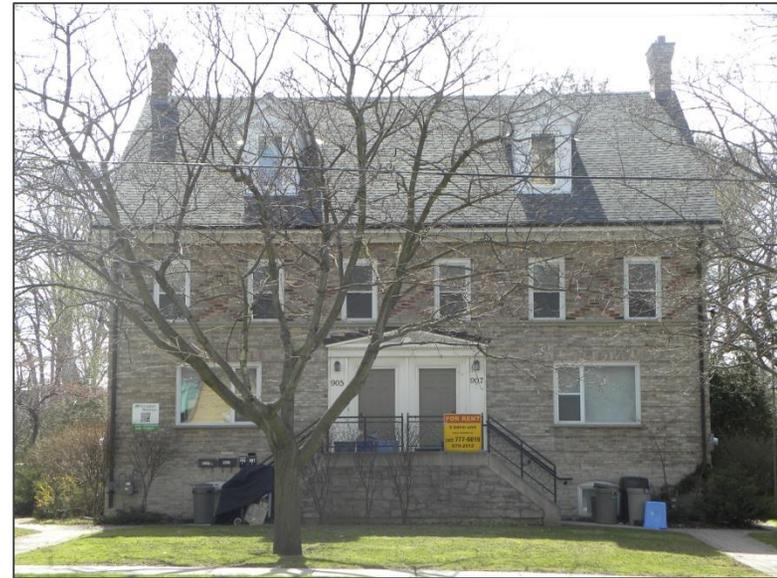
The building at 905-907 Richmond is a raised two and a half storey four-plex built in a Georgian Revival Style. This building has a side gable roof with flanking brick chimneys at either end. The front elevation of the building has central front doors approached up straight side steps parallel to the front of the building. Two front doors are framed with wood trim and a pediment with a sunburst pattern in it. The bottom of the pediment has small dentils. The house has large front windows on the first floor, one on each half of the building. Each of these first floor windows is approximately half way between the front door and the side of the building. The second floor has six 1/1 sash windows evenly spaced across the façade. The roof has two gabled dormers. This house has a common bond brick pattern on the first floor and Flemish Diagonal pattern in red brick between windows on the second floor, this pattern give the building distinctive “X” pattern on the second floor. The front of the roof has two gable dormers with a single pane casemate window in each.

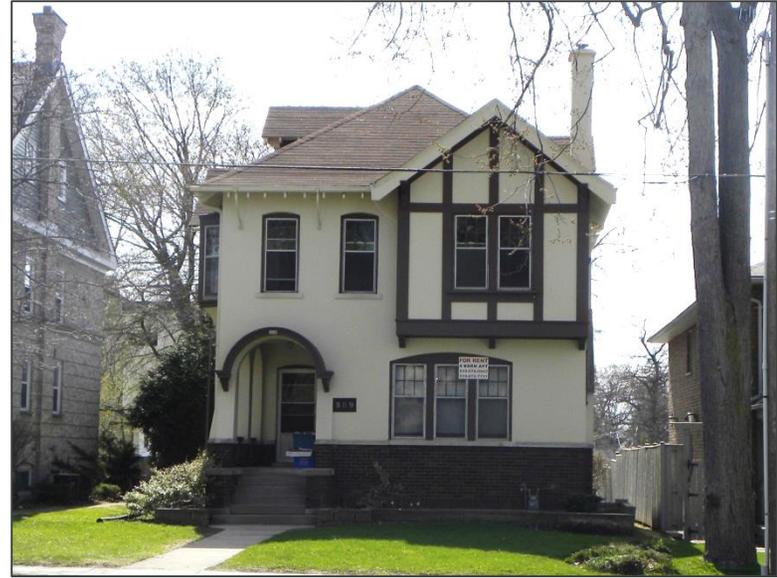
The house at 909 Richmond Street is a two and a half storey brick house faced in stucco with some timber frame construction elements visible in a second floor jetty. The framing visible on the jetty suggests nogging or infill between the timbers. This building demonstrates influences from the Arts and Crafts style of architecture in the half-timbering on a second storey gabled jetty and in exposed rafters under the eaves. The foundation cladding of this house is exposed brick. This house has a hip roof (almost pyramidal) with a front gable and gable in the southwest corner. The roof has two gabled dormers, one on the north side and one on the south side. A tall chimney is on the north side of the building.

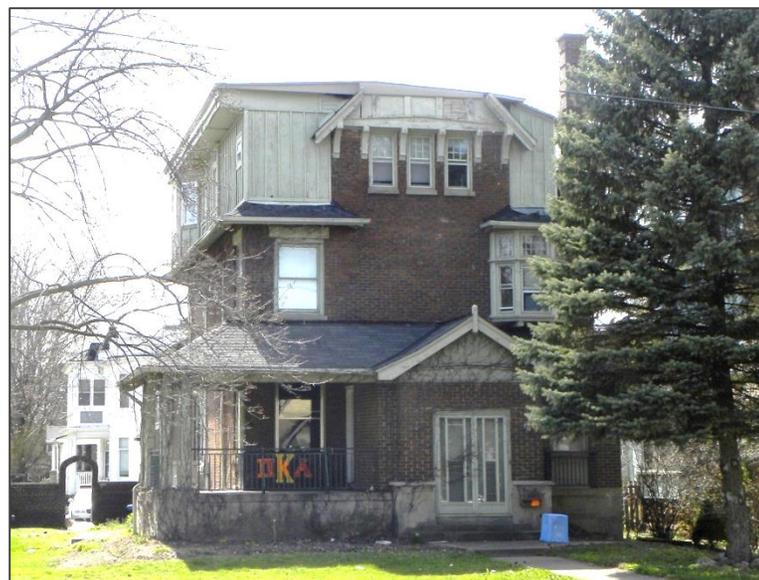
The building at 925 Richmond Street is a three storey brick house that has undergone several modifications over the years. This house was a two and a half storey until around 2005 when the roof was removed and additions were added to the north and south sides of the third floor. The moderately pitched roof was replaced at this time with a nearly flat roof. The third storey additions are clad in board and batten cladding.

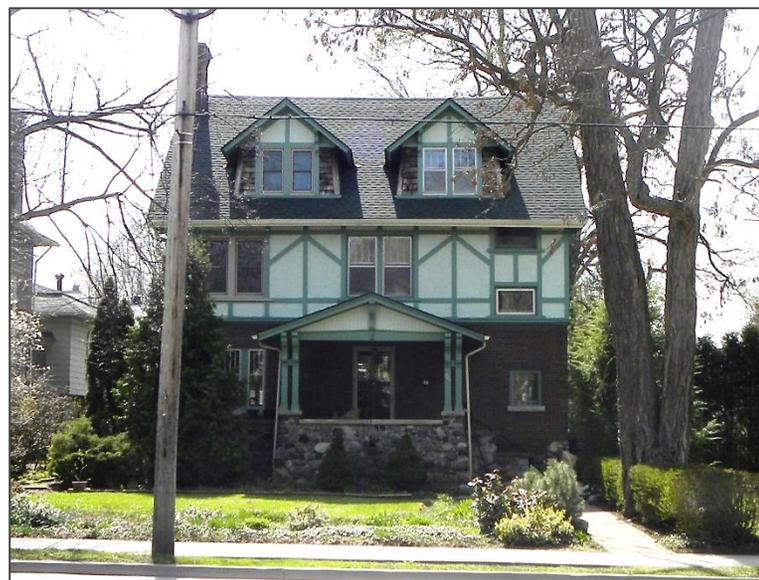
This house has a central front door accessed via a central front porch with shallow pitched gable roof. The porch roof is supported by paired square wood pillars and brackets. The foundation for the porch is fieldstone with a fieldstone parapet and plinths supporting the porch columns. This front porch is a side entry porch with steps on the north side. This house has a number of different size and types of windows on the front elevation including two 1/1 sash windows in the centre of the house above the front porch. A pair of casemate windows on the south side of the second floor of the house, a pair of windows on the first floor near the south side of the house and three single pane fixed or pivot windows on the north side of the front elevation of the house. Each dormer has two sash windows separated by a mullion.

The house at 927 Richmond Street has a moderate setback from and is in line with others on the street. It is just over 2 metres from the front property line and approximately 14.5 metres from the edge of the street. This house has parking in the rear yard accessed via a rear lane. The front walkway extends straight to the sidewalk from the north corner of the house.

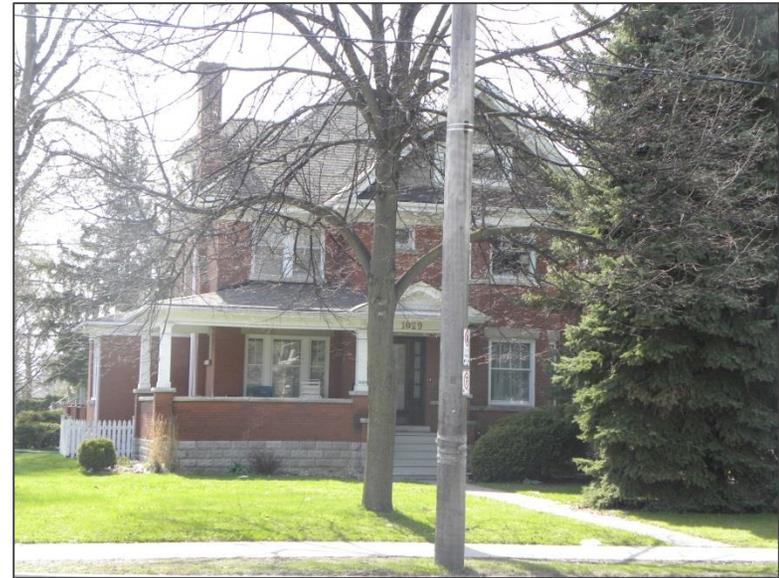
The house at 1029 Richmond Street is a two and a half storey red brick house in the Edwardian Classical style. This house has a roofed front porch in the southeast corner of the building. The porch roof has a pediment over the front steps leading to the front door and is supported by tapered square piers. The porch has an enclosed brick parapet and is six steps above grade with a rusticated concrete block base.
