St George-Grosvenor Heritage Conservation District Study

Volume IV Appendix F, [2016]

APPENDIX F: INVENTORY OF CULTURAL HERITAGE RESOURCES

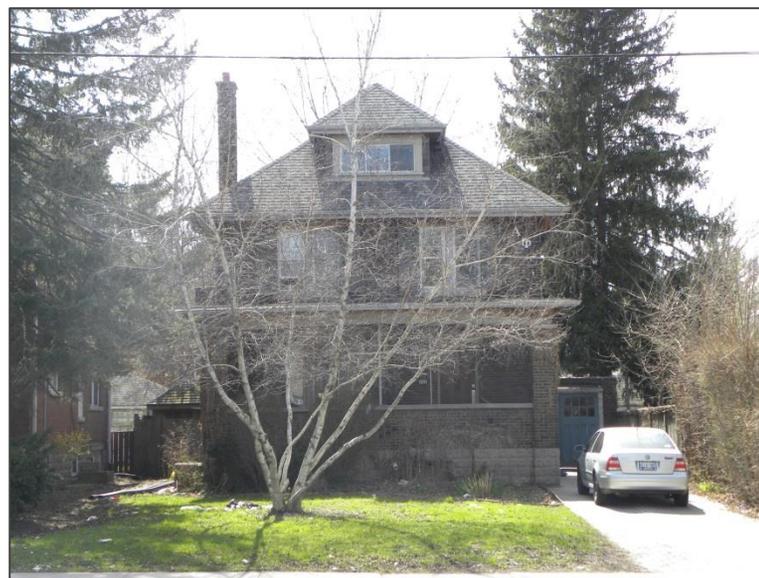
The house at 1031 Richmond Street is a two and a half storey frame house with brick veneer in a running bond pattern. This house has a hip roof (almost pyramidal) with central front hip gable. This house has rusticated concrete block foundation, which extends to the foundation for the veranda. The house has a tall brick chimney on the south elevation.

The front elevation of the house has a front door and large front window on the first floor. Both door and window have a stone or concrete lintel above. The second floor on the front elevation has two evenly spaced window openings with plain sills. Second floor windows are paired 1/1 sash windows separated by a mullion. The front hip gable has a long horizontally oriented window. Second floor windows have undersized shutters.

The house at 1031 Richmond Street has a moderate setback from the street with driveway on the north side of the property. This house is in line with others along the street. It is almost 4 metres from the front property line and just over 17 metres from the edge of the street. A rear lane runs behind this property.

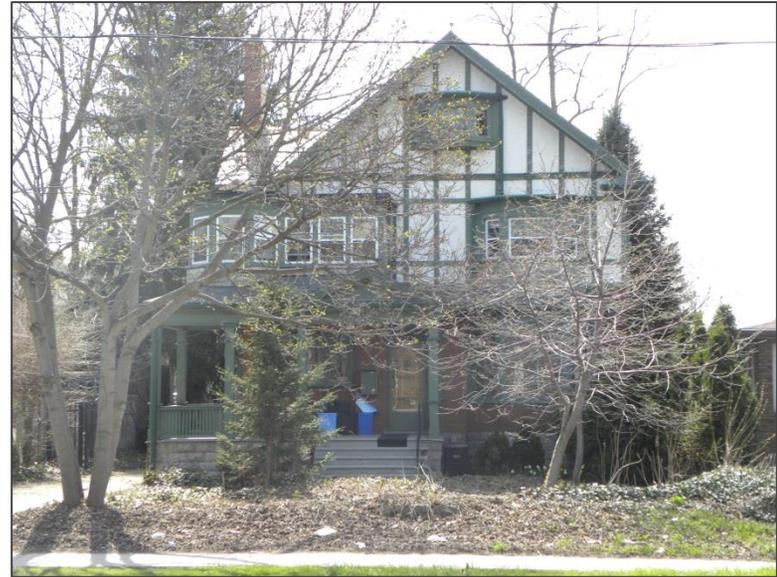
Decorative details of the house include dentils on the front fascia, around the window trim and on the cornice and pediment to the porch roof; Shingle siding around the octagonal room and associated windows, fish scale shingles on the main roof, returned eaves on the front gable end and decorative moulding on the half-timbering.

This house is in line with other buildings on its street. This house has a moderate setback from the road. It is approximately 3.5 metres from the front property line and just under 17 metres from the edge of the street. A driveway extends along the south side of the property from Richmond Street to the rear of the property. A walkway extends from the front steps along the front porch to the driveway.

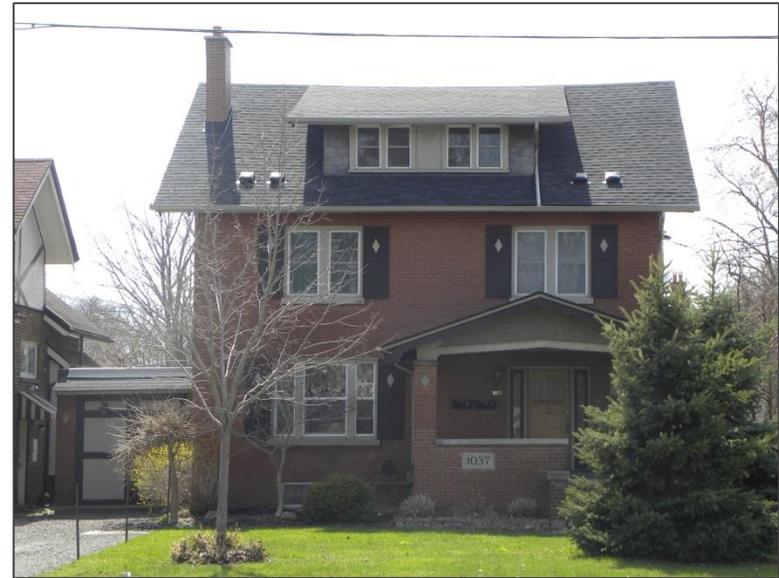
The front elevation has a covered front porch with brick pillars supporting the front gable porch roof and brick parapet. A diamond motif is set in in the brick pillars' supporting the porch roof. The front door has tall, narrow sidelight windows on either side. The door is wood with an arched window made up of four glass panes in it. The first floor has a large three section window with concrete sill. The window consists of three 1/1 sash windows separated by mullions, the central window is wider than the flanking windows. The second floor has two pairs of 1/1 sash windows with concrete sills evenly spaced on the house. The dormer has two smaller double 1/1 sash windows. First and second floor windows have undersized, fixed shutters; the diamond motif is included in the window shutters.

This house has a moderate setback from the street. It is approximately 2.5 metres from the front property line and almost 16 metres from the edge of the street. This house has a driveway extending from the south side of the house at the garage to Richmond Street. A walkway runs across the front of the house from the front porch to the driveway. This house is in line with others on the street. A lane runs behind this property that this property has access to.

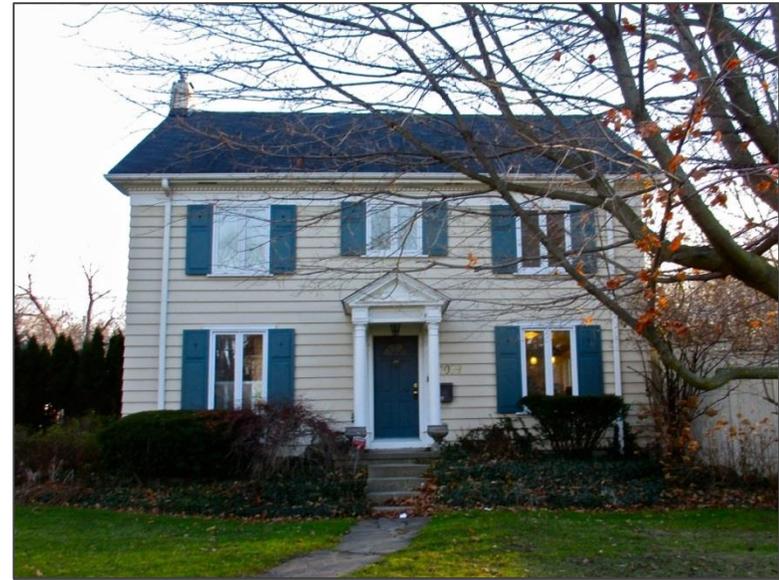
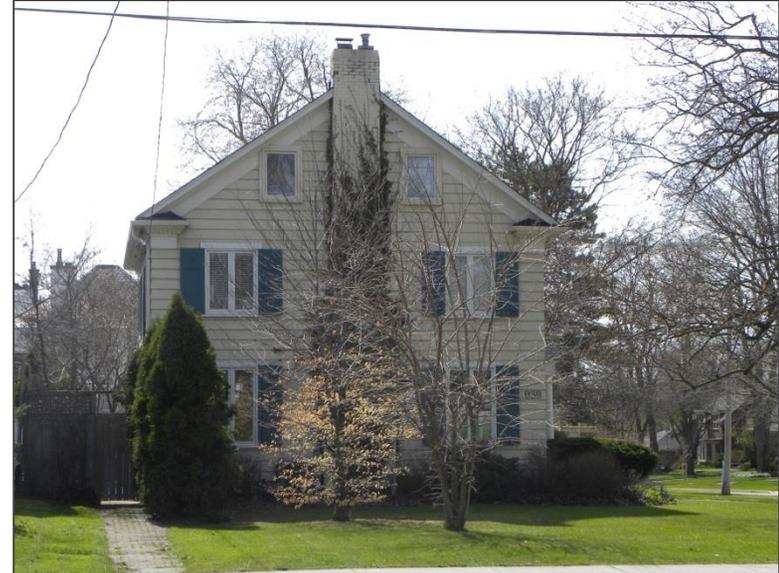
Window openings on the first and second floor are the same width but first floor windows are taller than second floor windows. The attic has small windows. The house has returned eaves. The house has shutters on all first and second floor windows. The front elevation has two windows on the first floor and three on the second. Windows are evenly spaced. The central second floor window is shorter than the other two. Windows have been replaced.

The front of the house facing Victoria Street has a central front door with small covered porch. The porch roof is a pediment supported by two smooth tapered columns. The porch is concrete five steps above

grade. The columns rest on the concrete porch. A plain cornice wraps around the porch pediment roof. The fascia of the pediment has small dentils.

This house has a cornice frieze under the eaves with dentils decorating it. This cornice is along the front and back of the house and around the returned eaves. The fascia on the gable ends is plain.

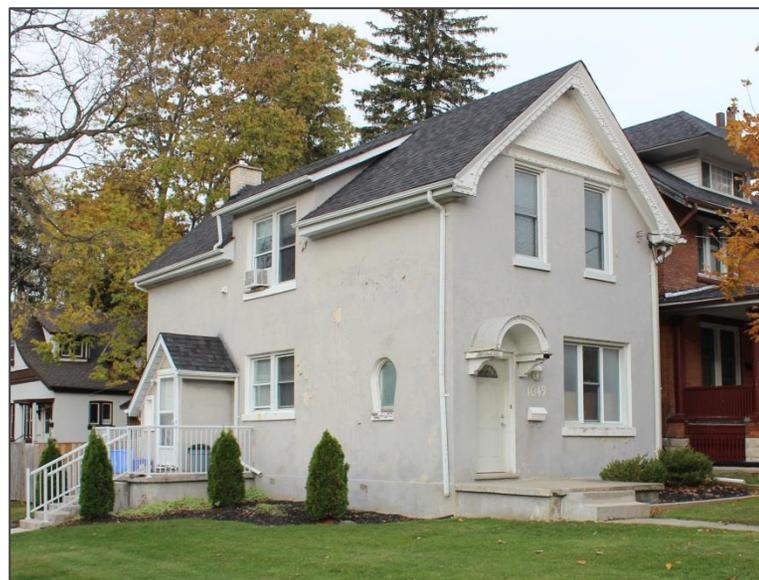
The south elevation has a plain keyhole window close to the front door and two sets of windows one on each floor in the centre of this side of the house. Near the rear on the south elevation is a concrete porch and enclosed side door. The porch has a plain white metal railing.

1049 Richmond Street is on the northwest corner of Richmond and Victoria Streets. The house has a moderate setback from each street. It is approximately 0.5 metres from the Richmond Street property line and just over 14 metres from the edge of Richmond Street. The house is approximately 1 metre from the Victoria Street property line and 15 metres from the edge of Victoria Street. This house is close to the northern edge of its property. Parking is in the rear yard accessed via Victoria Street. The house has a front walkway extending from the front door straight to the sidewalk on Richmond Street.

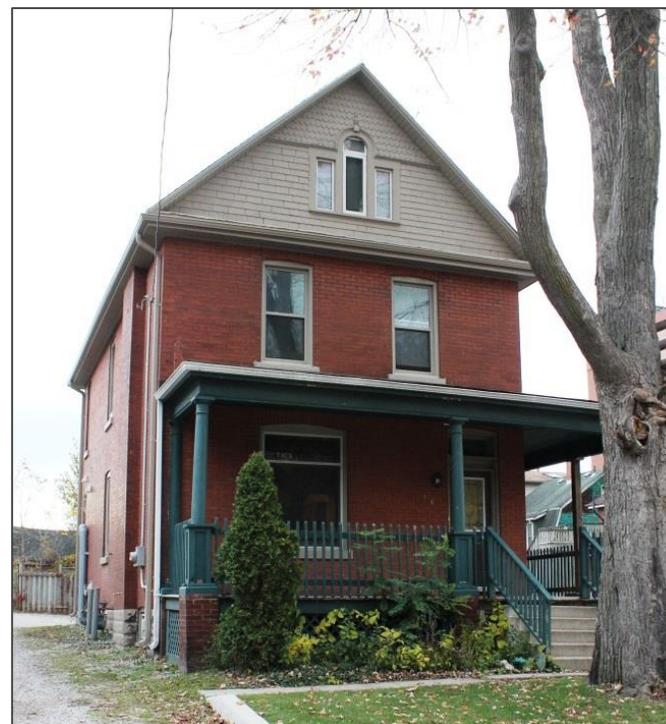
The roof of the front veranda is supported by smooth tapered columns that rest on square wood plinths on brick foundation plinths. The veranda has a flat roof and wraps around the south side of the building. The railing is plain wood with square spindles. An engaged column supports the veranda roof on the north side of the front elevation of the building. The deck of the veranda is wood and the skirt is a plain lattice.

This house has a moderate setback from the street. It is on the front property line and is 12 metres from the edge of the street. It is adjacent to a laneway on the north side. The south side of the house is a parking lot for buildings fronting on Oxford Street East. A large mature tree is in front of the house.

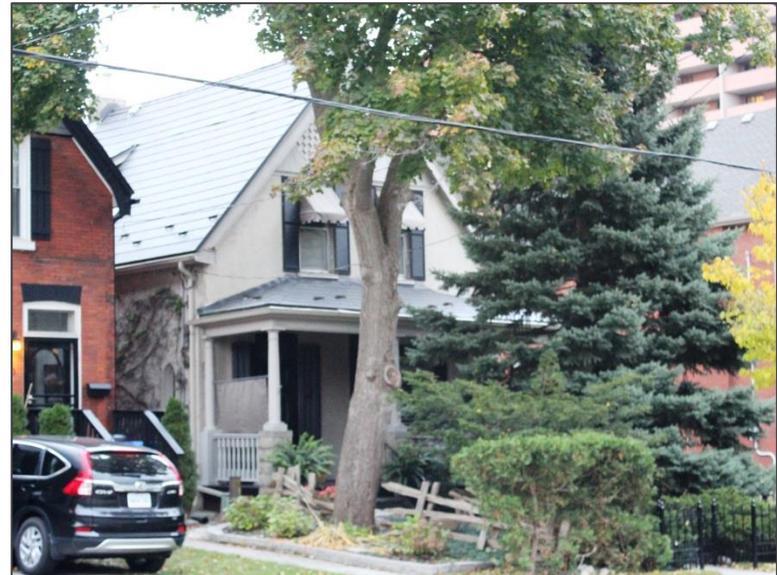
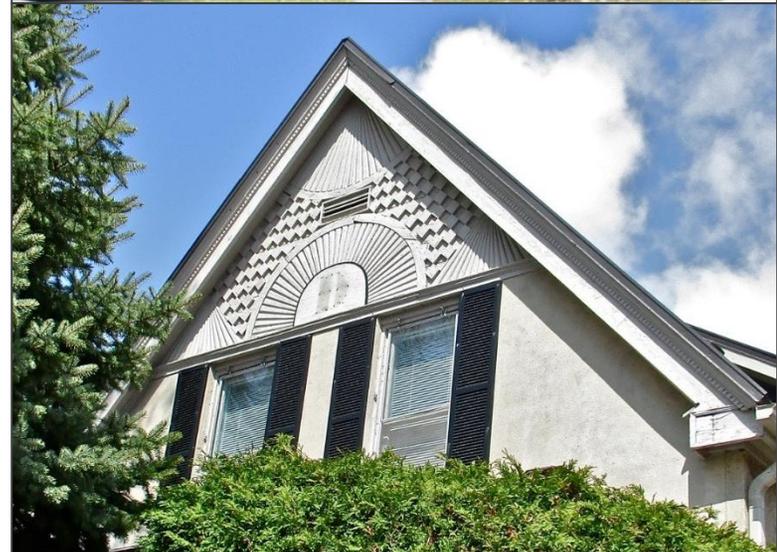
The vergeboard has a row of small dentils. The apse board has sunburst designs in each corner while the field projects a checkerboard effect caused by alternating rows of projecting and recessed blocks of wood. The bottom of the apse board has a pleated fan pattern. The centre of the apse board has a vent at the middle of the field.

The southern elevation of this building has four windows, two small windows closer to the front and a set of larger double windows near the rear.

This house has a similar setback from the street as most other homes on the street. It is on its front property line and is 14 metres from the edge of the street. This house has a laneway to the south and parking is alongside the laneway on the south side of the house. This house has large trees and mature shrubbery in the front garden filling the front yard of the house. The front garden is behind a black metal fence with gate. The rear of this property, visible from the adjacent laneway, is screened with a wood fence with wide boards and a scalloped curve along the top. A walkway extends straight from the front steps to the sidewalk.

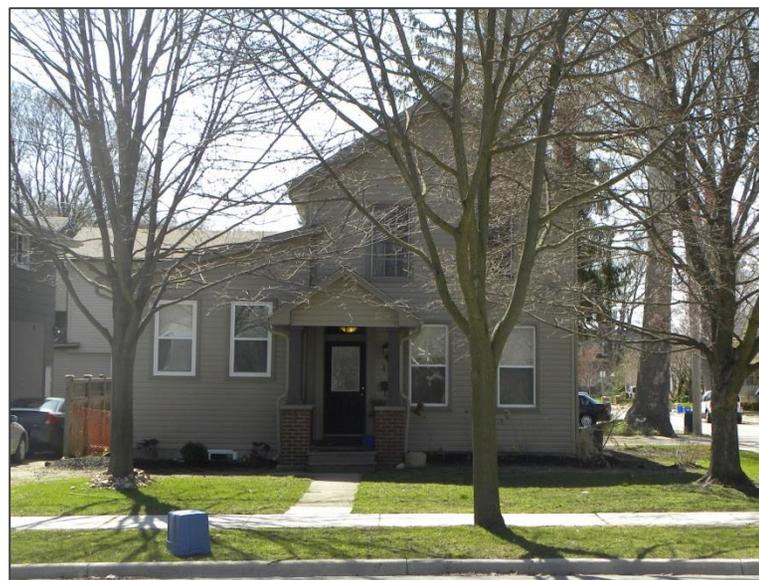
The front elevation of the house has the door approximately in the centre of the house. The front door opening is surrounded by plain trim. The door has a transom window above it. The door has a large frosted glass window in it. The first floor on the front elevation to the north of the front door has two sash windows. The first floor on the front elevation to the south of the front door is part of the addition added to the house in 2014-2015. This elevation has two sash windows. The second floor has two sash windows.

The north side of the building has three windows on each level. The centre windows are small and the windows on each end are larger vertically oriented windows. Windows on this house are framed in plain trim.

181 St. George Street is on the southwest corner lot at St. George and Sydenham Streets. The house has a moderate setback from the street matching most other houses on these streets. This house is just over 1 metre from the St. George Street property line and 15.5 metres from the edge of St. George Street. A walkway extends straight from the front door to the sidewalk on St. George Street. A driveway is at the back of the house off Sydenham Street.

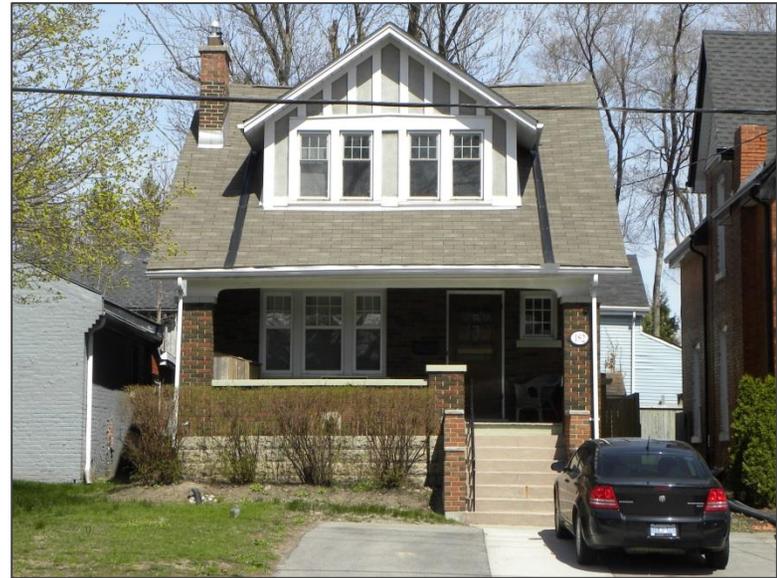
The front veranda is approached up seven steps. The steps are concrete, the veranda has a rusticated cast stone foundation with a brick parapet and brick piers. The parapet has concrete coping. The deck is wood. An arched wood beam supports the roof.

The front elevation of this house has a small fixed window with concrete sill next to the front door. The front door has a rectangular window in it. The front elevation also has a large window opening with a three sash window in it. Each window is separated with a mullion. The central window is wider than each flanking window.

This house is on a narrow and shallow lot. This house is slightly closer to the street than adjacent houses on its street. It is on the front property line and approximately 13 metres from the edge of the street.

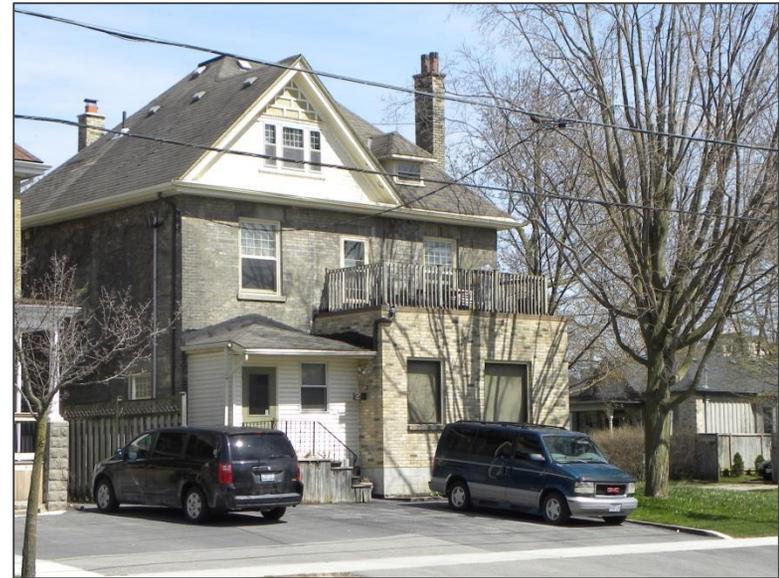
This is a two and a half storey buff brick home (it appears grey or brown depending on lighting conditions and viewing angle). This house has a truncated pyramidal roof with a gable on the northwest (St. George Street) side, facing west, and another gable on the southeast (Sydenham Street) side, facing south. The house has a hip dormer on the St. George Street side and a large shed dormer on the back. This house has had additions added to it over the years.

The front elevation of the house faces St. George Street. The front gable has a triple sash window in it, the central window is wider than the flanking windows. The gable has fish scale imbrication and decorative woodwork including dentils and fretwork above the window opening. The fascia of the gable is lined with dentils. The second floor front elevation has two windows and a door on it, the door is in the centre of the façade and opens to a rooftop balcony over one of the ground floor additions. The window openings have concrete sills and lintels. The door has a concrete lintel.

The south elevation of the house, facing Sydenham Street, can be divided into two bays. The eastern bay under the gable projects from the house. The Sydenham Street elevation holds a triple oriel window on the ground floor. Each window is separated with a mullion and is divided vertically with a muntin into two sections, the lower section is larger than the upper section. the frame for the oriel window is wood and has a three pannel piece below the window, a flat roof above the window and dentils under the roof trim. The second floor of this bay has a single sash window with concrete sill and lintel. The western bay on the Sydenham Street elevation has an exterior brick chimney and a small fixed window with concrete sill and lintel.

The additions to this house include an enclosed porch on the St. George Street elevation with a hip roof and clad in siding, a single storey addition with flat roof and clad in buff brick on the St. George Street side of the house and a larger two storey addition with flat roof on the back of the house. The rear addition has outdoor amenity space on the roof and exterior stairway providing access.

216 St. George Street is a corner lot on the northeast corner of St. George Street and Sydenham Street. This house is on its St George Street property line and is 14 metres from the edge of St. George Street. This house has parking on both streets. Both street sides of the house line up with adjacent houses.

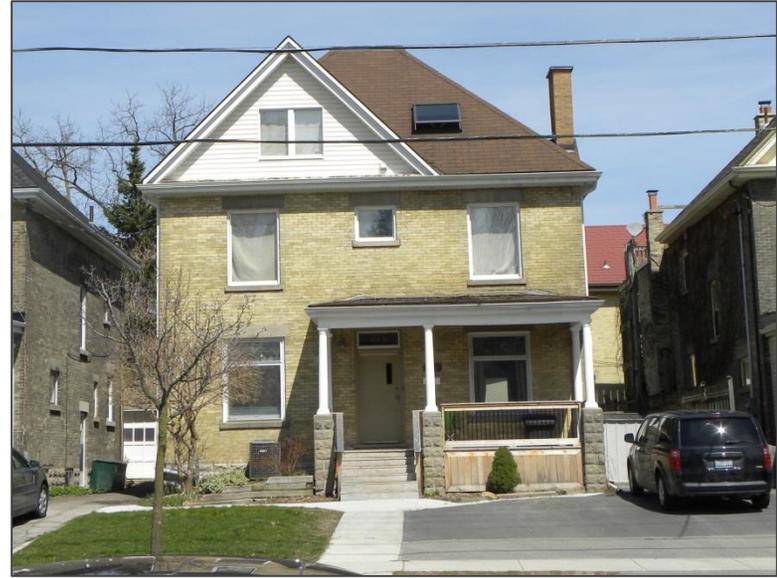
The house at 218 St. George Street is a two and a half storey white brick house with steeply pitched hip roof and off centre front gable and skylight. The brick is in a running bond pattern. The front elevation of this house is symmetrical. It has a central front door flanked by a window on each side on the first floor. The front elevation on the second floor has three windows, one large vertically oriented rectangular window on each side and a smaller square window in the centre. The gable in the roof has a double window centred on it. Door and window openings have plain concrete sills and lintels.

The front porch of this house is six steps above grade and supports its roof with three Tuscan columns on rusticated cast stone plinths. Two half columns in the Tuscan style hold up the porch roof against the house and rest on the porch deck. The porch has a flat roof supported by header beams across the columns. The steps, handrail and skirting of the front porch are cedar. The railing has round metal spindles.

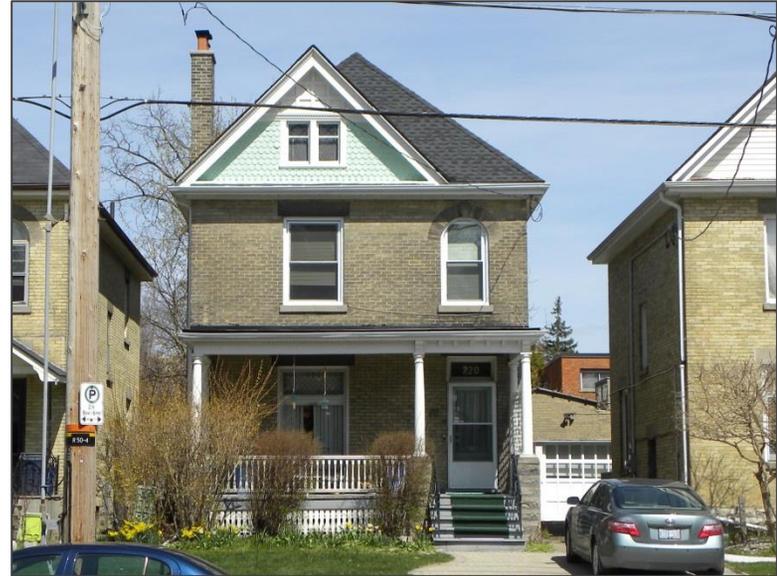
The house at 220 St. George Street is a two and a half storey buff brick building displaying influence of Edwardian architecture. This house has a hip roof with off centre front gable and a tall chimney. The front elevation of this building consists of a front door accessed over a covered veranda. The veranda has a flat roof and is supported by three individual smooth tapered columns and two engaged columns. The front three columns rest on rusticated cast stone block plinths and the two engaged columns are set on the veranda deck. The veranda deck and steps are wood. The railing of this veranda is plain with round spindles. The veranda roof is supported by a header beam. Decorative brackets are part of the cornice above the two columns that flank the steps and a series of seven modillions are between these columns. The cornice has small dentils between the central and northern column.

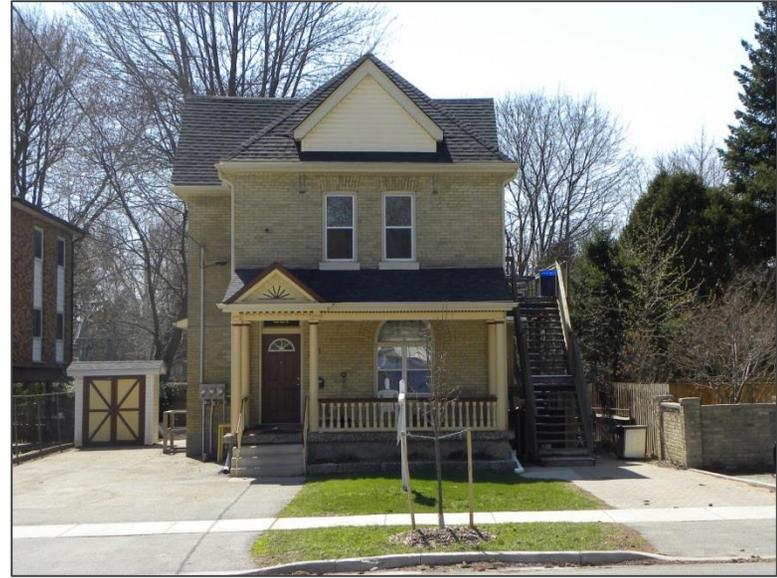
The house at 221 St. George Street is a two and a half storey white brick house. The house is rectangular in plan with a projecting wing on the south side. The house has a hip roof with cross gable dormers. Front and south gables are clad in siding. The north gable has a window in it. This house also has a large single storey addition on the back that is given the address 223 St. George Street.

The front veranda spans the width of the house. The veranda has a shed roof has a small gable over the front steps, with a sunburst pattern in the woodwork. The veranda roof is supported by five smooth tapered columns that extend from the floor of the veranda to the roof. The porch is concrete, with a concrete foundation and is four steps above grade. The veranda has a low railing with heavy round decorative spindles. The cornice of the veranda has dentils under the eaves and larger brackets above the front steps.

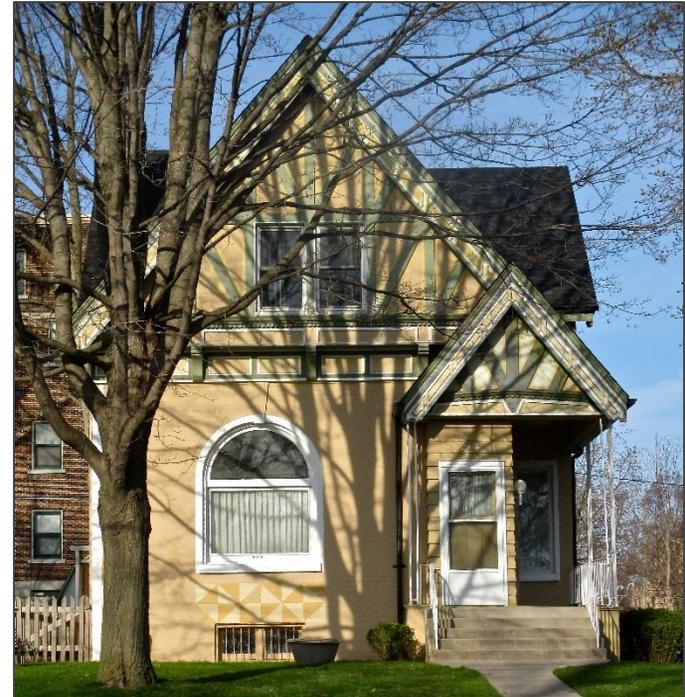
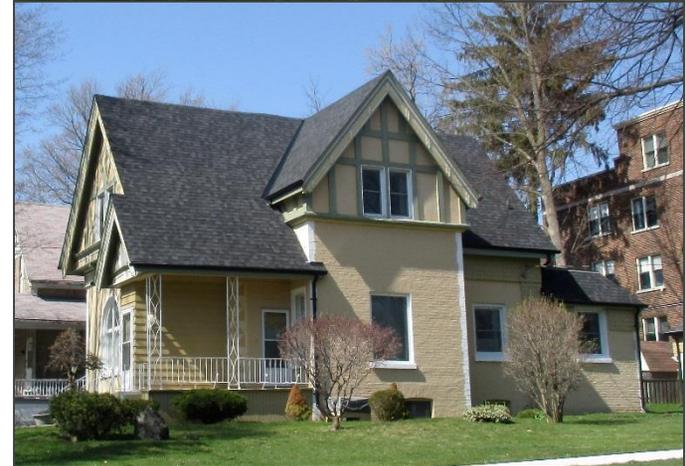
John M. Moore was the head of a prestigious and prolific firm that had its roots in the 1850s firm of Robinson and Leather; he later served as London's mayor. At the time this house was built, he was working with Fred Henry, who most likely designed the building and produced the elevations shown below. The

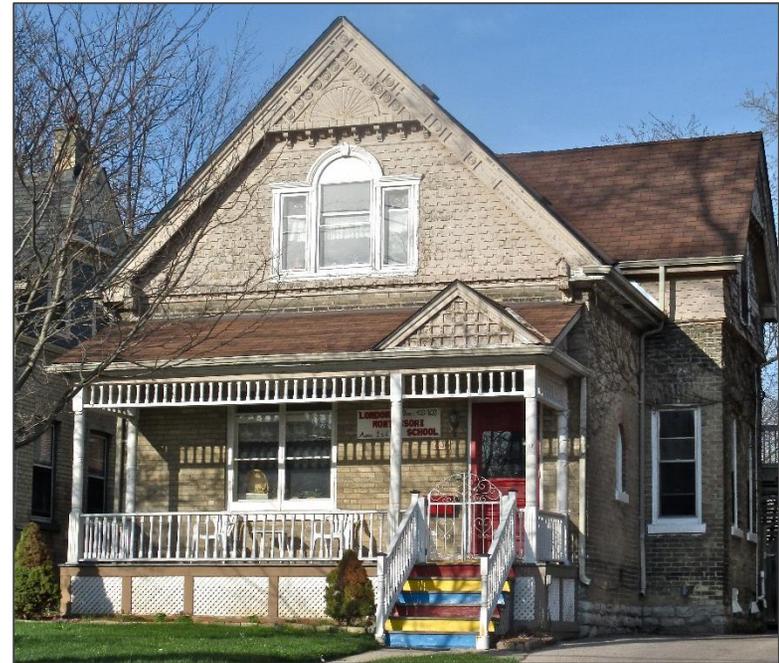
This house has the most elaborate gable treatments in the row of four very similar homes. Its bargeboard is decorated with parallel and perpendicular wood strips and with roundels; roundels also frame the arch board with its semi-circular sunburst motif. The arch board is supported by a combination of brackets and modillions; below that, a Palladian window, with stained glass panels remaining in two of the lights, is centred in a field covered with shaped shingles. On the south gable, the wood shingles extend below the line of the eaves. On the ground floor facade are (1) a sash window with a stained glass transom above and (2) a wood door with moulded panels, a glass insert, and a stained-glass transom above. A narrow, round-arched window is situated on the north side of

the house, and a 1/1 sash window on the west wall of the south wing. All windows have wood sills, and brick voussoirs, outlined by red mortar, support the walls above them. The shed-roofed verandah reaches across the main facade; the cross panel over the front door is decorated with a grid of wood squares. The porch roof is now supported by posts with a circular profile sitting on a square, fluted plinth; the verandah features spindlework under the eaves, railings with a vaguely classical profile, and latticework to line the space below the porch floor. The bright colours in which the porch steps and the front door have been painted gives the front of the house a playful quality fitting for its present use as a Montessori school.

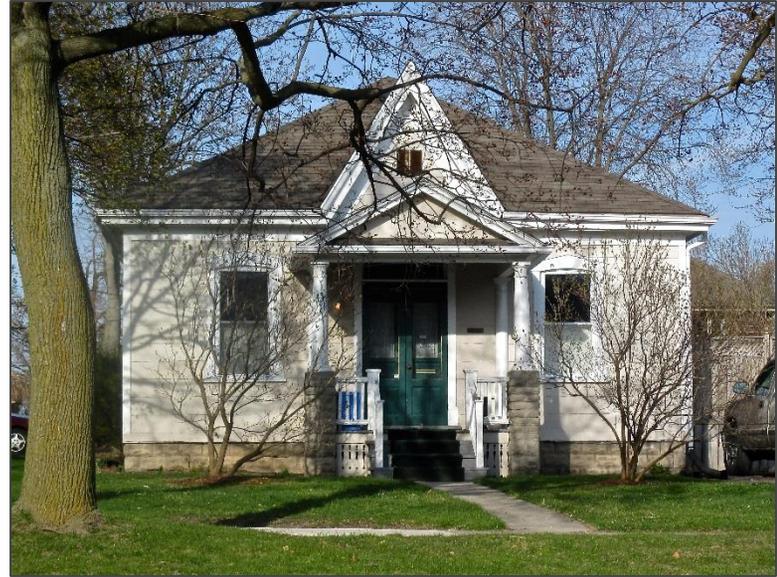
The building at 242 St. George Street, on the corner of College Street (once Thomas Street), is a three-bay Ontario Cottage, with a hipped roof, a door in the centre bay (albeit one that is slightly off-centre), a single sash window to each side, and now a steep cross gable over the front door. The basic cottage form and many architectural elements of the building appear consistent with its early date: the eared window frames with lintels suggestive of a pediment, for example, as well as the corner boards, and the deep, plain cornice. Many aspects of the building indicate a process of alteration and amalgamation, however. The roof is steeper than one would normally find in a 1863 house. The double-leaf front door, with a transom above, shows elements of the Eastlake Style popular from the late 1870s to the 1890s. The deep side of the house, visible along Cromwell Street, features a long, shallow cross gable, now centred in what might be considered the Cromwell Street facade. Cross gables were usually placed on cottages to provide light to an attic or half-storey, but the Cromwell Street gable has no windows, and the paired windows in the St. George Street facade are very tiny. There are a number of apertures (including a door) along the Cromwell side of the house, but they seem placed in a curiously random way (all in the back three/fifths of the long side), and although all feature eared and pedimented surrounds similar to those facing St. George Street, all differ in details, and the windows are of different sizes and styles (one

Venetian window and two 1/1 windows of slightly varying sizes). The centred front porch, with its shallow gabled roof, compressed Doric columns and high concrete block plinths, dates from the early 20th century. Moreover, the house now has a foundation of rusticated concrete blocks, which indicates, at least, that the house has been raised. It appears that the asphalt shingles that now cover the building give the building an attractive unified appearance while relegating many aspects of the home's architectural evolution to a mysterious past. One even wonders if it initially faced Cromwell Street; it seems curious that its earliest addresses were on Cromwell Street when St. George Street was even then a more major thoroughfare.

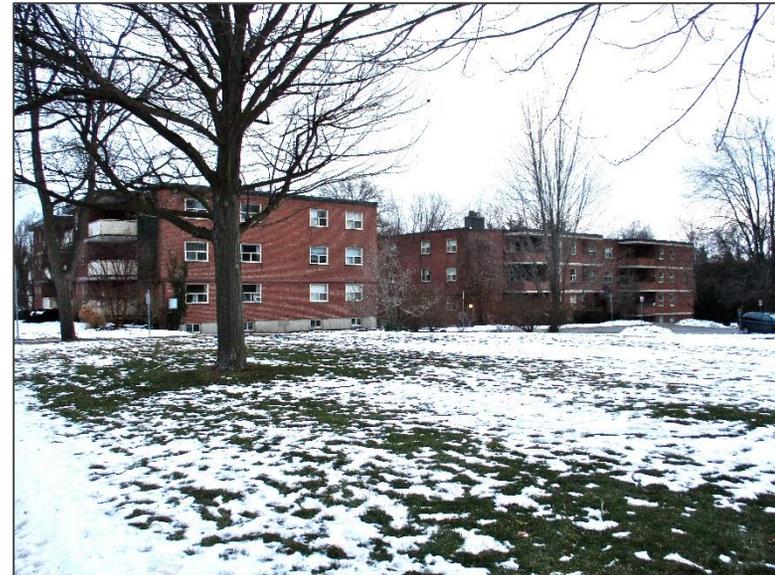
The 3-storey Grosvenor Apartments, at 291, 295, and 301 St. George Street were completed in 1955 and 1956. (The positions of these sets of buildings are shown here a detail from the 1958 Fire Insurance Plan, corrected to 1970.) For some time, 301 Grosvenor Street housed the offices of the Realty Development Company on its ground floor

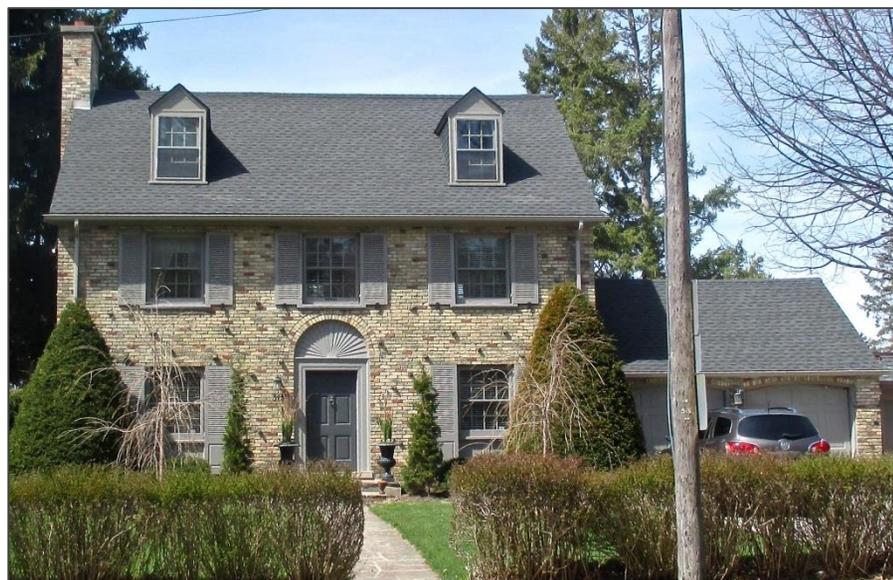
This gable-roofed, two storey brick house has a three-bay, symmetrical facade, featuring three identical 8/8 sash windows in the upper storey and a centre door and two 8/8 sash windows on the ground floor, all apertures on the lower storey placed directly below those above. Two gabled dormers, each filled with a 6/6 sash window and in line with windows beneath, pierce the relatively steep gable roof. All windows have wooden sills. Panelled spandrels are placed below the ground floor windows, creating a visual tie with the panelled, wooden front door. The door features a stone threshold reached via a low front stoup and a rather plain but broad architrave. Potentially working shutters flank all windows in the brick facade.

Two rather contradictory aspects of this Georgian Revival home make it particularly striking: (1) its delicate, refined, round-arched transom filled with a bevelled wood fan motif and outlined by two rows of voussoirs formed by brick headers, and (2) the robust, bright, multi-coloured brick itself, which in several ways seems aimed at recalling a rustic look. The brick hues range from a yellow-tan colour, sometimes with green overtones, to a terra cotta; black clinker - brick headers protrude at random intervals.

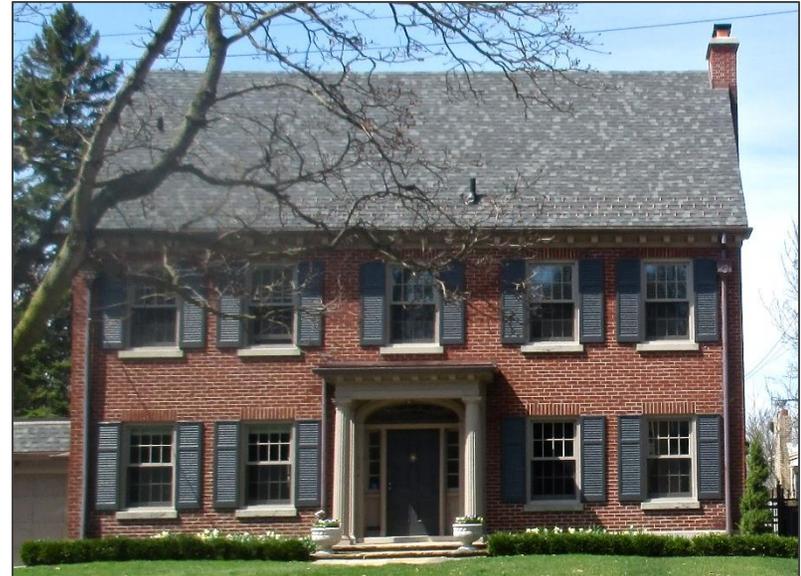
This two-storey, red brick Georgian Revival house is a textbook example of the genre. It has a gable roof, with the ridge parallel to the roof line, and a five-bay, symmetrical facade, with the centre bay slightly wider than the rest. Each bay holds an 8/8 window on each storey, with the exception of the centre bay, where the centre entranceway and a classical porch are located. All windows have wood sills and are flanked by wooden shutters. The entranceway features a panelled wood door, sidelights with panelled bases and small panes, and an elliptical transom with radiating dividers between the panes. In front of the entranceway, four fluted Doric columns support an entablature with dentils at the cornice level underlying the front porch. Matching dentils border the top of the house cornice. The individual bricks are made to stand out by the relatively thick layers of white mortar between them, and soldier courses accent the top of each window and line the concrete foundation. A brick chimney rises along the north wall.

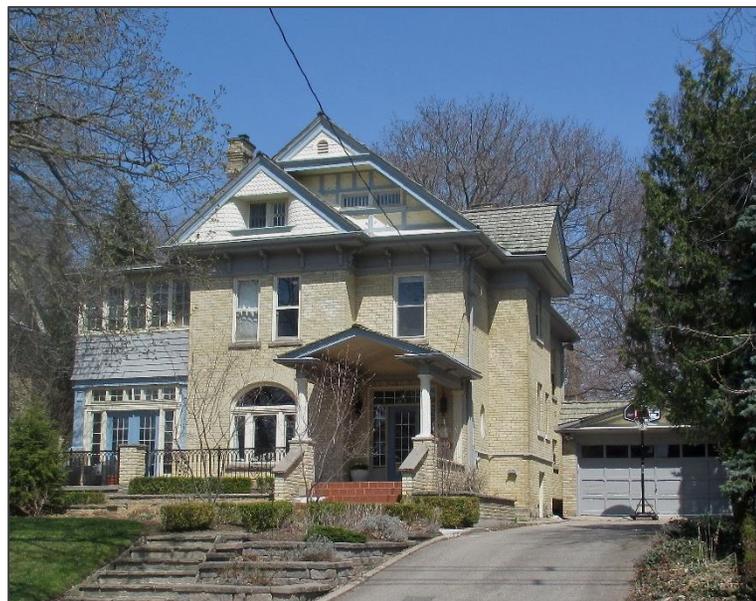
This house shares elements of most Queen Anne Revival houses in London, but the house forms an unusually broad and deep and example of the form, and it features numerous unique and finely crafted details. The house has intersecting gable roofs, one facing south, one west, and one projecting from the west gable; the house has an irregular footprint, reflecting this roof shape. The brick walls are built of local, buff-coloured brick, and the positioning of windows follows a common pattern: there are two 1/1 sash windows on the second floor of the most forward wall, with a large round-arched window on the first floor (though here the rectangular window below the arched transom is divided, following Venetian proportions, into three lights); a front door is located just south of the protruding wall under the most westerly gable. The detailing that makes this house so impressive is perhaps most strikingly found in the gables. As mentioned above, one west gable seems superimposed on the one behind. That in front is clad with shaped shingles on a wall that curves inward towards a deeply recessed window featuring leaded glass; the shallow wood sill beneath protrudes outward, supported by a gracefully curved apron. The partial gable seen behind features a shingled apex board flush with the bargeboard, in which is inserted a round-arched vent, outlined by wood trapezoids (in the shape of stone voussoirs).

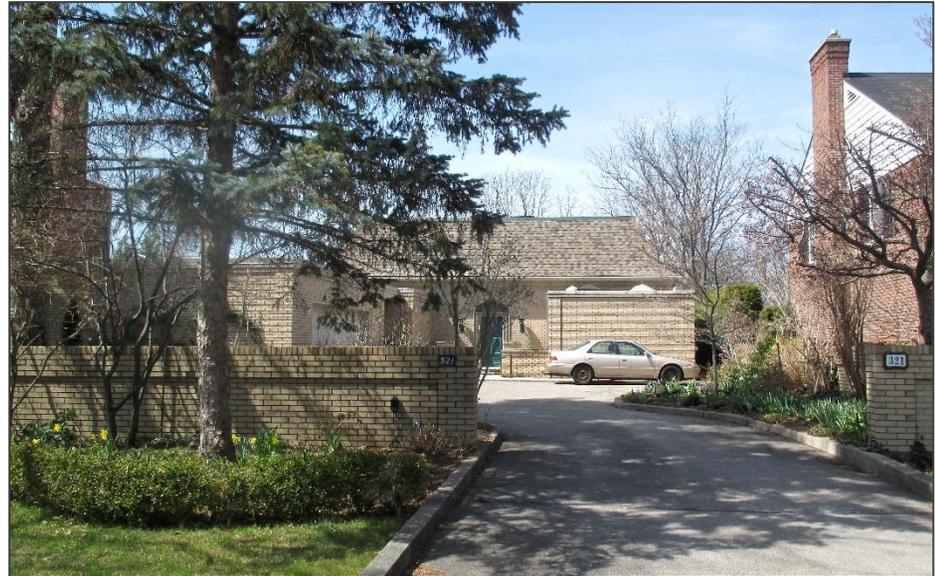
This house generally presents a closed face to the street, opening up at the back where many windows, now in three storeys, overlook the garden leading down the slope towards Gibbons Park. From the front, one sees what appears to be a very stylized suggestion of a Colonial house: a one-storey building with a steep, flared, hipped roof, a centre front door surmounted by a round-arched window, and one-storey protruding wings on each side that hint at an enclosed courtyard.³ The architect and/or previous owners seem to have used the brick "fences" found here to experiment with the concept of a courtyard. Short fences extending from the two protruding wings define space for a small garden and walkway between them, a kind of miniature *cour d'honneur*. Another brick fence that encloses most of the front garden, skirting along the sides and front of the property, encloses a working courtyard in a modern sense: cars drive through to reach the garage attached to the southern one-storey projection.

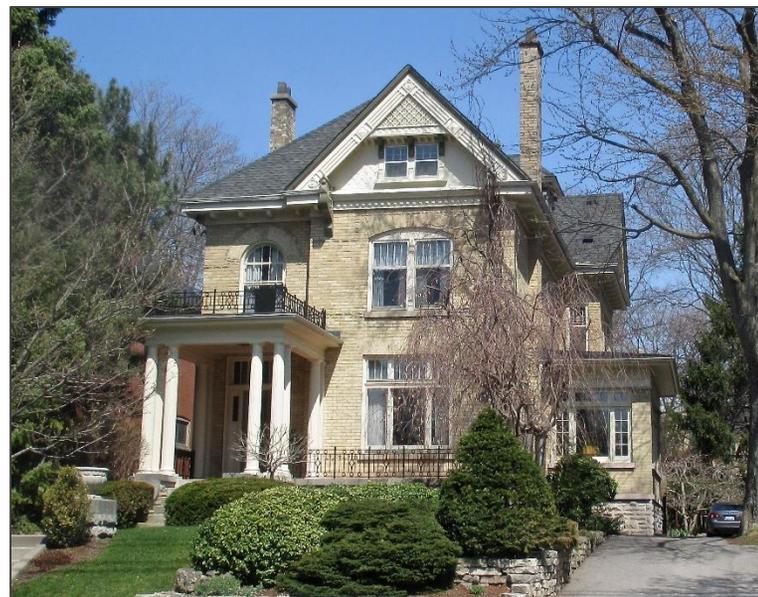
This two and a half storey, buff-brick house has had several sympathetic additions, but even the original, Queen Anne Revival house had a varied roofline and footprint. The house has a steeply pitched hipped roof, with a hipped-roof dormer on the south side and with cross gables to the south and west displaying ornate wood trim in the gable faces. Brackets, two at a corner, and one over the window appear to uphold the dormer roof. Each gable exhibits a bargeboard with raised geometrical shapes and an apex board featuring a checkerboard design in which are arranged rows of small medallions. In the recessed area below the apex board are paired sash windows with moulded jambs from which rise ornamental brackets that, along with a row of modillions, appear to support the apex board. The field of each gable is clad with diamond-shaped wood shingles, a row of round knobs stretches along its bottom. High brick chimneys rise along the north and south sides of the house, as well as the back. Broad, overhanging eaves appear to be supported by modillions. The front facade contains large windows in three different configurations: a round-arched sash

window, paired windows linked by a single segmental arch, with decorative mouldings along the common jamb and a pierced wood design in the space beneath the brick voussoirs of the arch; and a three light window surmounted by a three-light transom with a rectangular arch. All windows have in common rows of brick voussoirs with groups of three rusticated bricks at the centre and both ends of the rows; Rusticated brick courses outline the voussoirs on the upper windows and extend across the facade at the lintel level on the upper storey; two rusticated brick courses extend around the house at both sill levels. All front windows now display rows of vertical muntins in their upper sections, as does the transom over the front door. The wood entranceway has sidelights with a single narrow pane, which is roughly matched by the three vertical panes in the panelled wood door. The house has a rusticated, cut stone foundation.

Among the sympathetic additions to the house is the handsome, classical front porch, dating from the Edwardian period, and the sunroom on the south side of the house. The flat-roof of the porch is supported by grouped, fluted, Doric columns; the roof is now bordered by wrought iron railings in a design shared by a railing in front of a front deck. A shallow hipped roof covers the sunroom, which is clad in buff brick, surrounded by windows bordered by rows and columns of small panes, and, like the original house, features a high, rusticated cut stone foundation, though the stones of addition are generally shallower and longer than those of the house. There is also a one storey addition at the back, clad with reclaimed bricks.

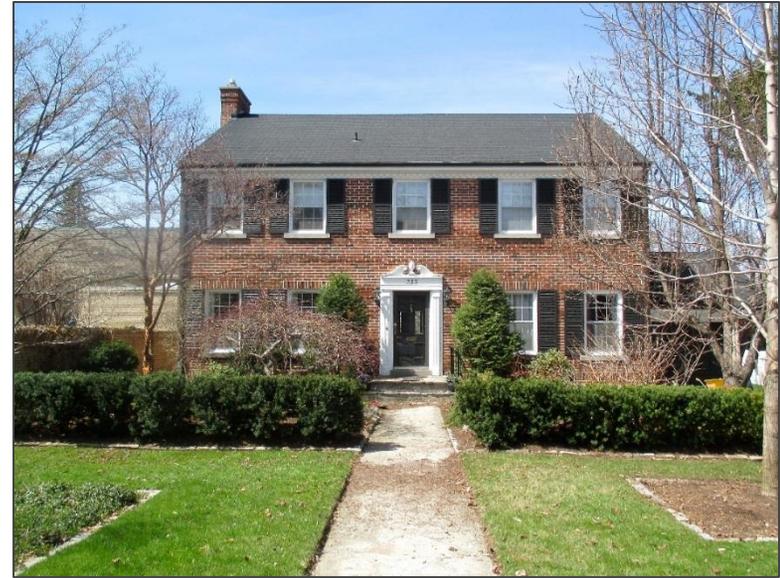
The house sit on top of the escarpment rising above Gibbons Park, and its back yard descends towards the treed slope of the escarpment. Because the house sits at the top of the hill rising from Oxford and Victoria Streets, the eastern part of its lot is level, and the formal garden in its front yard, with small, square or rectangular plots defined by bushes and stones, enhances the Georgian quality of the house.

- Form, including the cuboid form and shallow gable roof, with the ridge parallel to the street), mass, and scale of house
- Red-to-black rug brick facing of house, with applications of distinct white mortar between bricks
- Soldier courses along the tops of each window and along the foundation
- Deep brick chimney on south side of house
- Five-bay, symmetrical facade, with slightly wider centre bay.
- Spacing of 6/6 windows on the facade
- Wood rails and muntin bars
- Wood window frames and surrounds
- Wood sills
- Shutters flanking windows
- Entranceway featuring a panelled wood door with bevelled window inserts, fluted Doric pilasters flanking the door, and, above the door, a broken pediment enfolding an urn
- Dentils around cornice of house
- Attached garage

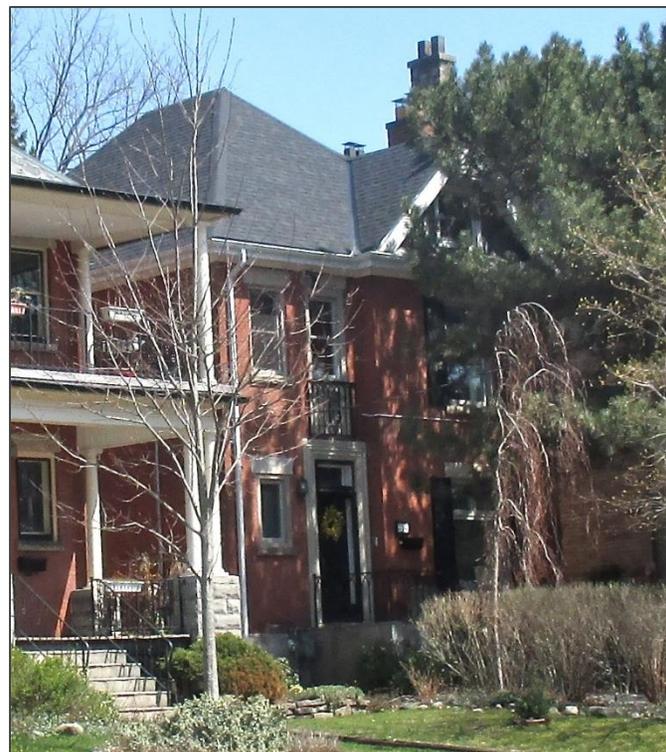
This 2-storey, late Edwardian house has a nearly square footprint, a steep hipped roof with a ridge along the depth of the house, and a front cross gable. There is a slight projection of the wall under the front gable. The wall of the gable itself, on the other hand, is deeply recessed behind the plane of the eaves and an apex board displaying a sunburst design; the gable contains a small-paned window, surrounded by a field shingled with scalloped slate tiles. The brick walls of the house are faced with pressed red brick, and the house has a rusticated concrete block foundation. On the projecting wall are a window on each floor, each now featuring vinyl-framed panes. The northern part of the wall now holds a door and an adjacent window on each floor. The upper door leads to a Juliette balcony and is abutted by another vinyl-framed window. The lower door is surmounted by a transom and is now surrounded by fluted wood entablature. Next to the lower door is a small rectangular window that was likely designed to contain ornamental glass. Except for the front door, all apertures feature deep rusticated stone lintels and shallower and more emphatically rusticated stone sills. The house has a rock-faced concrete block foundation.

There are relatively wide boulevards along this streetscape, and the front gardens are comfortably generous in depth, although 324 and 326 St. George Street are closer to the road than their immediate neighbours to the west. Because there is no lane behind this house and little space to either side, most of the front yard has been covered with patio stones to create a parking area there. Trees and shrubs line this paved area on both sides and along much of the sidewalk. Stone-covered front steps now curve up to the front

door, a wood door with a large window framed with a modified egg-and-dart design, now featuring, on top of the glass, an ironwork design that matches that of the railing along the steps and around the porch.

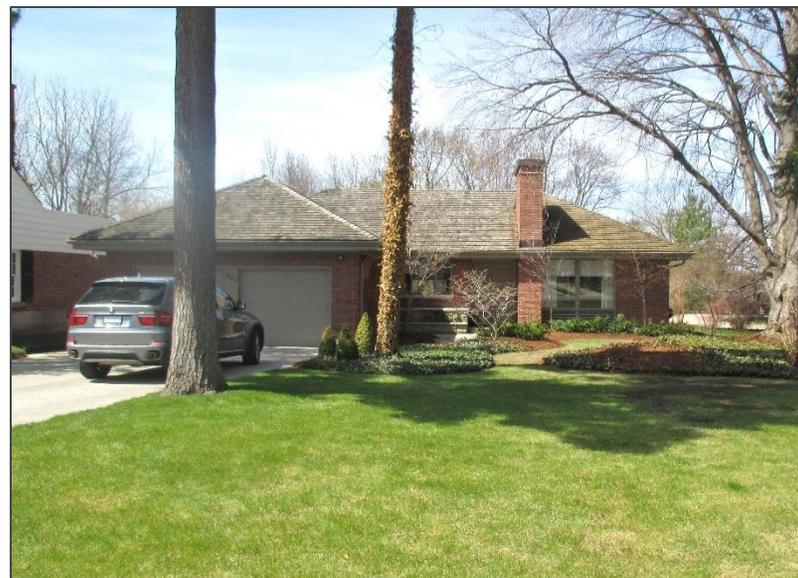
This one-storey, ranch-style house sits behind a two car garage and thus well distanced from a broad boulevard and public sidewalk. Both house and garage have hipped roofs, covered with wood shingles, and both are clad in unusually long bricks in a blend of light orange and tan hues. The building has very wide eaves, so that the brick chimney rising along the front wall pierces through the overhanging roof. North of the chimney are paired, large plate glass windows, with a metal frame around the windows and a series of horizontal metal slats forming a deep sill. Immediately to the south of the chimney are high, double-leafed doors with horizontal panels; a smaller, three-light window next to the garage has metal frames, a smooth stone sill, and, underneath, a long, rock-faced stone planter.

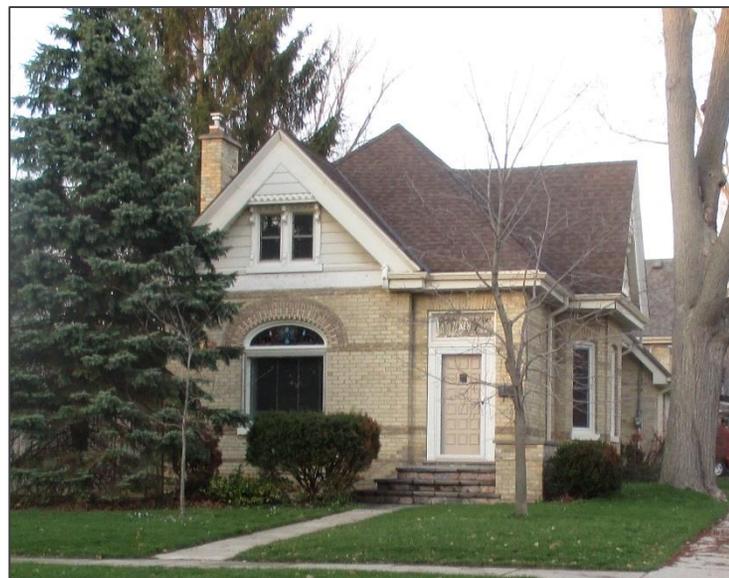
The hipped roof of this 1-and-1/2-storey Queen Anne Revival cottage at the corner of Cromwell and St. George Streets is interrupted by two cross gables, presenting a gabled facade to each of its exposed sides. Much of the decorative woodwork in both facades has been covered by clapboard, but the row of pointed squares at the base of the projecting apex boards still remains, as do the supporting brackets and the decorative frames of the paired windows in the gables. The walls of the house are faced with local, buff-coloured brick, with courses of slightly darker rusticated brick extending under the front gable and around the building at the lintel/impost and sill levels and also along the top of the brick foundation. A deep brick chimney rises along the north side of the house. The front gable surmounts a slightly projecting wall in which is placed a large plate-glass window with an elliptical, stained glass transom. Radiating out from and reflecting the elliptical arch is a striking composition of plain and rusticated brick voussoirs: voussoirs composed of alternating stretchers and headers and also of alternating plain and rusticated surfaces are also arranged in alternating lengths, so that a dentilled effect is created around the inside arch of the voussoirs; around the outer edge, enclosing the entire complex, is an arch of the rusticated bricks. The transom over the front doorway also holds stained glass. The present front door exhibits 6 rows and 3 columns of small panels, with a pane of clear glass inserted in place of one of the panels. The Cromwell Street side of the building holds its own architectural sources of interest. Below the side gable is a bay window in which windows are inserted in all three faces. An oval window is surrounded by brick voussoirs with a group of three rusticated bricks at 90-degree angles. At the east end of the house is an addition of re-claimed bricks, in which the rusticated courses of brick are continued.

- Form (1-and-1/2-storey cottage with hipped roof and two cross-gables), mass, and scale
- Bay window on south side of house
- Oval window on south side of house
- Remaining decorative woodwork in gables'
- Stained-glass transoms over front window and front door
- Spacing and size of all apertures found on the south and west sides of the building.
- Wood window frames and surrounds
- Facing of local, buff-coloured brick
- Brick voussoirs over windows
- Rusticated brick in lintel, sill, and foundation courses
