St George-Grosvenor Heritage Conservation District Study

Volume IV Appendix F, [2016]

APPENDIX F: INVENTORY OF CULTURAL HERITAGE RESOURCES

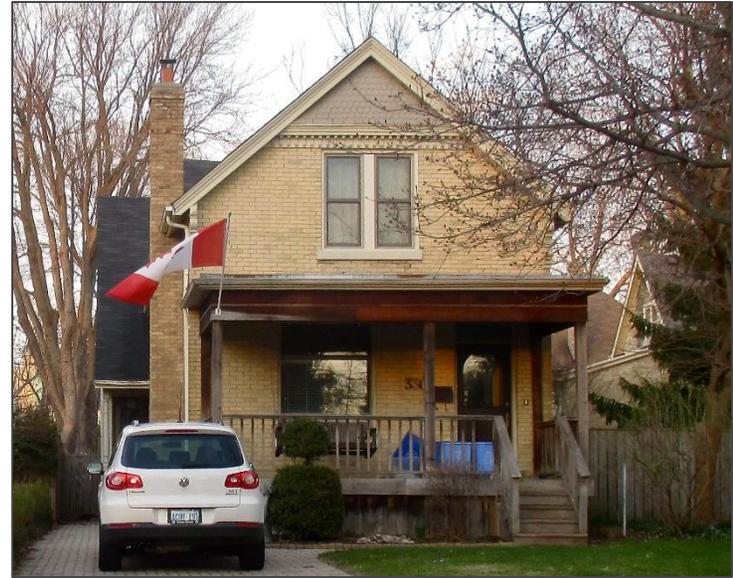
This vernacular, cuboid house has a gable roof with the gable facing the street. The house retains touches of the Edwardian flair for decorative detail in the protruding apex board, filled with octagonal wood shingles and supported by a row of small brackets, but little else now indicates the period's penchant for rich ornamentation. The building is faced with local, buff-coloured brick. The facade features paired 1/1 sash windows on the second floor and, on the first floor, a plate-glass window and a front door, both with transoms that probably once held stained glass. The front door is panelled, with a round-arched glass insert. All windows have wood sills, and most are surmounted by brick voussoirs. A tall brick chimney rises along the north wall. Prominent alterations to the house include the present front porch and a large addition at the rear, which is faced with modern siding.

- Form (1-and-1/2-storey, cuboid house with gable roof), mass, and scale
- Decorative apex board in the gable, exhibiting octagonal wood shingles and a row of small brackets
- Buff-coloured brick facing

- Spacing and sizes of windows and door with transom
- Wood sills
- Brick voussoirs
- Wood window frames and surrounds
- Panelled wood front door with round-arched window insert
- Brick chimney on north side of house

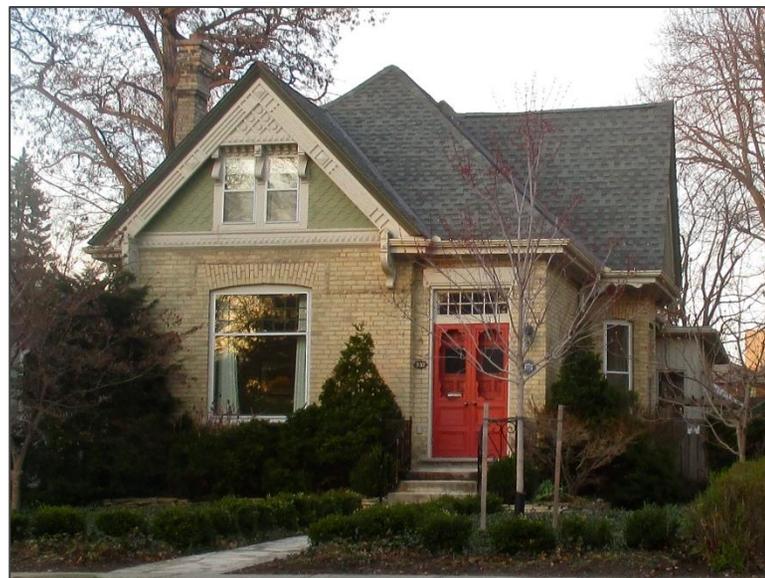
This 1-and 1/2-storey Queen Anne Revival cottage strongly resembles its neighbour at 328 St. James Street, though some details differ and more original features are evident here. Both cottages have hipped roofs interrupted by two cross gables, one facing west and one south. The gable faces contain more of their decorative woodwork here: bargeboards with geometrical designs, an apex board displaying a grid with small roundels in its squares, two sizes of brackets supporting the apex board, the larger attached to the jambs of the paired windows below, octagonal wood shingles in the field of the gable, and rows of pointed squares delineating the bottom of both the apex board and the gable as a whole. Large ornamental brackets appear to support the corners of the gable. The walls of the house are faced with local, buff-coloured brick, while a course of rusticated brick frames the voussoirs above the front window and extends across the projecting wall under the front gable. A deep, corbelled brick chimney rises along the north side of the house. The front gable surmounts a slightly projecting wall in which is placed a large plate-glass window with a deep transom now divided into small squares. Voussoirs above the transom are arranged with alternating headers and stretchers so as to form a straight line across the top, and they are outlined with red mortar. The transom over the front doorway is now also divided into small panes, possibly influenced by the rows and columns of square panels in the double leaf wooden doors that fill the front entrance (these are now partially covered by somewhat whimsical storm doors). Below the side gable is a bay window in which windows are

inserted in all three faces. At the east end of the house are two one-storey additions, one of reclaimed brick and one board-and-batten.

- Form (1-and-1/2-storey cottage with hipped roof and two cross-gables), mass, and scale
- Bay window on south side of house
- Decorative woodwork in gables'
- Spacing and size of all apertures found on the south and west sides of the building.
- Wood window frames and surrounds
- Double-leafed, wood front door with small square panels
- Facing of local, buff-coloured brick
- Corbelled brick chimney
- Brick voussoirs over windows, some outlined with red mortar
- Rusticated brick in lintel course
- Original window sills

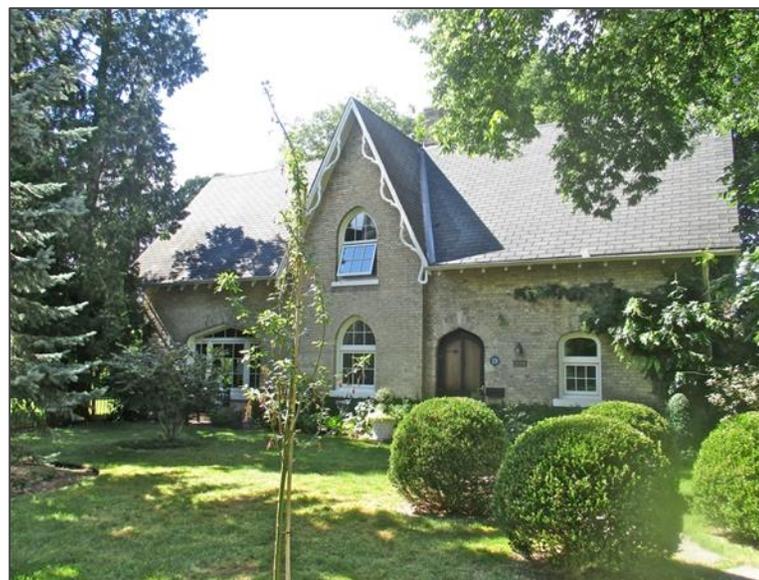
In 1852, H.C.R. Becher erected a picturesque Gothic Revival residence to replace an earlier mansion that had been destroyed by fire. The one and a half storey buff brick coach house he erected six years later was a practical means of housing horses and coaches, but also an architectural fantasy, using variations on Gothic and Tudor Revival architectural influences to enhance picturesque themes. The front facade, which once faced to towards the property's original Grosvenor Street entrance, now faces its side yard rather than the road. The front facade has a protruding frontispiece with a steep gabled roof featuring a sculpted bargeboard; the end gable facing St. George Street boasts a similar bargeboard. Doors and windows are surmounted by Tudor arches of various widths, heights, and degrees of curvature. Voussoirs comprised of alternate brick headers and stretchers

emphasize the arches of all apertures. Even the original entrance for coaches (now a broad window) boasts a striking Tudor arch. A brick "lean-to" on the northeast corner of the building appears to be original to the structure.

In the course of adapting the building from a coach house to a residence, numerous changes have been made at various stages to the interior of the building and some to the exterior (especially on the north side). These include introducing some new windows and revising the large entrances required for coaches and horses, extending the original "lean-to" to the west end of the building, and adding new wood doors, with iron hinges and studs, on the south and east facades of the building. All alterations have been introduced in a manner sympathetic to the original building.

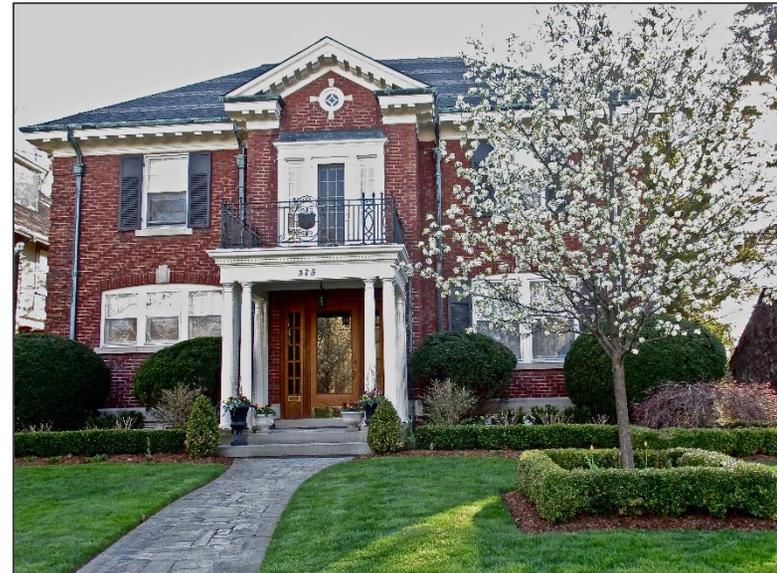
The Classical Revival house appears to have been designed to create plenty of work for the firm's artisans in that it features numerous intricate details. The house is three bays wide, with a projecting frontispiece, which terminates in a pediment that features pronounced returns. The relatively shallow hipped roof is now clad with asphalt shingles, with a scalloped shingle design in several courses forming a series of horizontal lines across the breadth of the building; these may replicate the design of original slate tiles.

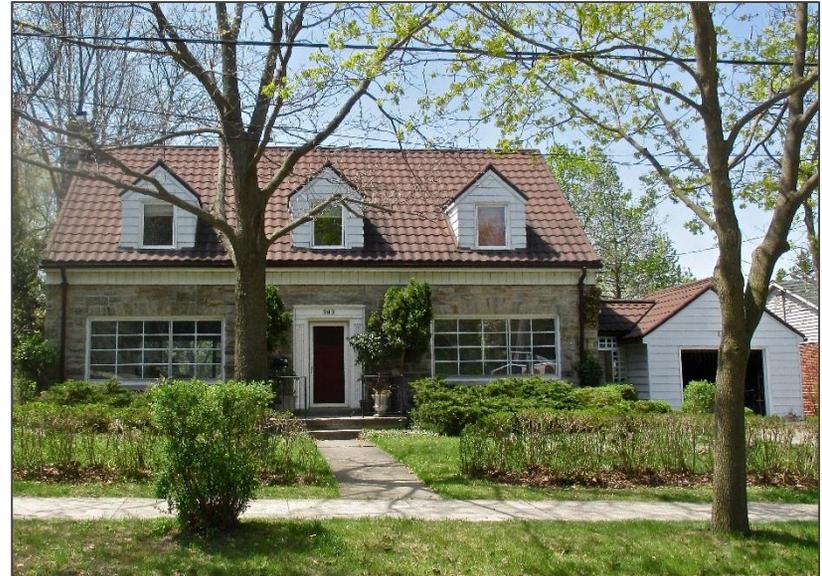
The front elevation of this house can be divided into three even bays, each with a gable dormer in the centre of the bay. The central bay holds the front door and each side bay holds a large horizontally oriented rectangular window openings topped with stone veneer voussoirs making an arch shape above the window opening. Each front window appears to be a sliding window with a larger and smaller section and consists of several panes each divided by munitn bars. The larger section of each window is the southern section and consists of 12 panes 3 over 4 and the smaller section is eight panes 2 over 4.

The front door of this house is approached from a walkway that extends straight from the sidewalk to the front door up three steps to a stoop. The front door has a rectangular opening and is surrounded by heavy moulding that resembles fluted square half columns topped with a shelf entablature that holds the house number. The front door is has a glass outer door in front of what appears to be an older wood door painted red.

The garage attached to this house has a front gable roof and white garage door. The house at 383 St. George Street is on its front property line and is approximately 14.5 metres from the edge of the street.

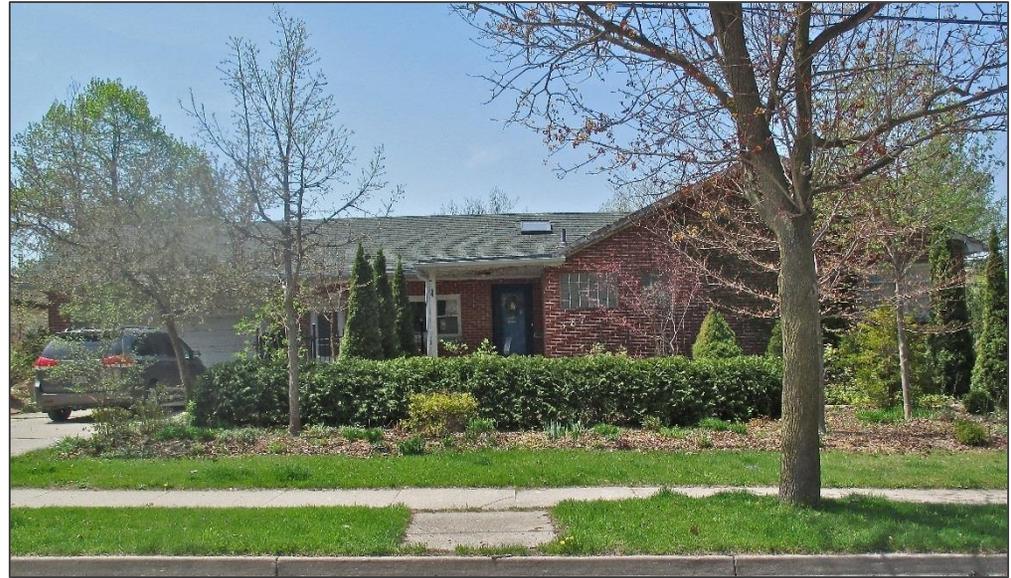
The house at 387 St. George Street is a one storey red brick house with attached garage. The layout is a “T” shape. This house has a low gable roof across each section of the “T”. The front door is in the junction of the “T” in approximately the centre of the front elevation of the house. The front door is in a small porch with a flat roof, supported by a square column. The garage is part of the house at the south end of the building; it is a 1 ½ car garage with the opening on the front of the house. This house has a second person door on the front of the house next to the garage door. Between the front door and secondary door the house has a long horizontally oriented window with 1 over 1 sash sidelights.

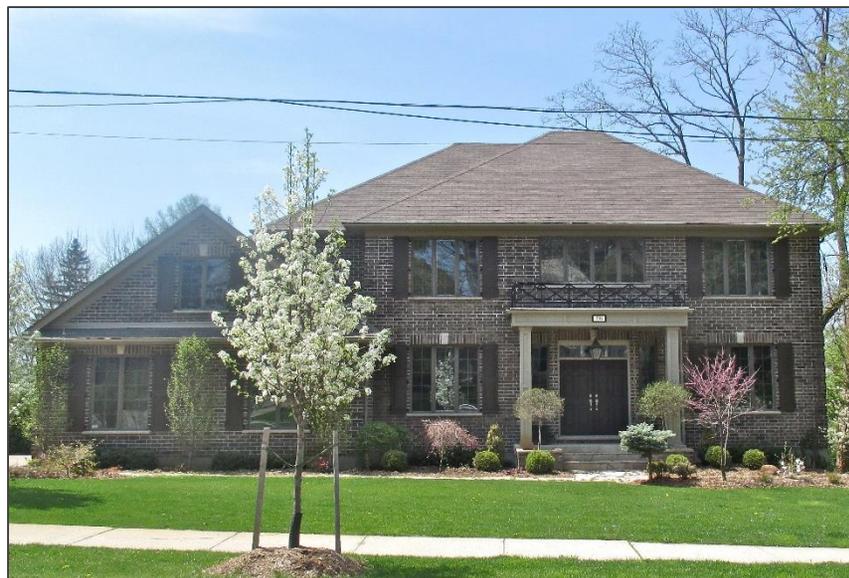
The house on 391 St. George Street is a two storey dark brown brick house with one and a half storey attached double garage. The house has a rectangular layout but the garage, accessed from the south side projects in front of the house.

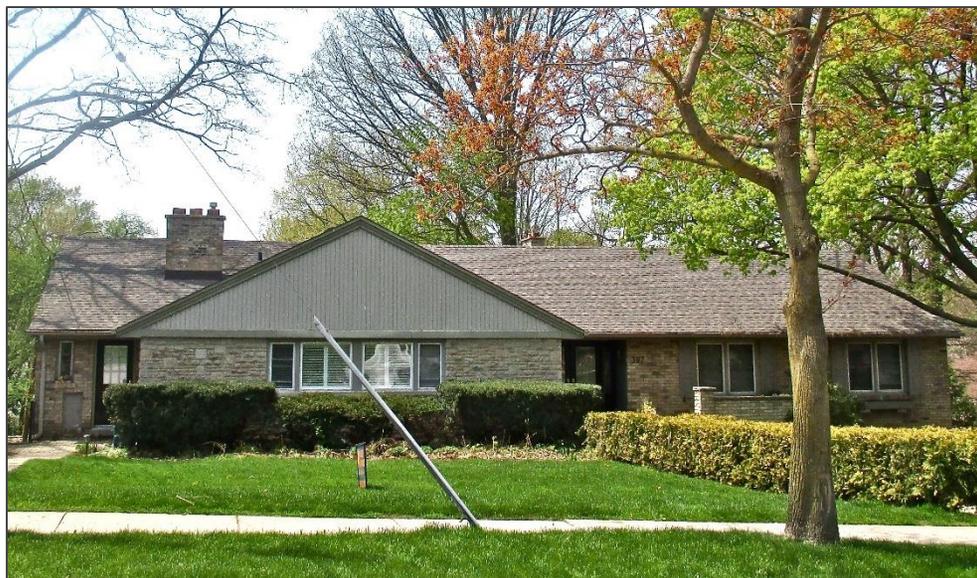
The house at 397 St. George Street has a small narrow window near the south end of the front elevation. A long horizontally oriented window opening on the front of the front wing holds four windows separated by mullions, the end windows are narrow and the central two are nearly square. The north half of the house holds two sets of double casemate windows with decorative shutters and window boxes.

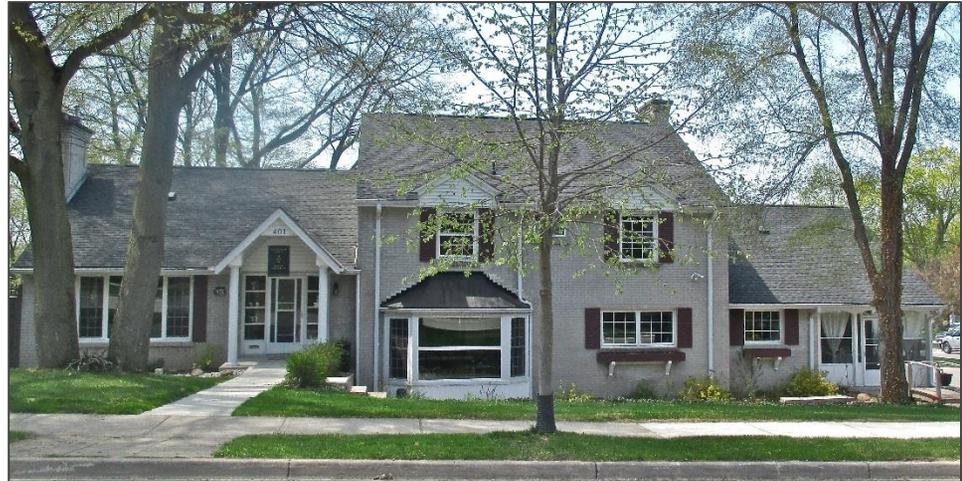
401 St. George Street is a corner property on the southwest corner St. George Street and Victoria Street. The property has a slight slope. The house at 401 St. George Street has been built accommodating the landscape. This house appears to be three separate sections. The southern section is a one storey piece; the central section is a two storey piece with a single storey wing on the back and the northern section is a one and a half storey piece that holds a double car garage accessed off Victoria Street. The house is a long rectangle with the wing out the back of the central portion. This house is clad in grey brick and has a side gable roof over each section.

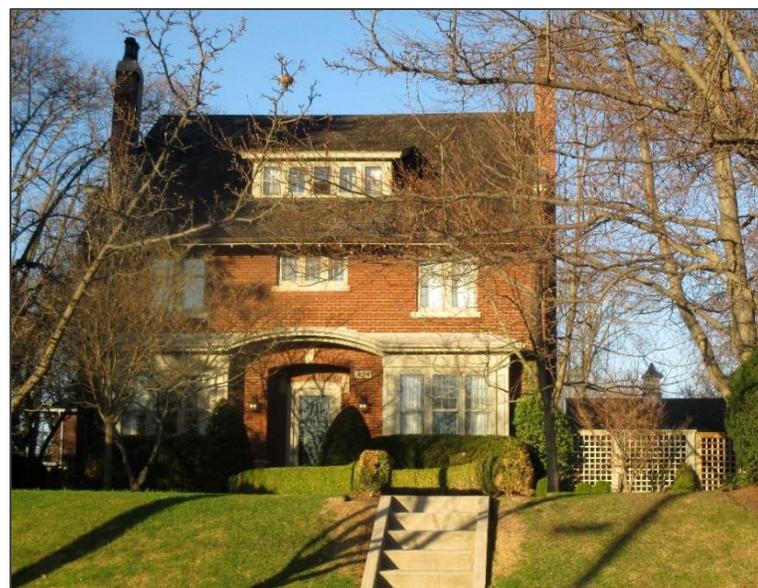
This sturdy, two storey, red brick Colonial Revival house stands on a height well above the road, with its yard sloped abruptly just east of the public sidewalk. This landscape feature, along with the tall gable roof, with taller chimneys to each side and side walls that end in parapets at the corners, accentuates the building's height. The house has a symmetrical plan, with oriented around the centre door. The two lower-storey bays are wood-framed and shallow, and are connected by an integrated semi-elliptical arch to a small porch in which the door is recessed. The shape of the porch repeats the arch in brick voussoirs, with a stone keystone, while the curve is further repeated in the shape of the panelled front door, the wood storm door, and the row of stretchers over the door. Columns of brick stretchers also frame the door, with stone corner blocks at their intersections with the arch. A row of three 9/1 sash windows is set within each square bay, while paired sash windows above, on the second storey, have 6 panes in the upper member and a long single pane below. In the row of three windows in the shallow complex over the front door, each separate window features a design of nine panes, those in the middle row substantially longer. A long shed-roofed central dormer contains a row of five windows, alternating sashes with solid windows, all with a two smaller panes along the top.

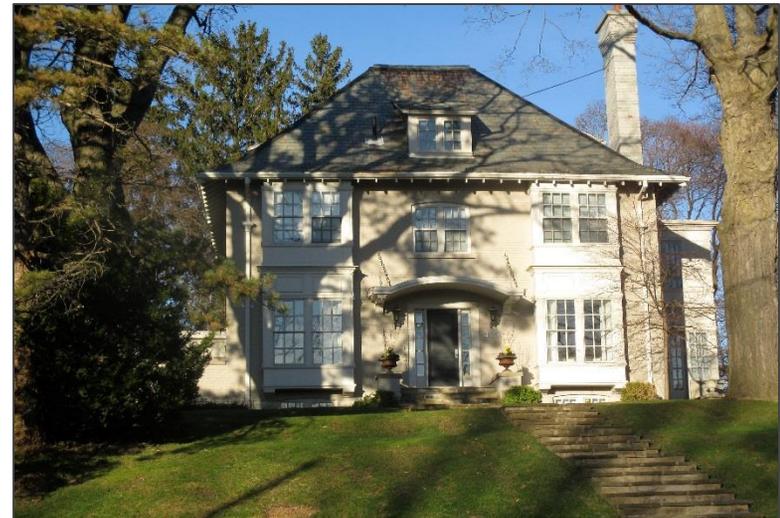
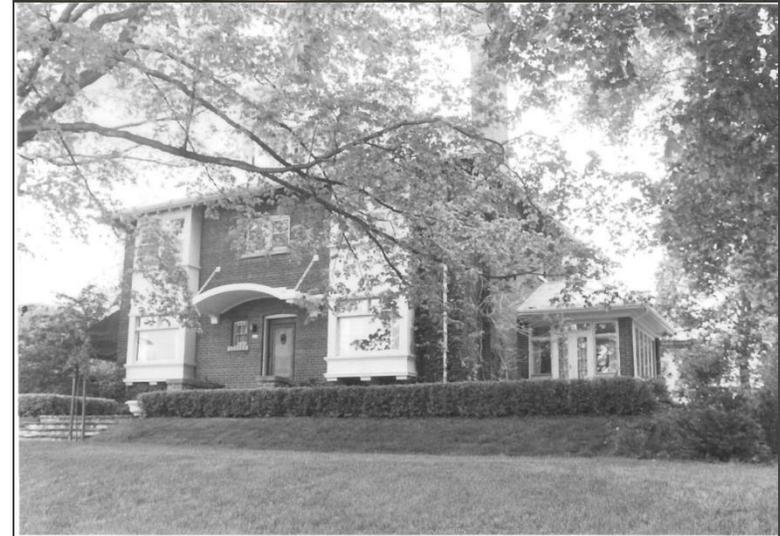
As built, this tall, two storey house was faced in unpainted red brick, and possessed many of the features it still possesses: a high, hipped roof that flares slightly over deeply overhanging eaves, decorated on all sides with ornamental purlins; shed-roofed dormers on all sides of the roof; two-storey oriel windows, shallow, rectangular, wooden projections supported by bulky, Craftsman-style brackets and decorated with panelling, dentil mouldings, and pilasters; and an arched hood that hangs over the front entranceway and is supported both by chains fastened to the wall above and by thick, shallow brackets. While retaining these definitive features, the exterior changes that comprised part of the Ivey's million-dollar renovation substituted references to the Georgian Revival for some of the building's period and Arts-and-Crafts features. The red brick was painted, thus blurring the distinction between the different materials comprising the facade. The front door complex, consisting of an off-centre wood door with a diamond-shaped glass insert and a small window to its north, was replaced by a centred, solid wood door with sidelights. The shallow set of segmental-arched windows above the hanging arch gave way to longer 6/6 sash windows, shorter versions of those that replaced older window shapes around the house. The windows of the former one-storey sun-room on the south side of the house were also replaced with new, wood-framed windows, and its flared hipped roof, which mirrored that of the building's main roof, was replaced by a second storey. The tall, corbelled brick chimney along the south wall, remained, albeit painted.

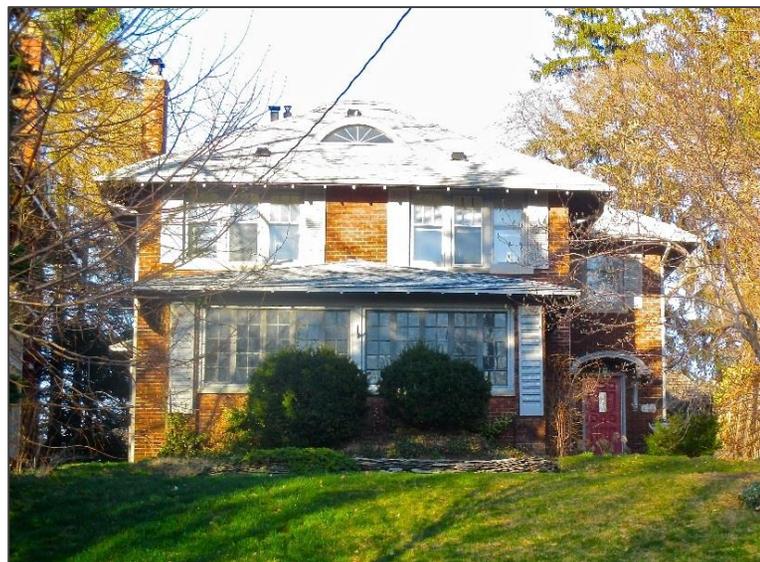
The top of an escarpment is gradually moving eastward here, the houses along the east side of St. George Street are located on top of a rise that descends towards the street and sometimes, as here, towards the north. At 434 St. George Street, steps rise along the southern border of the property towards the main entrance. A relatively new two-car garage at the back of the property is accessed from the laneway that runs behind the house.

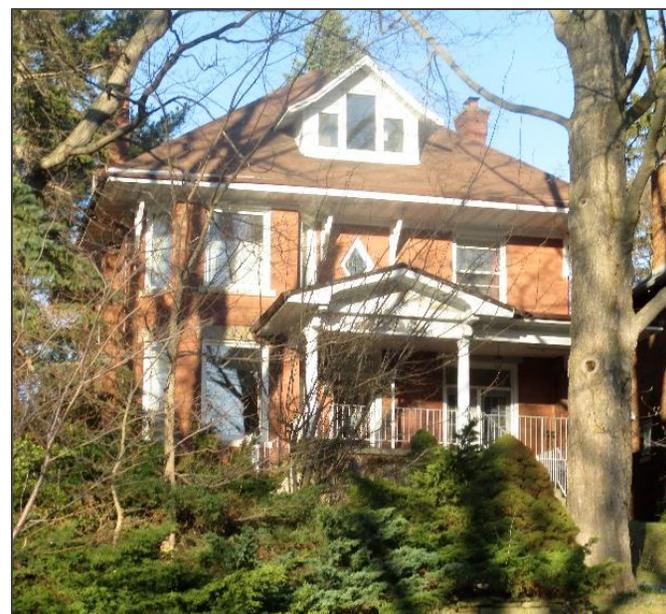
Because the top of an escarpment above the river flats is gradually moving eastward here, the houses along the east side of St. George Street are located on top of a rise that descends towards the street and sometimes, as here, towards the north. Off the laneway at the back of this house a two-car garage is part of a neat, flat-roofed, stuccoed structure, now featuring regularly spaced 6/6 sash windows with segmental arches, that appears to have been designed for a different purpose.

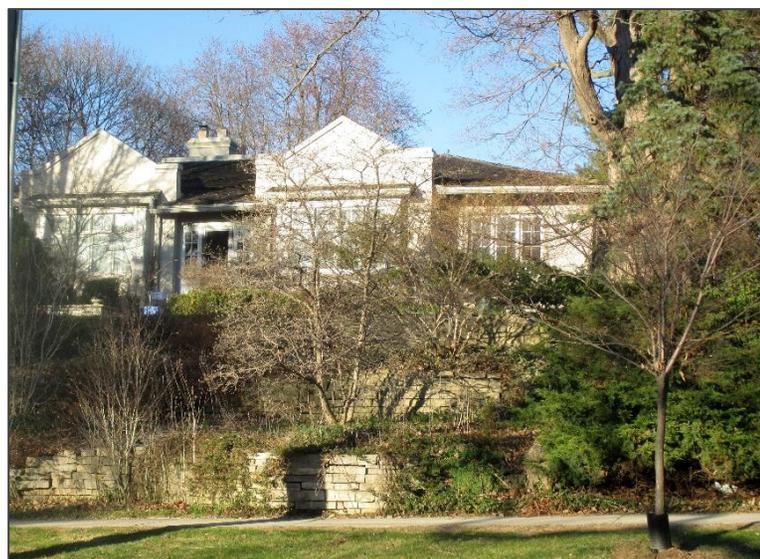
This one storey, stuccoed house, very unusual in a London context, employs a design strongly influenced by southwestern United States architecture. Its square floor plan is built around an atrium, lit by skylights that originally contained an ornamental pool. Wide window complexes around the building are designed to let in light and, in the right temperatures, to circulate air. The two gable-shaped crests in the front of the house reflect the geometrical shapes of southwestern designs. The house has a shallow hipped roof (possibly a concession to a northern climate). Its facade, especially when seen from the street some distance below, is dominated by the two crests, topping parapet walls; each wall displays a shallow rectangular bay window with a shed roof and a row of four long windows. The front entranceway between these walls comprises a solid panelled wood door with small-paned sidelights on either side. At the far ends of the symmetrical facade are rows of three small-paned windows.

Because the top of an escarpment above the river flats is gradually moving eastward here, the houses along the east side of St. George Street are located on top of a rise that descends towards the street. This house sits well above the street and sidewalk level, at the top of what are now a series of carefully landscaped terraces. Along the Victoria Street side of the house the street rises, so that the back of the property is approaching street level. A rear laneway provides access to a two-car garage, designed with a parapet gable that closely matches those on the facade of the house.

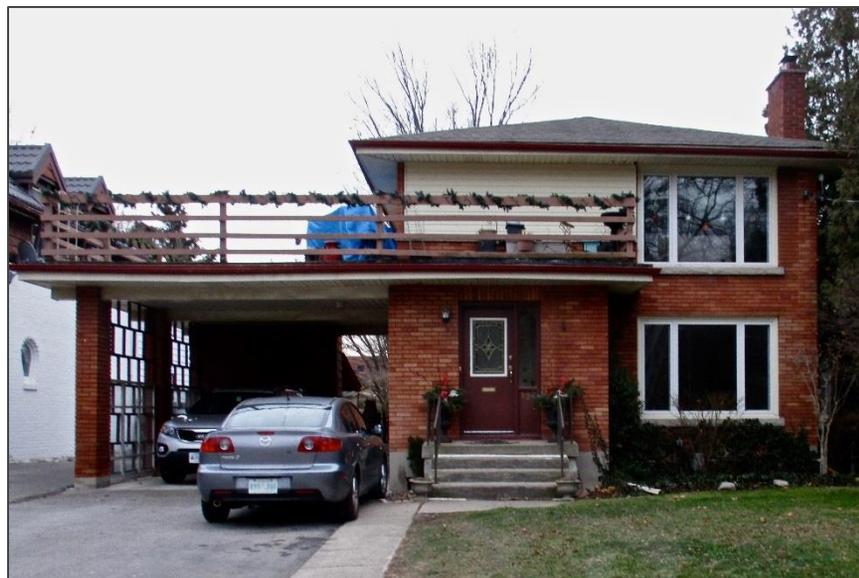
This building follows a pattern common among duplexes built in London during the 1950s and early 1960s. It is two storeys high (with an apartment on each floor), and it has a brick veneer facing, a shallow hipped roof, and a rectangular footprint. Here, the rug brick ranges in colour from pale yellow through various shades of orange to red. A wide three-light window, with a rusticated concrete sill, is found on both storeys, while a vinyl panel now covering the eastern half of the upper storey appears to cover an additional window there. A panelled front door, with a stained glass insert and a stained glass sidelight, presumably provides access to both apartments. A distinctive feature of this duplex is the carport, wide enough to house two cars; three heavy east/west beams, are supported by and appear to extend through three thick brick piers on the east side of the carport. An oversized wood lattice, outlining large square spaces, now fills the spaces between the piers on the east wall, and a thick wall now covered with bevelled boards extends across most of the back of the carport. The flat carport roof, which extends over the protruding front entranceway, is now surrounded by a fence of narrow horizontal boards and appears to serve as outdoor space for the second-floor apartment. The front door is approached by concrete steps, between wrought iron rails, and a concrete stoup. The building has a poured concrete foundation.

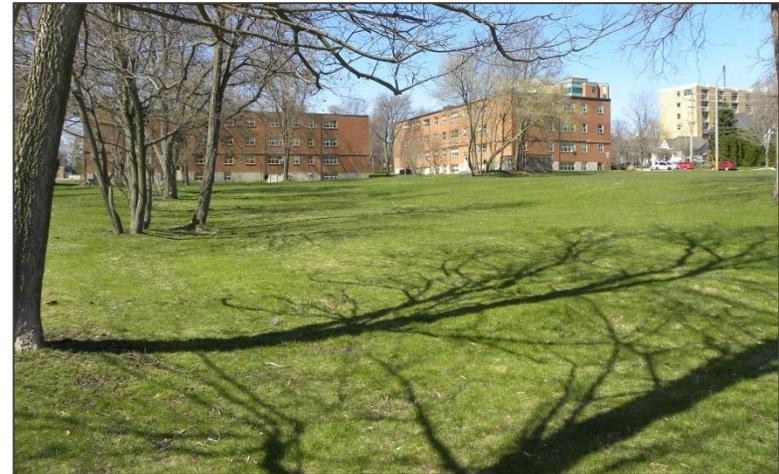
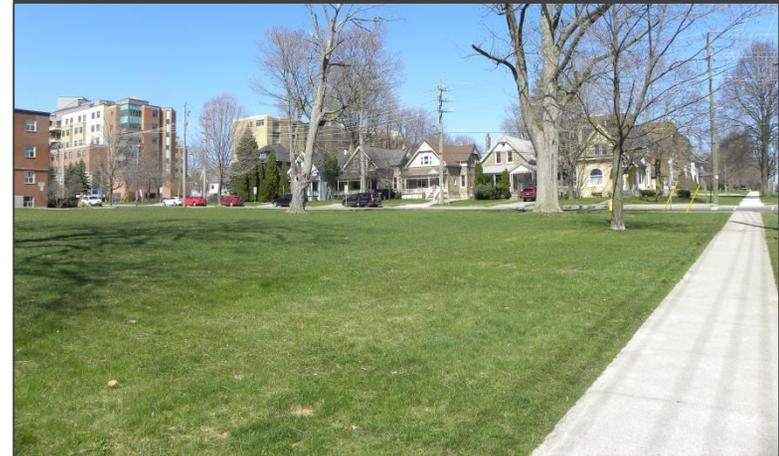
124, 140 and 150 St. James Street are a single piece of property. This parcel consists of mature trees and expanses of grass. A parking lot/driveway extends from St. James Street into the back of the Grosvenor Gate Apartments complex. The driveway entrance passes between three redbrick gateposts, two on the west side of the drive and one on the east. Several trees on the property are growing in rows and may mark property lines from the past.

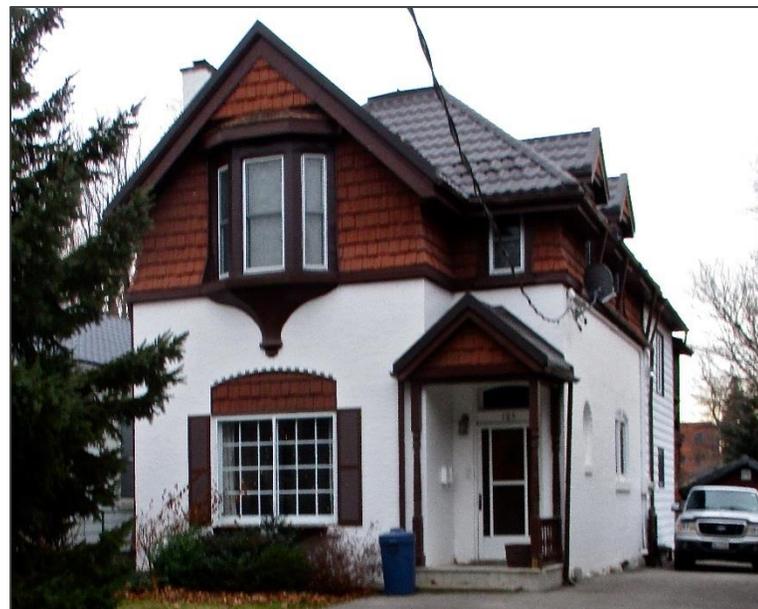
The use of some substantial new materials and treatments have nevertheless given the house an appearance that in some ways betrays its late Victorian origins. Large wood shingles in the gable replace what were undoubtedly smaller decorative wood shingles. The large, somewhat rough shingles have also been used to fill in a segmental-arched area above the present vinyl windows main-floor windows -- an area that once would have held a stained or leaded glass transom. Brackets at the tops of the wood divisions between the oriel windows seem to have been cut off at the top. The brick walls have been painted white. The gable roof over the relatively small front porch is now supported by very slim turned posts. A vinyl-clad addition extends the house to the back.

streetscape, many quite modest, resemble this one in having been significantly altered. Unlike most blocks within the study area, this one has no interior laneways, so that all homes, like this one, must have driveways leading from the street. Here, a drive along the west side of the house leads to a one-storey garage at its rear.

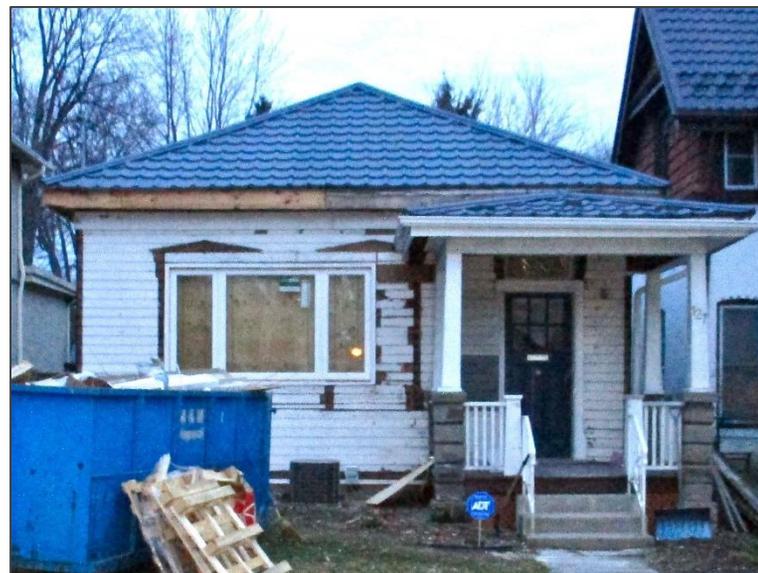
This was originally a relatively simple and modest one-storey, side-hall plan Victorian cottage that was perhaps somewhat passé at the time it was built. The photograph shown above, however, was taken in March 2016 when the cottage was in the course of renovations that seemed aimed at removing the most compelling exterior heritage attributes of the building. One can see where two eared, pedimented wooden window frames have been removed and replaced by a three-light vinyl window. Similar shadows appear where vinyl windows have replaced the originals on the sides of the building. That the wood corner boards have been removed suggests that the original tongue-and-groove wood siding. The shape of the house, with its hipped roof and cuboid shape remain, as does the front porch and entranceway, most of which appears to date from around 1915. The porch also has a hipped roof, supported by tapered wood posts sitting on a column of concrete blocks, each bevelled at the top. Spindles with square profiles fill the space between the porch rails. The front door features the vertical panels and six small window panes found on the doors of c. 1915 houses in the study area, but the frame and transom above are original.

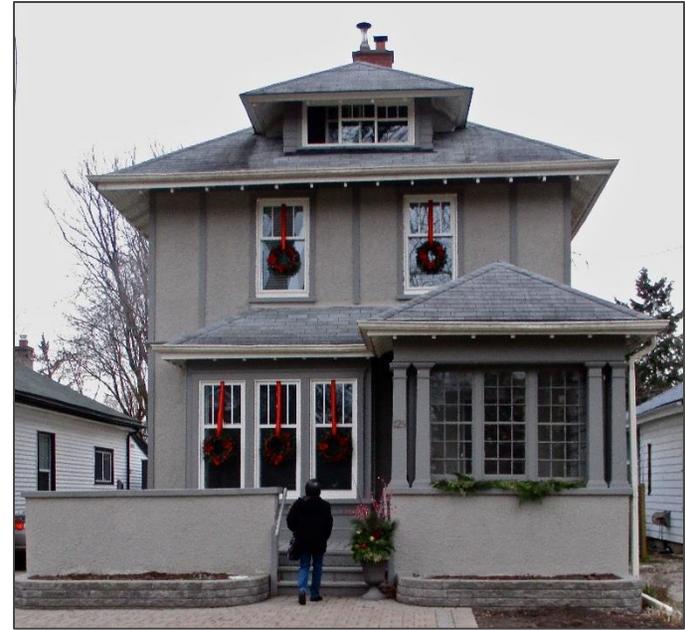
The strong vertical lines of this Craftsman façade, caused by the three evenly-spaced timbers and by the frames of the sash windows on the upper storey, the muntin bars and the proportionally narrow windows in the first-floor bay, the paired pilasters of the front porch, and even the relatively narrow dimensions of the façade, are an unusual feature in a Craftsman-style house, which more often displays the largely horizontal lines of the Prairie style. The half-timbering of the second storey, along both the front facade and the highly visible east side, consists exclusively of vertical members. The 4/1 sash windows have vertical muntins dividing the upper members. Paired square pilasters hold up each corner of the porch on the west half of the facade. A brick chimney rises just behind the peak of the hipped roof. And the house itself is relatively narrow. Certainly there are some strong horizontal lines that partially counter this verticality, but they work to stabilize it rather than to balance it: the broad, overhanging eaves (lined with ornamental purlins) found on both the main hipped roof of the house, the hipped roof of the dormer, and the ground-floor hipped roofs of both the

rectangular bay and the front porch; and, now, the concrete wall that effectively extends the porch wall in front of the east half of the house and even beyond. The west and north sides of the porch have been filled in with small-paned windows that provide protection for the fine, solid wood front door, with four panes of beveled glass towards its top. On the long east side of the house features, the plain stucco finish of the ground floor is more obvious, as it is now broken only by a two-storey, rectangular bay window about half-way down its length and a smaller, one-storey bay window beyond. The house has a rusticated concrete block foundation.

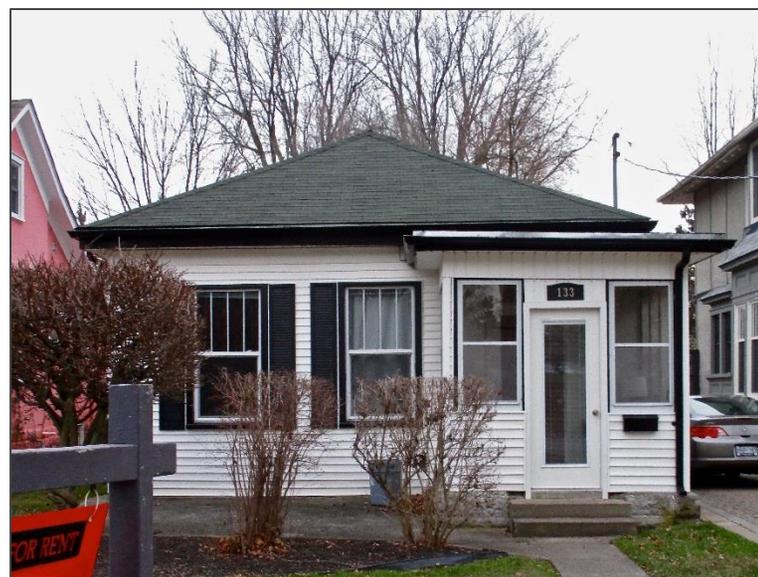
This one storey, side-hall plan cottage probably once looked much like that at 127 St. James Street, before the renovations to the latter. It has a similar hipped roof, cuboid shape, and very similar dimensions. Its original siding has now been covered in vinyl and, while two front windows occupy spaces typical of the form, the original window frames have been replaced by sash windows with slim vinyl frames and decorative shutters. A storm porch, also clad in vinyl, now extends across the original entryway. Its facade contains two sash windows, with a narrow door fitted between them. The porch has a flat roof and a rusticated concrete block foundation. The main block of the house now appears to have a poured concrete foundation.

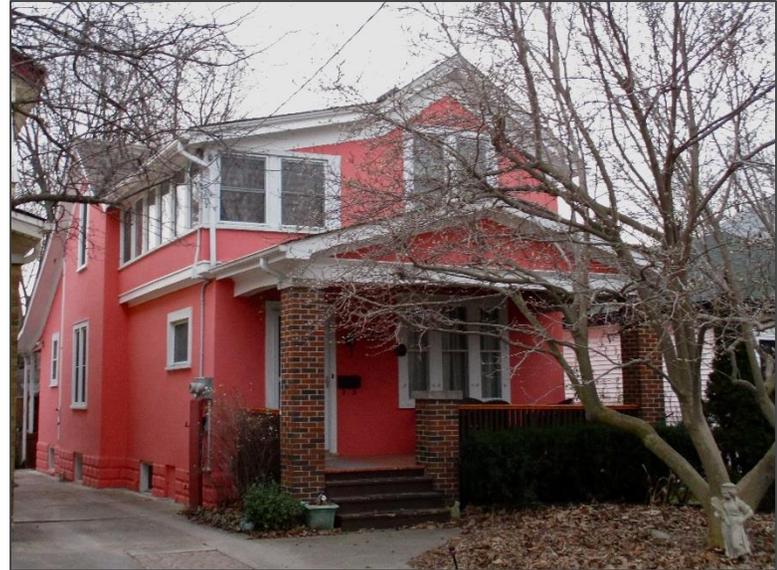
Beneath the flamingo stucco now covering this two-storey house one can still discern the outlines of a Queen Anne Revival building with front and side gables that likely protruded from what were once the general planes of the building's walls. The home's original massing has been largely hidden beneath a complex set of only vaguely discernible additions, all now combined and unified by the stucco cladding, a deep plain cornice that runs around the entire house except where crowded out by windows too close to the eaves, and the bright paint that envelops even the rusticated concrete block foundation. Bright white paint allows the cornice and other wood trim to stand out, revealing some wood window surrounds that may have been part of the original house; these entablatures are very plain, with a robust rounded moulding along the top edge of the lintel. They are found, for example, around the paired and three-light windows beneath the front gable, on the upper and lower floors respectively, and also around the single and paired sash windows under the east and west gables. The porch was added, probably in the second or third decades of the twentieth century, after some additions had already been made to the shape of the facade. It features a shallow gable roof, supported by substantial, square piers, made of rug brick in colours ranging from orange-red to black and now surrounded by a railing featuring closely placed square spindles that reach below the porch floor to the ground.

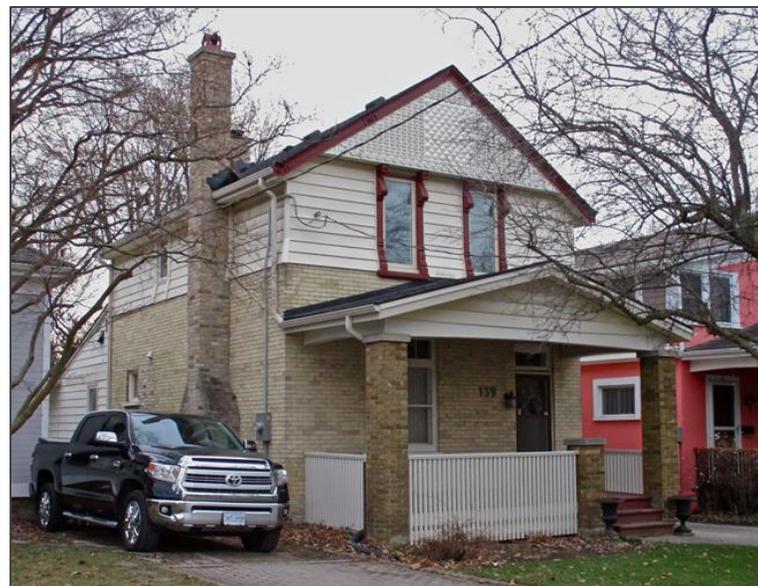
Although this house has been altered in several ways, it retains much of its original character. Its simple cuboid shape was surmounted by a gable roof, with the gable extending across the front of the house. It features a remarkably deep and broad apex board, filled with decorative woodwork of an unusually repetitive character: rows and columns of roundels, in different sizes, are tucked between vertical and horizontal applied strips of wood, while a large square patch at the centre features three-dimensional diamond shapes. This protruding board is supported by inverted console brackets on the jambs of the two windows immediately beneath it; these jambs are interesting, too, for the way in which thick mouldings transition between flat plane of the gable through the flared surface above the brick wall of the house. This surface, between the apex board and intersection some distance beneath the eaves, of the brick wall, is now covered with bevelled wood boards, which likely replace or obscure decorative wood shingles. The brick that forms the walls of the house is that of a buff colour (technically white), made from local clay. The building also retains the original window surround and entranceway of its ground-floor facade: the large window with a transom above, a stained glass transom above the front door, and a distinctive wood door displaying rows of three square fielded panels with fine bevelled mouldings around the outer edges with a robust moulding also surrounding a pressed glass insert. Tall brick chimneys now rise along the east side of the house and the back wall. There is a substantial addition, with a shed roof, at the back of the building. The front porch is also an addition to the original house, probably built in the second or third decade of the twentieth century, and strongly resembling that next door, at 137 St. James Street. It has a shallow gable roof supported by substantial brick posts, here made of rug brick in shades of tan and brown, with railings now formed of closely placed square spindles that reach to the ground.

St. James Street has relatively deep boulevards and houses have a comfortable setback beyond the sidewalks. This house is approximately 2 metres from the front property line and 17.5 metres from the edge of the street. Many of the homes within this streetscape resemble this one in having been significantly altered. Unlike most blocks within the study area, this one has no interior laneways, so that all homes must have driveways leading from the street. Here, what appears to be a shared driveway fills the space between this house and that to the west, at 137 St. James Street.

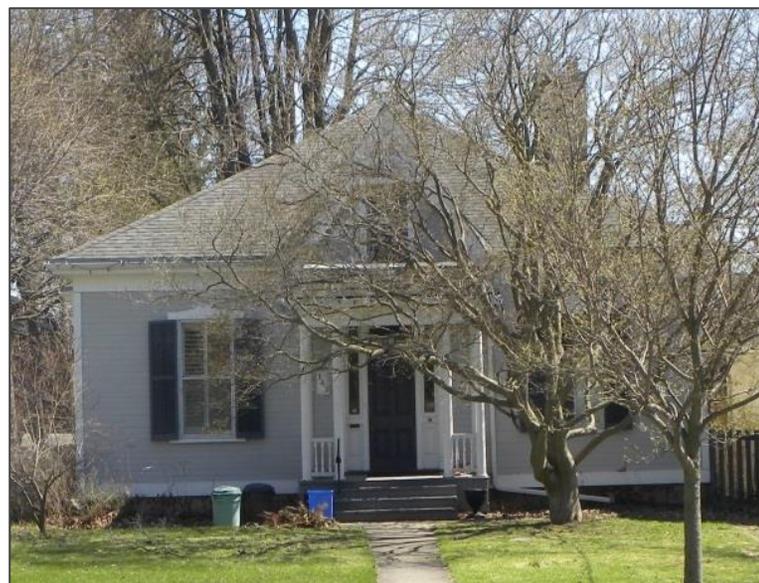
The house is designed as a single storey, three bay, Ontario cottage with a hipped roof, and centrally located peak raised over the front door. The front entrance includes a covered porch supported by white wood posts, and short white balustrades. The front door consists of a wood, four panel door flanked by symmetrical sidelights and a transom. Singular wood sash windows, including shutters are located on either side of the front entrance. The house is clad with wood siding, and includes a plain white cornice that wraps around the top of roofline. The central gable is accented with a gable window, and decorative wood scalloping, bargeboard, and finial.

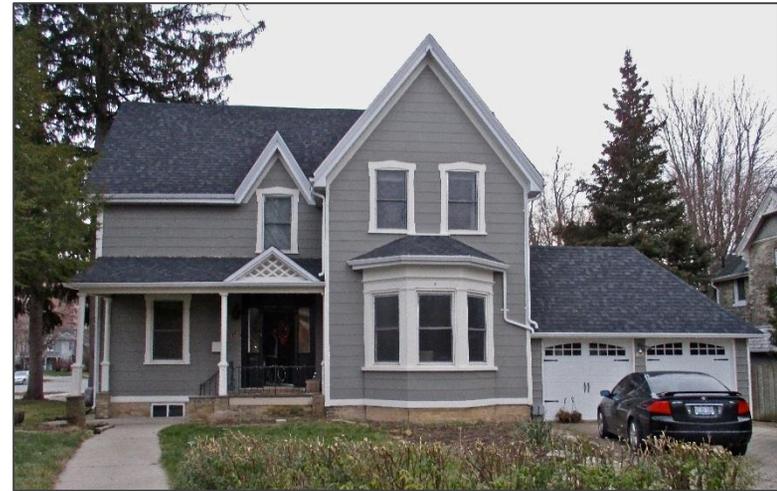
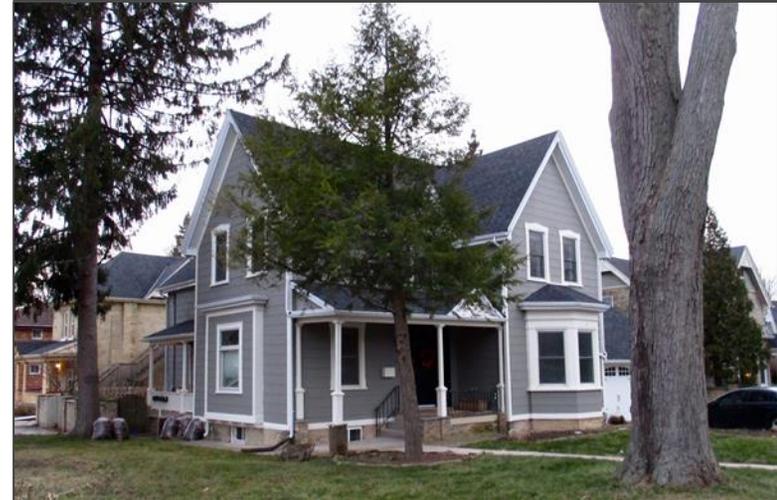
One of the more substantial homes in its block, the two-storey house at 159 St. James Street is an architectural anomaly for the area. Its form is like that of a farmhouse, with an L-shaped main block, a gable over the protruding foot of the ell and a longer stem displaying a verandah along its length, and a smaller gable over the front door. The eared window surrounds, featuring a pediment-shaped lintel, are a feature usually found on houses of around the 1860s in London, though the form did survive longer in more modest vernacular homes. This house has been acclimated to its suburban setting in several ways. The 1 and 1/2-storey rear wing extends along St. George Street, with a verandah along its length, so that the house has what seems to be a second L-shaped facade, making effective use of its corner location. It also has a

number of features that originate in later styles, making it a kind of sampler of historical motifs. Both protruding gable wings feature protruding first-storey window complexes: the bay window facing St. James Street shows three faces of an implied octagon, a form popular with the Italianate homes of the 1870s and early 1800s, while the eastern oriel window is rectangular in shape and holds a sash window with a stained glass window with a stained glass member in its upper section, a form contemporary with the date of the house. Both of these windows are now unusually simple in their surrounding ornamentation, allowing them to blend with the

relatively plain qualities of the earlier forms. In the bay facing St. James Street, a line of robust mouldings separates the otherwise unadorned architrave and frieze above the 1/1 sash windows; mouldings also form a hint of a capital at the top of otherwise plain pilasters separating the windows. Both verandahs have shed roofs; that of the front verandah features a pediment-shaped cross gable with diamond-shaped ornamentation. Both verandah roofs are supported by narrow round posts. In front, there have been substantial changes to the one-time verandah: the original floor has been cut out, so that the corner post now sits on a brick plinth while steps with metal railings lead up to a stoup in front of the main door. The impressive entranceway comprises a solid wood door, surrounded by glass sidelights and transom. The side verandah displays a full floor and turned spindles. The house is clad in what appear to be asbestos shingles; the foundation is formed of local, buff-coloured bricks. A hipped-roof, two-car garage has been attached to the west side of the building; doors featuring long metal hinges and segmental-arched small-paned windows reflect an attempt to make it blend with the historic house.

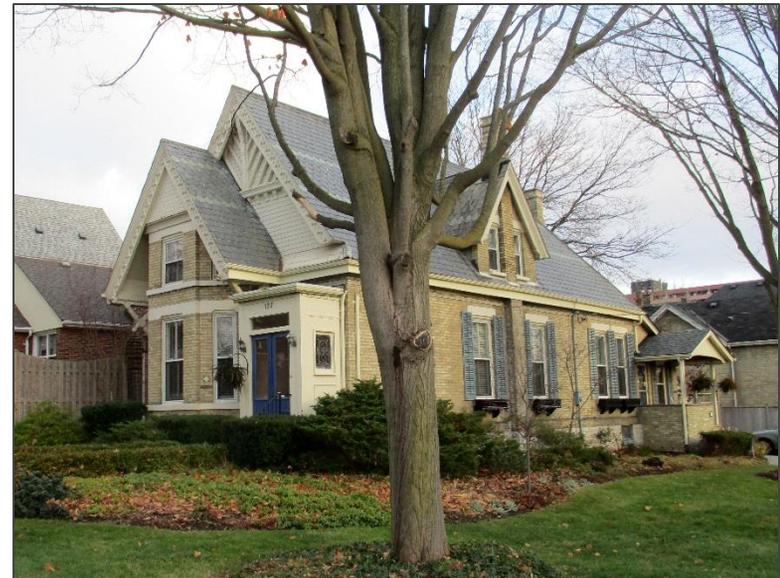
Most of the many 1-and-1/2-storey, brick cottages in London show Queen Anne Revival influence, but this one is unique in its elegant application of the style's motifs. The cottage has a steep gable roof, clad with grey slate tiles, and it features a double gable, facing St. James Street and dormers, with brick walls, to both the east and west. Most tiles are rectangular, but eight courses of

The few changes to the building comprise the demolition of a one-time wood extension at the back of the house and its replacement with a smaller brick addition, from which extend a railed deck and a stairway; a small stained glass window along the west side and towards the north facade; and a storm porch that covers the original front door, with its moulded panels in various shapes and two narrow stenciled glass inserts.

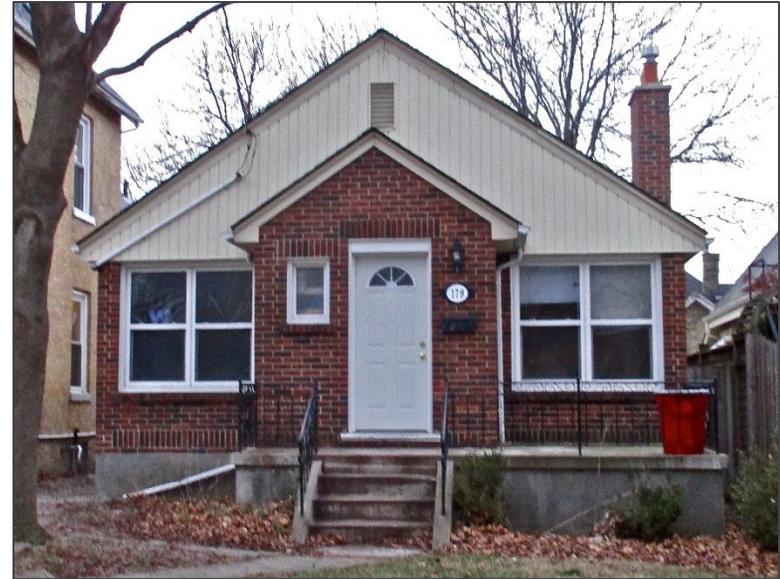
This one storey house has a gable roof, with the gable facing the street. The facade is generally symmetrical: a protruding centre storm porch with a gable roof that matches the slope of the house roof. The front door is slightly skewed from centre to accommodate a small window to the east and a light fixture (which may be original to the house) on the west side. Broad windows (now vinyl-framed pairs of 1/1 sash windows) fill the facade on both sides of the vestibule. The first storey is clad in rug brick with hues ranging from red to black, giving an overall impression of red, with soldier courses along the foundation and over both the front door and the adjacent window. Window sills are made of brick headers. The facade has now been covered with vinyl cladding arranged to imitate vertical boards, with a vent over the peak of the vestibule roof. The house has a concrete foundation and a tall brick chimney along the west side of the house.

St. James Street has relatively deep boulevards and houses have a comfortable setback beyond the sidewalks. This house is approximately 3.25 metres from the front property line and approximately 18.25 metres from the edge of the street. A laneway runs behind this house, and parking spaces for this house can be accessed from the lane.
