St George-Grosvenor Heritage Conservation District Study

Volume IV Appendix F, [2016]

APPENDIX F: INVENTORY OF CULTURAL HERITAGE RESOURCES

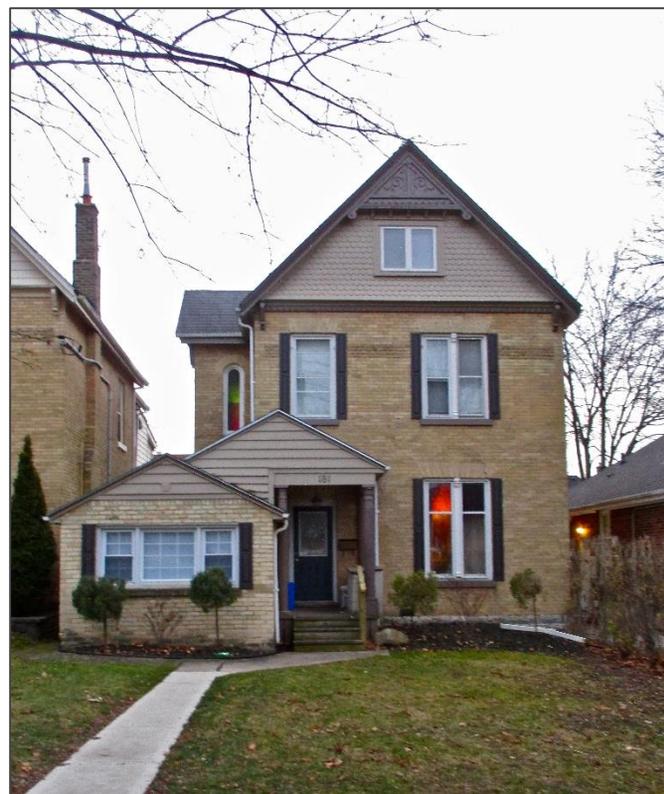
The house at 181 St. James Street retains its original ornamented wood gable. Its protruding apex board features a delicate pierced design within the outline of a strut design. It is supported by a row of brackets, just above small, paired, sash windows now surrounded by a plain frame. The rest of the gable is covered by scalloped wood shingles, while single rows of a square, pyramidal motif line both the bottom of the apex board and the lower lip of the gable. Large brackets at the lower corners of the gable appear support its outer edges. The facade features three window complexes, all of somewhat different sizes: a single 1/1 window; paired, narrower 1/1 sashes; and a set of longer, paired sash windows with much shallower upper members. The wood, panelled front door

now has a pressed glass, metal design inserted in its top section, and stylized columns of a relatively recent vintage are found on three corners of the front porch. A short one-storey, gable-roofed addition now extends from the northeast corner of the house. It is faced with recycled bricks that attempt to match those of the main house and features a three-light window with small panes. The front porch has been broadened to allow access to this addition; its gable roof echoes that of the addition, and the gables of both roof and addition are at least partially covered with clapboard siding.

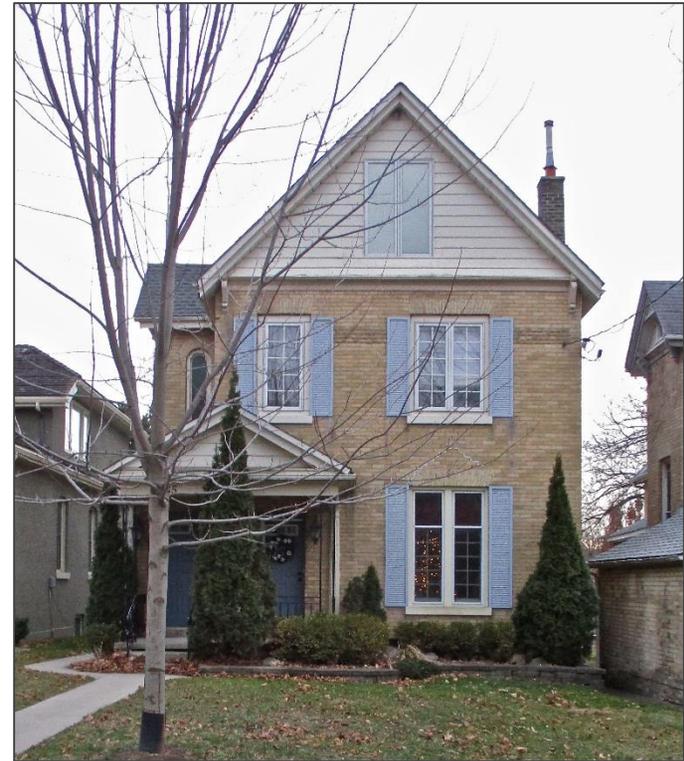
The gable at 185 St. James Street has been re-clad in vinyl siding, and the original small window complex has been replaced with large paired windows. In the brick facade below, the window apertures retain their original sizes and surrounds (see Inventory sheet for 191 St. James Street), but the windows themselves have been replaced by new vinyl substitutes with applied rails and muntins defining small panes. Decorative shutters have been added. The front porch has been broadened to accommodate an additional front door just east of the original. Both doors are wood, with glass inserts near the top. The porch has a gable roof, the gable faced with vinyl cladding, mainly supported by wrought iron posts with iron railings; what appears to be an original fluted Doric pilaster

remains up against the house just west of the door. The additional door testifies to the building's division into a two living units. The house retains the tall brick chimney rising along its western wall.

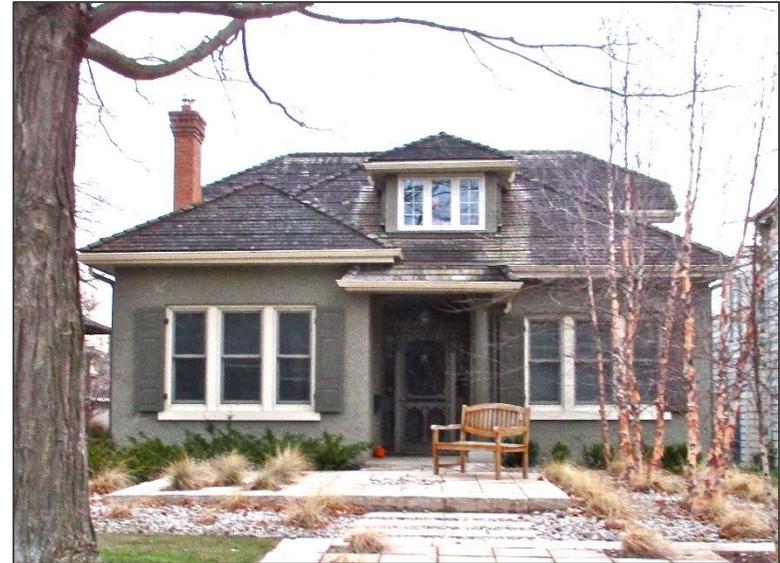
The Fire Insurance Plan corrected to 1907 shows one-storey brick cottages of the same size at 189 and 191 St. James Street, and they seem to have the same dimensions as the cottage at 191 St. James Street now possesses. The underlying form of an Ontario cottage is still discernible in both cottages: common to both is a rectangular footprint, a hipped roof, an entranceway with sidelights (above a panelled wood base) and segmental-arched transom. Both Victorian cottages have undergone some changes, however, that, except for the underlying Ontario Cottage form, make them appear to be considerably later. Several additions have been made to this house, additions which are now blended together by the stucco covering and, at the roofline, by wood shingles. The main additions visible from the front include an approximately square protruding bay on the east part of the facade, with its own hipped roof; a hipped-roof dormer slightly west of centre in the front slope of the roof; and, the half-hipped roof of a large rear (vinyl clad) extension. New windows have replaced the old on the facade, but the impression of symmetry basic to the Ontario Cottage form is to some extent maintained by the positioning of a row of three 1/1 sash windows west of the door and an identical row on the facade of the protruding east wing. Windows have wood sills. The porch in front of the centre door has a flat roof with a hipped border and is supported by the wall of the protruding wing and a substantial column in the northwest corner. The house retains its original bay window on the east side, which features, narrow 1/1 sash windows on three of the octagonal walls, and its original front entranceway. The orange-red, corbelled chimney along the east wall bay may also be original to the 1890s cottage.

The overall impression of the house now is of a certain jaggedness combined with strong, if broken, horizontal lines. An imaginative landscaping of the front garden, using stone slabs and pebbles in geometric formations, on different levels, captures that quality. While the design is somewhat hard and formal, the introduction of a bench and a swing hanging from a large tree in the yard counters with suggestions of play and hospitality. St. James Street has relatively deep boulevards and the landscaping here makes effective use of the comfortable setback beyond the sidewalks. This house is approximately 3 metres from its front property line and approximately 18 metres from the edge of the street. What appears to be a shared driveway, composed of paving stones, runs between 189 and 191 St. James Street to a two-car garage at the back, but both residences also now have separate two-car garages accessible from the laneway that runs along the rear lane. That at 189 St. James Street is a relatively new board-and-batten building, which, along with a high wood plank and trellis fence, provides privacy to the back yard.

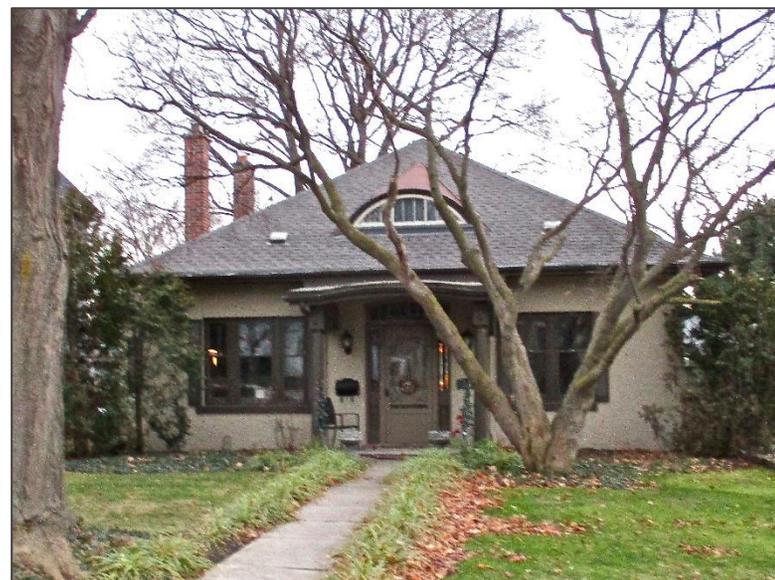
The Fire Insurance Plan corrected to 1907 shows one-storey brick cottages of the same size at 189 and 191 St. James Street, and they appear to have the same dimensions as the cottage at 191 St. James Street now possesses, although the insurance plan shows a bay window along the east side of this house that is no longer there. The Victorian cottage has undergone some changes, however, that, except for the underlying Ontario Cottage form, make it appear to date from around the second quarter of the twentieth century. The house is now covered with stucco, has asymmetrical window complexes on each side of the front door (a Venetian window with 3/1 or 2/1 sashes on the east and paired 3/1 sashes on the west), and also displays rows of grouped windows along the east side of the building. The front porch over the centre door features a shallow, curved roof supported by Doric columns. A round-arched half window, divided into several vertical panes, is positioned in the roof above the porch and is covered with a unique, long, metal funnel roof that comes to a point near the peak of the cottage's hipped roof. The front entranceway features sidelights over panelled bases and a small-paned transom surmounted by a segmental arch. Along with the hipped roof and the home's dimensions, this entranceway is likely among the original features of the cottage. A sunroom with grouped sash windows on all sides now protrudes from the east wall, and tall chimneys rise to each side of it. Substantial additions have also been made to the back of the house.

St. James Street has relatively deep boulevards and houses have a comfortable setback beyond the sidewalks. This house is approximately 4 metres from its front property line and approximately 18 metres from the edge of the street. Here, mature trees add to the ambience of the front garden. What appears to be a shared driveway, composed of paving stones, runs between 189 and 191 St. James Street to a two-car garage at the back, but both residences also have separate two-car garages accessible from the laneway that runs along the rear lane.

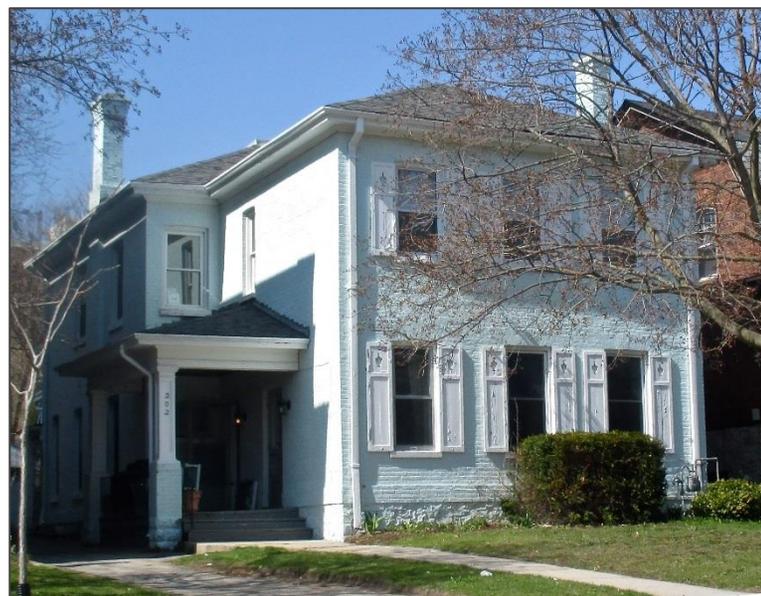
One wonders if in fact the front and back sections of the house were built at different times, well before the O. Roy Moore and Co. renovations of 1942. While the front part of the house has a now paraged fieldstone foundation, the back section has a foundation of brick, though the raised water table links both. The voussoirs of the windows in the back part of the house are arranged in a shallow curve while those at the front are insistently flat. The rear section has a hipped roof terminating in a flat deck; that at the front also a hipped roof, with a long ridge line that intersects the back roof. It is tempting to suspect that Oliver McClary opted for a larger home quite early in the building's career.

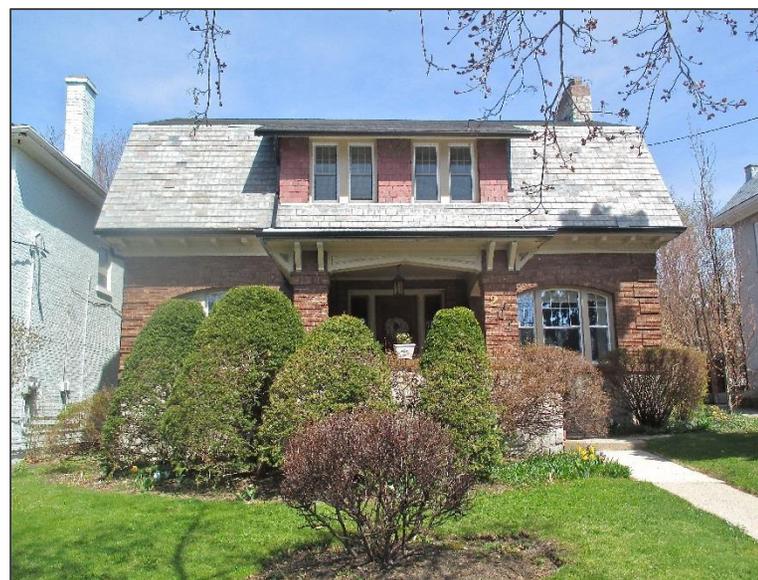
Oliver Roy Moore bought Lot 24, just to the north of his then deceased father-in-law's land, soon to be in the possession of his brother-in-law's wife, in 1913. It had been occupied by one Frank McGrory, but during the next two years, a new house was built there for O. Roy. Although the building was officially designed by J.M. Moore, Architect, it is difficult to know exactly what member of the firm may have produced the unusual and sophisticated plans for this house (see the elevations below). The skills and interests of both J. M. and O. Roy Moore generally involved the engineering and marketing aspects of the firm's work, and both were usually more involved in the firm's industrial and commercial aspects of the firm's business than in their less lucrative domestic work. However, O. Roy was had already completed his apprenticeship in his father's firm with one of J.M. Moore's best designers, Fred

Henry; by 1913, he was playing an increasingly active role in all aspects of the firm's work; most of the projects in this block were O. Roy Moore's idea; and he may in fact have designed this house himself. Moreover, both homes planned for O. Roy in this cluster, this house and the cottage at 189 College Street, show a similar sophistication in design. O. Roy Moore may have used these homes to showcase his talents in the area of domestic design. He lived here, at 204 St. James Street, from 1915 to 1928.

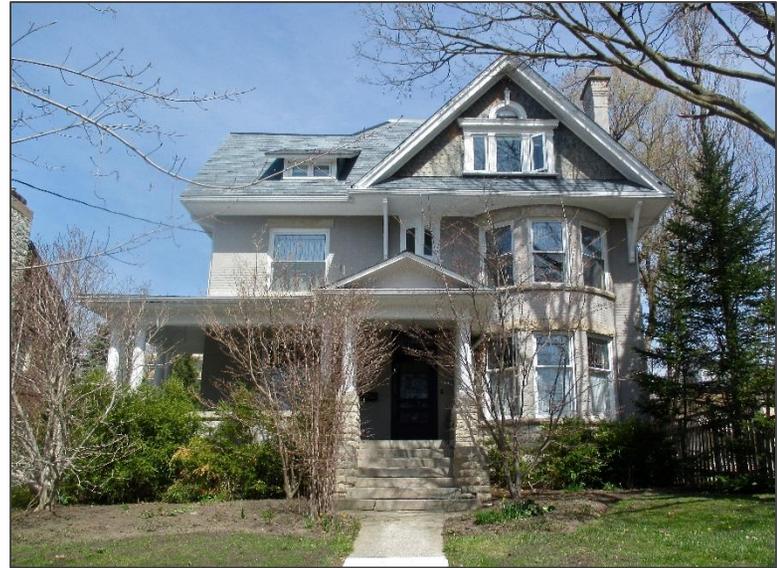
The painted brick house at 206 St. James Street seems built on a larger scale than its neighbours to the west, partly because it is located on the flat land at the top of a gentle slope and partly because the house is a tall two storeys. Its high, hipped roof features cross gables to the south and west, ending in gables with deep-set fields covered in slate tiles like those that would once have covered the roof. Fluted pilasters form the jambs of the Palladian window in the front gable, while the semicircular component sitting above a richly moulded entablature is surrounded by its own robust moulding, featuring a deep ornamental keystone. West of the gable, a small shed-roofed dormer holds two small windows. A corbelled, buff brick chimney, with brick dentils beneath its stone coping, rises along the east side of the house, and the very broad soffits beneath the eaves are lined with narrow tongue-and-groove boards. The gable, which extends forward over the plane of the house even further than the rest of the roof structure, appears to be supported by large, relatively plain brackets in a strut design. Filling up part of the space below the gable is a deep, two-storey bow window; its sash windows are flat, but their rusticated stone sills and lintels curve with the shape of the window and nearly meet the abutting sills and lintels, thus appearing to form continuous rounded courses. The two other second floor windows are a small two-sided oriel window over the front door below and a broad sash window sits over a plate glass window and transom on the floor below. The wood and glass front door also features a transom. Deep, rusticated stone lintels top all apertures, and the windows all have shallower rusticated stone wills. Moreover, all windows have a leaded glass design in their upper members: a border of rectangles surrounds the more typical narrow vertical panes found within this frame. The high foundation of the house consists of cut limestone. A deep veranda extends west from the front door and wraps partway around the west side of the building. It is protected

by a low, cut-stone wall. The posts, grouped into sets of two or three, sit on stone bases featuring alternating courses of narrow, smooth stone and deeper rock-faced stone. On these bases are abbreviated Doric columns that support a dentilled entablature and, above that, a shallow hipped roof. Like the house roof, that of the porch has very deep overhanging eaves, with their original tongue-and-groove soffit, and a pediment over the front door has a field, bordered with dentils, that is as deep as that of the gable above.

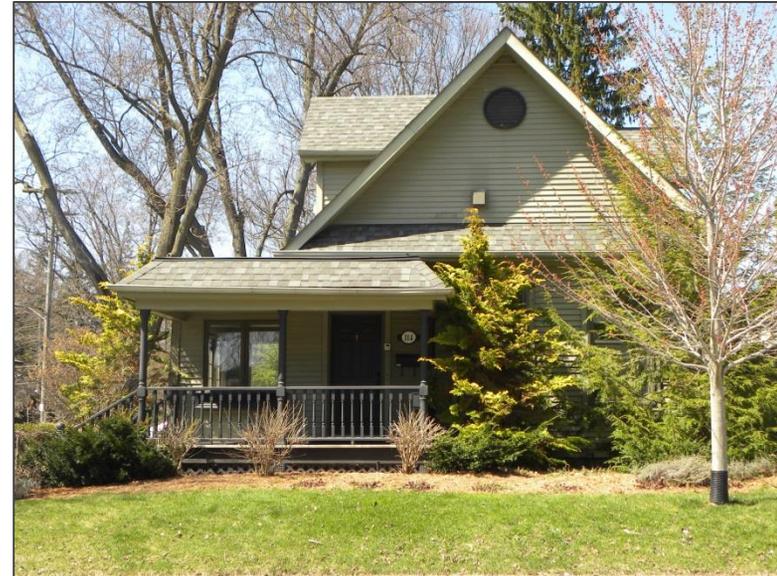
The house at 114 Sydenham is a one and a half storey frame house with a gable roof, clad with vinyl siding. The property has frontage onto both Talbot and Sydenham Street. The Sydenham façade is relatively vernacular with an end-gable, side hall front door, and two first storey windows. The Talbot Street façade is more elaborate and includes 2 first storey bay windows, and 3 roof dormer windows that are accented with shutters. A covered front porch is accessed by a set of wood stairs on the Talbot façade of the house. The porch wraps around both sides of the house and is lined with a wood balustrade, and a set of slim wood posts supports its flat verandah roof. A paved driveway is located on the Talbot Street portion of the driveway and a rear yard is fenced in surrounding the property. Most of the landscape additions have been installed on the Talbot Street façade.

The property is one of several corner lots found throughout this area of London, and had prominent façade frontage onto both Talbot Street and Sydenham Street. Stylistically, the house acts as a transition between the larger houses located on Talbot Street, and the more modest one storey dwellings on Sydenham Street. This house is set back approximately 1 metre from the Sydenham Street property line and just over 7 metres from the edge of Sydenham Street.

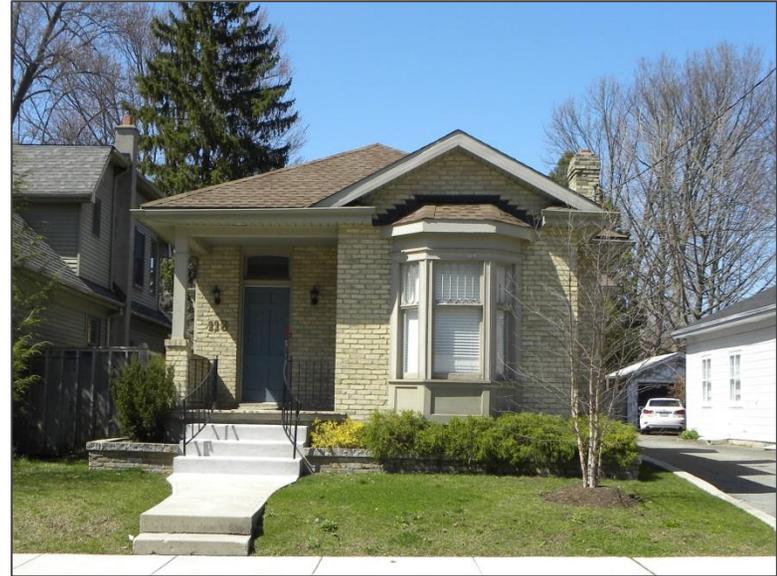
The house at 118 Sydenham Street is a one storey cottage with buff brick exterior cladding and a hipped roof. A projecting bay on the front façade also includes a gable roof. A set of concrete steps and a walkway lead to its six-panelled wood front door that also includes a wood transom window. The projecting bay on the front façade is the focal point of the front elevation and includes a set of three wood sash windows framed by detailed woodwork. The elaborate window trim includes dentil work along an entablature, wood frames and sills, and panelling below the windows. The roofline of the house is lined with relatively plain fascia board and a chimney is located on the east side of the house. The remnants of a laneway, terminating at this properties rear yard, run along the east side of the house.

The house has a short setback on the property and is generally in line with the majority of the houses on the north side of Sydenham Street. It is approximately 0.25 metres from the front property line and 6.5 metres from the edge of the street. Its spacing along the street is similar to the rest of the houses in that it has a narrow lot with minimal side yards. The remnants of a laneway run along the east side of the house. A series of laneways are found throughout this area of London, however, unlike the rest, this one terminates at a rear yard rather than carrying through to another street.

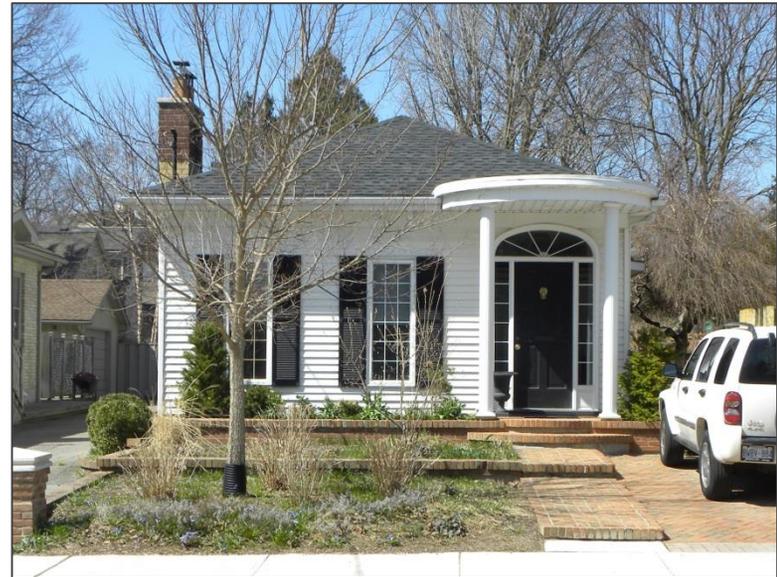
The house at 122 Sydenham Street is a one storey vernacular cottage with a hipped roof and white vinyl exterior cladding. The off centred front door includes elegant sidelights and an elliptical transom. Fluted columns, also clad in vinyl, flank the front door and support a curved porch cover that hangs over the front entrance to the house. Two vinyl windows are evenly spaced on the front façade and are accented with black shutters. A brick chimney extends above the roofline on the west side of the house, and a brick walkway extends from the sidewalk to the front entrance. A brick driveway also extends along the east side of the house to the rear yard. Corbelled brick columns with concrete hipped caps are placed on the front corners of the lot.

The house on the property has a short setback and sits close to the sidewalk along Sydenham Street. This house is set back just over 3 metres from the front property line and 9.5 metres from the edge of the street. Much like the majority of houses on the street, this setback is fairly consistent with the rest of the houses on the street. In addition, the remnants of a former laneway extend along the west side of the property. However, unlike other laneways found in this area of London, this one terminates at the rear yards of the bordering properties.

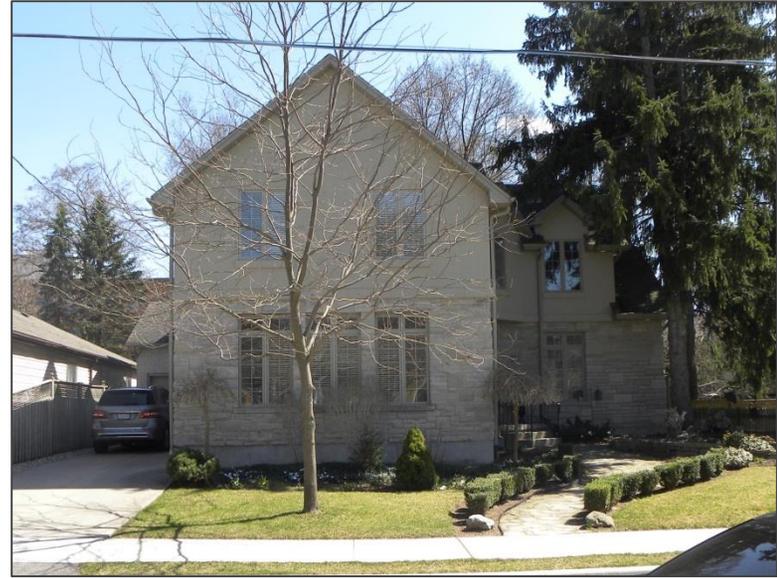
The house at 125 Sydenham Street is roughly an “L” shape house. It is two storeys and clad in stone on the first floor and stucco on the second floor. The house has an attached garage in the rear east corner. This house has a gabled roof. The front door to this house is in the joint of the “L”. the front door is flanked by narrow side light windows. The houses windows are double windows with plain sills. The front elevation of this house is symmetrical with three sets of windows on the first floor and two sets on the second.

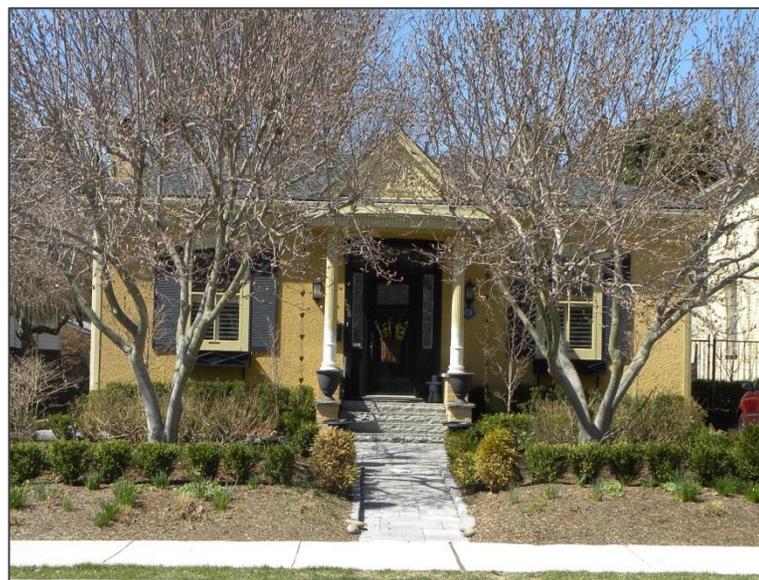
The house at 126 Sydenham Street is a one storey Ontario Cottage with a hipped roof and centrally located gable peak that includes the remnants of an arched gable window. The edges of the peaked gable are decorated with dentils. The existing Designation By-law for the property indicates that the house was originally clad in siding, however, the present exterior is clad with stucco. The front façade of the house is symmetrical including a centrally located door that is surrounded by sidelights and a flat transom. The symmetrical flanking windows consist of two-over-two wood sash windows with wood shutters and moulded wood lintels. The front porch includes a set of wood fluted wood columns that support a porch cover that includes entablature highlighted with dentil work. The front yard of the property is heavily landscaped and includes a concrete walkway that leads to the front steps of the porch.

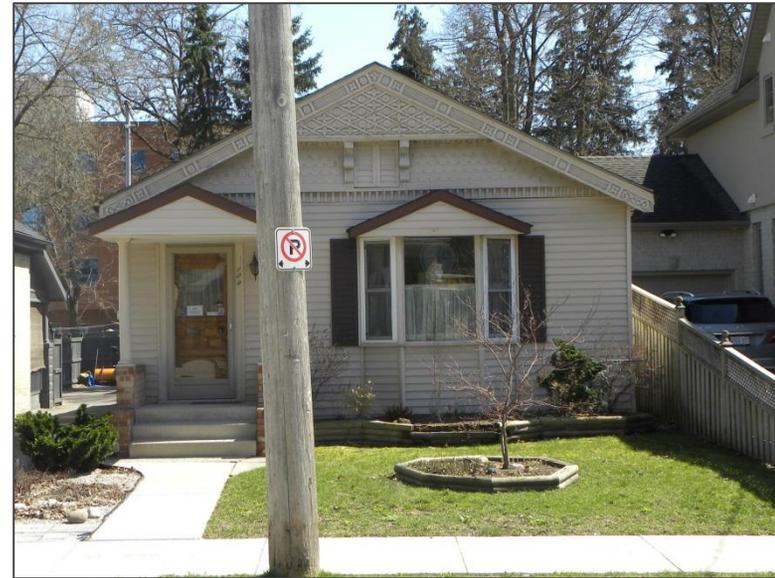
The house at 129 Sydenham Street is a one storey cottage with a hipped roof and is clad with gray aluminum siding. The roofline is elaborately decorated on this house with highly detailed wood mouldings along the fascia, bargeboards, and gable peaks. Details just below the gable peak include a set of wood brackets that border closed wood shutters. The texture in the gable consists of a layered square scalloping, and the row of dentils separate the elaborate woodwork of the gable peak from the siding of the house. A central bay window is located prominently on the front façade and is bordered by a set of shutters, and a plain pediment clad with siding. An off-centered front door includes a window and wood panelling and a glass storm door. Brick columns and Doric wood columns support a plain pediment that provides a porch cover over the front door. The front entrance is accessed by a concrete walkway that extends from the sidewalk. The west side of the property is bordered by a fence constructed of modern dimensional lumber, and a narrow paved driveway extends along the east side of the property and provides access to a garage at the rear of the house.

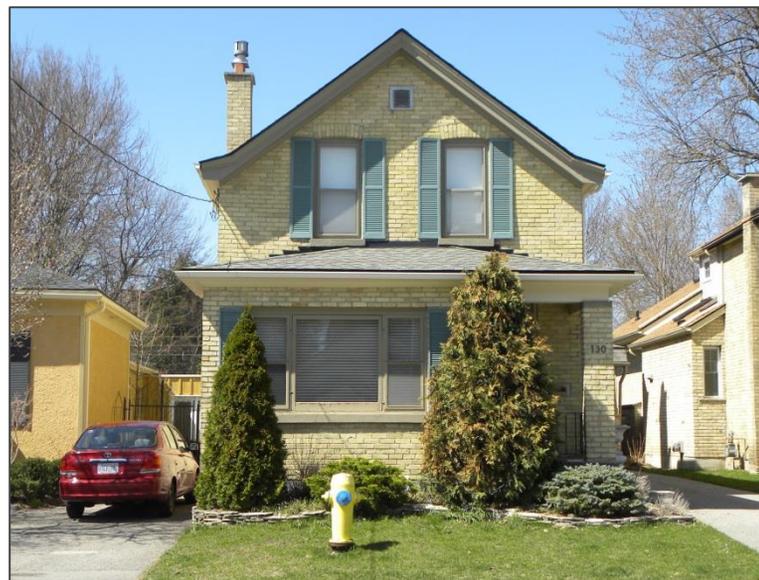
The house at 130 Sydenham Street is a two storey vernacular house constructed of buff brick with a gable roof. The edges of the roof sweep outwards from the roofline and the roofline is lined with a plain fascia board. A set of two symmetrical windows are located on the second storey of the building and are accented with brick flat-arch lintels, concrete sills, and shutters. A projecting square bay on the first storey consists of a grouping of three windows, also highlighted with shutters. A brick column supports the hipped roof that extends over the projecting bay and the front porch entrance of the house. A brick chimney extends above the roofline on the west side of the house and a narrow paved driveway runs along the east side of the property.

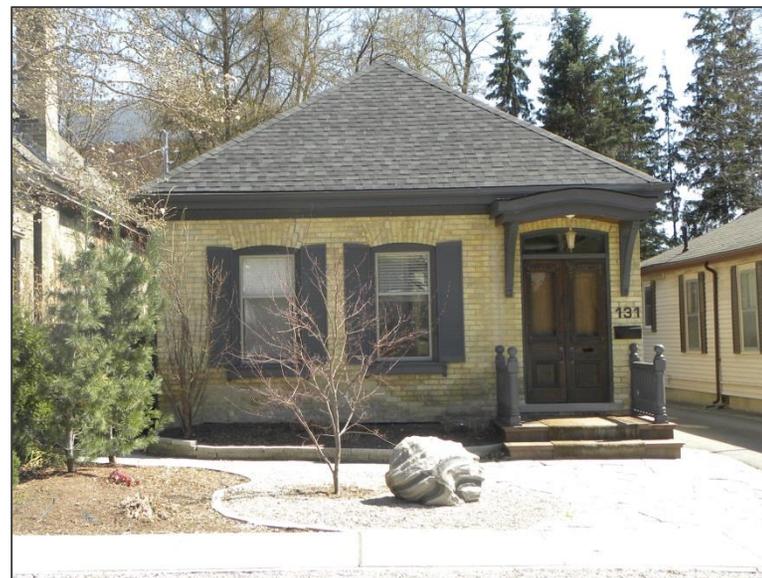
The house located at 131 Sydenham Street is a one storey buff brick cottage with a steep hipped roof. The off centered door reveals the houses’ side hall plan and exhibits the most decorative element of the street-facing façade. The door consists of a set of wood panelled double door that include narrow windows and decorative wood detailing. A wide arched transom window is located above the door. A curved eyebrow porch cover is supported by wood brackets above the entrance and a set of two steps lead to the front door. Wood balustrades are located on either side of the porch entrance. A set of two windows are located on the front façade and have brick arched lintels, moulded wood sills, and wood shutters.

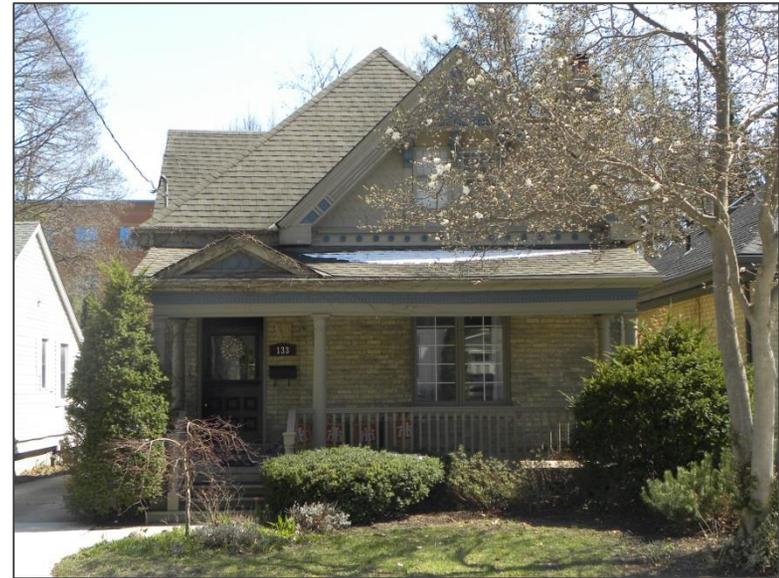
The house at 133 Sydenham Street is a one and a half storey buff brick vernacular dwelling with a hipped roof and sizeable projecting gable dormer on the front façade. The projecting gable exhibits a high degree of decorative detail including dentil work and wood mouldings that line the fascia and bargeboard of the gable, wood brackets that border a pair of wood gable windows, and wood scallop texturing that serves as a the exterior cladding in the gable. A covered front porch spans the entirety of the front façade and also includes a high degree of detail. Wood columns support the porch roof that also includes an elegant entablature that is accented with wood dentils. A wood pediment rises out of the porch roof above the front entrance to the house. The door itself is a wood paneled door with decorative wood mouldings that surround a central door window. A balustrade spans the entirety of the front porch. A set of steps lined with balustrades and newel posts leads to the front door. A narrow driveway extends along the east side of the property.

Separated from the sidewalk by a very narrow strip of yard, the house on the property has a short setback. This house is just under 1 metre from the front property line and approximately 7.5 metres from the edge of the street. However, the spacing between properties remains consistent. The house is one of the few buildings that deviates from either the one storey cottages or two storey brick dwellings located on the street.

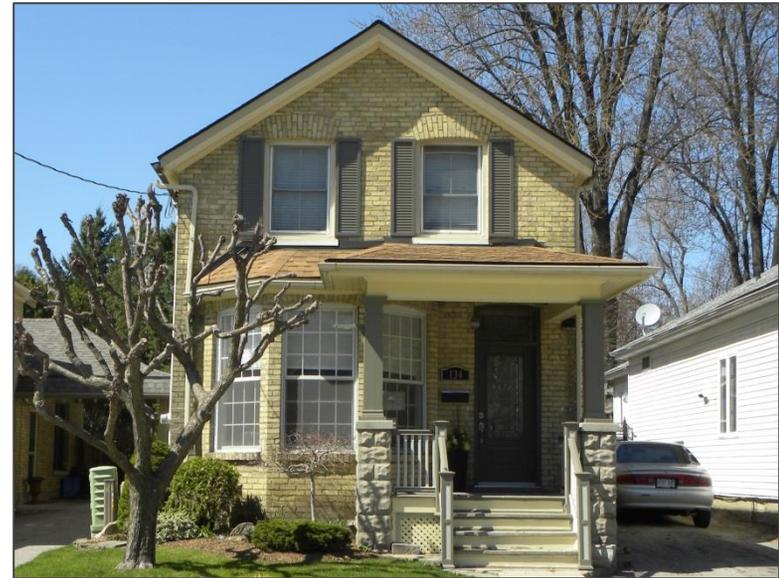
The house at 134 Sydenham Street is a two storey buff brick house with a gable roof. The 2nd storey of the house features a set of symmetrical sash windows that are highlighted with brick arch lintels and shutters. The sills, likely to be constructed of concrete, are covered with what appears to be aluminum flashing. A projecting first storey bay window includes three multi-pane double hung windows with brick sills. On the front entrance of the house, a pair of rusticated concrete block posts support a pair of short wood posts that hold up the porch cover that extends over the front door. The front door includes a wood trim that a narrow transom window. The front steps of the front entrance are constructed of wood and include wood panelled newel posts. The front entrance is accessed by the concrete walkway that extends from the sidewalk to the steps. A narrow, paved driveway extends along the east side of the house.

Much like its neighbour to the west, this property has one of the shortest setbacks on the north side of Sydenham Street. This house is approximately 2 metres from the front property line and just over 8 metres from the edge of the street. A narrow strip of front yard separates it from the sidewalk. The house was constructed in a similar style and form to 130 Sydenham Street and is one of a small number of two storey brick dwellings on the street.

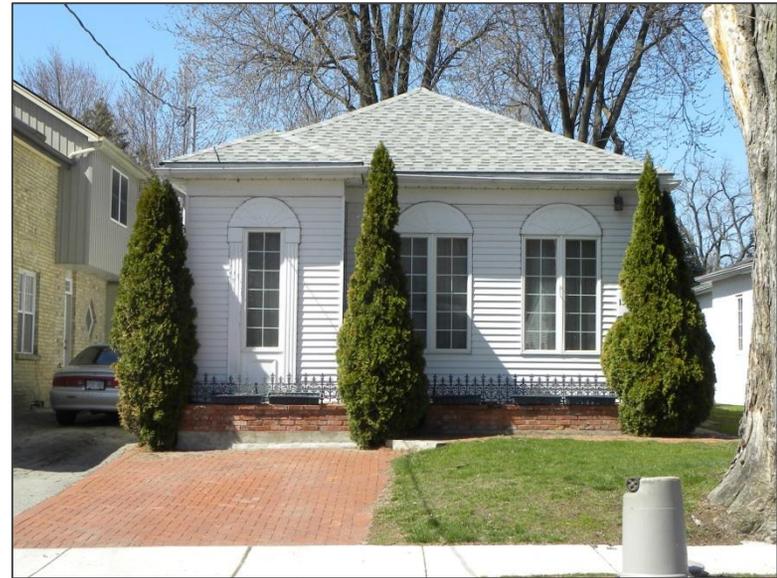
Constructed as one of the last houses on Sydenham Street, this house is a one storey cottage with a hipped roof and white aluminum siding. A plain white cornice board also lines the top edge of the house, separating the house from the roofline. The non-symmetrical front façade includes three windows, all with arched fanlight detailing above the window openings. The western most window on this façade is included in a projecting bay and its trim includes wood pilasters and panelling. A separate hipped roof is located above the projecting bay. Oddly, there is no front door on the front façade of the house. Instead, the interior of the house is accessed from a side door on the east side of the house that is reached by following the red brick walkway that wraps around the side of the house. A red brick retaining wall is also located at the front of the house and is capped with decorative iron cresting. Unlike most of the paved driveways on the street, this property has a red brick driveway.

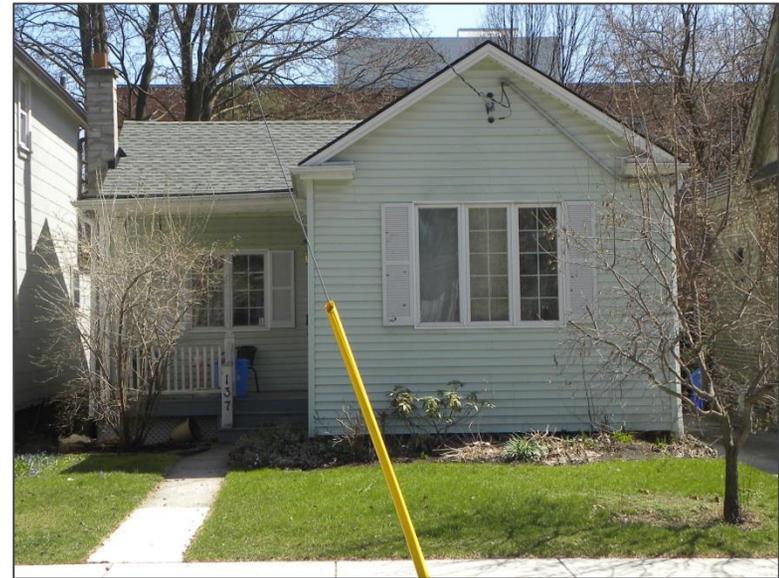
The house at 137 Sydenham Street is a one storey cottage with a hipped roof and aluminum exterior cladding. A projecting wing extends out along the front façade of the house, and includes a grouping of three windows flanked by aluminum shutters. A small pair of windows are set back on the setback portion of the house adjacent to the front door, which is not visible from the street. A set of wood steps leads to a small off-centered porch. A straight concrete walkway extends from the sidewalk to the porch. The property does not appear to have its own driveway.

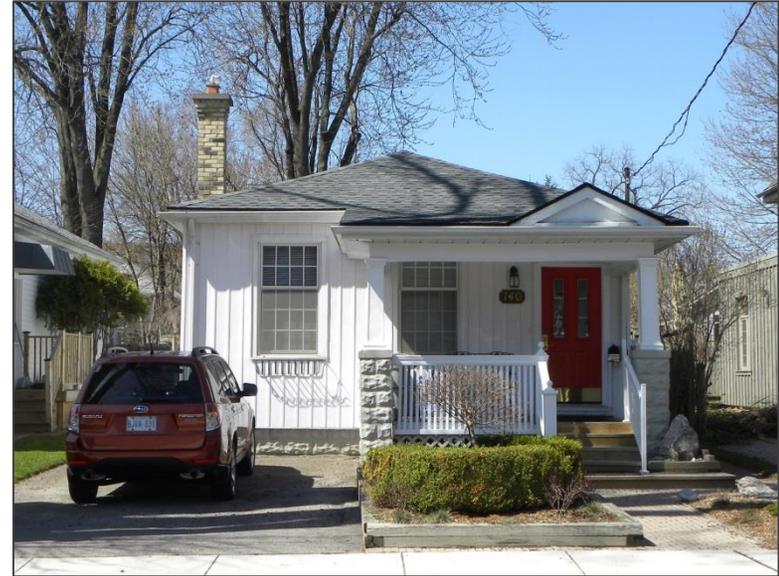
Constructed as one of the earlier houses on Sydenham Street, the house at 140 Sydenham Street is a one storey cottage with a hipped roof that extends out over the front porch. The building has a rusticated concrete block foundation that appears to be a later alteration from the original construction, and is clad with white board-and-batten wood siding. The buff brick chimney on the west side of the house extends high above the roof peak. A pair of eight-over-twelve wood sash windows on the front façade forms the window openings while an off-centered front entrance includes the front door to the house. A pair of rusticated concrete block and wood posts supports the front porch roof that is an extension of the main roof. The edge of the porch is lined with white wood balustrades, and the wood steps of the front porch as accessed from the paved walkway that extends from the sidewalk.

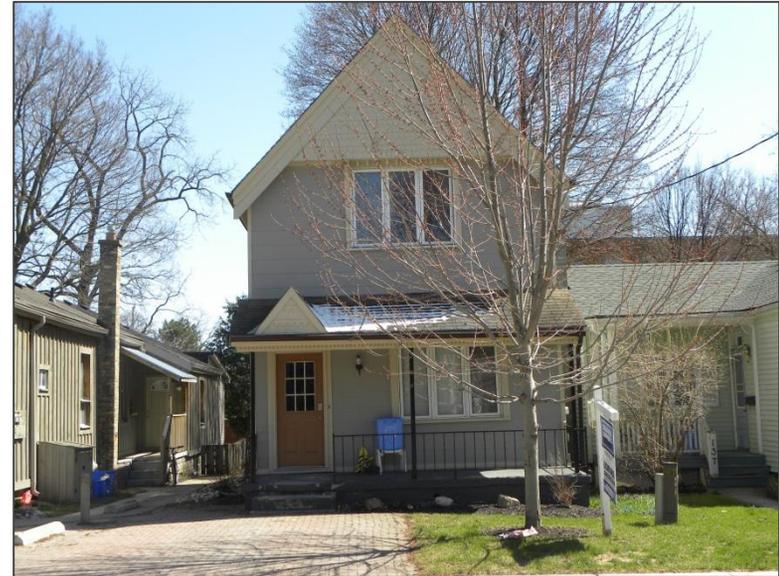
The frame house located at 141 Sydenham Street is a two storey house with a steep gable roof and wood cladding. The fascia that extends along the roofline is constructed of wood and is plain in its detail. Alternatively, the gable is decorated with wood scallop texturing and adds a distinct separate finish from the rest of the wood siding. A grouping of three windows is located on the second storey below the gable, and is separated from the scallop texturing by a row of dentils. An identical window is located on the first storey next to the front door. A shed-style porch roof extends along the front façade supported by a set of thin metal posts. A wood pediment with similar scallop texturing rises out of the shed roof above the front door. The roofline of the porch roof is lined with a set of dentils. A concrete front porch extends along the entire front façade of the house.

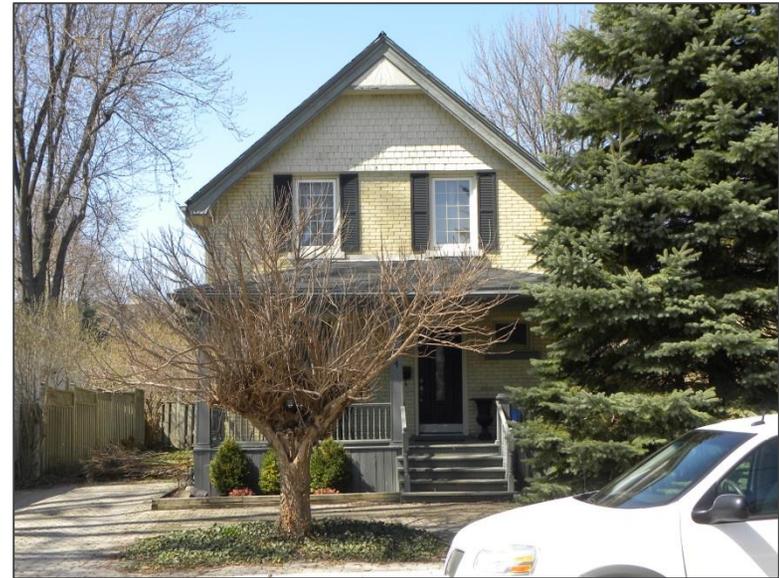
The house located at 144 Sydenham Street is a 2 storey vernacular house with a variety of design details. The house has a gabled roof with plain wood fascia boards, and a fan bargeboard design. Beneath the gable is a wood shingle finish that adds another layer of texture and colour to the house. The remainder of the exterior cladding on the house is buff brick. Two symmetrical vinyl casement windows are located on the second storey and include shutters and concrete sills. On the first storey a front porch spans the entirety of the front façade. An off-centered front door is located between a large window and a smaller fixed window with a concrete sill. The porch is covered by a hipped roof and the detailed woodwork that includes wood panelled posts, balustrades, newel posts, and steps. The front yard of the property has been mostly covered with a driveway paved with interlocking brick, with the exception of a centrally located tree.

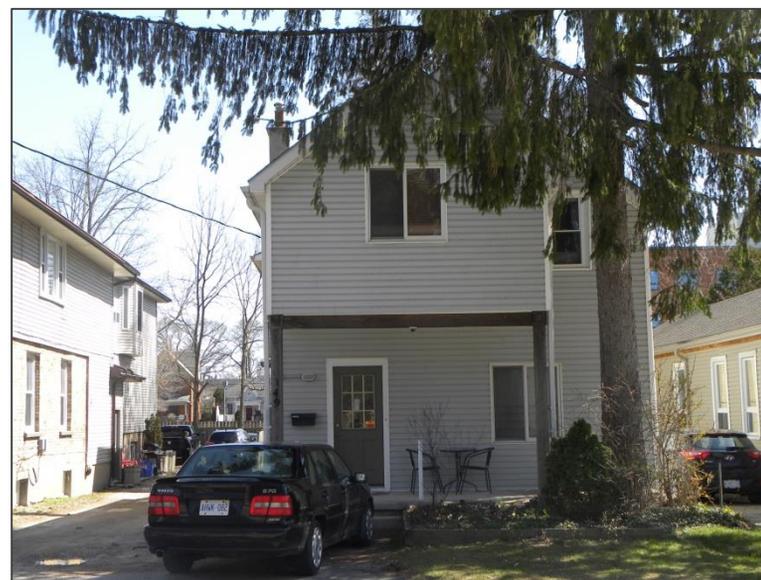
The house located at 149 Sydenham Street is a two storey dwelling with a gable roof and aluminum siding. A majority of the house’s exterior features and materials have been removed, updated, or covered with more modern construction materials. The windows appear to have all been replaced with vinyl and the siding may be covering buff brick, similar to the brick found on the other 2-storey homes on the street. A concrete chimney is located on the east side of the house, along with a narrow driveway. Decorative timber lines the front entranceway and a concrete porch extends across the front façade.

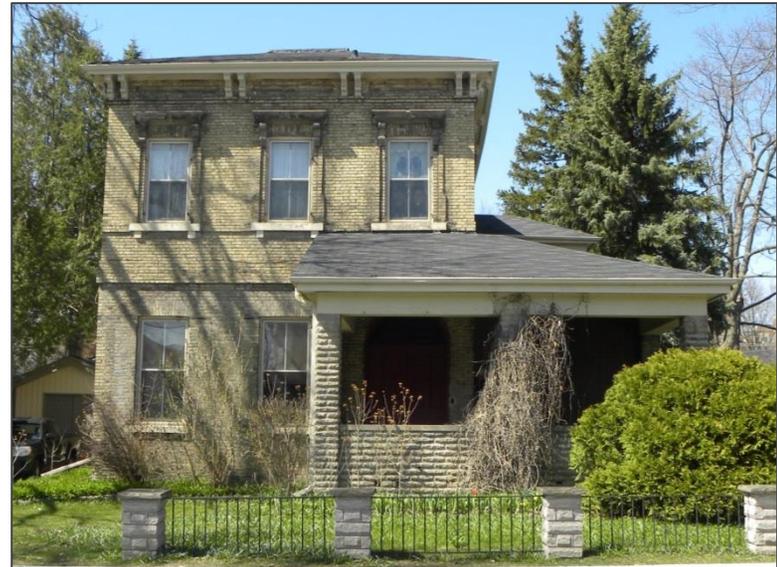
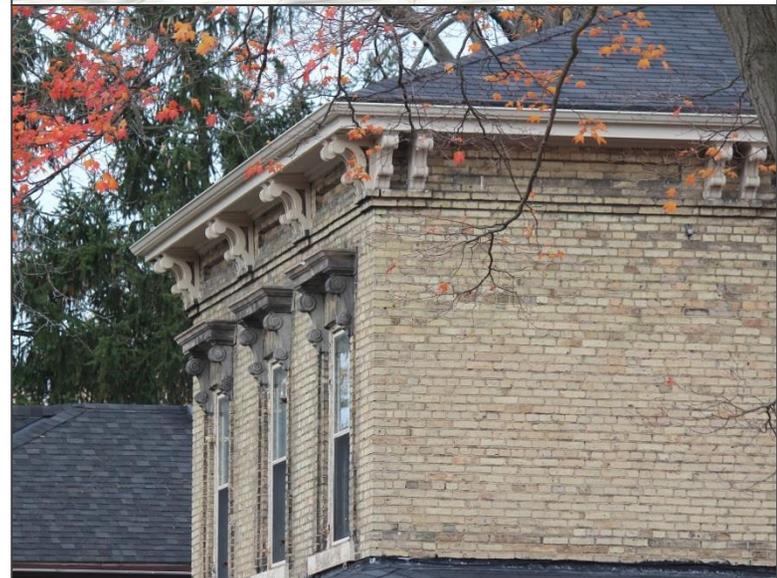
This house is an Italianate building. It is a two storey white brick house. A porch wraps around the front and two thirds of the side of the home. Significant modifications have been made to the main level of the house. An original porch was removed by 1922. A new porch was added at some time after 1940. An addition on the side and rear of the home of St. George Street with a lot of windows is a different style than the original house.

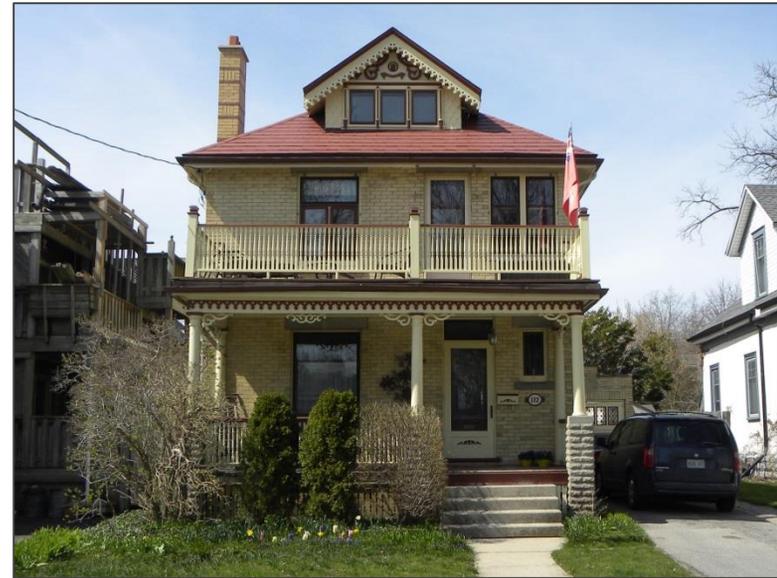
The house at 182 Sydenham Street is a two storey home with attic living space. The house is a yellow brick with red roof, a combination of front gable and hip roof styles. The house has a front dormer with three section window, fish scale siding and decorative trim.

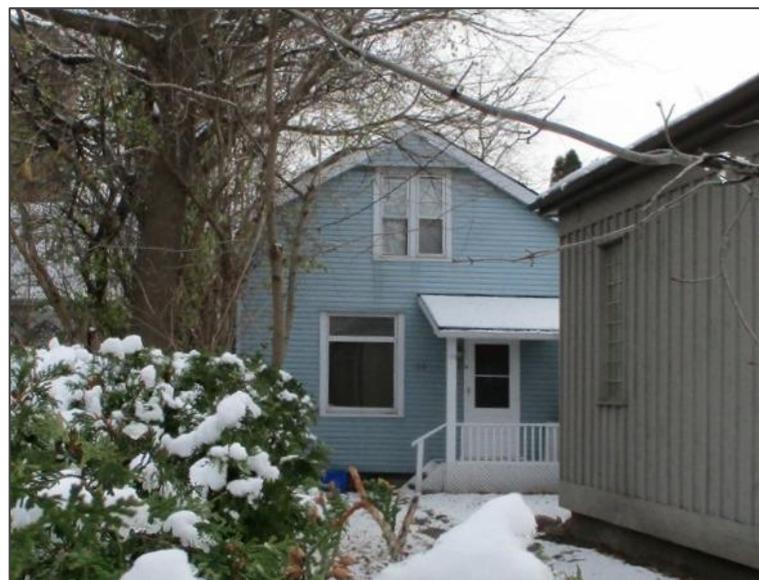
This is a one and a half storey frame house clad in blue siding. The house has an asymmetrical front elevation with covered porch and front door on the western half of the front elevation and a single window on the eastern half. The top floor has a double sash window centred on the house. This house has no decorative trim. The roof over the front porch is a shed style roof supported by two square columns. The porch is three steps above grade. This house has medium pitched gable roof. This house has a small single storey section out the back.

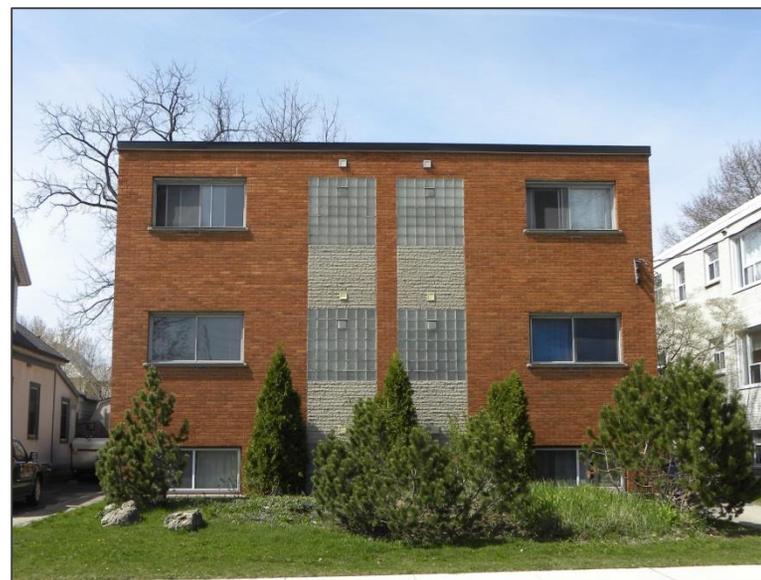
This apartment is a two and a half storey red brick building with elements of modern architectural style including horizontal lines and a clean façade. The front elevation of this building has six windows and areas of glass block treatment. The building has a flat roof. Access is on the side walls.

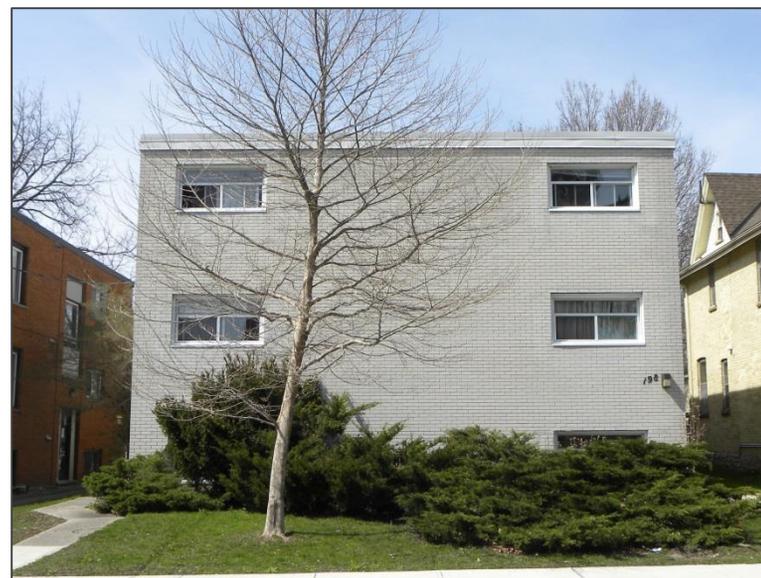
This apartment building is a two and a half storey grey painted brick structure with elements of a modern style of architecture, horizontal lines and a clean façade. The front elevation has six windows. The building has a flat roof. Access to the building is on the sides. Parking is in the back.

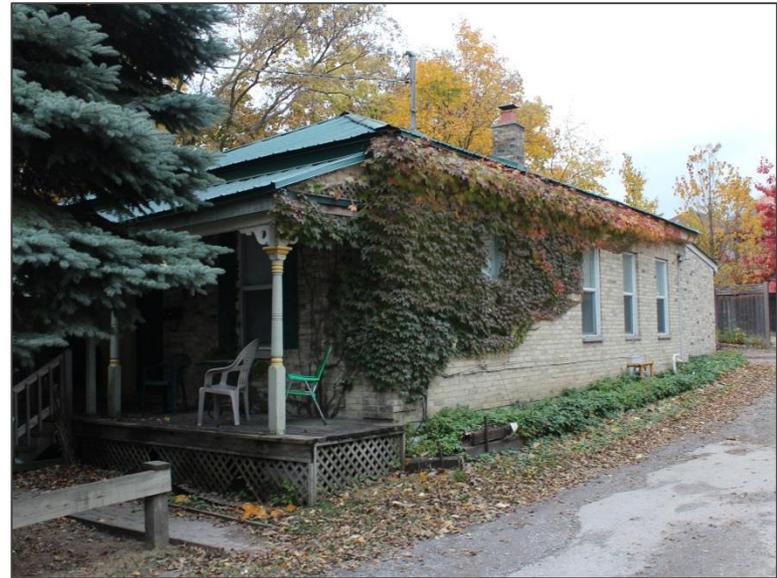
This small cottage displays architectural elements considered consistent with the Regency Cottage style of architecture. It is a single storey cottage. It has a low hipped roof, a symmetrical front elevation with central door and two windows, shutters and a broad porch. The cottage has decorative columns supporting the porch roof with more decorative woodwork under the porch roof. A small addition has been added to the rear of this house. Windows are vertically oriented with plain sills. This house has a white brick veneer, although was originally a frame structure (Gibbs 1989).
