St George-Grosvenor Heritage Conservation District Study

Volume IV Appendix F, [2016]

APPENDIX F: INVENTORY OF CULTURAL HERITAGE RESOURCES

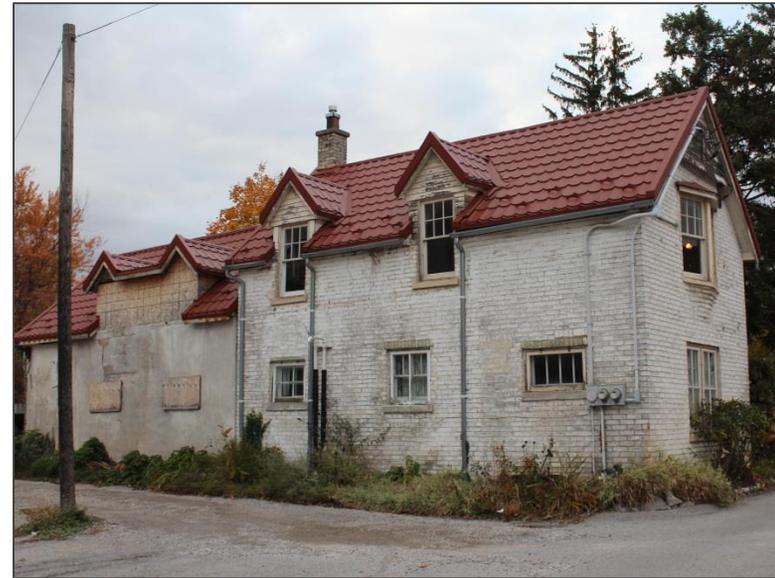
Windows are small, main floor ones are largely square while second floor windows are rectangular and vertically oriented. The building has a single window on each floor in the eastern wall. The second floor window in the eastern wall is a double window angled out from the building, a bay made of two windows. The peak of the gable has some decorative woodwork on it.

This house is set at the rear of its property and is adjacent to two rear lanes. It is approximately 39 metres from the Sydenham Street property line and 45.5 metres from the edge of Sydenham Street.

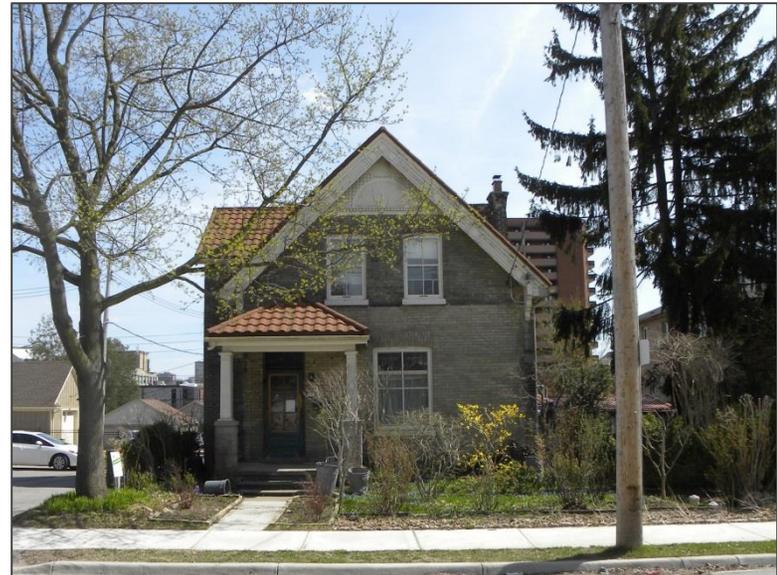
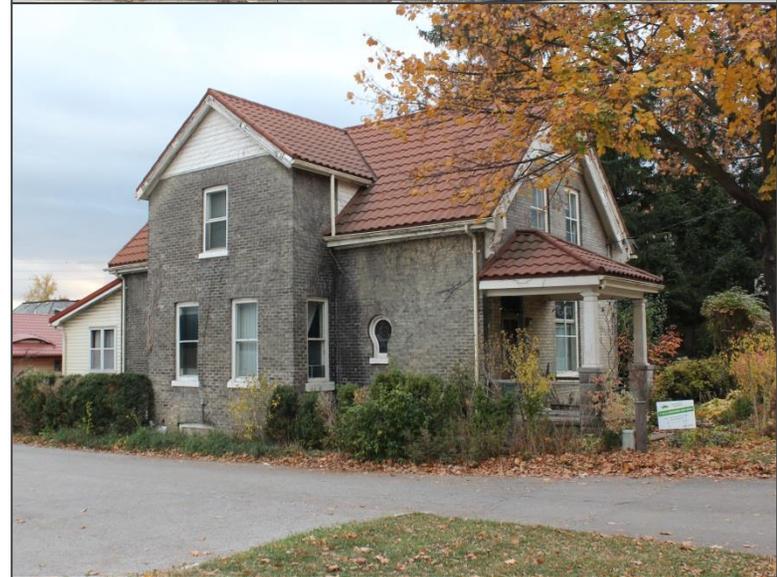
The front elevation of this house has an off centre front door in a covered porch, two steps above grade. The front also has a single large window almost centred on the building. The second floor has two evenly spaced sash windows. There is bargeboard on the front gable.

This house has a small keyhole window on the east side with stained glass. The windows on the sides of the house are vertically oriented sash windows with plain sills.

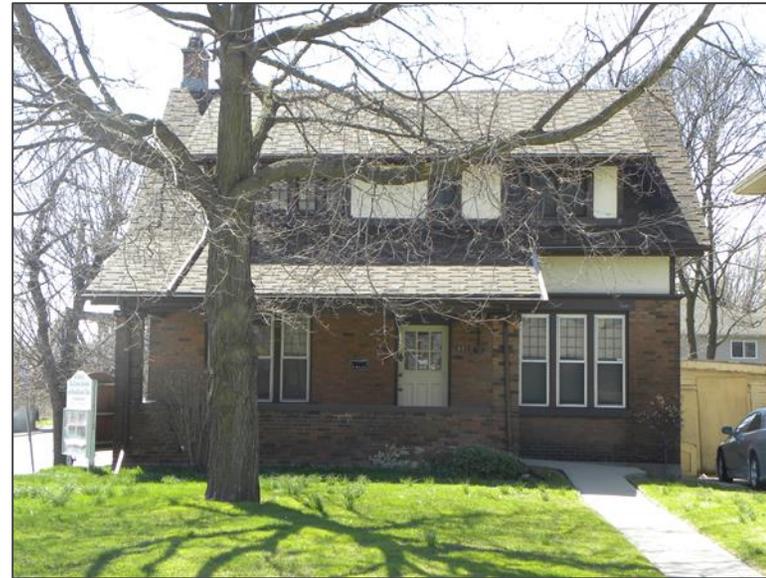
The building at 801 Talbot Street, currently used as a commercial building in a former residential building was designed as a one and a half storey bungalow. The house is clad in a dark red and brown brick and includes a centrally located front door flanked by two symmetrical sets of narrow triple 12 over 12 sash windows separated by mullions. The roof profile is a medium-pitched gable roof that includes a central shed style roof dormer with a small central window and two sets of small triple windows, similar to the ones

found on the ground level. The sloping roof extends over the entrance to form a porch, typical of the bungalow style. The front porch has a brick parapet and columns that match the brick of the house. The porch is concrete and is one step above grade.

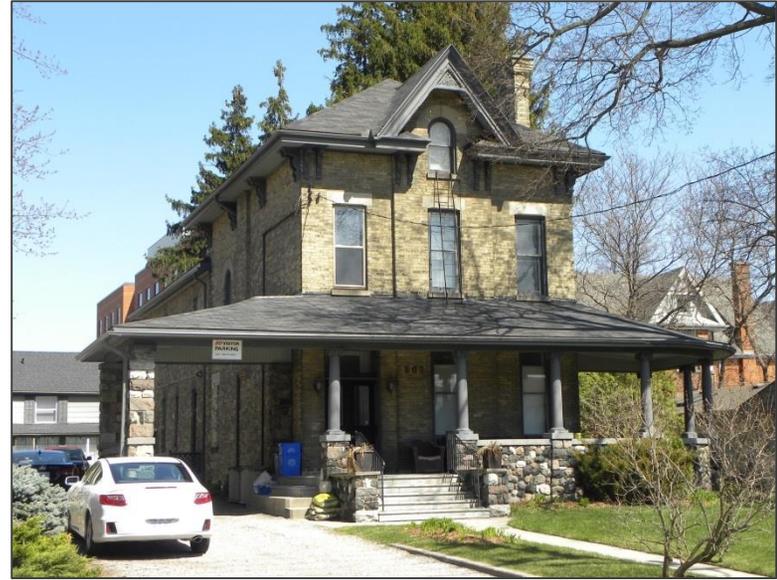
The house at 801 Talbot Street is a 2 and a half storey buff brick house constructed in the Italianate style. The house has a hip roof with a central peak, highlighted with decorative bargeboard. A tall brick chimney extends above the roofline on the south side of the house. The roofline includes a plain wood fascia and a bracketed cornice, typical of the Italianate style. The east (front) façade of the house consists of three bays with a set of three symmetrical second storey windows, two first storey windows and a front door.

Decorative pillars on a raised porch support a veranda roof that extends over the driveway as a porte-cochere on the north side of the house. The veranda wraps around the south side of the house. The veranda foundation and parapet is finished with a field stone veneer. The porch and porch steps are painted wood.

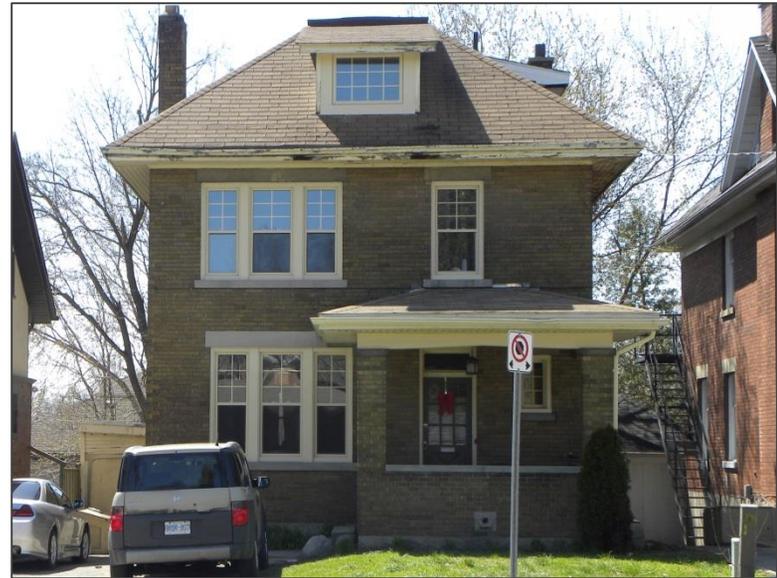
The house at 803 Talbot Street is a two and a half storey buff brick foursquare house with vernacular details. The house has a truncated hip roof with a central shed dormer with a window in it, and chimneys located on the north and south side of the house. A plain wood fascia lines the rooflines on all side of the house. The exterior entrance on the first floor reveals the side-hall plan of the house. The fenestration on the first and second storey of the west (front) façade include groupings of three narrow wood windows with mullions, concrete sills and lintels. A narrow covered porch is supported by brick columns and brick parapet with concrete coping. The front door opening includes a transom window. The front door is wood with a 9 pane window in the centre. The front elevation under the porch also has a small, high, fixed window with concrete sill adjacent to the door.

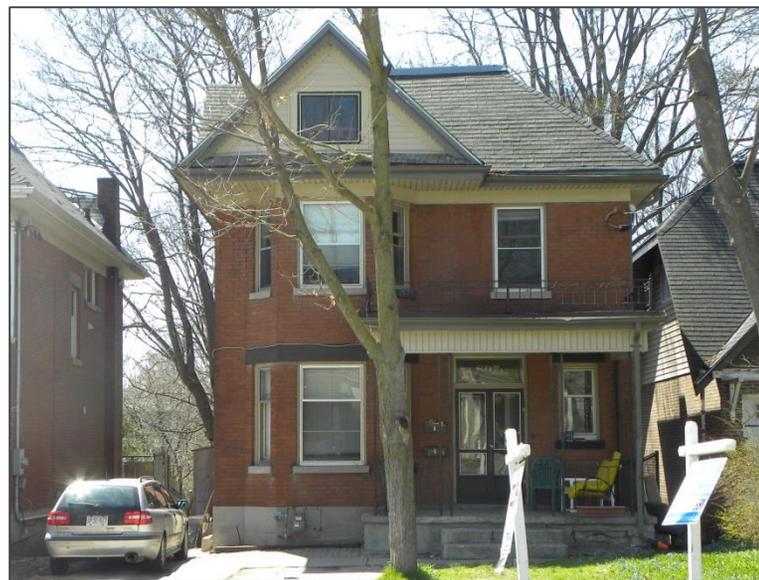
Built as almost identical to 805 Talbot Street, this house is a two and a half storey red brick vernacular dwelling exhibiting some simple Edwardian details, best exemplified by its smooth red brick materials and simple beige trim details around window openings, and along rooflines. This house has a truncated hip roof with an off centre front gable. The house includes a two storey bay-and-gable feature with bay windows and a projecting gable roof dormer that stands out from its otherwise asymmetrical roof form. The dormer retains a small section of wood scalloping as part of the skirt roof along the base of the gable. A flat porch roof is supported by a set of four thin black posts. The front door is a double door with wide transom. A leaded glass window is adjacent to the front door. A plain beige fascia board wraps around the house at the edge of the roofline, and a side by side sliding window is present in the roof dormer. The house window openings have plain concrete sills and the window openings on the first floor have concrete lintels. Lintels on the second floor window openings are hidden behind the plain cornice. Some of the windows are wood frame sash windows and some are aluminum frame sash windows.

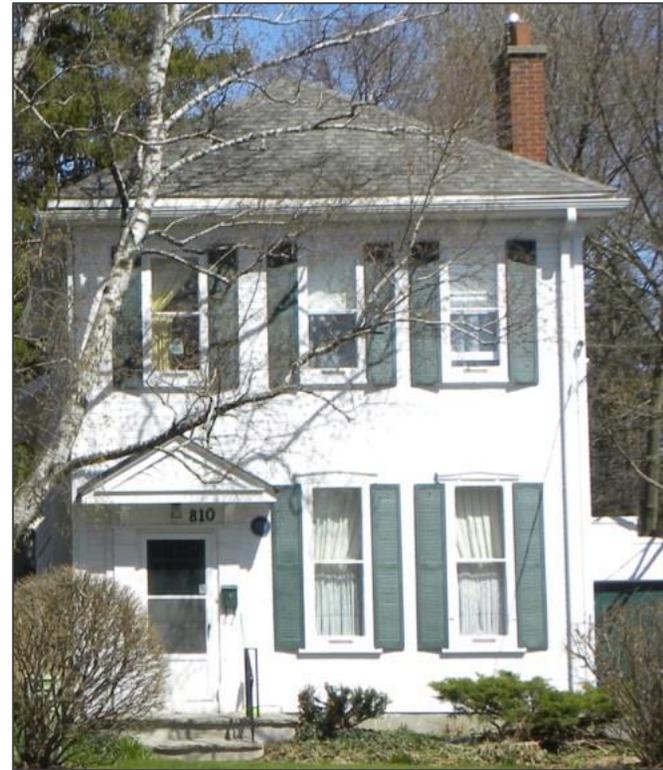
The property includes a two storey frame house constructed in a simple vernacular style with Italianate influence in its form. The exterior of the house is clad with white wood tongue and groove siding and includes a low-pitched hipped roof. The front entrance of the house includes a cantilevered pediment with a sunburst pattern that covers the front entrance. The front door is approached over a concrete stoop two steps above grade. The doorway is noted in the property's designation by-law as a more recent alteration to the property. The ground floor of the front façade includes two wood sash windows with wood shutters and wood window surrounds with pointed pediments for lintels. The second storey consists of three symmetrical wood sash windows with wood shutters. A red brick chimney, also noted as a more recent alteration to the house extends above the roofline on the south side of the house. A paved driveway also runs along the south side of the house and leads to a garage clad to match the house.

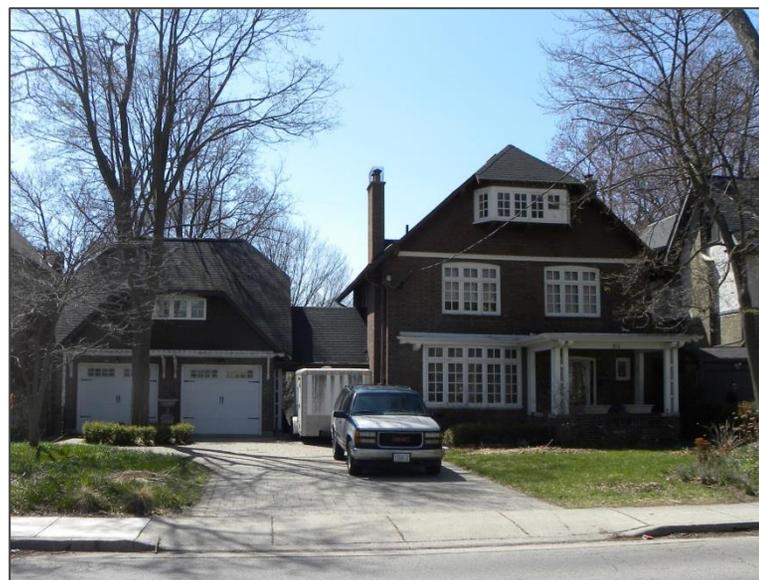
The property includes a two and a half storey house that displays Arts and Crafts influence. Its simple design includes a hipped gable roof, with a project bay dormer and chimneys on the north and south side of the house. A covered porch surrounds the front door and includes a flat roof supported by decorative wood posts and brackets. Dentil work spans the trim around the porch roof and forms a belt-course of sorts just above the second storey of the house. The windows found on the front façade are multi-pane wood windows set in groupings of three on the second storey, and a grouping of five on the first storey. An attached 2 storey garage exhibits much of the same architectural detail such as the hipped gable roof, dark brick exterior cladding, dentils, and white wood brackets. The garage has two garage doors that appear to be carriage doors with black metal hinges and small windows in the upper panels of the door. A mature tree is located just on the edge of the property.

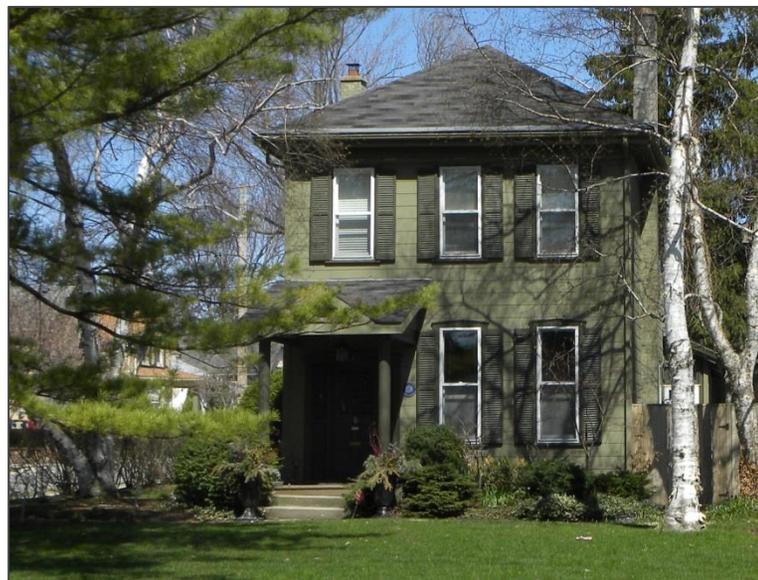
Designed to complement its counterpart at 810 Talbot Street, the house on this property is a two storey frame house constructed with vernacular Italianate details. The exterior of the house is clad with green wood clapboard siding and includes a low-pitched hipped roof. The front façade of the house can be divided into three evenly spaced bays. The front entrance of the house is in the northern bay on the ground floor. The front entrance includes a small covered porch with sloped shed-style roof. The porch roof is supported by a set of fluted columns on square bases and tied into the roof. The front porch has a wood deck three steps above grade with two concrete steps. The other two ground floor bays of the front façade include two wood sash windows with wood shutters and wood window surrounds with pointed pediments for lintels. The second storey consists of three symmetrical wood sash windows, one in each bay. The windows have wood louvered shutters. Chimneys are located on both the north and south sides of the house.

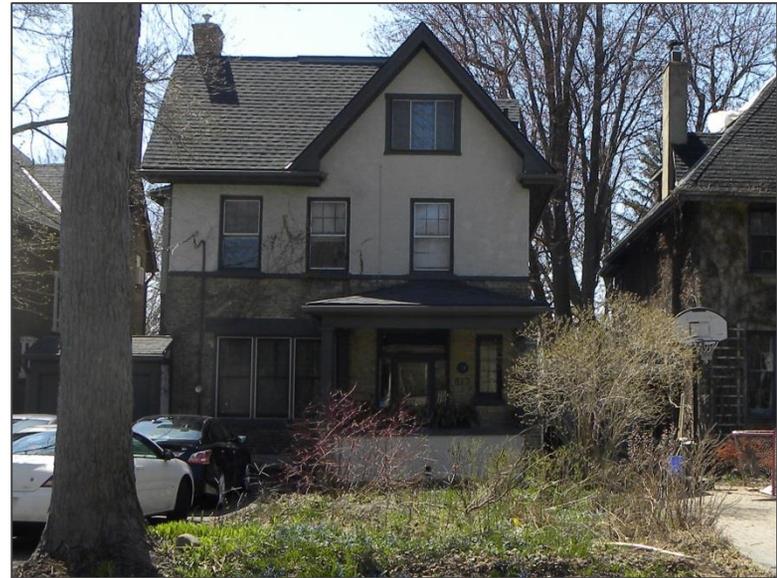
The house at 813 Talbot Street is a two and a half storey house that displays Arts and Crafts influence. The house exterior is a combination of buff brick and roughcast stucco. The roof is a truncated gable roof at the back of the house with an offset gable in front and on the south side. This house has a wide brick chimney extending above the roof peak. A grouping of three windows separated with mullions are located on the first storey, three singular six over six wood sash windows on the second storey, and a grouping of three windows are located in the gable peak on the front façade of the house. The front doorway include a simple set of sidelights and a transom window around the front door. The house has a glass storm door on the front. A narrow multi-pane window is adjacent to the doorway. Simple wood posts on brick piers support a hipped roof over the front porch. A single-car garage is attached to the south side of the house, and mature tree is located on the west edge of the property.

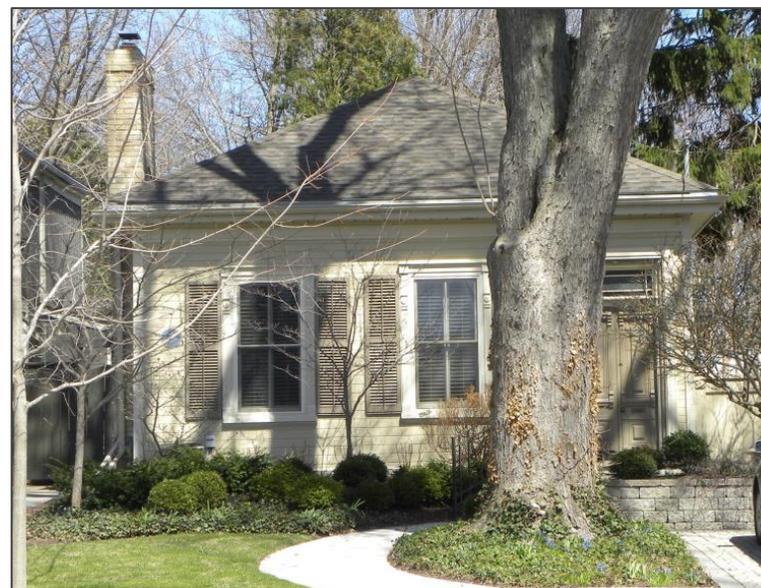
The house on this property is a single storey wood frame cottage with a side hall plan layout. It is clad with tongue-and-groove wood siding. The house has a hipped roof and a buff brick chimney on the north side of the house. The wood-sash windows on the front façade are flanked by operating wood shutters and Eastlake style window surrounds. The Eastlake style double-doors also include a transom above the door and decorative wood mouldings on the door proper. The corners of the house are accented with engaged wood pilasters and the roofline is highlighted with a plain, wide cornice board. A curved walkway bends around a mature tree that is located in the centre of the lot, and a paved driveway runs along the south side of the property.

Contextually, the house on this property is the smallest house on Talbot Street, but remains at a consistent setback with the rest of the houses on the east side of the street. It is on its front property line and is approximately 16.5 metres from the edge of the street.

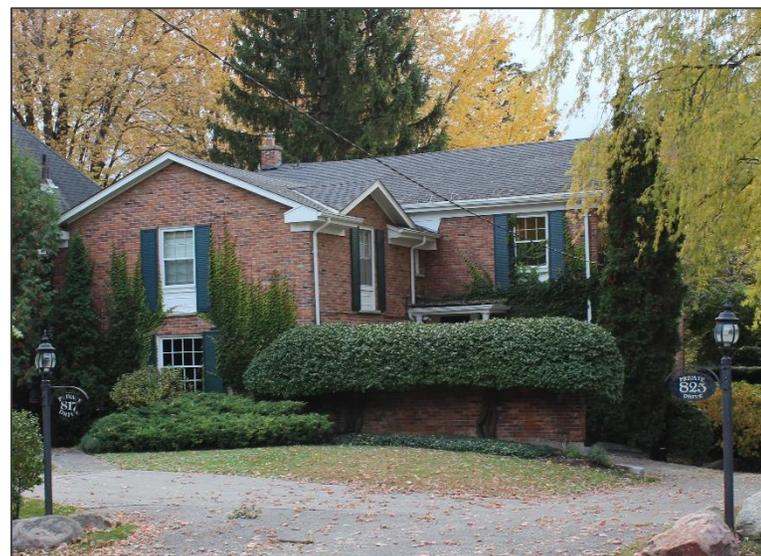
The house at 817 Talbot consists of a two storey house, designated for its contextual value on Talbot Street. The house includes a low-pitched intersecting gable roof with its street-facing façade consisting of a gable-end wall with 2 multi-pane windows. The setback, shrubs, and plantings hide the entrance from public view, however, a set of decorative posts and entablature are visible above what appears to be the houses' doorway. A private laneway extends along the north side of the property and a curved walkway weaves around on the front yard behind the sets of shrubs, and wraps around to the south side of the house. A lamppost set at the edge of the laneway indicates the address of the property. A short concrete block wall separate the property from 815 Talbot Street.

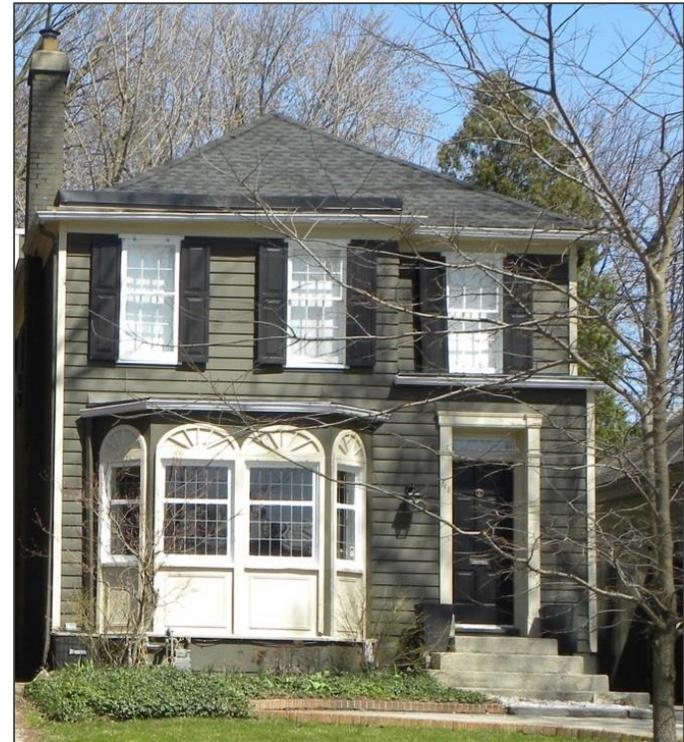
The house located at 818 Talbot Street is a two storey vernacular dwelling with influences of neo-classical architectural style. This house is clad with wood clapboard siding and includes a low-pitched hipped roof and a brick chimney that extends above the roof peak on the north side of the house. On the first storey a wide projecting bay includes a set of four windows that are accented with exterior finishes that includes fine wood dado paneling and blind elliptical moulding. The six-paneled front door is surrounded with wood pilasters and a transom window. The front door is approached up a set of four concrete steps. A set of two wood sash windows with wood shutters are placed above the projecting bay on the second storey, and a third wood sash window is set back above front entrance. A paved driveway extends along the south side of the property.

The setback of the house on the property is consistent with the other properties located along Talbot Street. This house is approximately 3 metres from its front property line and almost 18 metres from the edge of the street. Although not built in the late-19th century or the first few decades of the 20th century, this property blends well with its context given its architectural form and details.

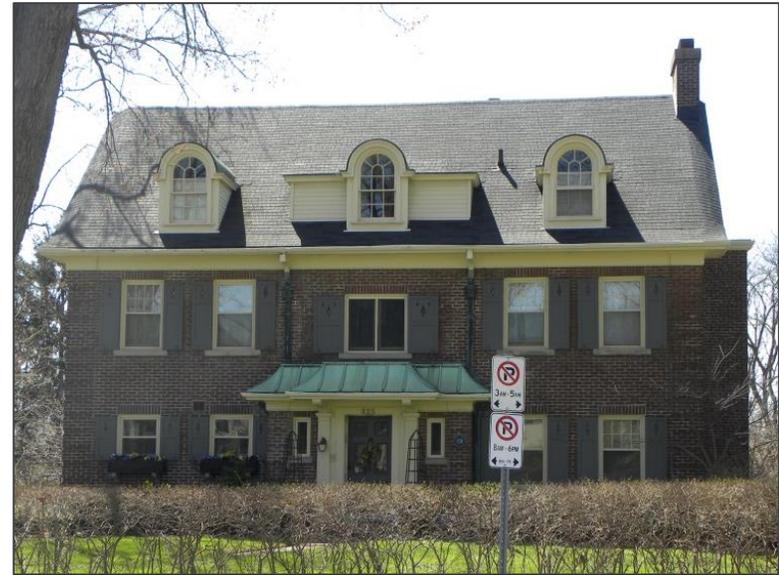
The property features an imposing two and a half storey Colonial Revival house with a steep bellcast gable roof that includes three prominent hooded window dormers. Its five-bay front façade is punctuated by a projecting central bay that consists of an elegant six-panelled front door surrounded by wood pilasters, entablature and a copper bellcast overhang. A second storey window with wood shutters is located above the door. The projecting central bay is flanked on each side by two bays of first and second storey windows wood sash windows that include concrete sills, brick lintels, and decorative fixed wood shutters. The first storey windows on the south side of the façade appear to be smaller in size with their counterparts on the rest of the façade however, their design and location is consistent with the rest of the first storey windows. Windows have plain concrete sills and soldier course brick lintels. The house has a brick chimney on the north side. Decorative copper letterbox downspouts extend from the eaves of the roofline past the cornice board and down the front of the house. The property also includes a set of winding walkways that lead to the front steps of the house and the south façade. Two mature trees are planted on the west edge of the property and the perimeter of the property is lined with hedges.

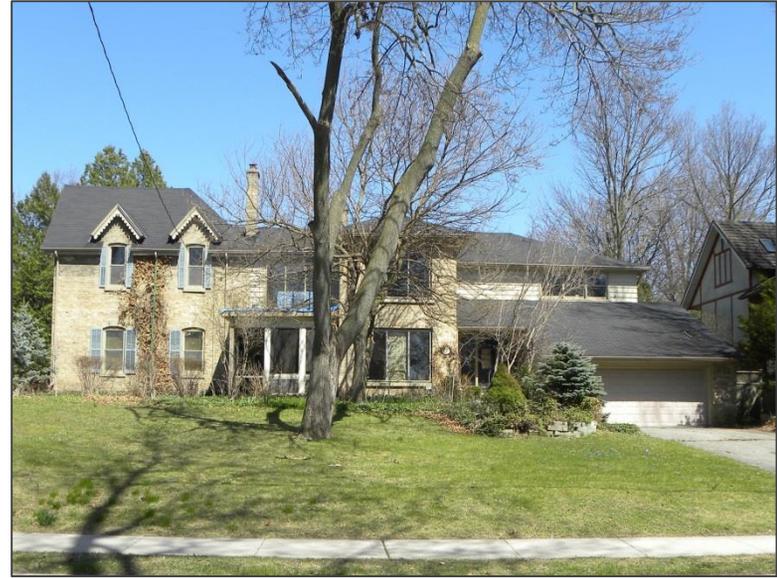
This house is described as a Gothic Revival style. The house has undergone several additions over the years. Fire Insurance Plans and Geodetic Survey maps show a small addition on the south side between 1907 and 1915, another addition on the south west corner between 1926 and 1929. Fire Insurance Plans and aerial photographs shows a large garage and addition to the back, south east corner of the house was added between 1940 and 1965.

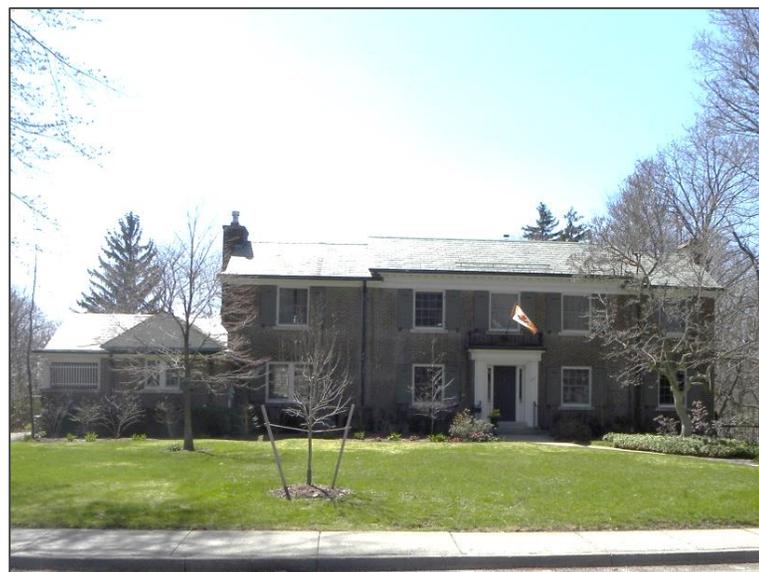
The house at 831 Talbot Street is a two storey Georgian Revival style designed by O. Roy Moore. The front elevation consists of five bays. The three bays in the centre of the house have a higher roof than the bay on each end. The central bay features an elaborate front door that consists of sidelights, fluted pilasters, entablature, and a balustrade that sits above the entryway. The central three bays surround the front door with five wood sash windows and pine shutters. Two additional bays are set back from the main façade and also consist of first and second storey windows. The roofline is highlighted with a cornice that features dentil work. The roof itself is a low-pitched gable roof clad with slate. The house is surrounded by landscaped yards designed by landscape architect Gordon L. Culham. The yard and its gardens were designed to reference the changes in elevation towards the Thames River. A curved walkway follows the edge of the driveway on the north side of the property and leads to the stone steps of the front entryway. A single storey addition is located on the south side of the house.

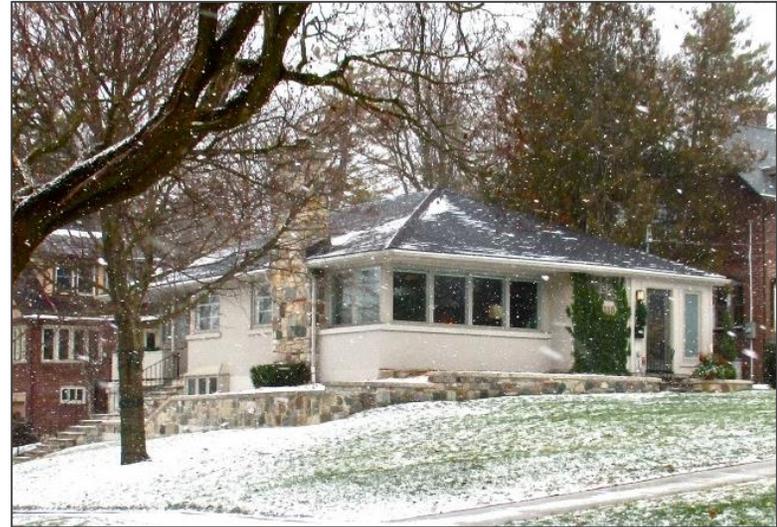
The house at 188 Victoria Street is a Mid-century Modern structure on the northeast corner of Victoria Street and St. George Street and faces Victoria Street. A row of six plate glass windows (two on the west side of the house and four on the south side of the house) wraps around the corner of the house, as does the multi-coloured stone retaining wall that provides a level site for the house on its sloping lot. A broad stone chimney on the west side of the house provides a visual balance for the projecting front door and front entryway window in the southeast corner of the house. Most of the building is faced with white brick. It has a hipped roof, with a long ridge parallel to St. George Street. All windows are of the same height, approximately half the height of the exterior wall, and most are placed directly under the deep eaves. Exceptions are the long window east of the front door and a shallow, small-paned window at the top of the brick wall directly to its west. The two windows south of the back (west) door have sashes.

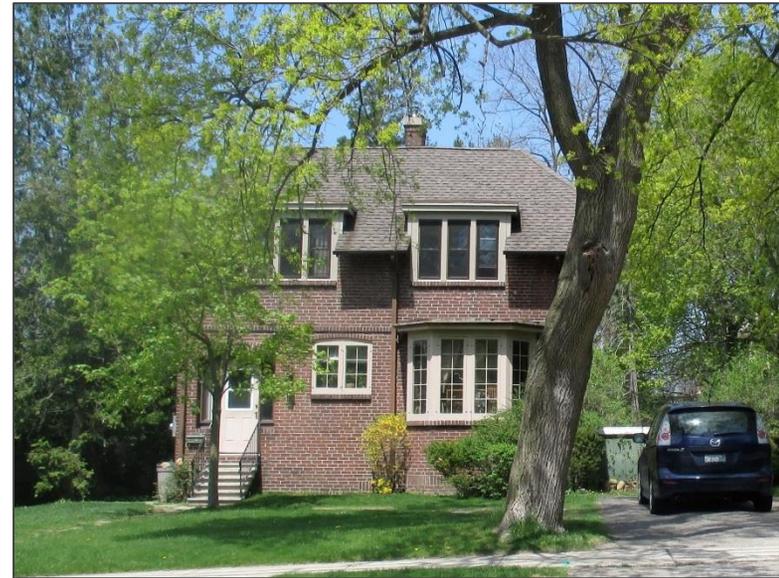
An inventive example of the application of English Arts and Crafts ideas in Canada, the house at 190 Victoria Street effectively balances the symmetry of a Georgian Revival style with a suggestion of older, more random and utilitarian modes of visual organization. Possessing 1 and 1/2 storey's, the house is of a mottled red brick separated by relatively thick applications of mortar, a technique that calls attention to the craftsmanship involved. The hipped gable roof seems to enfold the building, not only because of the broad hipped gable ends but also because of the way in which the roof edges fold around the two three-light dormers of the facade. The flat roofs of the dormers contrast dramatically with the more traditional roofs of the house, and are echoed by the flat roof of the ground-storey bay window, creating strong horizontal lines that are picked up and emphasized by the header course separating the storeys in the west part of the facade. The symmetry of the second floor gives way to the marked asymmetry of the first floor, where a bay window with four exposed sides on the east side creates a very different visual mass than the combined smaller window, recessed front entranceway, and somewhat longer front wall as the ground gradually descends to the west. Both the recessed front porch and the smaller ground-floor window are surmounted by segmental arches, that of the entranceway formed by a double row of brick headers and that of the window by a single row. The front door has now been moved forward so as to enclose the original porch, but an arch identical to that over the front door now covers two sash windows where the porch once opened to the west side of the building. All original window sills are formed by protruding rows of brick headers, and headers top the short walls now flanking the front door. A soldier course marches around the base of the bay window and then drops in steps to mark the bottom course of the west part of the facade, as the ground drops in front of the house. A brick chimney rises in the middle of the roof ridge at the rear of the house. The windows of the bay and the shorter ground-floor window hold small panes, ten in each of the six bay windows and

four in each of lights in the shallow arched window. It is tempting to suspect that the sash windows of the dormers once featured smaller window panes as well.

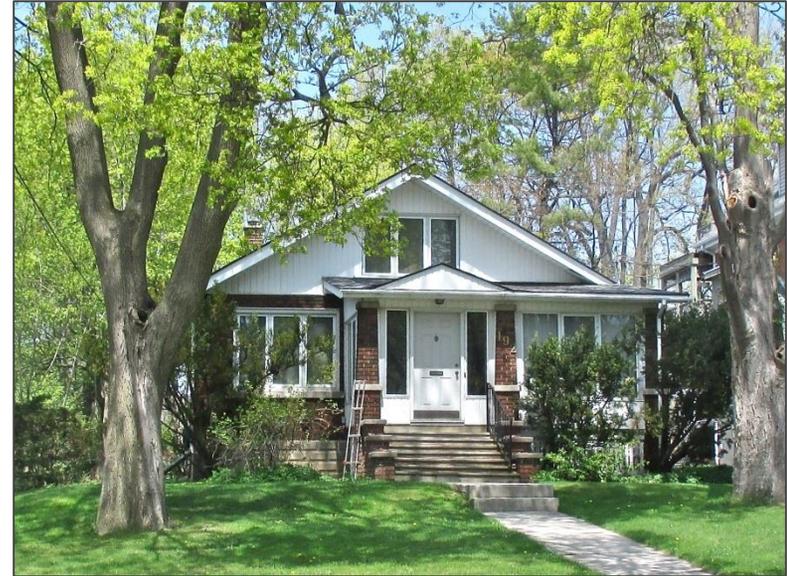
The one and a half storey house at 192 Victoria Street has a gable roof, with the gable facing the street, and a rug brick finish on the ground floor, in the characteristic red-to-black range of colours. It sits on a chamfered concrete block foundation. What were originally the tapered rug brick posts of a porch under a shallow shed roof now form the corners of a room formed by closing in the porch, and the front door has been moved forward under a modest shed roof with gable over the door. The gable is now covered with a modern vertical siding. Three-light windows in the gable and within the west half of the facade appear to occupy their original positions; those set within the brick cladding have a concrete sill. The house has eight concrete steps leading up to the front door.

Although the ground slopes downward towards the west, the house is built on fill. Like all houses along the west side of Victoria Street, this one is set back from the street, behind a broad boulevard and a sizeable front yard; this house has a wide west side yard as well. This house is approximately 4 metres from the front property line and 20 metres from the edge of the street. A driveway on the east side of the house leads to a two-car garage in the back that is shared with the adjacent house. The garage is faced with the same brick as the house. The garage has a front gable roof.

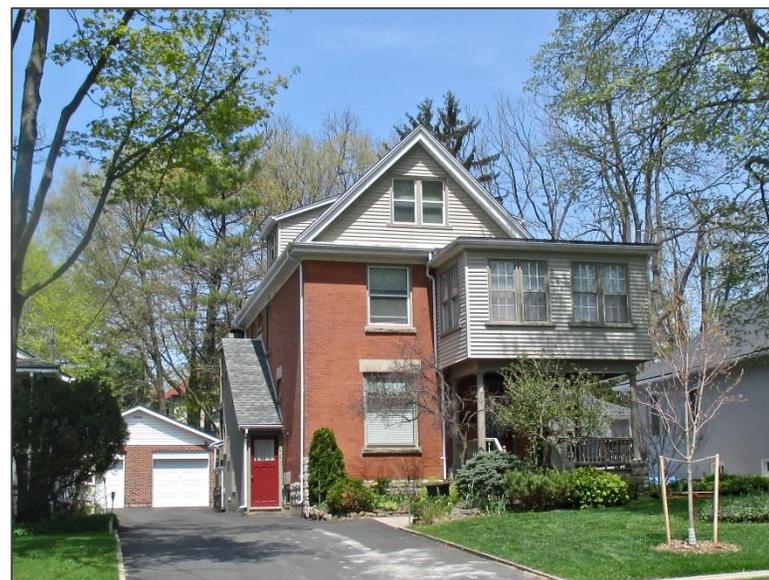
This 2 and a half storey brick house retains several attributes of an Edwardian Classical building. The pressed red brick facing is typical, as is the red mortar used to enhance the impression of a smooth, solid wall. The rusticated foundation, which appears to be of stone, is also typical, as is the steeply sloped, front-facing gable and L-shaped footprint of the facade. Here, the rusticated blocks of the foundation climb up the southwest corner of the house, and are echoed in the rusticated window sills throughout and in the bases of the Doric columns that support a deep fascia board and a porch roof that is now covered with a sun room on the east side of the upper facade. The porch and the room(s) now above it reach to a broad hexagonal bay window on the east side of the house; a brick chimney rises along the east side of the bay and up through the gable in which it terminates. A side door sits in the front angle of the bay. The original windows are 1/1 sash windows or, on the ground floor, a plate glass window with a transom. Both the

front transom and a small vertical window on the east side of the house display a distinctive tulip design in the stained glass. The frames of upper floor windows reach to the cornice; other window openings boast smooth stone lintels. The front door, is wood, with a large glass insert and a transom above. The gable is now covered with a modern siding, as is the sunroom with its 6/6 sash windows. Among the other changes made to accommodate the two upper apartments are the enclosed stairway along the west side of the building and at least two shed-roofed dormers.

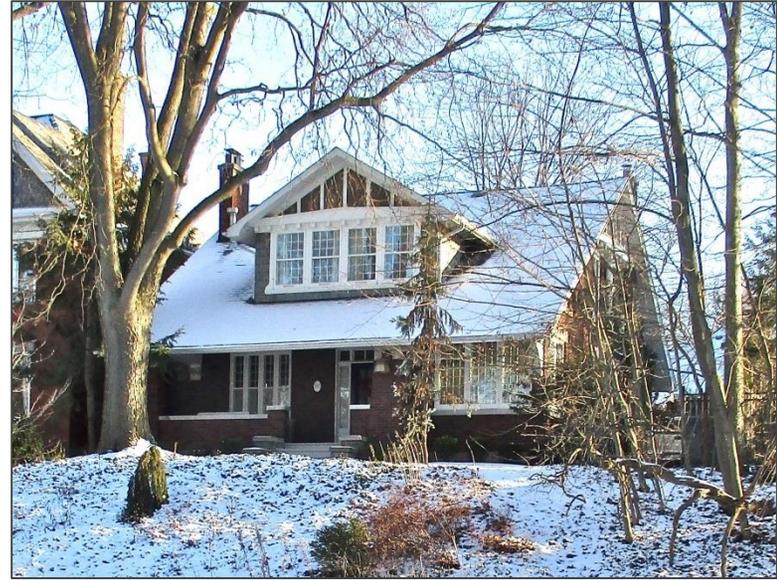
This house is an unusually spacious 1 and a half storey Bungalow-style dwelling, with particularly fine detailing. In keeping with the definitive character of the style, a deep gable roof slopes from a ridge parallel with the front of the house over a front porch, with a wide dormer in front and a very deep gable at the side providing a substantial upper storey. The treatment here is unusual in that the porch extends along only part of the facade: the wall of the western section of the facade protrudes beyond the plane of the front wall behind the porch, but not as far as the porch itself, leaving the roof with a very wide overhang at the western end of the facade, supported by a plain, solid, oversized bracket with an arc along the outside edge. The soffits under the eaves of the house and the gable roof of the dormer are covered with narrow tongue-and-groove boards, as is the ceiling of the porch. Windows on the facade are clustered in rows: four 12/12 sash windows in the dormer; four narrow 8/8 sashes behind the porch; three 12/16 sashes to its west. With the exception of those in the dormer, windows have stone sills and are otherwise surrounded by a narrow wood frame. Small window panes comprise the sidelights and transom of the front door, and the door itself holds small panes separated by substantial rails and muntins and surrounded by a wood frame. The house is clad in rug brick with hues ranging from red to black. The dormer is faced with slate tiles, while the rest of the roof is now asphalt, and its gable, like that of the upper side gables is half timbered with straight wood slats filled in with pebble dash. The slightly protruding lintel of the dormer windows, cut in a shallow pediment shape, is supported by thick wood dentils; ears at the bottom of the side surrounds balance the heavy lintel. The porch has a low brick wall surmounted by stone copings; its thick posts, also of rug brick, are tapered along their outer sides and terminate in a stone course just below the soffit, with decorative stone inserts bordering the upper courses of brick. Craftsman-style light fixtures extend from the roof of the porch and the column adjacent to the front

steps. The house has a rusticated stone foundation, which extends to form low borders beside the front steps. The brick chimney that rises along the east wall terminates in a stone coping, below which are rectangular stone insets similar to those in the porch posts, as well as diamond-shaped stone inserts below.

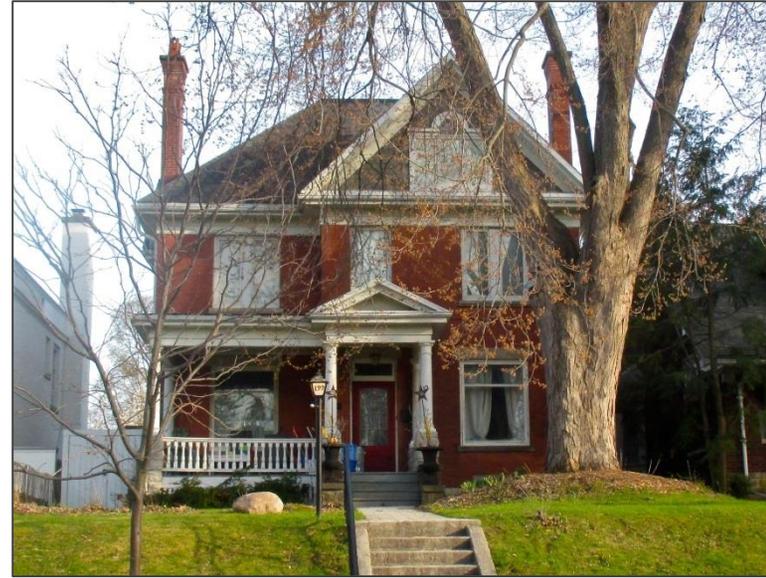
This house is a good example of Edwardian Classicism as it evolved in London. It possesses a number of classical elements: the Palladian window in the gable, the Doric columns, balustrade and pediment of the porch, and the near symmetry of the facade, broken only by the slightly protruding gable wing; the west gable also sits above a slightly protruding wing below. The gables are clad with scalloped slate tiles that reflect those of the hipped roof, the latter terminating in a flat deck at the top. The house is faced with pressed red brick laid with a red mortar; a protruding brick course marks the level of the second-storey floor. The front door has a wood frame, panelled in its lower section with a long, bevelled glass insert above and a leaded transom. The main floor windows feature a large plate glass in the bottom sections with narrower leaded glass transoms. All lower floor windows feature rusticated stone sills and deeper rusticated stone lintels, the latter also a feature of the basement windows; upper storey windows also have rusticated stone sills, but they push directly against the broad cornice of the house. The house has a rusticated foundation of either stone or concrete blocks. Tall, corbelled, brick chimneys rise along both sides of the house; a third chimney rises along the rear wall.

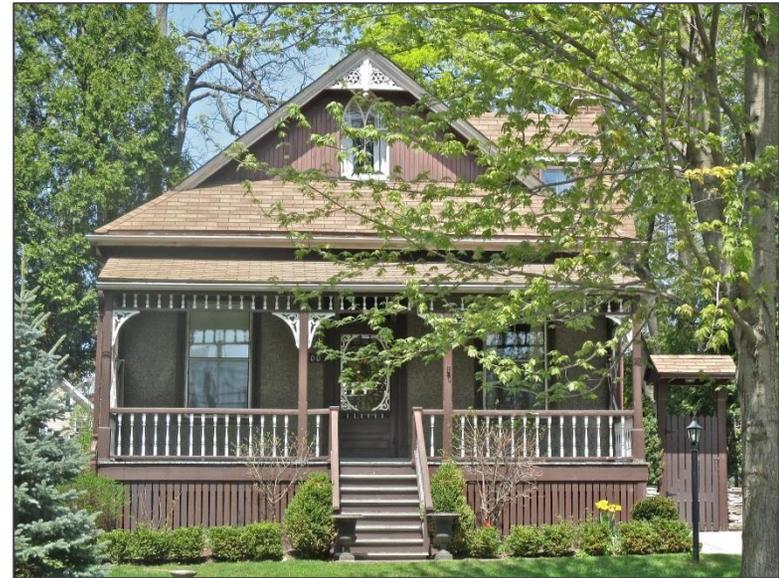
This house displays elements of the Ontario Cottage style with a rectangular footprint; the symmetrical, three-bay facade that it still retains with a centre door and a 1/1 sash window to each side; and a moderately pitched hipped roof. A very broad dormer now rises across the front of the roof and two smaller dormers on the east side. They adopt a Gothic Revival influence, with a pointed window in the front gable and what appears to be a historic pierced bargeboard. This blends with the spindle-work across the front of the verandah and the pierced wood work of the spandrels. The verandah has a shed roof, its posts have chamfered edges, the balustrades comprise unusually tall versions of the traditional classical turned shape, and shaped porch skirting. The house itself is now covered by pebble dash and very simple half-timbering.

A driveway runs along the east side of the house. Like all houses along the west side of Victoria Street, this one is set back from the street, behind an unusually broad boulevard and a sizeable front yard. It is approximately 4 metres from the front property line and just over 20 metres from the edge of the street. A row of mature maple trees, planted on the house side of the sidewalk, marks the south end of the front gardens as the road rises towards Richmond Street.

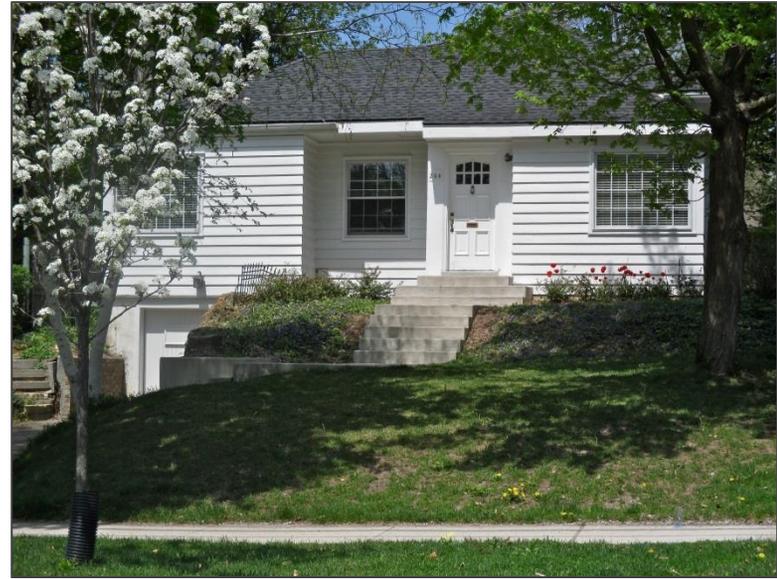
This one-storey house, faced with clapboard siding, has a hipped roof that reaches a relatively high point over the eastern part of the house and then extends along a lower ridge towards the west. The roof juts forward over a projection containing the front door and a 24 pane window against the east end of the building. A recessed bay, adjacent to the entry door has an 8/8 sash window. The form projects again with a second 24-pane window at the far west end of the building. In the upper section of the front door is an 8-pane window shaped into a segmental curve along the top; fielded panels fill the rest of the door.

A driveway leads to a street-level garage beneath the west end of the house. East of the garage, the ground rises quite steeply from the sidewalk to the front door. The front garden is landscaped to accommodate concrete steps leading from the drive to the house. Like all houses along the west side of Victoria and the east side of St. George Streets, this one is set back from the street, behind an unusually broad boulevards and a sizeable front garden. This house is approximately 4.75 metres from the front property line and 21 metres from the edge of the street.

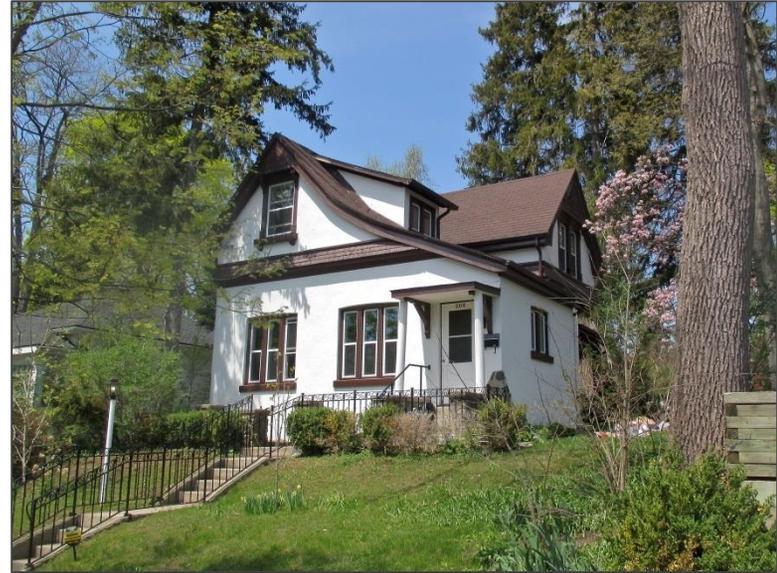
The current building has a picturesque quality in the broad sweep of its front gable, the various sizes and shapes of the roof dormers, and the clustered windows along the front facade. The house is now clad in stucco. One can detect outlines of former buildings in the proportions and roof shapes of this house, however, and the building reveals its eclectic History in various details, in the Queen Anne Revival ornamentation in the apex of the east gable and the Queen Anne Revival window surrounds in the front gable, for example, or the combination of columns and Craftsman-style struts supporting the front porch. Such qualities as the clustered windows on the front facade, the stucco finish, and the oriel window and prominent stone chimney on the west side of the house are in keeping with the styles of around 1920, which likely represents the period when the building assumed the form it has now.

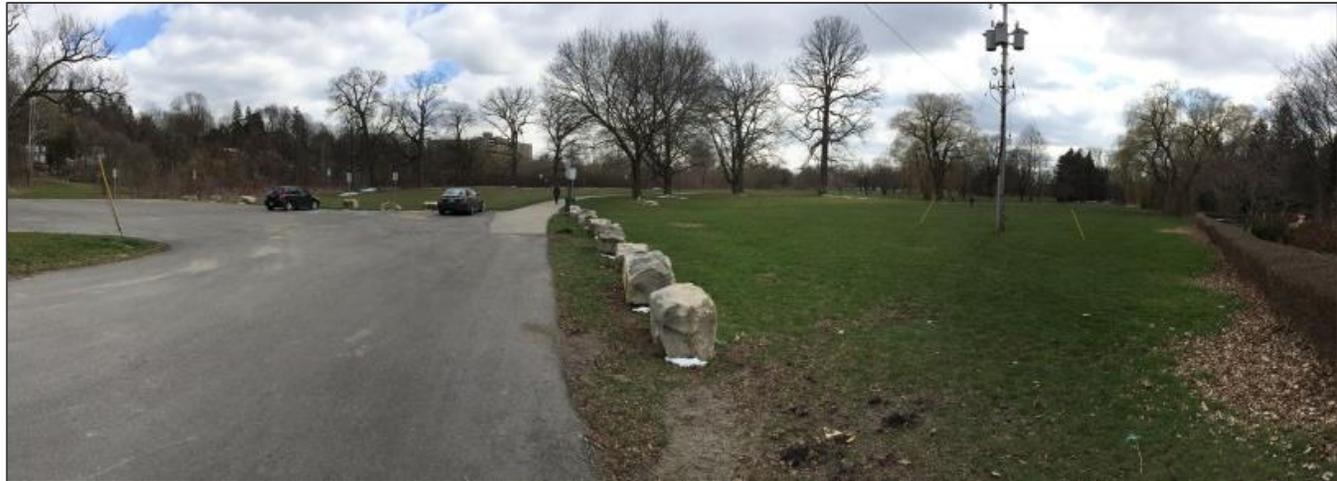
As indicated on Figure 6.2 of this study and defined in the Glossary in Volume 1 this is a Panoramic View A: wide unobstructed view.

Viewscape Ranking: Contributing (for definition of this term refer to the Glossary in Volume 1).

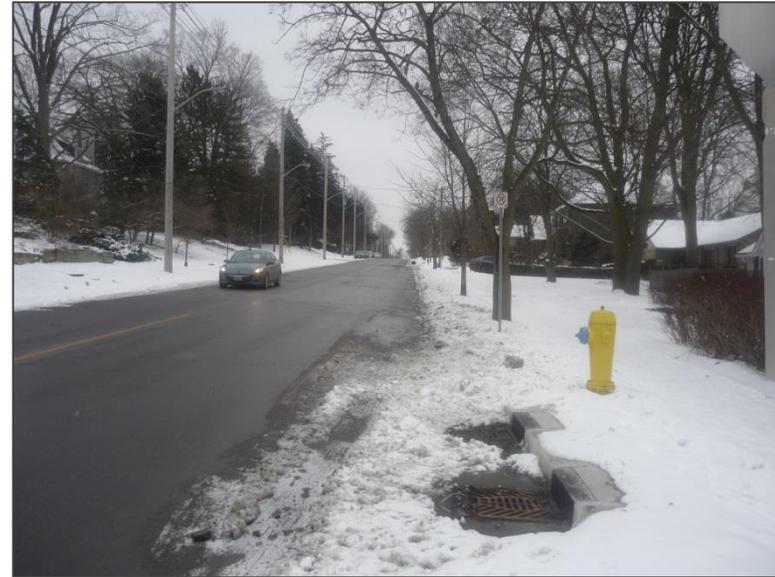
As indicated on Figure 6.2 of this study and defined in the Glossary in Volume 1, this is a continuing corridor filtered by ridge on road

Viewscope Ranking: Contributing (for definition of this term refer to the Glossary in Volume 1).

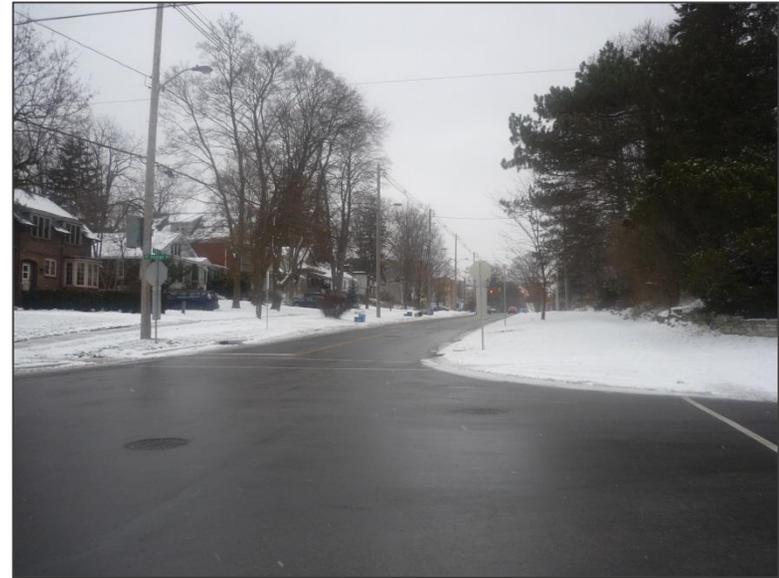
As indicated on Figure 6.2 of this study and defined in the Glossary in Volume 1 this is a filtered corridor (due to hills and drops in topography)

Viewscope Ranking: Contributing (for definition of this term refer to the Glossary in Volume 1).

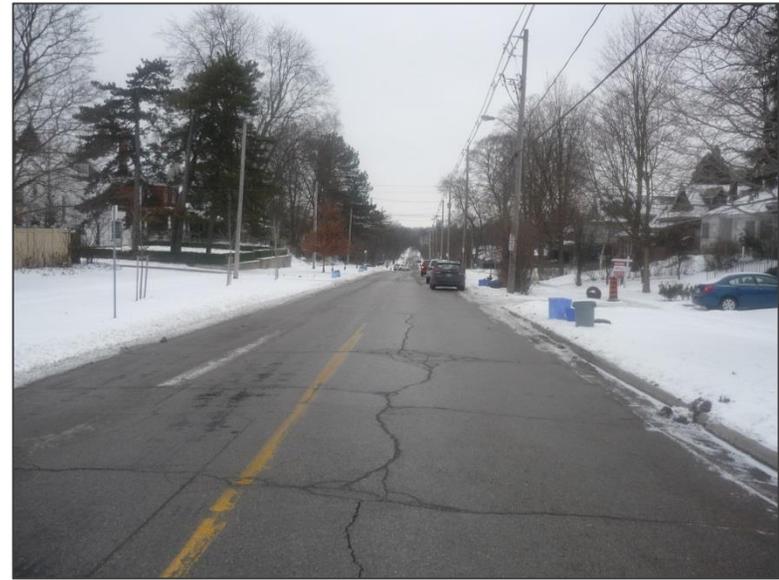
As indicated on Figure 6.2 of the St. George-Grosvenor HCD Study and defined in the Glossary in Volume 1 this is a continuing corridor.

Viewscope Ranking: Contributing (for definition of this term refer to the Glossary in Volume 1).

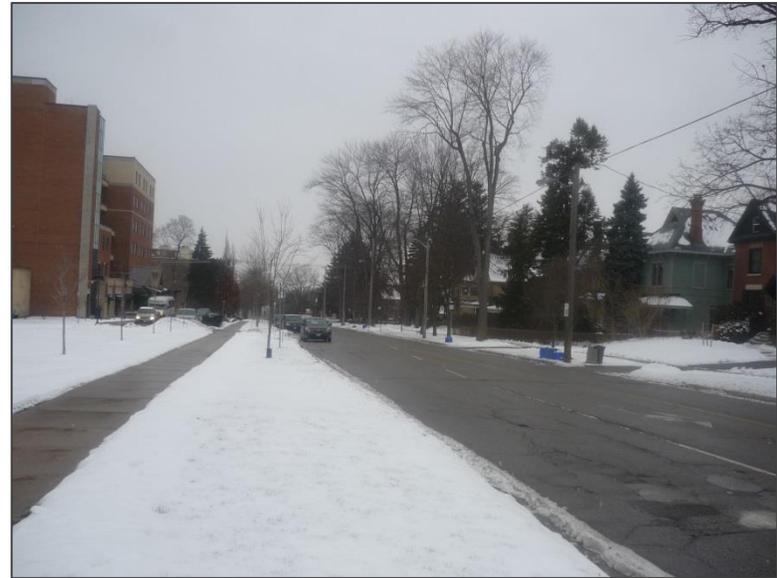
As indicated on Figure 6.2 of this study and defined in the Glossary in Volume 1 this is a continuing corridor (view continues to Gibbons Park)

Viewscope Ranking: Significant, for the view on the north side of Grosvenor Street (for definition of this term refer to the Glossary in Volume 1).
