St George-Grosvenor Heritage Conservation District Study

Volume IV Appendix F, [2016]

APPENDIX F: INVENTORY OF CULTURAL HERITAGE RESOURCES

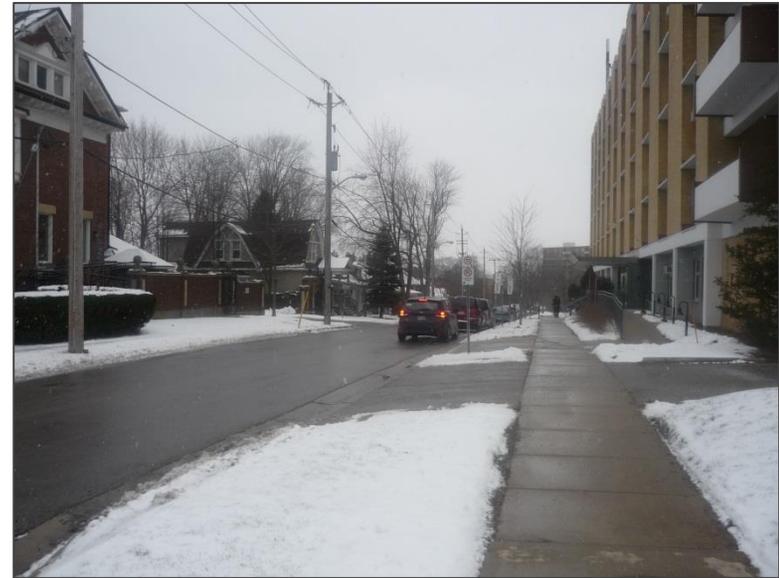
As indicated on Figure 6.2 of this study and defined in the Glossary in Volume 1 this is a Terminating corridor

Viewscope Ranking: Non-Contributing (for definition of this term refer to the Glossary in Volume 1).

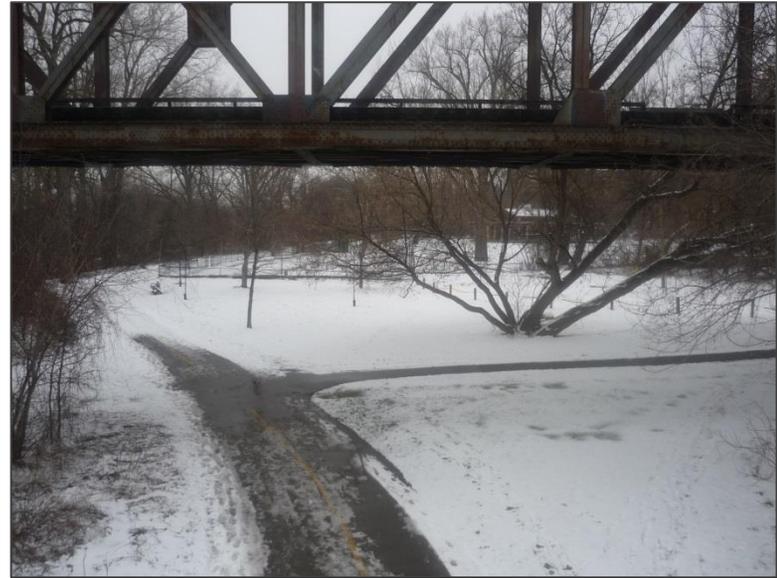
As indicated on Figure 6.2 of this study and defined in the Glossary in Volume 1 this is a panoramic view: filtered wide view, influenced by vegetation/seasonality

Viewscope Ranking: Contributing (for definition of this term refer to the Glossary in Volume 1).

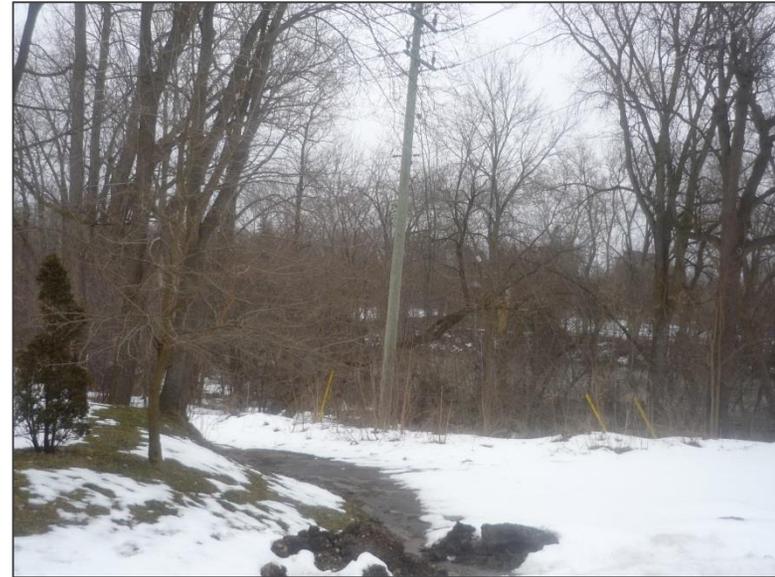
As indicated on Figure 6.2 of this study and defined in the Glossary in Volume 1 this is a panoramic view b: heavily filtered wide view influences by vegetation/seasonality

Viewscape Ranking: Non-Contributing (for definition of this term refer to the Glossary in Volume 1).

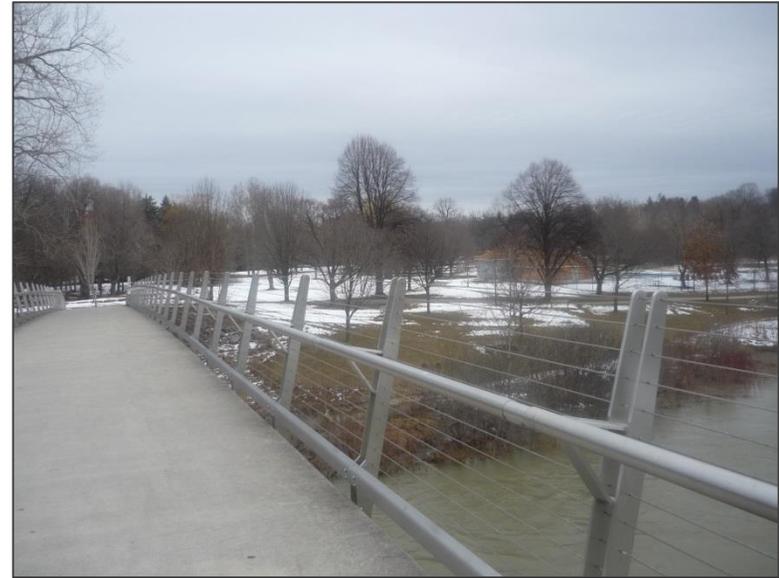
As indicated on Figure 6.2 of this study and defined in the Glossary in Volume 1 this is a panoramic view a: wide, unobstructed view

Viewscape Ranking: Contributing (for definition of this term refer to the Glossary in Volume 1).

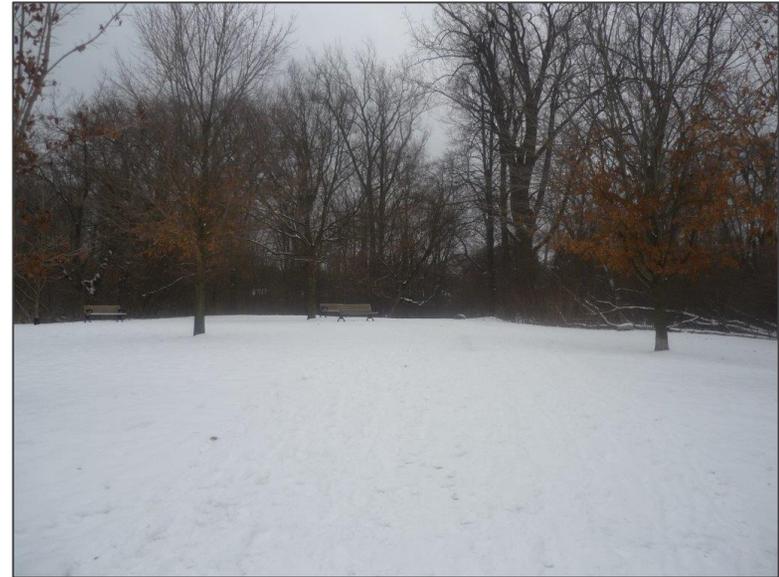
As indicated on Figure 6.2 of this study and defined in the Glossary in Volume 1 this is a terminating view (terminates at river curve)

Viewscope Ranking: Non-contributing (for definition of this term refer to the Glossary in Volume 1).
